170 Bleeker Street

170 Bleeker Street: Existing Conditions

170 Bleeker Street Historic Conditions

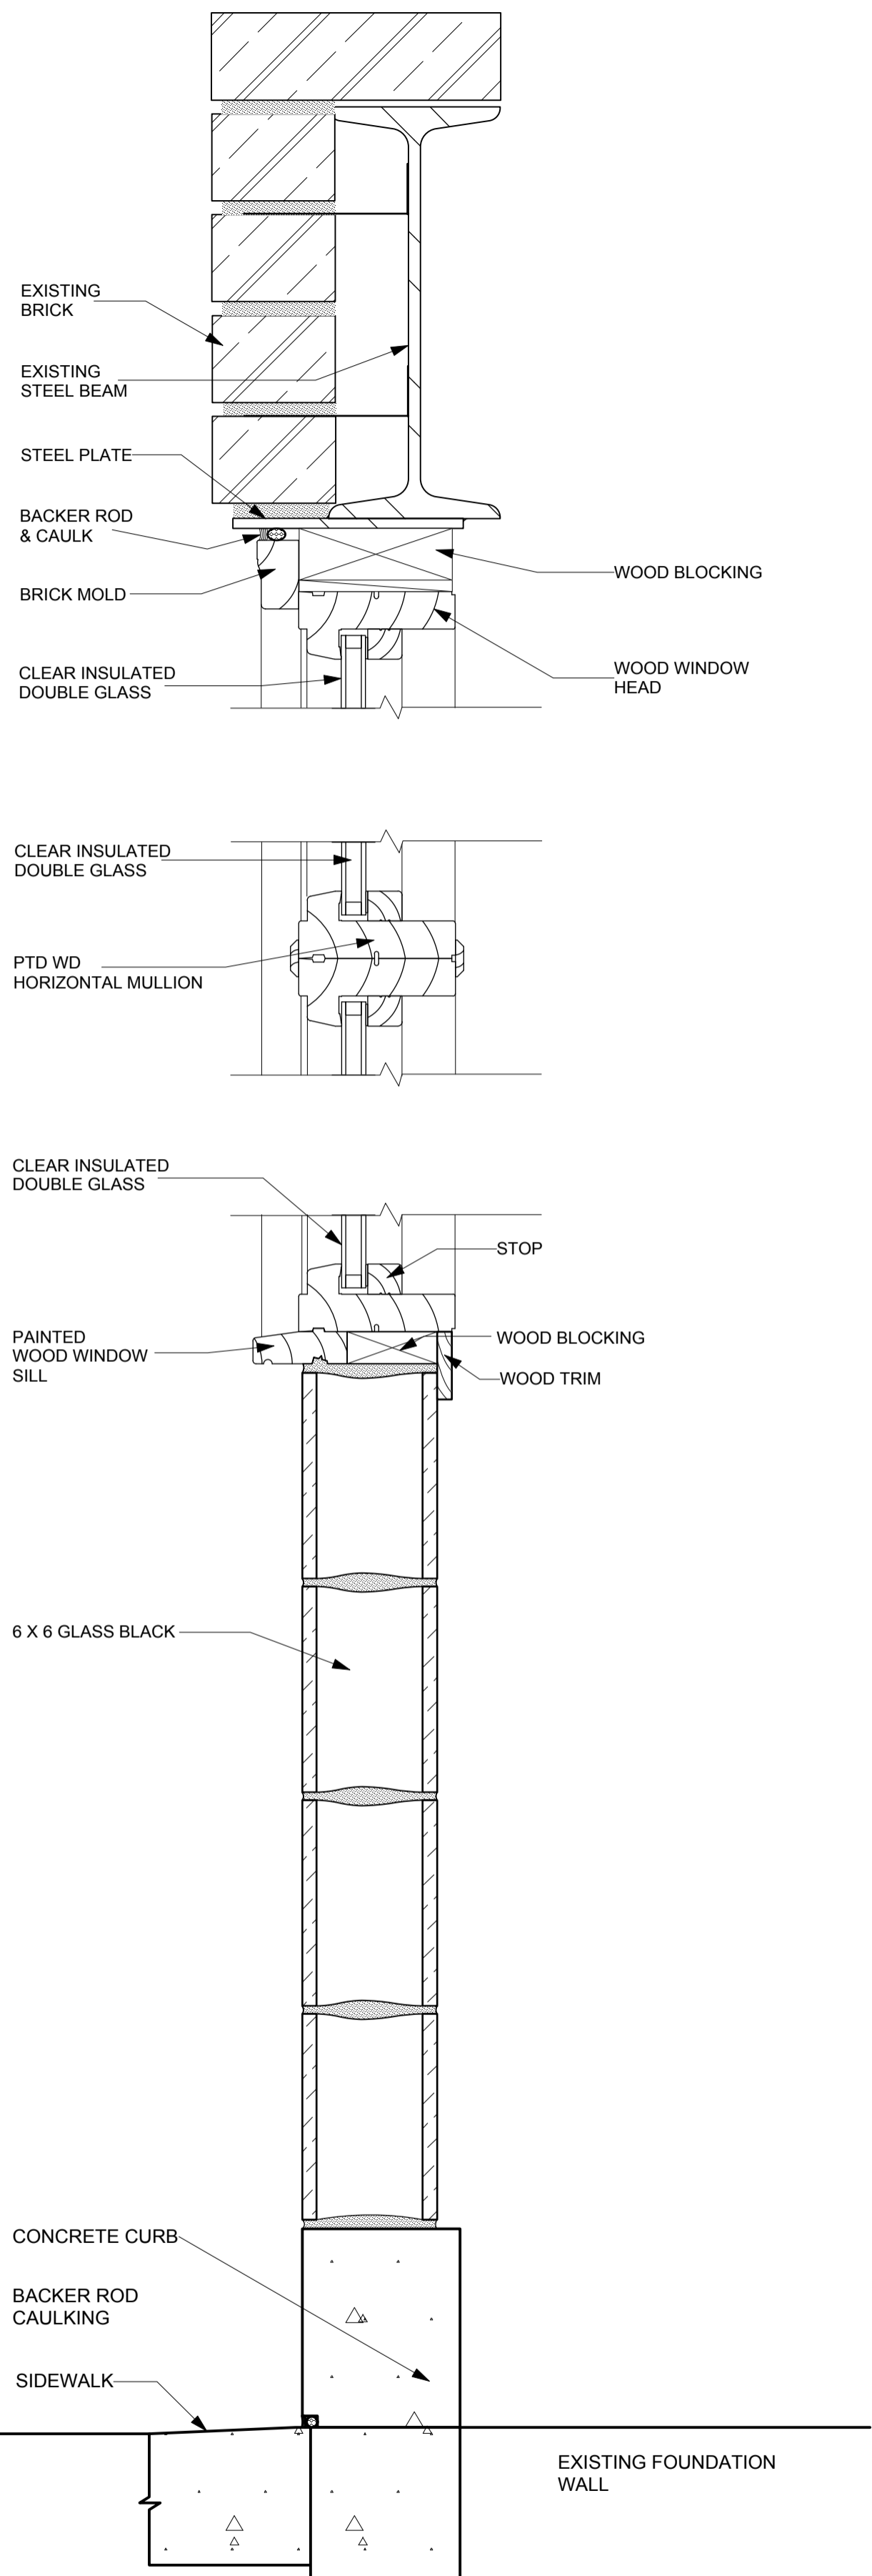
9 Sullivan Street Typical Window Wall Section
Scale: 3" = 1'-0"

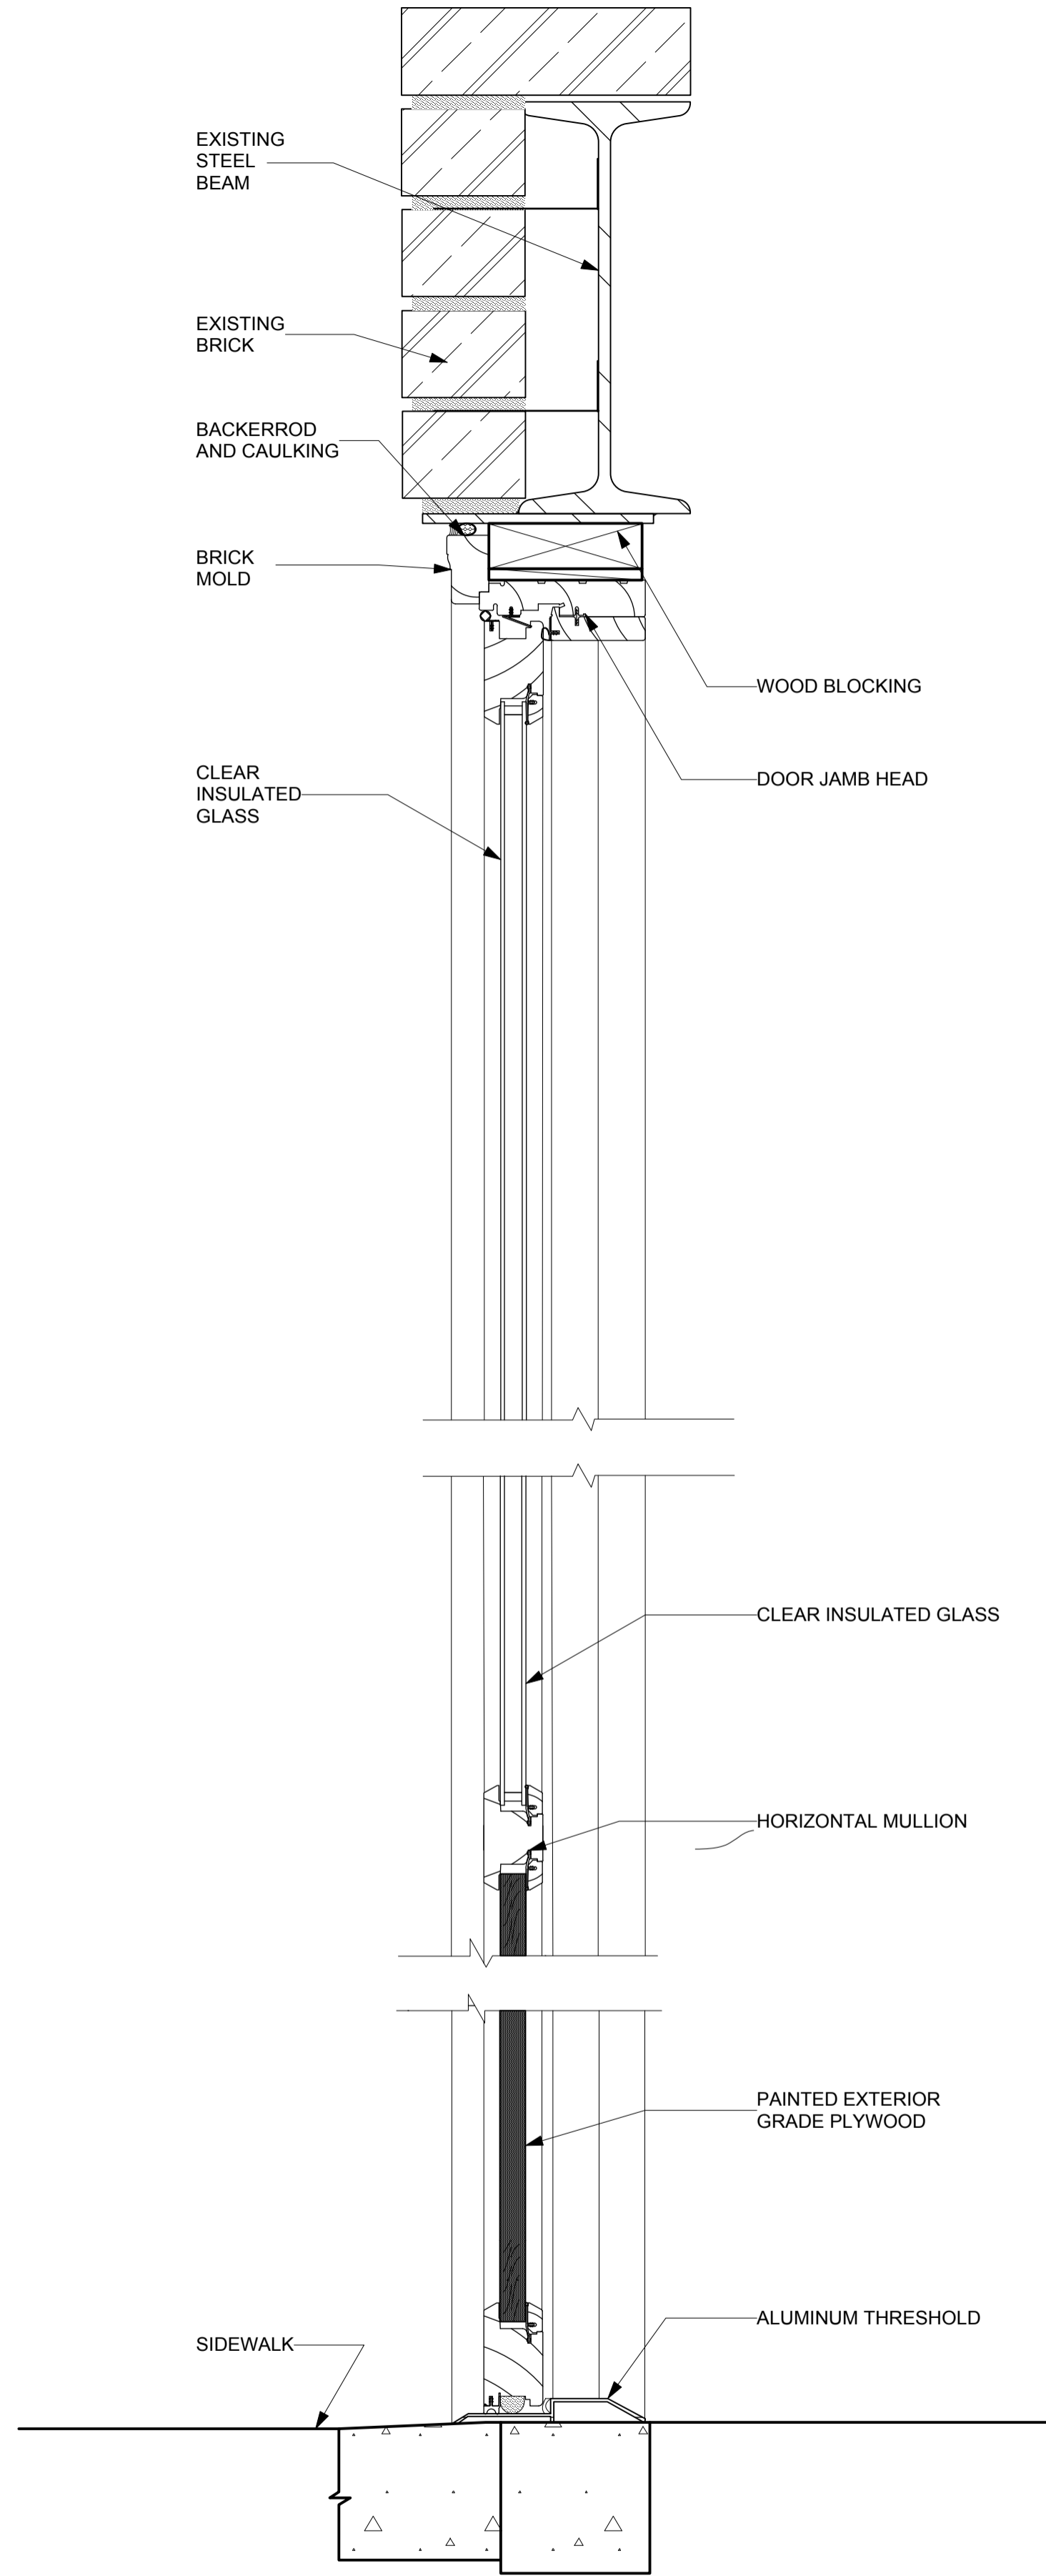
10 Sullivan Street Door Wall Section
Scale: 3" = 1'-0"

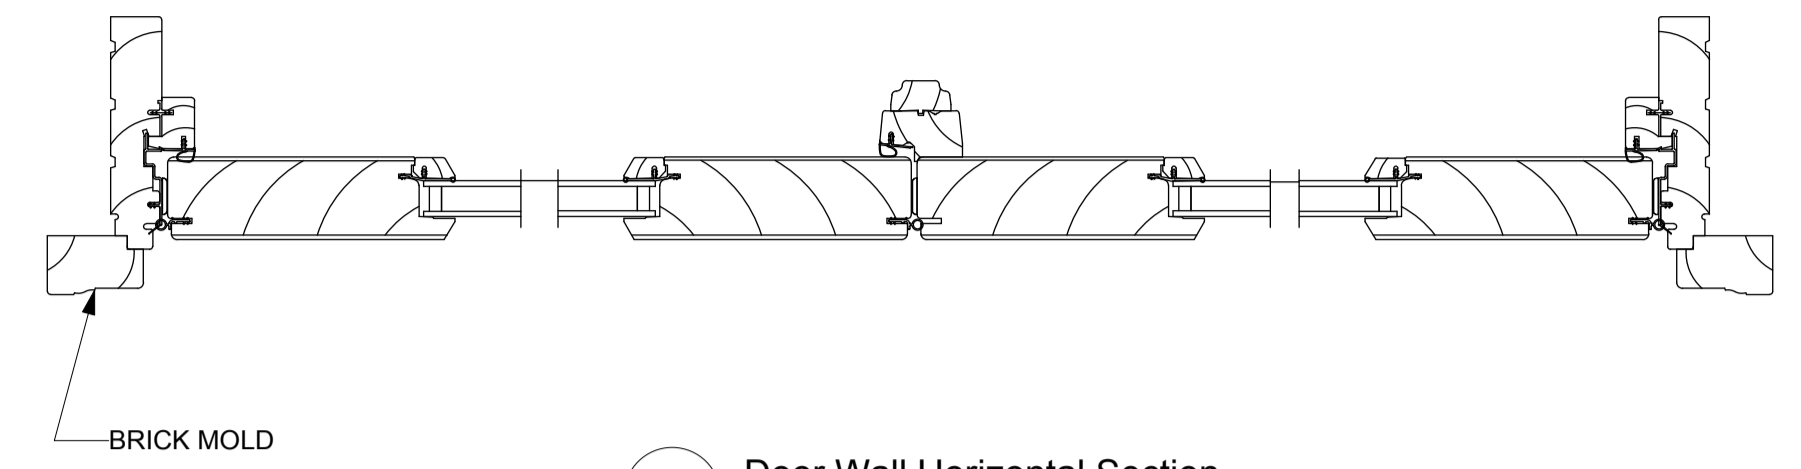
11 Door Wall Horizontal Section
Scale: 3" = 1'-0"

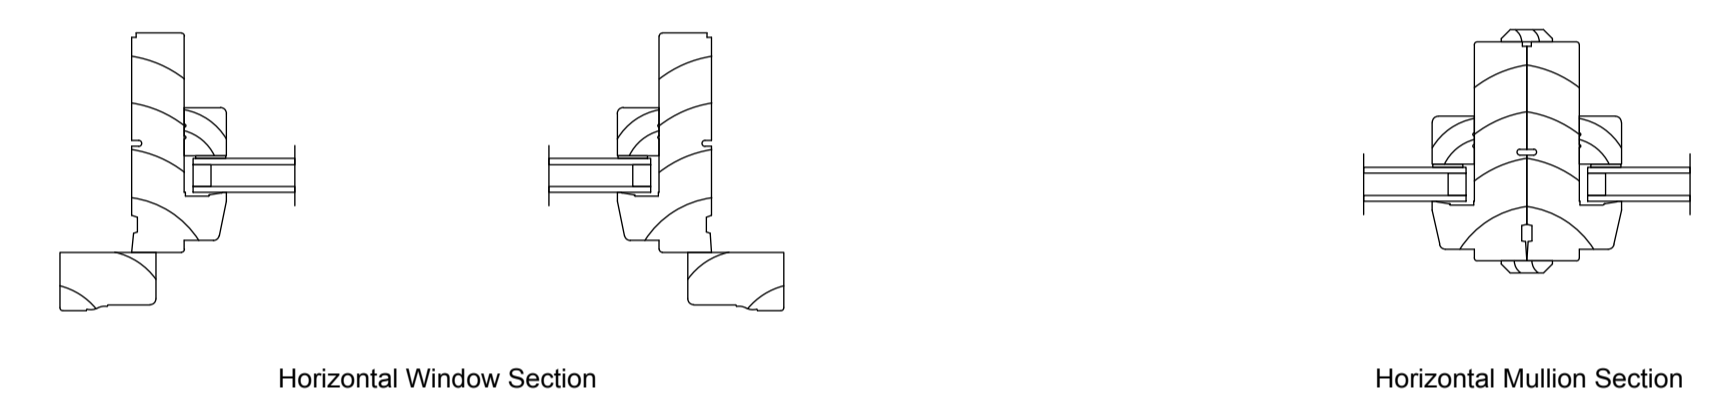
1 Horizontal Window and Mullion Section
Scale: 3" = 1'-0"

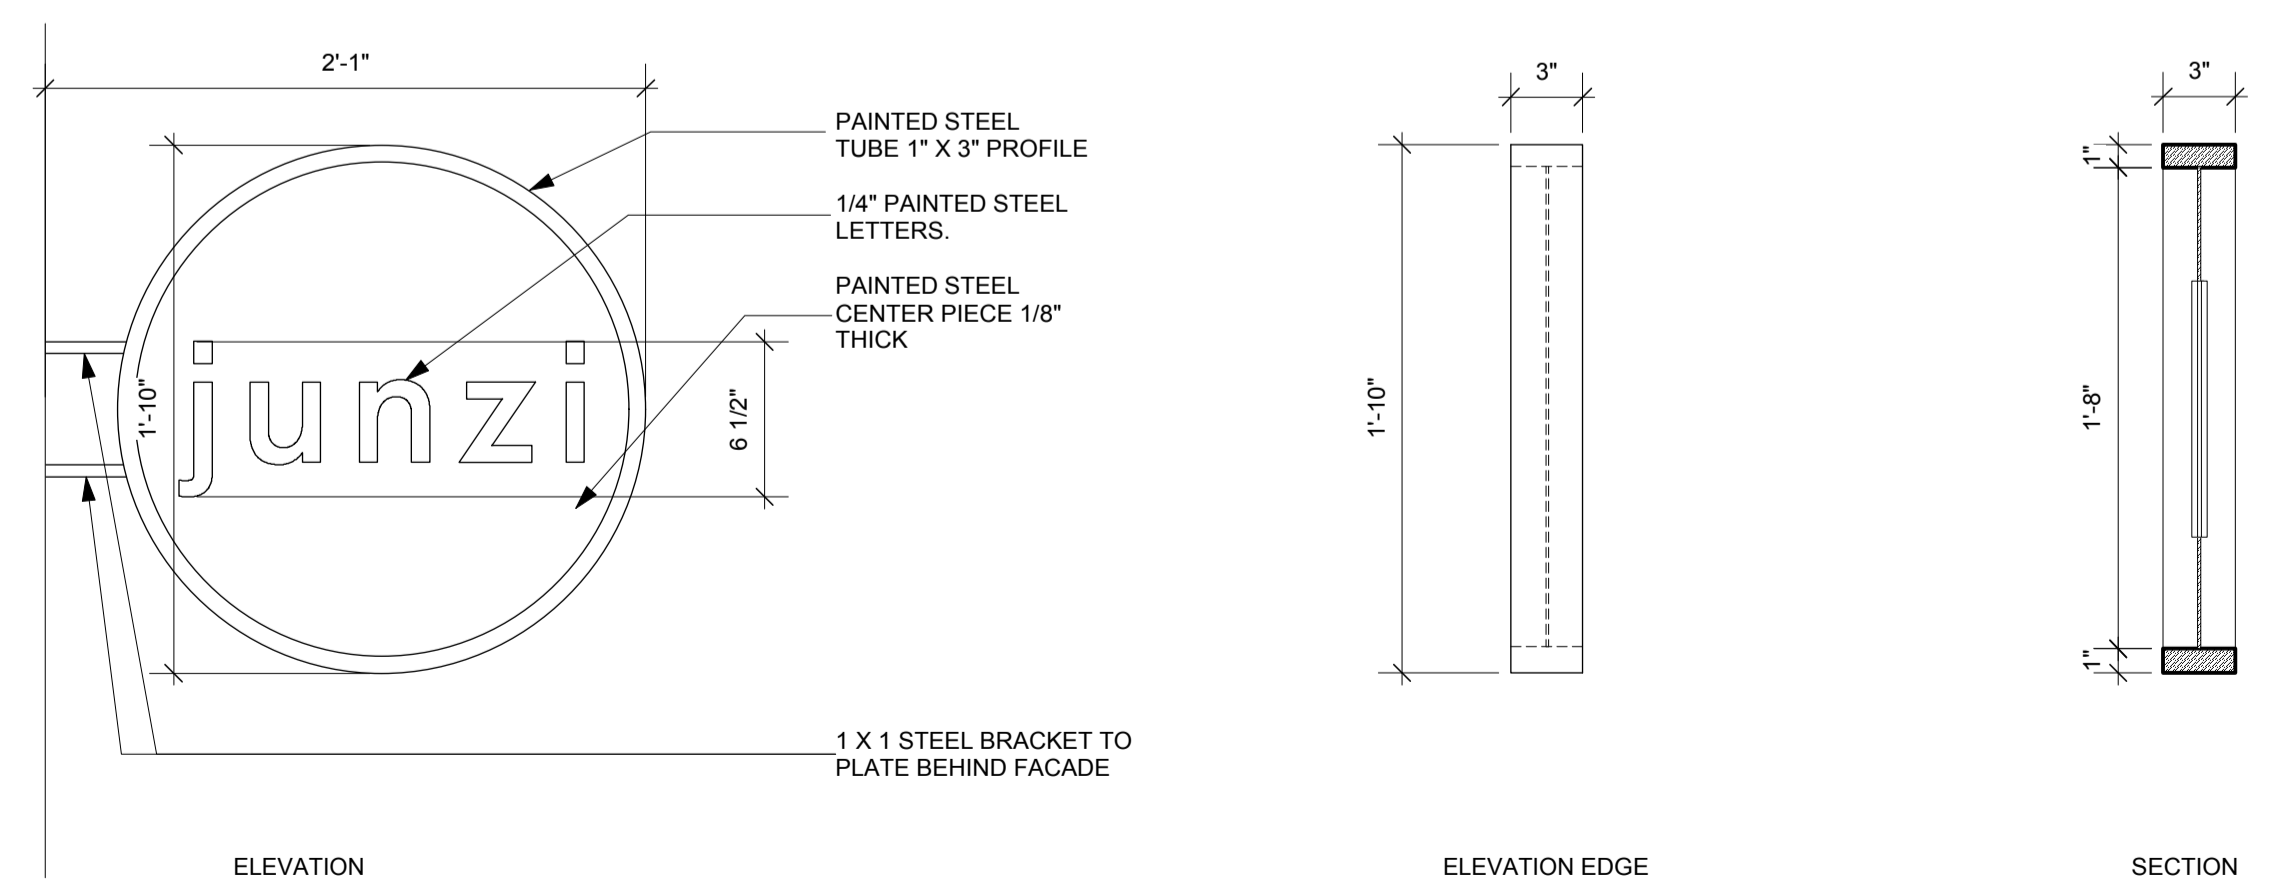
14 BLADE SIGN DETAIL
Scale: 1 1/2" = 1'-0"
