75 Varick Street | Horizon Media

March 16, 2017

Community Board 2 Landmarks Presentation

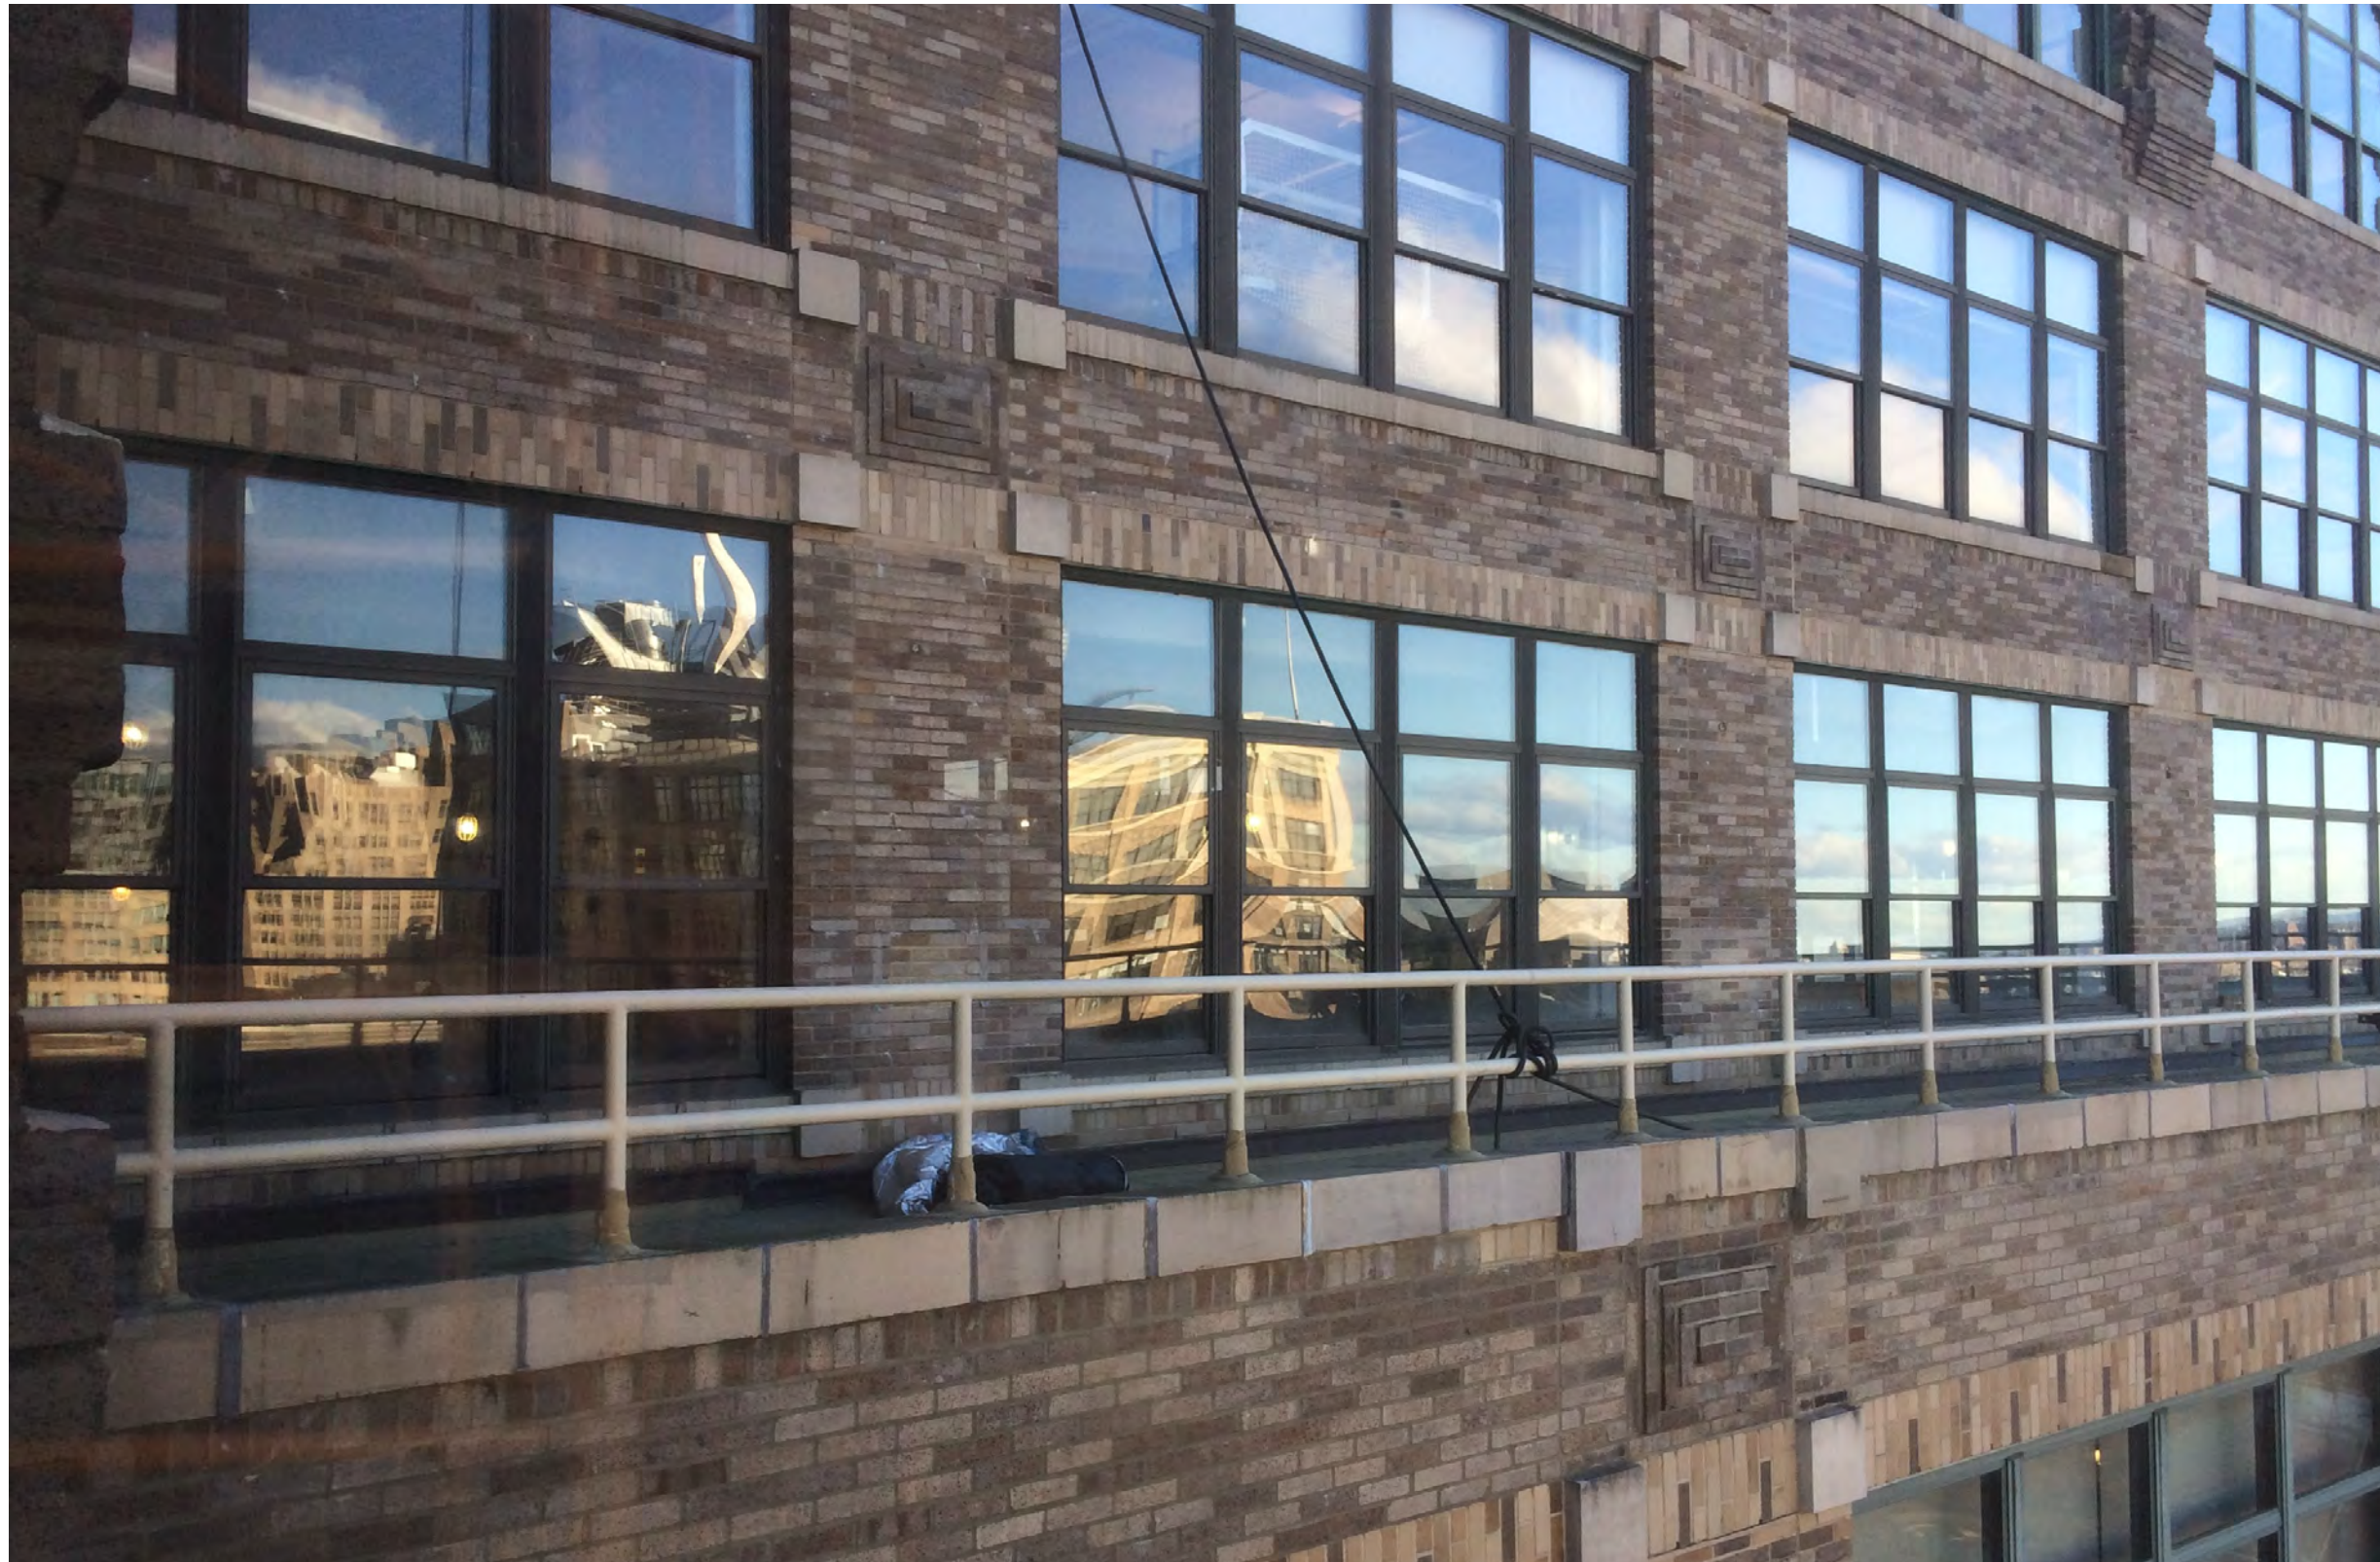
Existing Site

Photo shows the three existing window bays that will be removed for new accordion style glass doors that will align with the vertical and horizontal mullions of the existing windows

The color and finish of the new glass doors will match the existing windows on the same floor

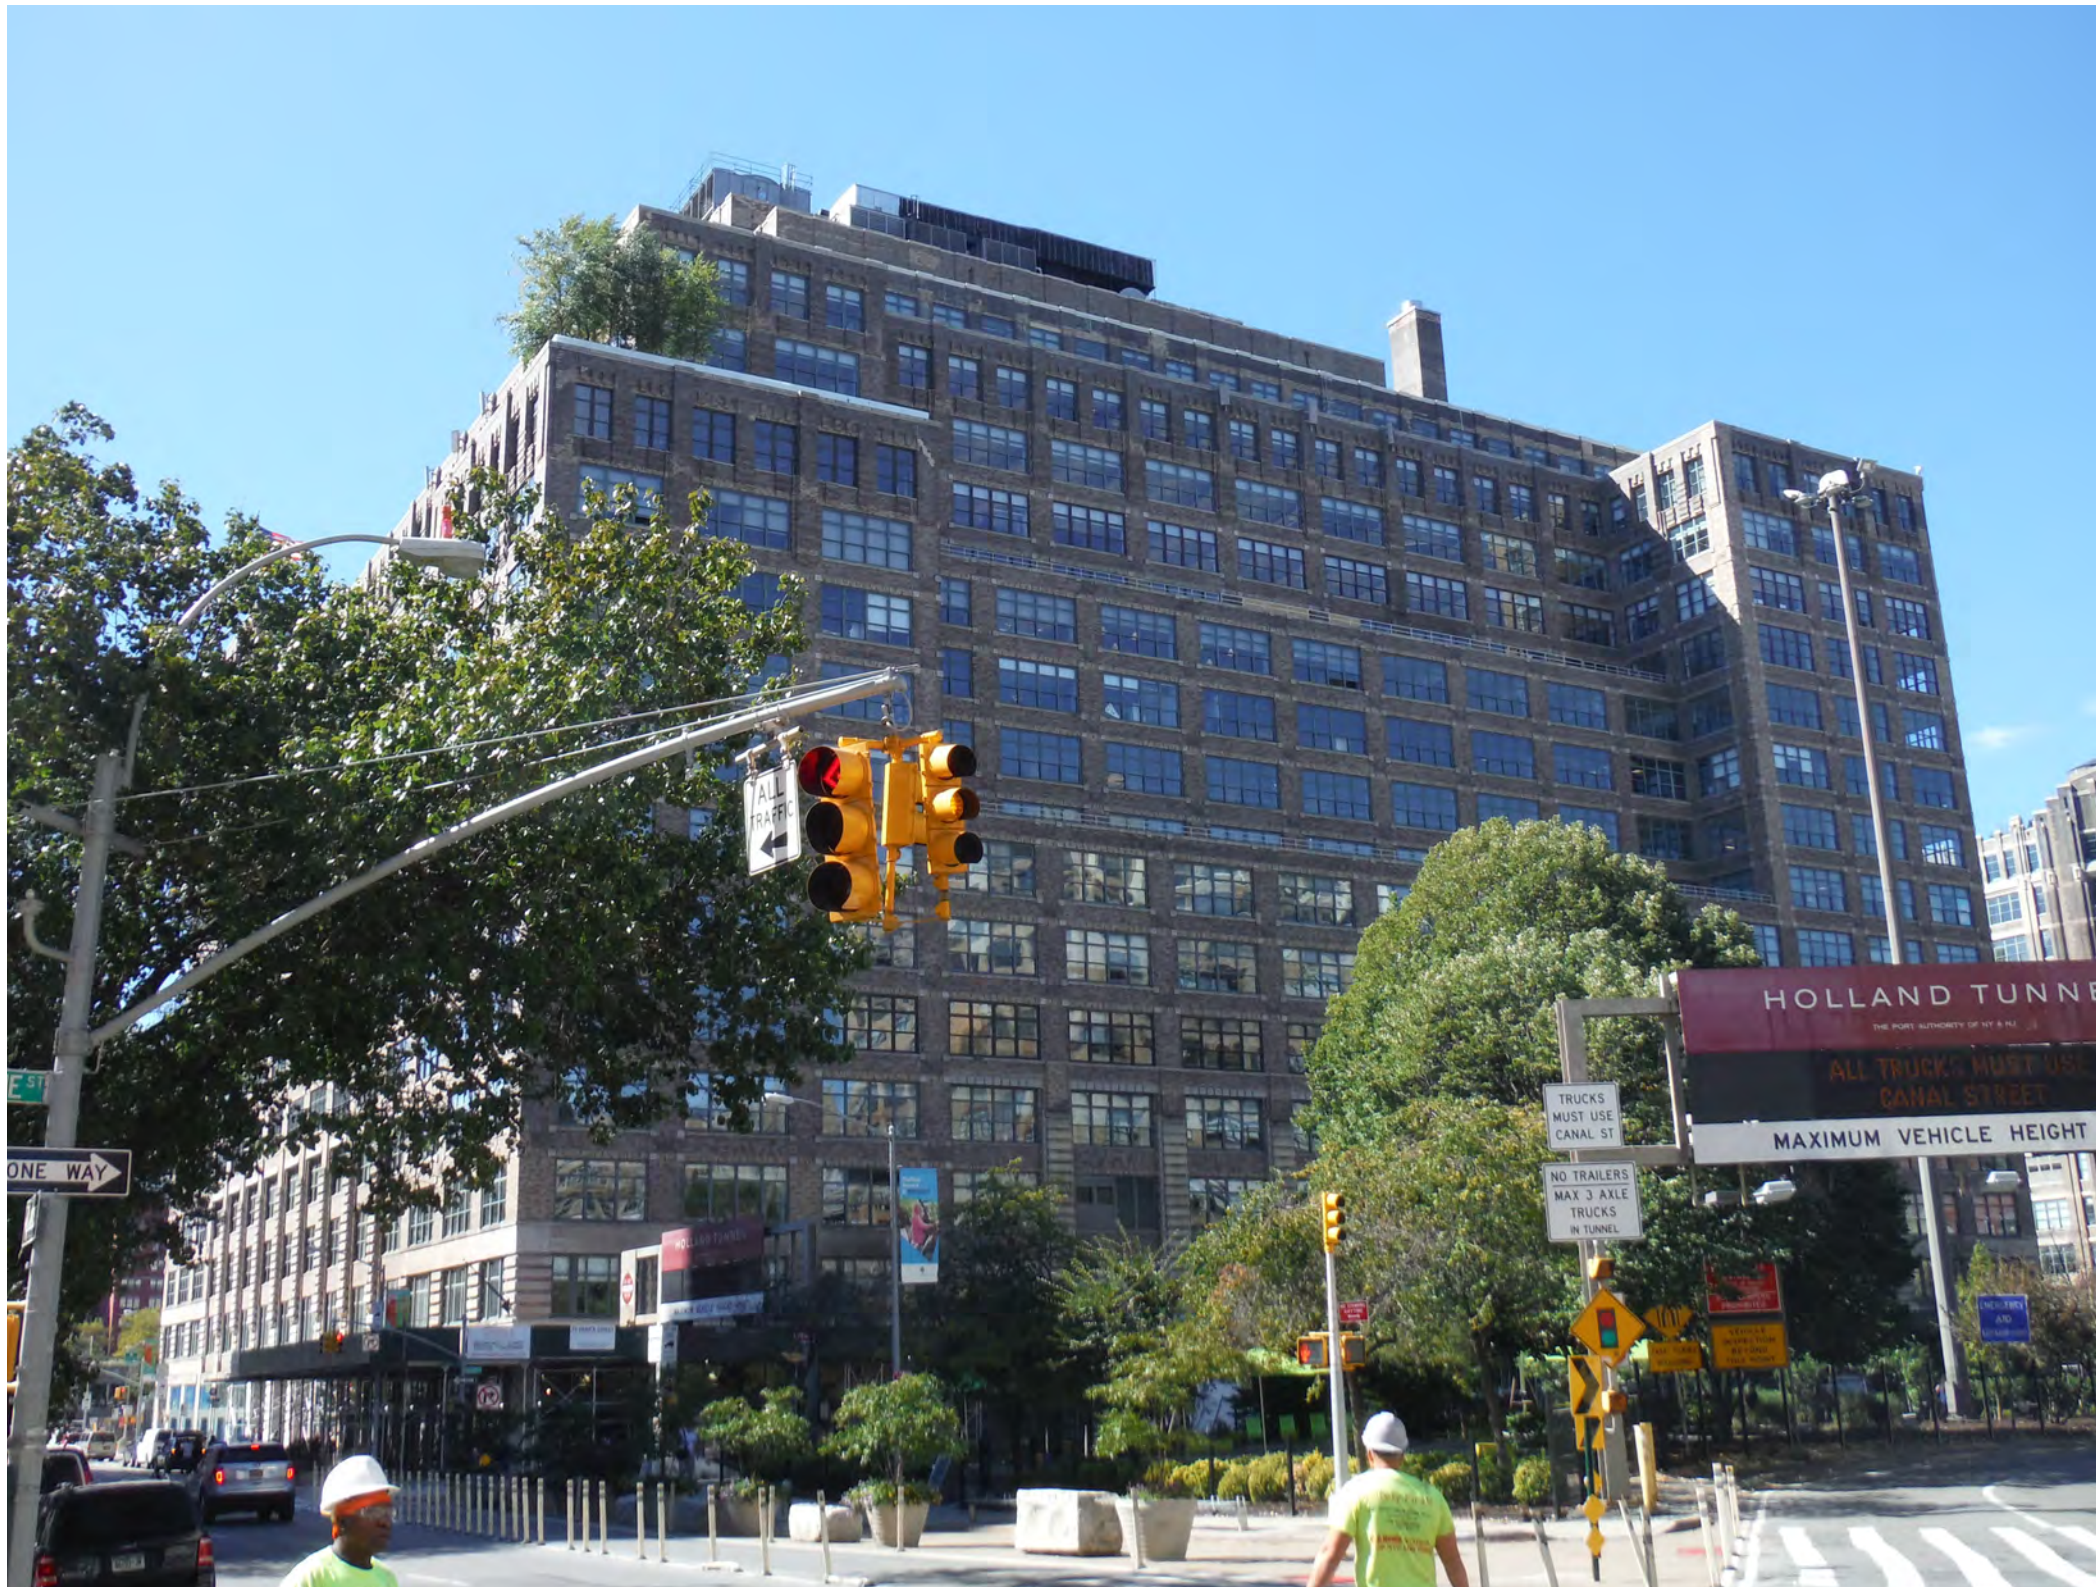
Street View #1

Photo shows very limited visibility of affected windows due to existing pipe rail on parapet

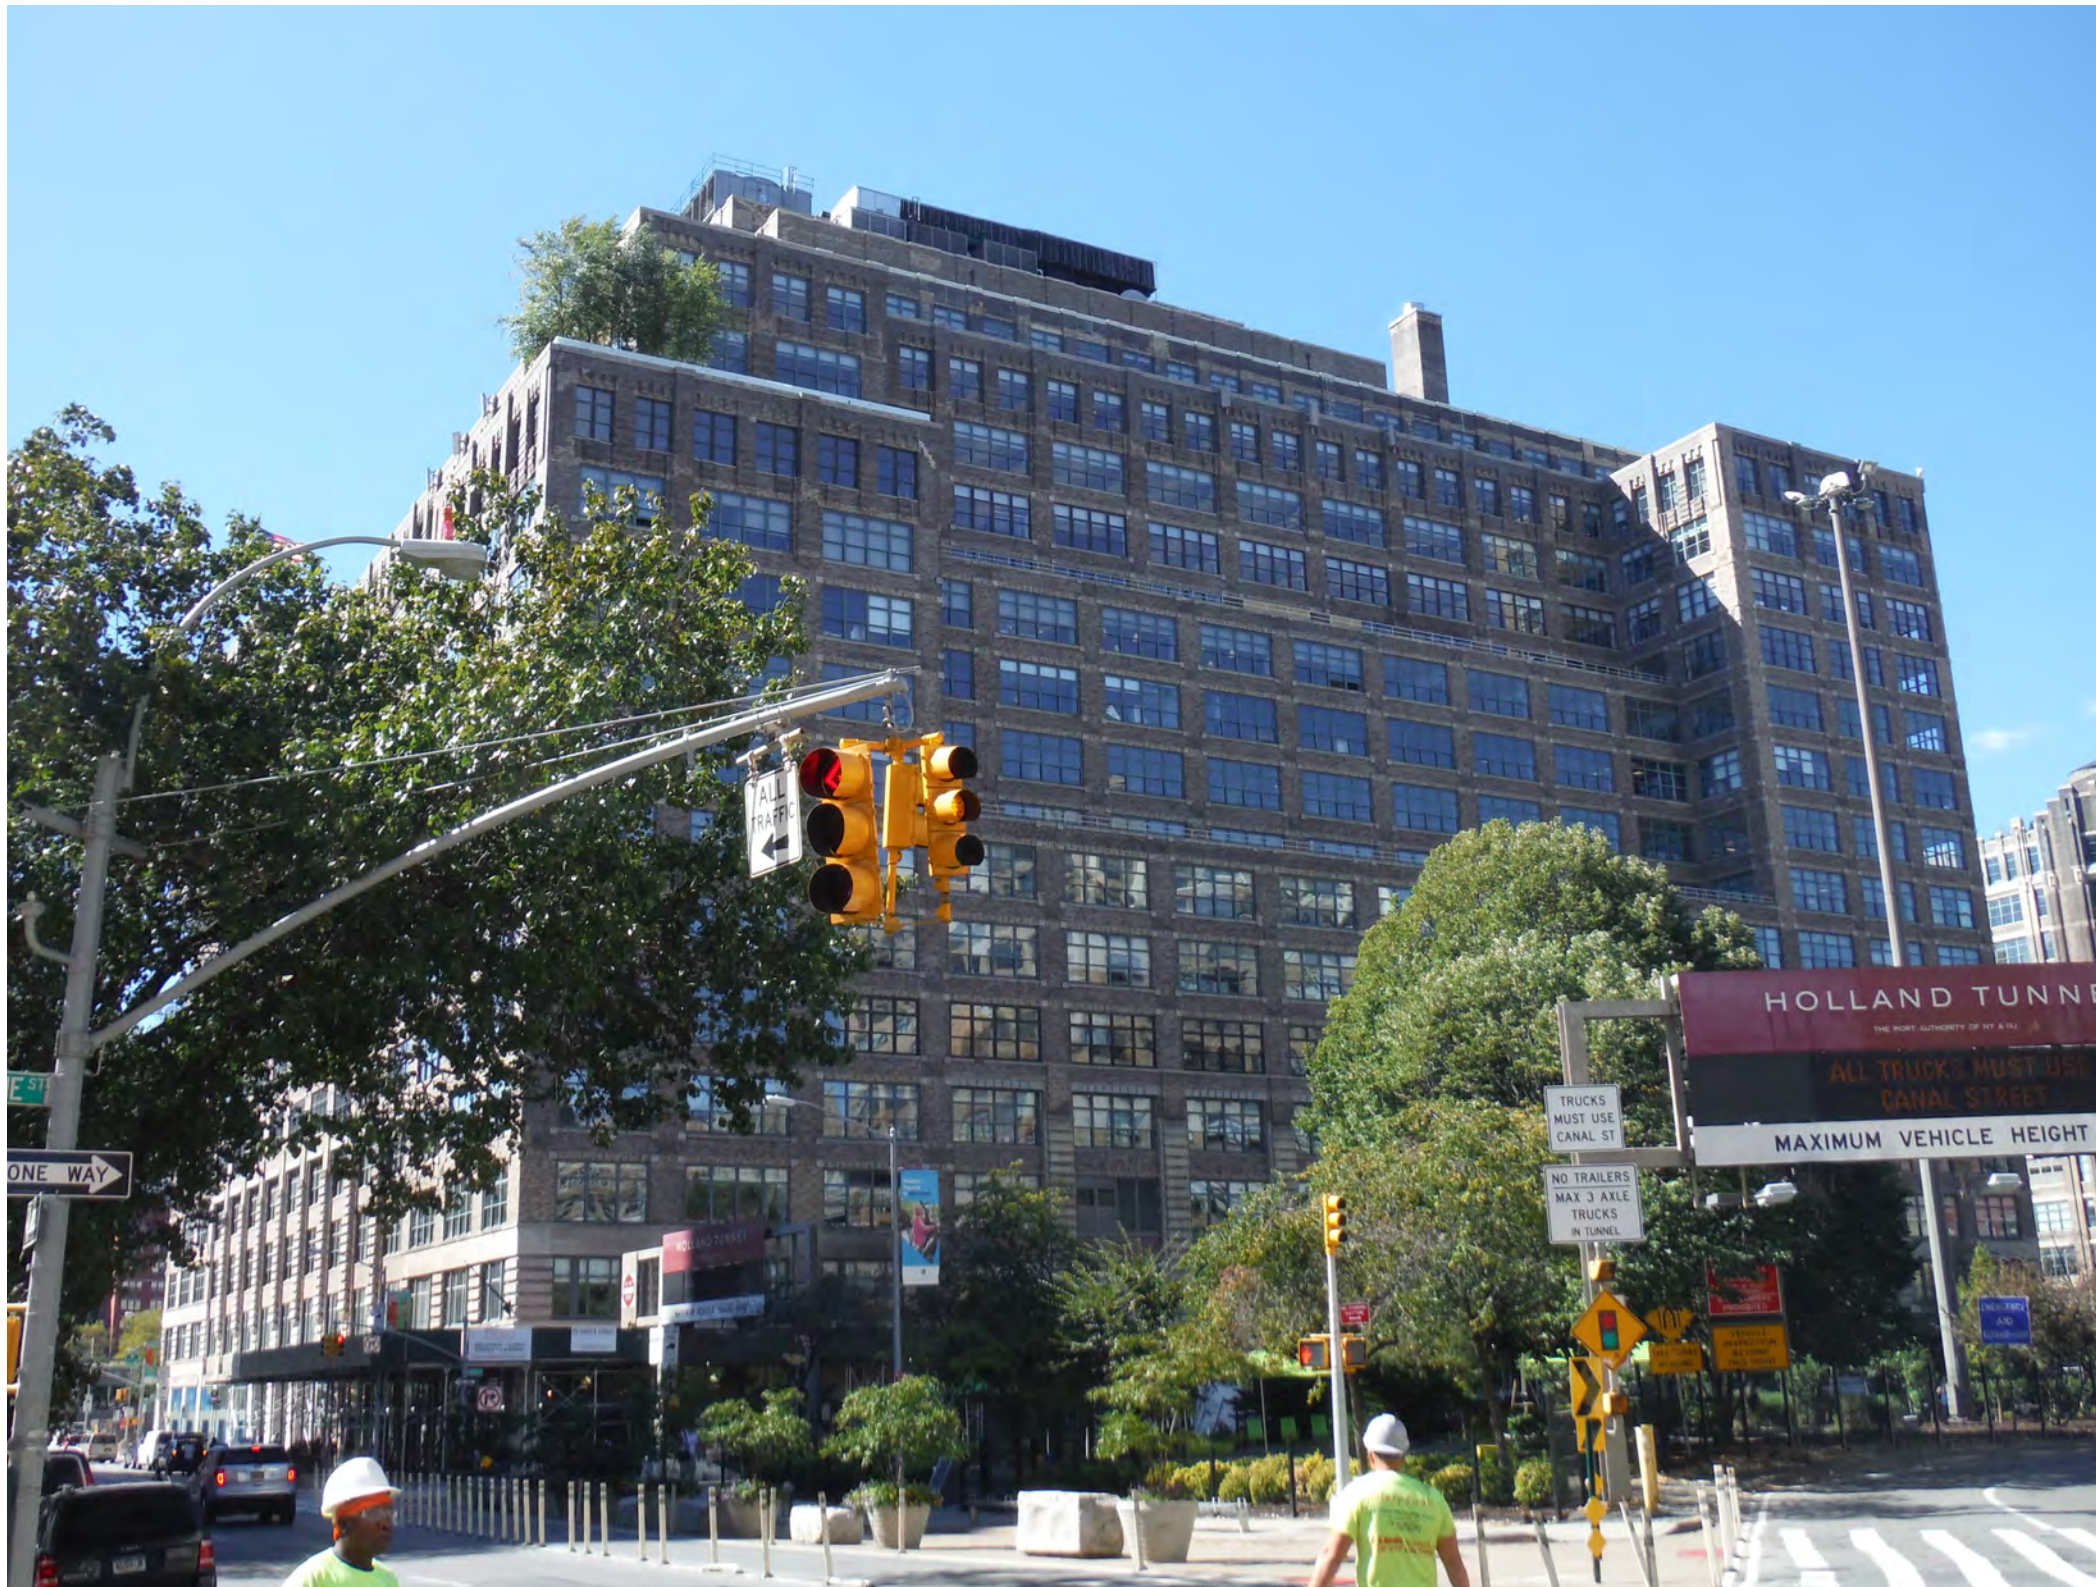
Street View #1 - Proposed Work

Photo shows very limited visibility of affected windows due to existing pipe rail on parapet

View shows rendered view of new proposed terrace doors when in open position

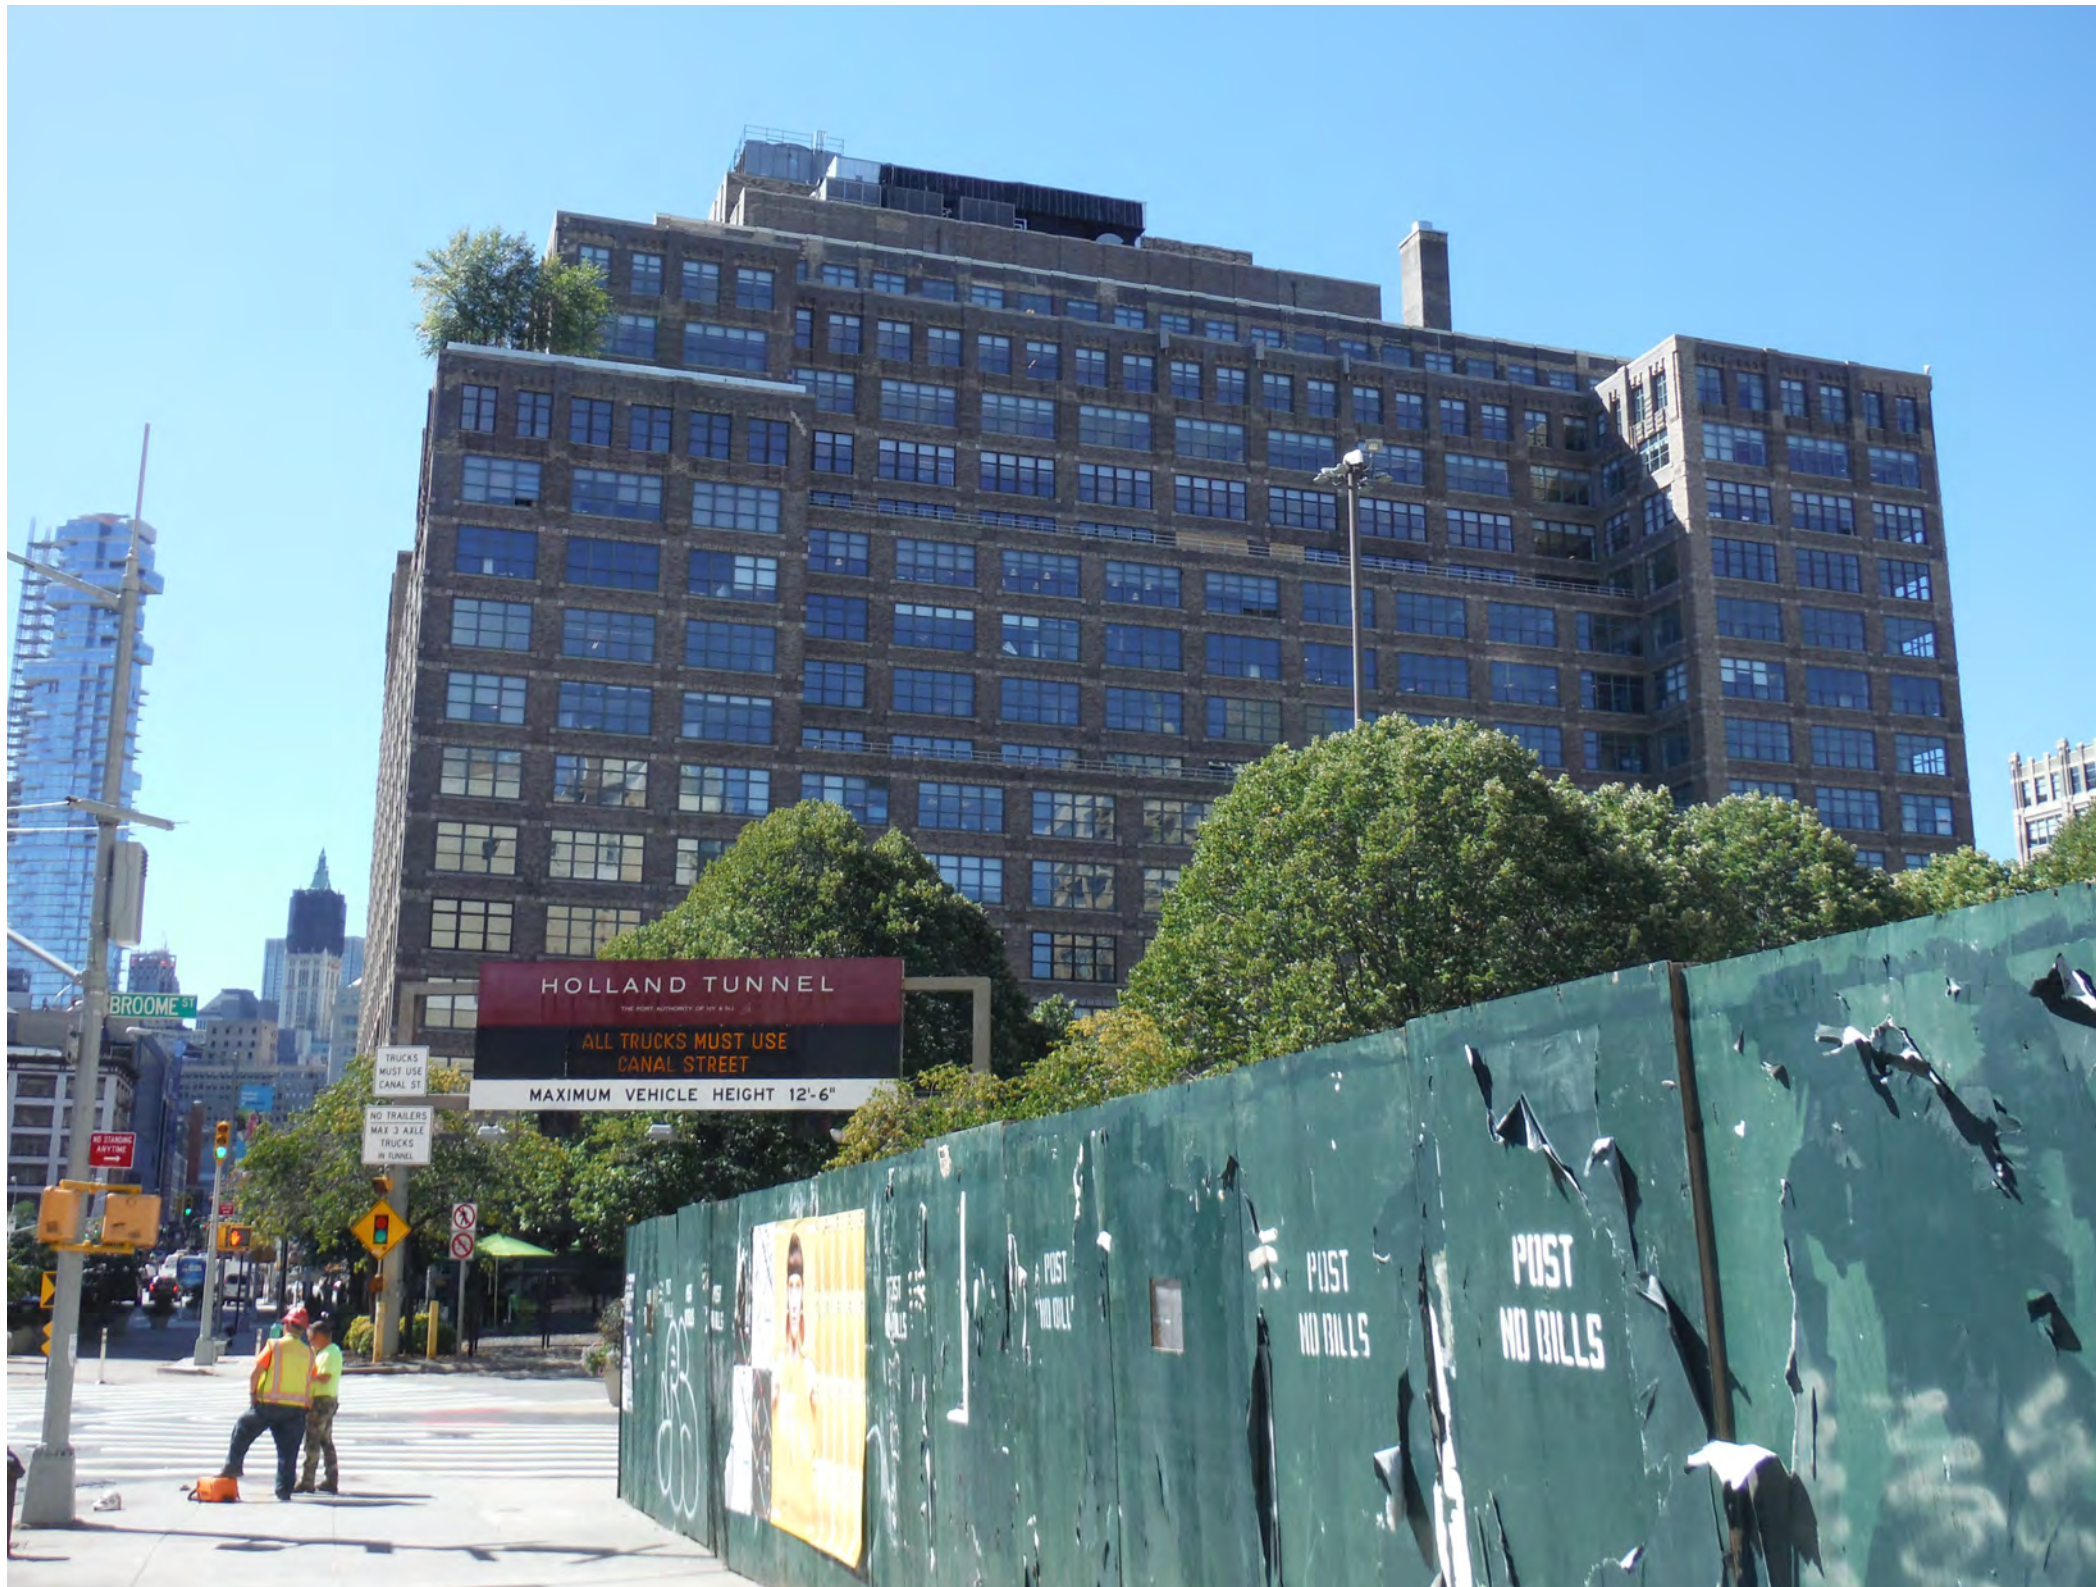
Street View #2

Photo shows partial visibility of affected windows due to existing pipe rail on parapet

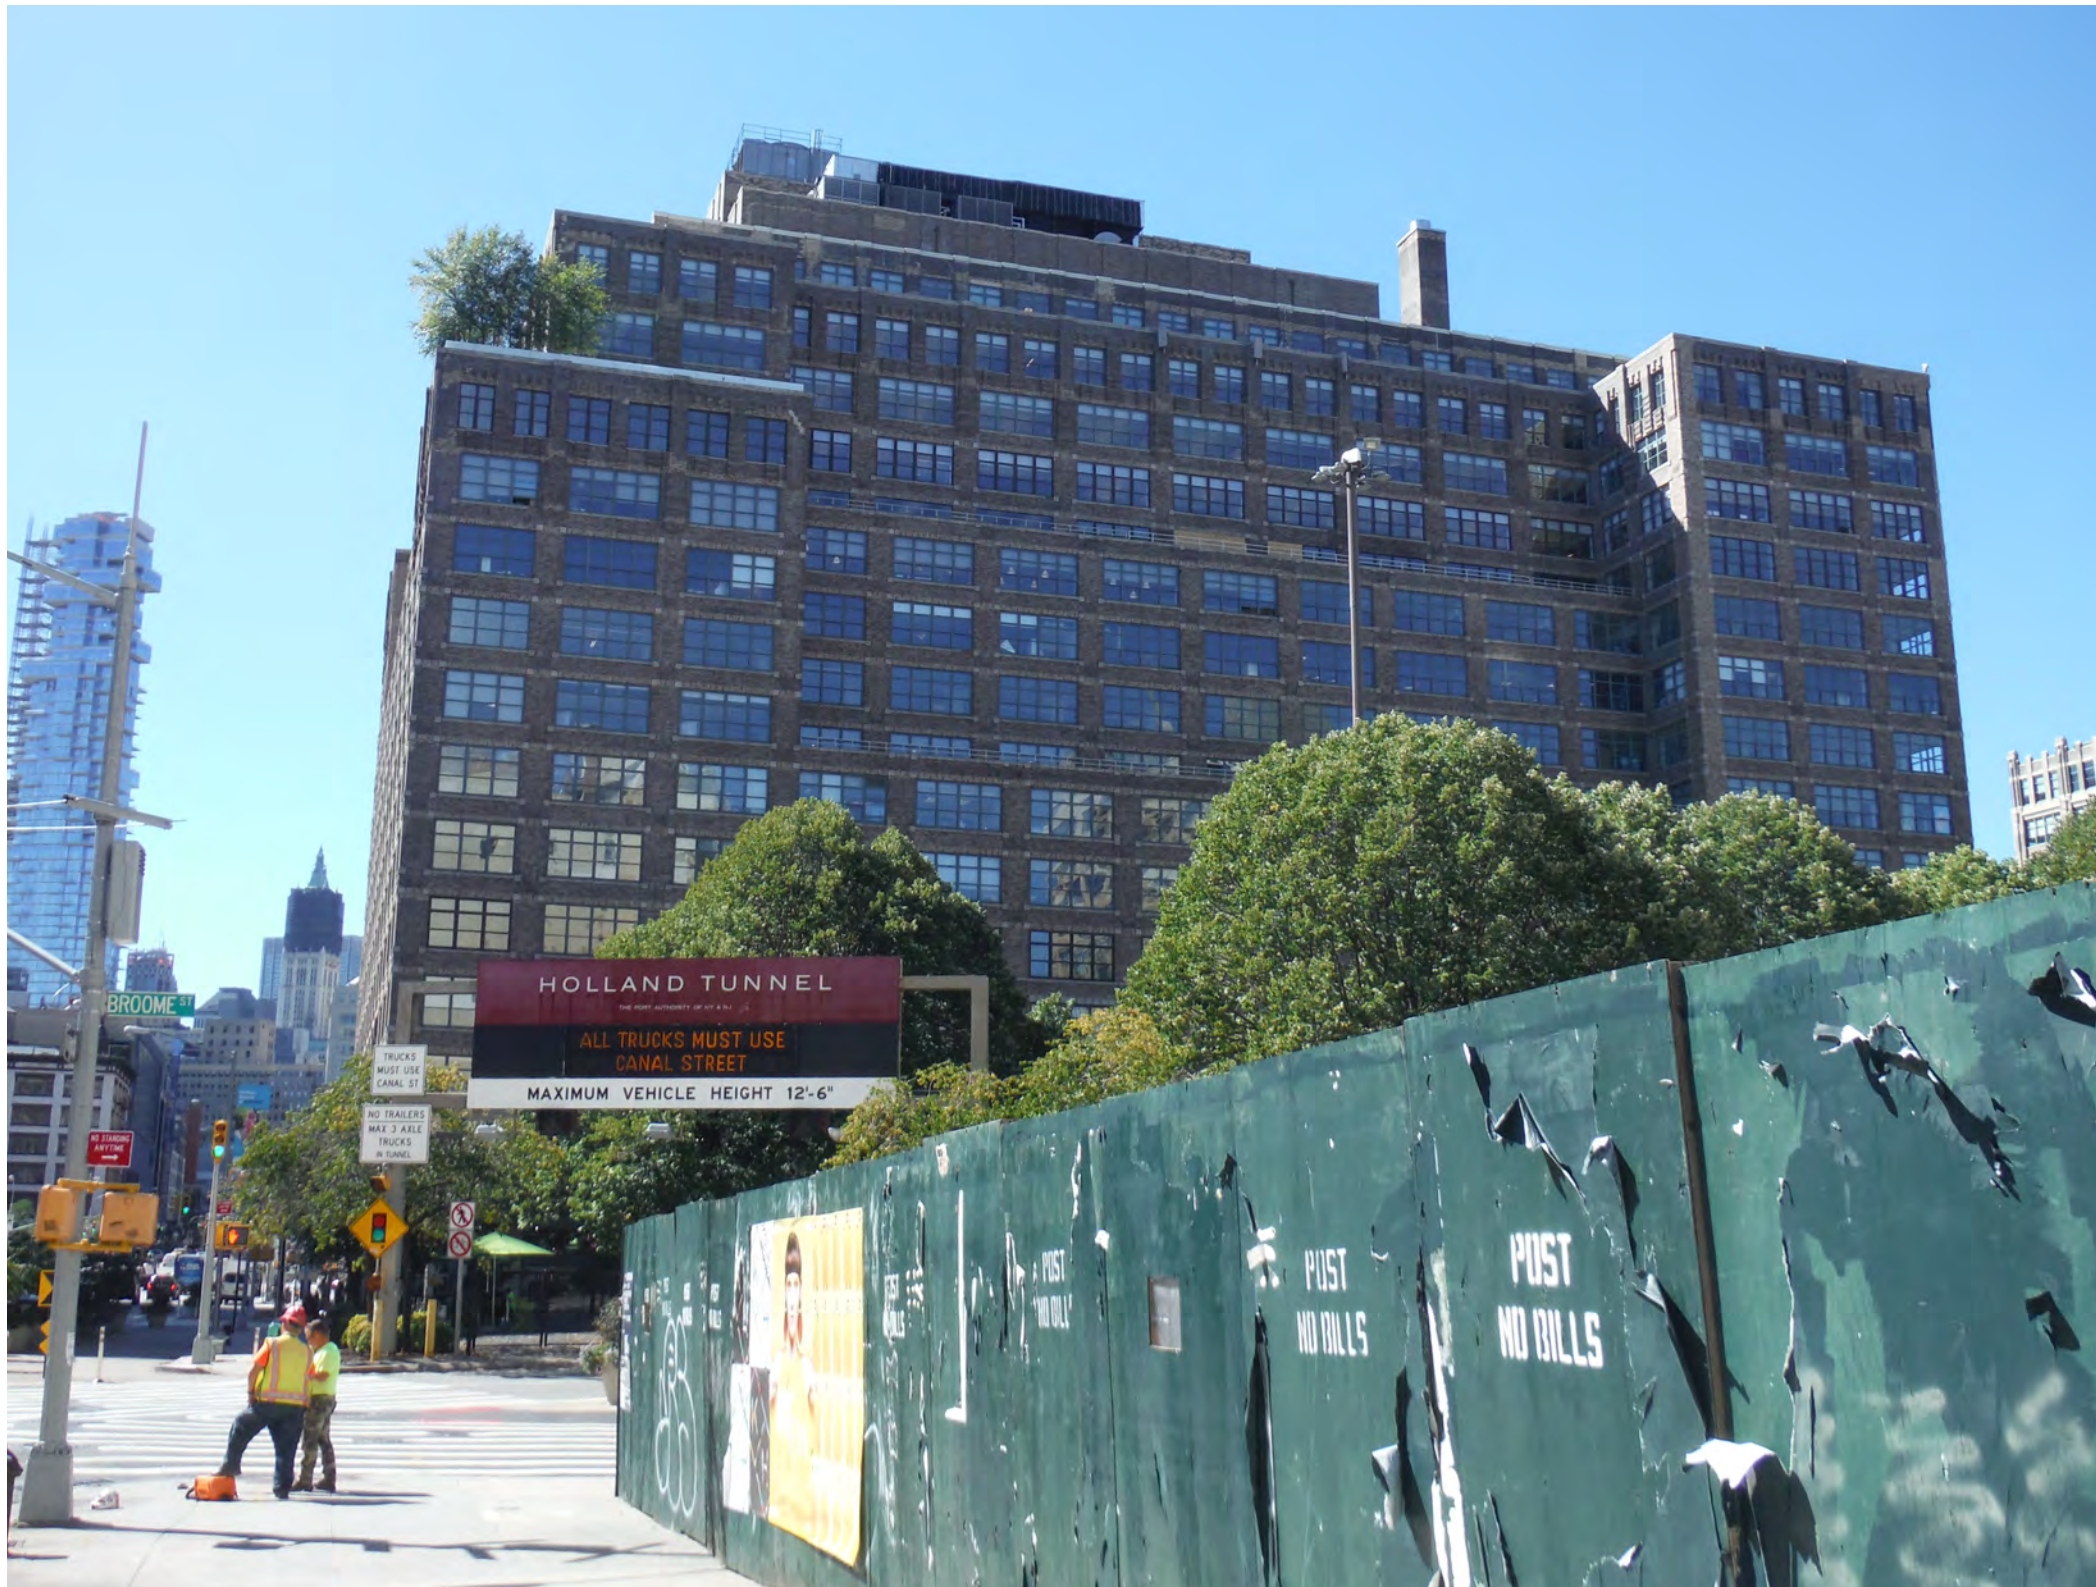
Street View #2 - Proposed Work

Photo shows partial visibility of affected windows due to existing pipe rail on parapet

View shows rendered view of new proposed terrace doors when in open position

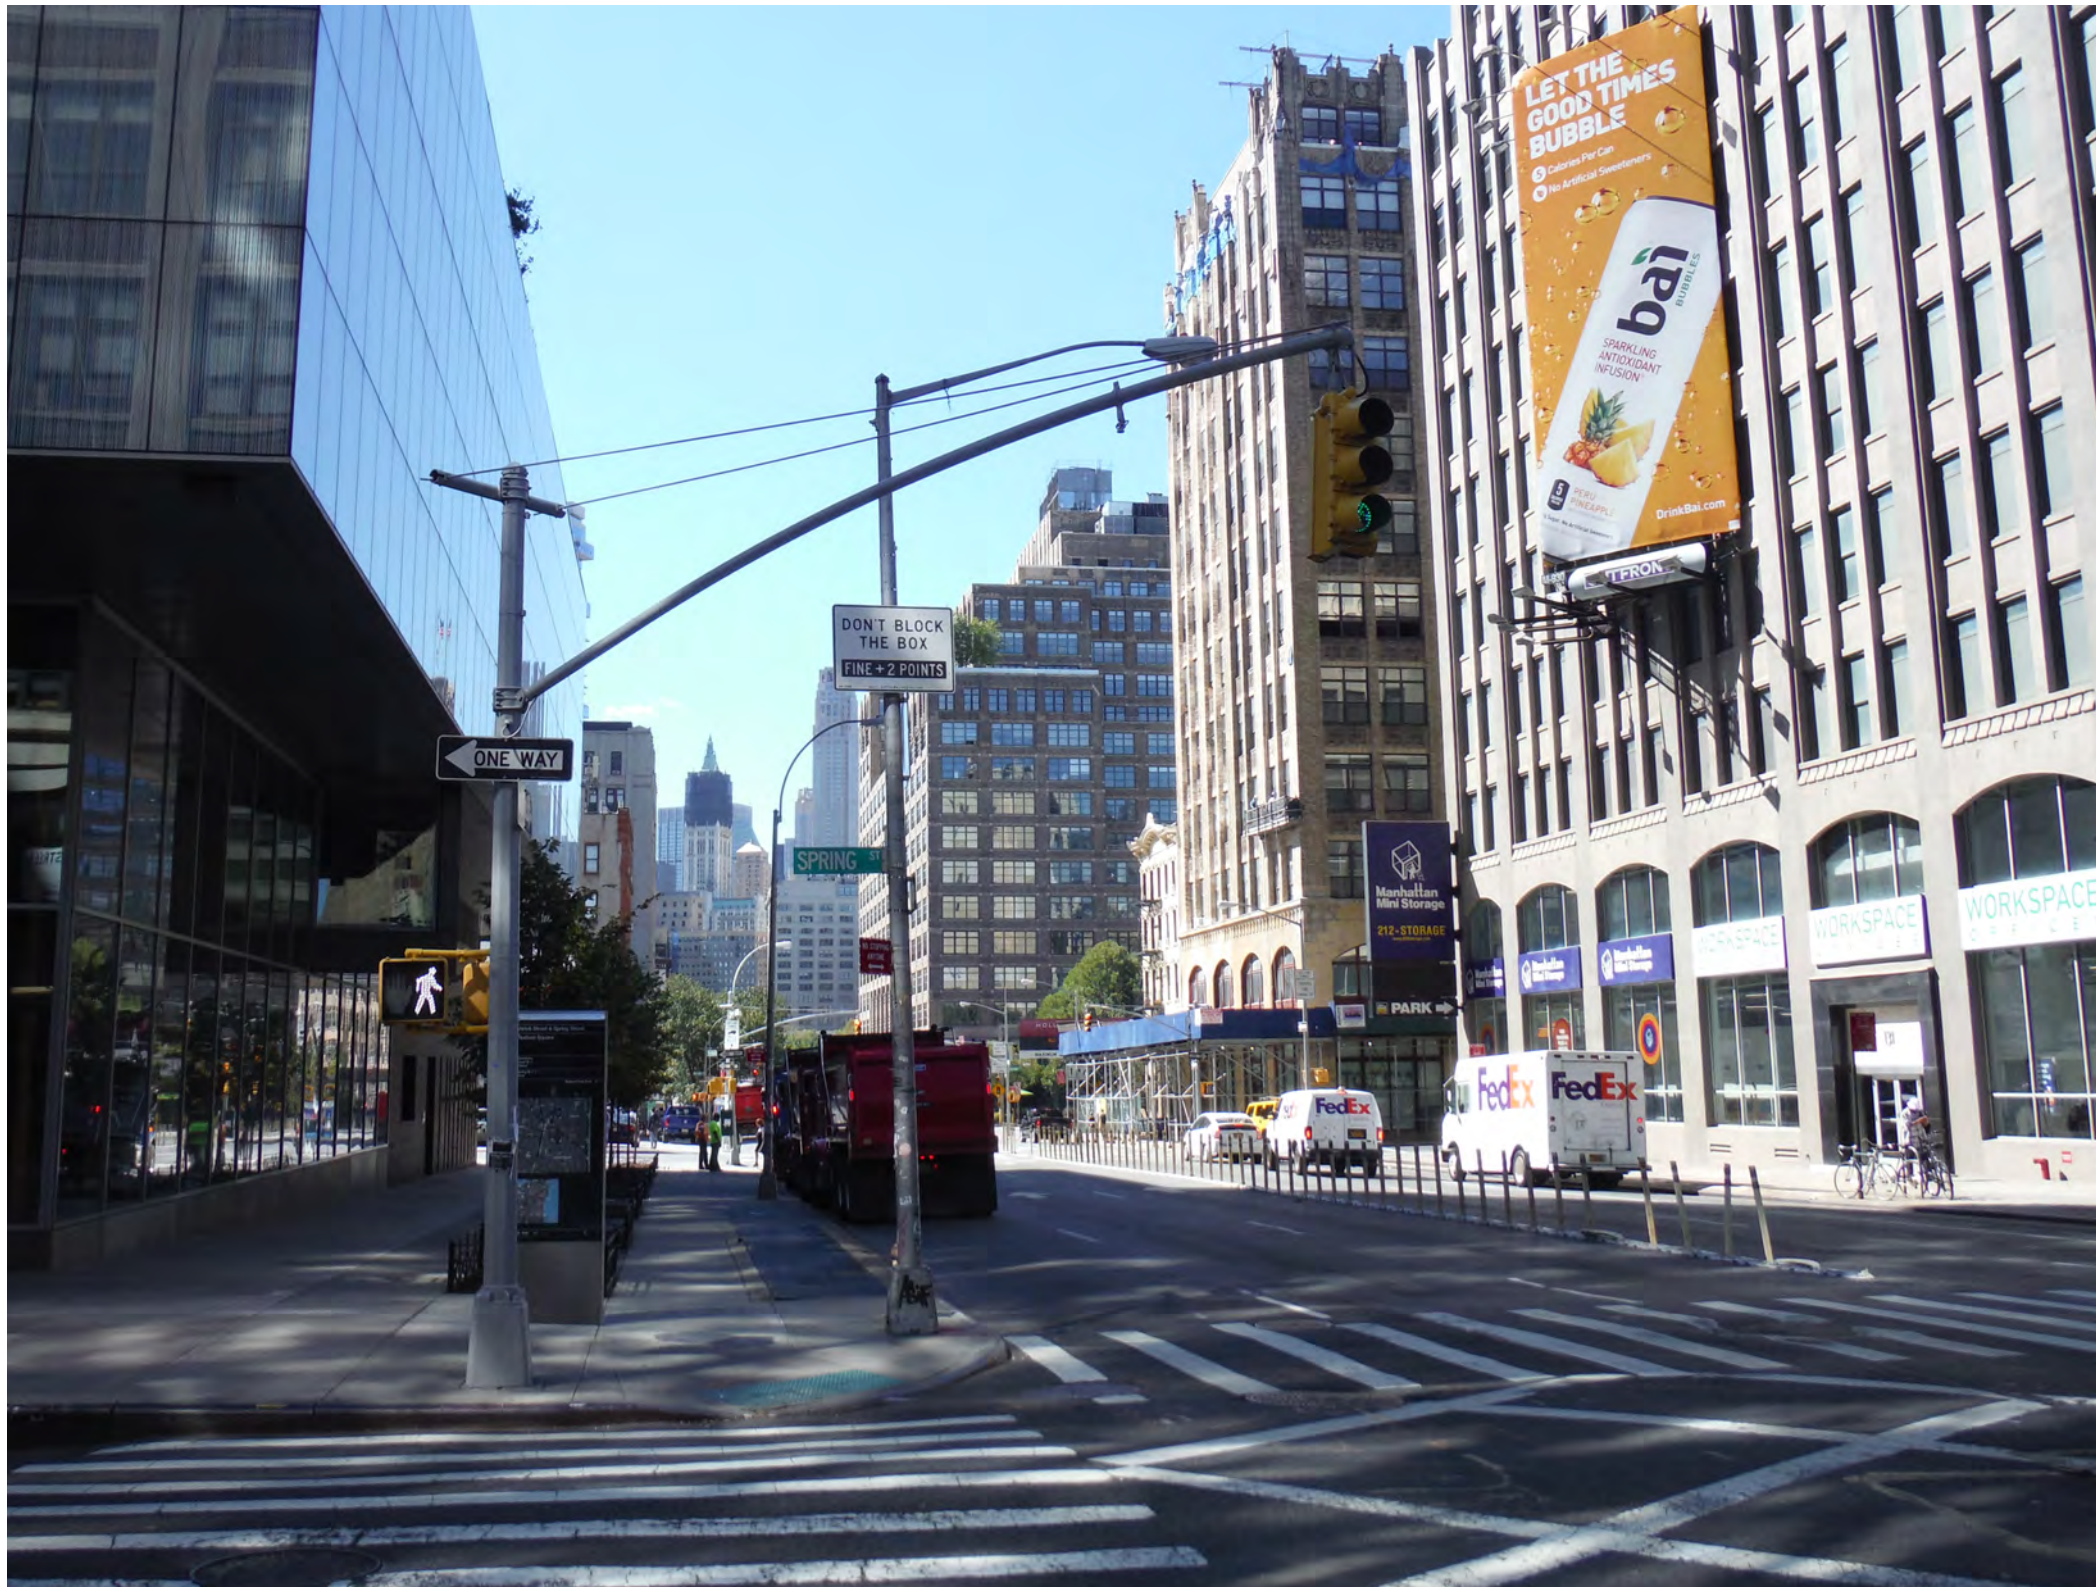
Street View #3

Photo shows maximum visibility of affected windows from Spring St. 3 blocks away

Only top two panes visible of partial view of 1st and 2nd window bays
