75 Varick Street | Horizon Media

March 16, 2017

Community Board 2 Landmarks Presentation

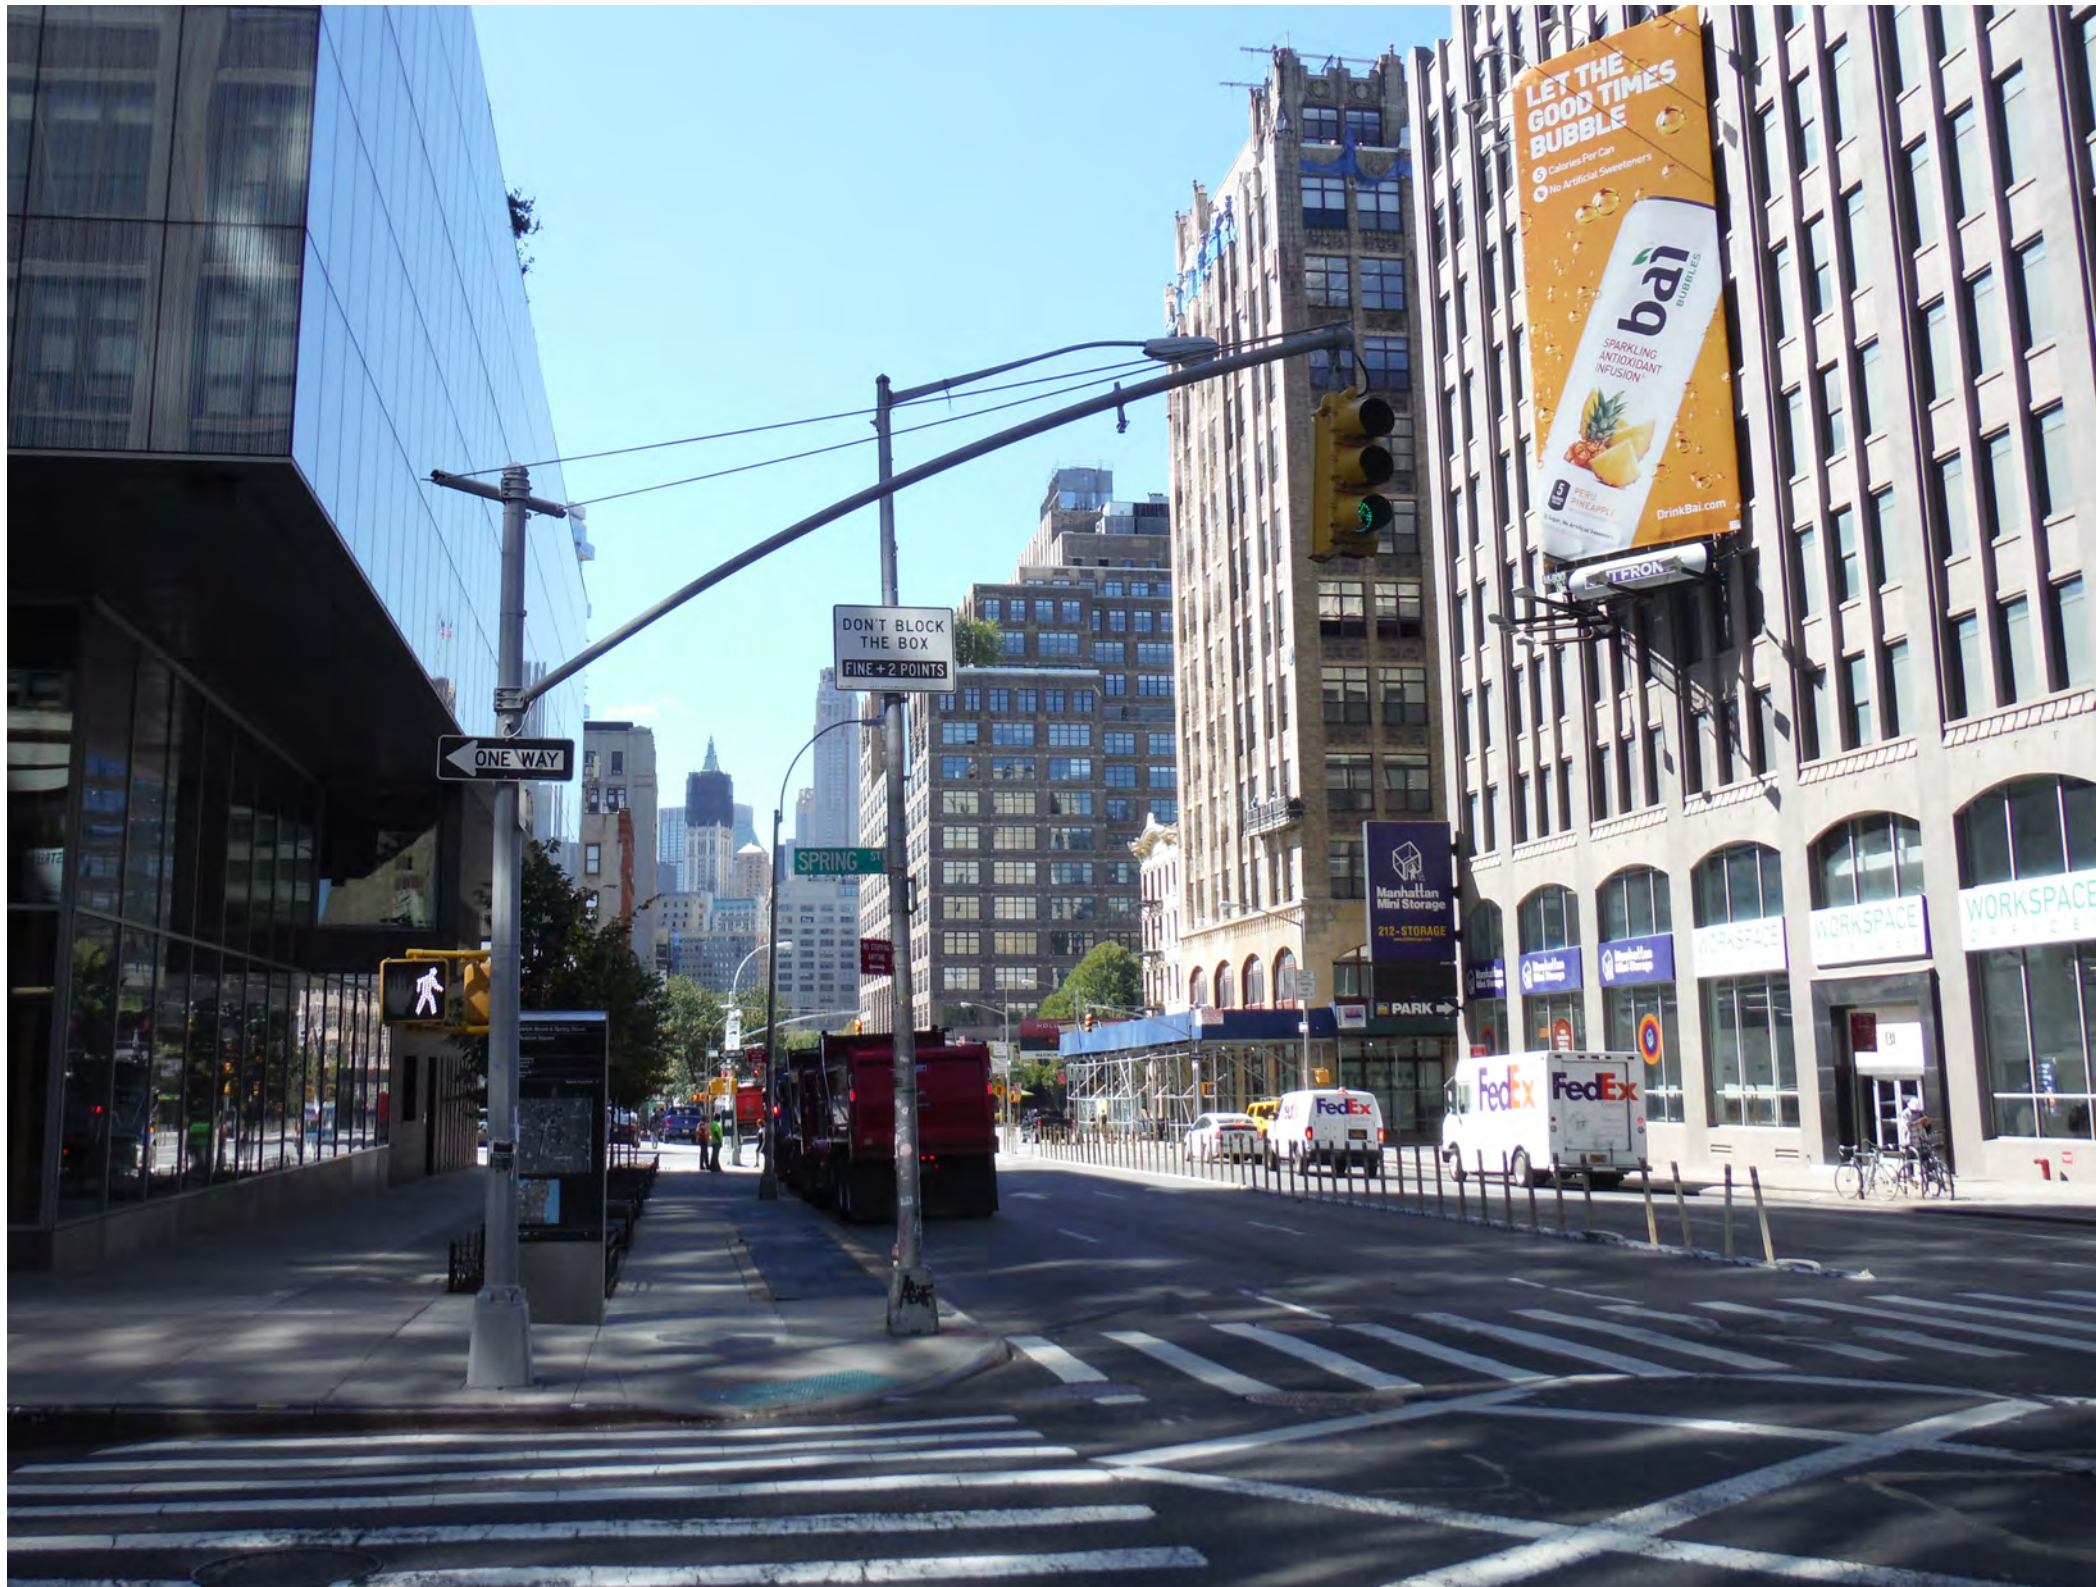
Street View #3 - Proposed Work

Photo shows maximum visibility of affected windows from Spring St. 3 blocks away

View shows rendered view of new proposed terrace doors when in open position

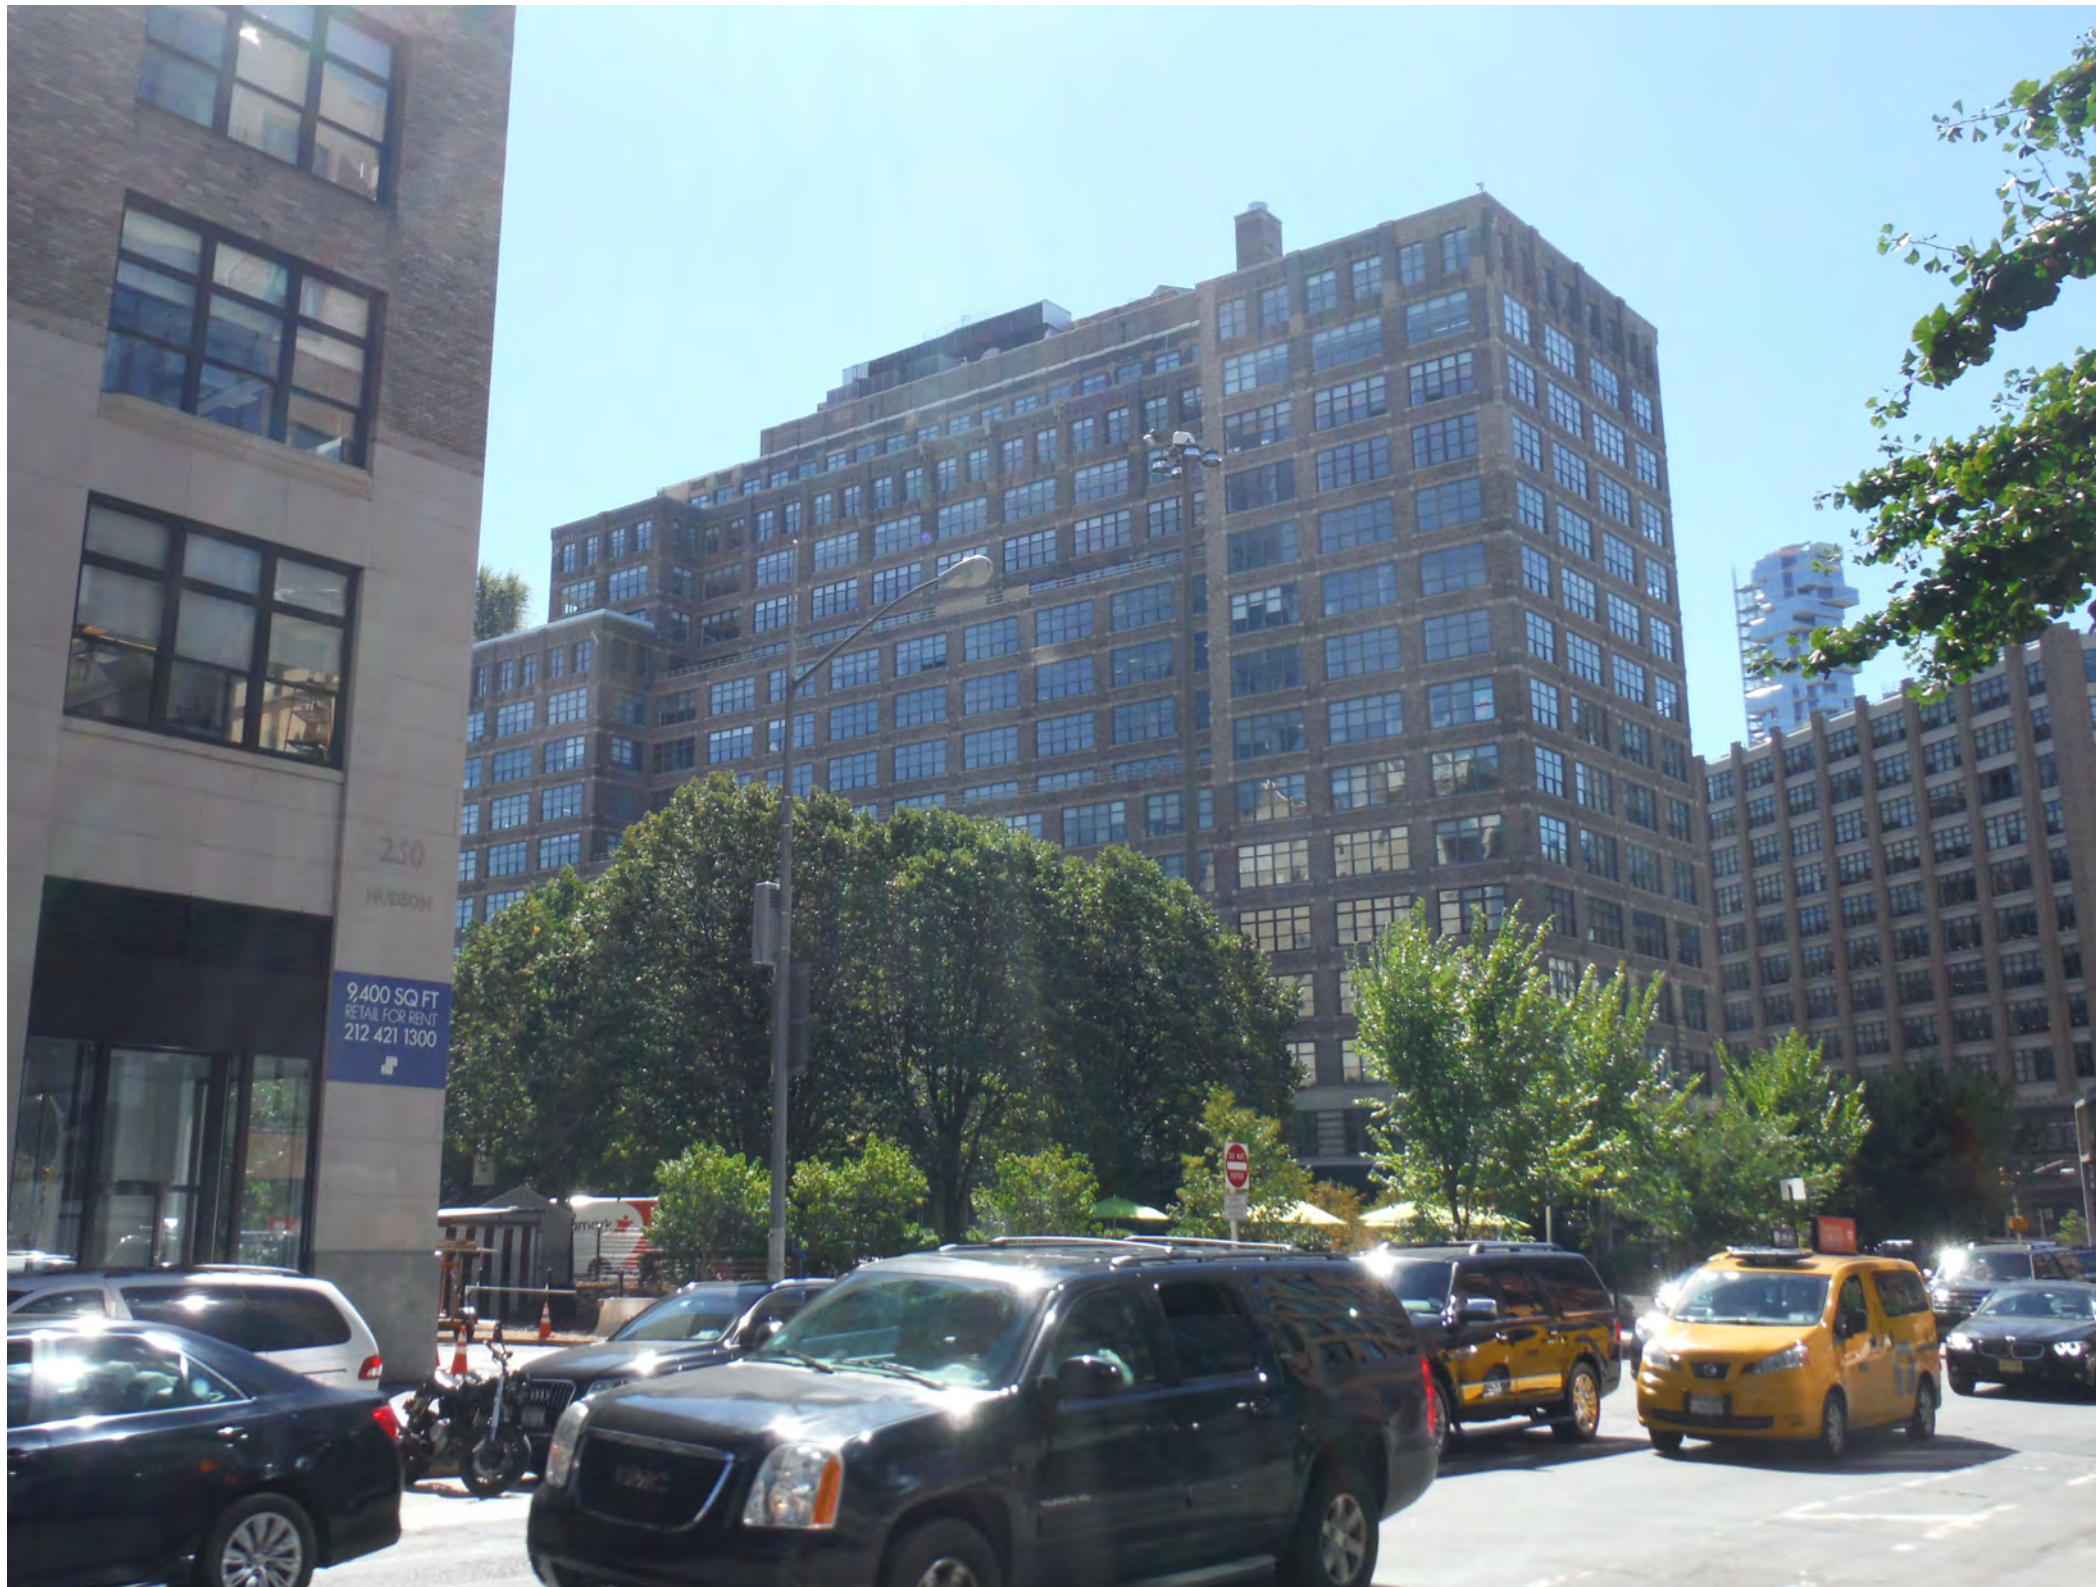
Street View #4

Photo shows partial visibility of affected windows due to existing pipe rail on parapet

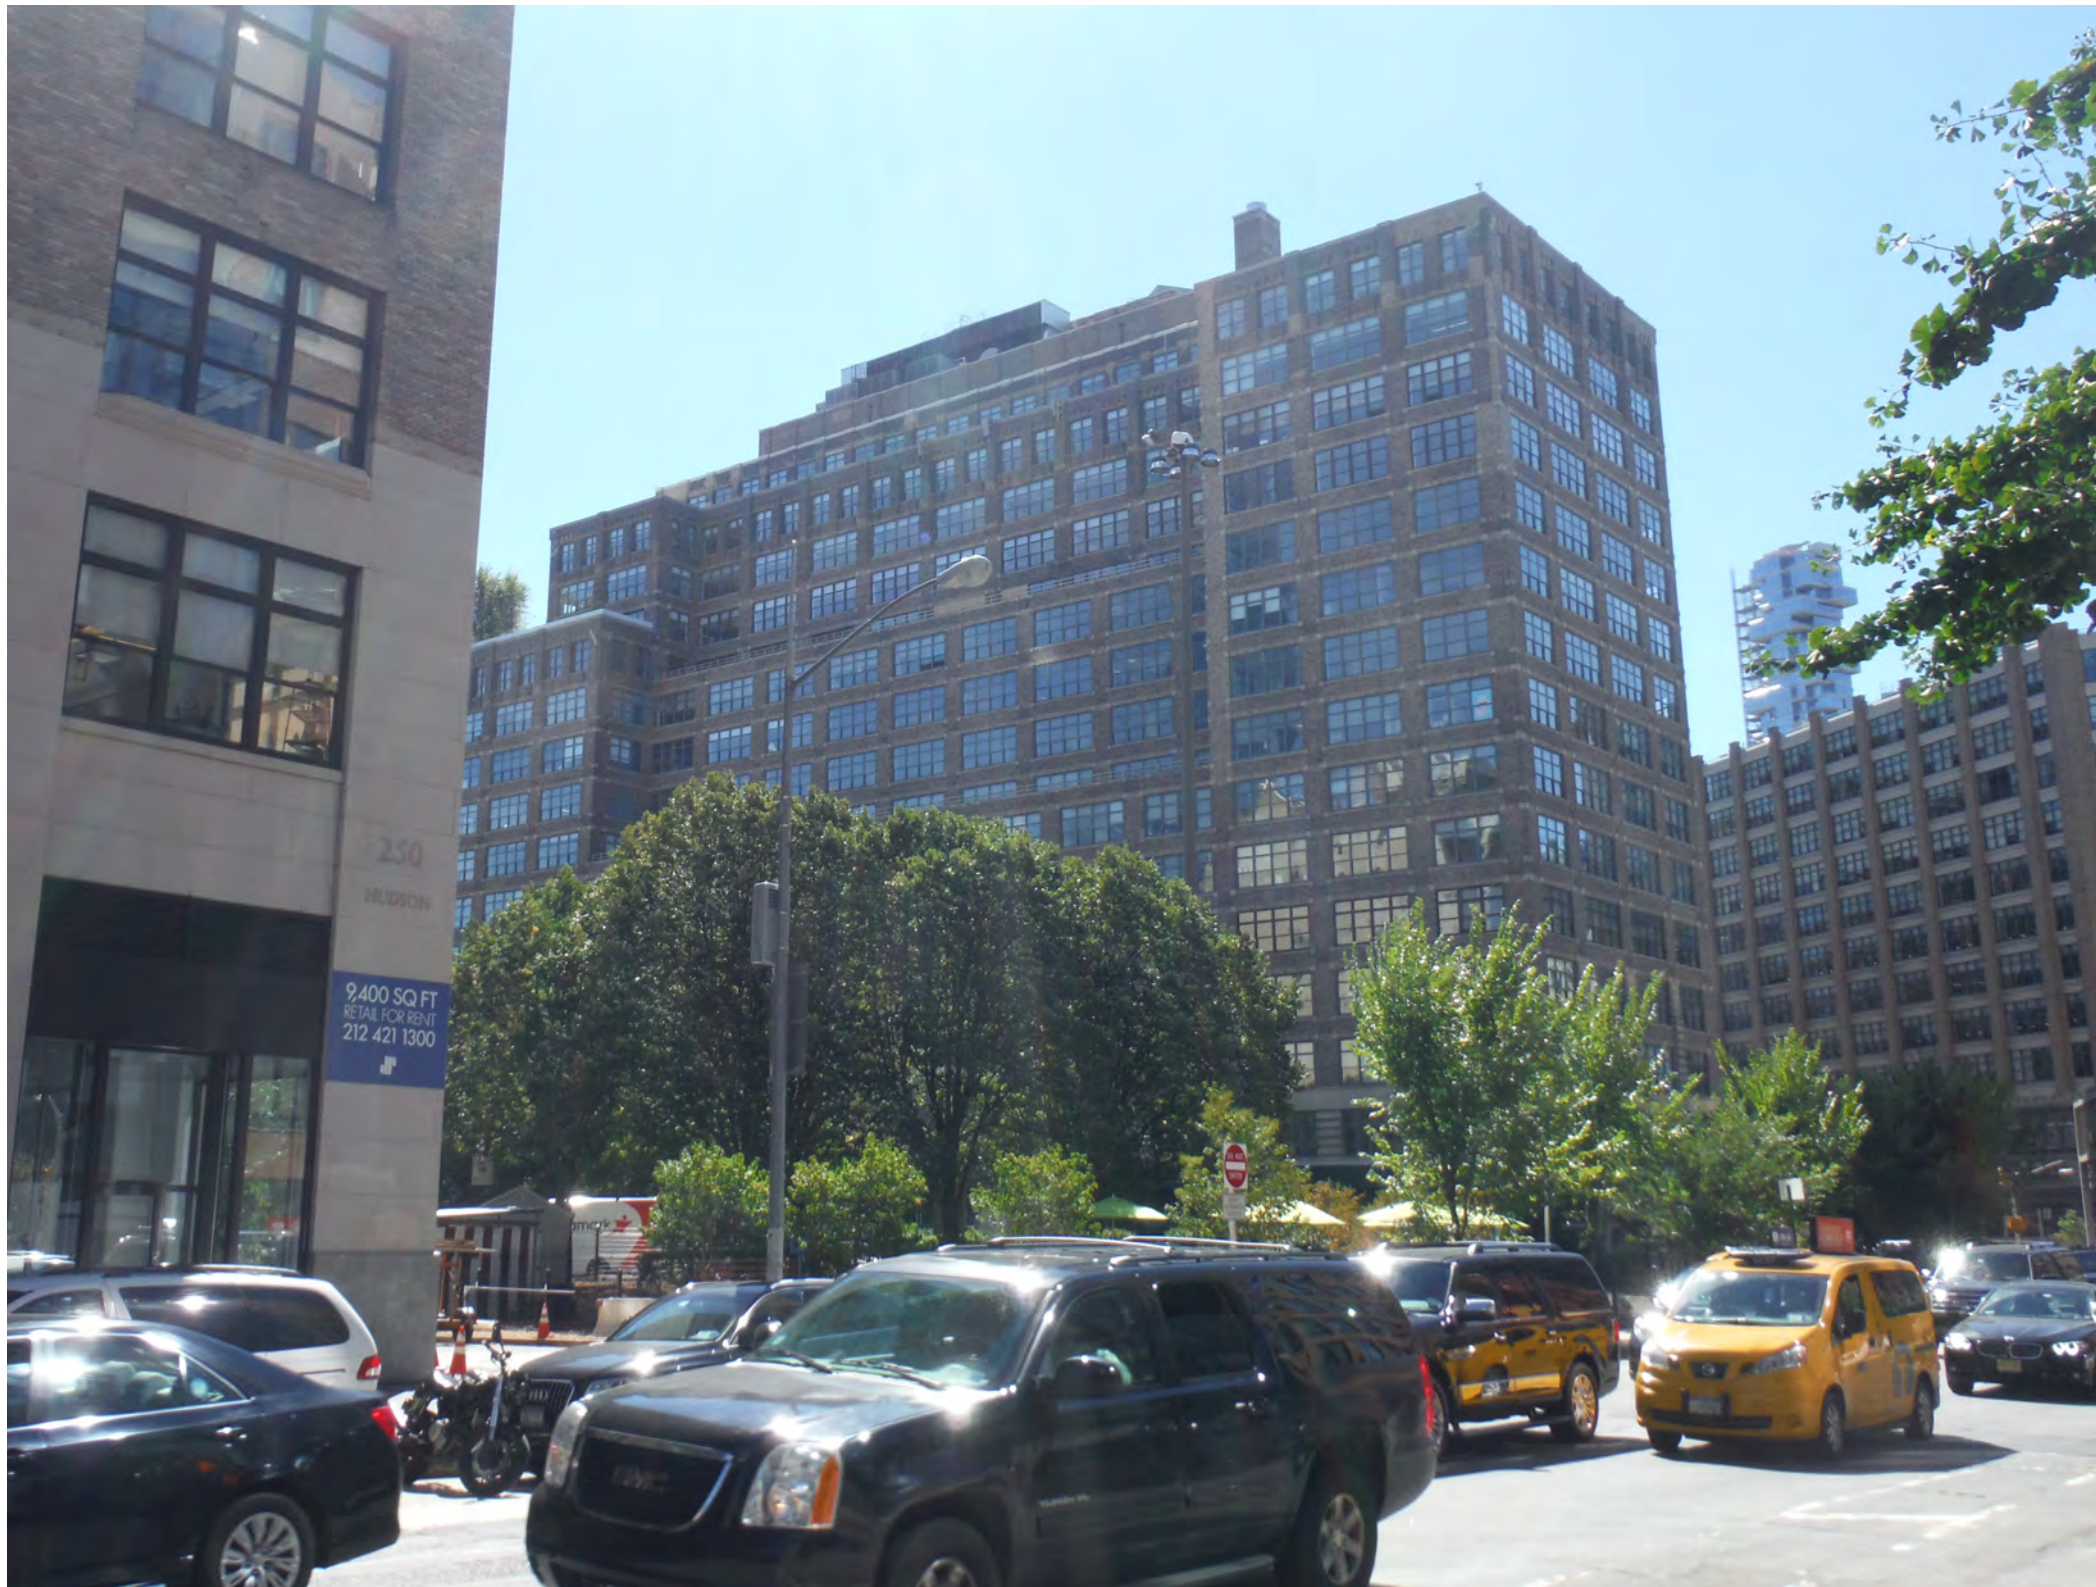
Street View #4 - Proposed Work

Photo shows partial visibility of affected windows due to existing pipe rail on parapet

View shows rendered view of new proposed terrace doors when in open position

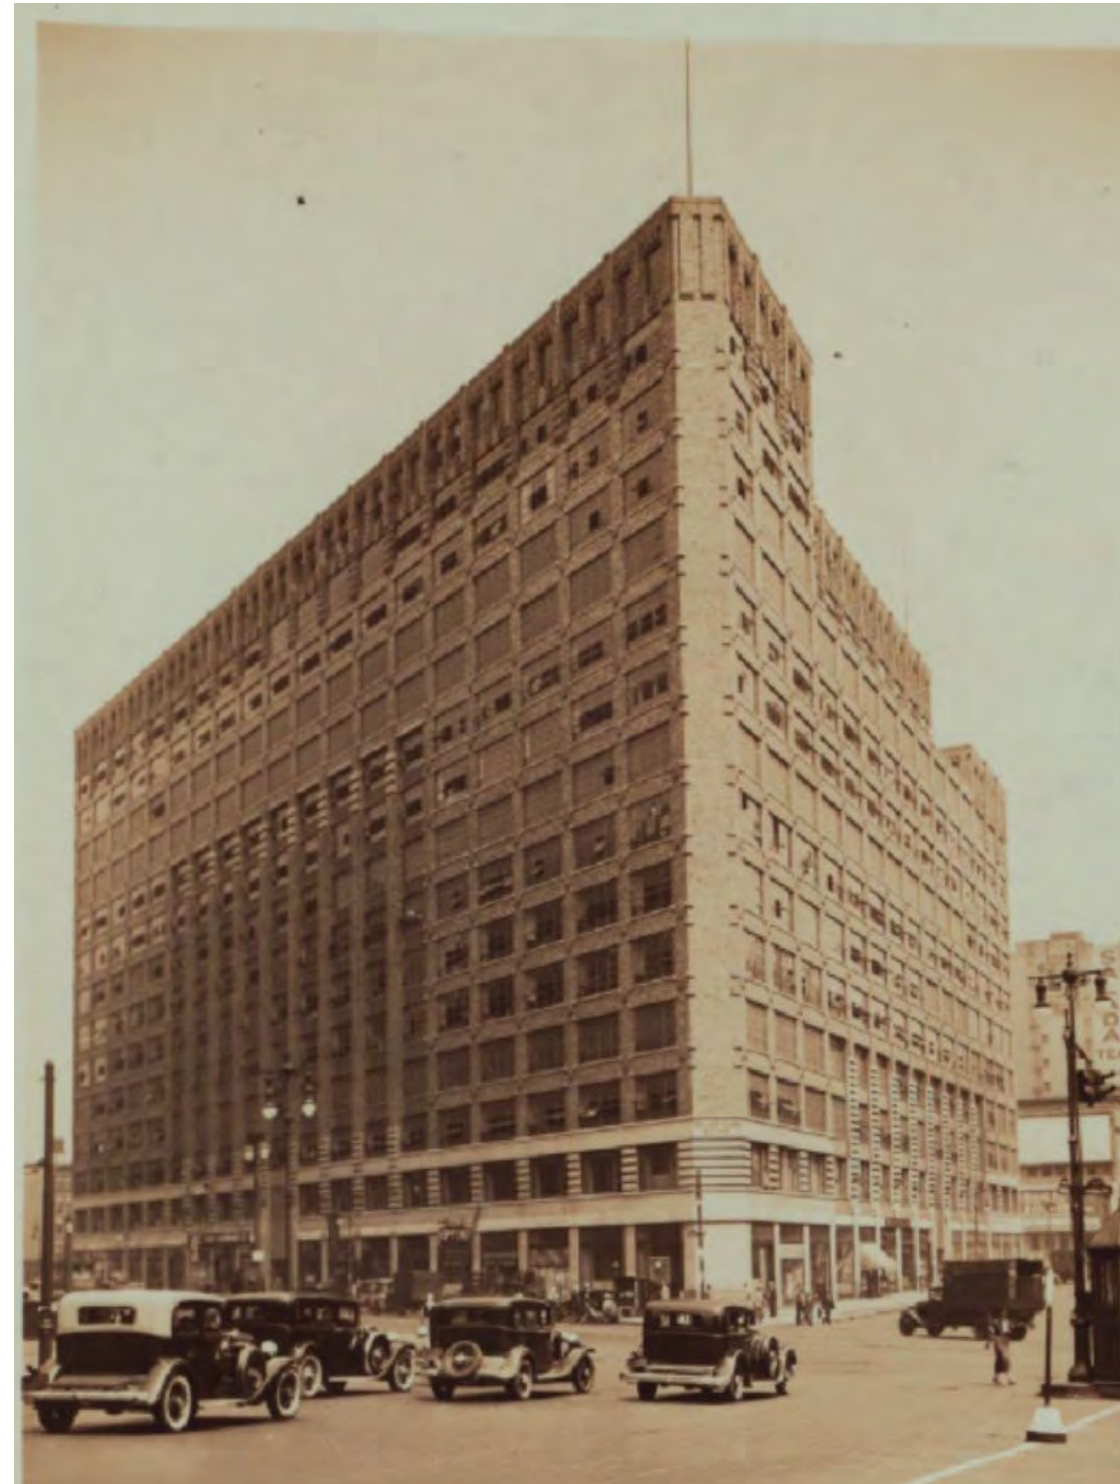
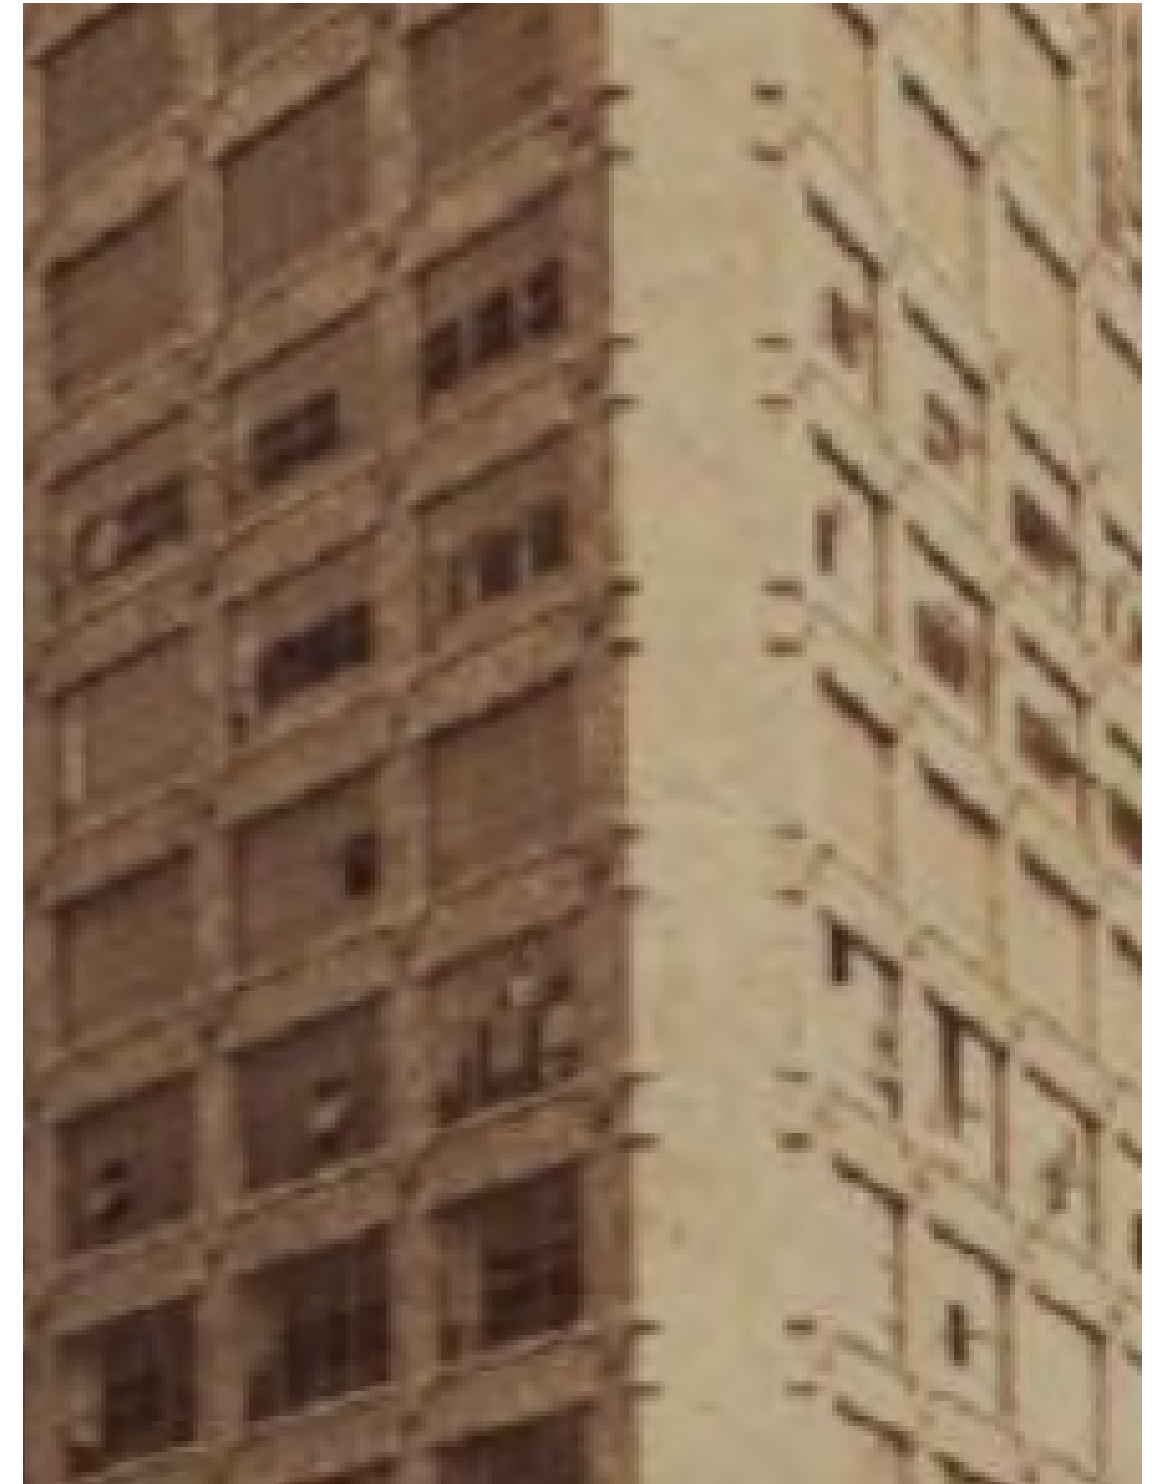
Photo taken of SE corner of 75
Varick Street.
Date Taken: 1929

Enlarged photo showing
original fenestration with 3
stacked window panes and
muntin dividers. Middle panels
are operational horizontal pivot
windows

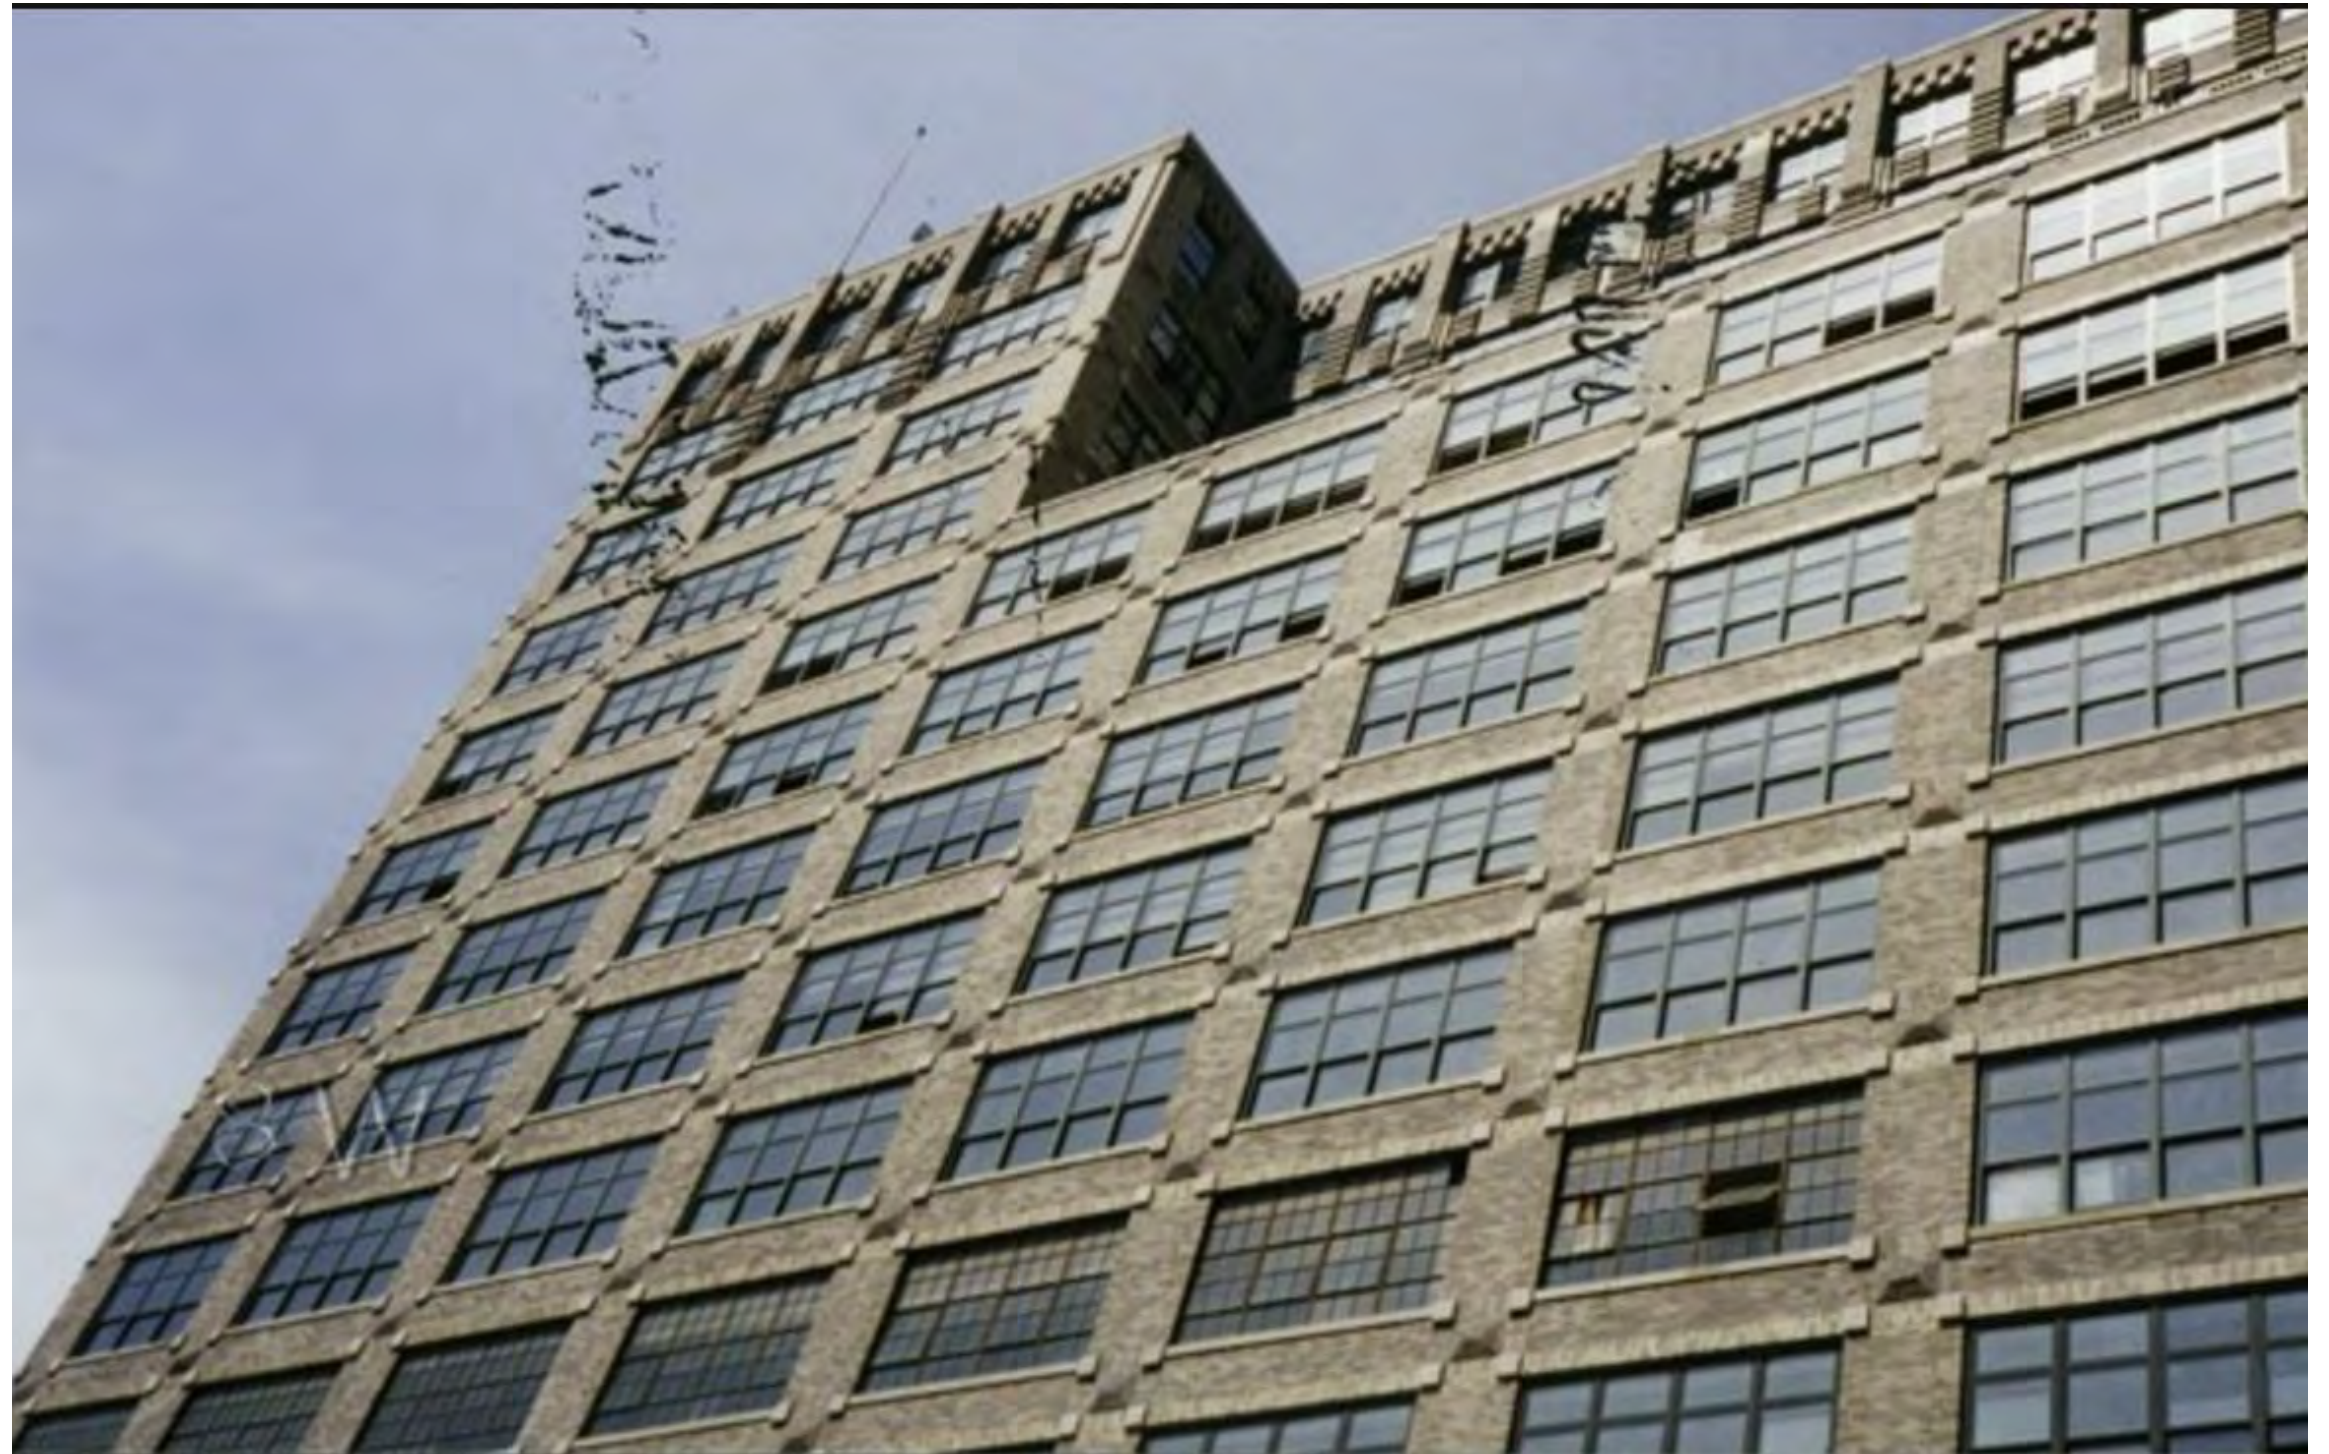
Historical Photos

Photo taken of East facade of
75 Varick Street.
Date Taken: 1999

Photo shows original
fenestration and current
fenestration. Operation of both
types of windows is shown:

- Horizontal Pivot below
- Double hung windows above

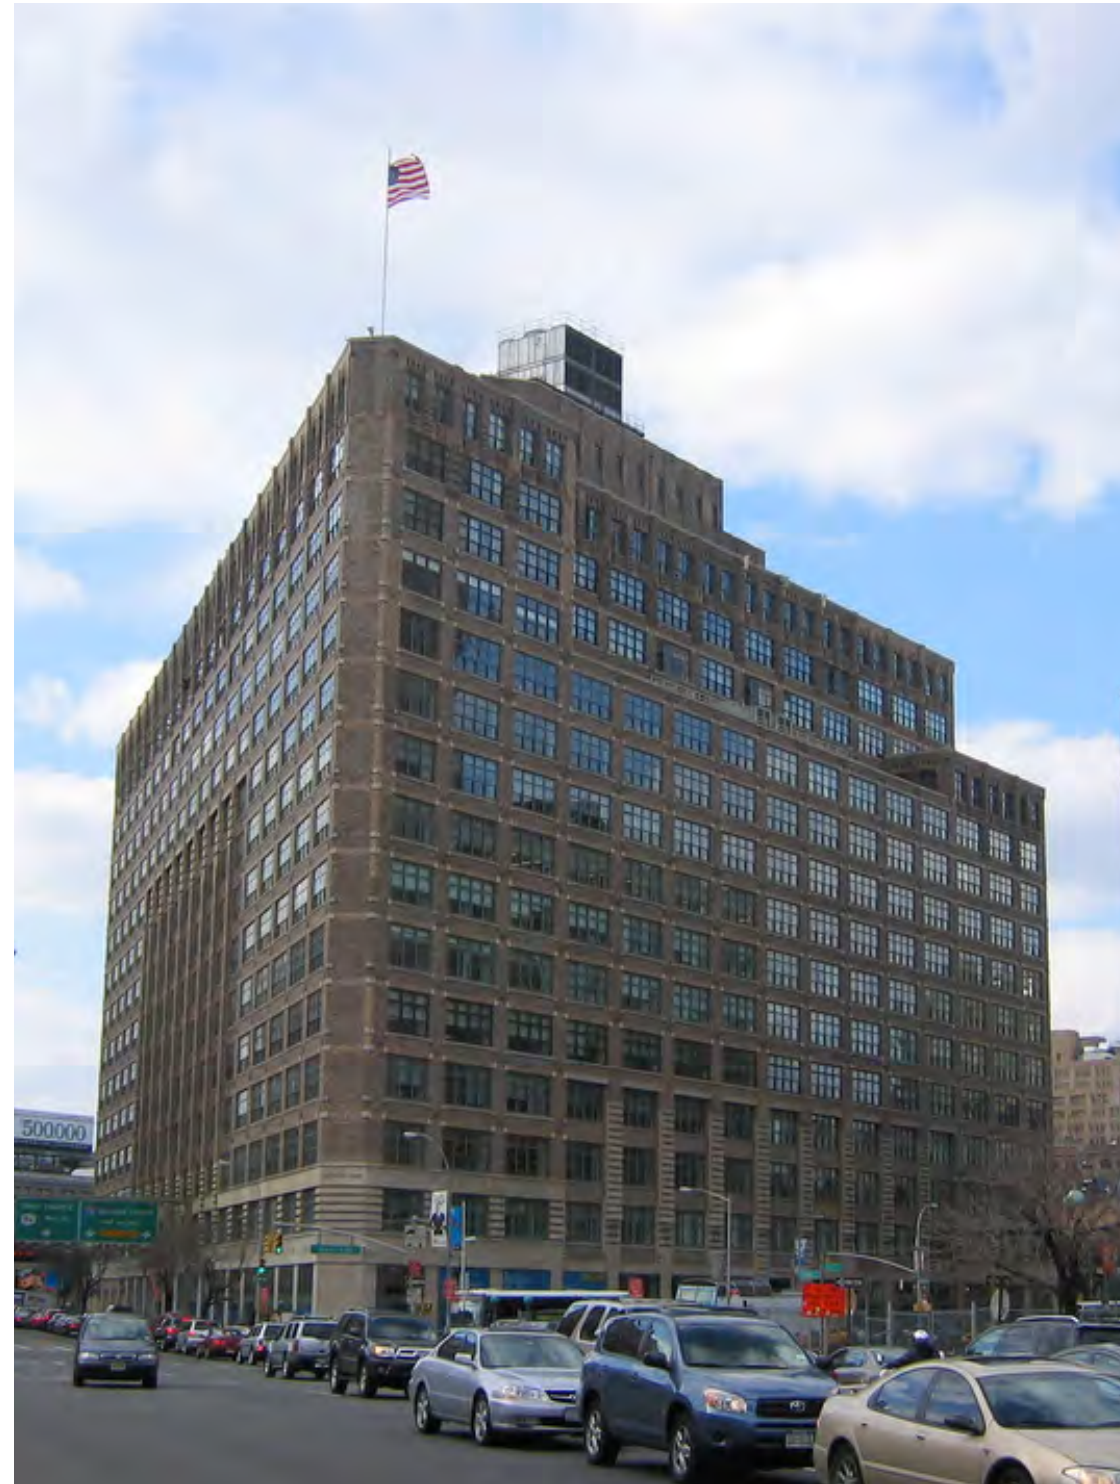
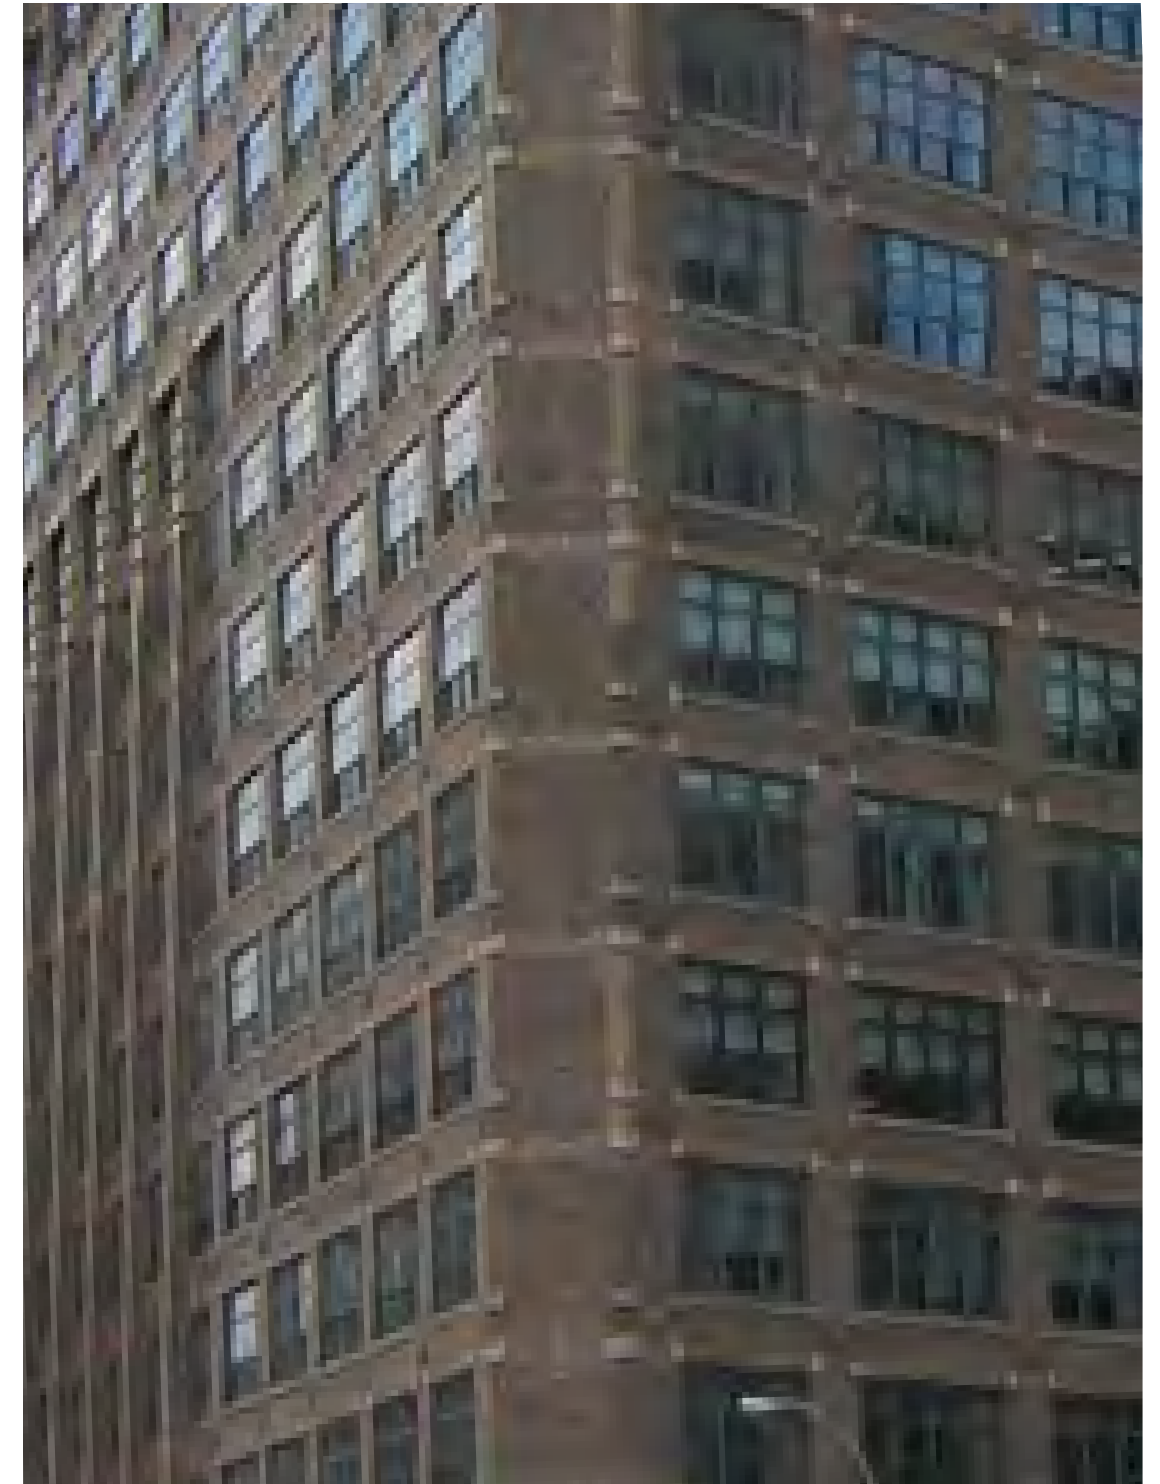
Current Photos

Photo taken of SE corner of 75
Varick Street.
Date Taken: 2016

Enlarged photo showing
current fenestration. Windows
with 3 stacked panels. Bottom
two panels are operational
double hung windows. Color
of existing windows vary from
floor to floor.
