75 Varick Street | Horizon Media

March 16, 2017

Community Board 2 Landmarks Presentation

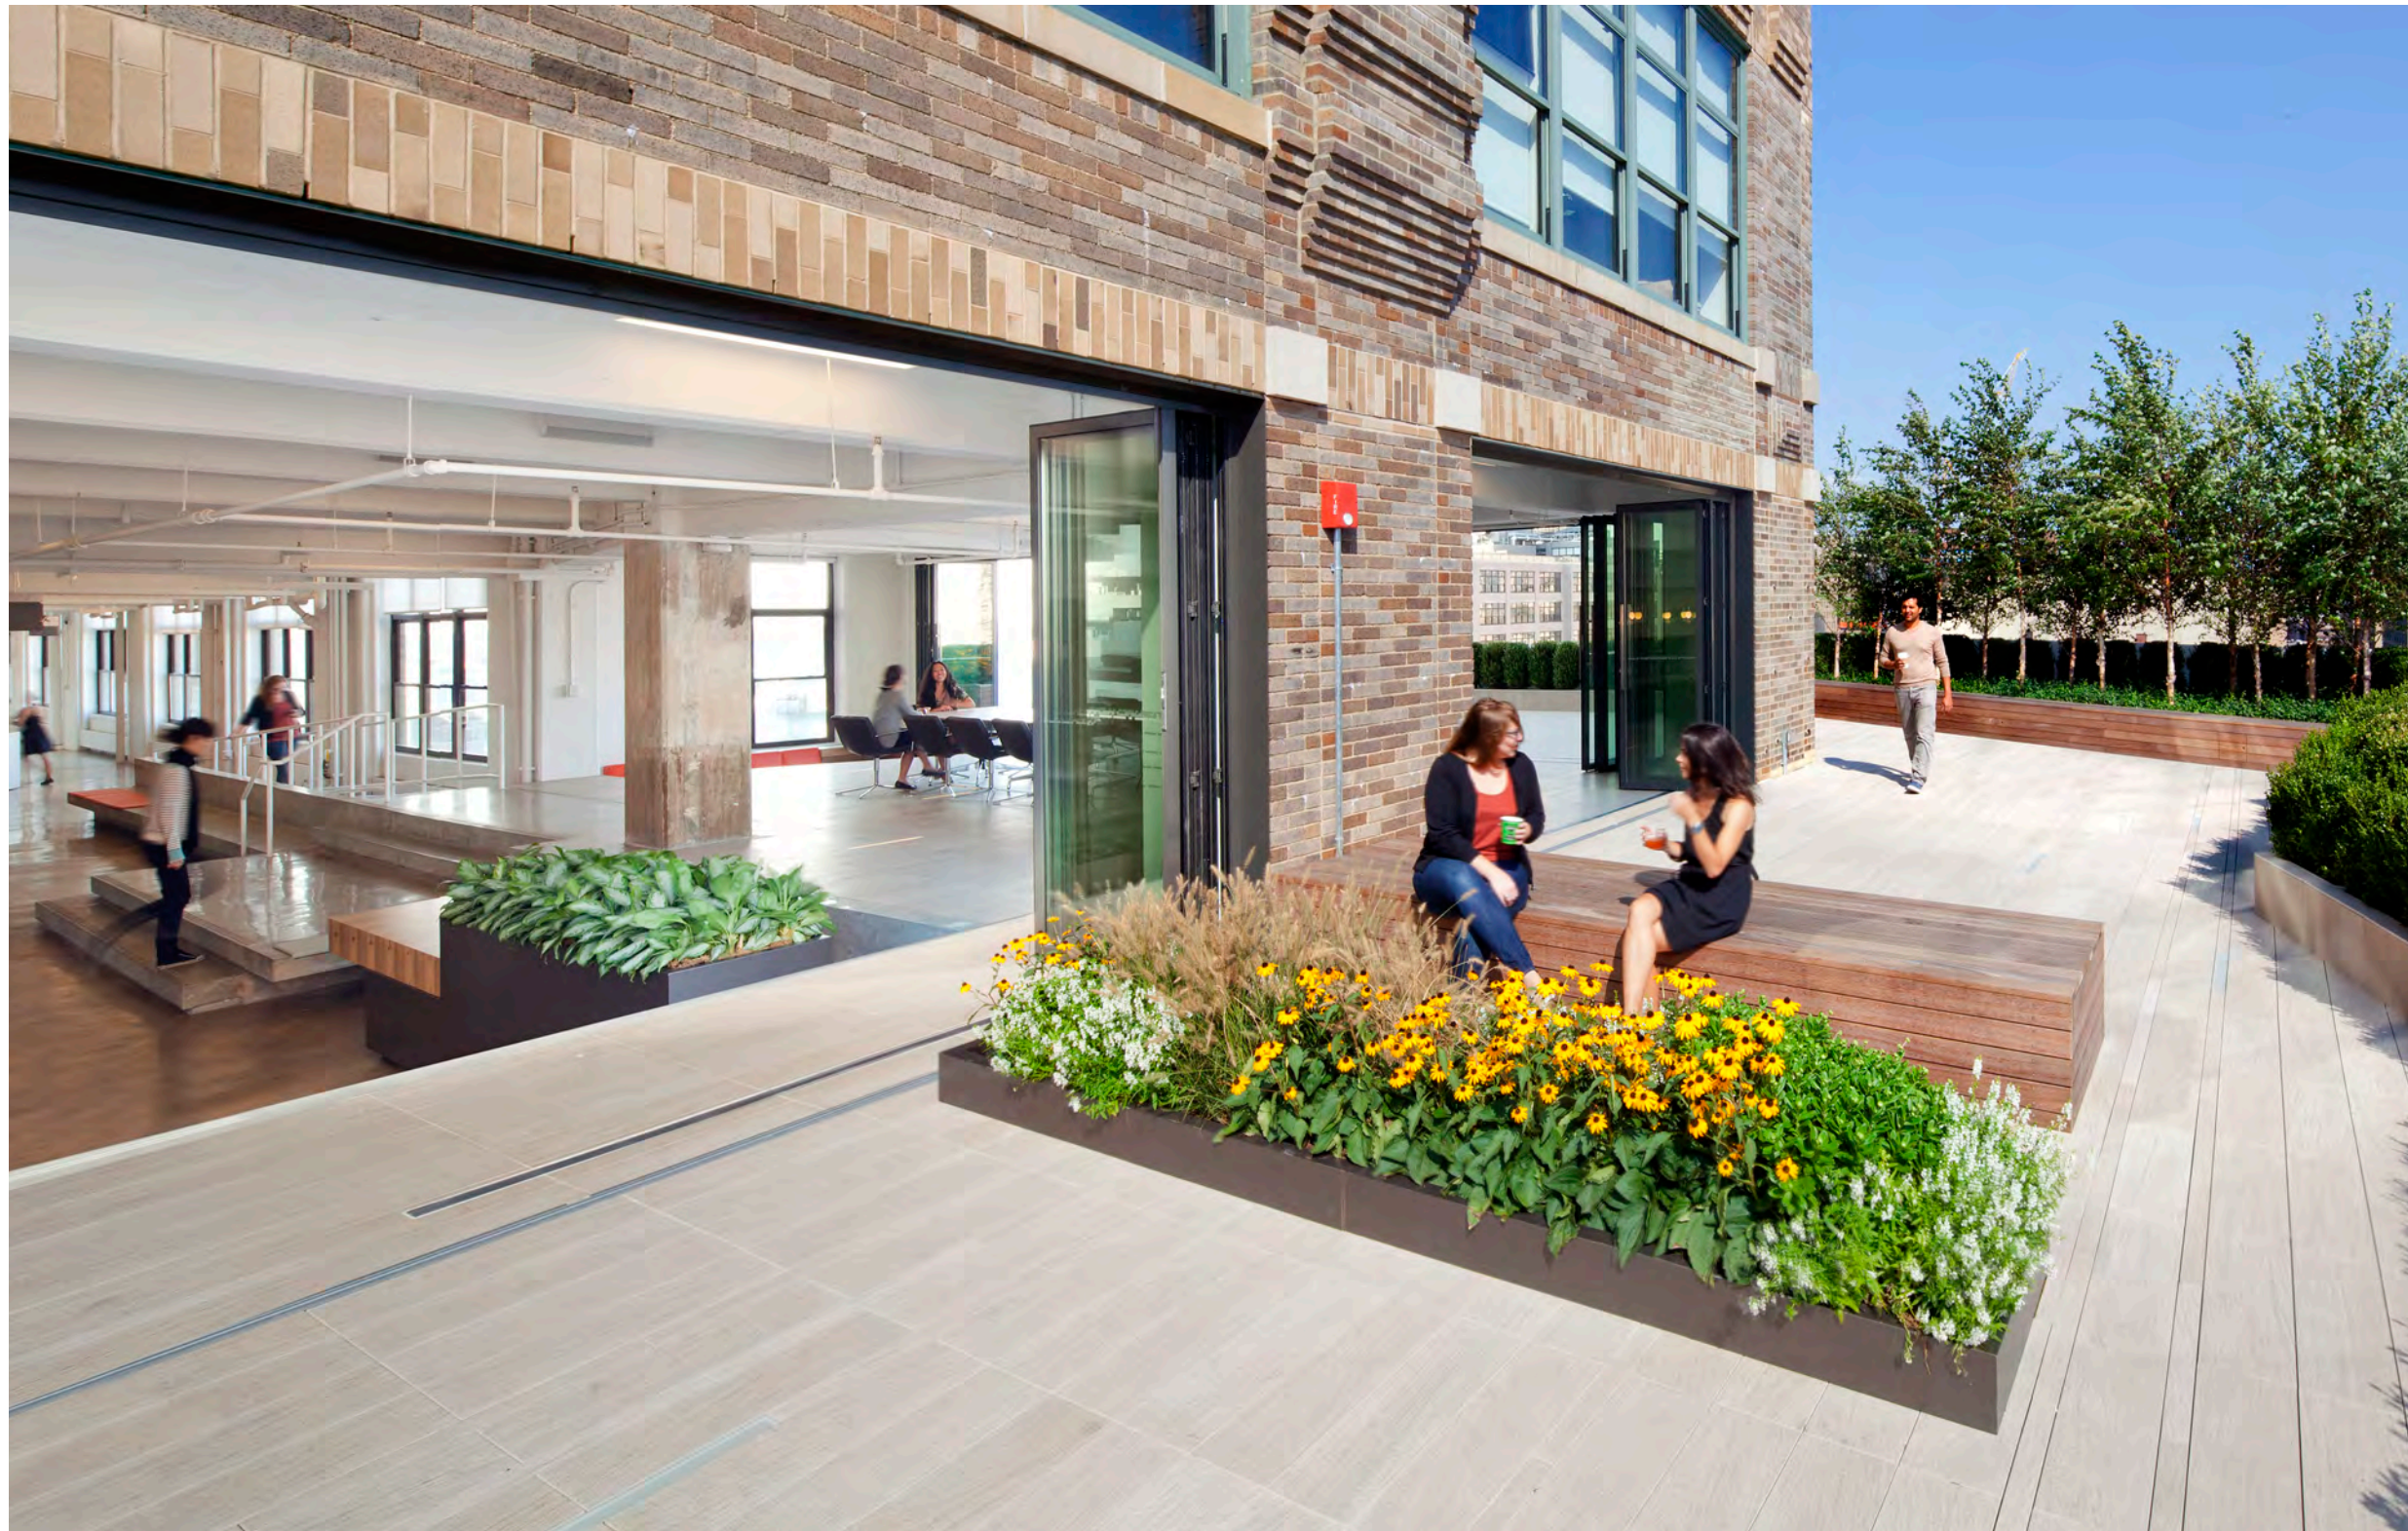
Photo of similar accordion style doors placed in 2011 on the 13th floor terrace at the corner of Varick St and Watts St
