134 SPRING STREET / 84 WOOSTER STREET

EXISTING VS PROPOSED WOOSTER STOREFRONT

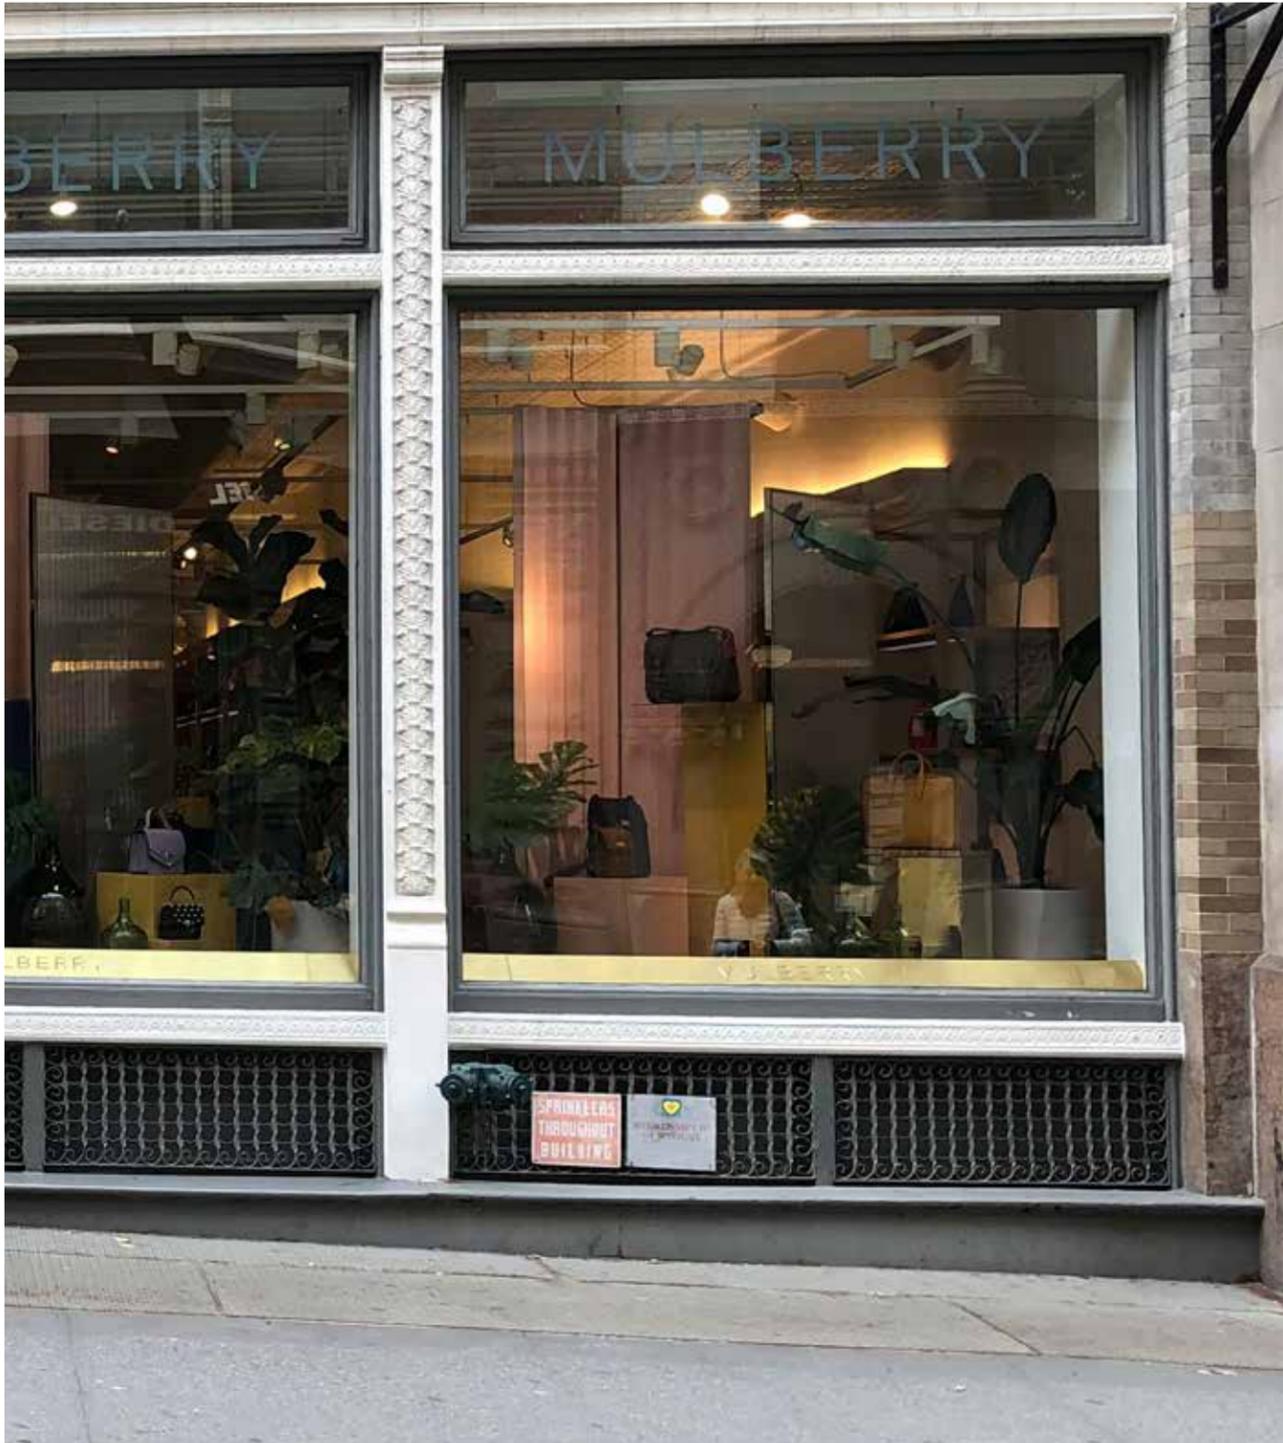
134 SPRING STREET
SINGLE PANEL BULKHEAD

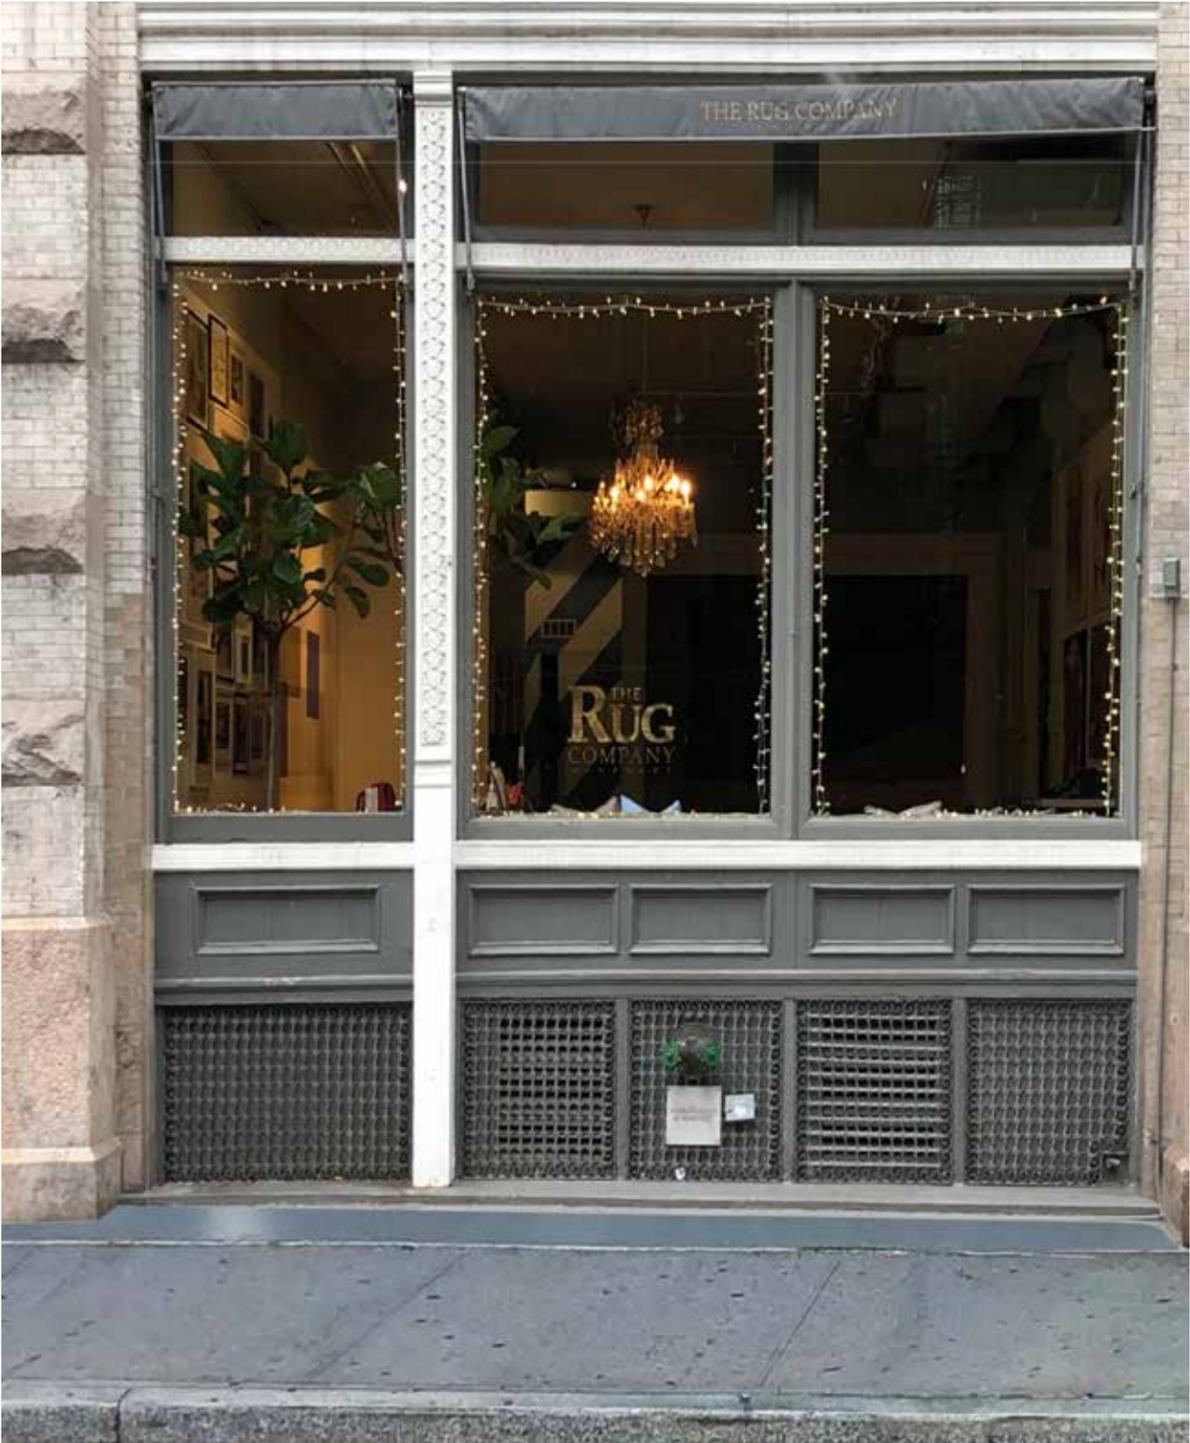
84 WOOSTER STREET
DUAL PANEL BULKHEAD

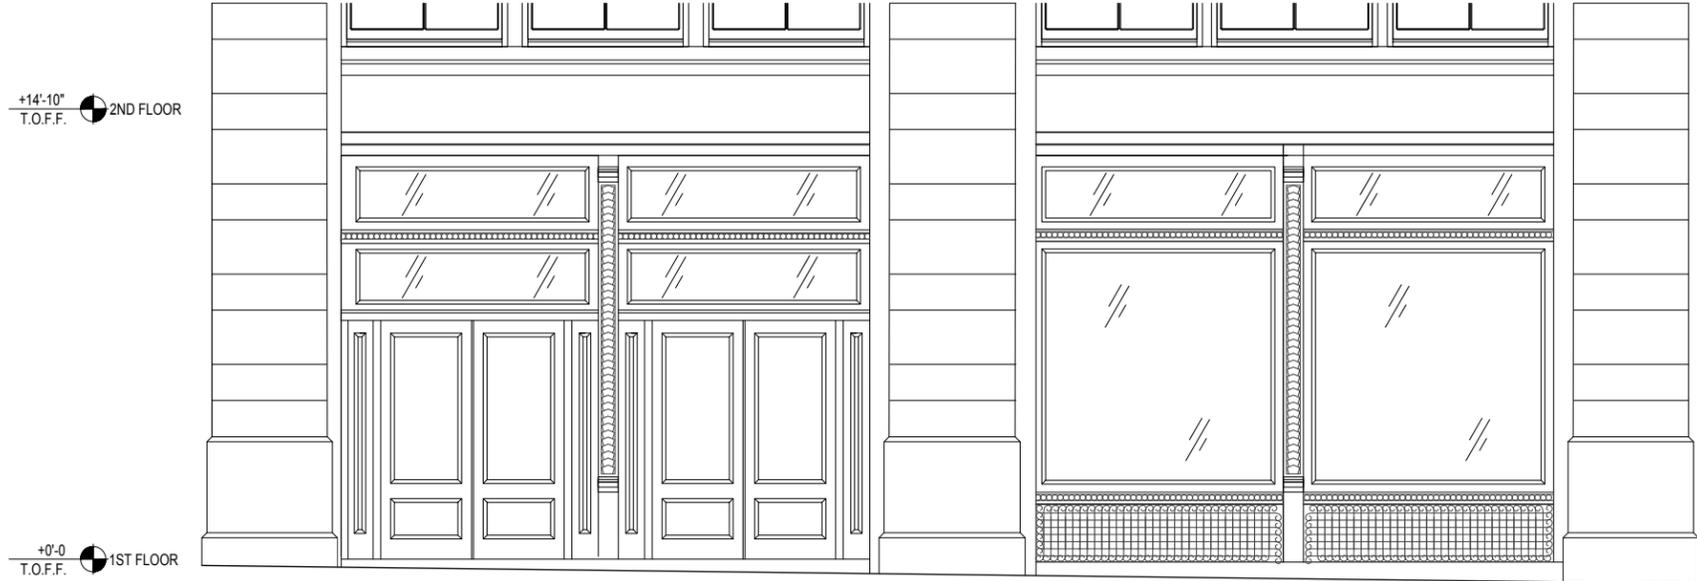
134 SPRING STREET EXISTING STOREFRONT ELEVATION

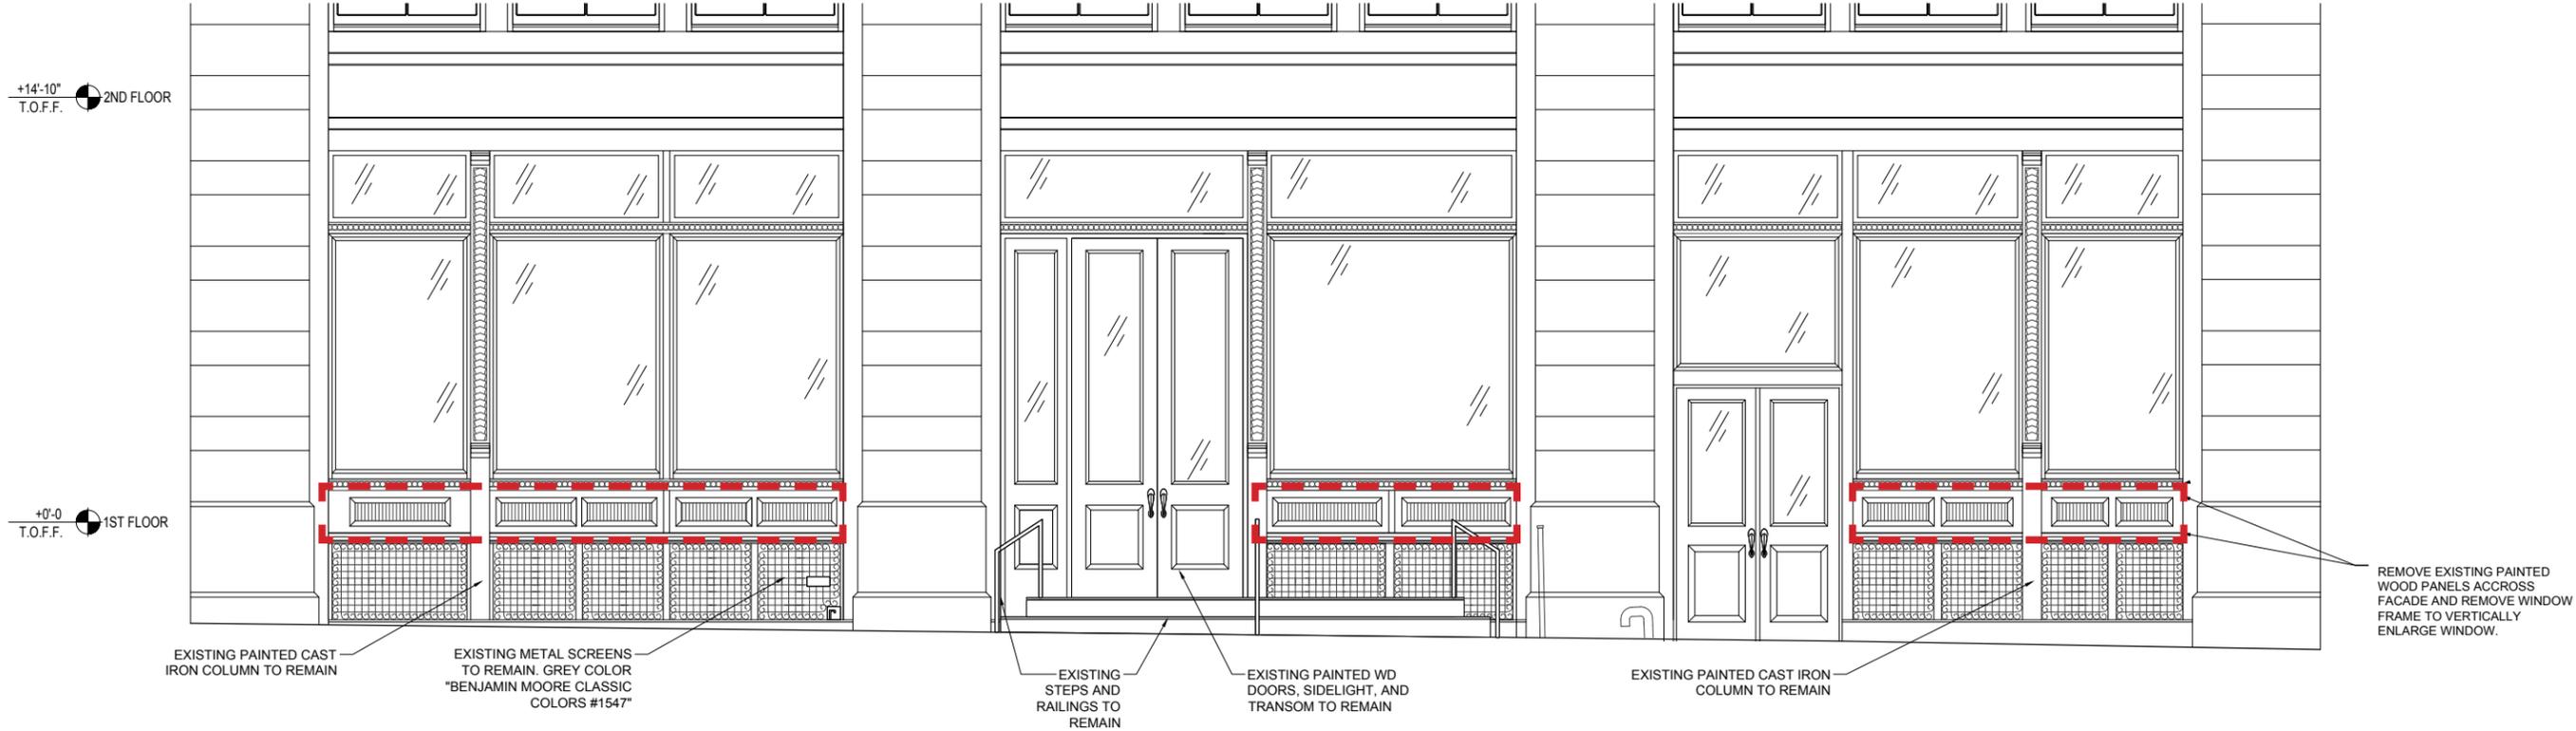
84 WOOSTER STREET EXISTING STOREFRONT ELEVATION

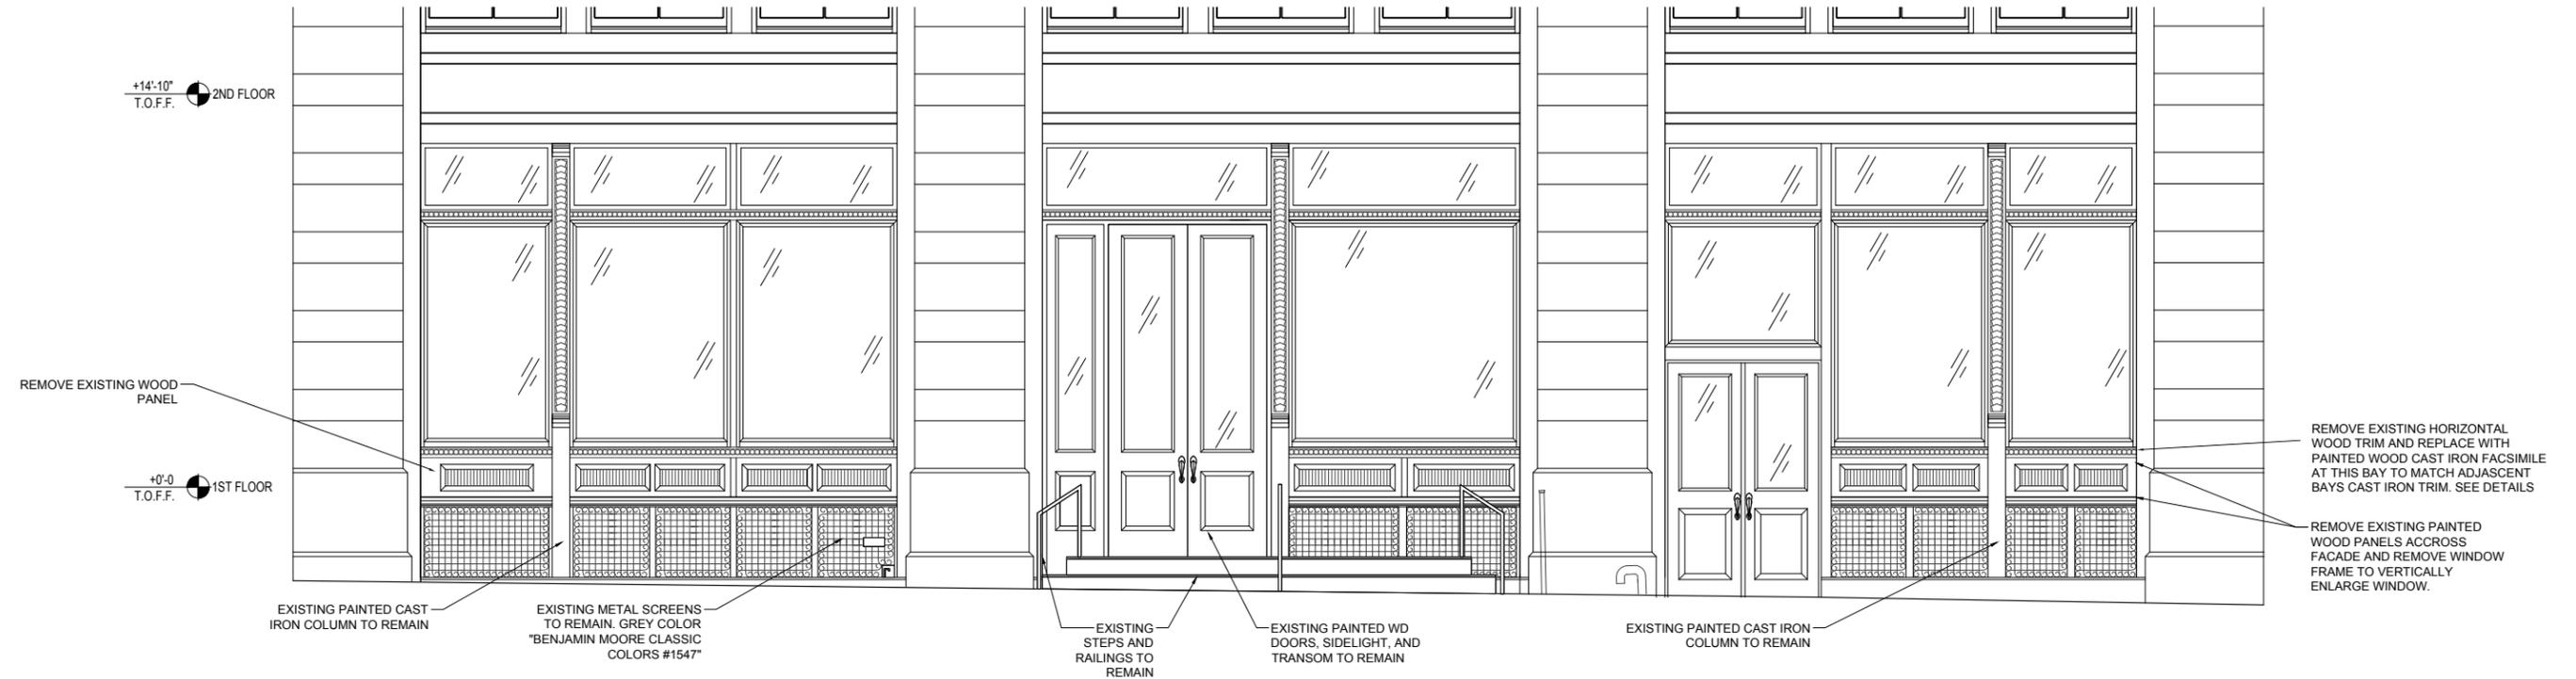
EXISTING STOREFRONT ELEVATION

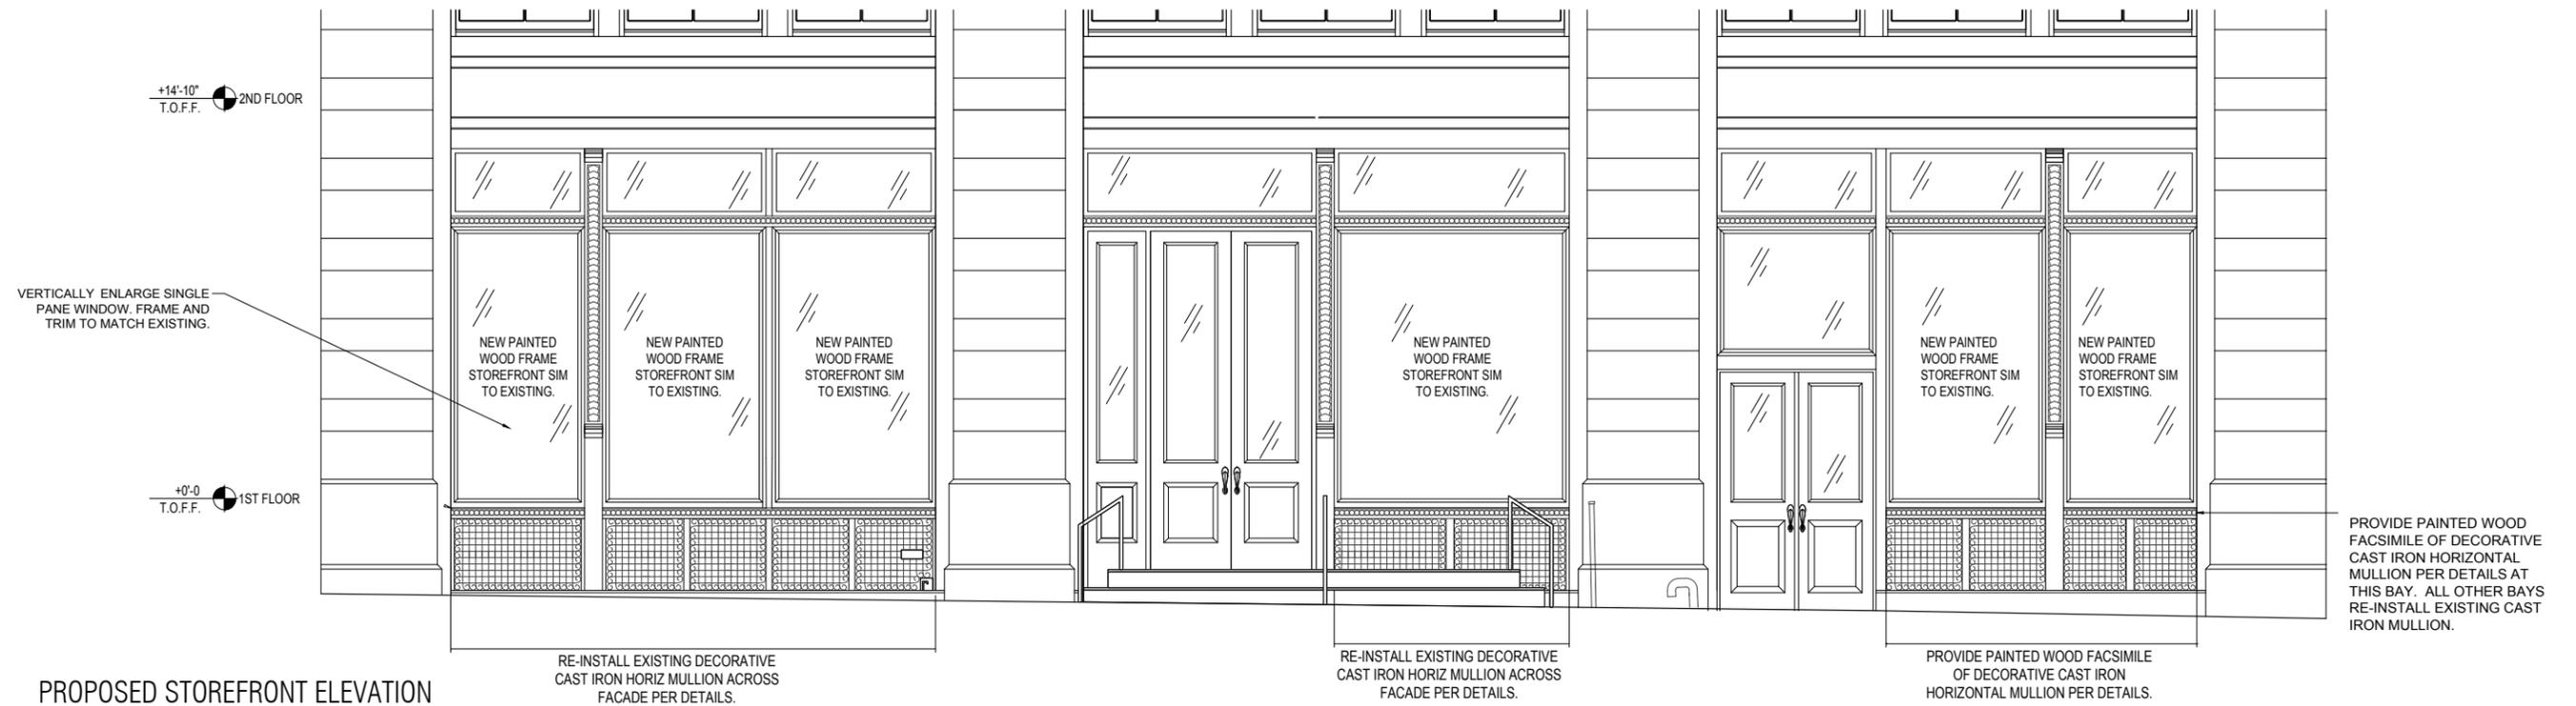
PROPOSED STOREFRONT ELEVATION

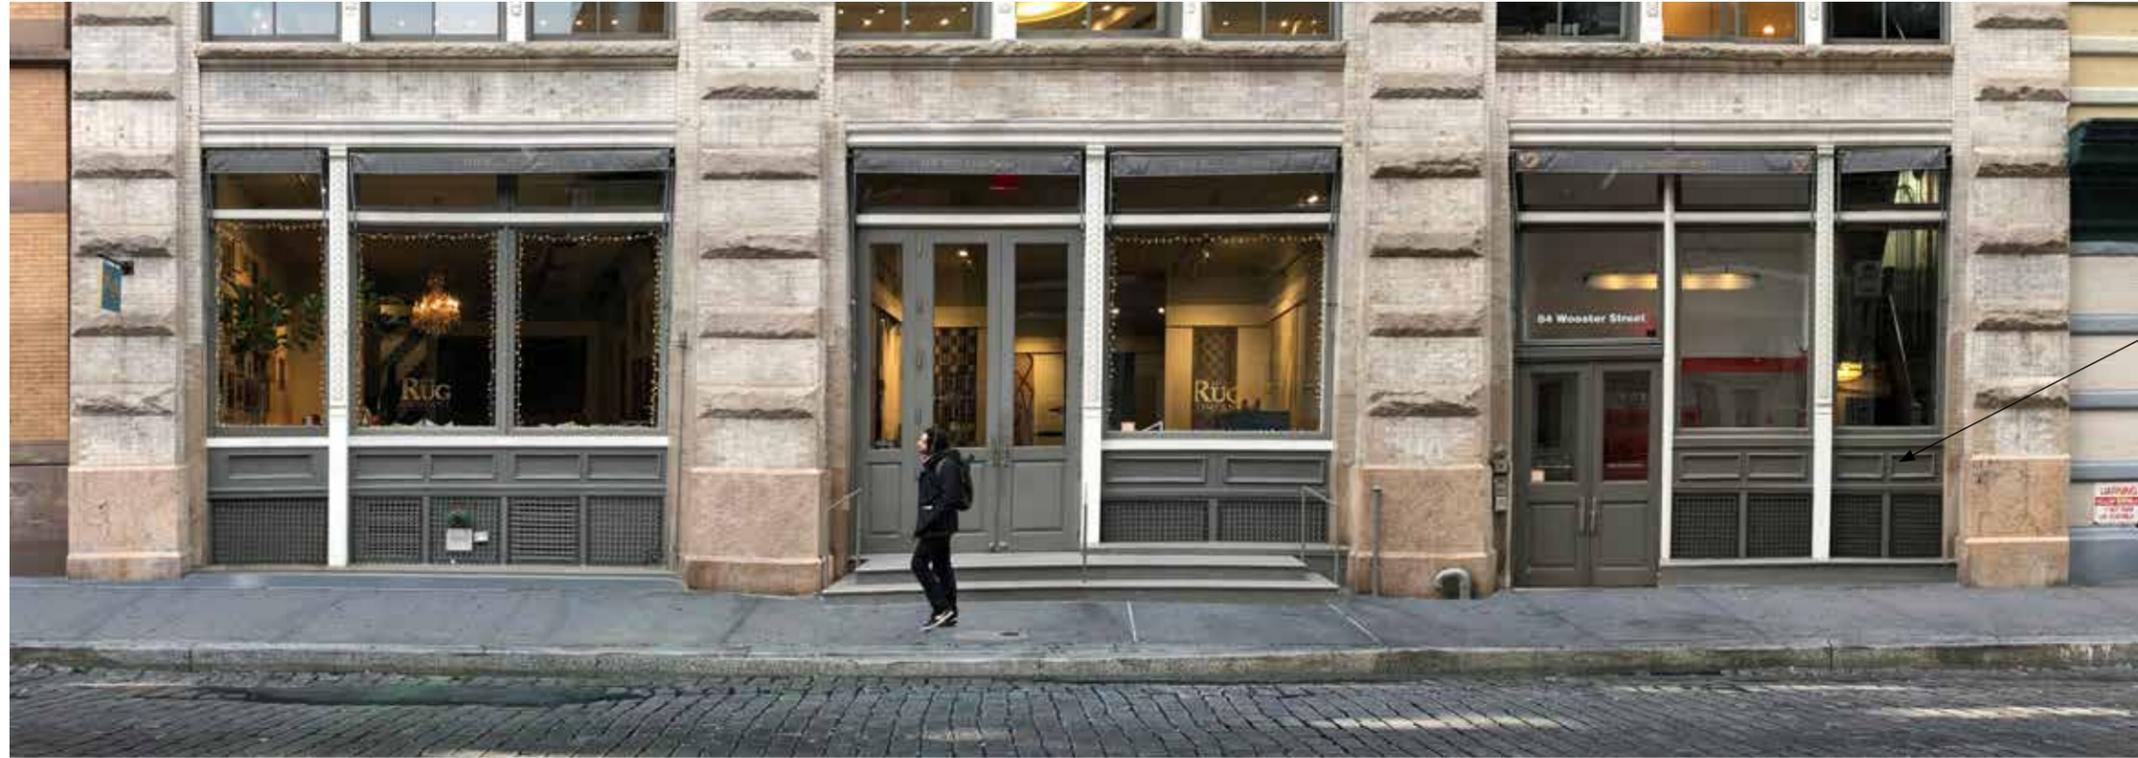
REMOVE BULKHEAD INFILL PANEL

EXISTING STOREFRONT

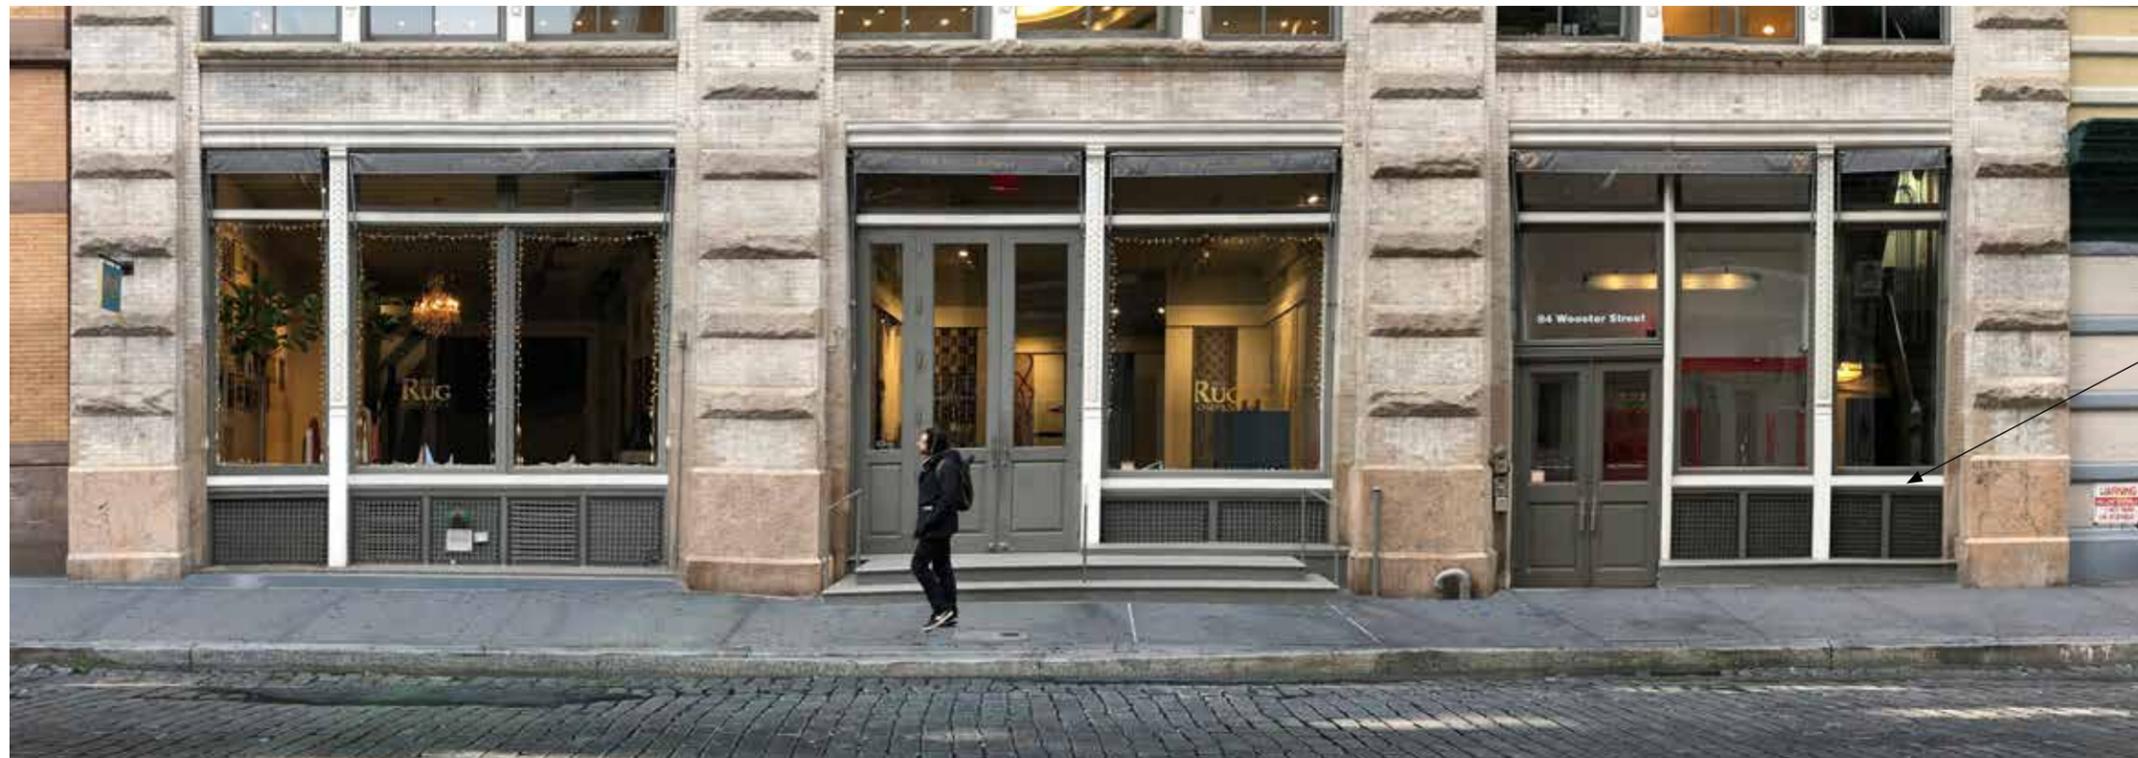
VERTICALLY ENLARGE SINGLE PANE WINDOW & FABRICATE NEW TRIM PIECE.

PROPOSED STOREFRONT

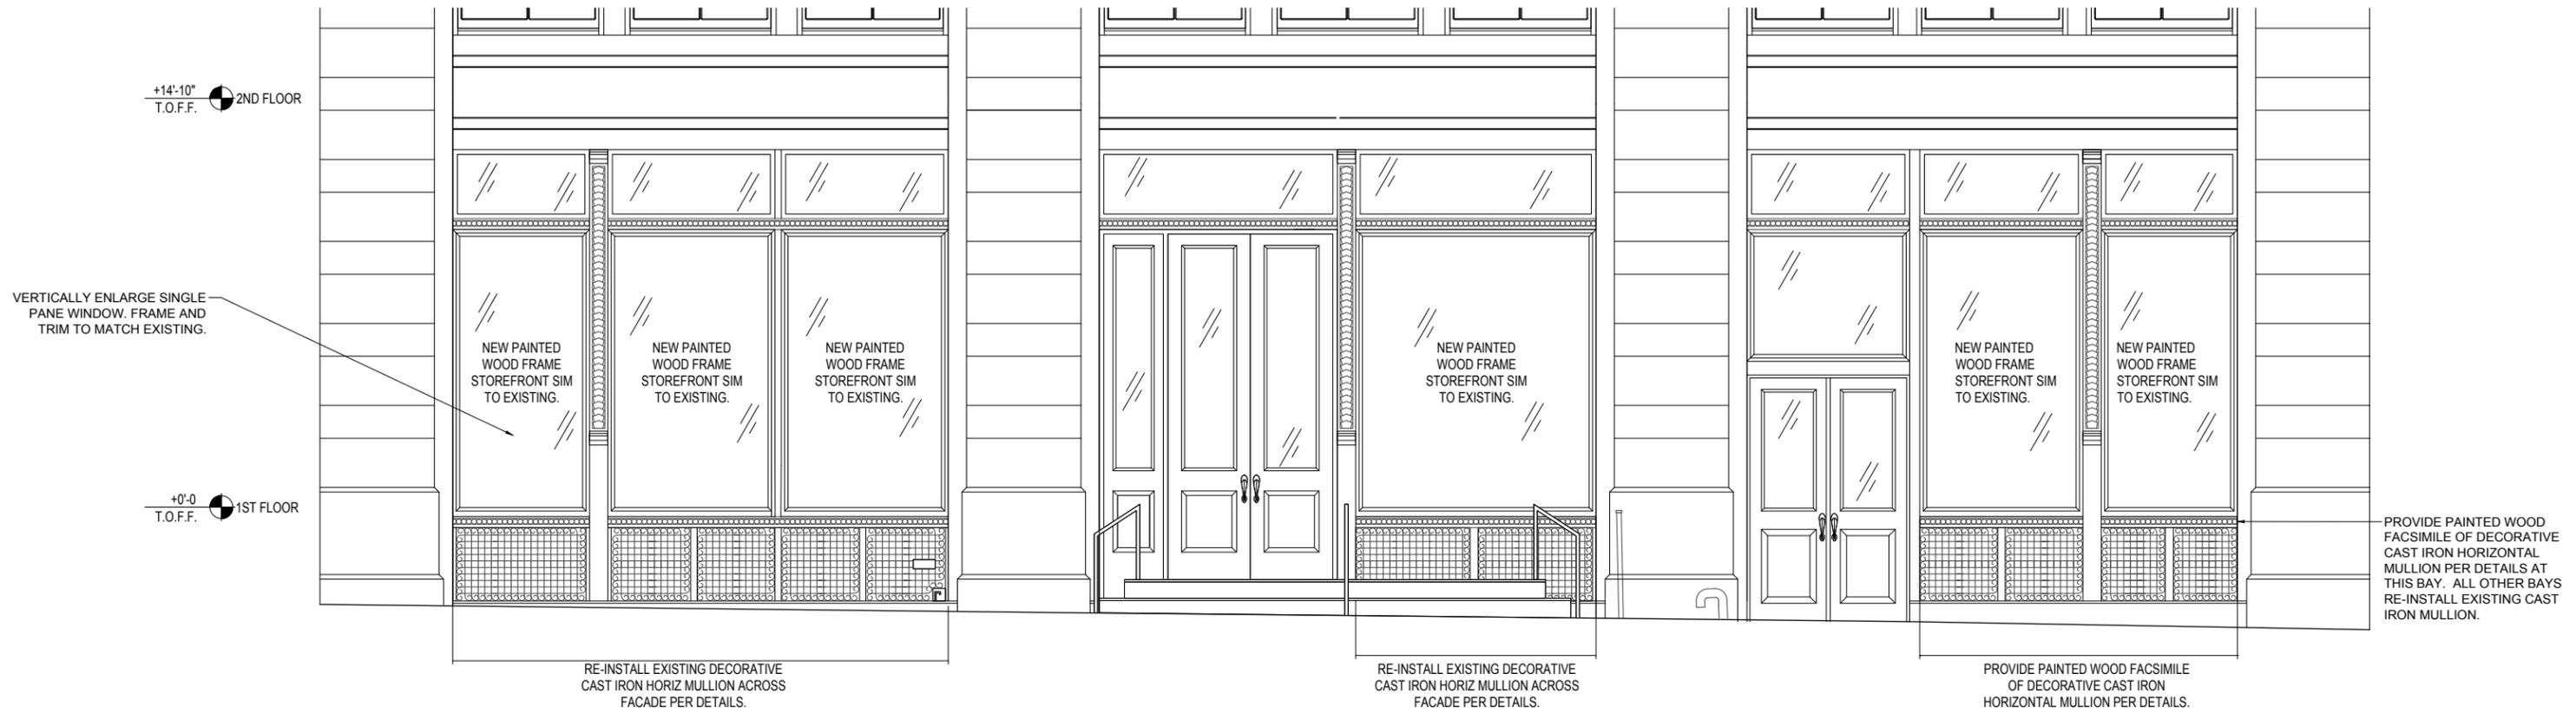
PROPOSED STOREFRONT ELEVATION

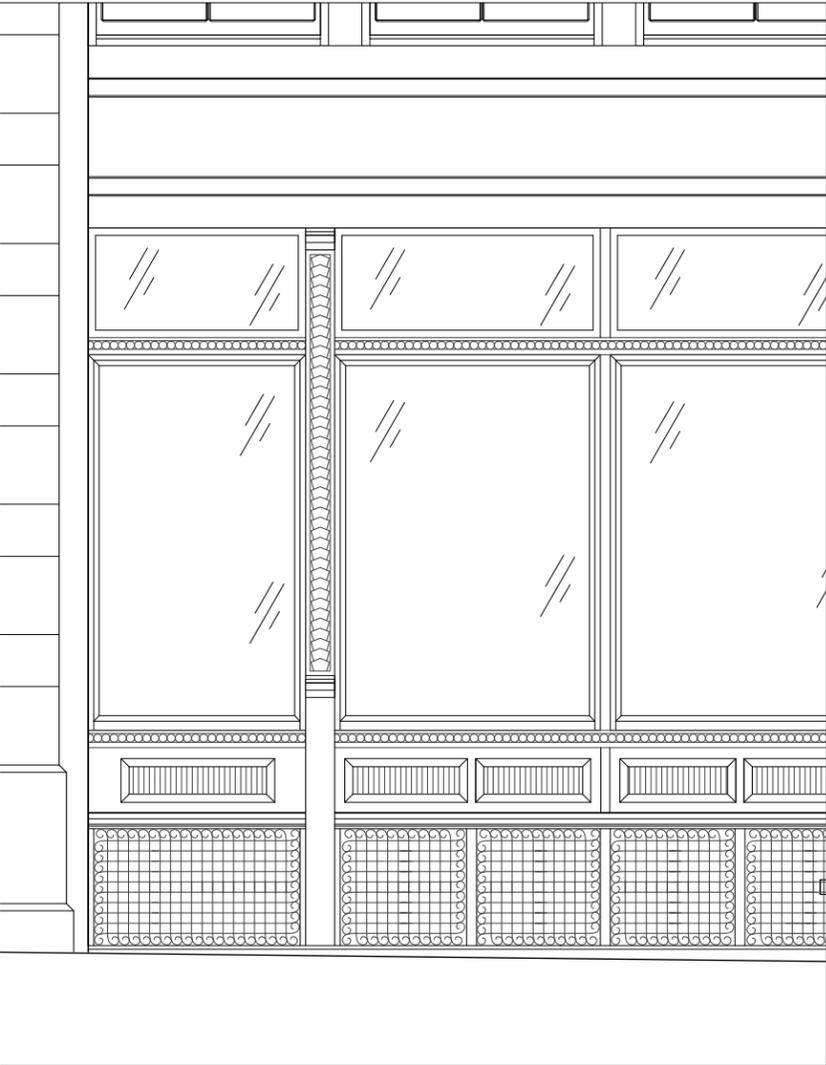
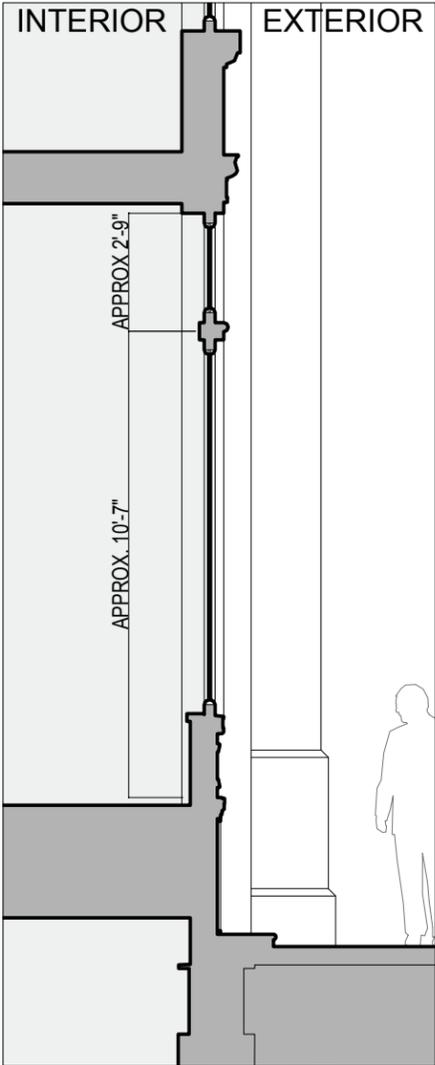
EXISTING CONDITION

SECTION A

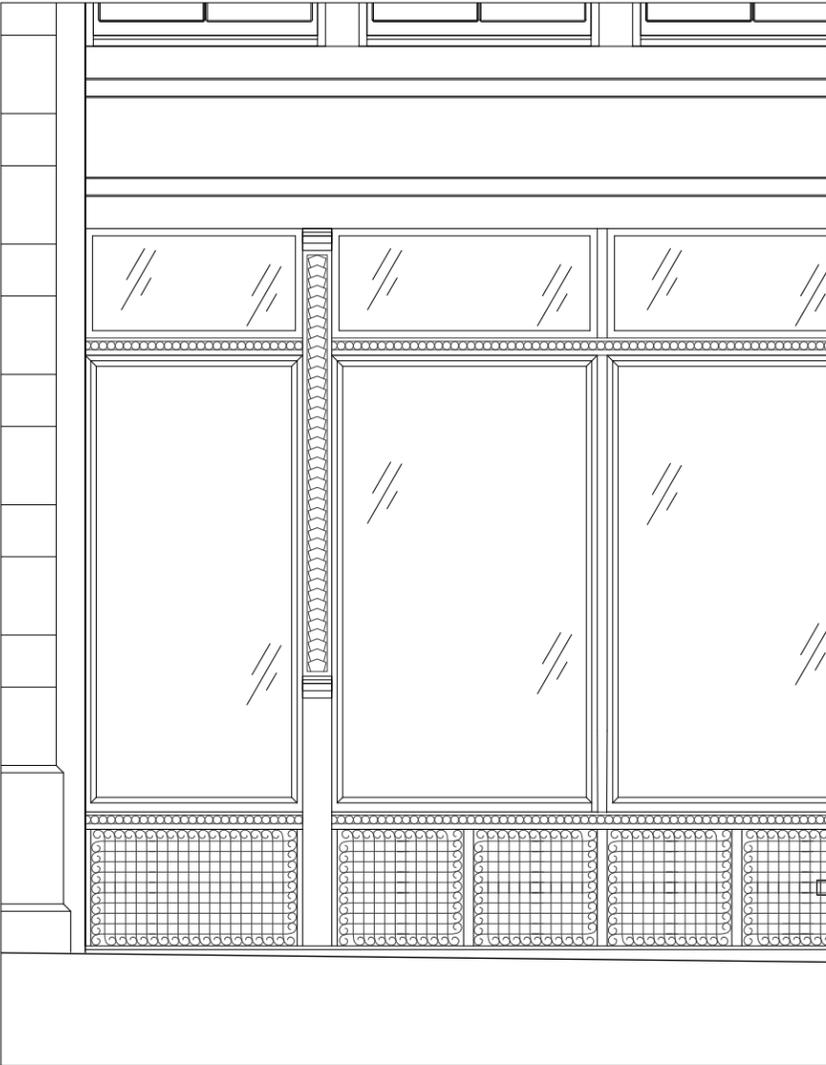
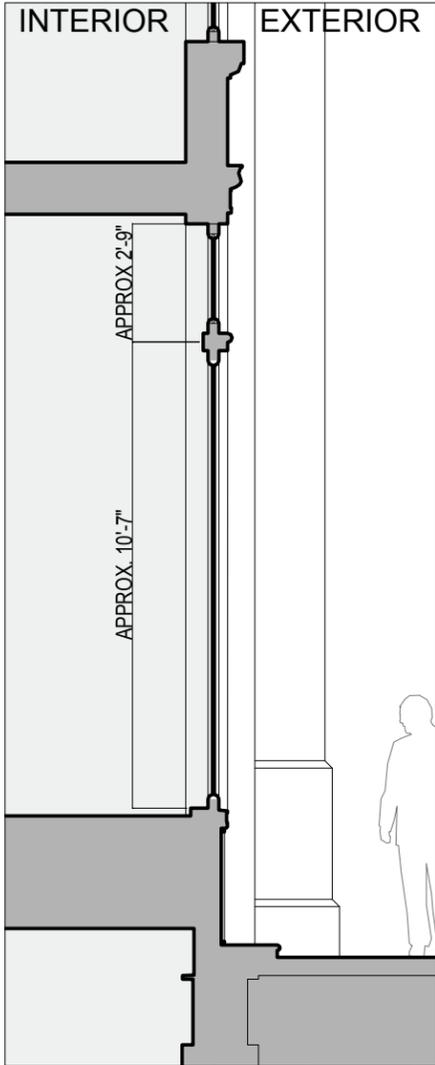
PROPOSED CONDITION

SECTION A

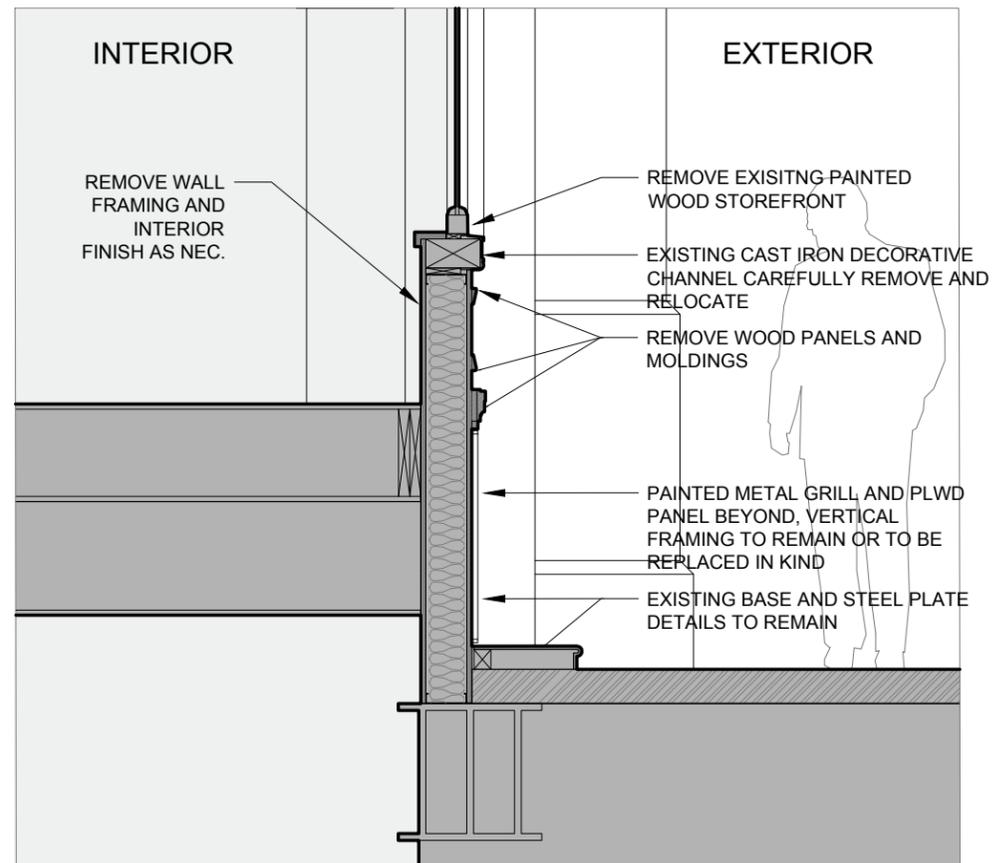
EXISTING CONDITION
SECTION A

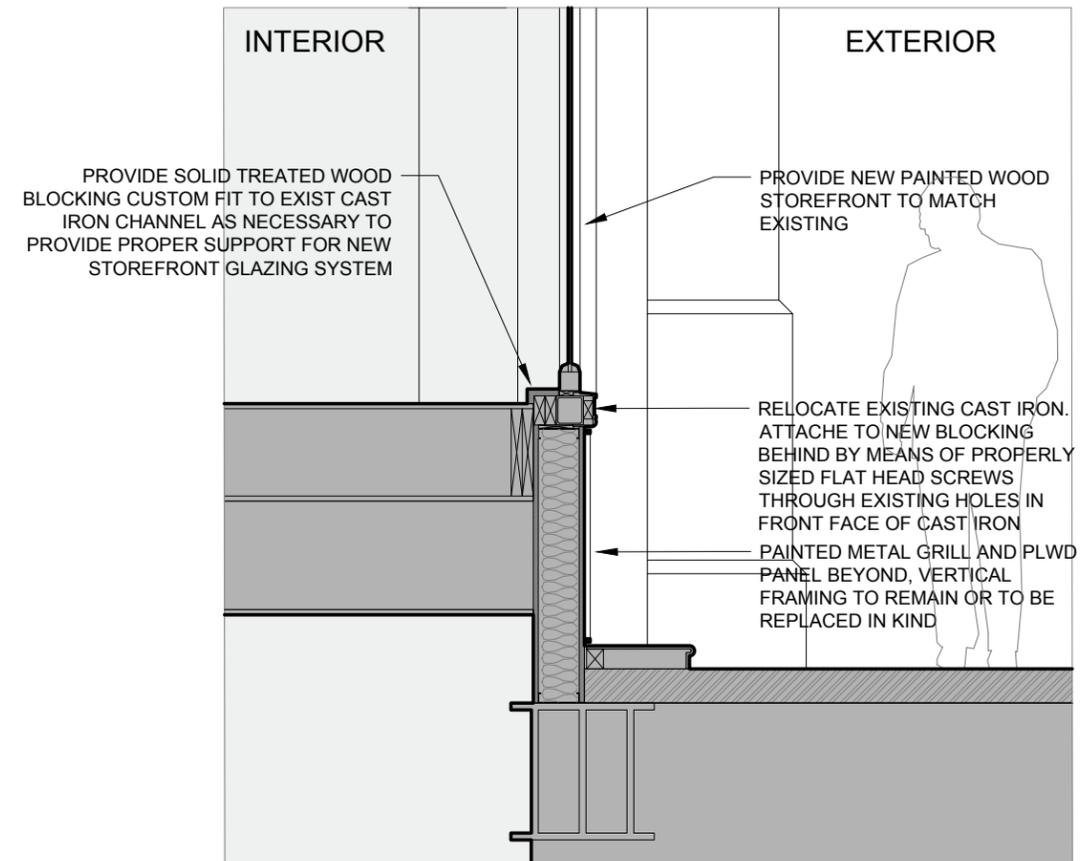
PROPOSED CONDITION
SECTION A

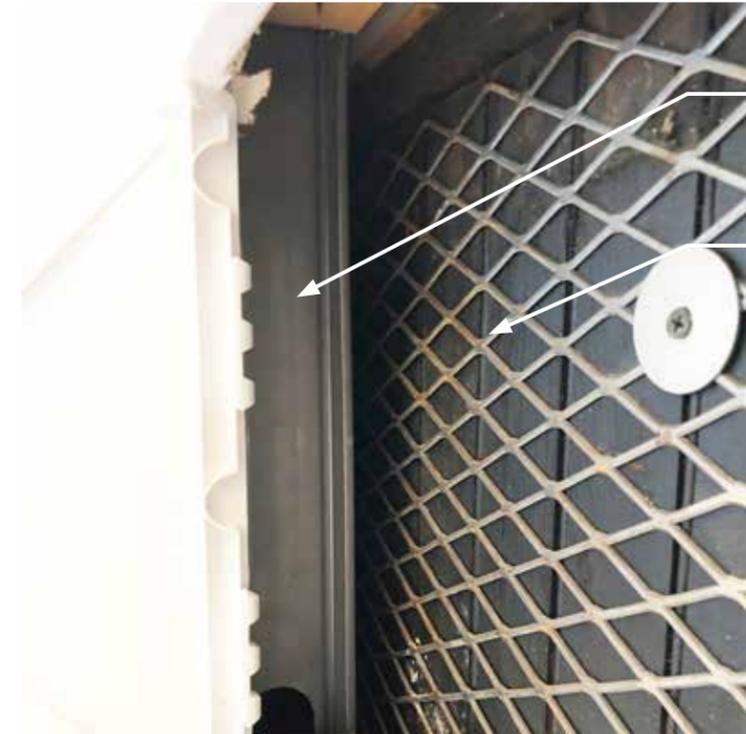
NEW STEEL STUD CONSTRUCTION (NOT ORIGINAL)
MODERN PLYWOOD BEADBOARD AND STEEL LATH

WALL ASSEMBLY DETAIL PHOTO

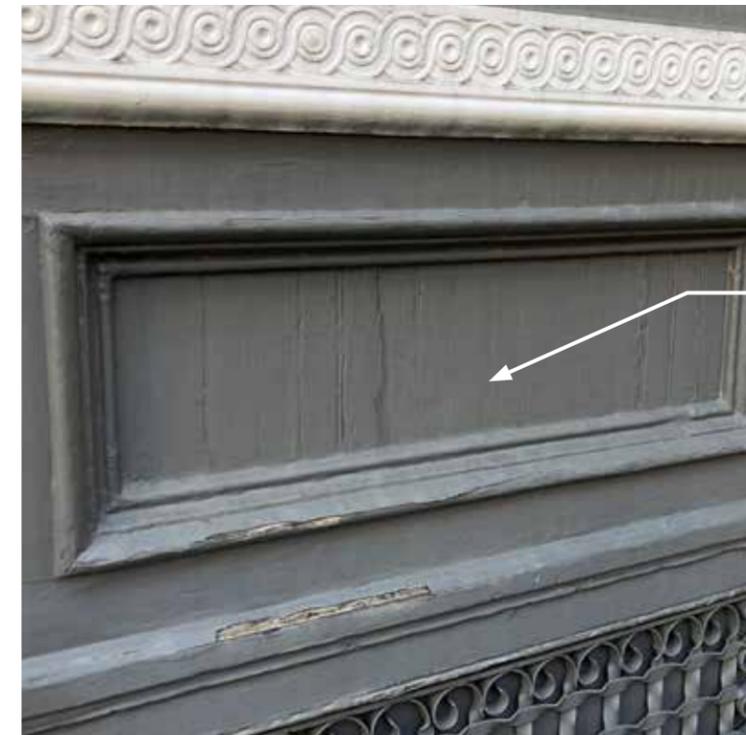
PLYWOOD BEADBOARD AND TRIM ATTACHED TO NEW STEEL STUD (NOT ORIGINAL)

WALL MATERIAL DETAIL PHOTO

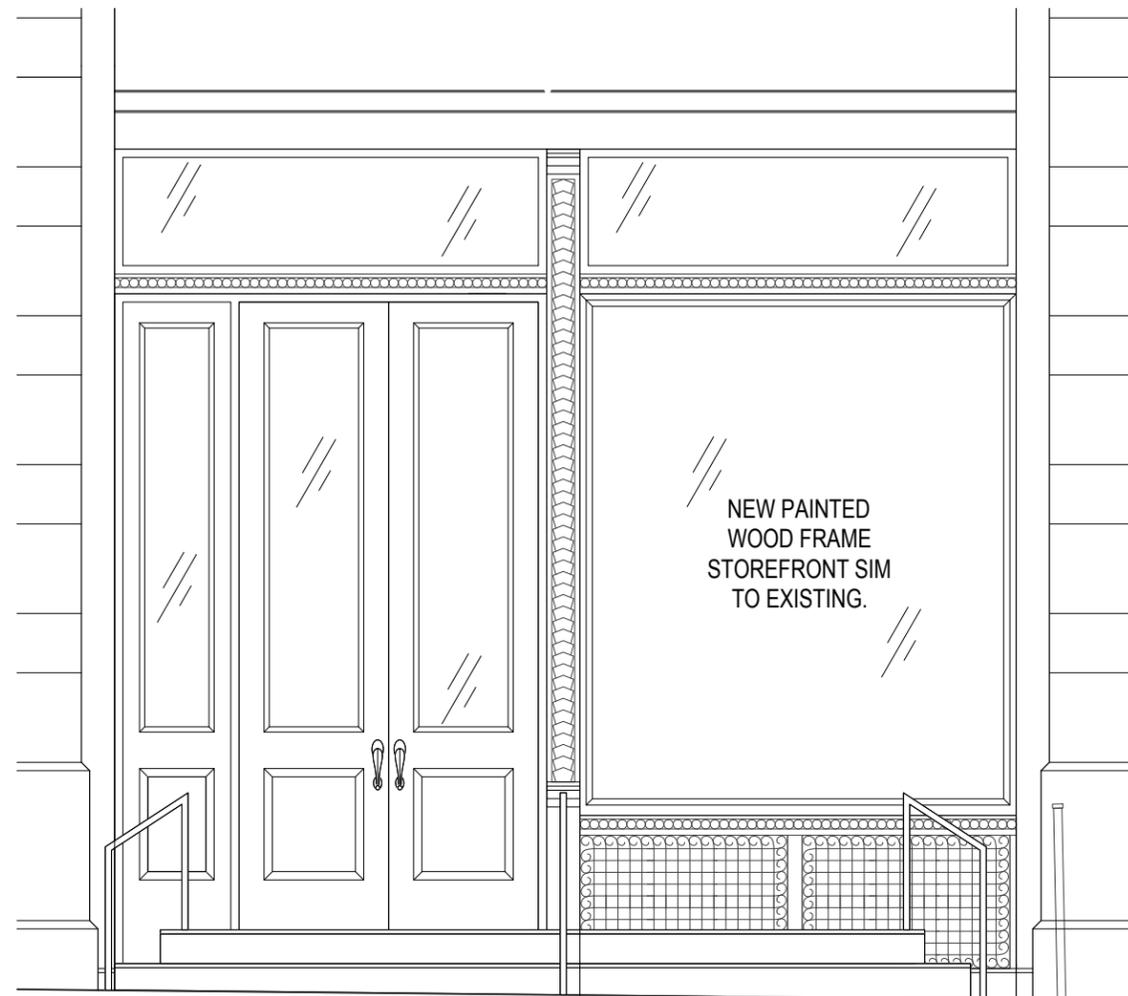
RE-INSTALL EXIST DECORATIVE CAST IRON HORIZ MULLION ACROSS FACADE PER DETAILS.

RETAIL LOBBY ELEVATION
