134 SPRING STREET / 84 WOOSTER STREET

EXISTING VS PROPOSED WOOSTER STOREFRONT

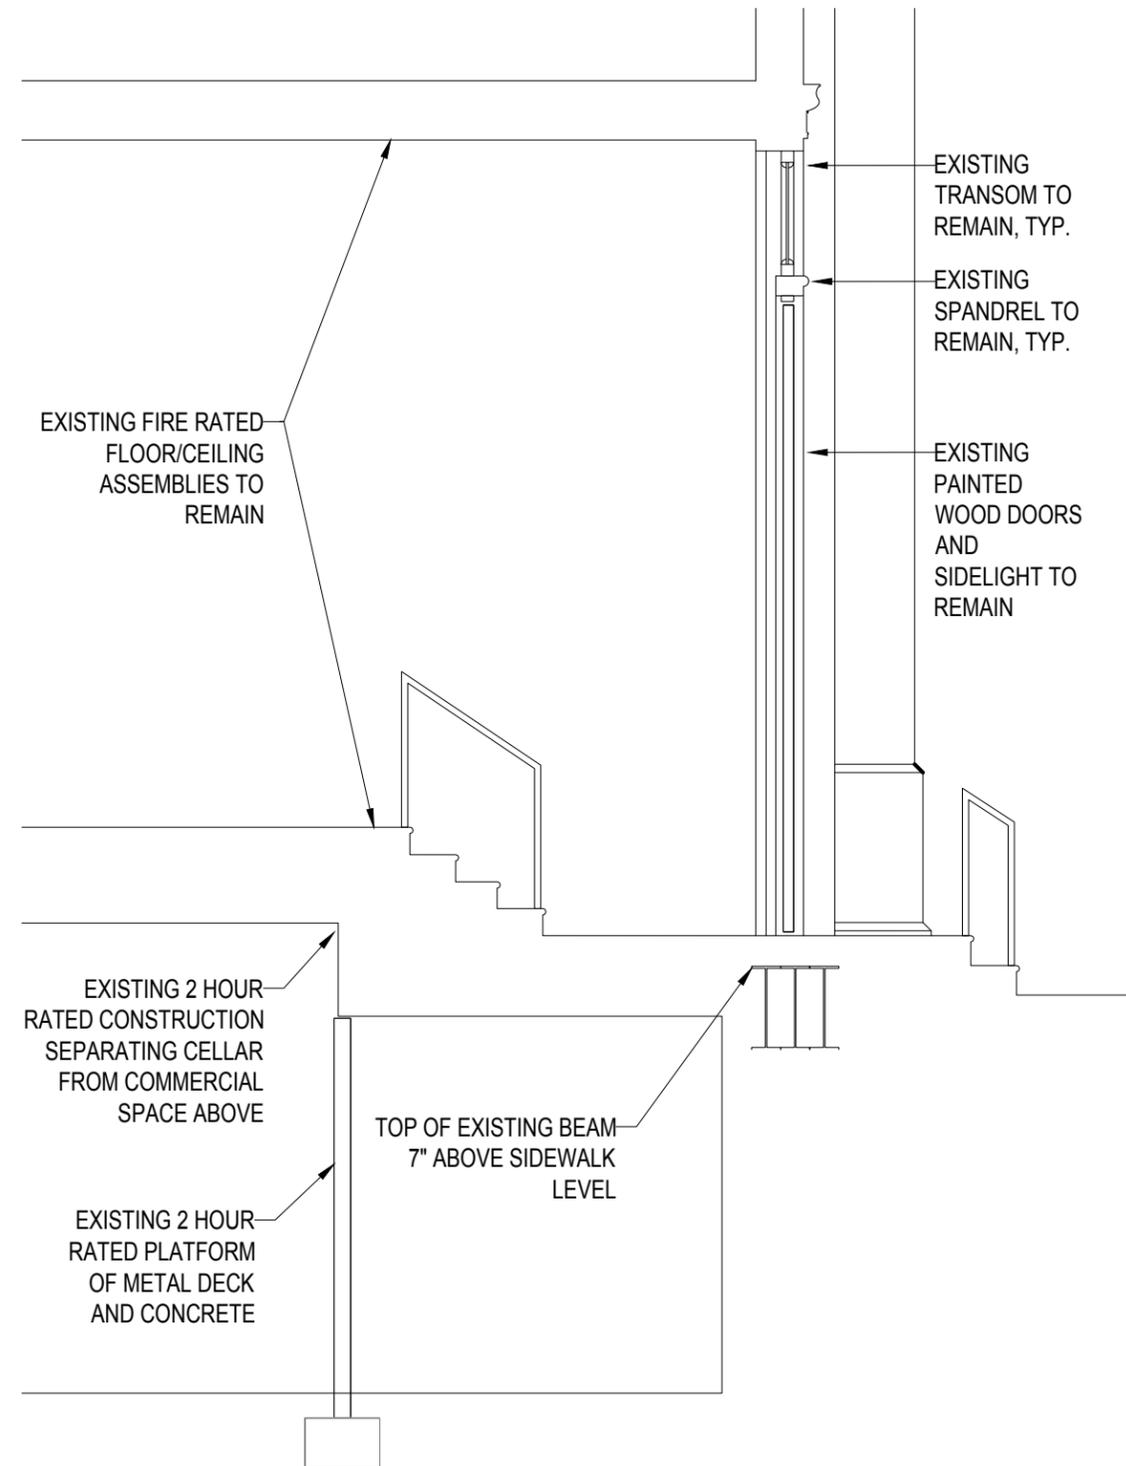
EXISTING FIRE RATED FLOOR/CEILING ASSEMBLIES TO REMAIN

EXISTING TRANSOM TO REMAIN, TYP.

EXISTING SPANDREL TO REMAIN, TYP.

EXISTING PAINTED WOOD DOORS AND SIDELIGHT TO REMAIN

EXISTING 2 HOUR RATED CONSTRUCTION SEPARATING CELLAR FROM COMMERCIAL SPACE ABOVE

EXISTING 2 HOUR RATED PLATFORM OF METAL DECK AND CONCRETE

TOP OF EXISTING BEAM 7" ABOVE SIDEWALK LEVEL

RETAIL LOBBY SECTION

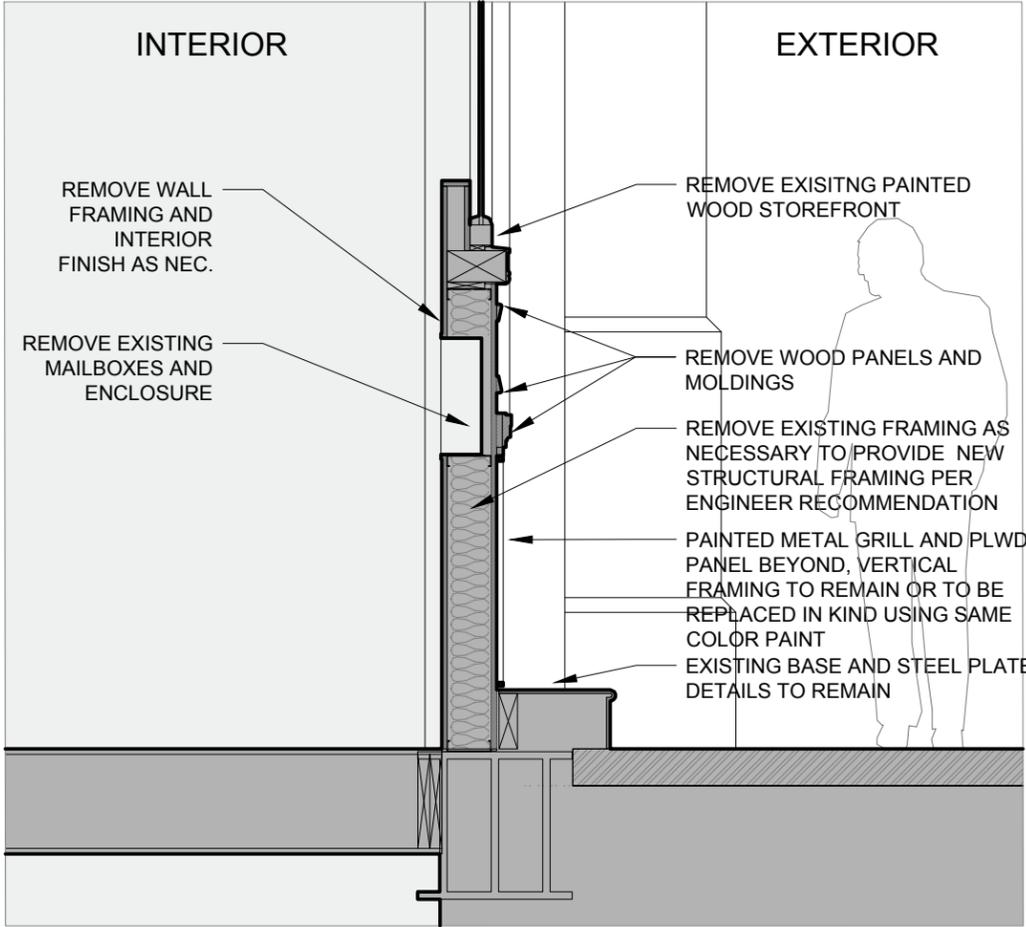
EXISTING CONDITION
SECTION C

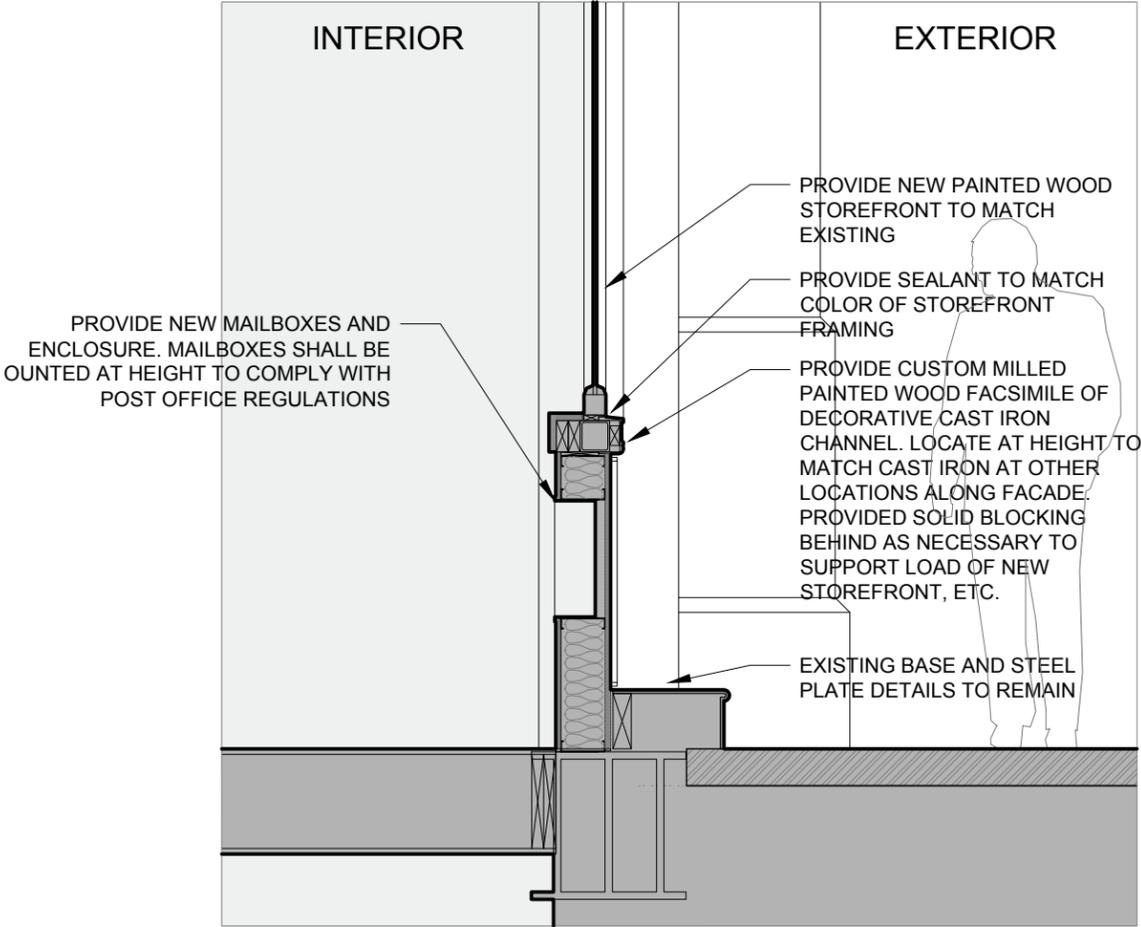
PROPOSED CONDITION
SECTION C
