769 GREENWICH STREET

PROPOSAL FOR RELOCATING ROOFTOP BULKHEAD AND ADDING GLAZED ENCLOSURE TO THE THIRD FLOOR BALCONY

APRIL 2017

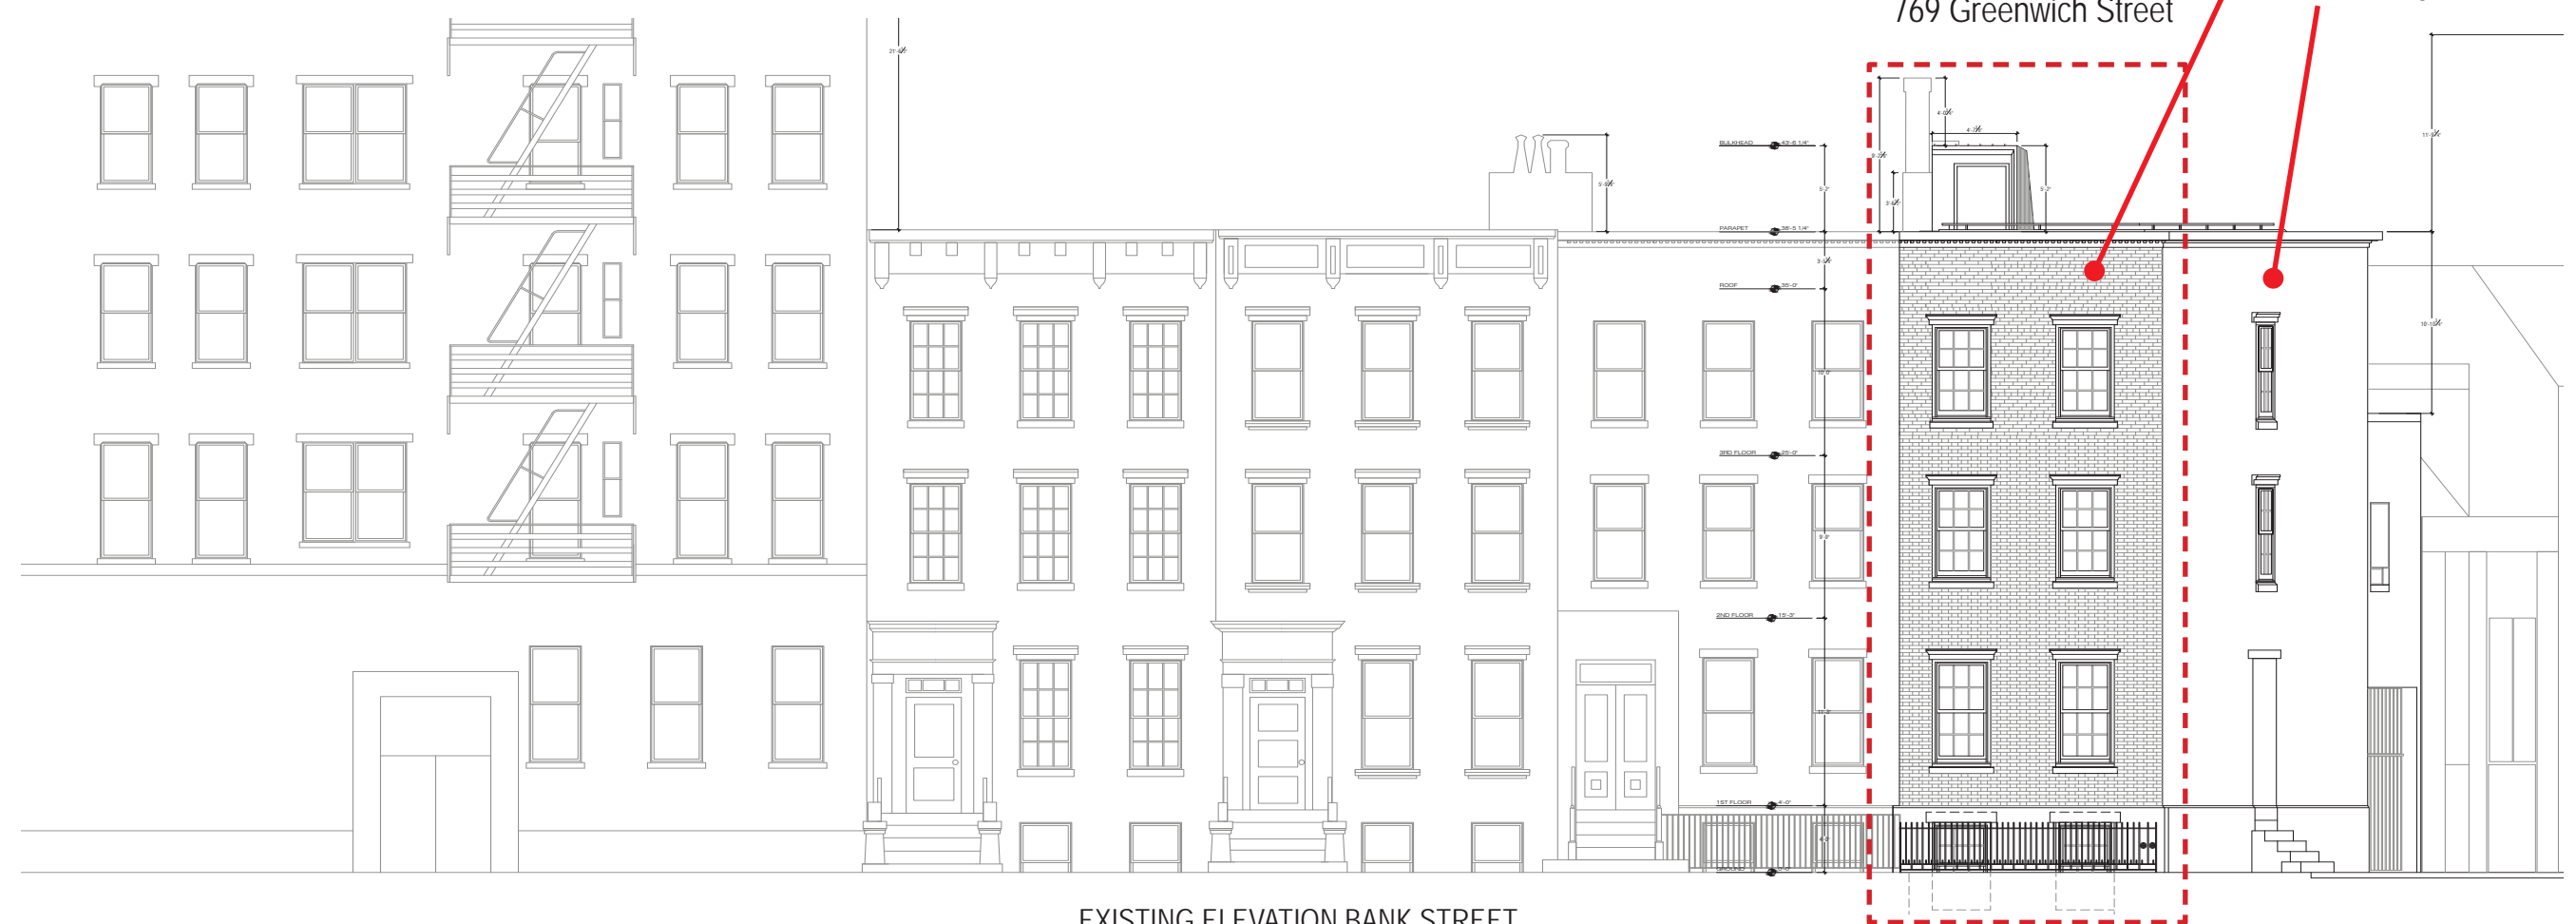
EXISTING ELEVATION BANK STREET

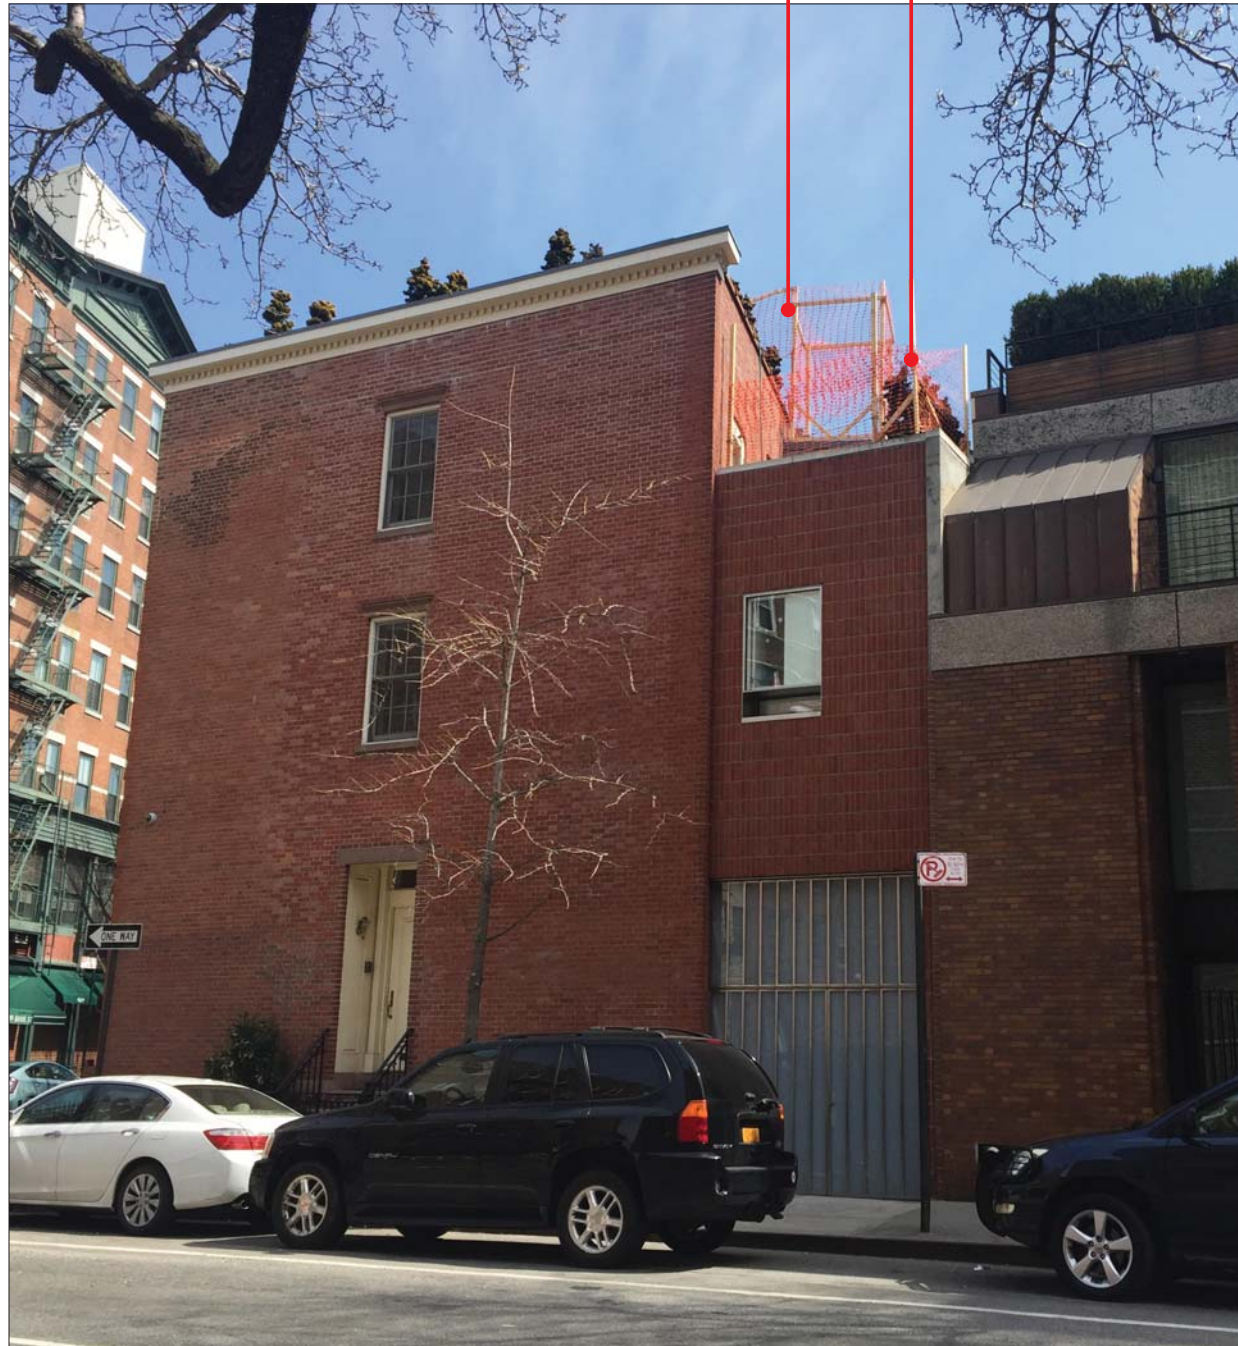
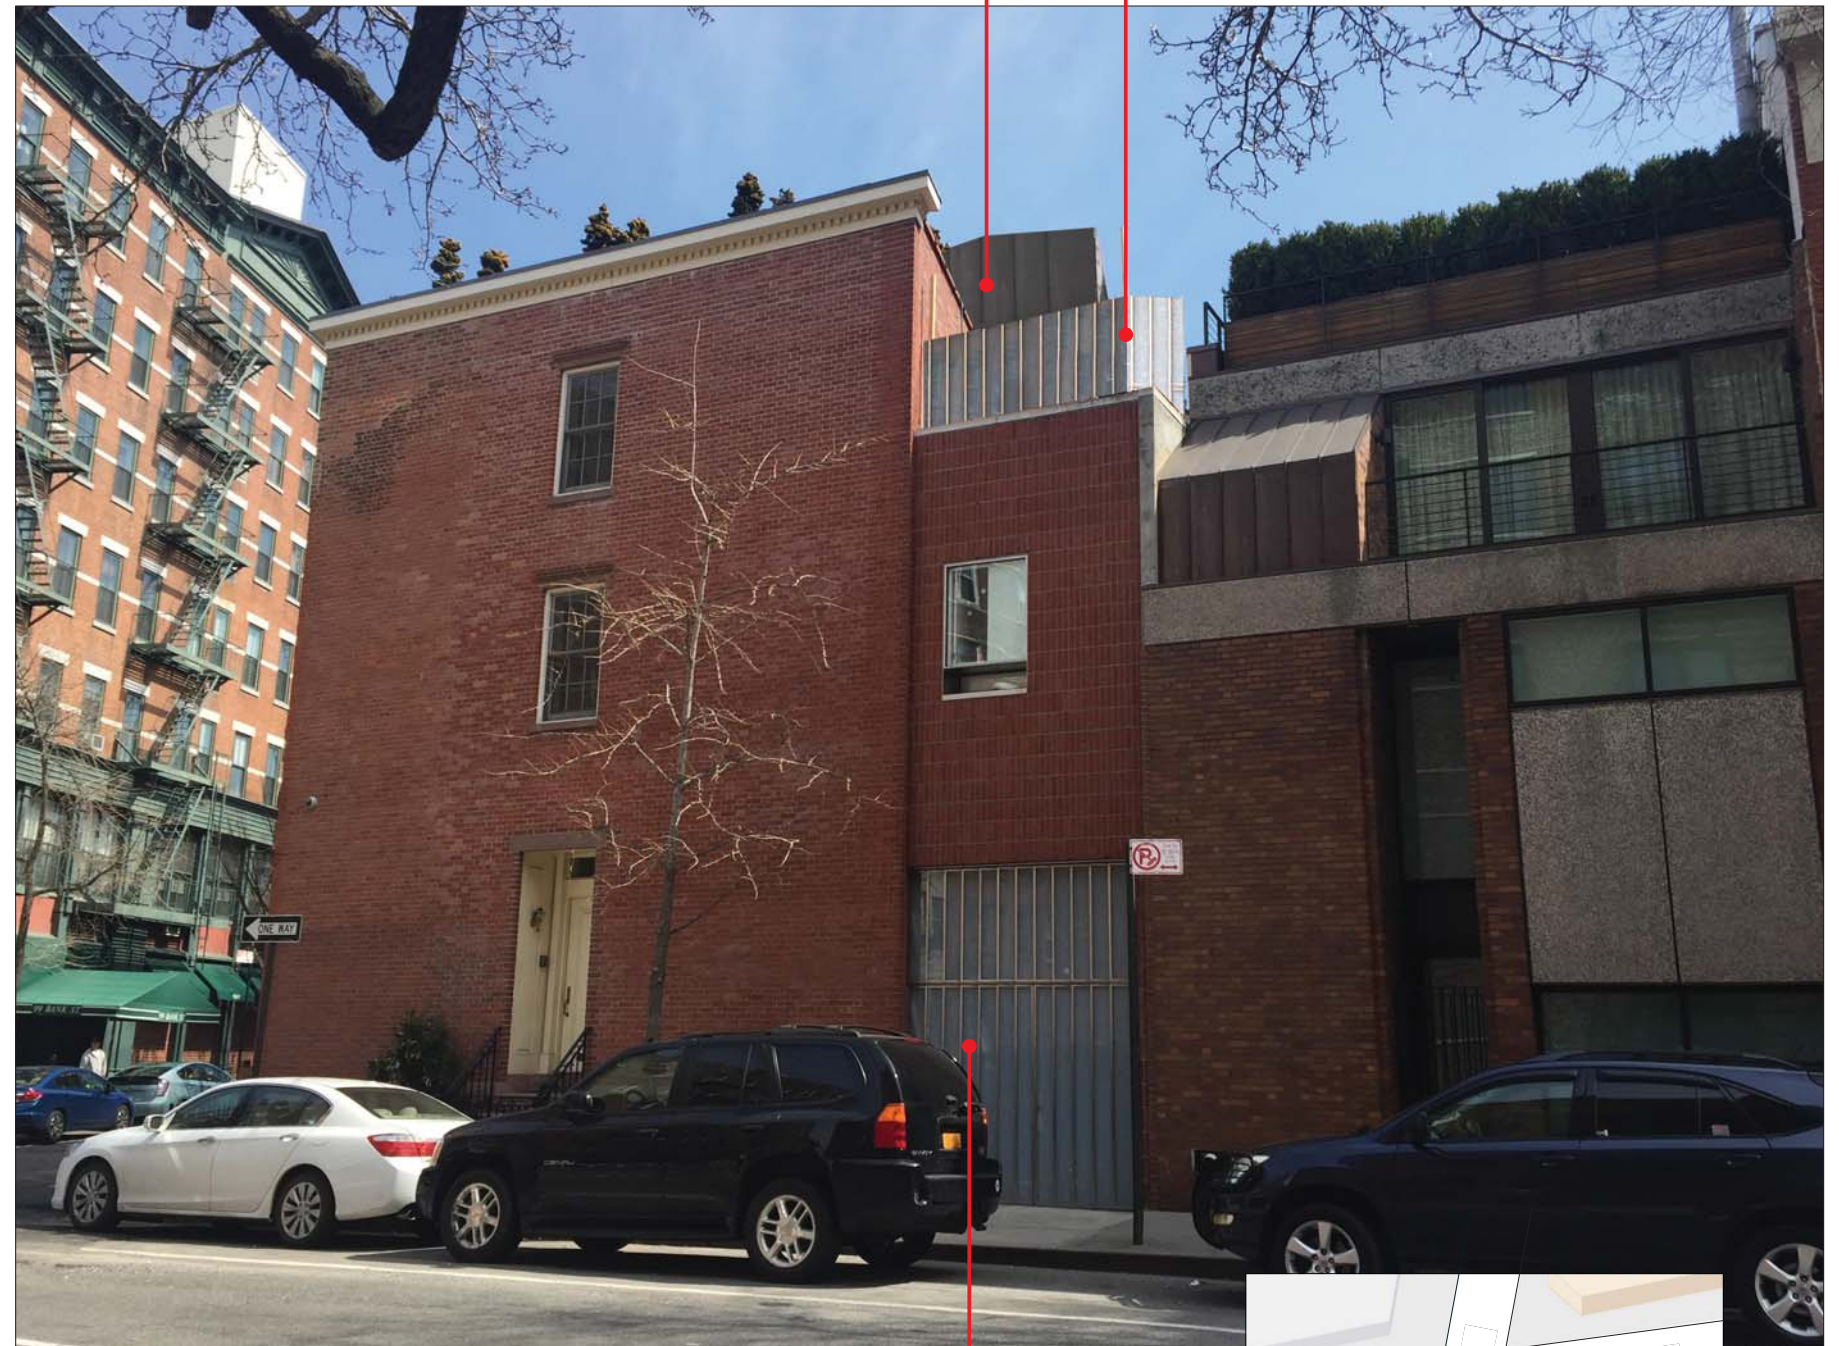
View 1: From West Side of Greenwich Street

Mock-up of Shaft Extension & Bulkhead. Orange Fence indicates top of Elevator Shaft and Bulkhead

Mock-up of Glass Enclosure at Third Floor Balcony. Orange Fence indicates 5' Height of Glazing along the parapet

Proposed Shaft Extension & Bulkhead with zinc cladding to match existing elevator shaft.

Proposed Glass Enclosure at Third Floor Balcony, with frosted glass louvers to match existing louvers at street level below

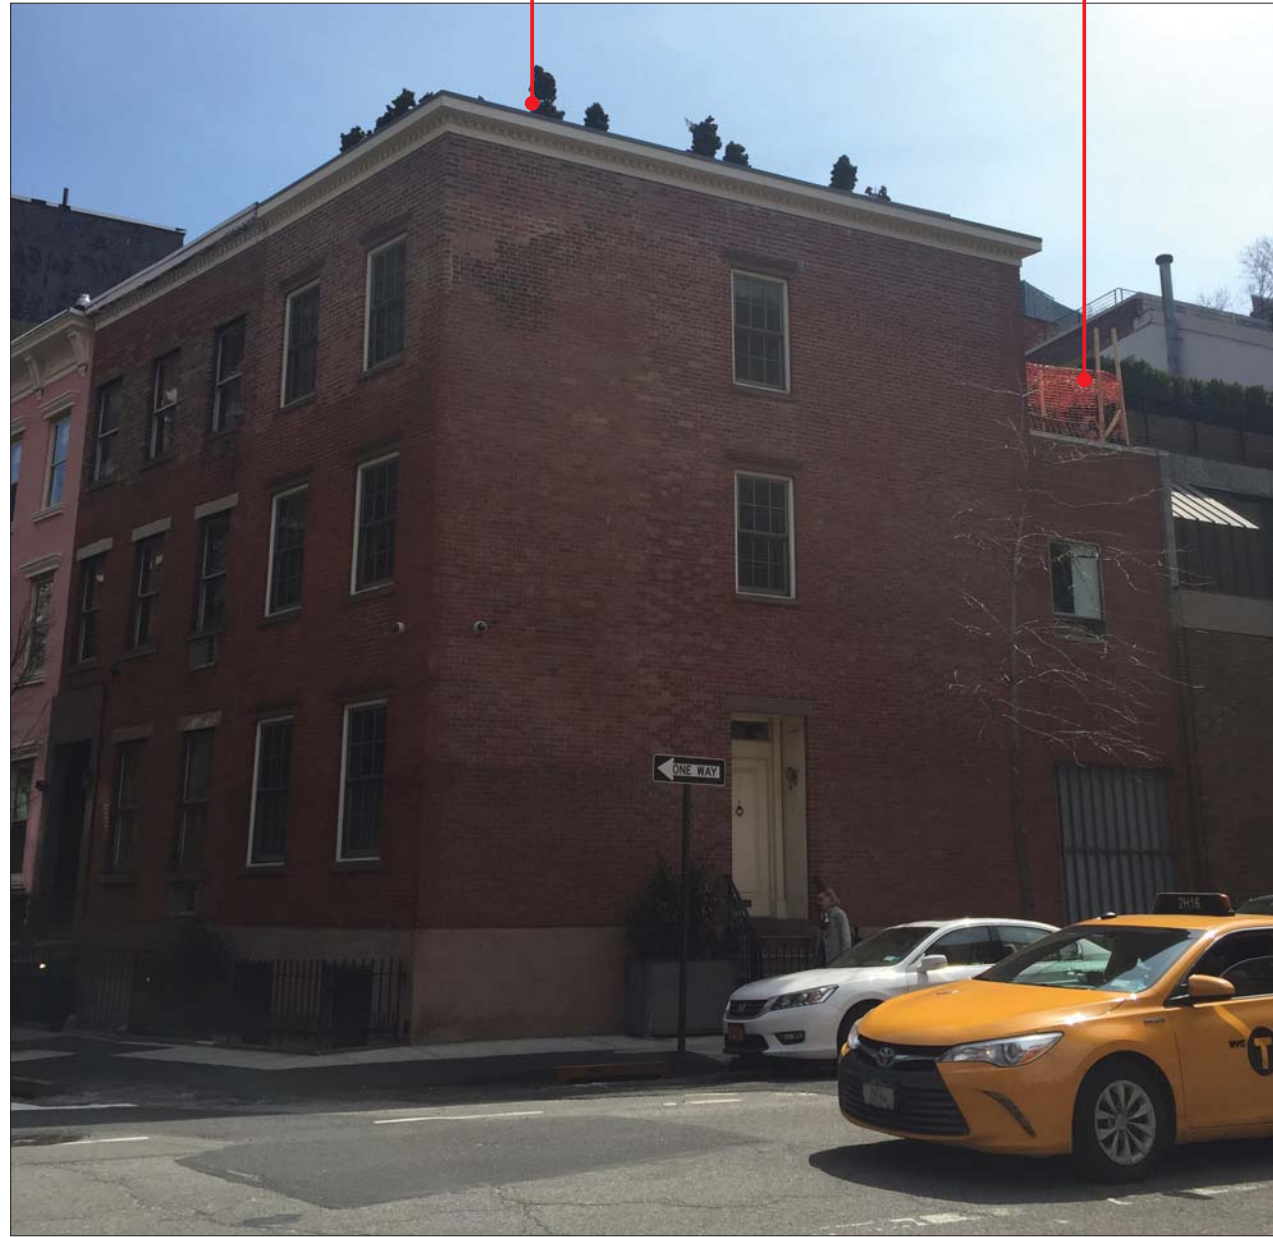
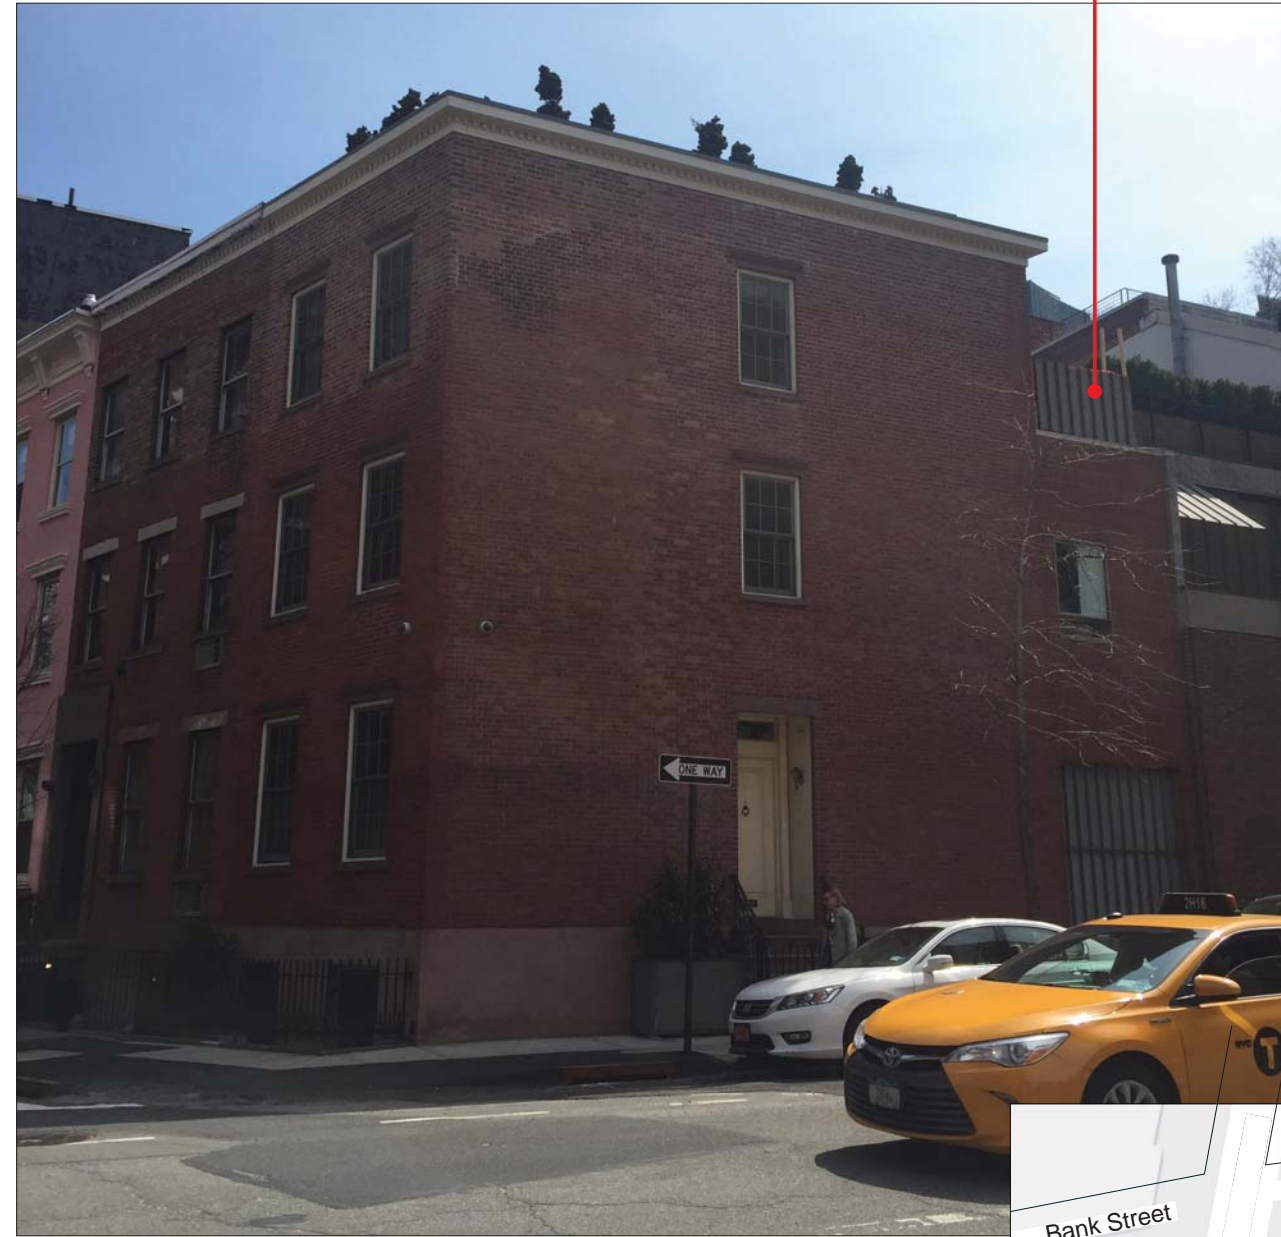
View 3: From Northwest Corner of Greenwich & Bank Streets

Mock-up of Proposed New Glass Enclosure at Third Floor Balcony

Proposed Glass Enclosure at Third Floor Balcony. with frosted glass louvers to match existing louvers at street level below

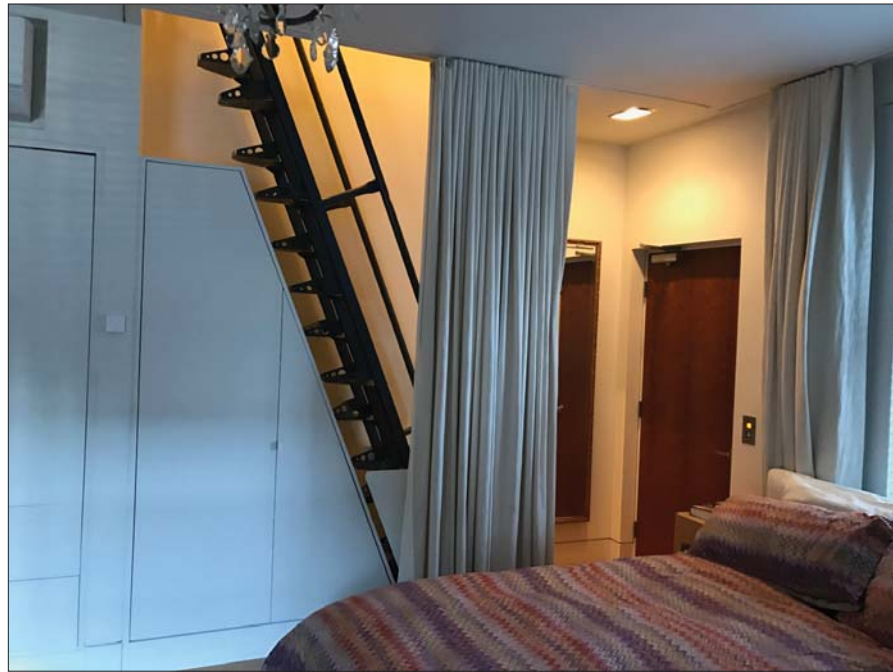
The existing steel Lapere Staircase is very steep and it's nearly impossible to climb up or down safely without holding both handrails. The rise of the steps is too tall for the children to be able to use the stairs and carrying them would be unsafe given the tight width of the steps and the steep climb. The owners currently don't utilize this wonderful space because it is inaccessible for their children and very difficult to bring anything up or down the stairs. To make this roofdeck a functional exterior space, the elevator shaft can be extended up one more floor (9'-3") to provide safe and convenient access to the roof.

Photos of Existing Staircase to the Roof and Elevator Door in Master Bedroom
