41 Greenwich Avenue  
Landmarks Preservation Commission  
July 10, 2017

# Greenwich Village

Greenwich Village Historic District  
Manhattan  
Designated April 29, 1969

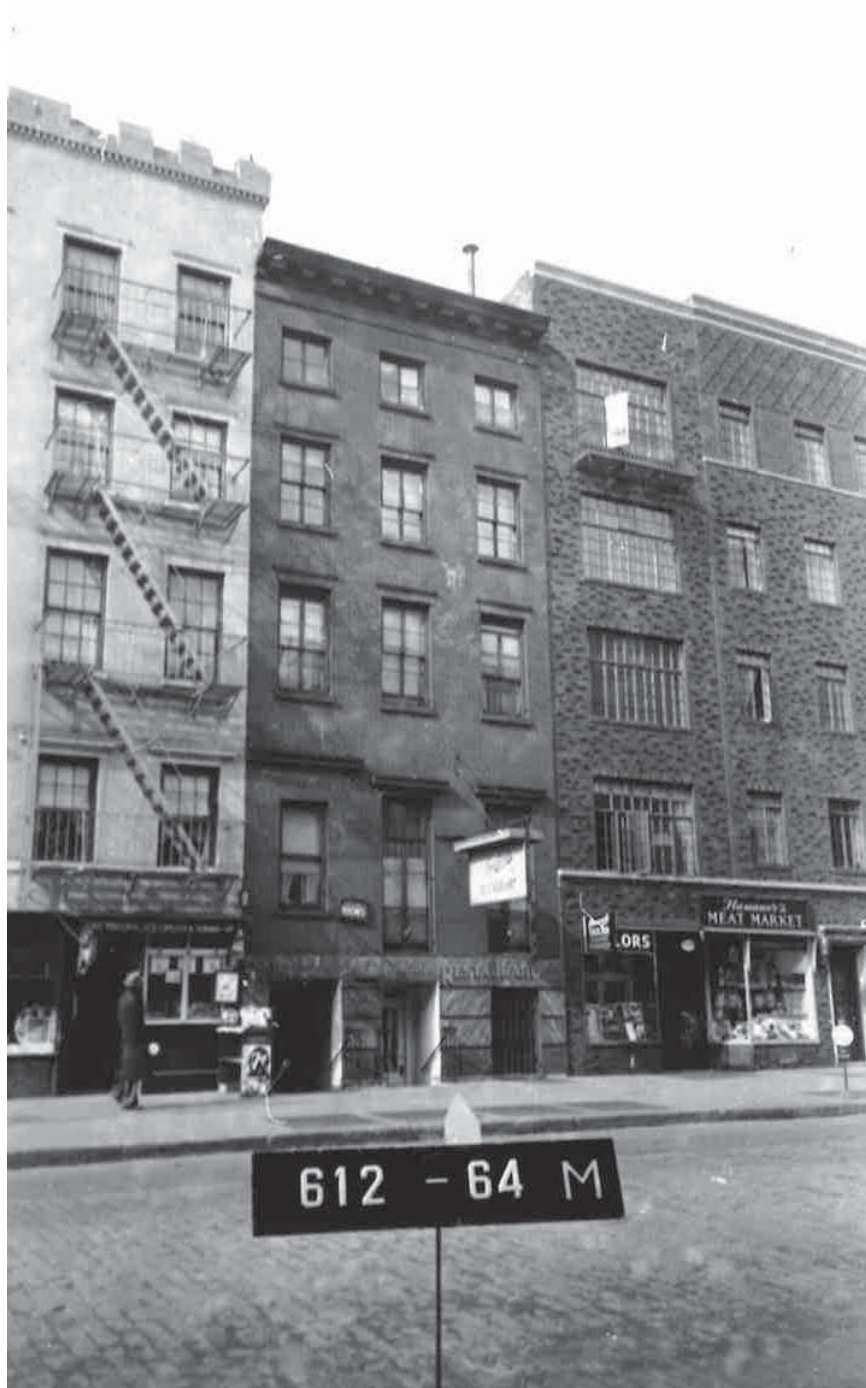
1940 Tax Photo

No. 41, alone of the entire row, still displays low attic windows and modillions at the roof cornice. It may be considered late Greek Revival in style. Now a five-story house, it has been remodeled to provide a basement entrance with restaurant. Originally it was four stories high with basement, as may be seen from the high stone lintel of the doorway which remains embedded in the masonry, when a small window took the place of the door at the left side. The house was built in 1848-49 by Foster & Van Ostrand. In the early Eighteen-fifties, this was the home of R. W. Jeffery.

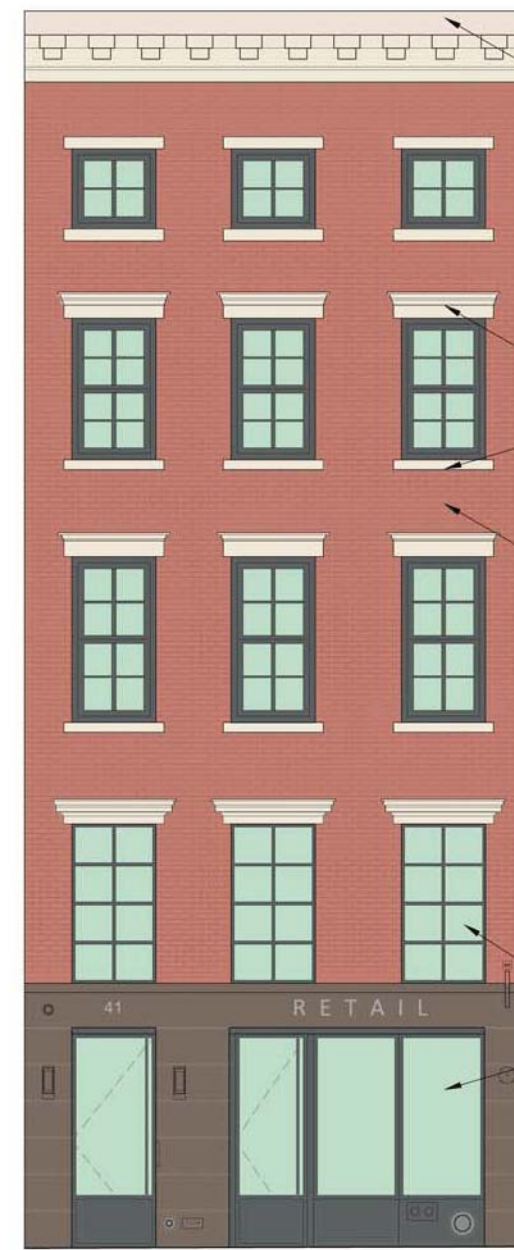
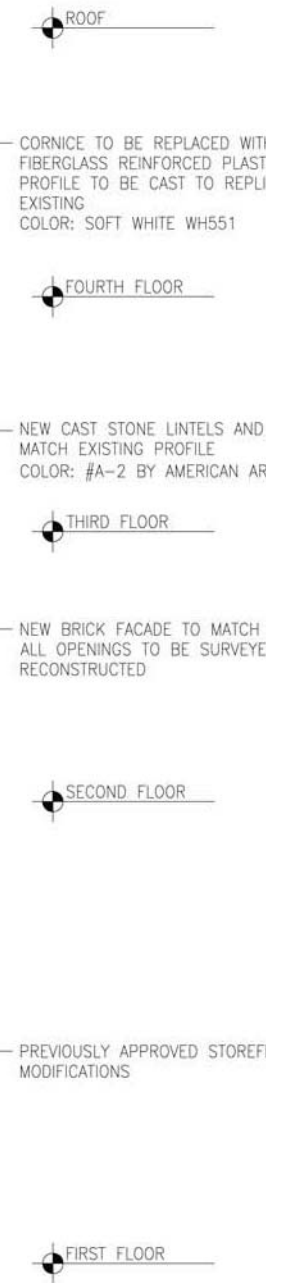
02 PROPOSED FACADE

CORNICE TO BE REPLACED WITH FIBERGLASS REINFORCED PLAST PROFILE TO BE CAST TO REPLI EXISTING COLOR: SOFT WHITE WH551

NEW CAST STONE LINTELS AND MATCH EXISTING PROFILE COLOR: #A-2 BY AMERICAN AR

NEW BRICK FACADE TO MATCH ALL OPENINGS TO BE SURVEYE RECONSTRUCTED

PREVIOUSLY APPROVED STOREF MODIFICATIONS

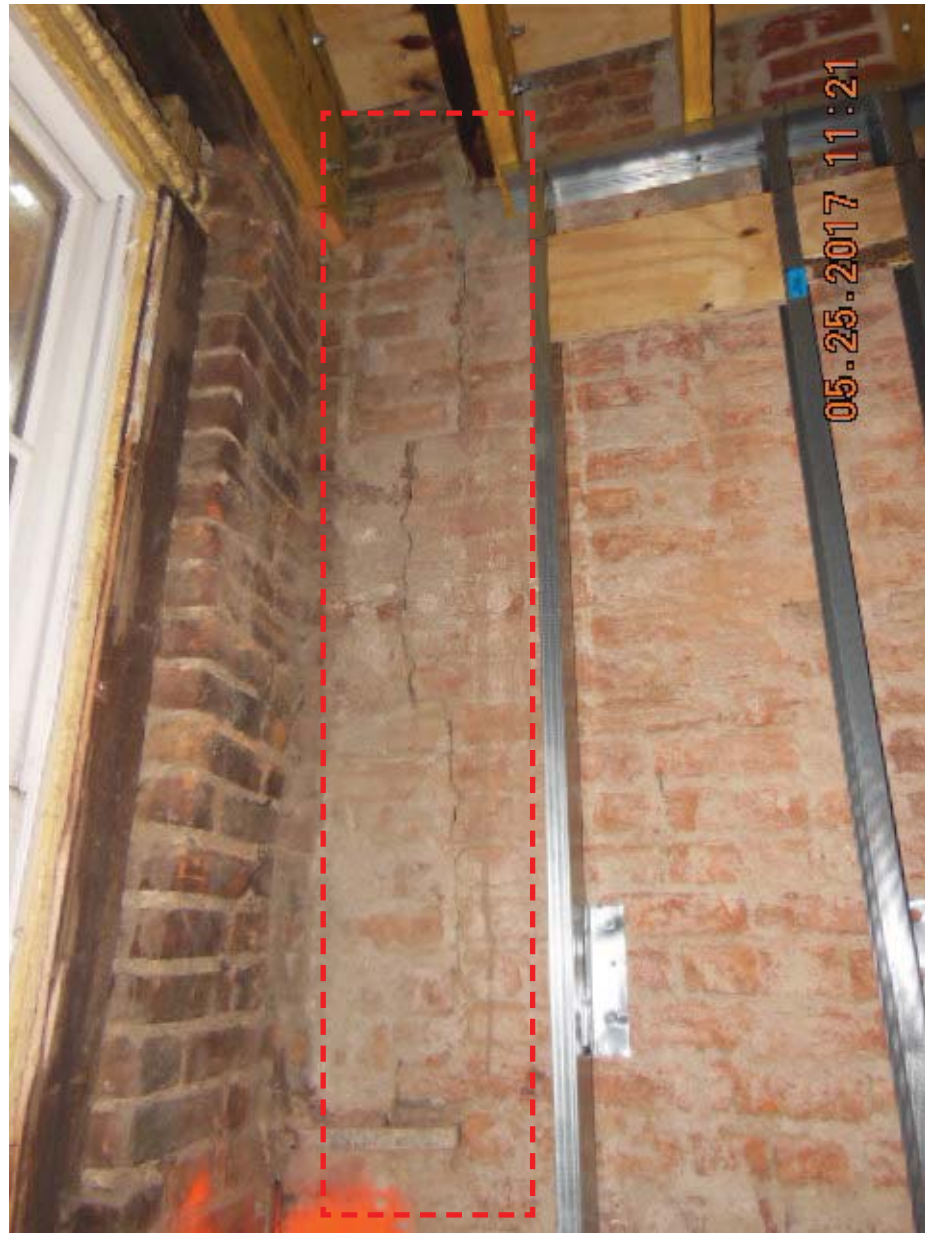
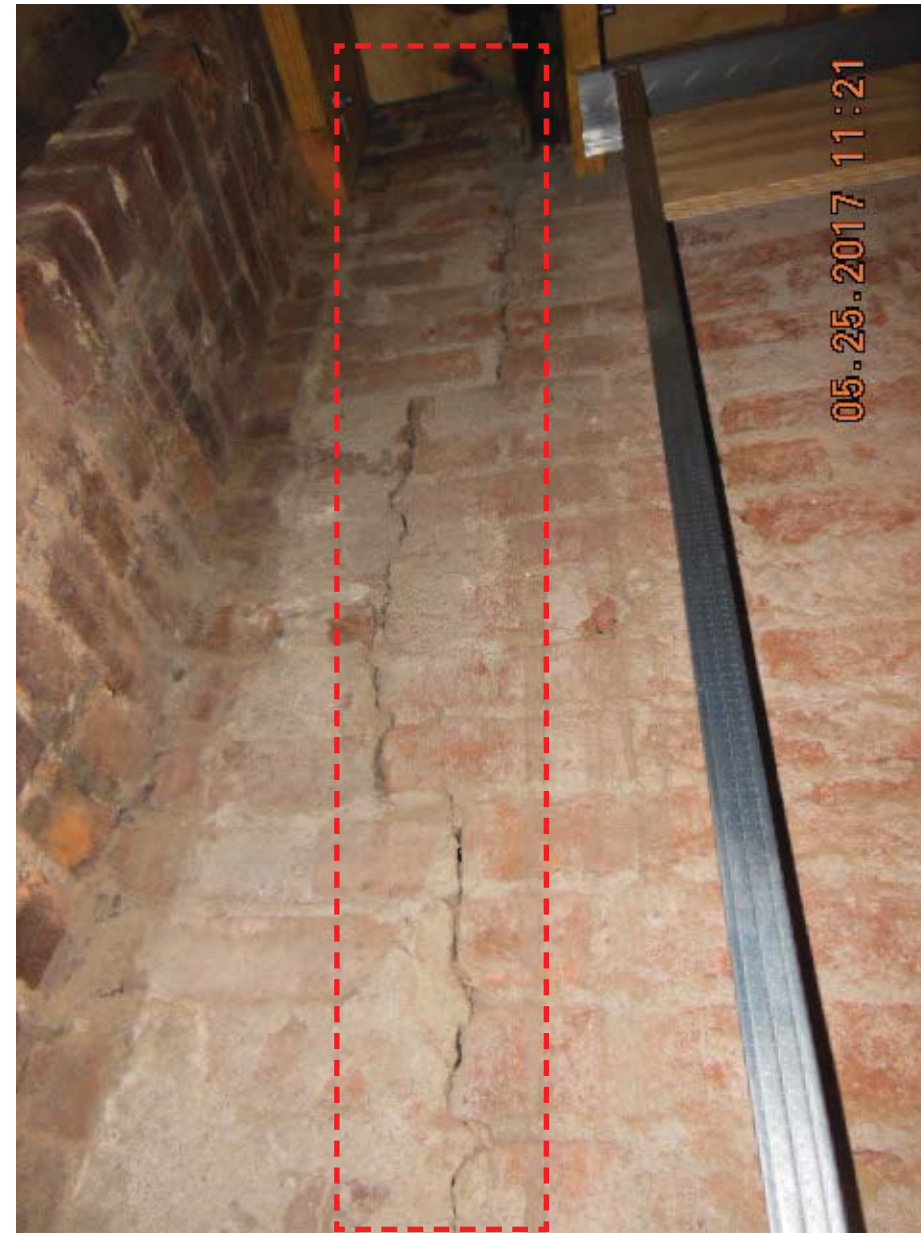
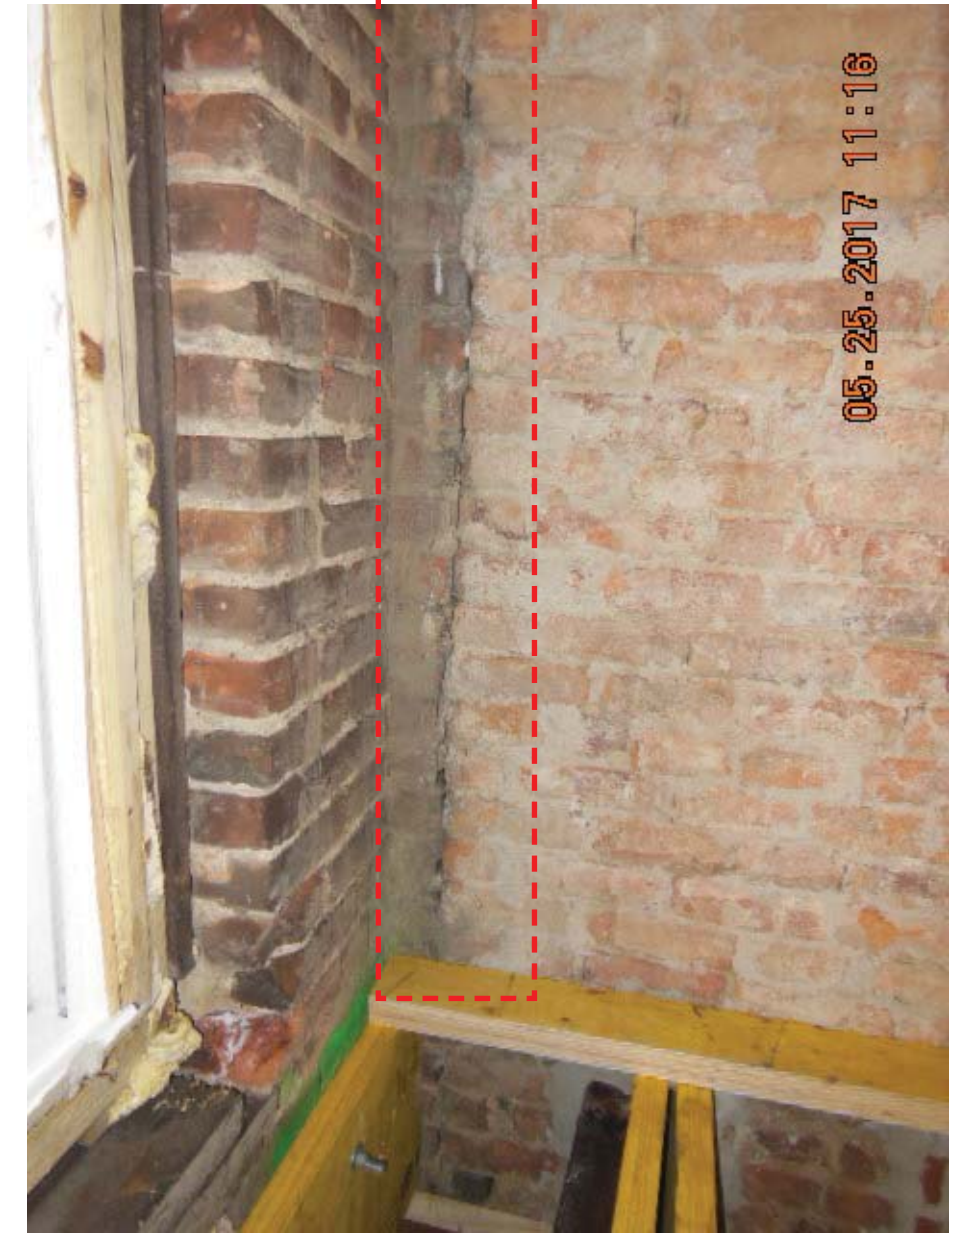
Interior Front Facade Photos

ENGINEER'S REPORT dated MAY 25, 2017:

- Cracks and fractures where front wall meets party wall
- Loss of strength of mortar over time
- Front facade is structurally unstable - can be moved by hand
- Recommended removal and replacement of brick facade

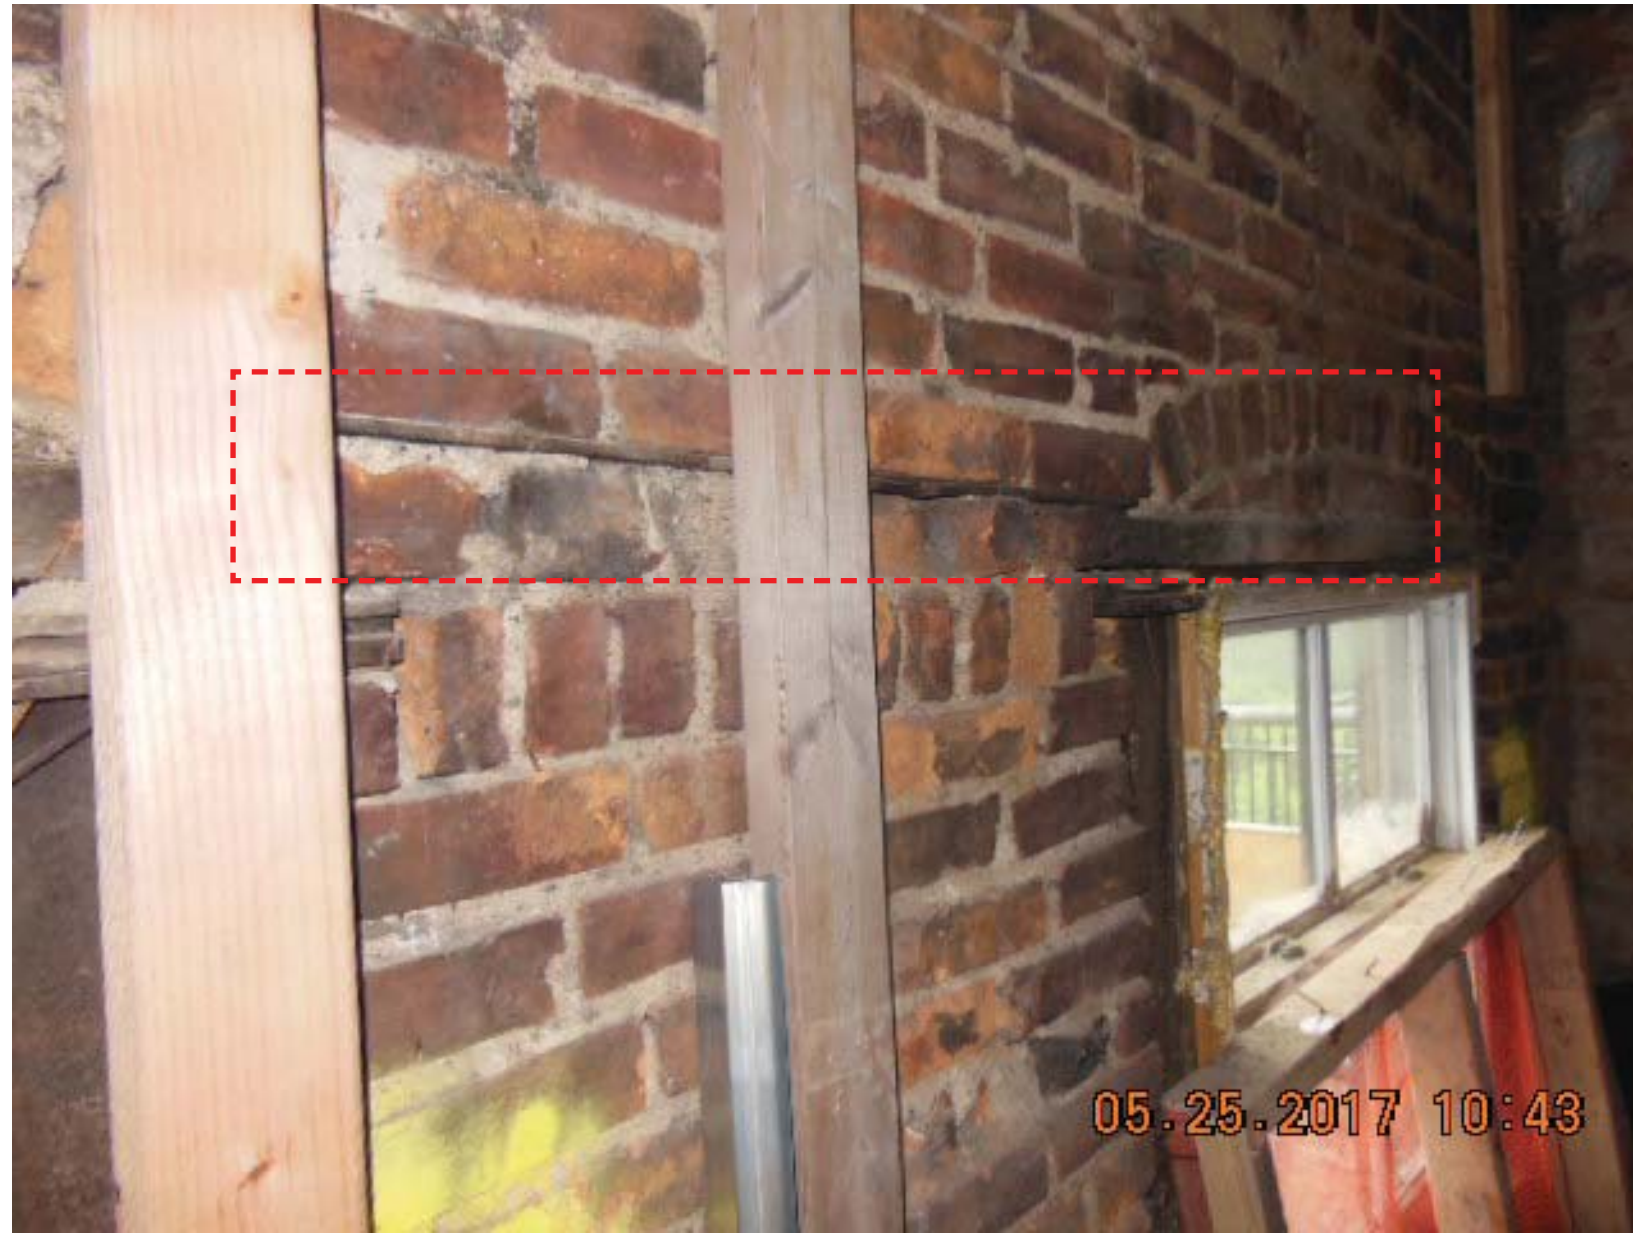
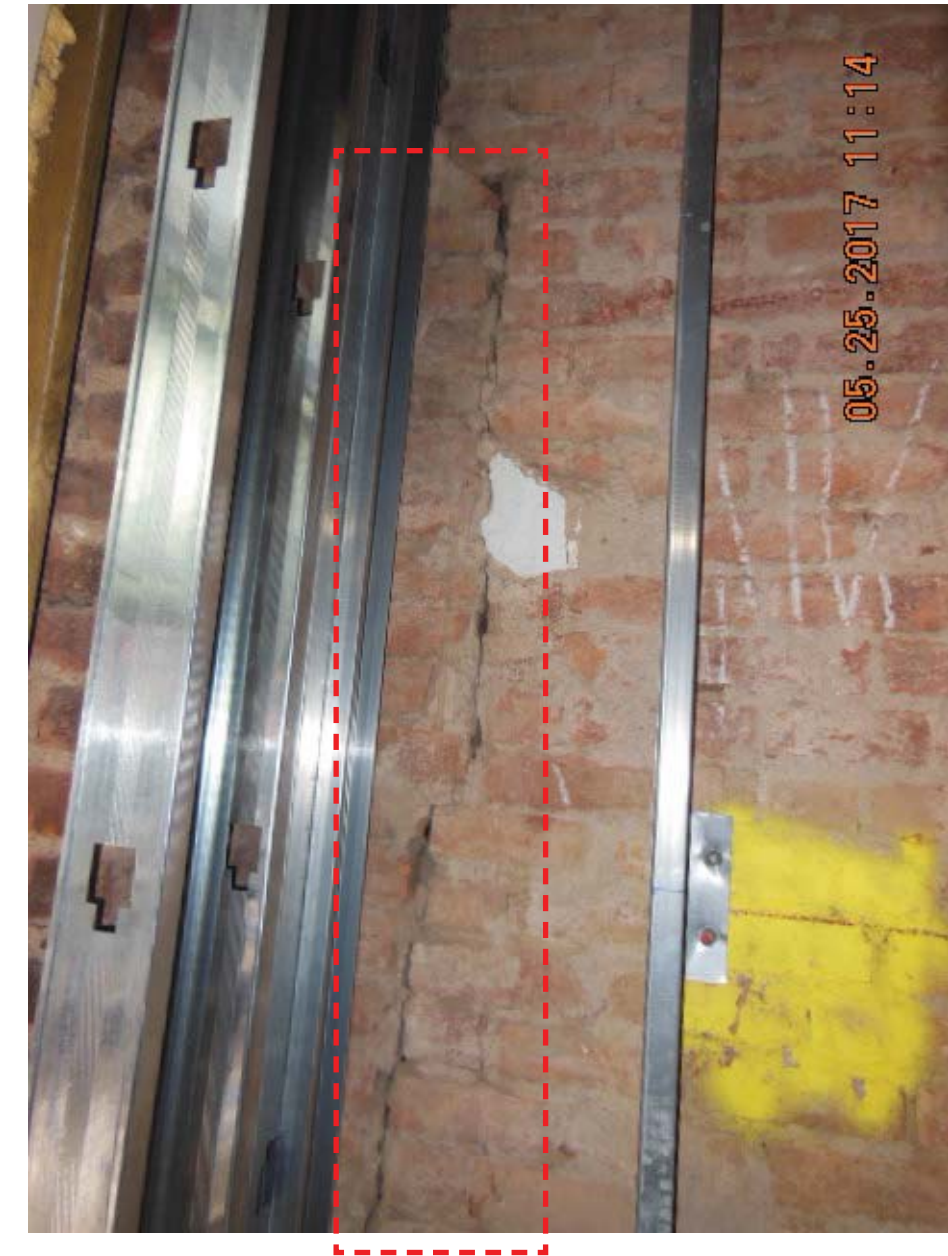
Interior Front Facade Photos

ENGINEER'S REPORT dated MAY 25, 2017:

- Cracks and fractures where front wall meets party wall
- Loss of strength of mortar over time
- Front facade is structurally unstable - can be moved by hand
- Recommended removal and replacement of brick facade
