85 Sullivan Street, New York, NY Presentation to Community Board 2 Landmarks Committee 11 July 2019

85 Sullivan Street, New York NY

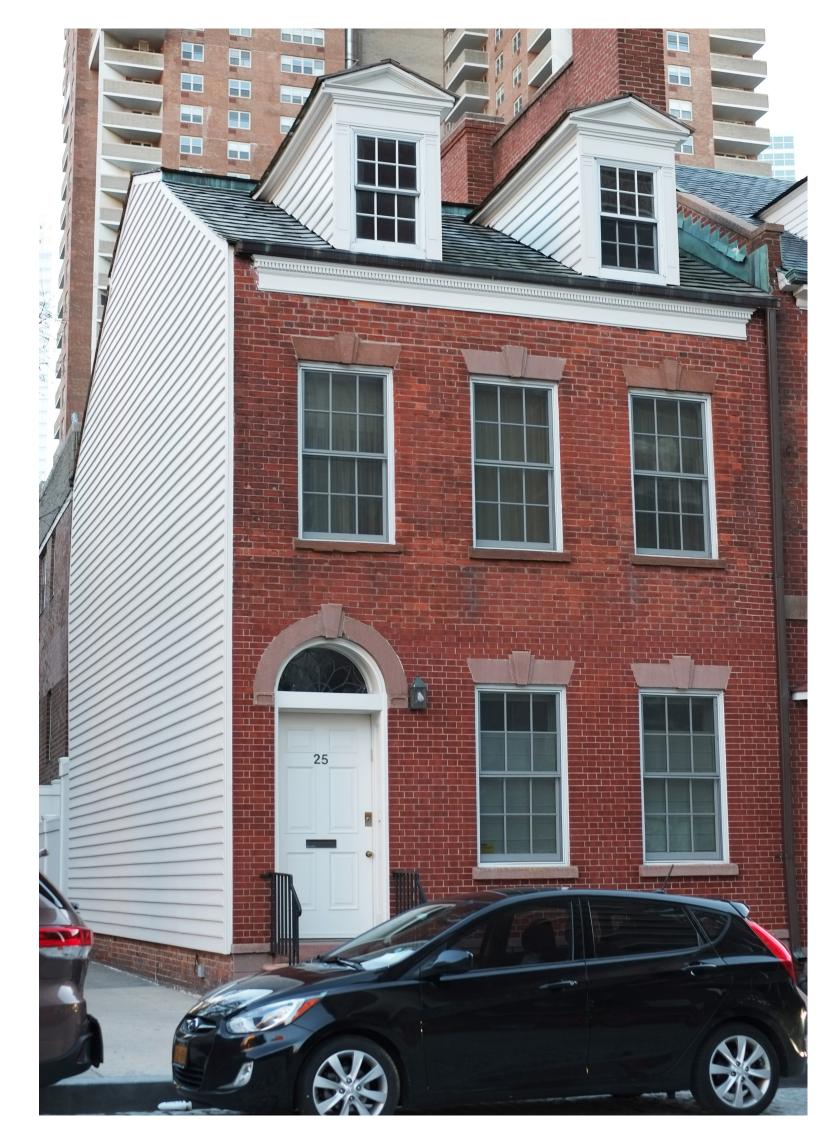
25 Harrison Street, 1804 (formerly 314 Washington Street) Individual Landmark, designated 1969

Typical historical characteristics:

- Red brick
- Modest decoration
- Six over six windows
- Brownstone window and door details
- Painted wood door trim and cornice, typically white
- Painted wood clapboard on exposed side facade (white) •

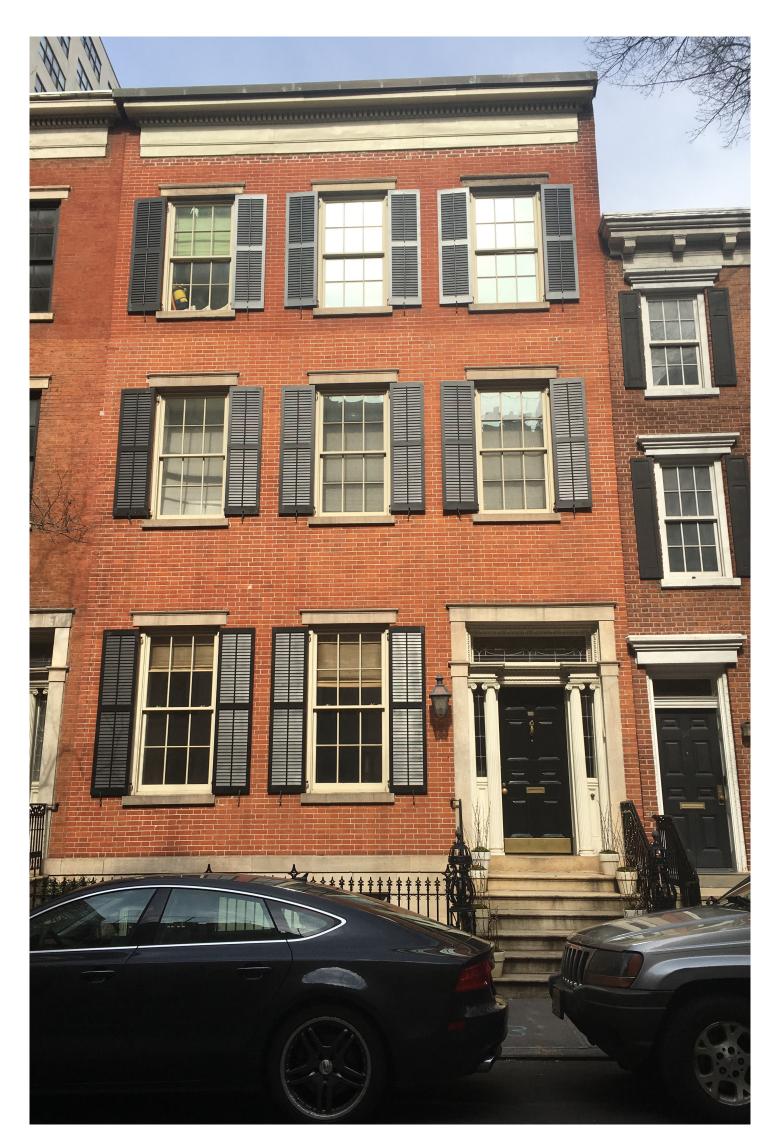
37 Charlton Street, 1820s Charlton-King-Vandam Historic District, designated 1966

Typical historical characteristics:

- White painted windows
- Light colored door trim and cornice
- Contrasting dark parinted wood shutters and door

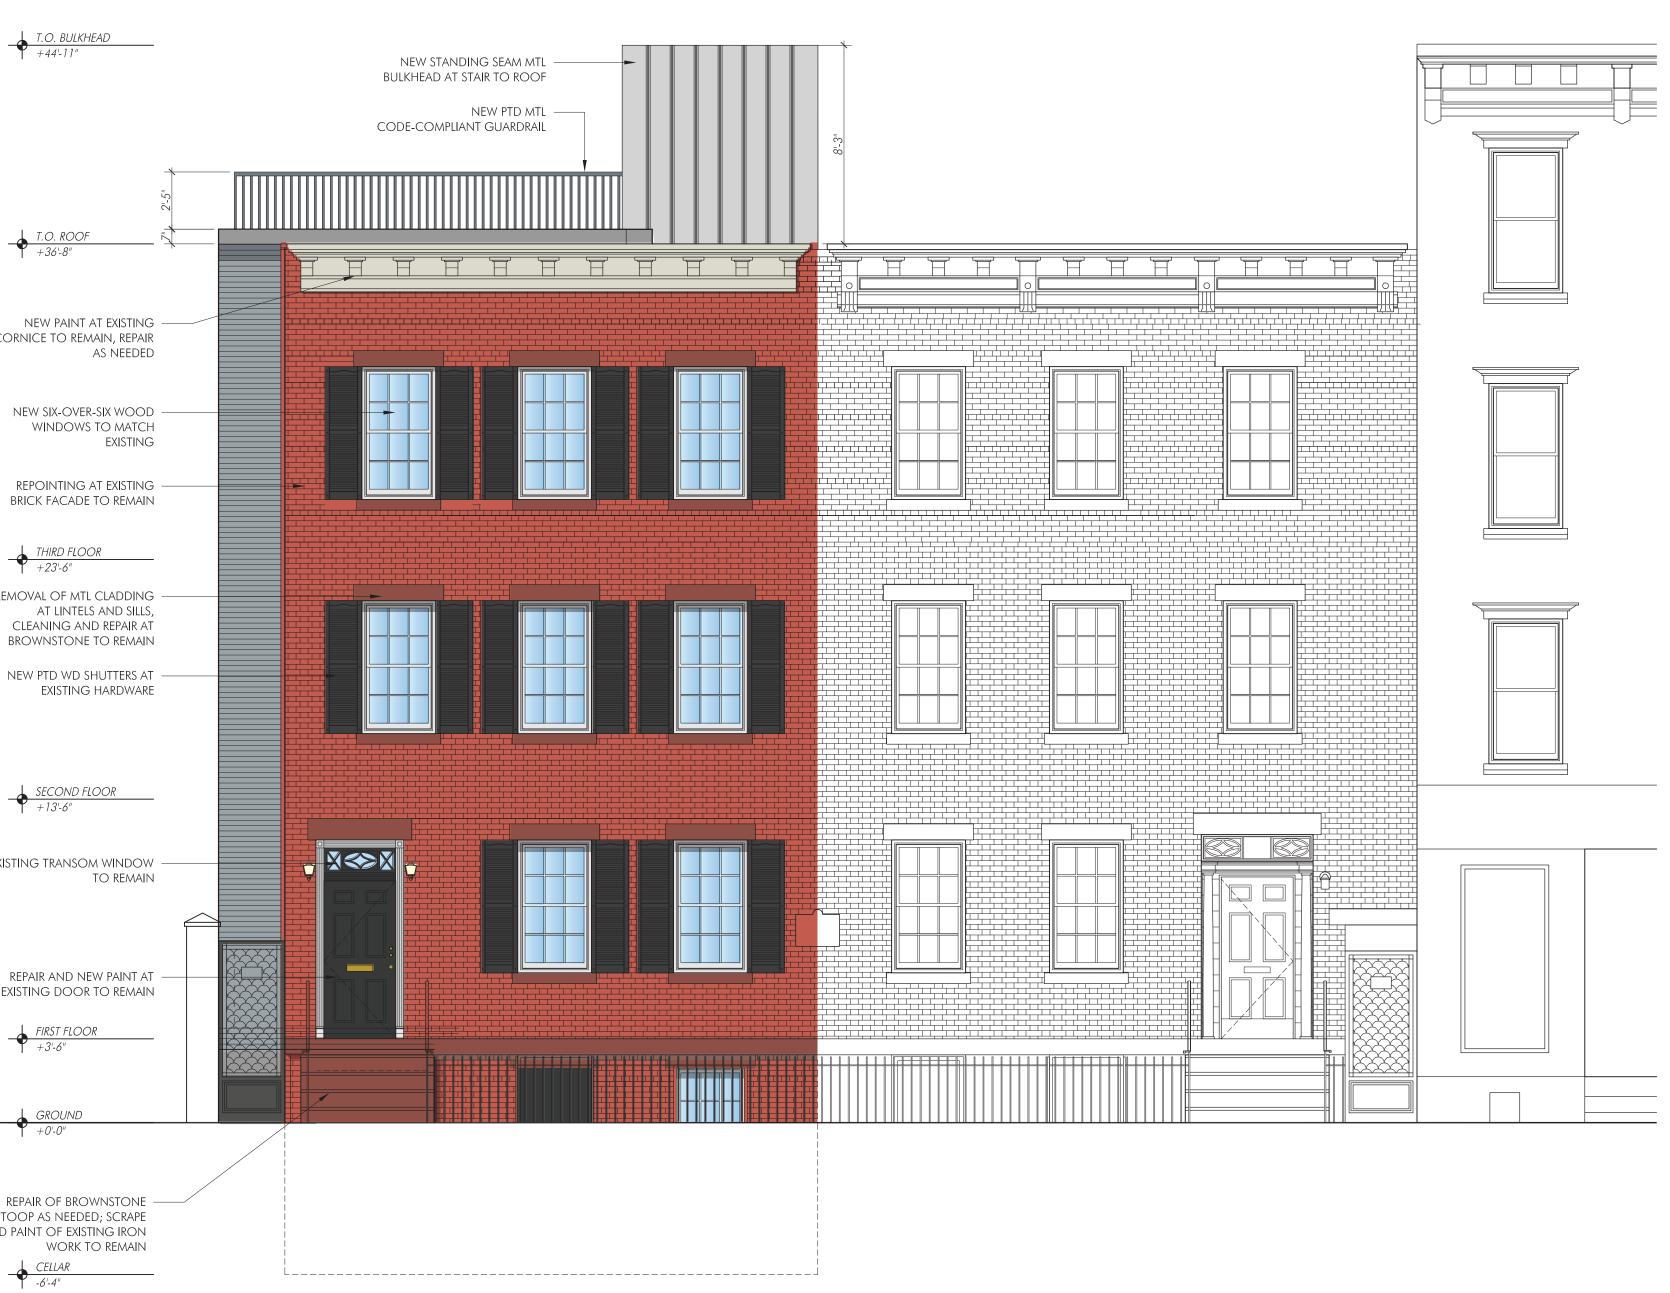
Proposed Restoration: Front Facade

Scope of work includes:

- Repointing of existing brick •
- New wood windows with historic profile and configuration
- New painted wood shutters
- Restoration of brownstone lintels and sills •
- Restoration of original wood door and lead transom ٠

T.O. BULKHEAD +44'-11" *T.O. ROOF* +36'-8" CORNICE TO REMAIN, REPAIR +23'-6" REMOVAL OF MTL CLADDING -AT LINTELS AND SILLS, CLEANING AND REPAIR AT **BROWNSTONE TO REMAIN** NEW PTD WD SHUTTERS AT *SECOND FLOOR* +13'-6" EXISTING TRANSOM WINDOW EXISTING DOOR TO REMAIN *FIRST FLOOR* +3'-6" GROUND +0'-0"

> REPAIR OF BROWNSTONE STOOP AS NEEDED; SCRAPE AND PAINT OF EXISTING IRON

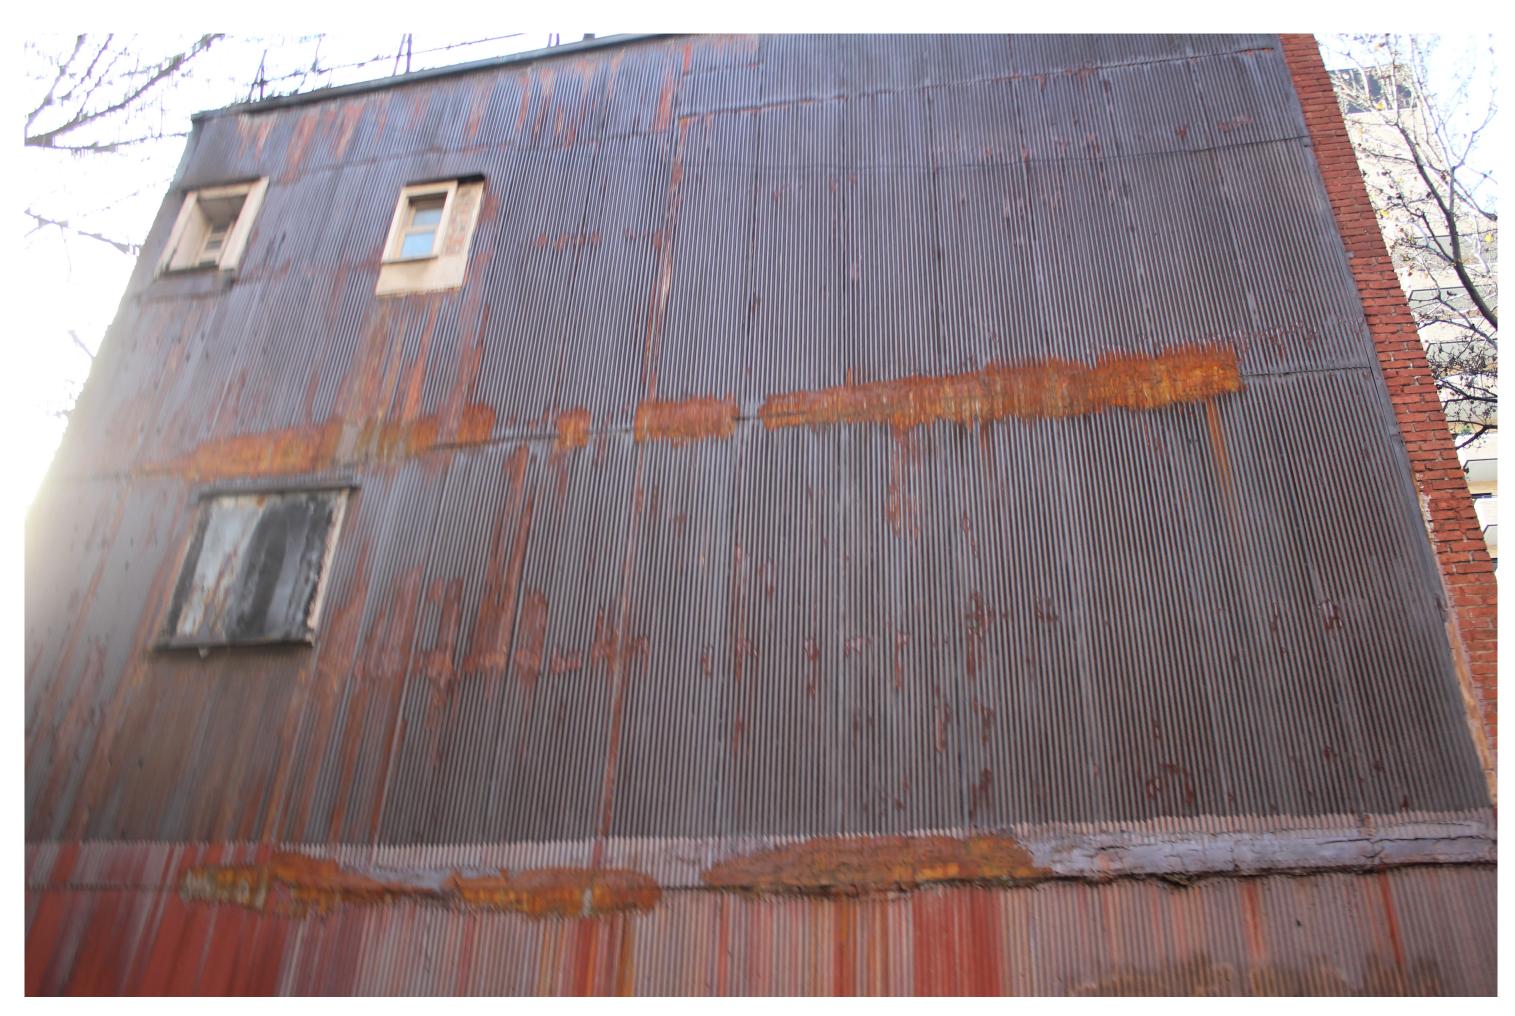
metal panel, view from neighboring lot

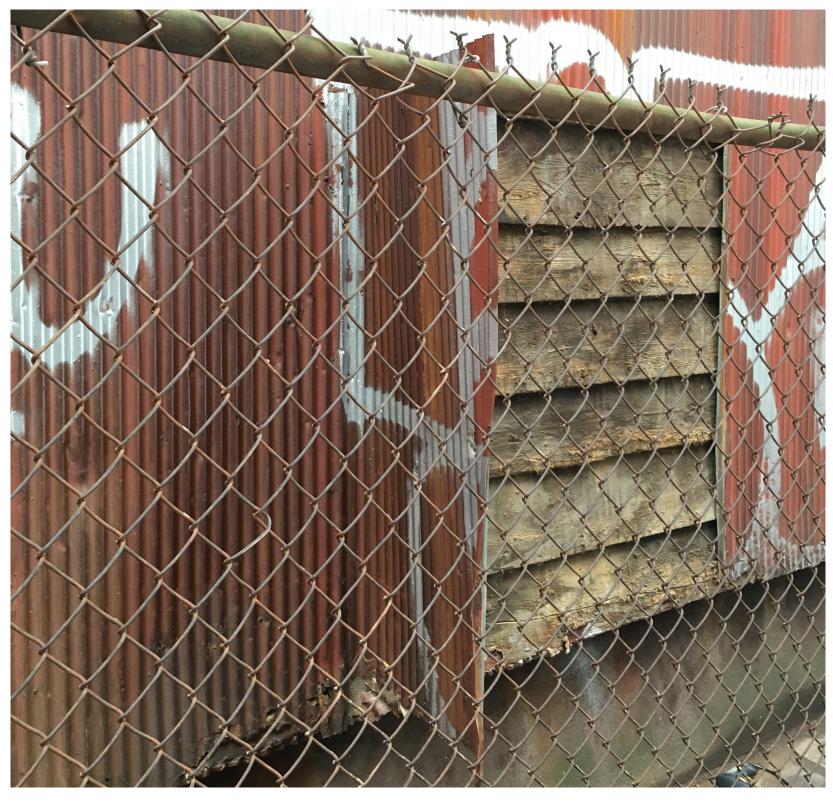
view of clapboard siding under metal panel

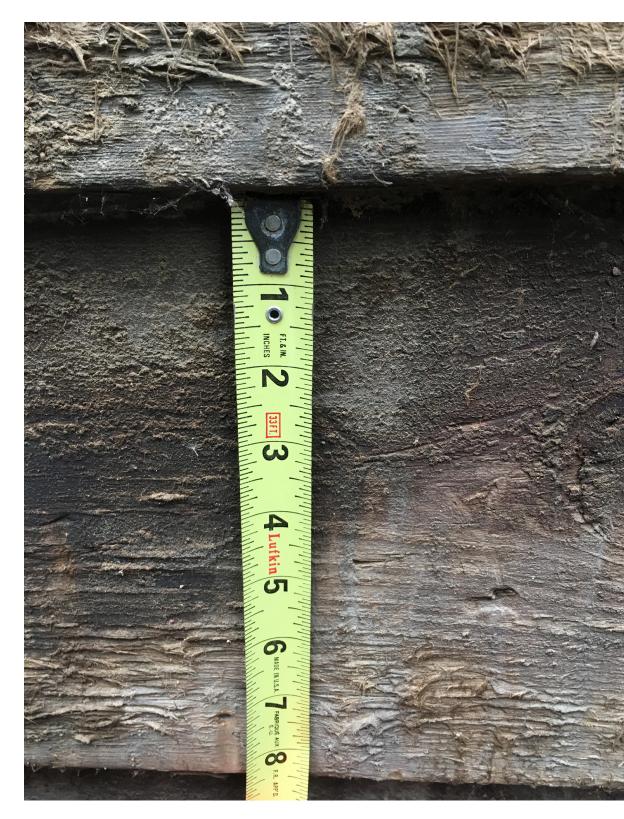
typical height of clapboard siding

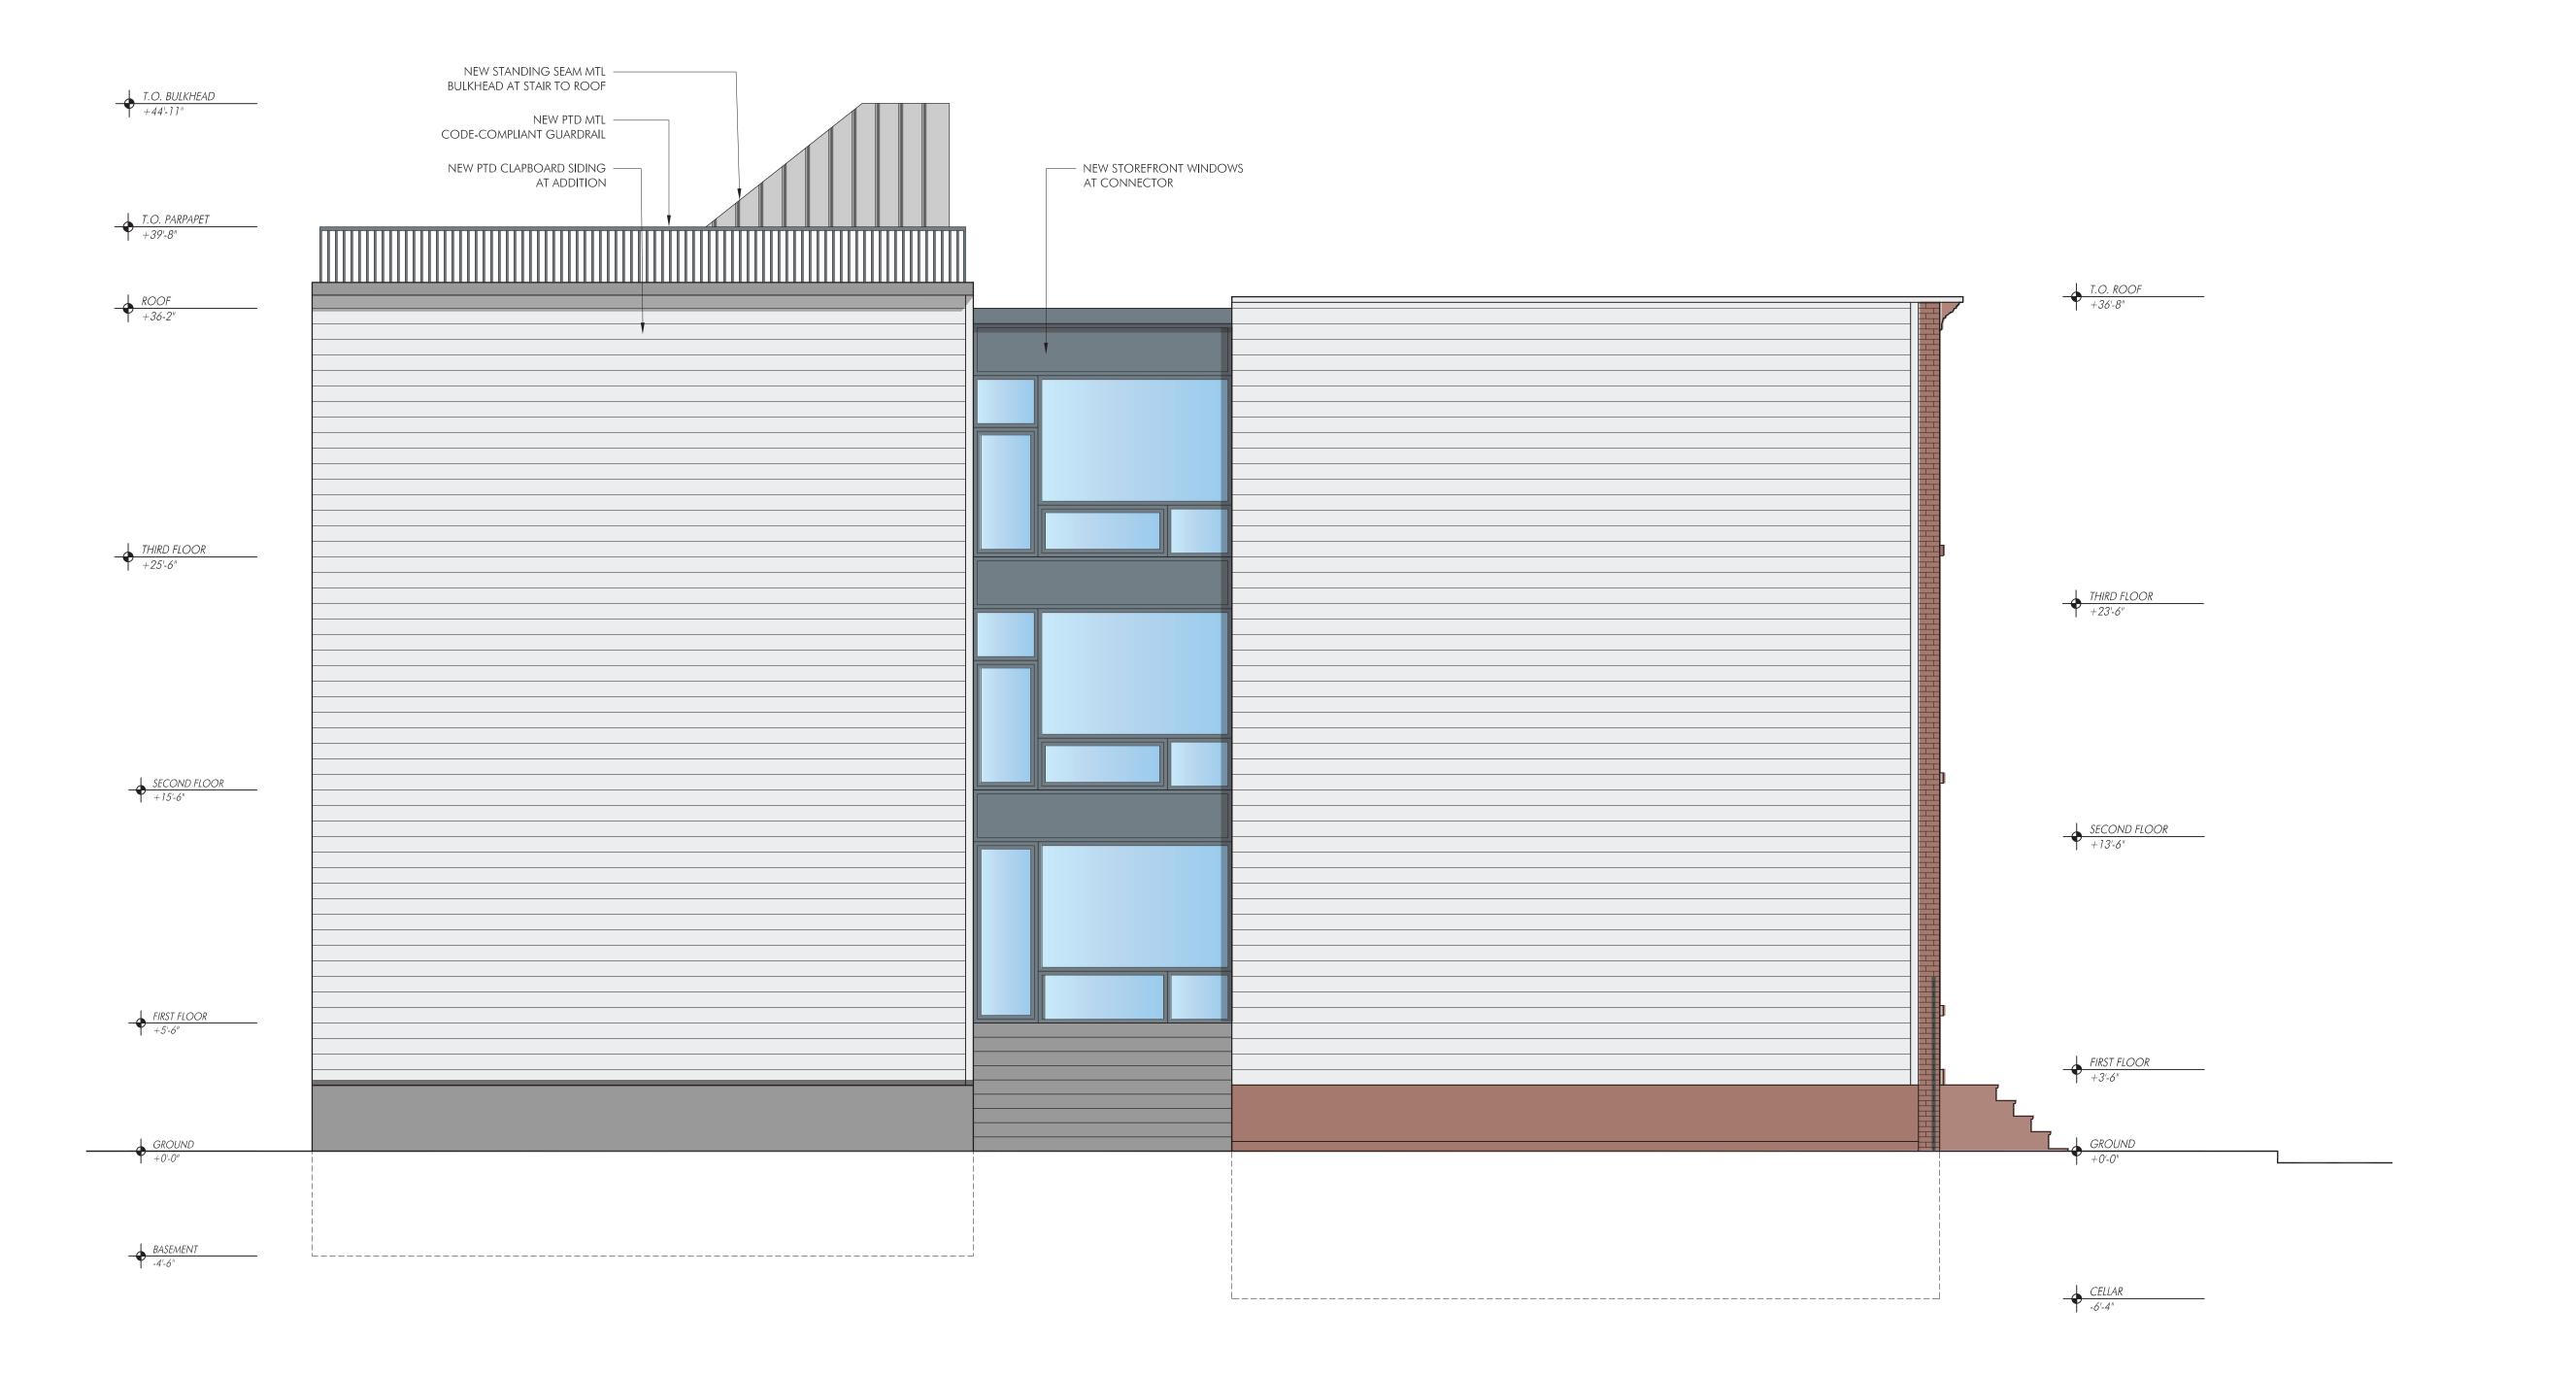
Proposed Restoration: Side Facade

Scope of work includes:

- Construction of new side wall
- New painted Hardie Board siding
- New parging at existing brick base

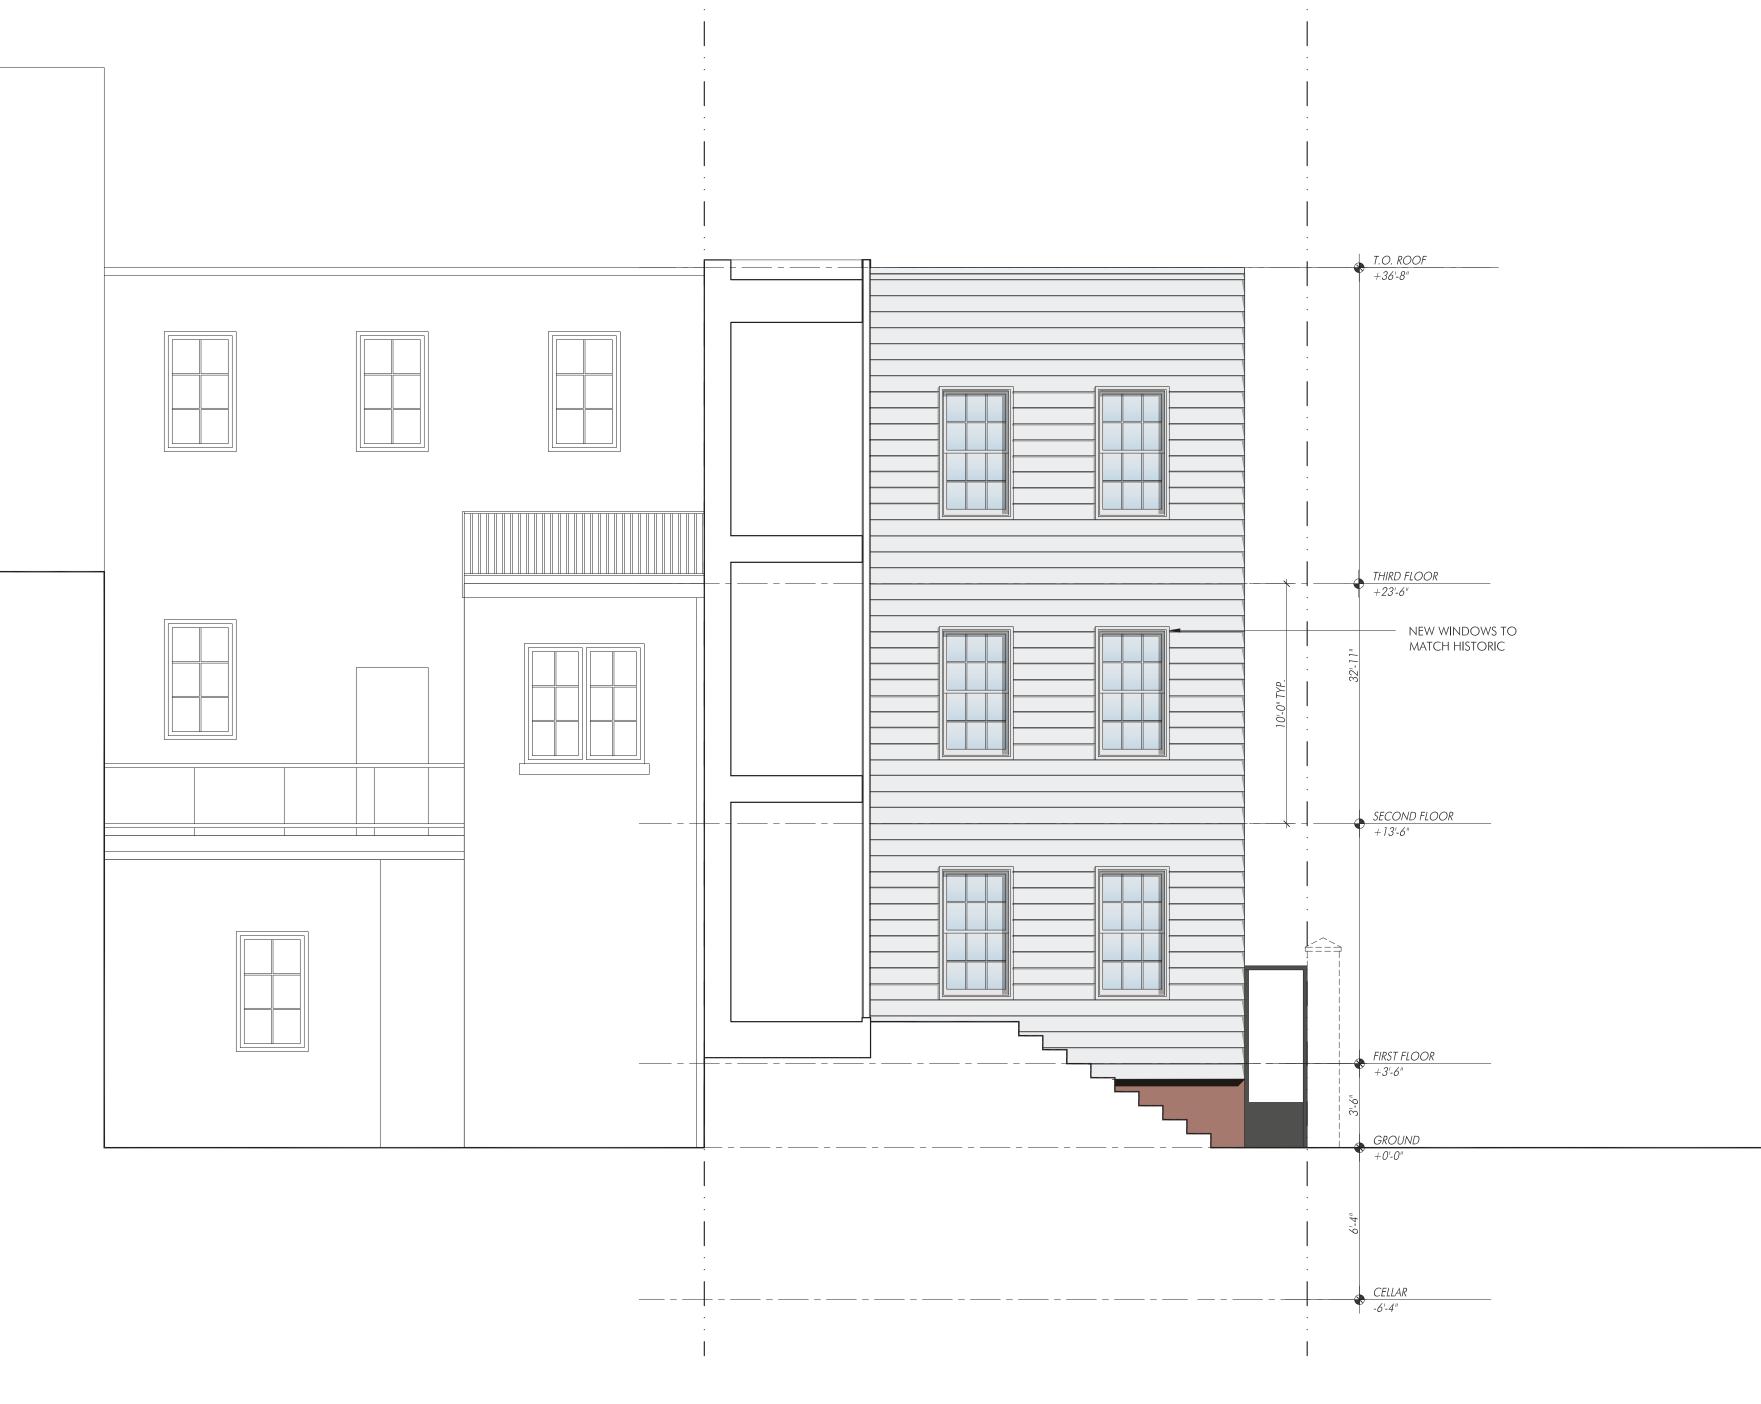
Proposed Restoration: Rear Facade

Scope of work includes:

- Construction of new rear wall
- New wood windows with historic profile and configuration
- New painted Hardie Board siding
- New parging at existing brick base

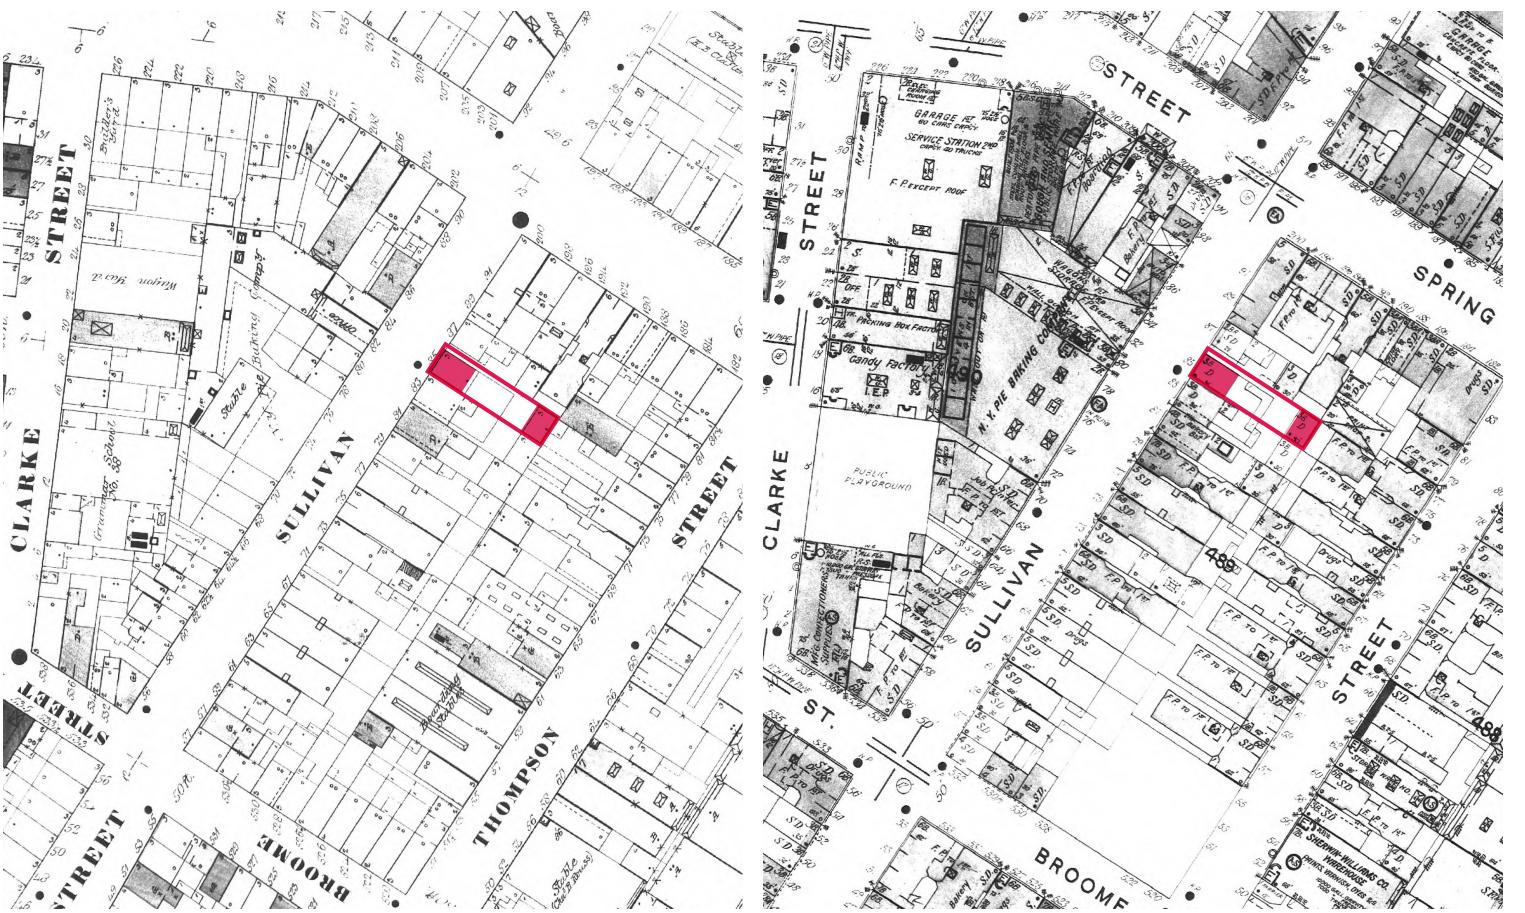
1894 Evidence of 3 story back house at rear of site

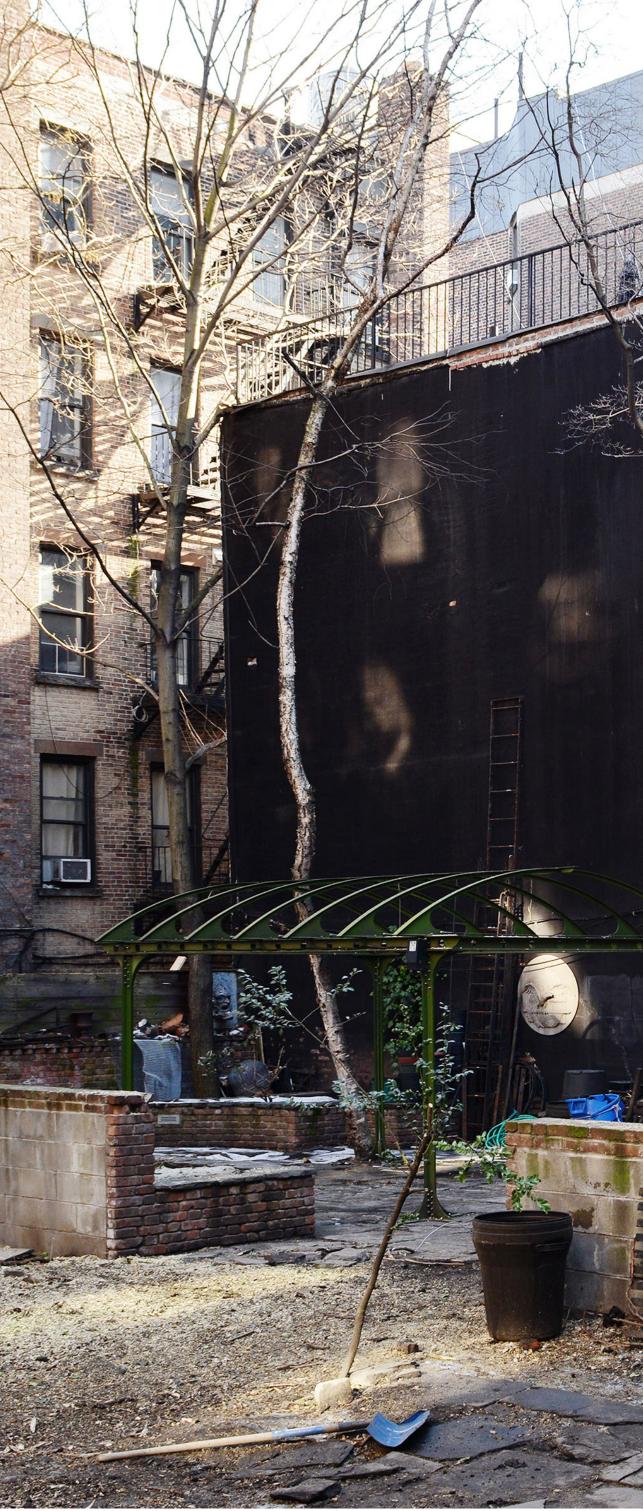
Three-story back house at 81 Sullivan Street
