55 Christopher St.
Awning & Signage

MVN Architect LLC

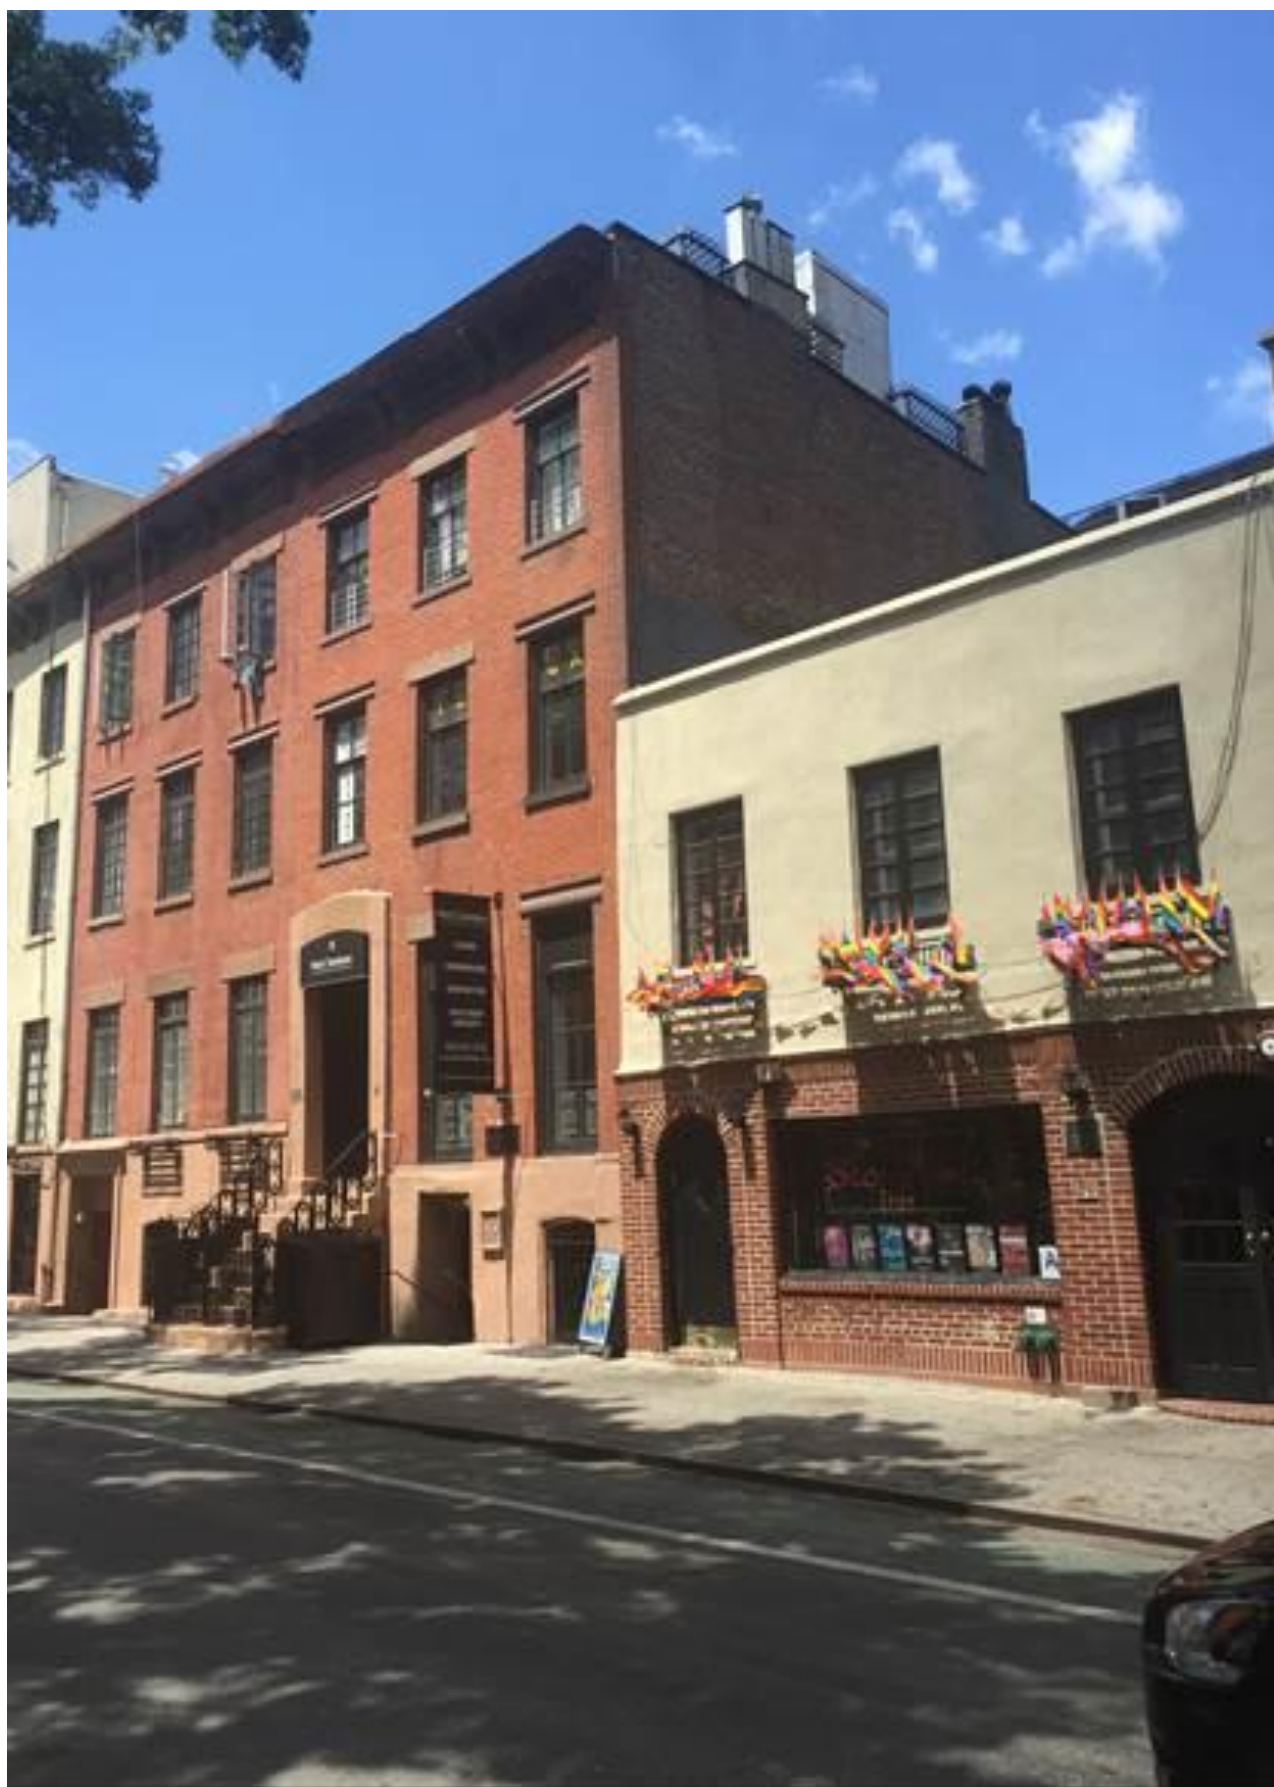
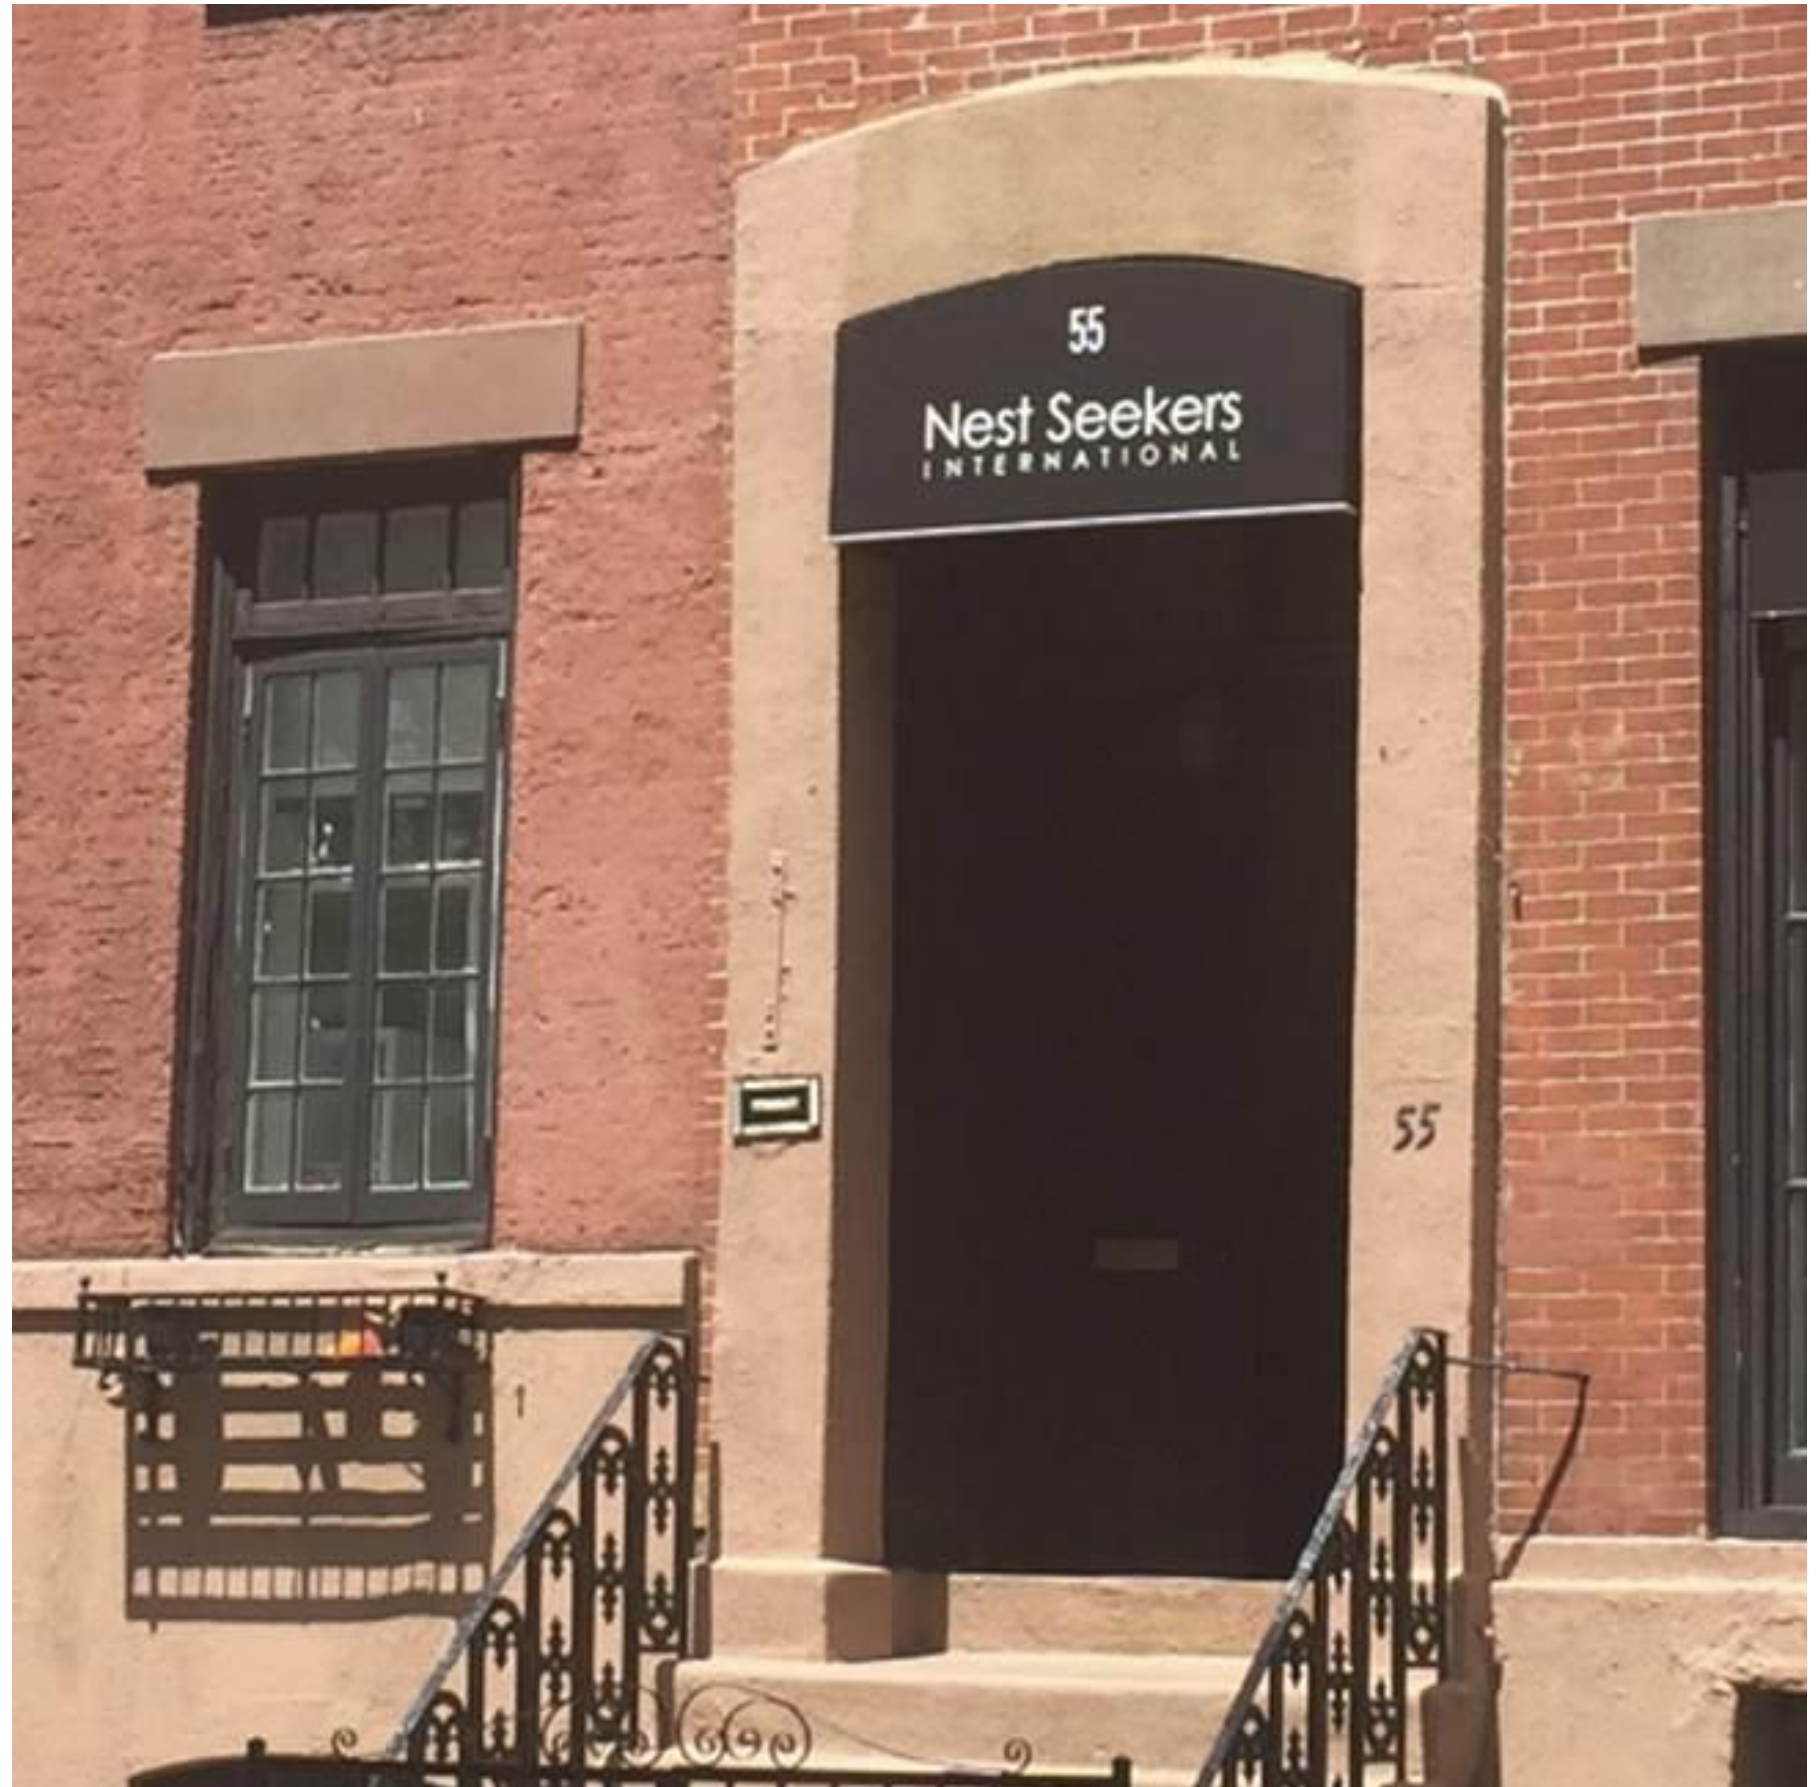
EXISTING CONDITIONS 55 CHRISTOPHER ST. FOR WHICH
LPC VIOLATION (16/1069) WAS ISSUED Awning [pictured here] and plaque, banner [next slide]. 2

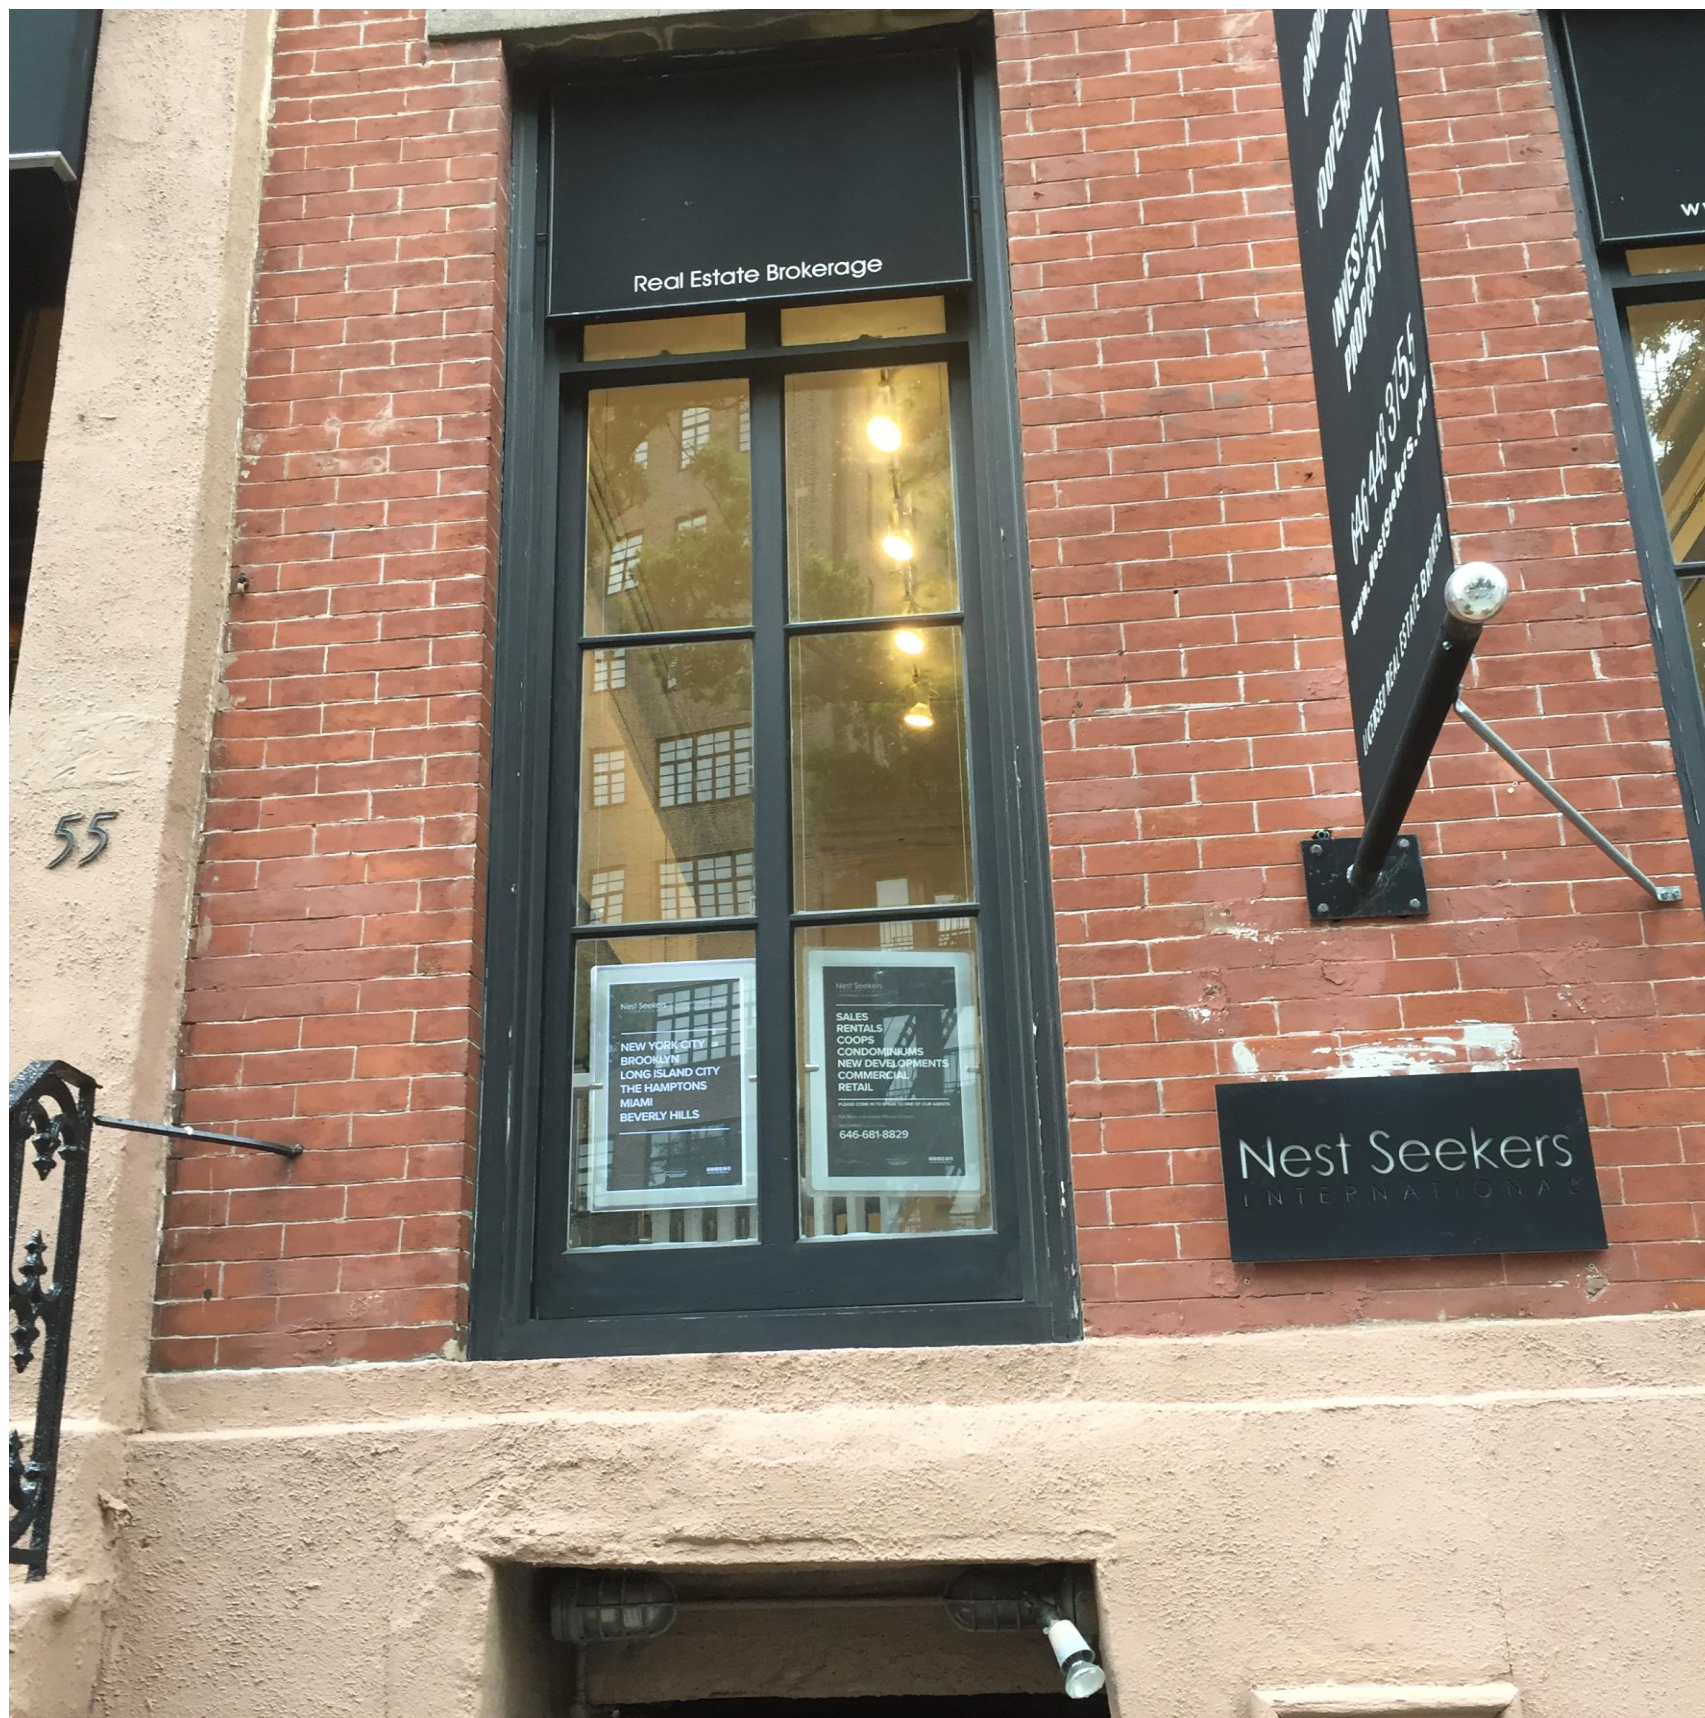
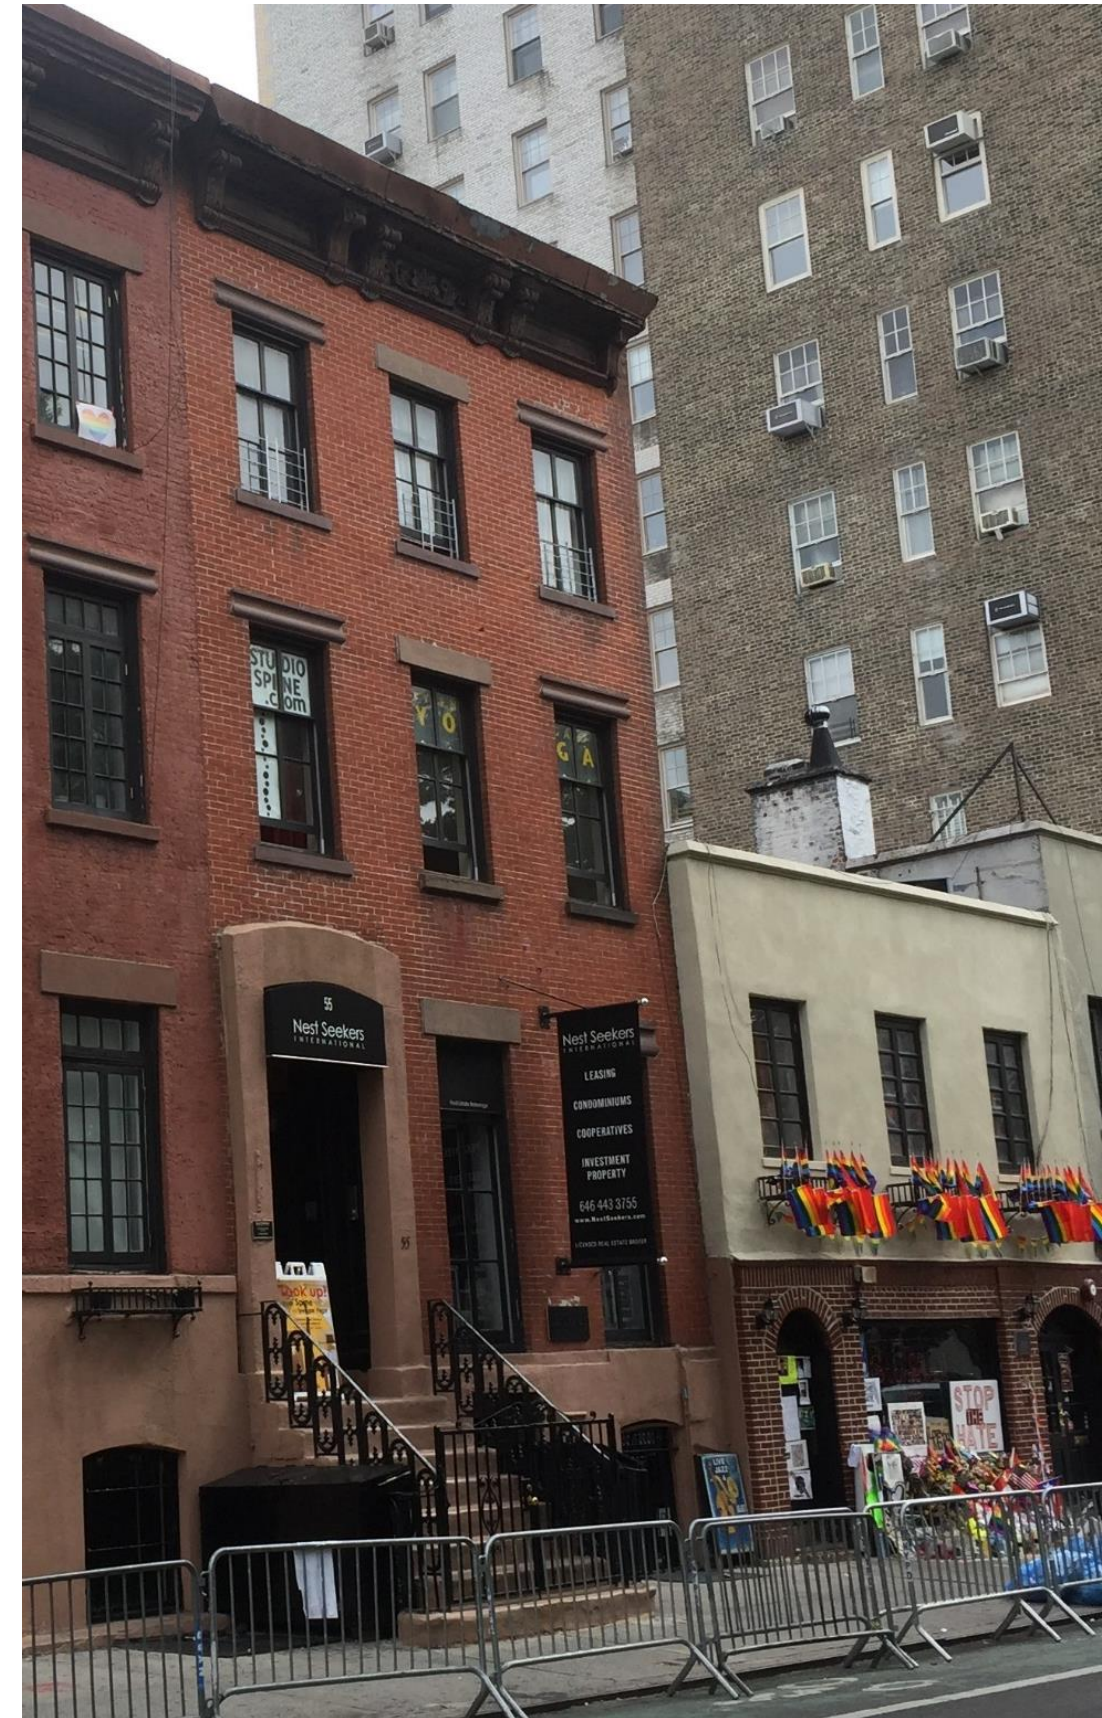
EXISTING CONDITIONS 55 CHRISTOPHER ST for which LPC Violation (16/1069) was issued for non-compliant plaques & banner. The need for commercial identification by commercial tenants and the placement of additional signage within the building behind the plane of the glass lends a haphazard and inconsistent appearance detracting from the historic character of the building.

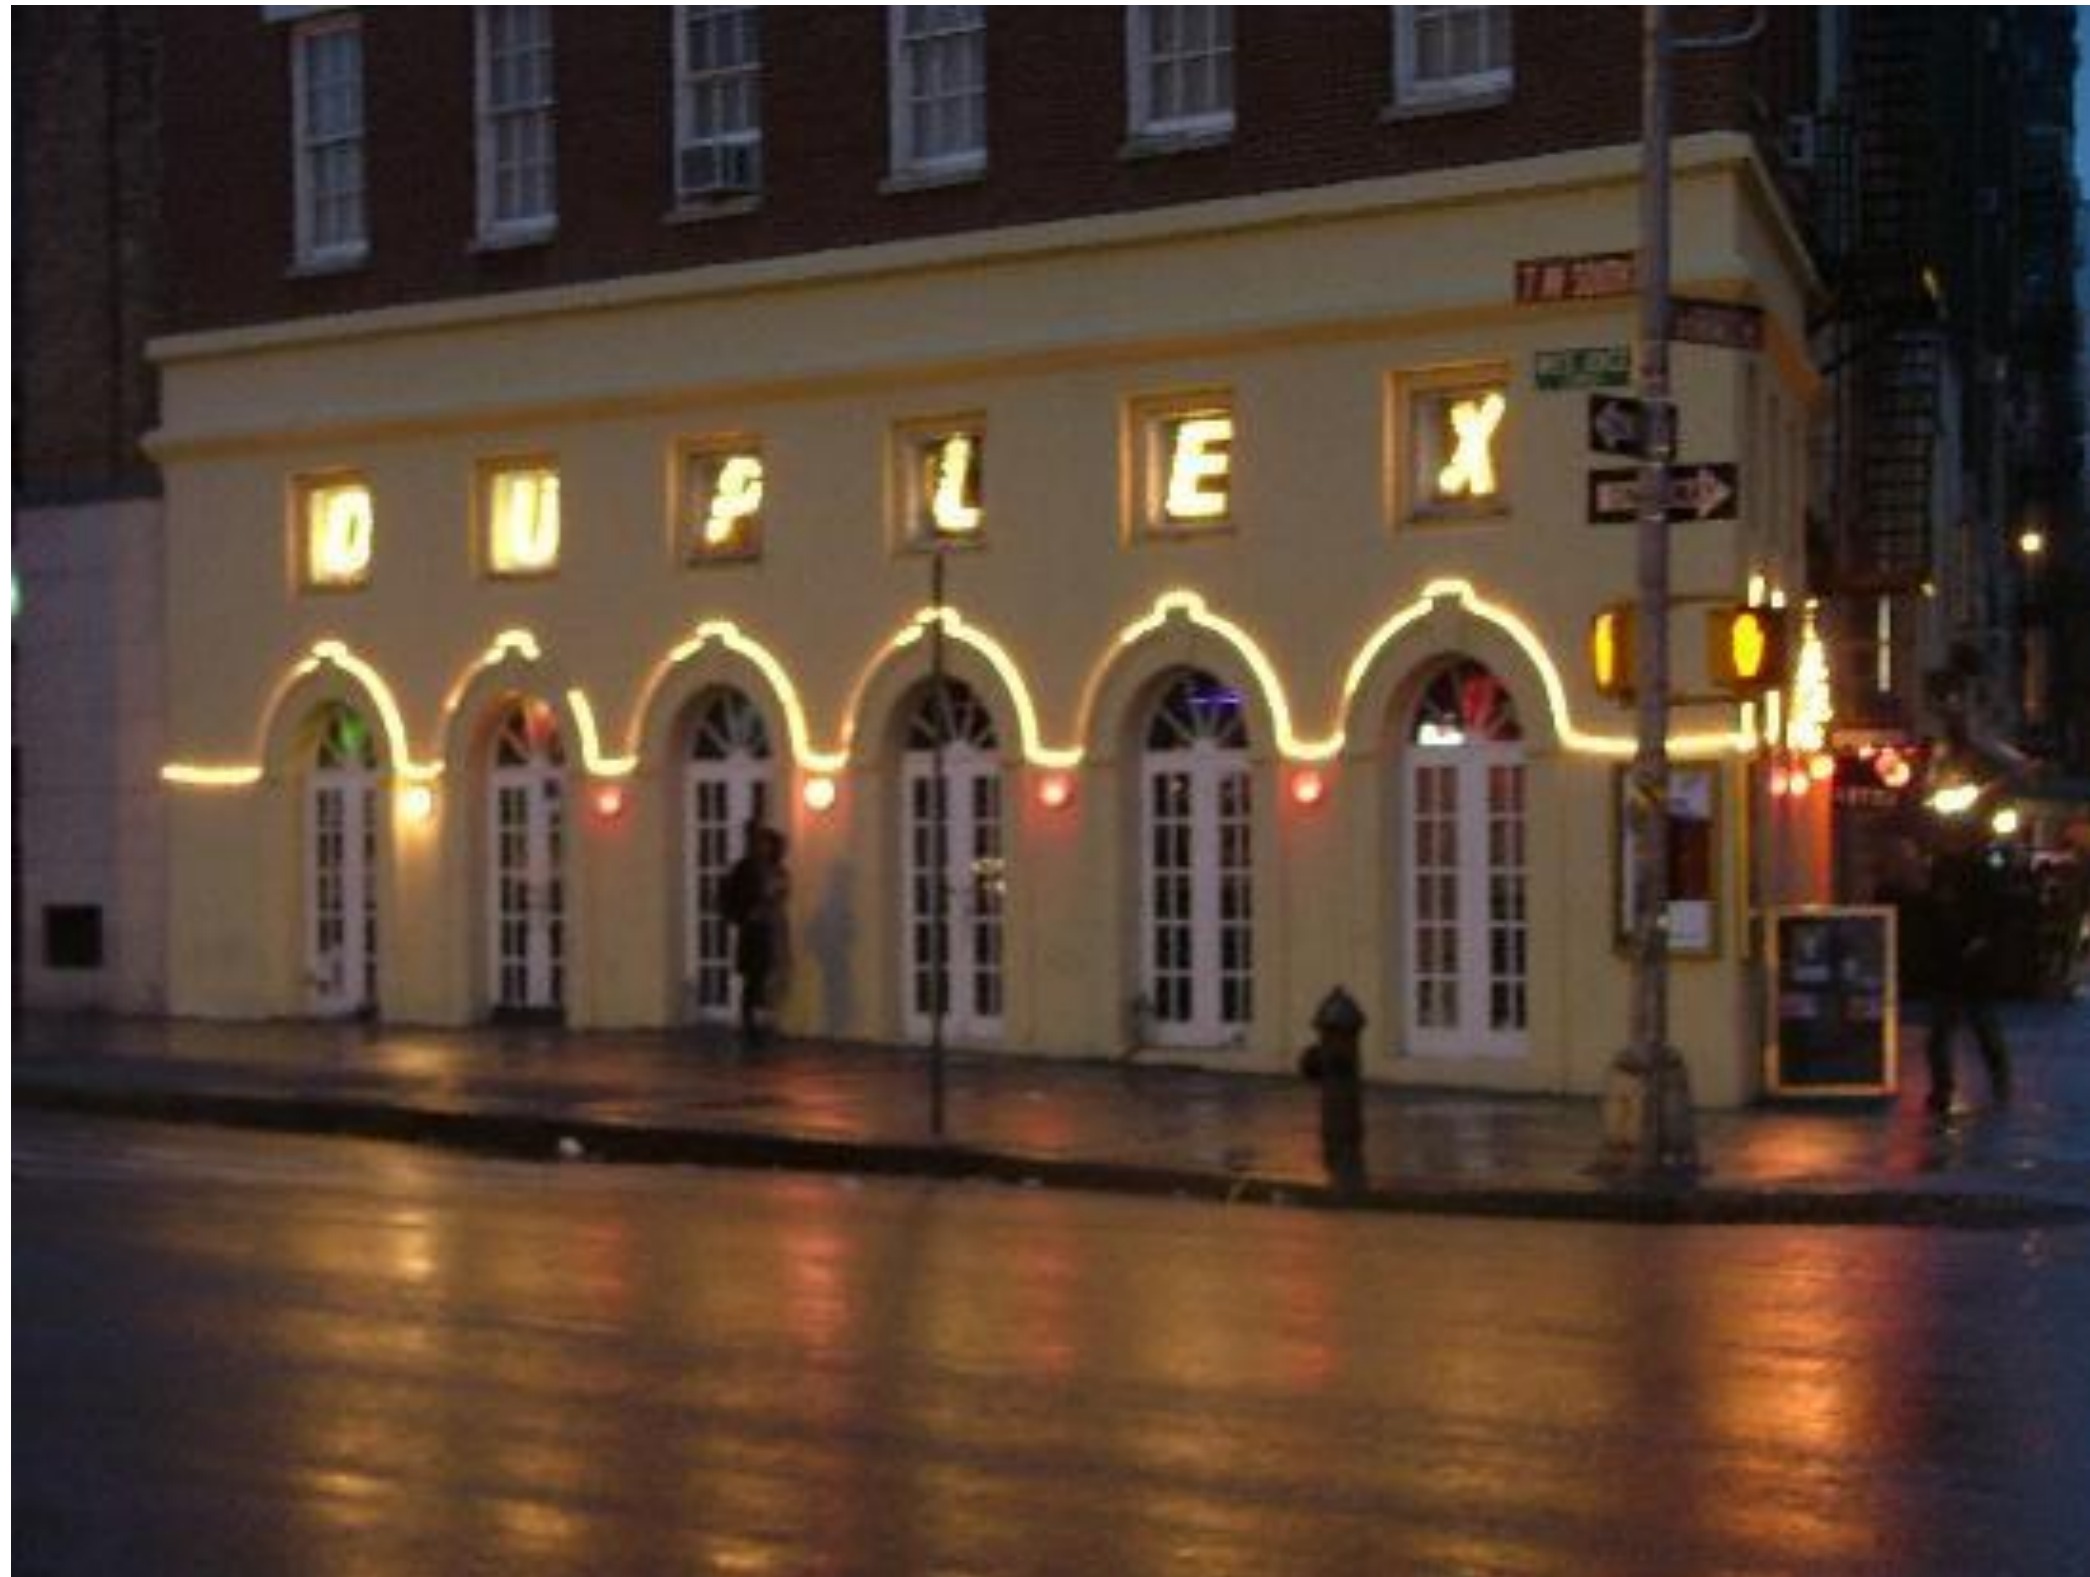
7TH AVE SOUTH & CHRISTOPER ST.

SIGNAGE LOCATED BEHIND PLANE OF GLASS,
POTENTIALLY OBJECTIONABLE TO HISTORIC CHARACTER

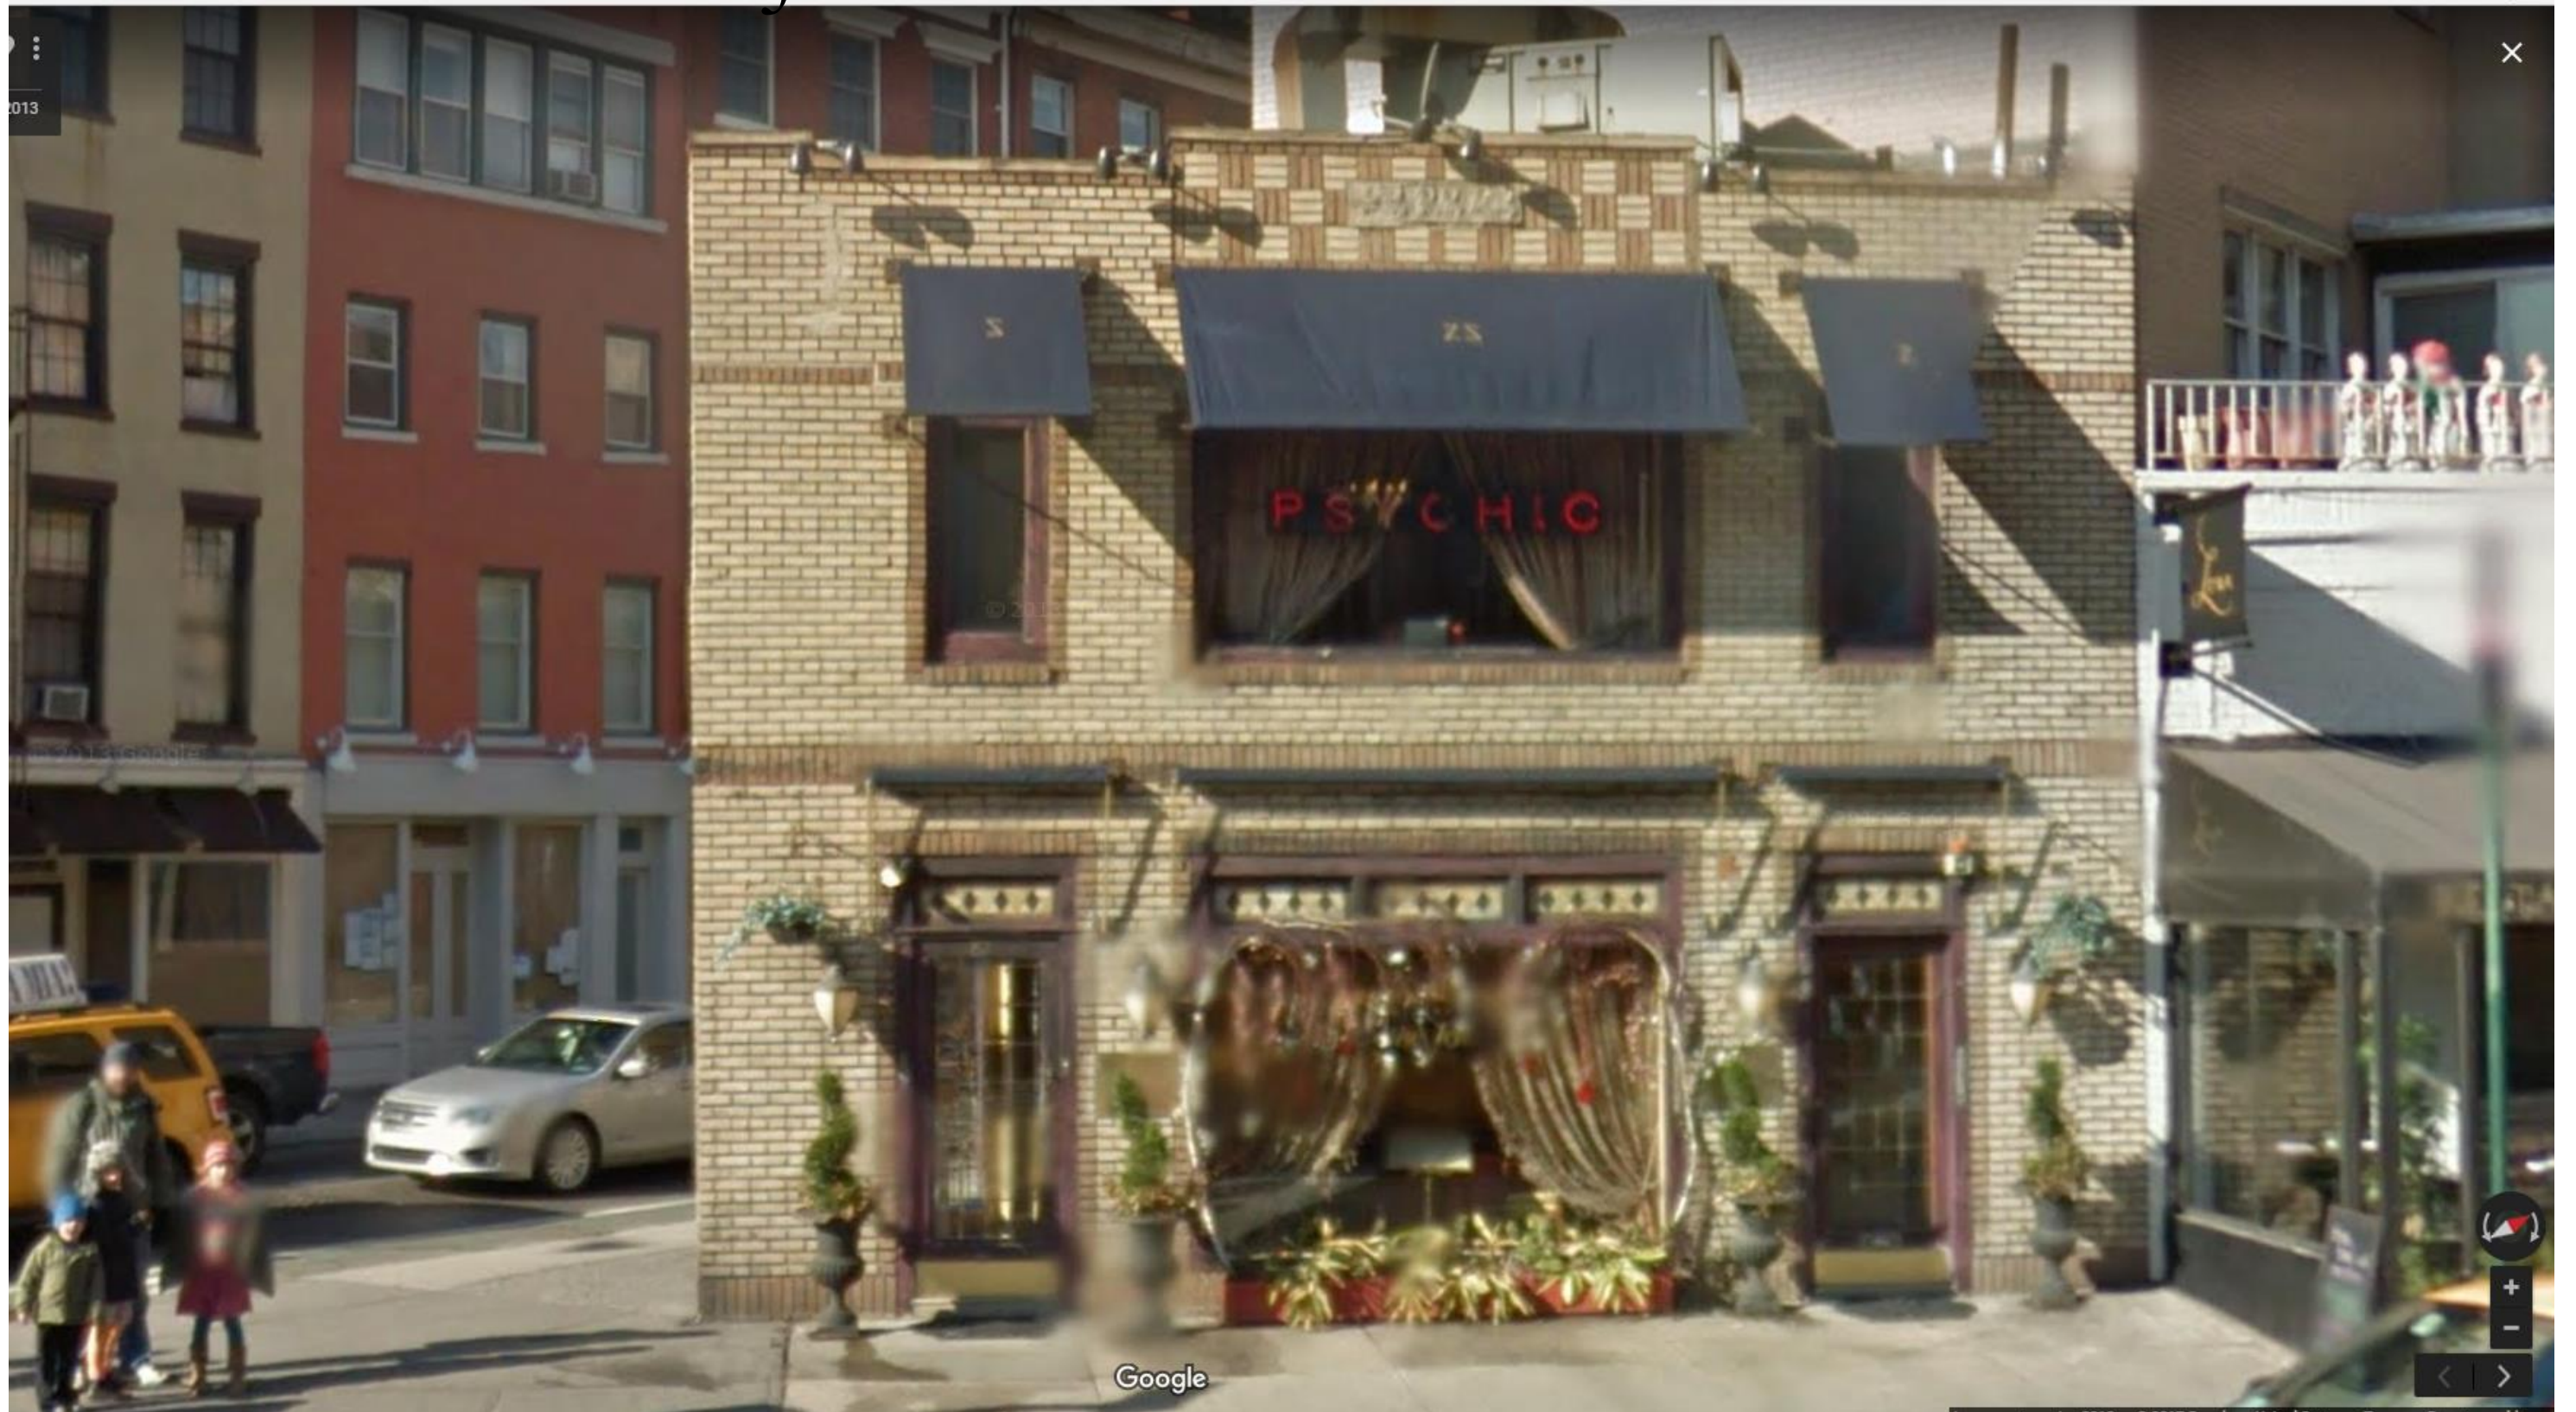
CORNER OF BLEECKER ST & 7TH AVE SOUTH

COMMERCIAL SIGNAGE LOCATED BEHIND PLANE OF GLASS,
POTENTIALLY OBJECTIONABLE TO HISTORIC CHARACTER
