Phase II Work Plan (Short Form)

**96-98 Degraw Street
Brooklyn, New York 11231
Block 329, Lot(s) 22 & 23
OER Project Number *NA***

PHASE I
ENVIRONMENTAL
SITE ASSESSMENT

VACANT PARCELS
96 DEGRAW STREET (BLOCK: 329 LOT: 22)
AND
98 DEGRAW STREET (BLOCK: 329 LOT: 23)
BROOKLYN, NEW YORK 11231

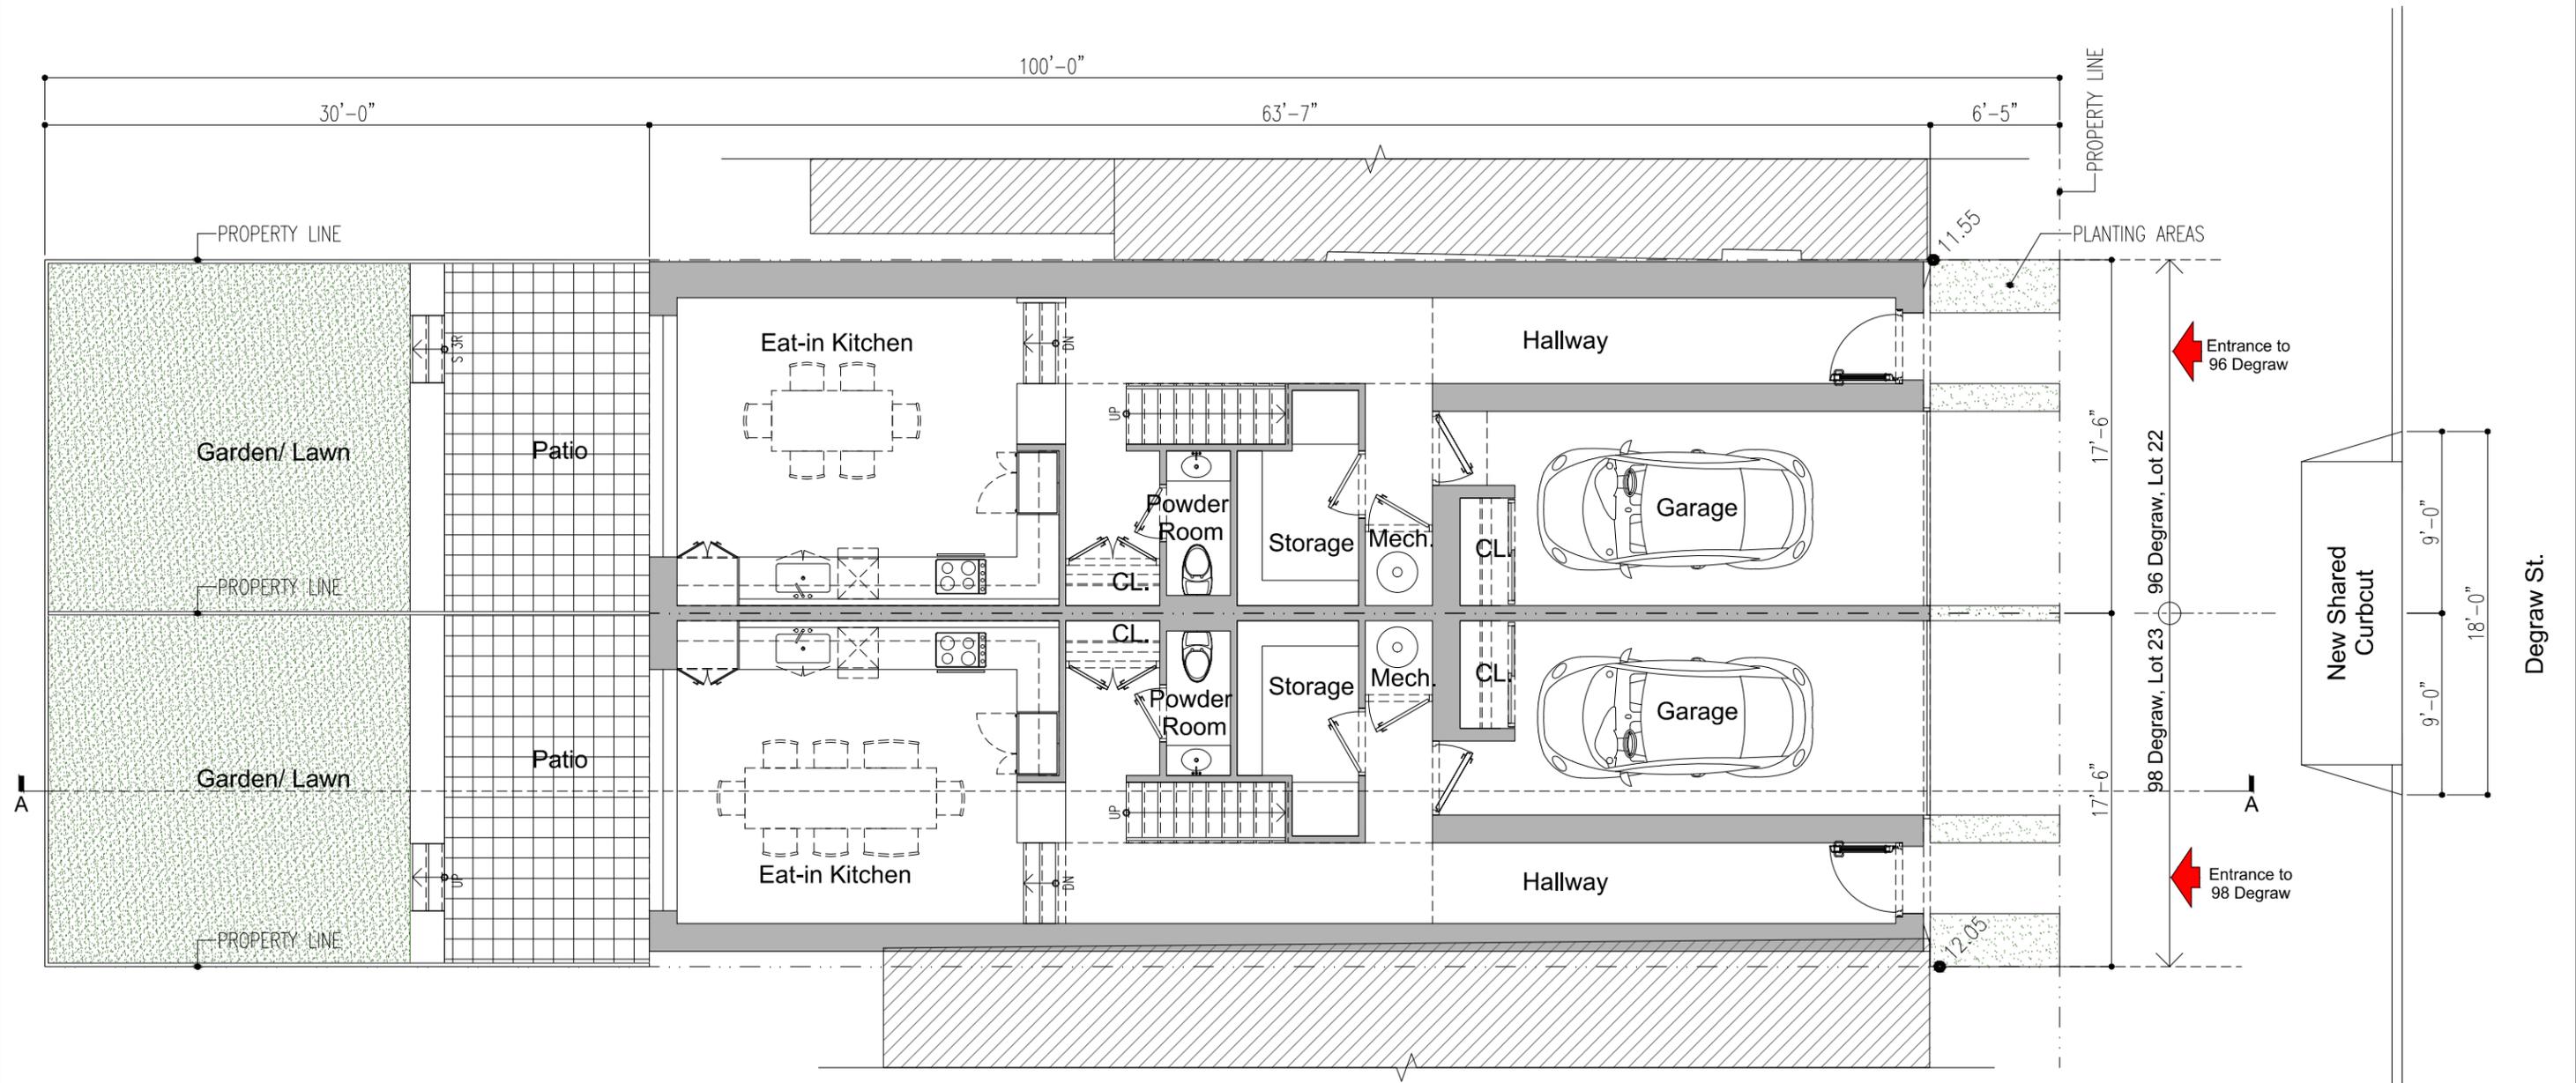
First Floor Plan
1/8" = 1'-0"

96 Degrav st.	98 Degrav st.
1FL Gross Area: 1,107 sf	1FL Gross Area: 1,065 sf
Lot 22, Block 329 BSA Calendar: 13-13 BZ	Lot 23, Block 329 BSA Calendar: 13-14 BZ

The Site is located in the Columbia Street Waterfront District of Brooklyn and is identified as Block 329 and Lot(s) 22 and 23. Currently, the Site is comprised of two adjoining undeveloped parcels, with a combined footprint of approximately 3,500 square feet. The Property is currently used for vehicle storage purposes, and as such, is unpaved, but graded with gravel. The development project consists of the construction of two single-family residential buildings. The proposed buildings will be three stories, have wall height of 31'-8", and a setback of 6'-6" from the street. The buildings will span the width of the property, be 63'-7" long, and will each maintain a 30' partially paved patio/rear yard. The water table is expected at approximately 14 feet below grade surface (bgs). Layout of the proposed site development is presented in Figure 1.0.

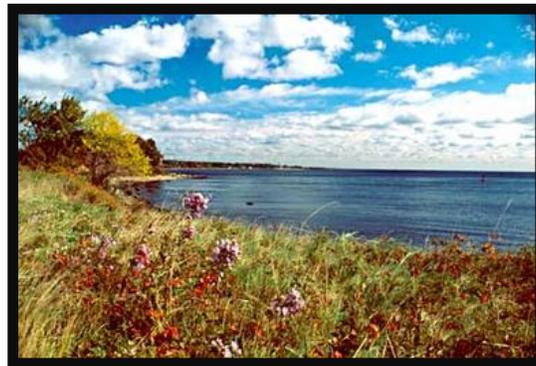
ZONE I - COASTAL LOWLANDS

Geology	This zone is a terminal moraine of the great ice sheet. Topographic relief is low.
Elevation	Ranges from sea level to 200 feet
Soils	The soils are glacial outwash and deltaic sands medium to moderately coarse-textured on gravel and recent alluvium. The soils tend to be strongly acid and are of low fertility.
Vegetation	All of the Coastal Lowlands are included in the oak natural vegetation zone. Much of the forest is scrubby due to the poor soils. Oak is the principal hardwood tree, while pitch pine is the principal conifer.
Land Use	This zone continues to experience a rapid expansion of urban and suburban development.

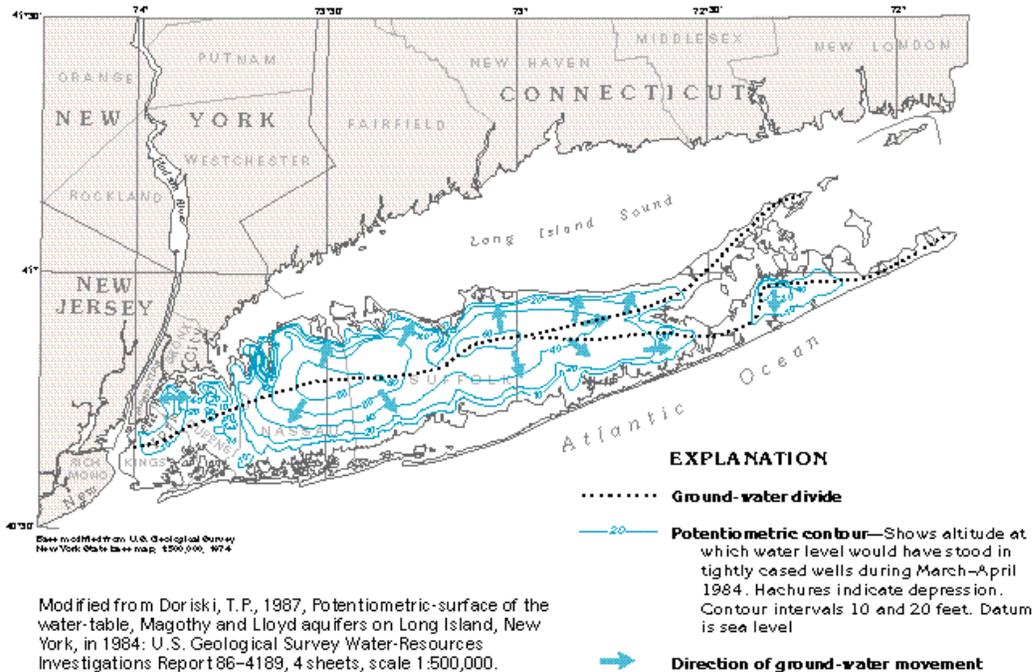
Figure 72. The potentiometric surface of the upper glacial aquifer slopes gently to the north and south from a central high, except in the western part of the island where ground-water withdrawals have lowered the water table and created cones of depression.

Modified from Doriski, T.P., 1987, Potentiometric-surface of the water-table, Magothy and Lloyd aquifers on Long Island, New York, in 1984: U.S. Geological Survey Water-Resources Investigations Report 86-4189, 4 sheets, scale 1:500,000.

According to groundwater contour maps provided by the NYCDEP and the NYSDEC, Topographic Quadrangles provided by the USGS, and previous work performed by **LEA** in the area, the subject property has an elevation of approximately 15 feet above mean sea level. Regional groundwater is estimated to be 14 feet below grade at the subject property and flowing in a westerly direction, towards the East River. A site specific hydrogeologic study is warranted to confirm localized on-site groundwater flow direction, which is beyond the scope of this report.
