INDEPENDENT COMMUNITY MONITORING

REPORT No. 5

Monitoring Period: Saturday, March 15, 2025 through Sunday, May 4th, 2025

1.0 Project Background and Role of the Independent Community Monitor (ICM):

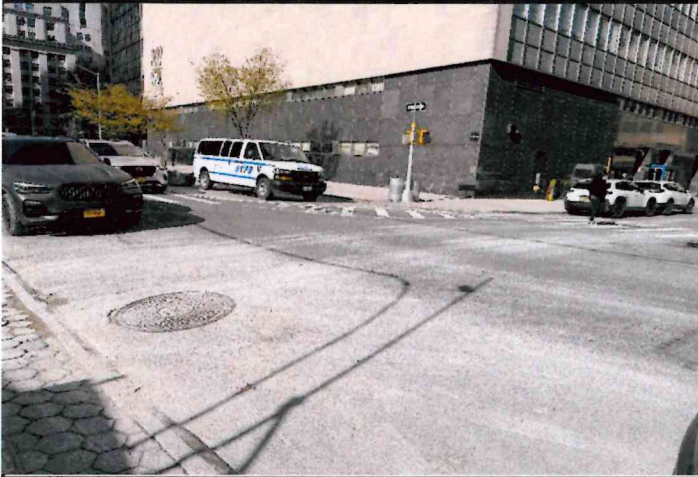
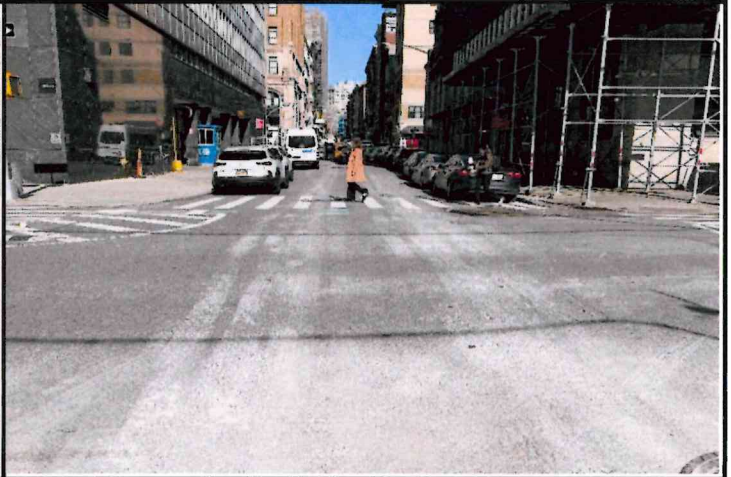
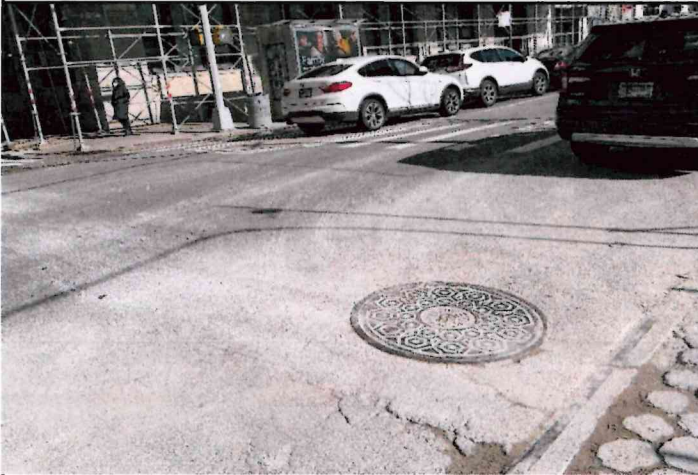
- **Offsite CAMP Station AQS 998:** No measurable dust/particulates and noise measured below the action level at 64.1 dBA.
- M. DeMatteo visually inspects the sidewalk and roadway opposite the Site entrance/exit for any visible sign of dust/particulate tracking offsite and finds evidence of dust tracking offsite onto Center Street and White Street and pointed out to onsite personnel to ensure that the tracking

pad is properly maintained (**See Photos No. 1 through 3, Page 16 of 18 of the enclosed Data Summary Report No. 5**).

4. Photographic Summary: Photo 1: View of the intersection of Centre St. and White St. looking west from the site entrance.

Photo 2: View of Centre St. and White St. looking west from the Site entrance.

Photo 3: View of Centre St. looking north from the Site entrance.

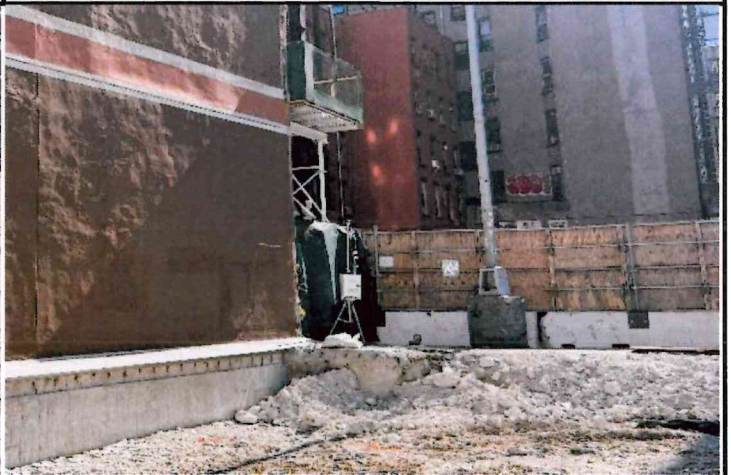
- M. DeMatteo observed the onsite, downwind CAMP station in the northeastern corner of the Site in the vicinity of AQS-998 which was set up and is managed by Langan to monitor air quality associated with the ongoing geotechnical investigation (**See Photo No. 4, Page 16 of 18 of the enclosed Data Summary Report No. 5**).

Photo 4: View of the northeast corner of the interior of the Site showing the onsite, downwind CAMP station set up for the geotechnical investigation.

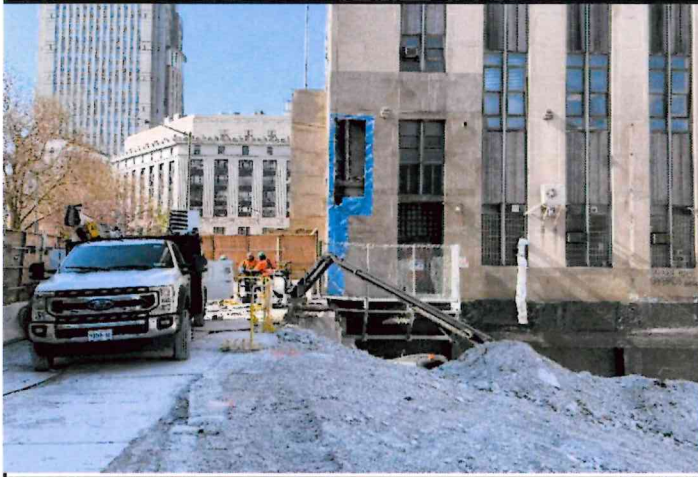
- M. Schnurr escorts M. DeMatteo across the Site and she photographs the Site conditions and ongoing activities which include brick work in progress on the Courthouse building, continued dismantling of the remnant Sally Port (**see Photo No. 5, Page 17 of 18 of the enclosed Data Summary Report No. 5**) drilling of geotechnical soil borings being advanced using mud rotary and sonic drilling techniques (**see Photos No. 6 through 8, Page 17 of 18 of the enclosed Data Summary Report No. 5**), and regrading/grading of crushed concrete to facilitate drill rig access to the various geotechnical and other soil boring locations (**see Photos No. 9 through 12, Page 18 of 18 of the enclosed Data Summary Report No. 5**).

Photo 5: View of the southeast corner of the Site showing the brick work and concrete slab work in progress.

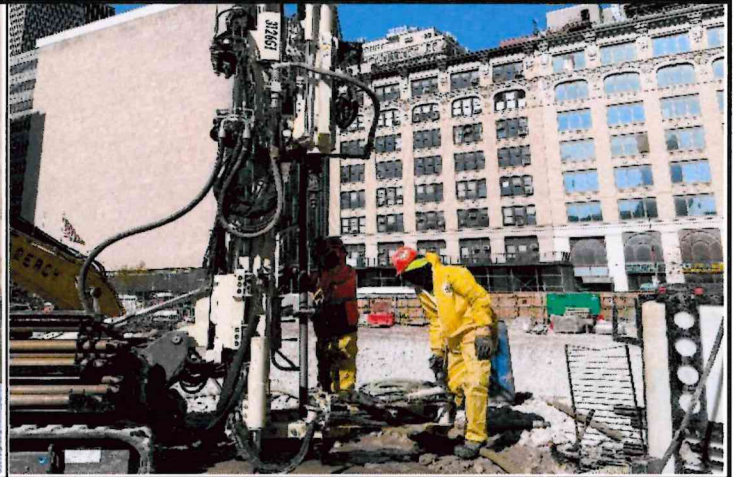
Photo 6: View of a Geoprobe drill rig and a soil boring for the geotechnical investigation in progress.

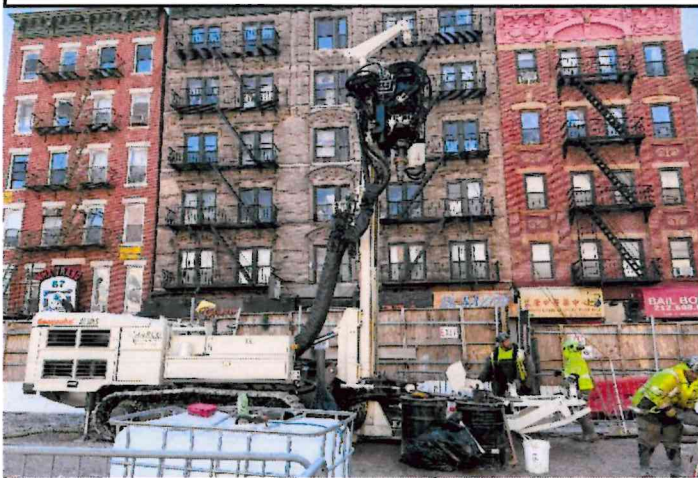
Photo 7: View of a sonic drill rig and a soil boring for the geotechnical investigation in progress.

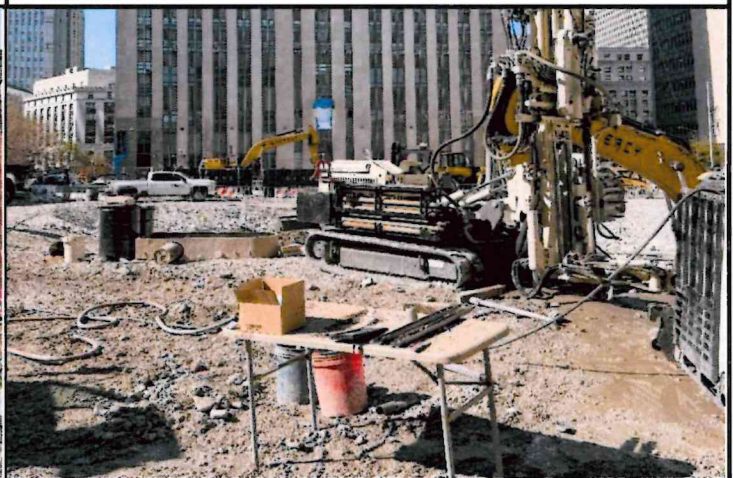
Photo 8: View of a Geoprobe drill rig and a soil boring and soil sampling for the geotechnical investigation in progress.

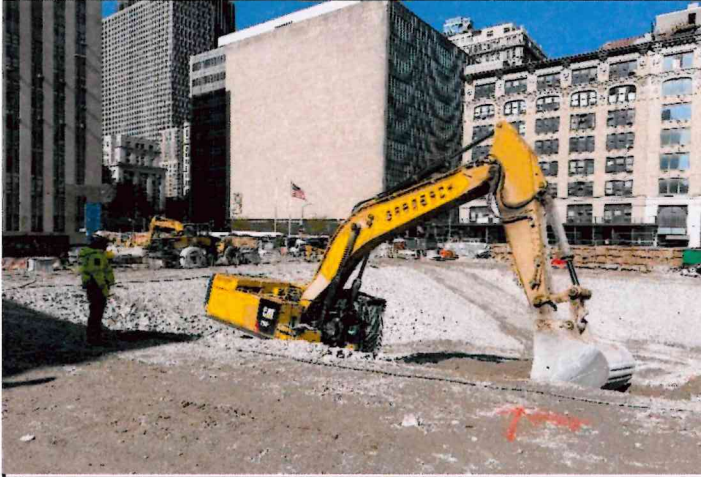
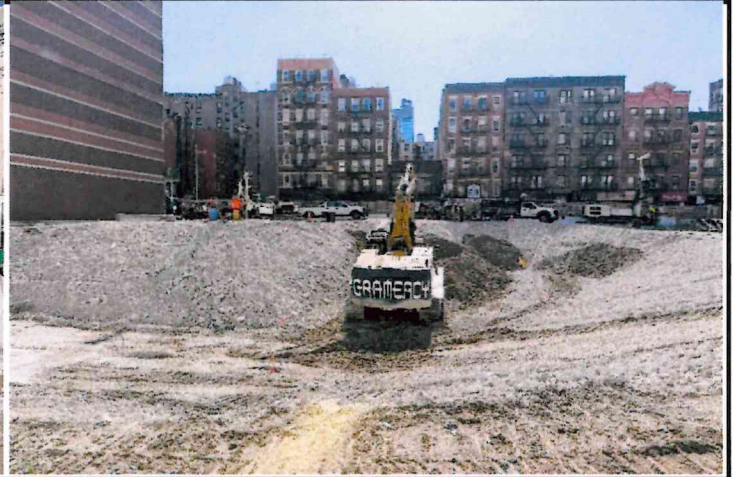
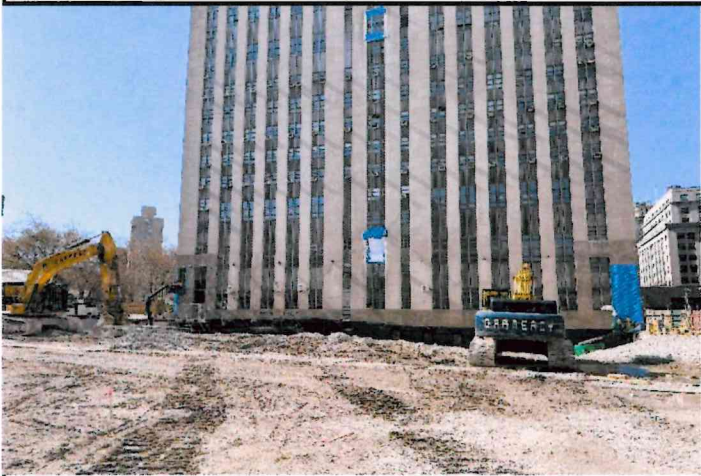
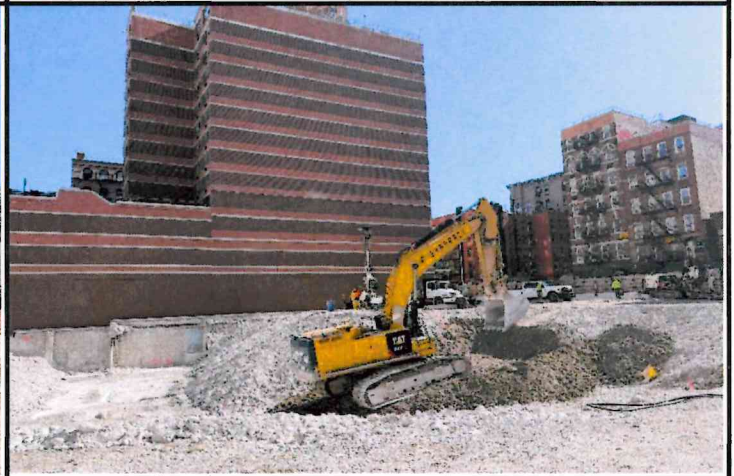
Photo 9: View of an excavator working on grading to facilitate access to drill rigs for the geotechnical investigation.

Photo 10: View of an excavator working on grading to facilitate access to drill rigs for the geotechnical investigation.

Photo 11: View of an excavator working on grading to facilitate access to drill rigs for the geotechnical investigation.

Photo 12: View of an excavator working on grading to facilitate access to drill rigs for the geotechnical investigation.
