FAÇADE FAILURES IN HIGH RISE BUILDINGS

BUILD SAFE | LIVE SAFE
CONFERENCE 2019

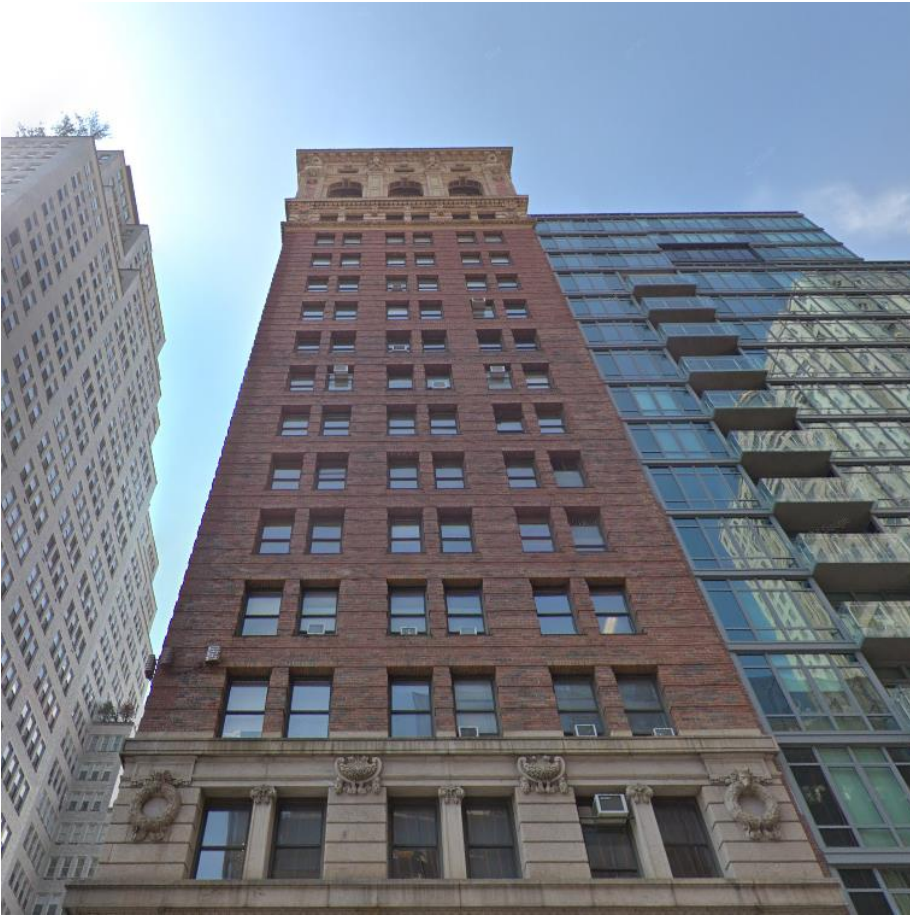
TERRA COTTA CASE #1

- Built in 1899
- Landmarked
- 14 Stories, mixed use

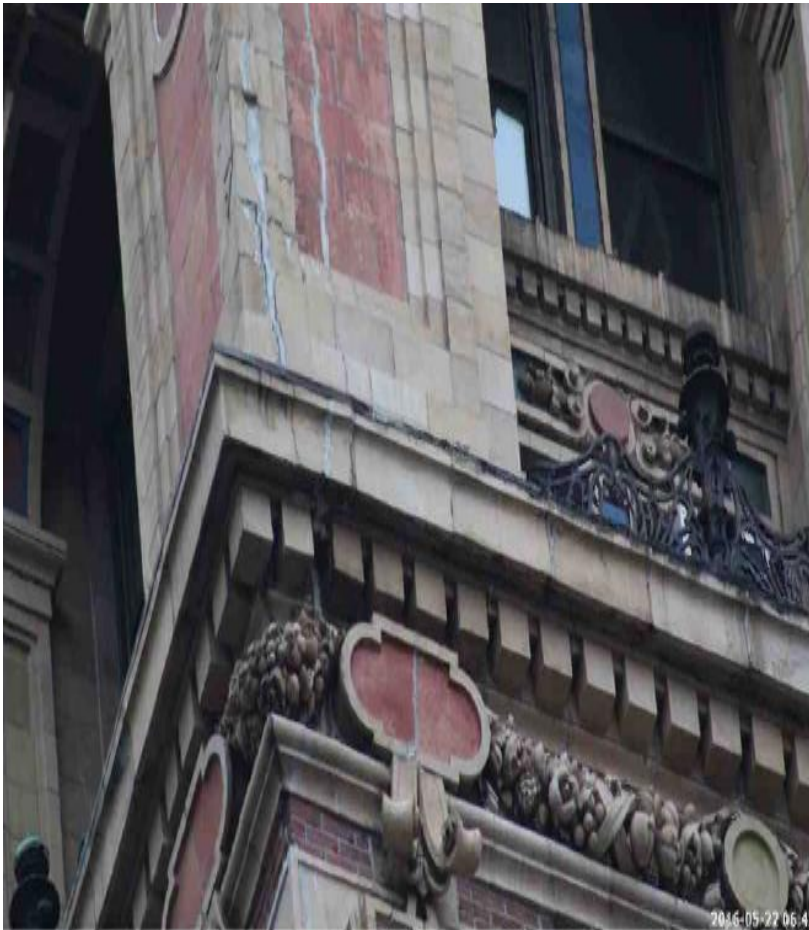
TERRA COTTA CASE #1

- Sept 2015 – Cycle 8A filed: **SAFE**
- May 2016 – Complaint and violation for cracked TC
- June 2016 – Subsequent filing: **UNSAFE**

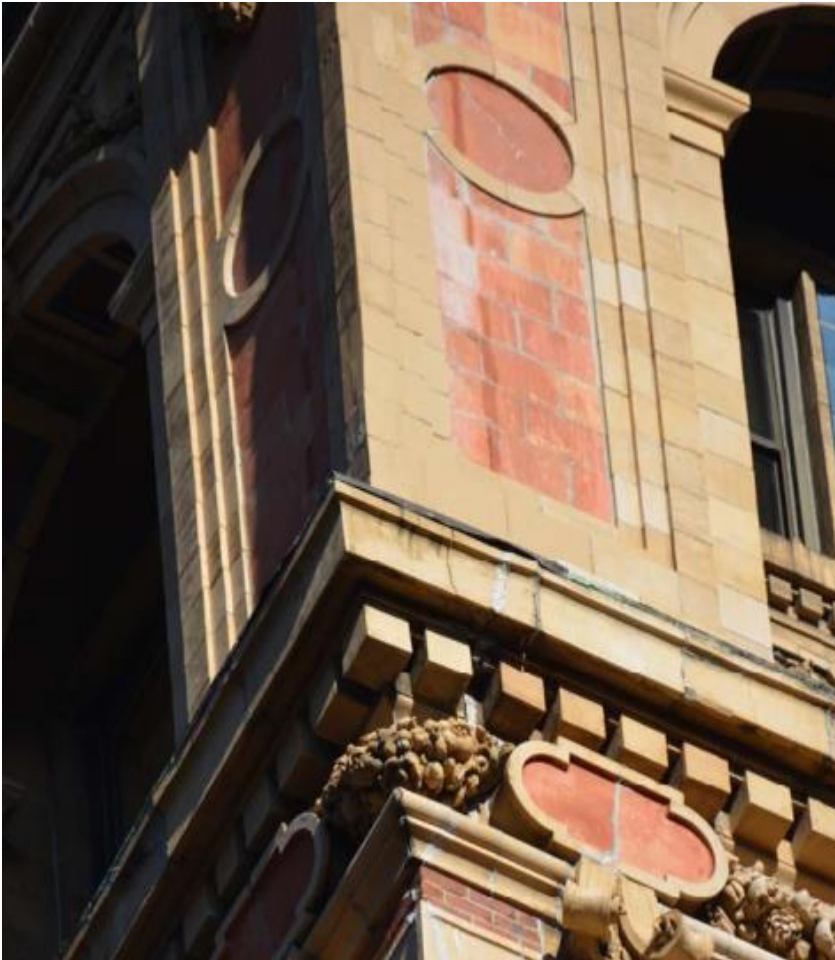
TERRA COTTA CASE #1

- August 2017 – Repair work signed off
- Oct 17, 2017 – Filed Amended report with **safe** status
- Oct 20, 2017 – Violation for cracked TC

(report rejected by DOB plan exam after results of the inspection)

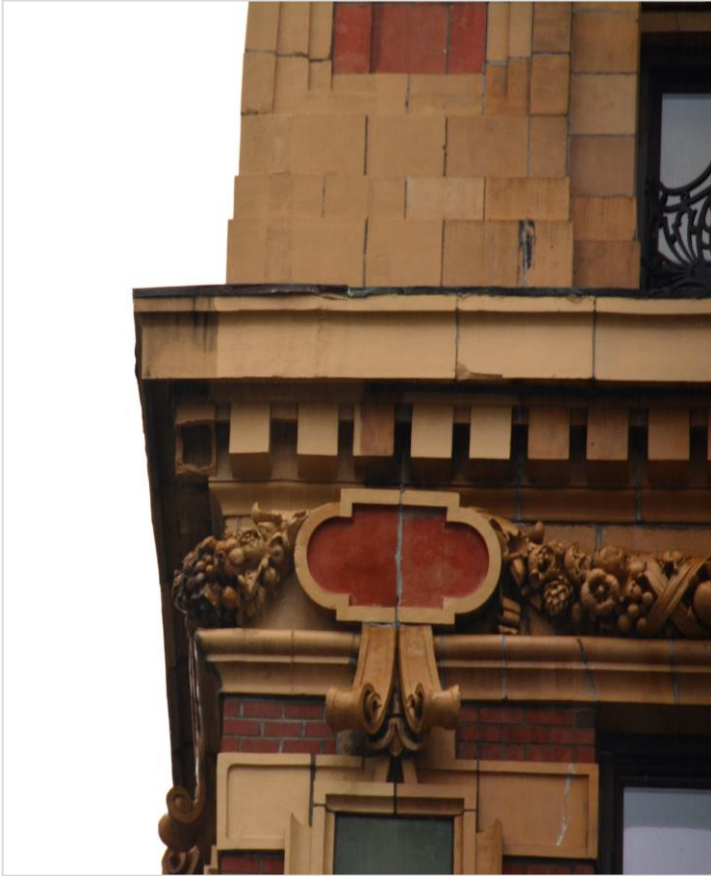
- **April 2018** – Certificate of Correction Accepted
- **August 2018** – Amended report accepted SAFE
- **January 2019** – Piece of TC fell off the building (violation served)

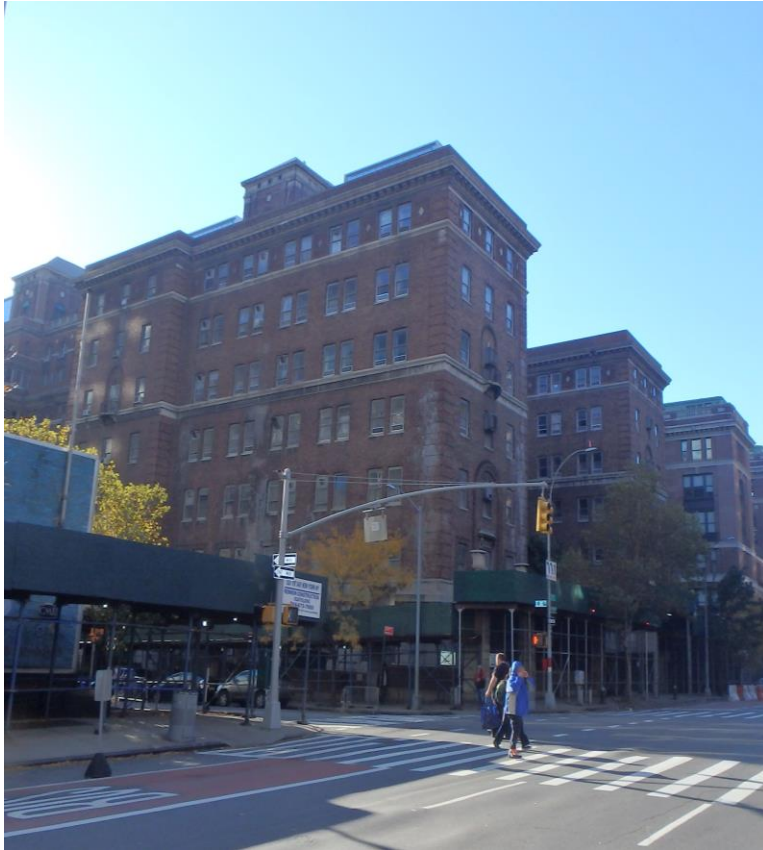
TERRA COTTA CASE #2

- Built ~1920
- 9 stories
- Hospital/shelter facility
- Filed **Unsafe** 3 cycles in a row

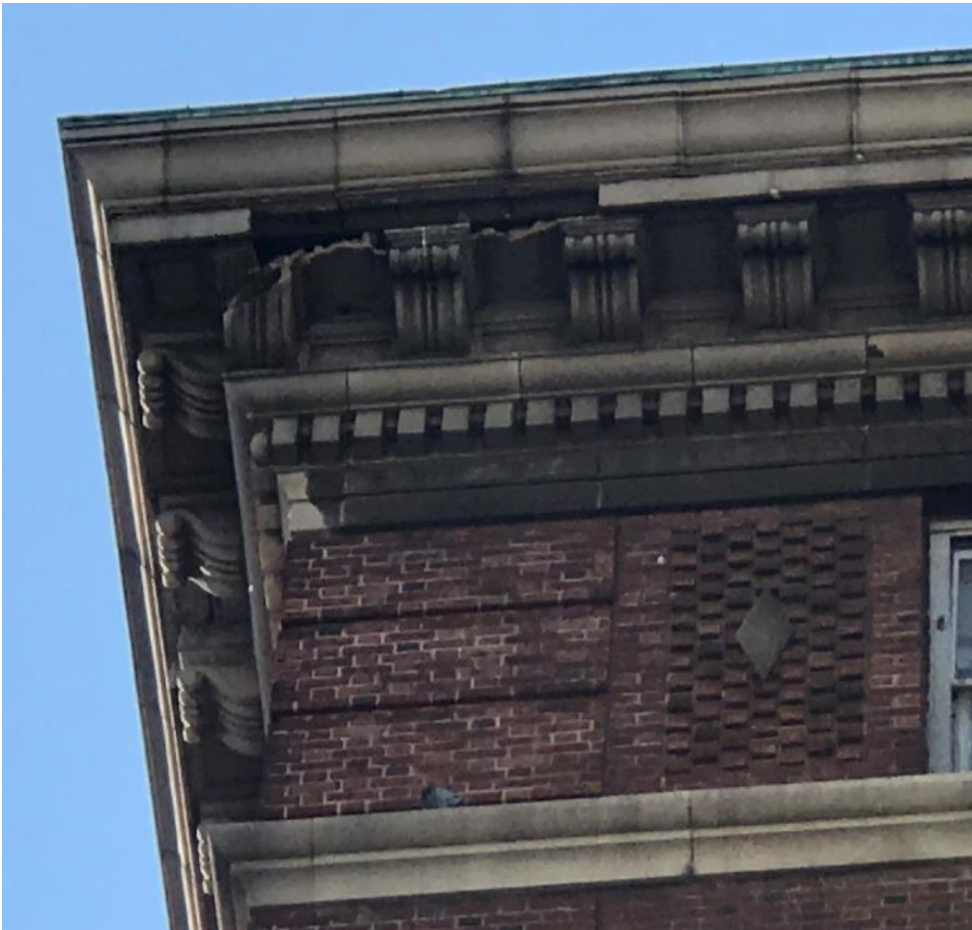
How did these pieces come off?

Were they carefully removed under controlled methods?

No. They fell off in an uncontrolled manner.

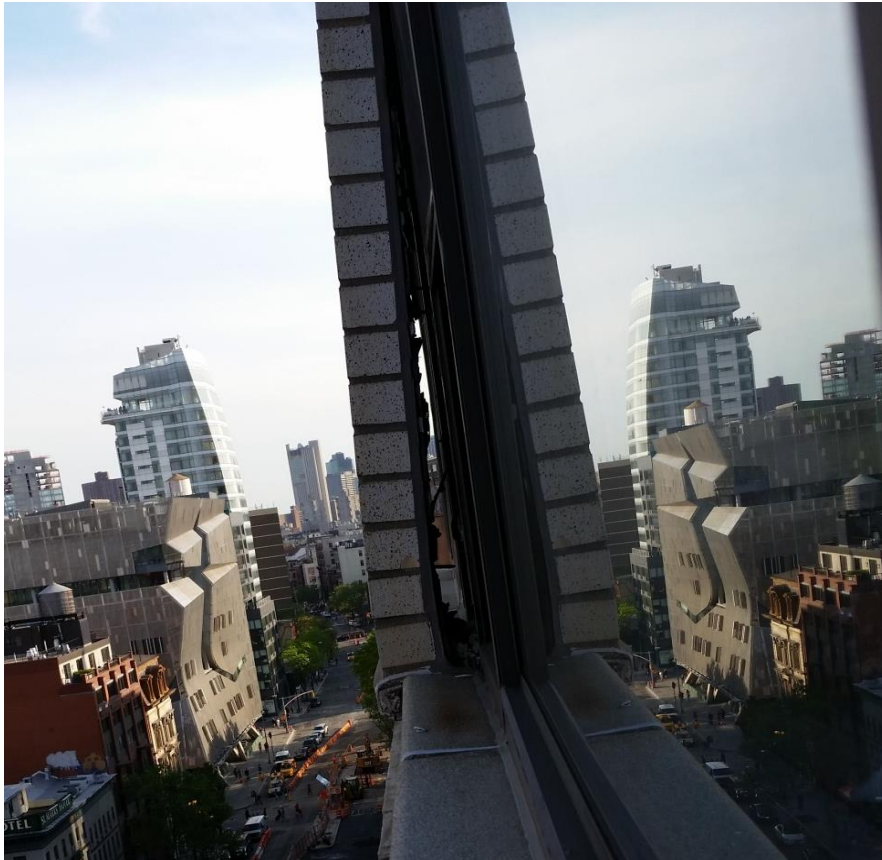
East Village condition caught before failure

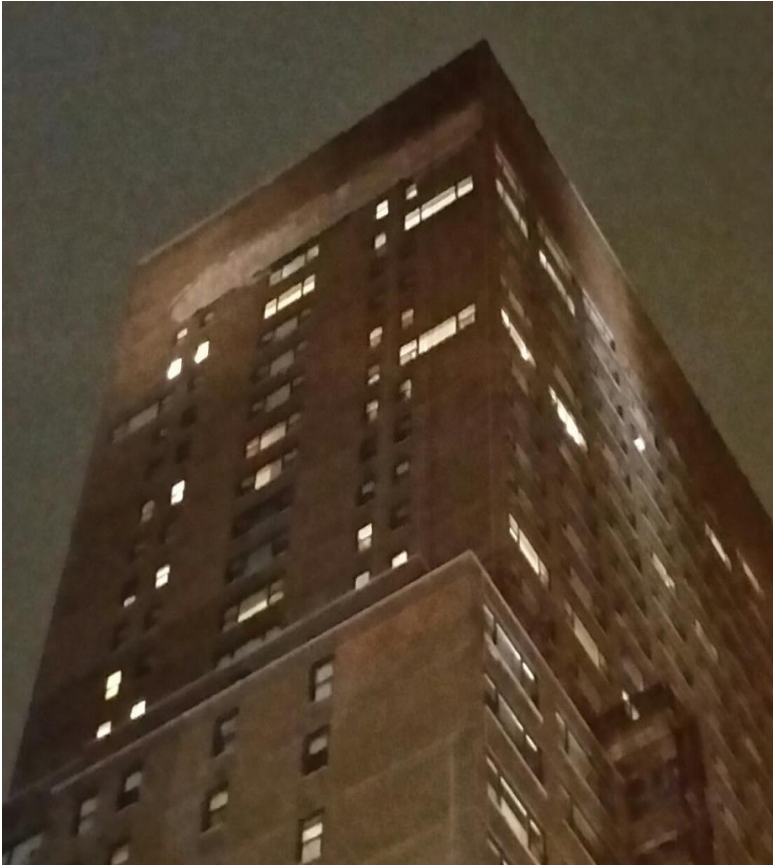
Upper East Side Cavity Wall Failure

- Surface erosion
- Joint failure, cracked, spalling, or missing bricks
- Deteriorated anchors indicating possible instability of masonry
- Failure of supporting structure – stability of the façade is compromised

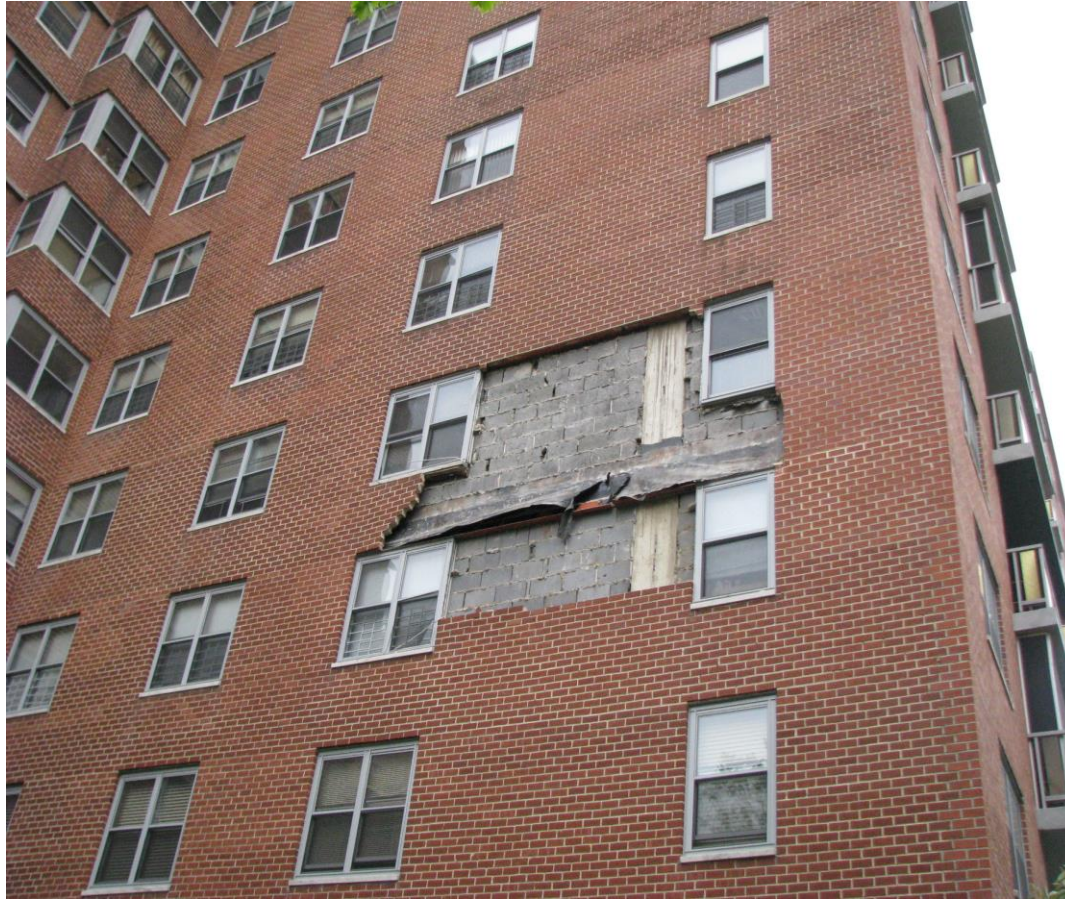
CAVITY WALL #1

- Residential building in Queens built in 1963

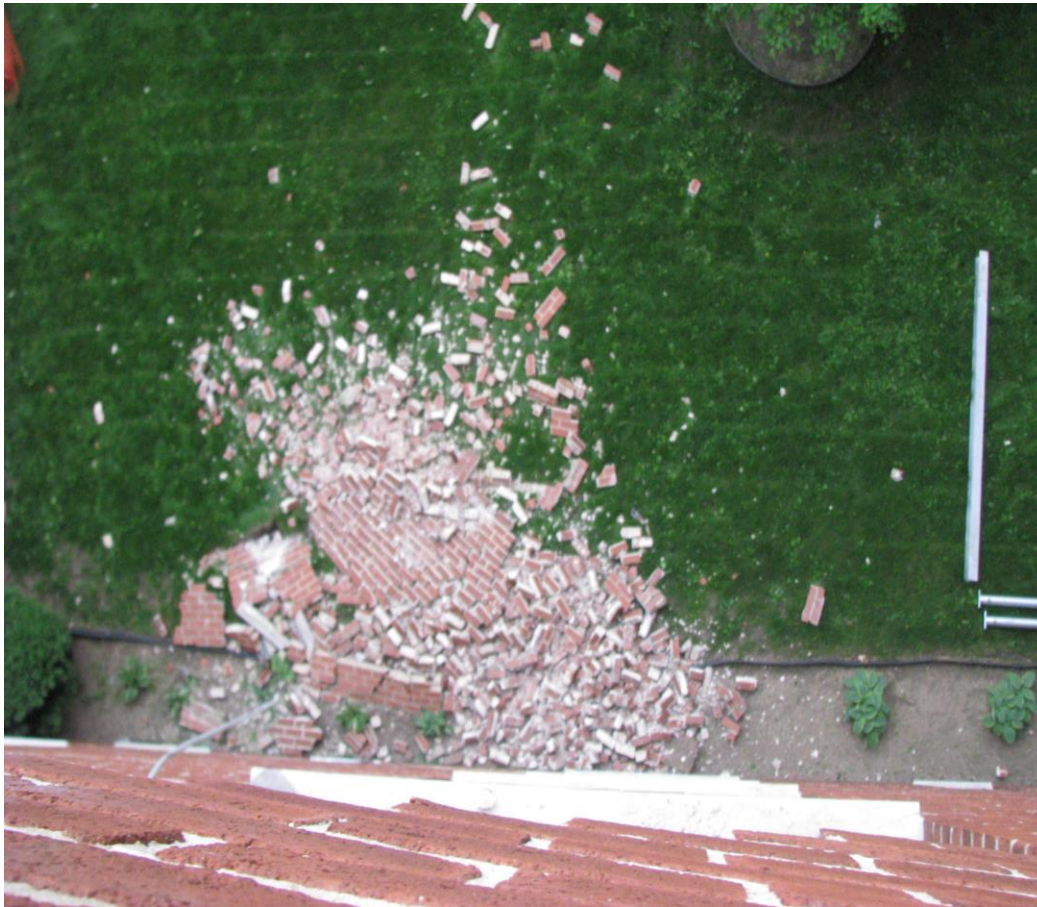
- Two story section of face bricks failed and landed on the ground

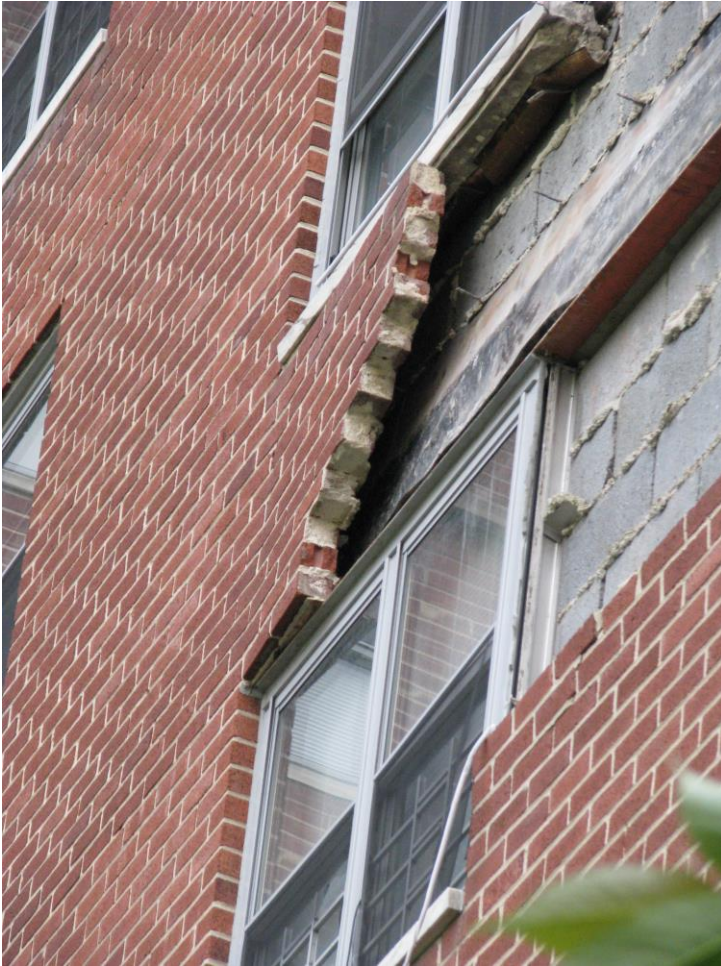
- Many failures of masonry wall caused by the lack of bond between the outer wythes and backup masonry.
- Omitted or failed ties

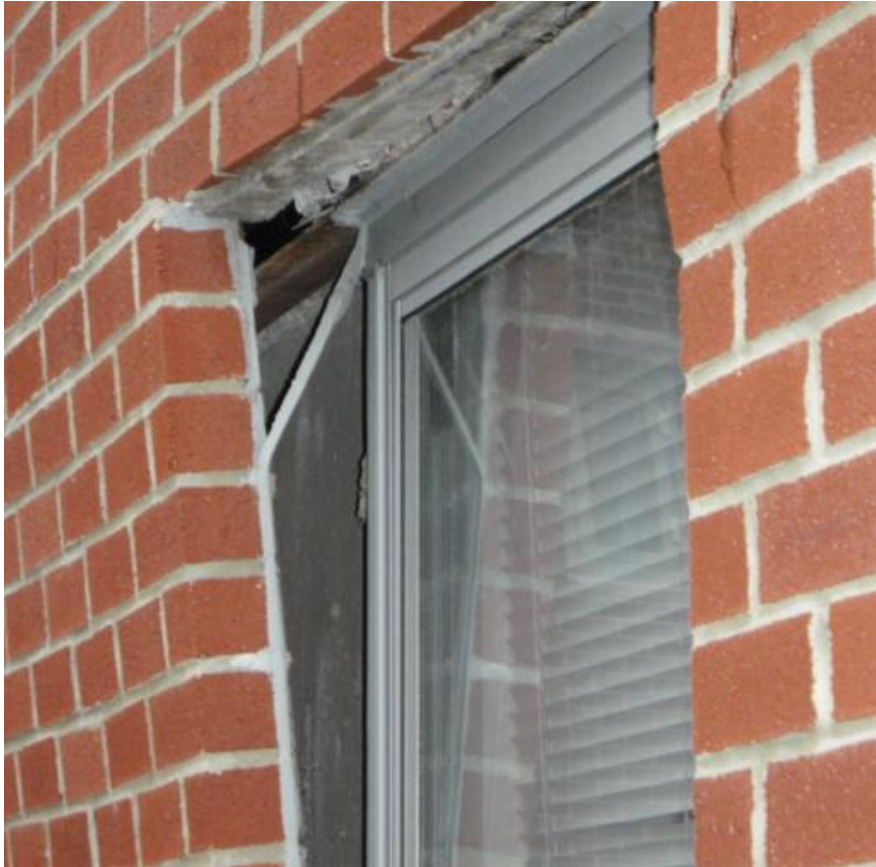
- Anchors were not installed as frequently as required

OR

- Anchors possibly deteriorated and caused the outer wythe to pull away from the backup masonry

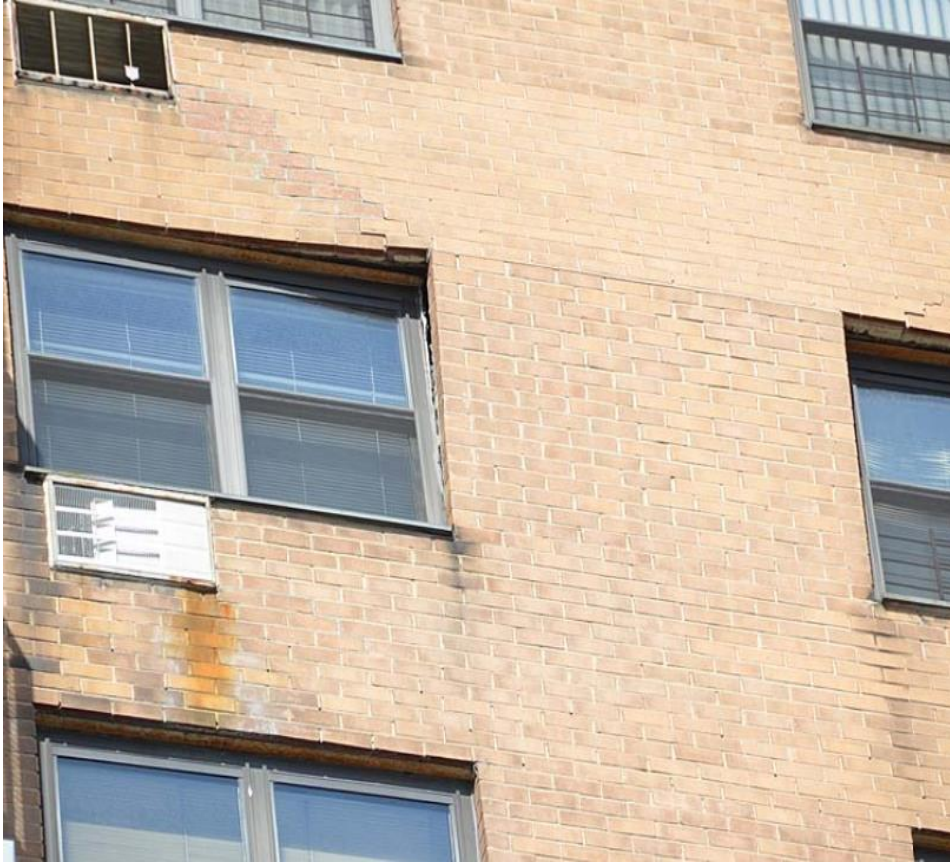
- The cumulative weight of inadequately anchored wall may cause areas of masonry to buckle outwards.

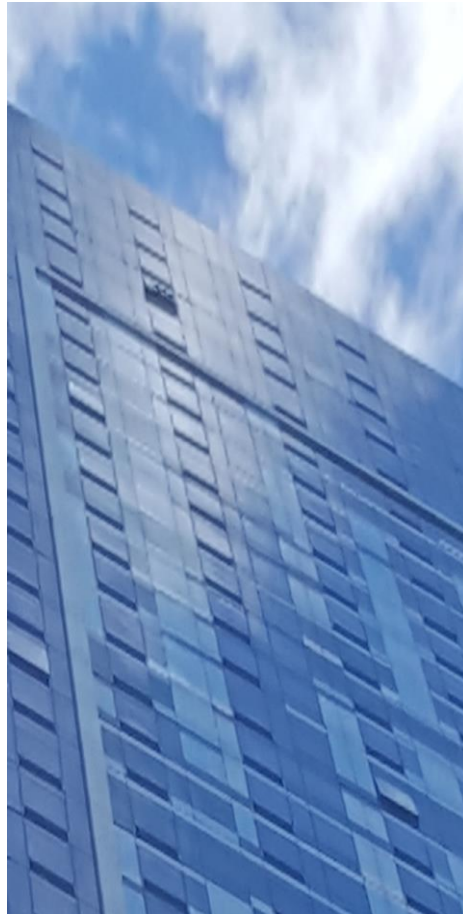
CASE #1: FAILURE DUE TO IMPACT

- FDNY responds to report of debris falling from a façade; requests DOB

- It was determined the initial crack was caused by the house window washing rig
- DOB inspectors found similar cracks on other panels
- Full repair pending along with retrofit of house rig

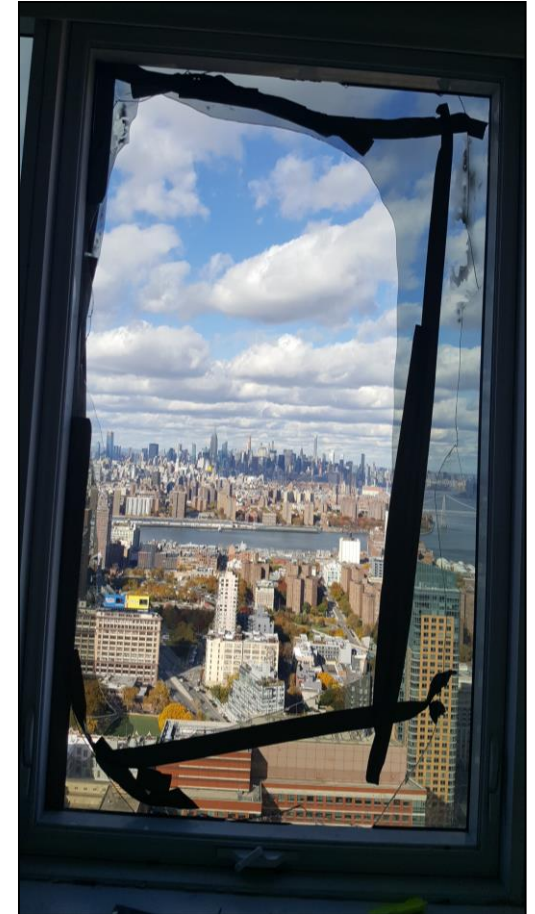
- What we found

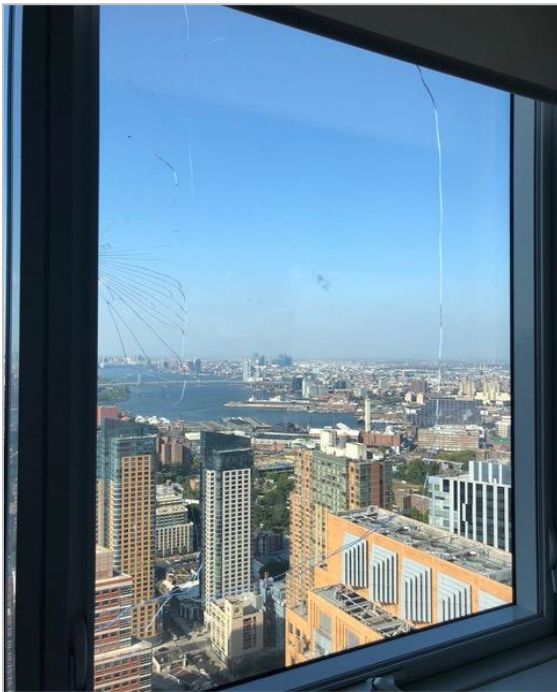
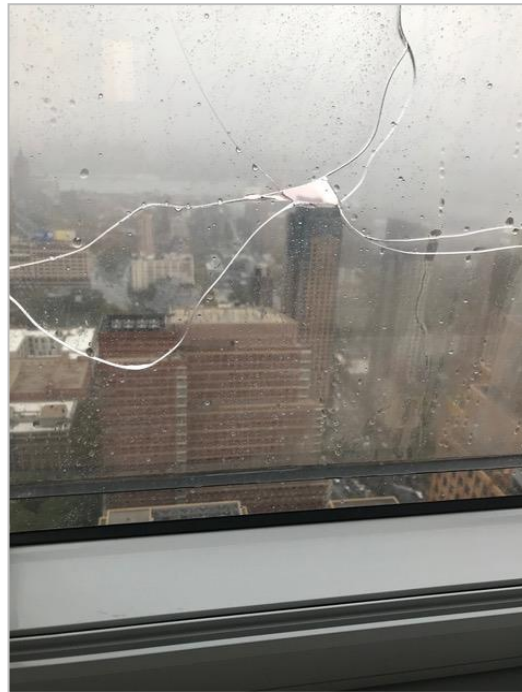
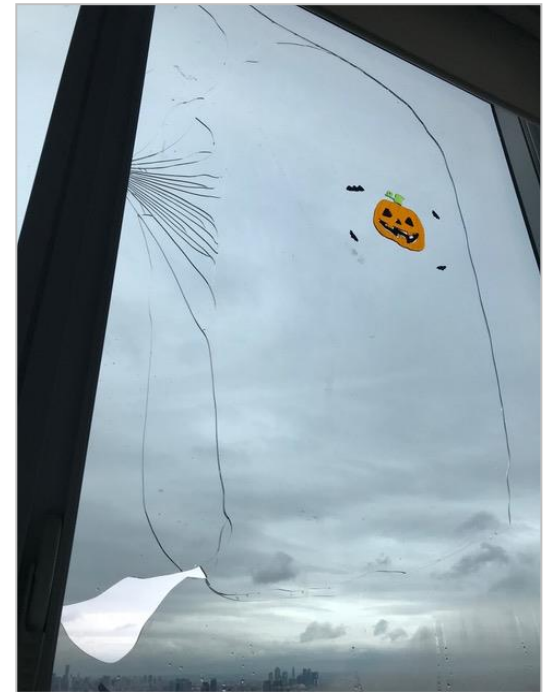
- In the meantime...DOB receives email from occupant of the apartment with these photos

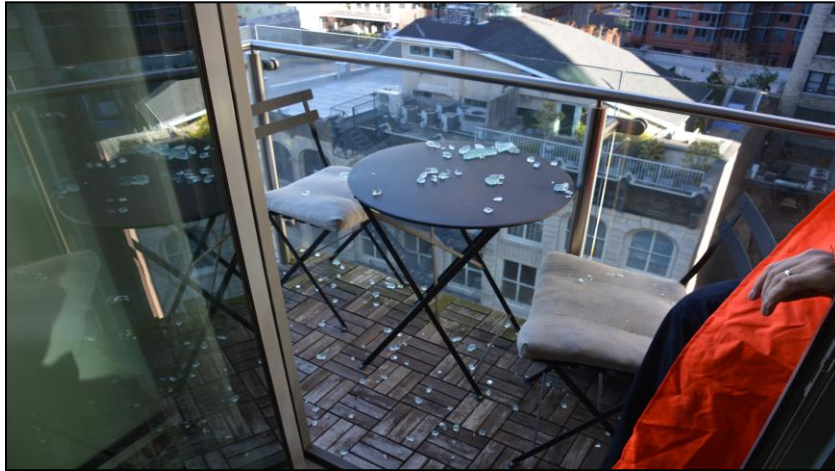
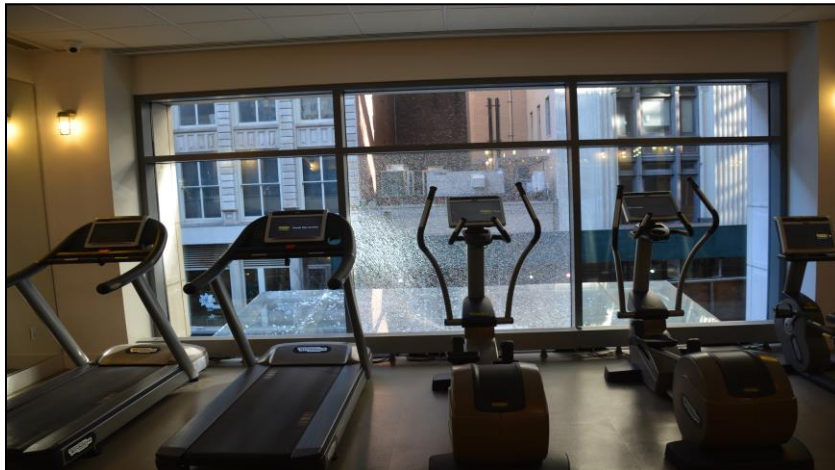
CASE #2: WHEN WE GOT THERE

- Aluminum post and rail system with clamps welded to posts
- Glass panels secured with gaskets, screws, and washers
- Almost all conditions varied
 - Rubber gaskets
 - Glass panels
 - Attachment

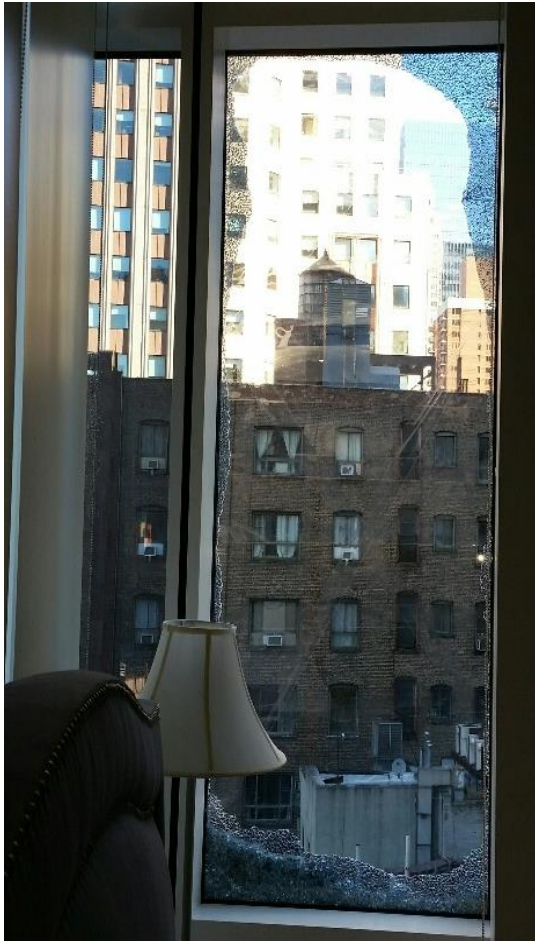
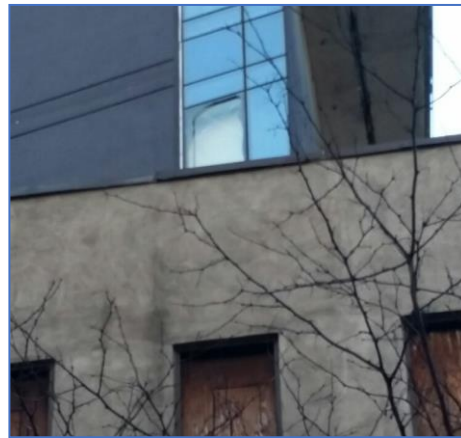
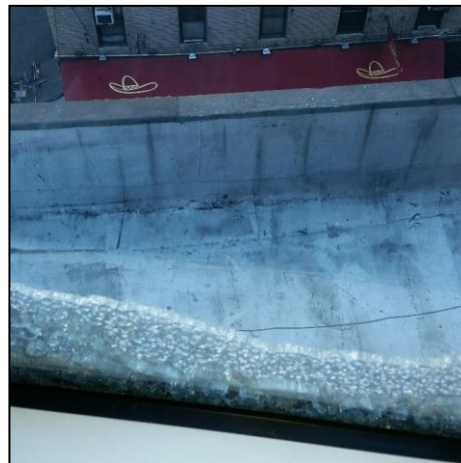
EOC report of glass falling from penthouse of a building

Double pane insulated glass, approximately 2'X 5' had exterior pane shatter and fall onto adjacent roof

- *Likely* NiS inclusion
- Difficult to pinpoint as a cause
- Inspection revealed additional lites of glass to be removed and replaced
- Glass breakage rates were 0.08%
- Impact on evaluating legislation
