COURSE DESCRIPTION

This presentation will review the fatalities and significant near misses that occurred in 2018. The participant will be able to identify the factors that led to each incident and review the appropriate methods to use to avoid future incidents at construction sites.

ANNUAL CONSTRUCTION-RELATED INJURIES AND FATALITIES vs. AVERAGE NYC CONSTRUCTION EMPLOYMENT*

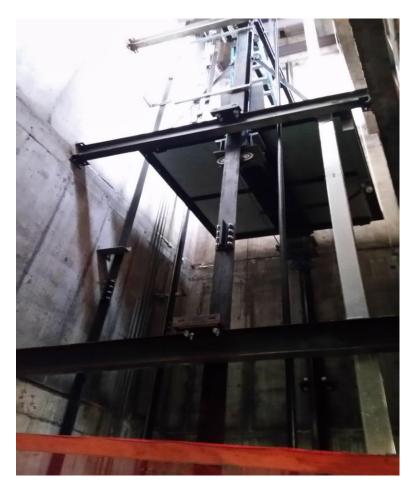
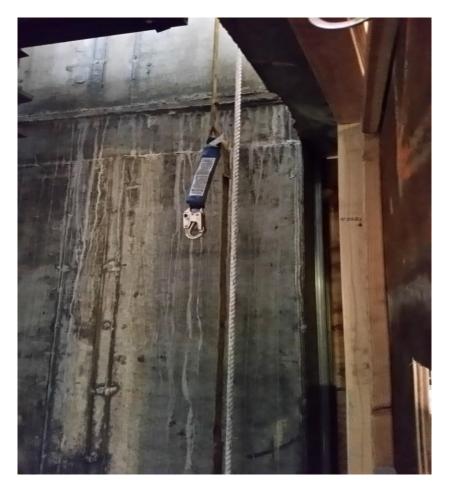
1/23/18 WORKER FELL: MOVING ELEVATOR CAB

Two workers on a moving elevator cab floor were told to tie-off by Site Safety Manager. Shortly thereafter a third worker, the Competent Person/Foreman, got on the cab and did not tie-off. While moving, the platform up the controller for the motor failed. The three workers jumped off the platform before it hit the top. Two workers were saved by harnesses. The third fell 8 stories to his death.

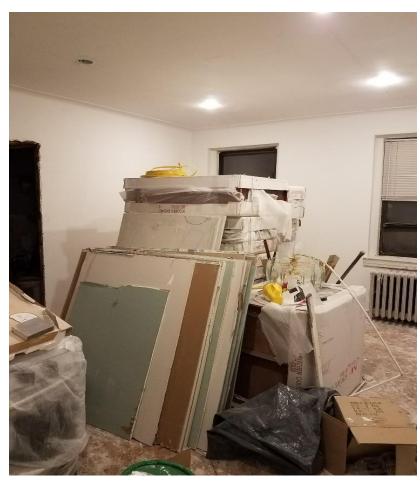
1/23/18 **WORKER FALL**

Father and son doing illegal rehab work in an apartment. The father was working on window sill with the window open. He fell out 4 stories to his death.

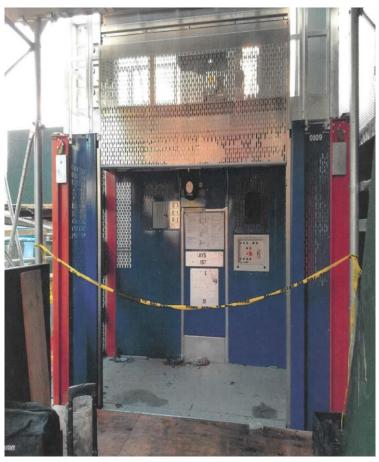
4/19/18 WORKER STRUCK: HOIST

Worker was making a repair to the hoistway. The worker did not power down the hoist before bypassing the safety on the gate. The hoist was above him. He opened the door and placed his upper body into the shaft to make the repair. The hoist came down and crushed him between the hoist and the deck.

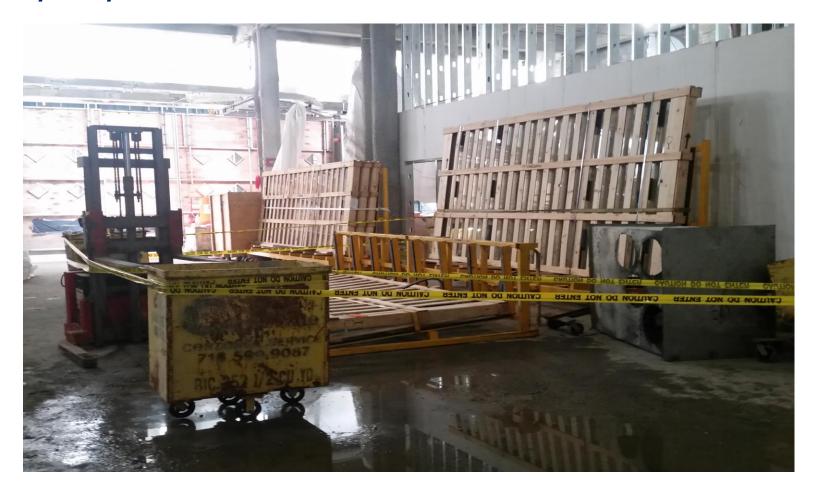
5/26/18 SECURITY GUARD CRUSHED

Worker was moving heavy duct work adjacent to a group of windows stored on the loading dock. The worker backed into a window unit which was improperly stored. The 1,200 lb window fell over and crushed the Security Guard who was patrolling the floor.

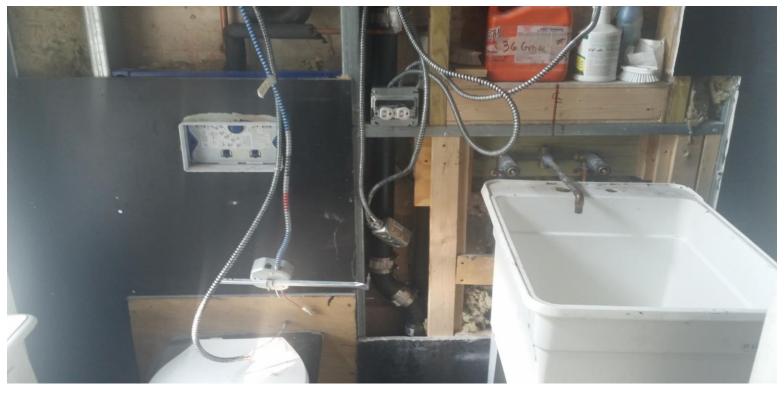
7/16/18 ELECTROCUTION

Worker was doing electrical work on a live wire circuit in a bathroom and electrocuted himself.

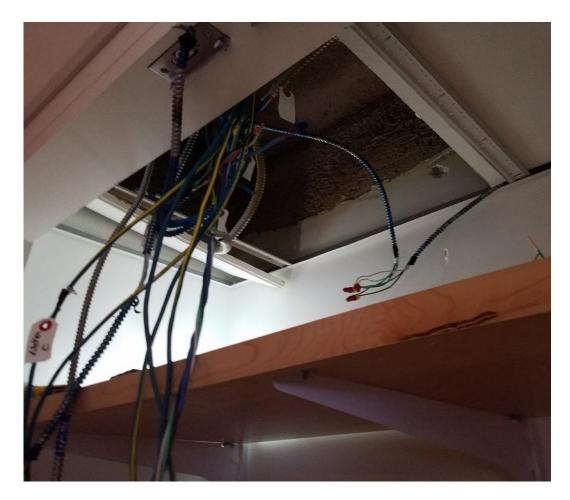
9/01/18 ELECTROCUTION

An electrician wiring an air conditioning unit in a drop ceiling failed to shut off circuit and electrocuted himself.

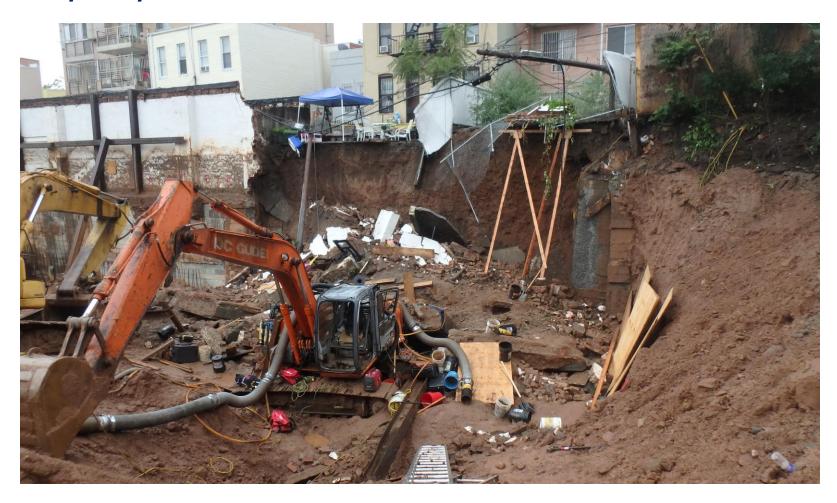
9/12/18 UNDERPINNING FAILURE

Contractor was doing excessive underpinning contrary to plan and did not properly brace the wall. A worker was at the base of wall when it collapsed on top of him burying him alive. It took two days to recover his body from under a 20 ton slab.

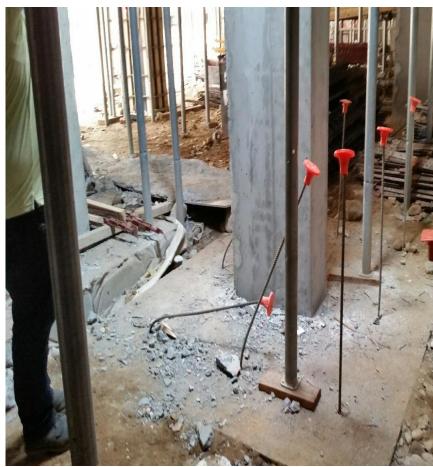
FAILURE: OPEN HOLE FALL

Worker was conducting stripping operations and was not tied off. He fell through hole landing on rebar caps which saved him from impalement.

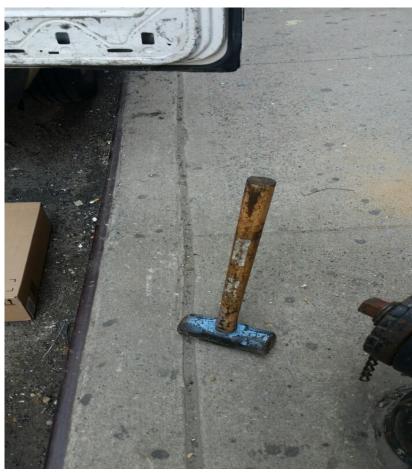
FAILURE: LOSS OF CONTROL

Worker was jumping a crane and lost control of a sledge hammer which fell 20 stories hitting a van roof. A delivery man was unloading packages from the van. The sledge landed on the sidewalk next to the delivery man.

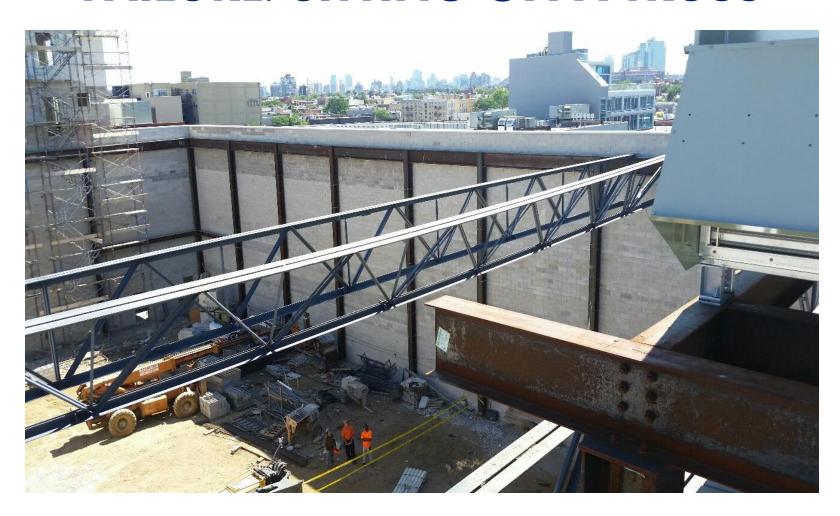
FAILURE: SITTING ON A TRUSS

Worker was setting a truss when the truss moved and the worker fell 30 feet.

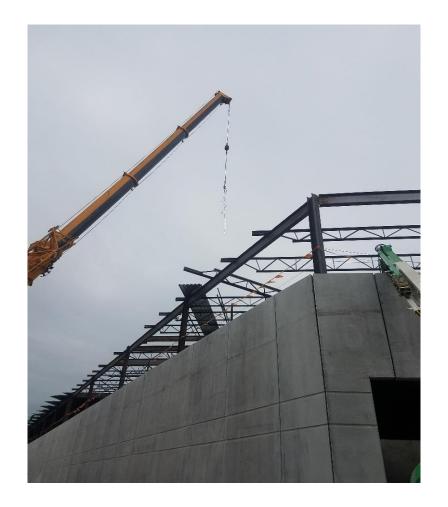
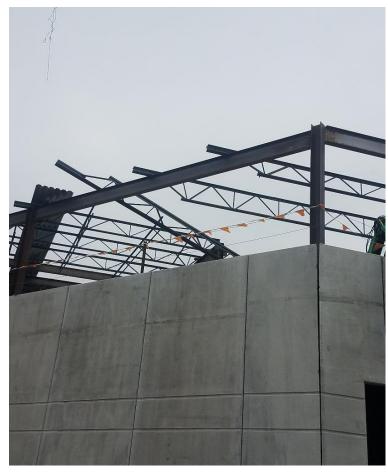
FAILURE: CRANE CHOKER HANG-UP

Crane was setting a truss. The worker unhooked the rope. As it was pulling away the rope caught the truss lifting it and caused the worker to fall.

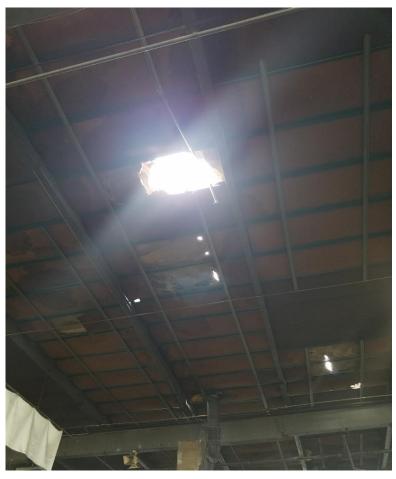
FAILURE: ROOF ASBESTOS ABATEMENT

Worker was doing asbestos abatement on the roof of a two story warehouse. The contractor did not assess the roof condition. The roof gave way under the weight of the worker.
