WORKER SAFETY OVERVIEW DAY 1

© 2020 New York City Department of Buildings

2020 DIGITAL: SAFETY, INNOVATION & SUSTAINABILITY CONFERENCE

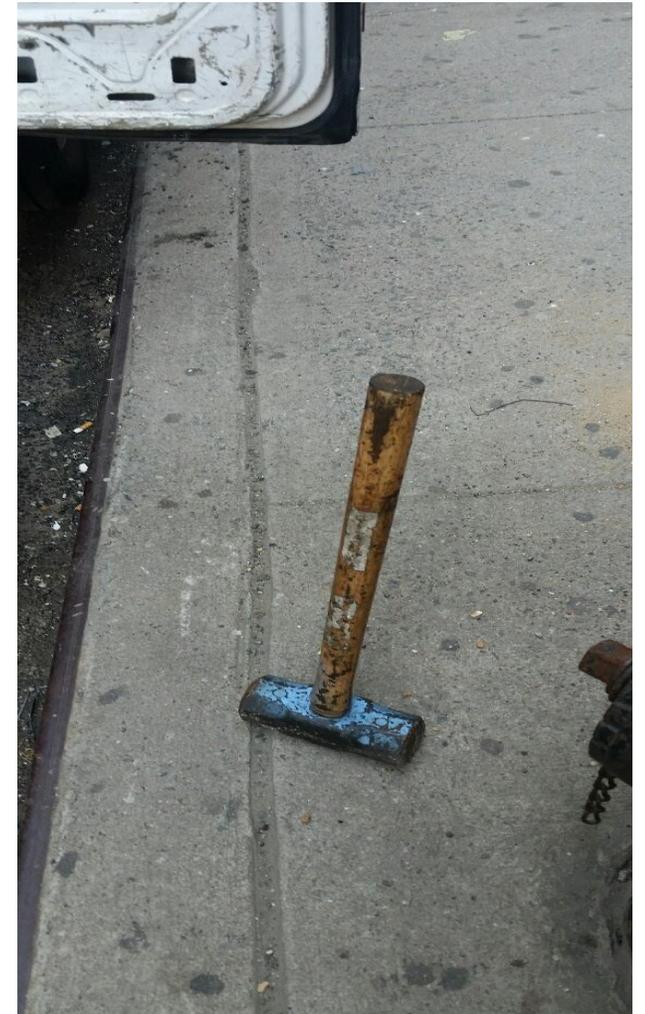
NEAR MISSES: Material Fall

- Iron worker was working on top of a 20-story tower crane.
- Worker dropped the sledgehammer when he hit a pin.
- Sledgehammer fell from a crane bounced off the van, and landed on the sidewalk, next to the head of the Amazon delivery personnel.
- Hammer was not tethered nor secured.

PREVENTION: Material fall protection should be in place ensuring tools are tethered.

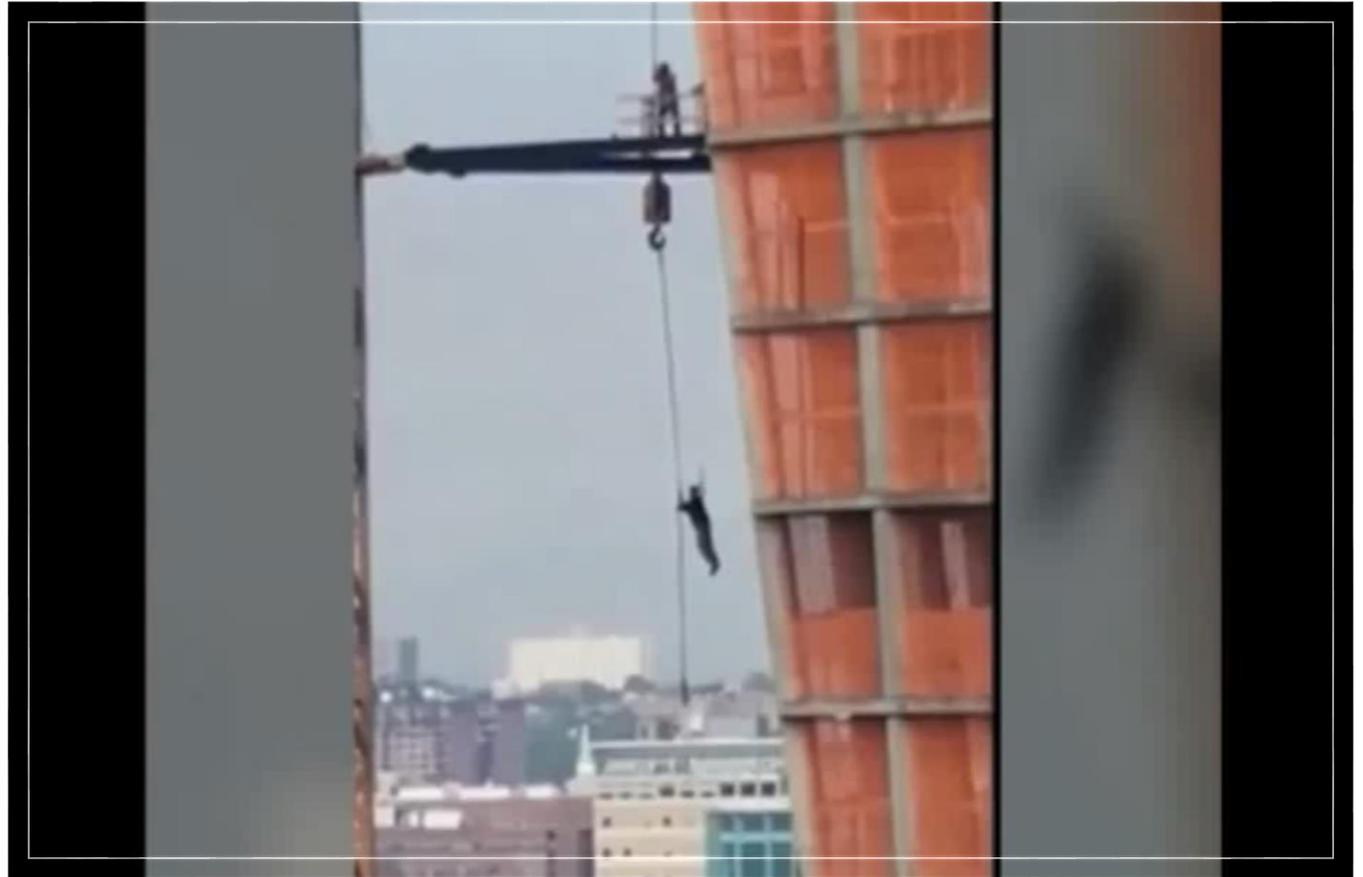
NEAR MISSES: Worker Fall from Crane

- Worker fell off a construction tower crane.
- Workers were tied on and wearing their harness properly.
- Worker fell and was caught by their Personal Fall Arrest System (PFAS).
- The worker suffered minor injuries.

PREVENTION: When working above 6 ft. ensure the appropriate fall protection is utilized.

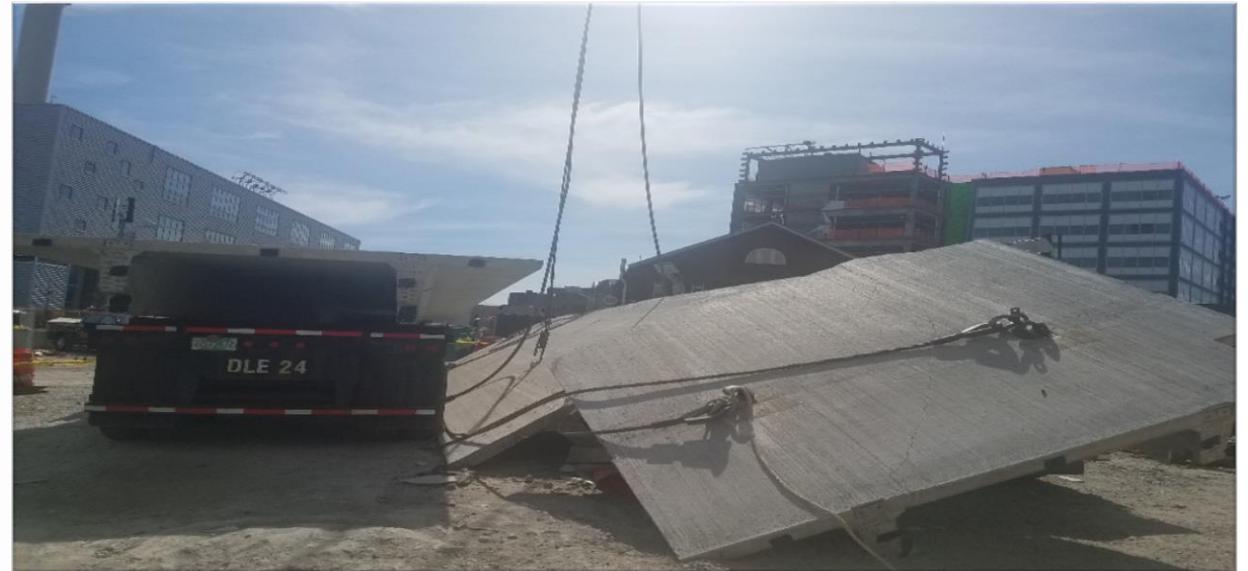
NEAR MISSES: Material Fall from Crane

- During a hoist of a precast panel load, the rope disconnected, and the load fell approximately 15 ft.
- Rope end connection pin did not have a keeper installed.
- Pin dislodged, which allowed the rope to disengage.
- Crane was hoisting 12'x 60' precast panels (double T) 33.3 tons.
- The load fell to the ground damaging a trailer on site.

PREVENTION:

- Always inspect machinery and equipment before use.
- All ropes should have a certification tag showing the capacities.
- Do not use under-rated ropes or ropes without tags.
- Ensure machinery is appropriate for load being lifted.
- Special attention should be given to inspecting connection pins and other mechanisms critical to maintaining control of the load.

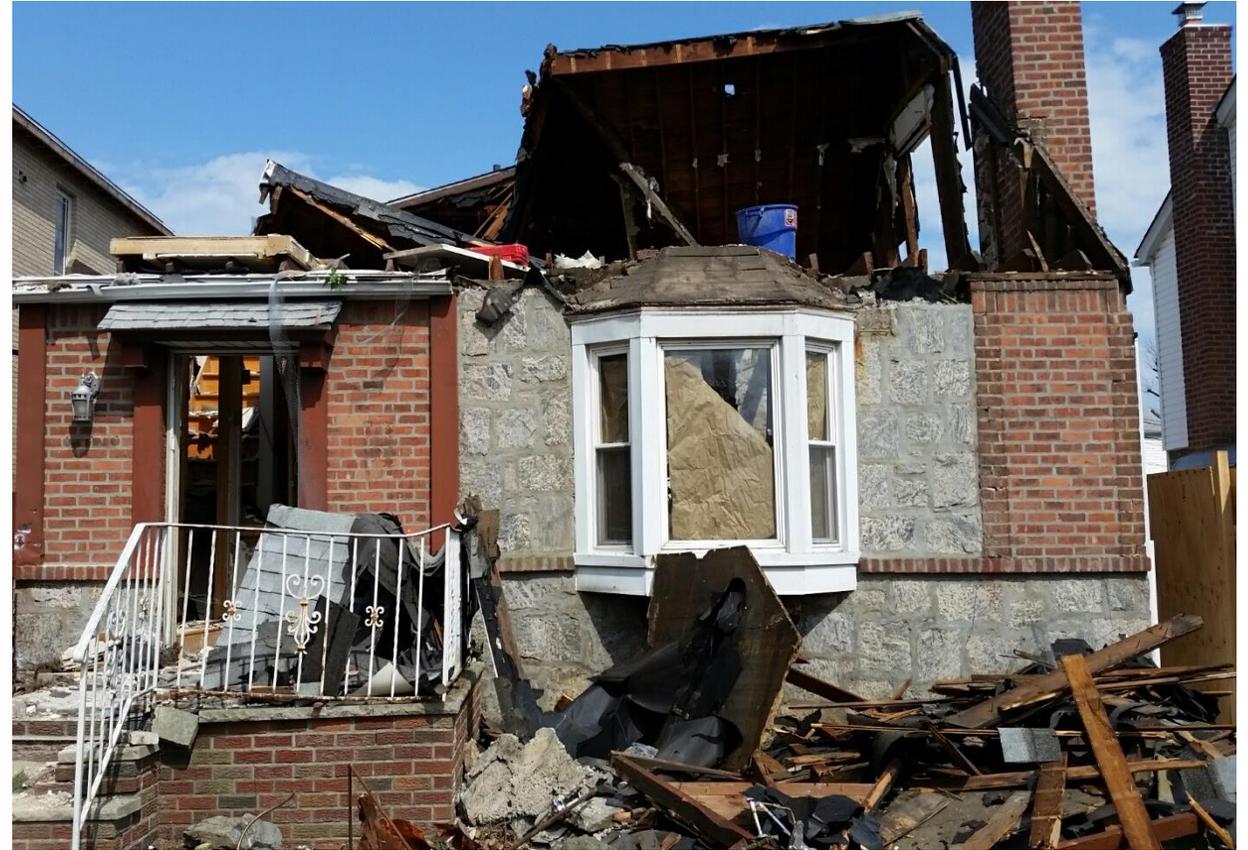
NEAR MISSES: Roof Collapse

- Six workers in the attic were doing interior demolition and removed the supporting walls.
- An inspector was visiting a site across the street when he noticed that the support beams were removed.
- Inspector asked for all the workers to get out of the attic.
- As workers were coming down and the roof collapsed as they were exiting.

PREVENTION:

- Verify structure and associated supports.
- Ensure demo sequence is followed.

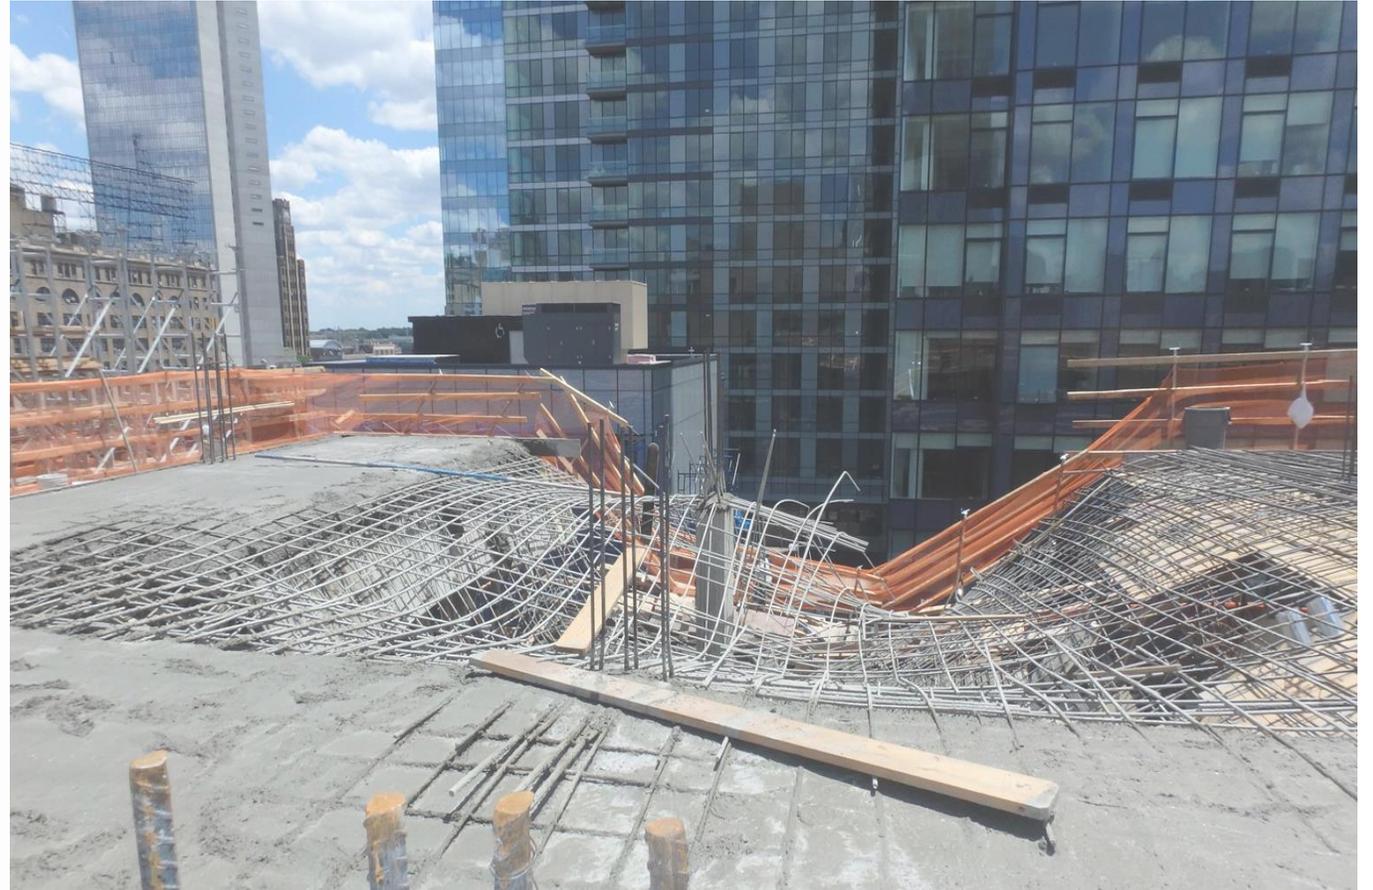
NEAR MISSES: Shoring Failure

- Undersized shoring; drawings called for 3" shores instead 1 3/4" were utilized.
- Six workers fell to the level beneath them.
- The entire section had to be cut out and redone.

PREVENTION: Ensure materials used are called out in the approved drawings and are followed as planned.

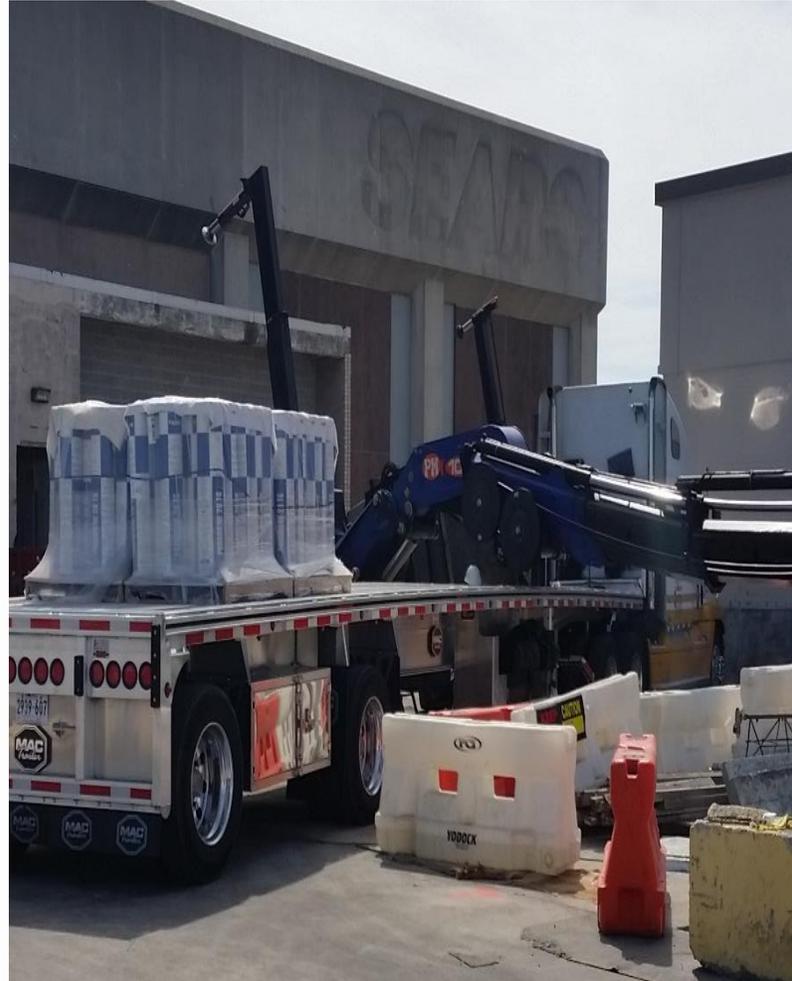
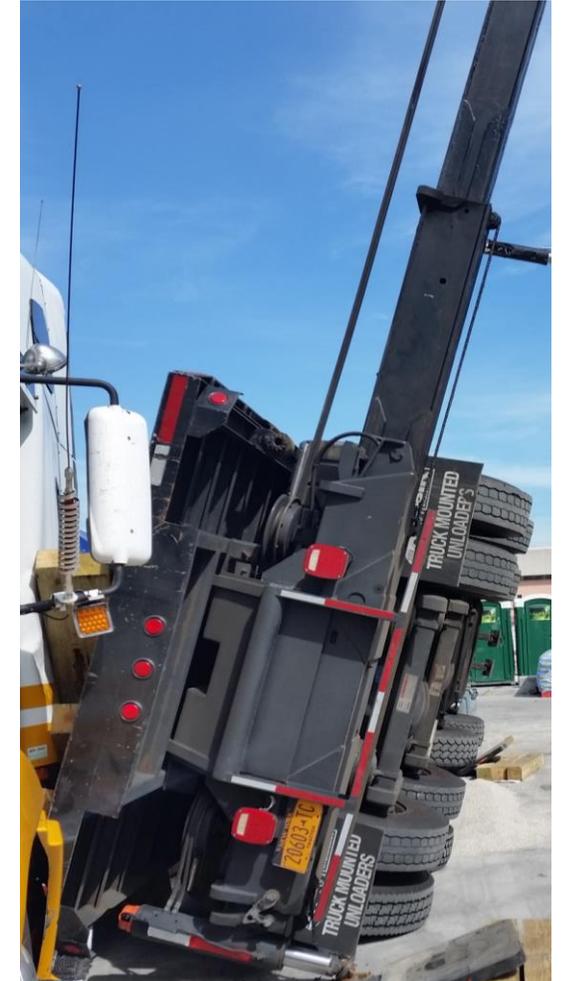
NEAR MISSES: Outriggers

- Knuckle Boom Crane outriggers were pulled in for a delivery of roofing materials to pass.
- In a rush to go on lunch break, outriggers were not re-extended.
- As the load was lifted, the crane tipped over, destroying the crane.

PREVENTION: Perform a pre-inspection prior to lifting loads & when situations change.

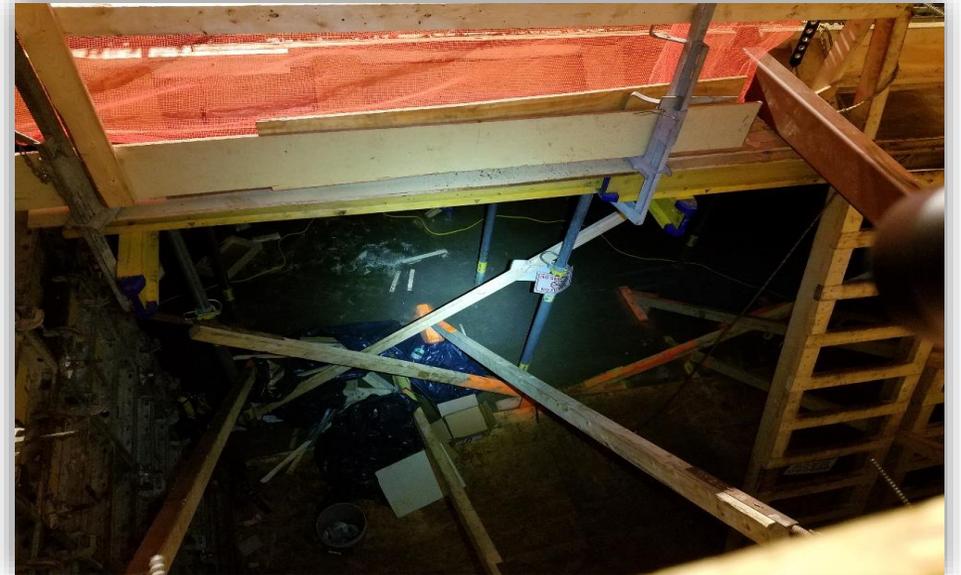
Carbon Monoxide Poisoning

- Manhattan - February 2019
- Workers were shoring cellar formwork at grade.
- Workers began to feel ill and were overcome with carbon monoxide sickness.

- The only opening was the elevator shaft. There were two gas generators at grade under the formwork that emitted carbon monoxide.
- The sub-cellar was not adequately ventilated, which caused ten workers to be overtaken by the fumes.

- Generators or other machinery/equipment that produce fumes should be situated outdoors when possible.
- If generators or other machinery/equipment that produce fumes must be used indoors, then ensure proper ventilation & monitoring.
- Confined spaces and other low ventilation areas should be inspected prior to work being performed.

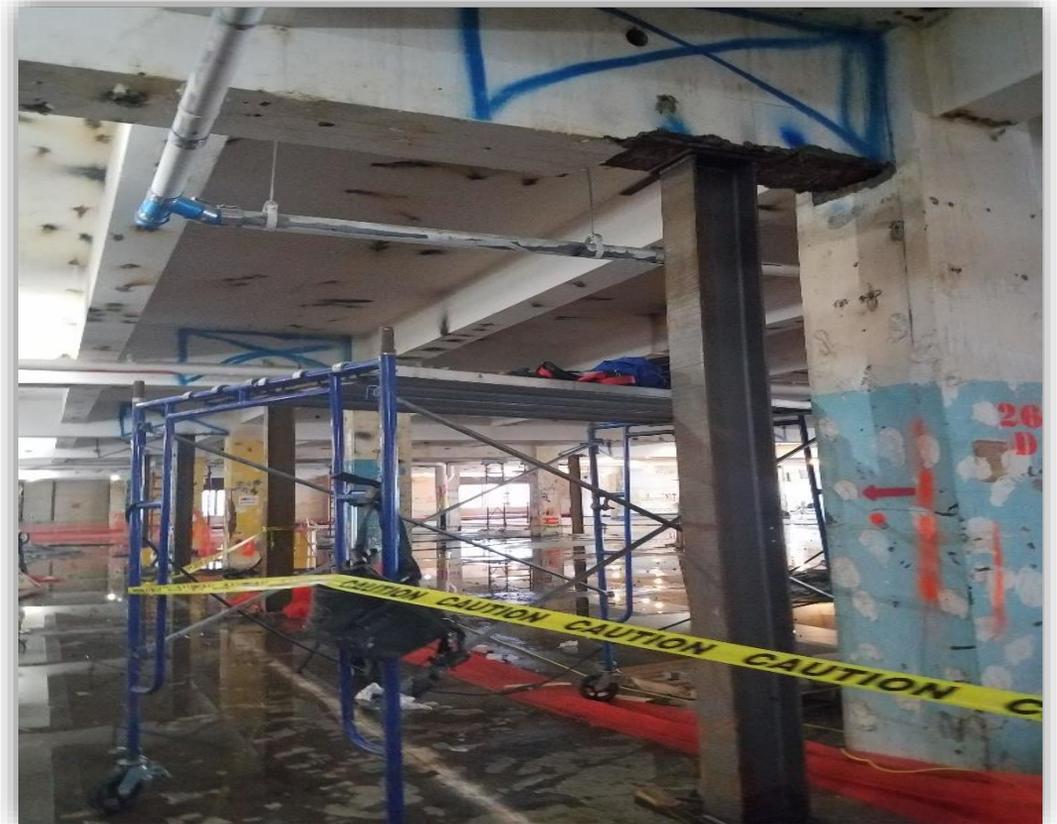
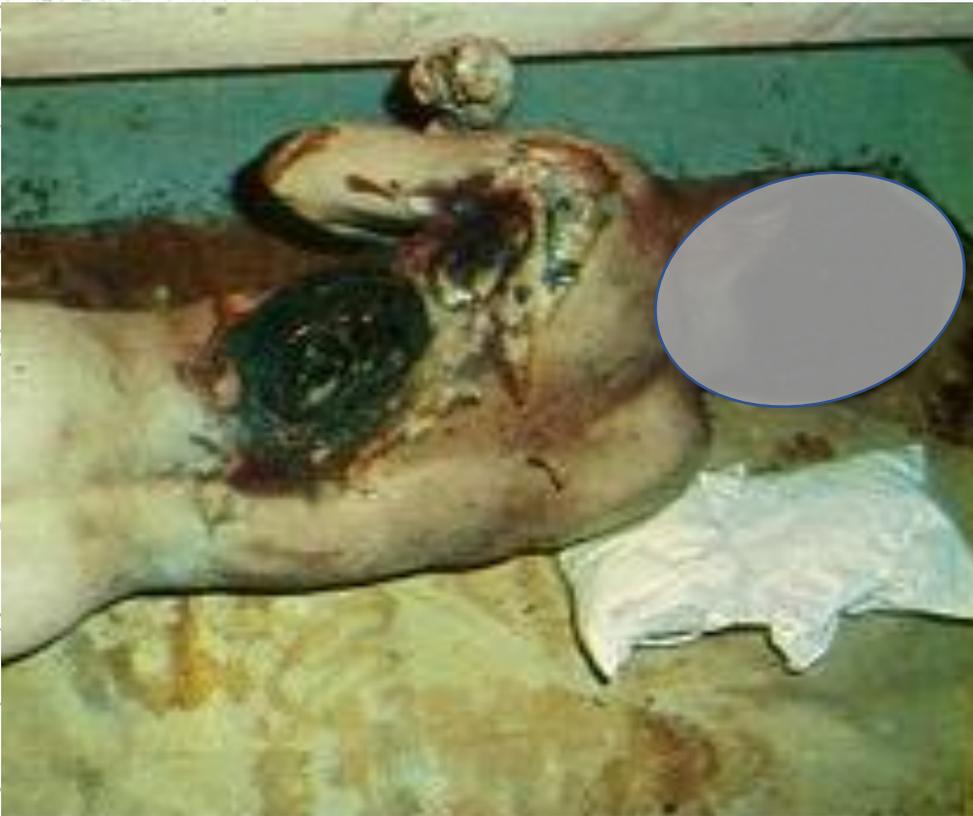
Electrocution

- A welder was ascending a scaffold while he had two cables in his hand.
- Cables touched the scaffold; the worker suffered a shock to his left side.

- Daily Pre-Shift Meeting & Toolbox to review work and identify dangers for the tasks.
- Ensure workers are wearing appropriate PPE.
- Workers must be trained on the safe operations and the hazards of a piece of equipment or machinery before they are allowed to use them.
- Workers who will utilize a scaffold shall participate in four-hour scaffold training.
- Ensure all electrical switches and components are de-energized.

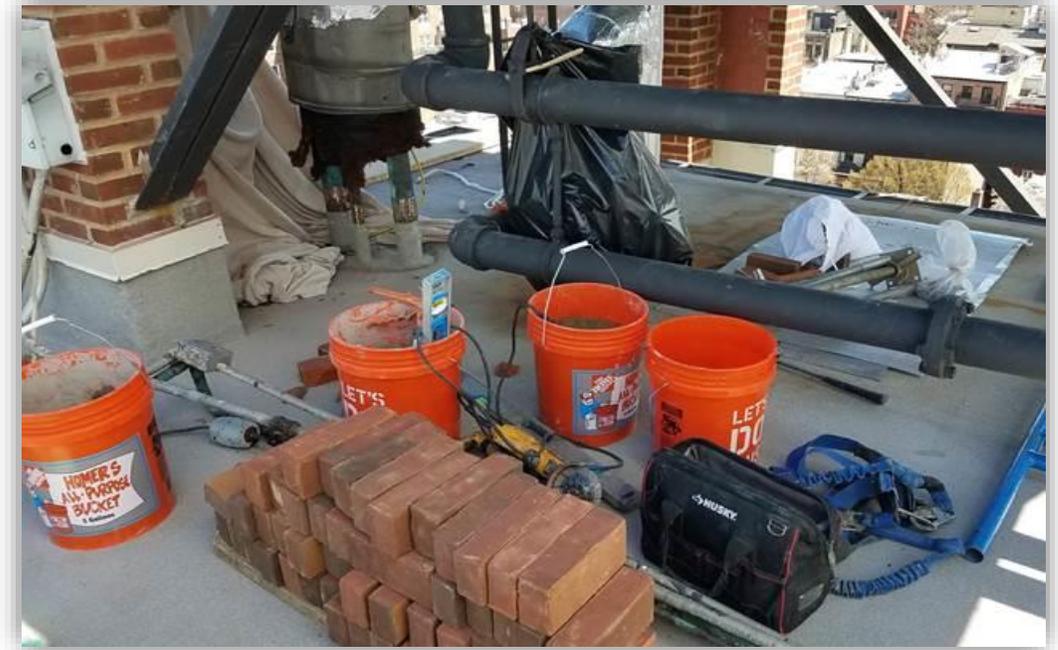
Fall: Not Tied-Off

- Harness was found on the roof with no specific tie-off points observed.
- Workers were not trained for fall protection nor site safety.
- No railings or fall protection were provided in the work area.

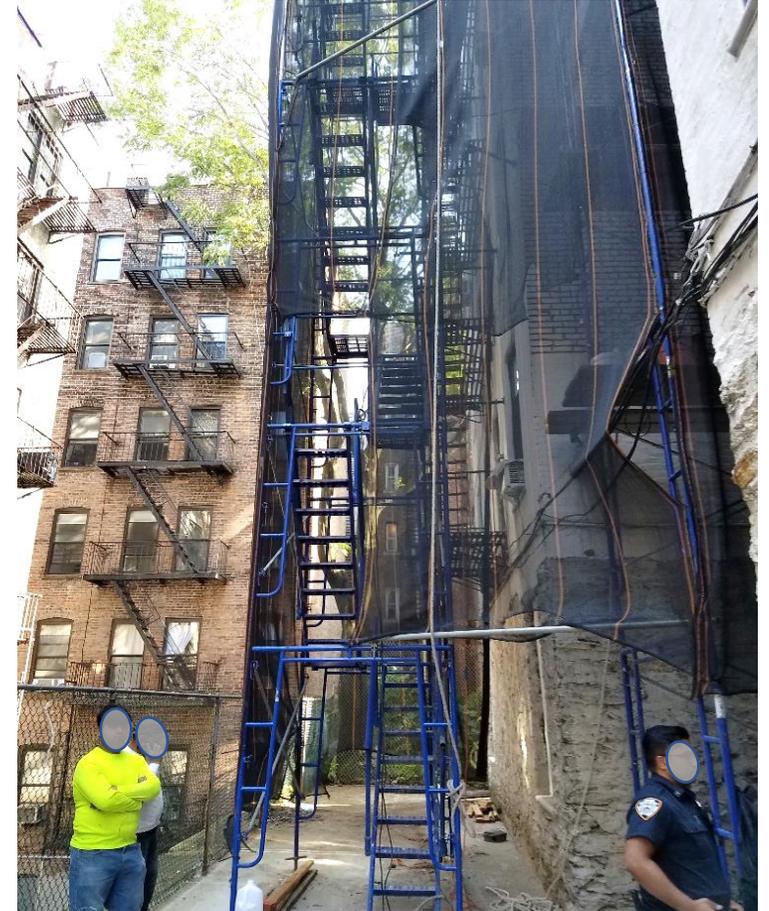
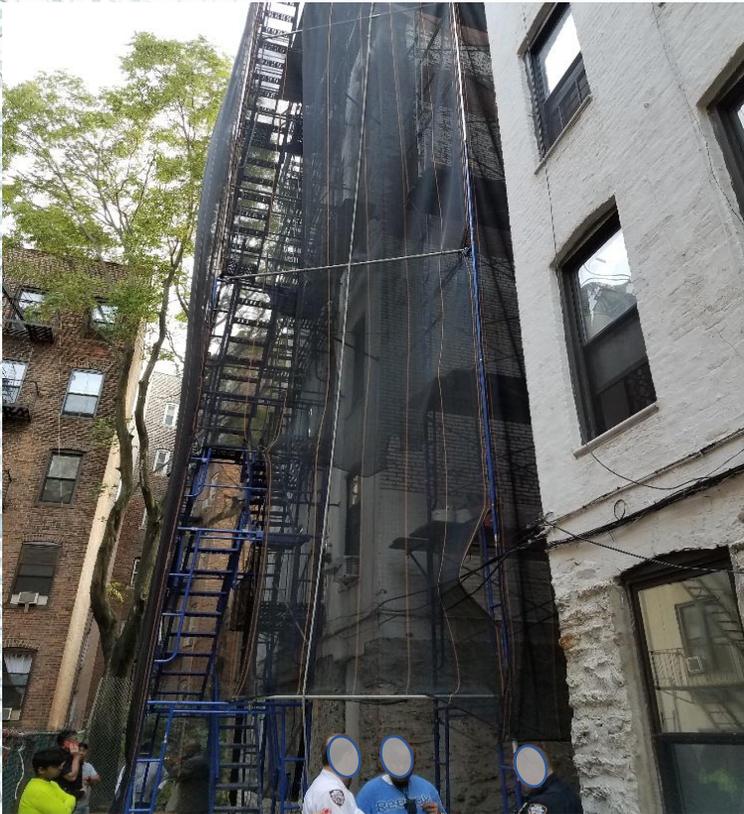
Fall: Not Tied-Off

- Worker succumbed to injuries from the fall.
- There were no permits for the scaffold erection and there were no Design Drawings for the scaffold present on-site.
- No permits, limited decking and no guardrails.

- Daily Pre-Shift Meeting & Toolbox to review work and identify dangers for the tasks.
- Ensure appropriate Personal Protective Equipment (PPE) is worn at all times while on an active construction site.
- Complacency can cause workers to think they will never be injured.

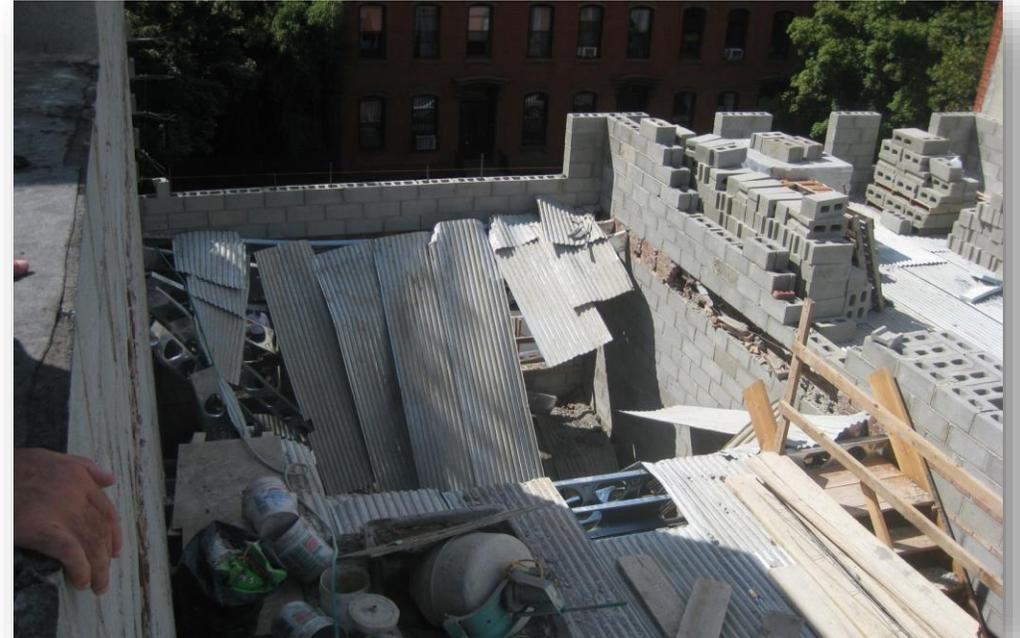
Caught In Between: Overload

- A four-story new building, CMU blocks delivered the were found on the third-floor deck.
- The third-floor deck was in the framing stage and was not shored and braced against rotation or lateral movement.
- This collapse caused death to one worker and injuries to five others.

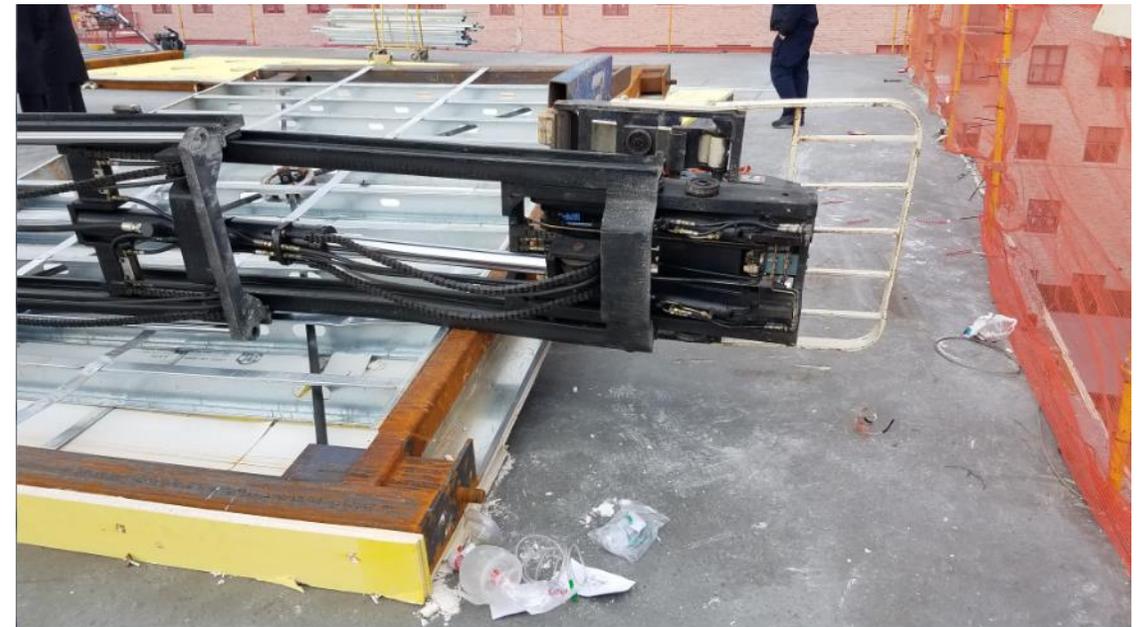
- Brooklyn – November 2018
- Prefabricated concrete panels were moved by a forklift.
- Due to high winds, the crane operator ceased operations.
- Workers decided to use the forklift, which they overloaded.
- The forklift tipped over, and a worker was caught underneath.

- Close area with a Controlled Access Zone.
- Equipment should never be overloaded with materials.
- Weather conditions such as wind should be considered when determining safety factors.
- Materials and equipment should never be moved outside during heavy wind events.

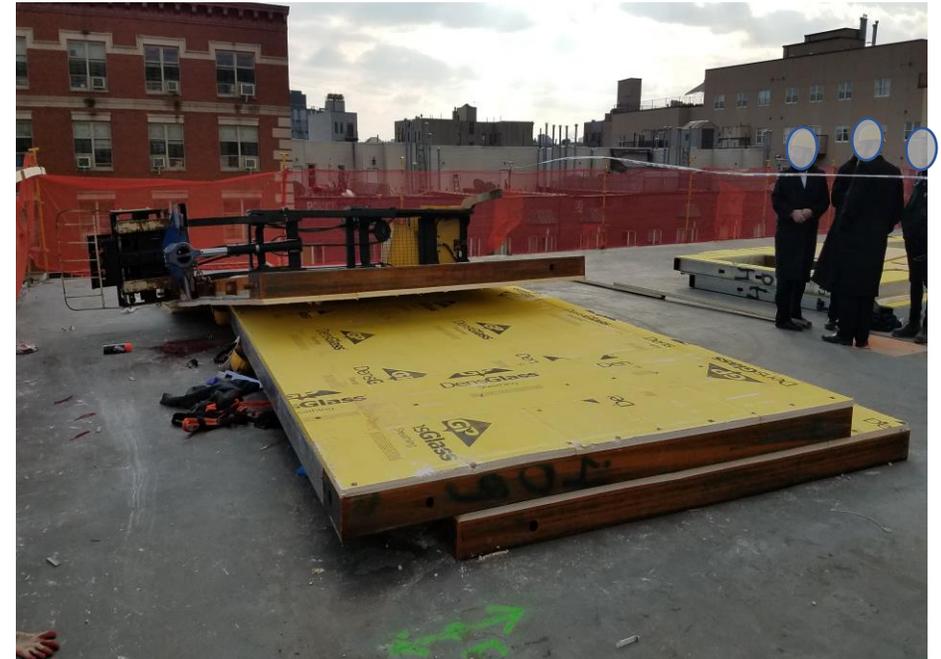
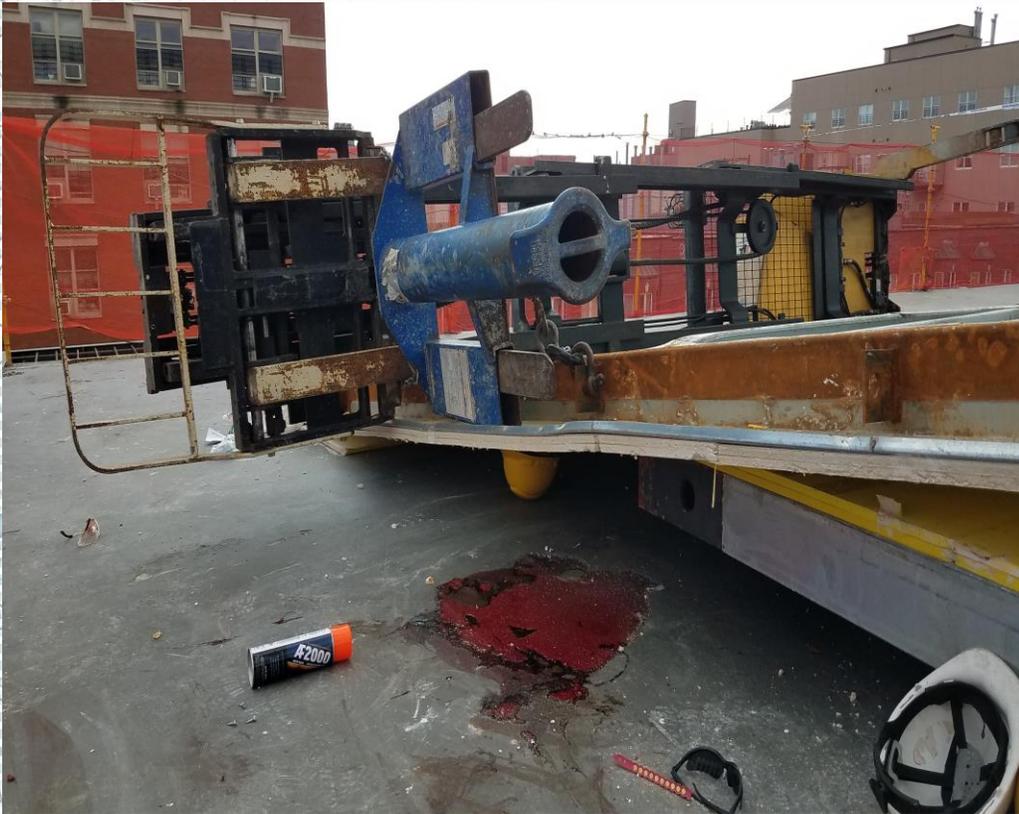
Caught In Between: Overload

- The crane delivered the load on the 4th floor near the edge of the slab.
- Workers were moving the panels towards the edge of the exterior wall for installation.
- The forces from the wind on the panels increased the pounds, which made the panel heavier and unstable.
- A worker was guiding the panel when the forklift operator lost control and was crushed by the panel.
- The forklift was only rated for 965 lbs., and the panel weight over 1,200 lbs., not including the wind force, which led the panel and forklift to tip over.

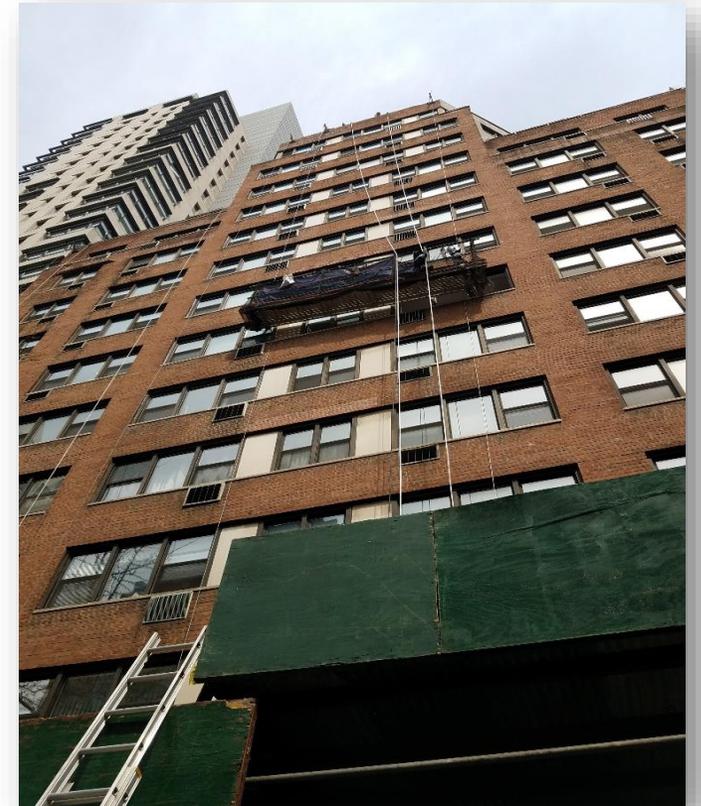
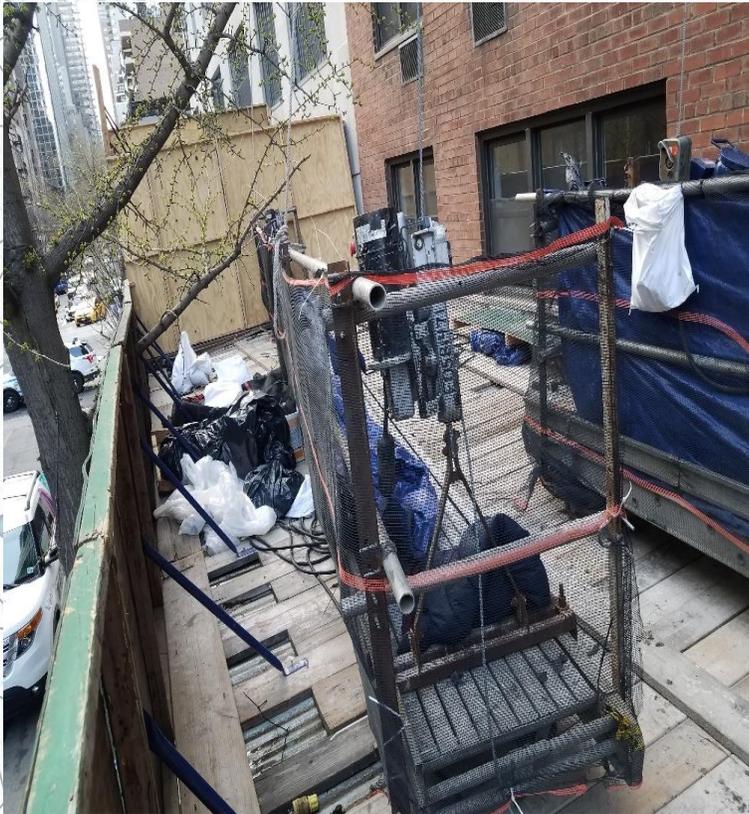
Struck By: Installation Failure

- Manhattan-April 2019
 - Standoff bracket slipped, C-Hook twisted and dislodged coping stone, striking two workers on a suspended scaffold.
 - Both workers were in possession of 16-Hour training cards for scaffolding.
- ### Cause & Effect
- Two workers lowering a suspended scaffold platform in order to take their lunch break.
 - The workers were between the sixth and seventh floor when a piece of loose coping stone that was under one of the C-Hooks fell onto one of the workers.

- Daily Pre-Shift Meeting & Toolbox to review work and identify dangers for the tasks.
- Periodic inspection to ensure recent installations were performed correctly and do not pose a hazard.
- Periodic inspection of the worksite to ensure that loose materials and equipment are secured and unable to fall or injure workers.
- Ensure the following of approved plans, set-up, or manufacturer's instructions.

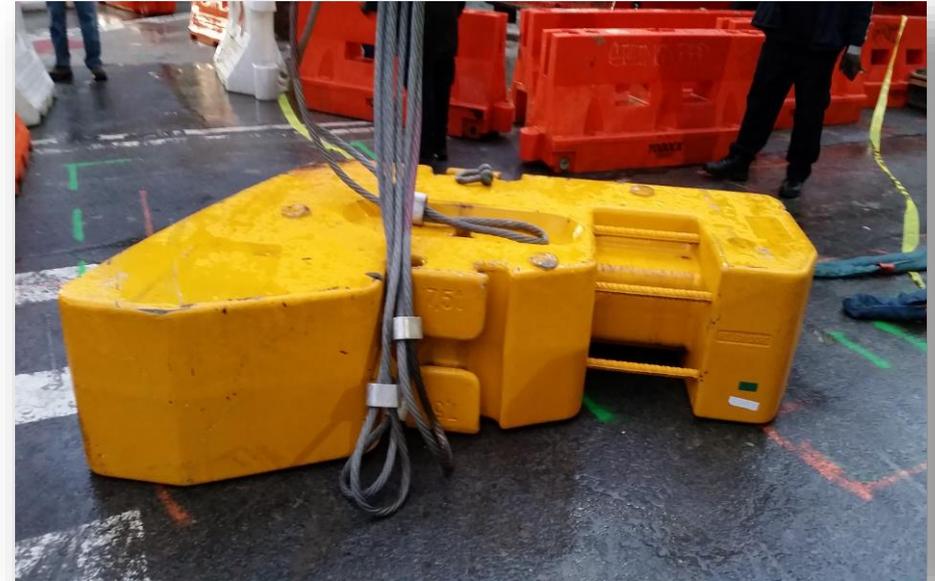
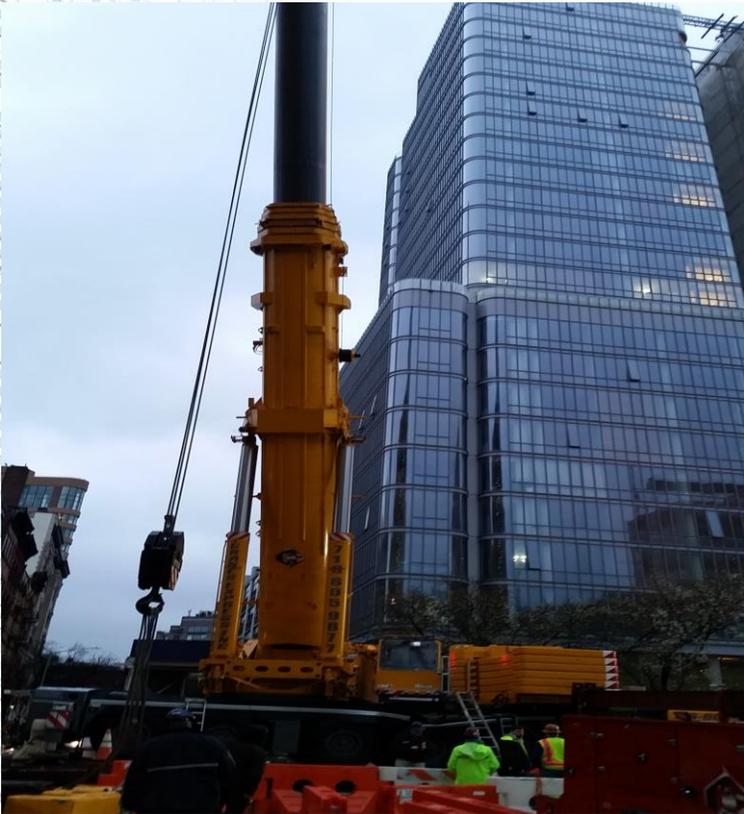
Struck By: Equipment Failure

- Manhattan -April 2019
- Loading of a 7.5-ton crane counterweight.
- The counterweight fell approx. 15ft, crushing one worker & striking another worker.
- The counterweight damaged the carrier.

- Prior to picking up this counterweight, they failed to remove the extra rope.
- The worker only cleared two of the three ropes. The third rope snagged the lifting lug pulling the counterweight off.
- No radio communication was being used as of the time of the incident.
- The worker that was crushed did not survive the event.

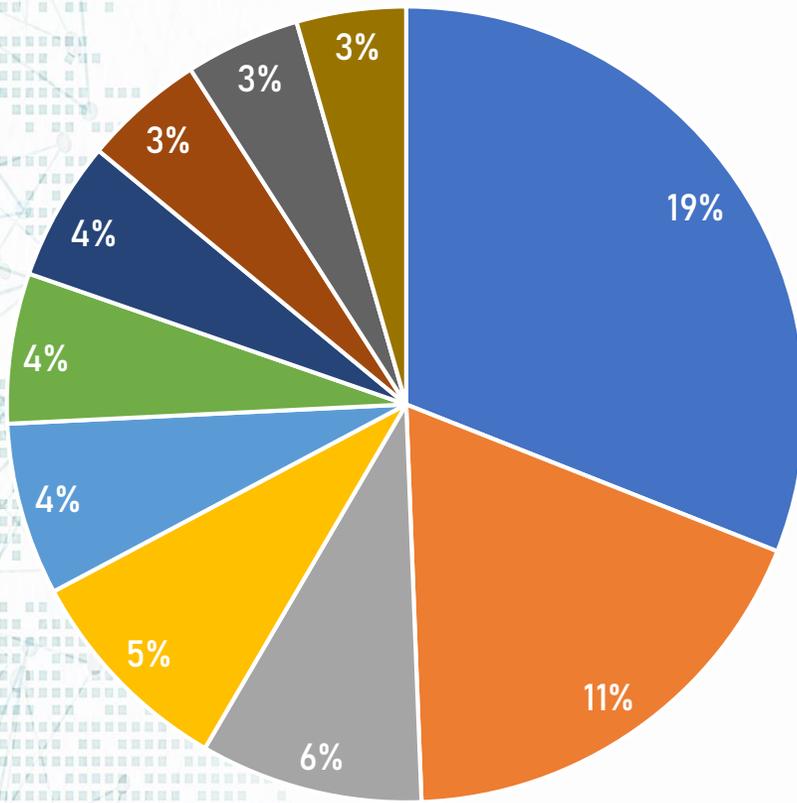
Top 10 Construction Safety Compliance Violations 2019

- Failure to safeguard (Class1)
- Failure to provide pedestrian protection
- Failure to maintain adequate housekeeping per
- Construction Superintendent failed to perform duties
- No guard rails
- Work does not conform to approved drawings
- Failure to safeguard (Class 2)
- Failure to ensure workers completed required training
- Filed certificates with false statements
- Work without a permit

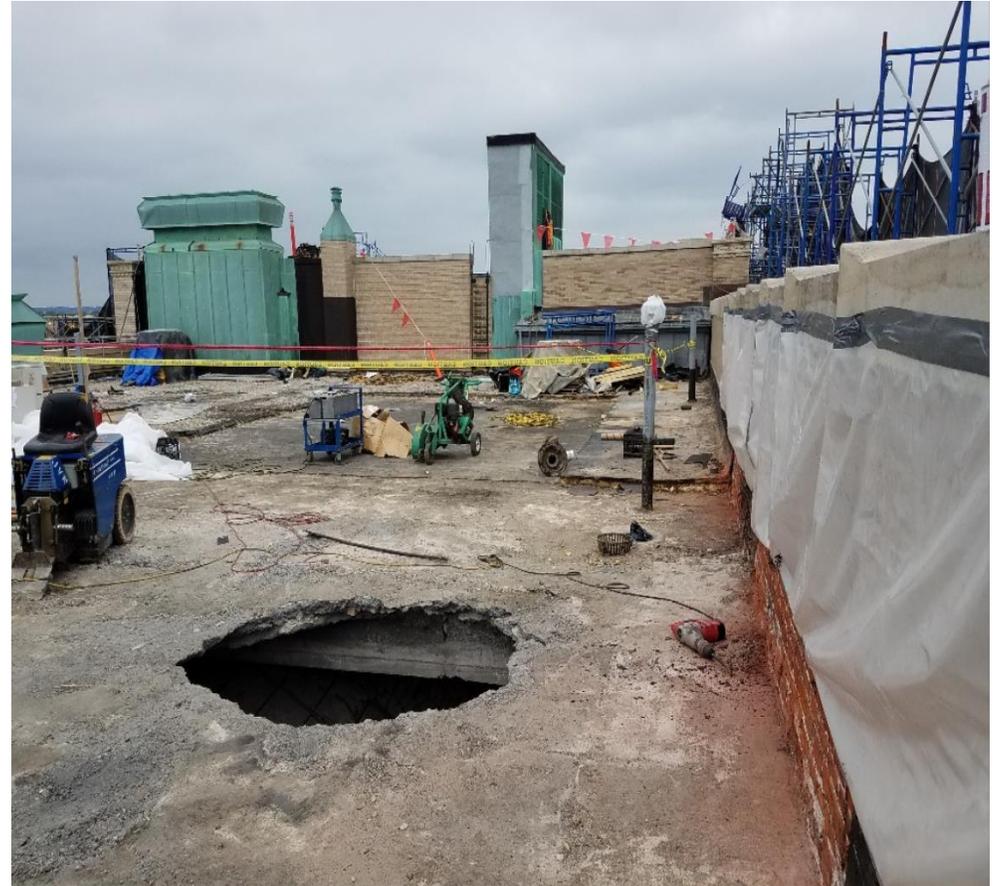
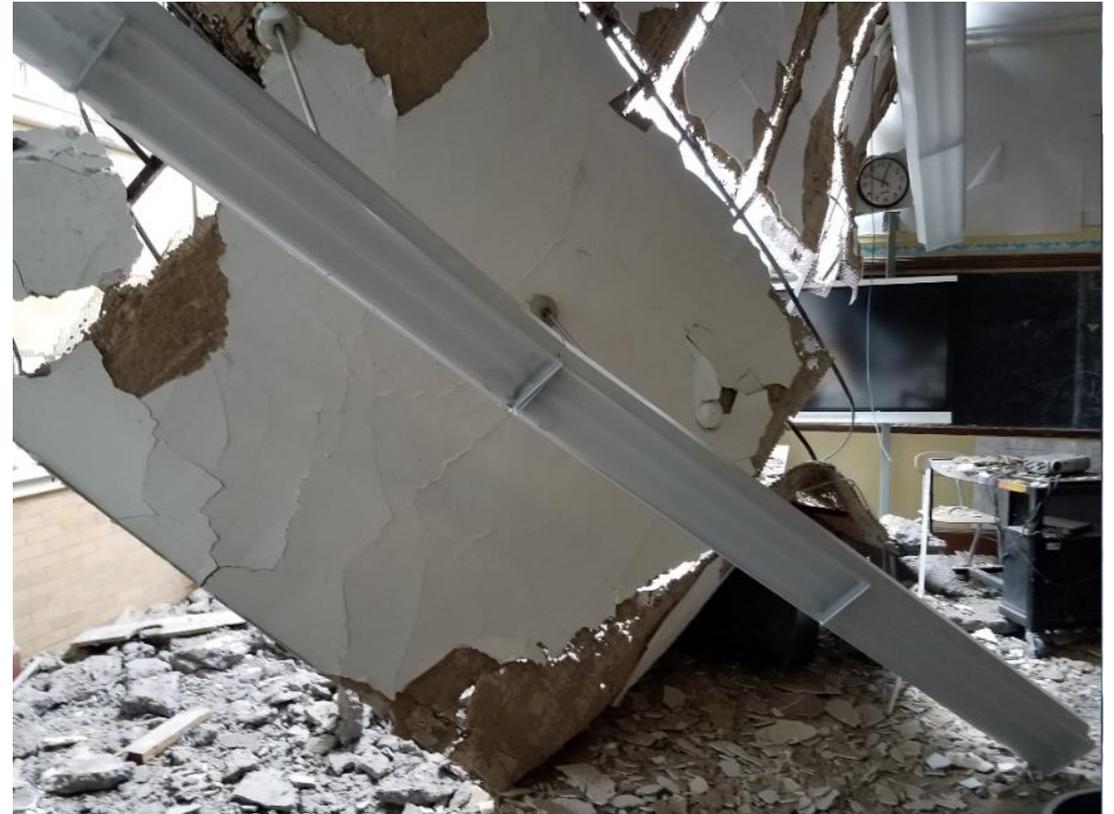
Failure to Safeguard - 19%

- Brooklyn - July 2019
- Workers on two 600 lb. scrapping machines that were in around a 10' X 10' area.
- Approximately 8" of reinforced concrete slab collapsed through into an empty classroom below.
- One worker suffered an injury and was brought to a hospital in a conscious state.

- One worker was riding on one of the machines, and another worker was pushing another one of the machines.
- Workers were not properly instructed on the plans of the work being performed.
- The machinery being used was too heavy and overloaded the deck.

- Daily Pre-Shift Meeting & Toolbox to review work and identify dangers for the tasks.
- Workers must understand the full scope of work being performed and the risks associated with that work.
- Approved plans must be followed to avoid the failure of equipment or materials.
- PE to assess the slab to ensure it can carry the weight of the load.

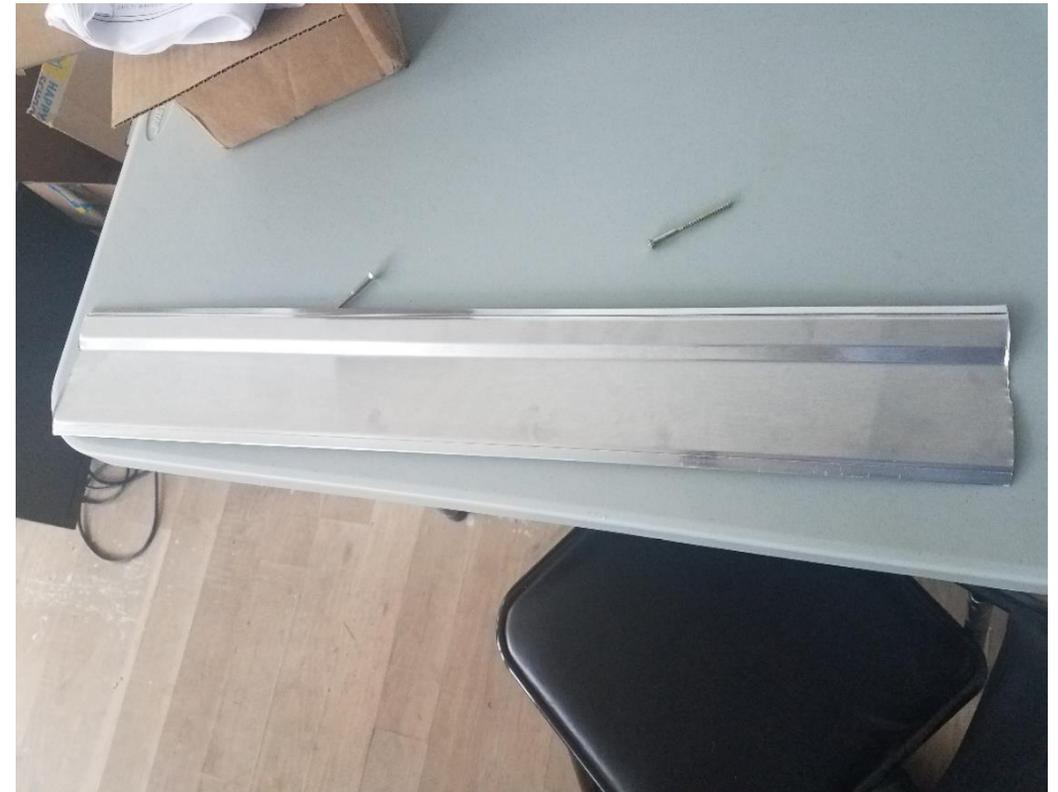
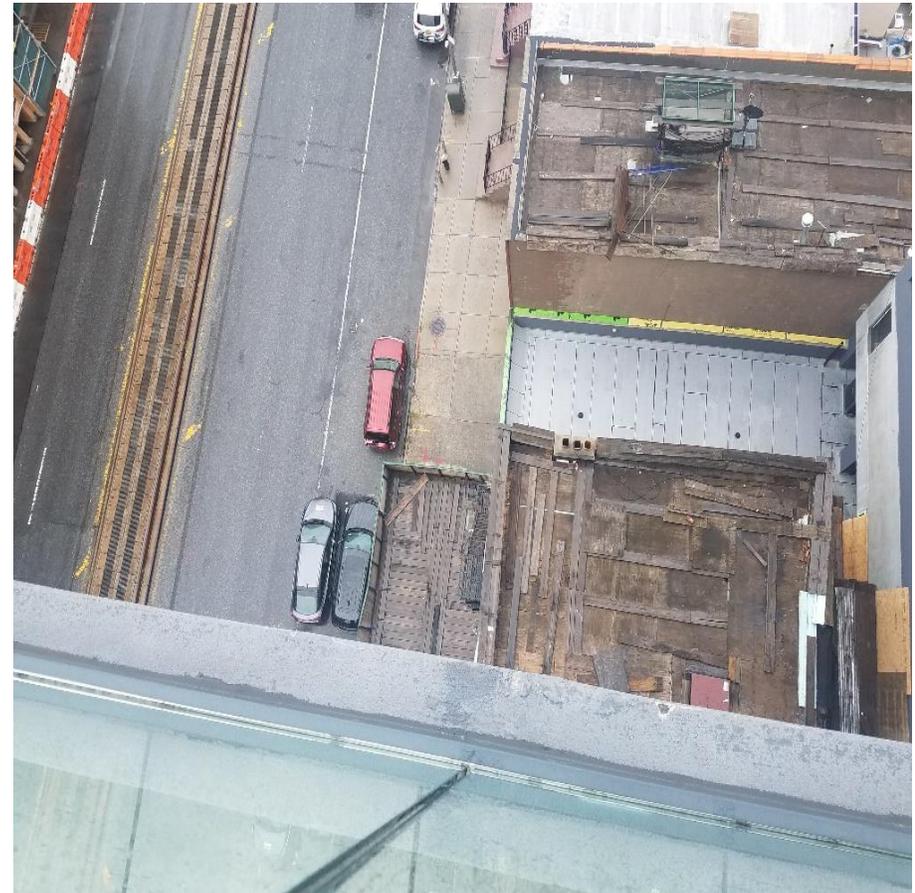
Failure to Provide Pedestrian Protection – 11%

- Brooklyn – September 2019
- Workers were installing metal flashing on the roof of an 11-story new building when a piece of metal flashing that was approximately two feet long came loose and fell.
- The piece of metal flashing flew about fifteen feet outside of the sidewalk shed and hit a pedestrian in the arm.

- No controlled access zone was set up for this site.
- Workers were not paying any attention to where they were leaving unused materials.

Sidewalk sheds are temporary structures built to protect people or property. Property owners must install a shed when constructing a building more than 40 feet high, demolishing a building more than 25 feet high — and when danger necessitates this type of protection.
