WORKER SAFETY OVERVIEW DAY 1

© 2020 New York City Department of Buildings

2020 DIGITAL: SAFETY, INNOVATION & SUSTAINABILITY CONFERENCE

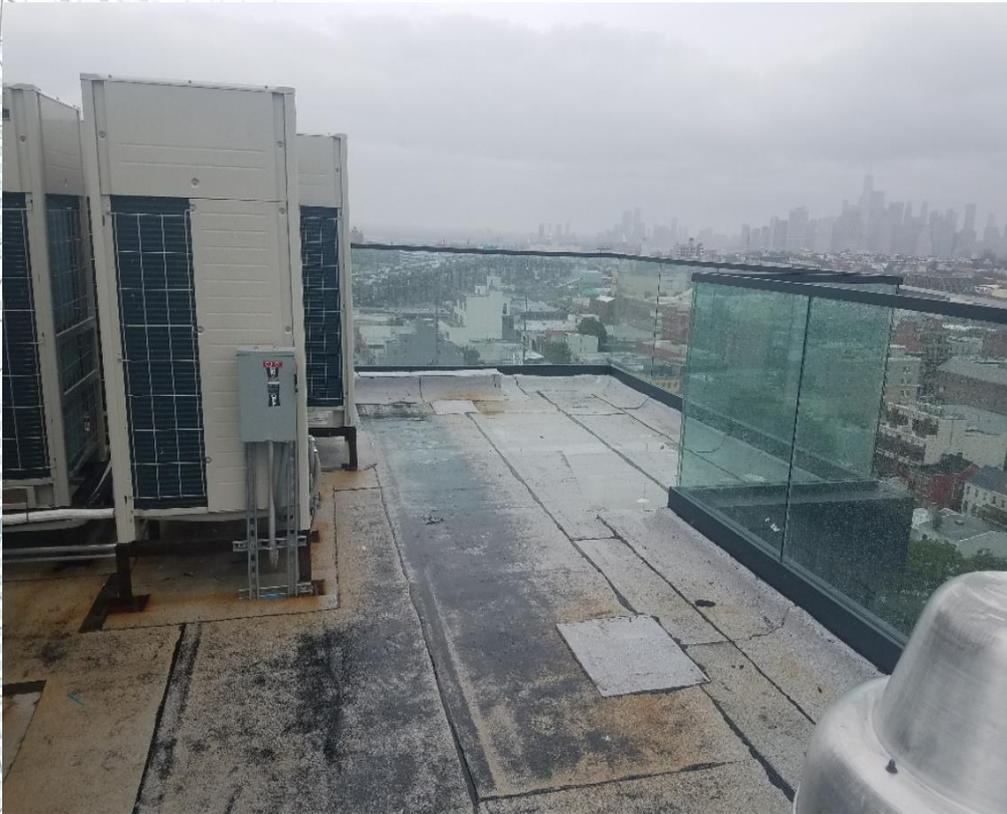
Failure to Provide Pedestrian Protection – 11%

- Brooklyn – September 2019
- Workers were installing metal flashing on the roof of an 11-story new building when a piece of metal flashing that was approximately two feet long came loose and fell.
- The piece of metal flashing flew about fifteen feet outside of the sidewalk shed and hit a pedestrian in the arm.

- Daily Pre-Shift Meeting & Toolbox to review work and identify dangers for the tasks.
- Sidewalk shed and/or controlled access zone must be installed anytime work is being performed at an elevated level above the sidewalk.
- Ensure all safety measures are being taken for workers and the public.

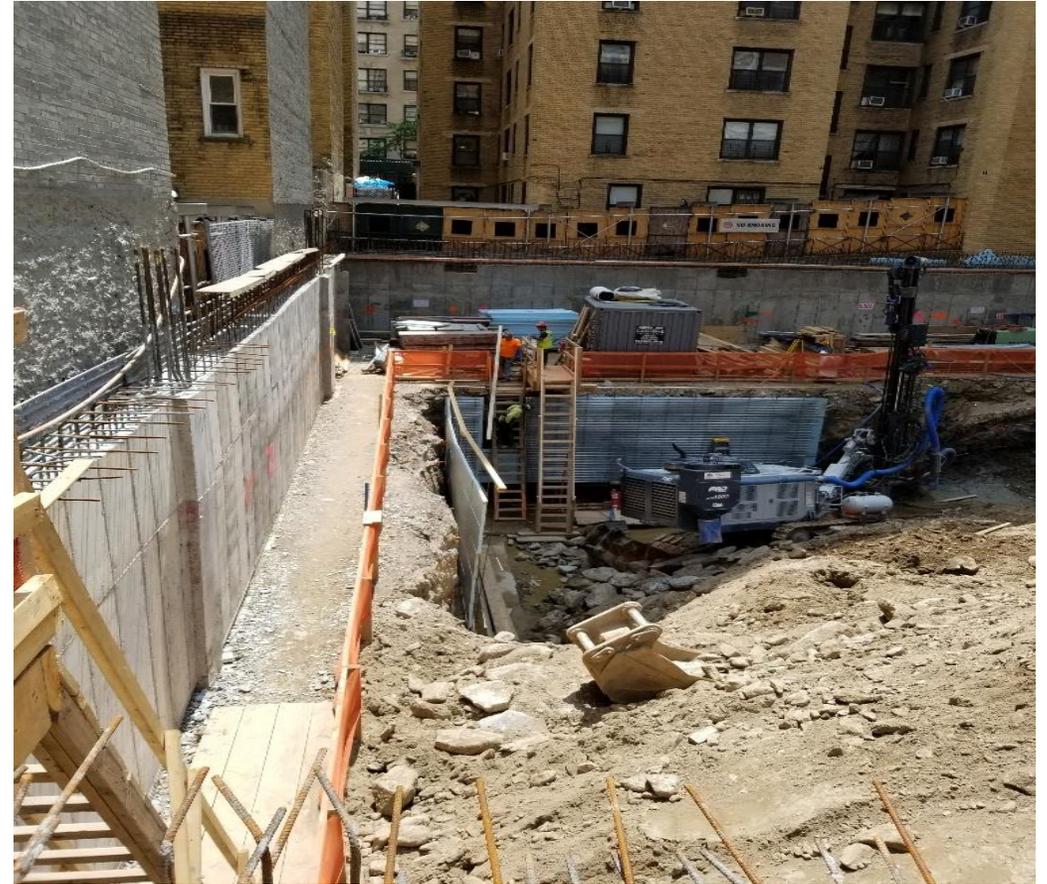
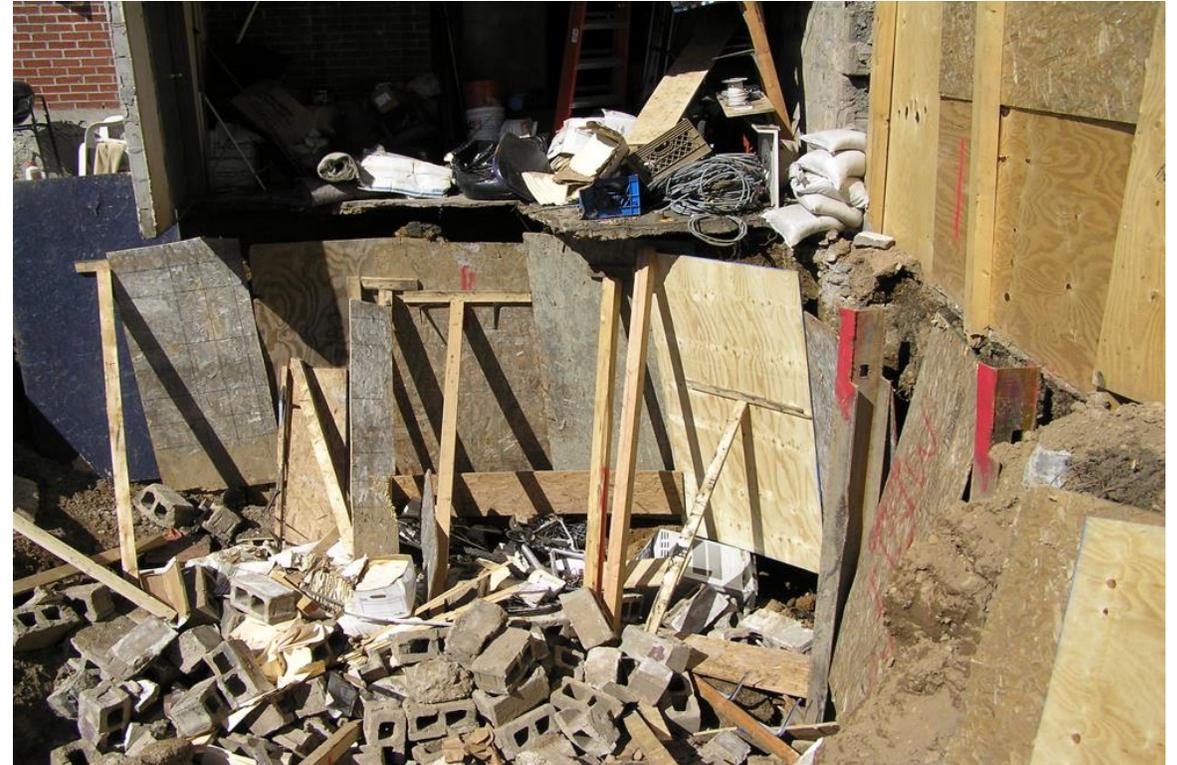
- Brooklyn – February 2019
- A DOB inspector reported that there were workers that were working on support of excavation inside of a trench.
- The workers were dropping materials inside of the trench when a piece of wood hit another worker on his foot.
- The struck worker was taken to a hospital by ambulance.

- No housekeeping plan was in place.
- Workers were throwing materials throughout the site creating multiple safety hazards.

- Develop and Maintain a Housekeeping Plan.
- Clean up as work is being performed; don't wait until the end of the day.

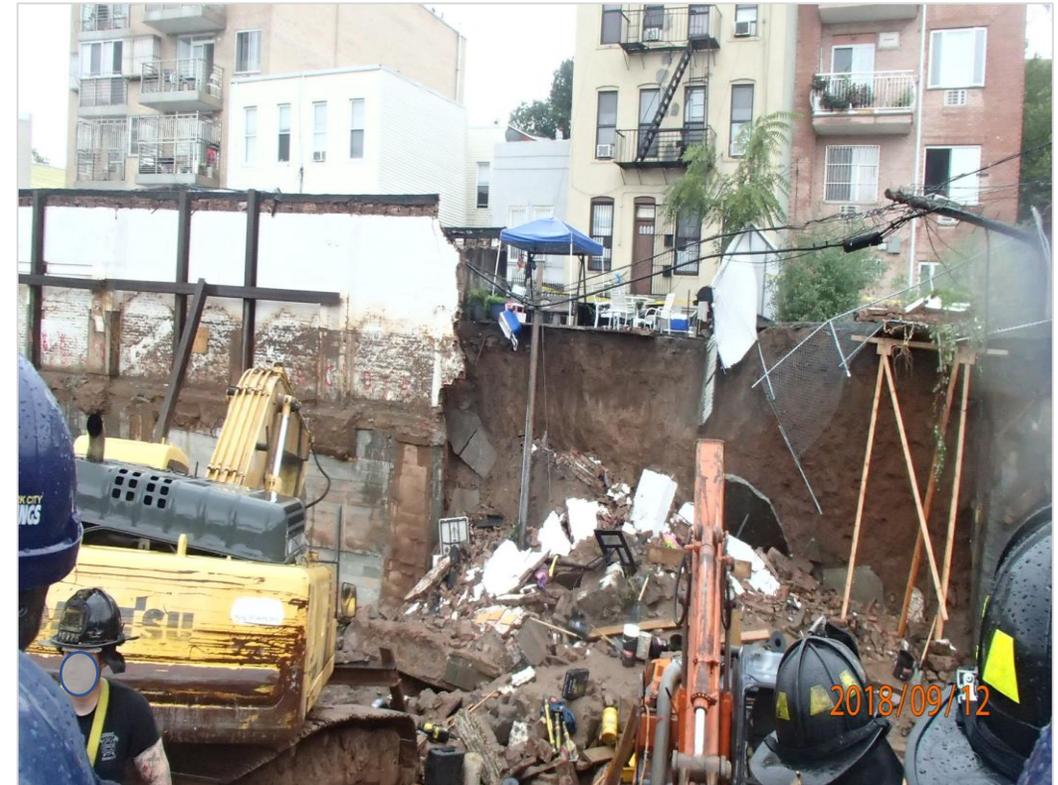
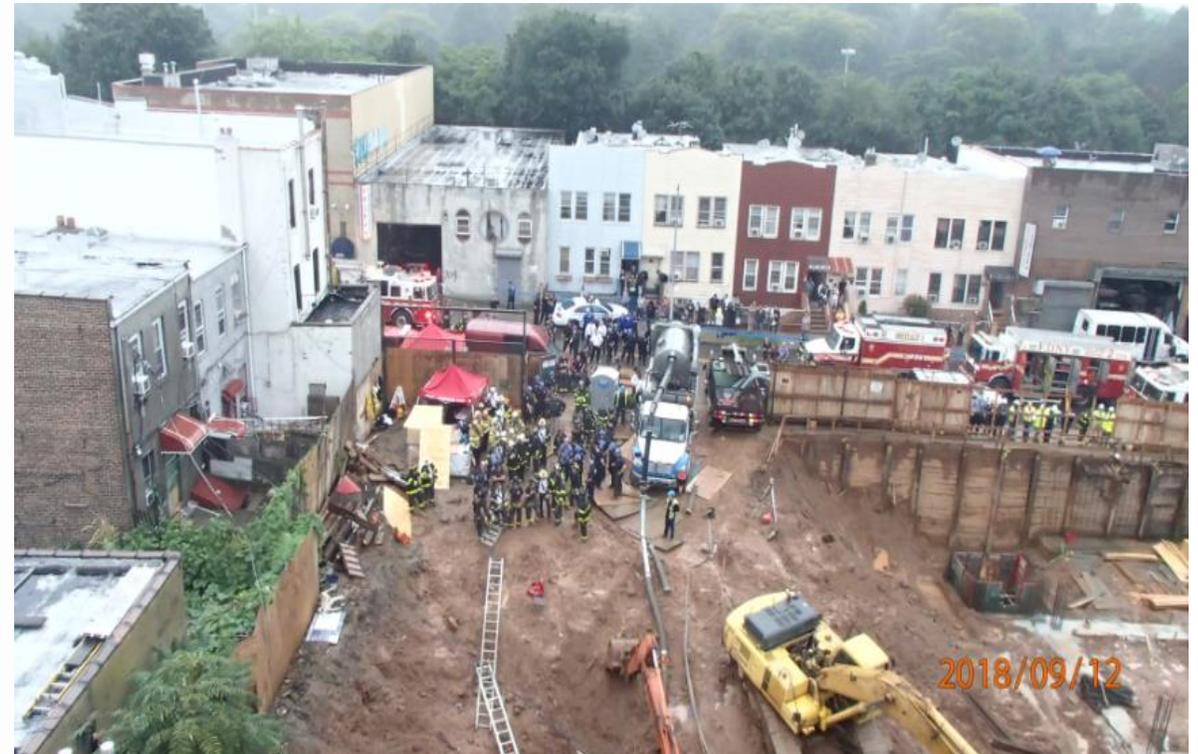
Failure to Perform Duties (SSM,SSC, CS) – 5%

- Fatality in Brooklyn where a worker was buried by a collapse. When emergency personnel and DOB inspectors arrived on the scene, the CS was not on site.
- The Construction Superintendent arrived later, not wearing proper PPE.
- Took three days for rescue operations to recover the body of the trapped worker.
- Work was being performed in the rain.

- Shore and braced the existing wall, 4-5 ft underground. Did not shore and brace the underpinning, about 14 ft. Did not tie the wall to underpin.
- 26-28 ft wall, bottom underpin starts to collapse, and the full force of the white wall came down behind it, placing 25 tons of concrete directly onto the job site and worker.

- A site safety representative must be on-site at all times.
- Ensure all safety protocols are followed.

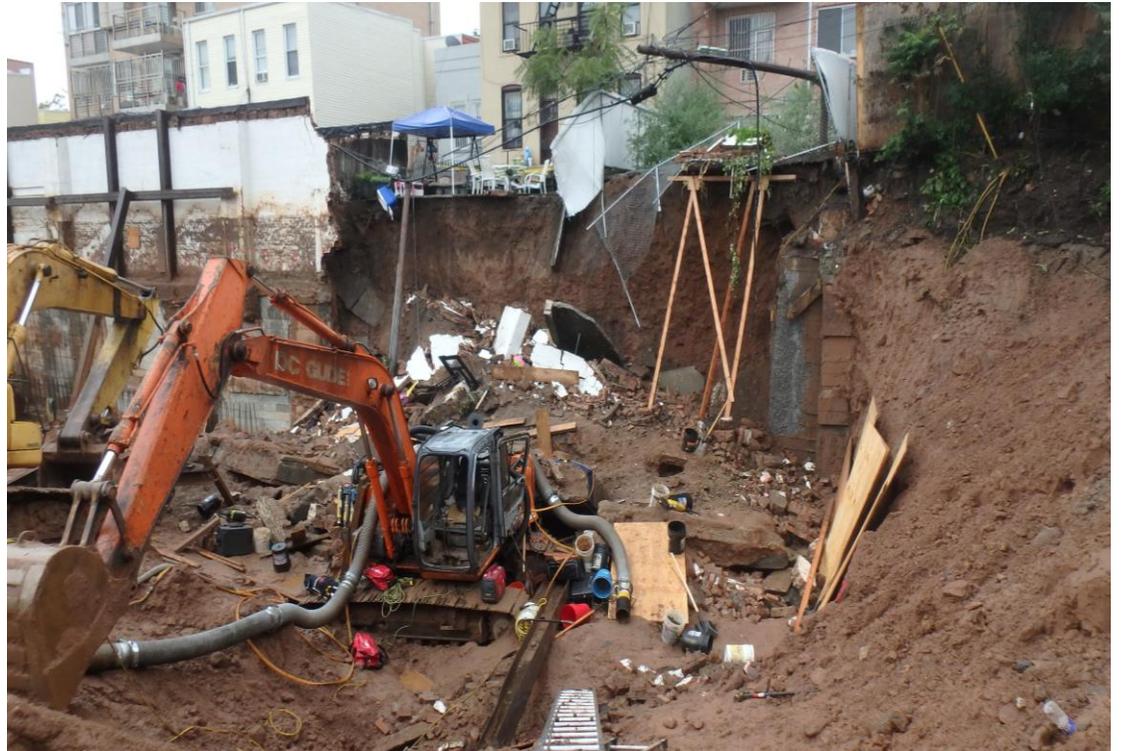
Construction Superintendent failed to perform duties per Code.

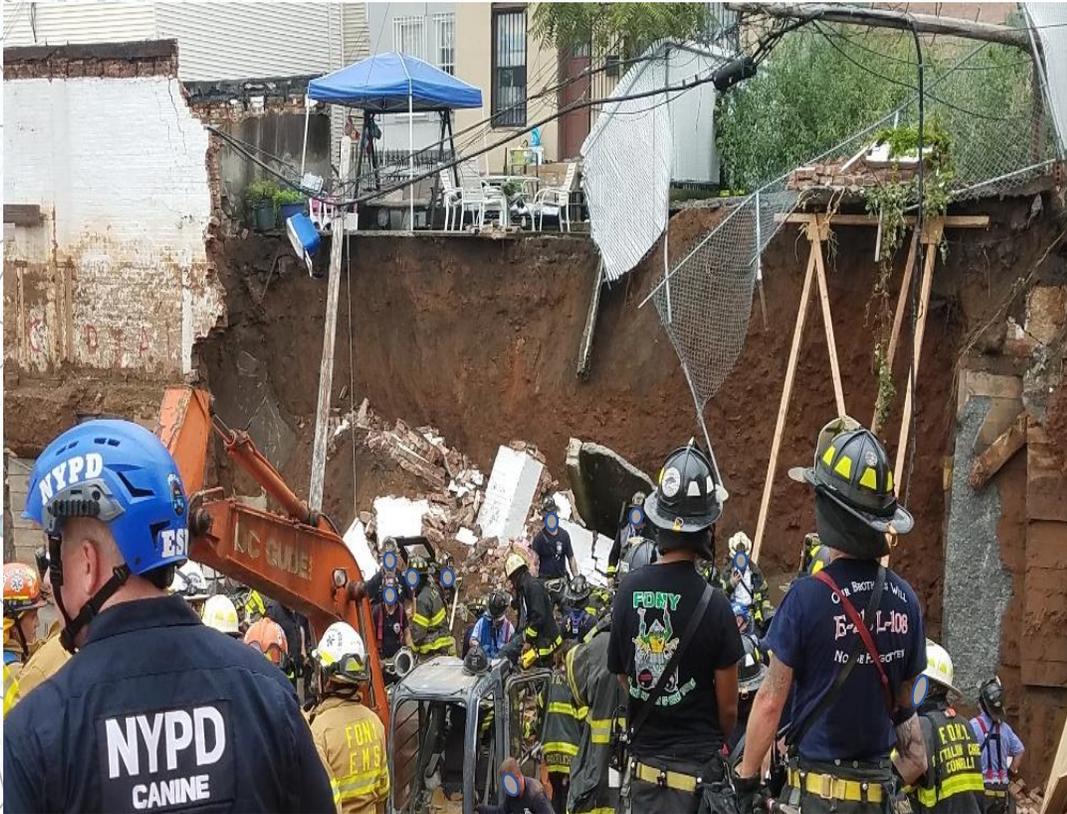
- Always maintain a site safety presence.
- Follow the approved plans.
- Ensure workers are properly trained in the construction activities taking place (excavation, underpinning, and bracing).
- Shoring and bracing of the existing wall should have been on the entire wall, not just a portion of the section of the wall.

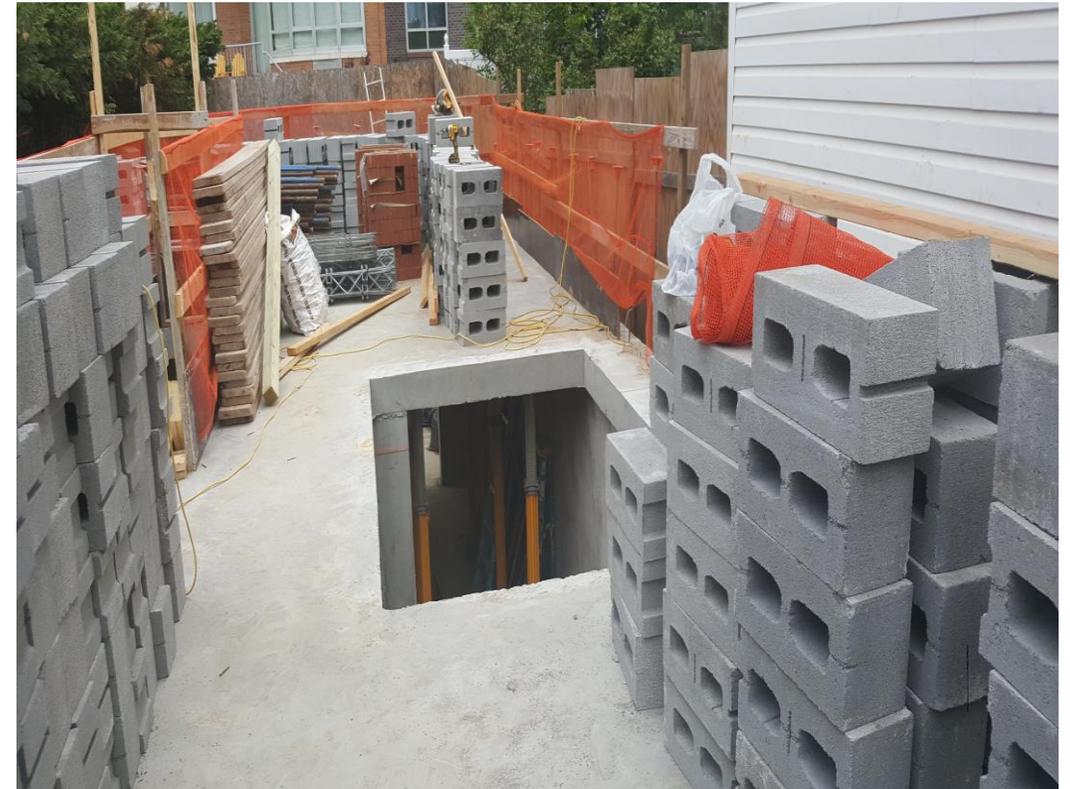
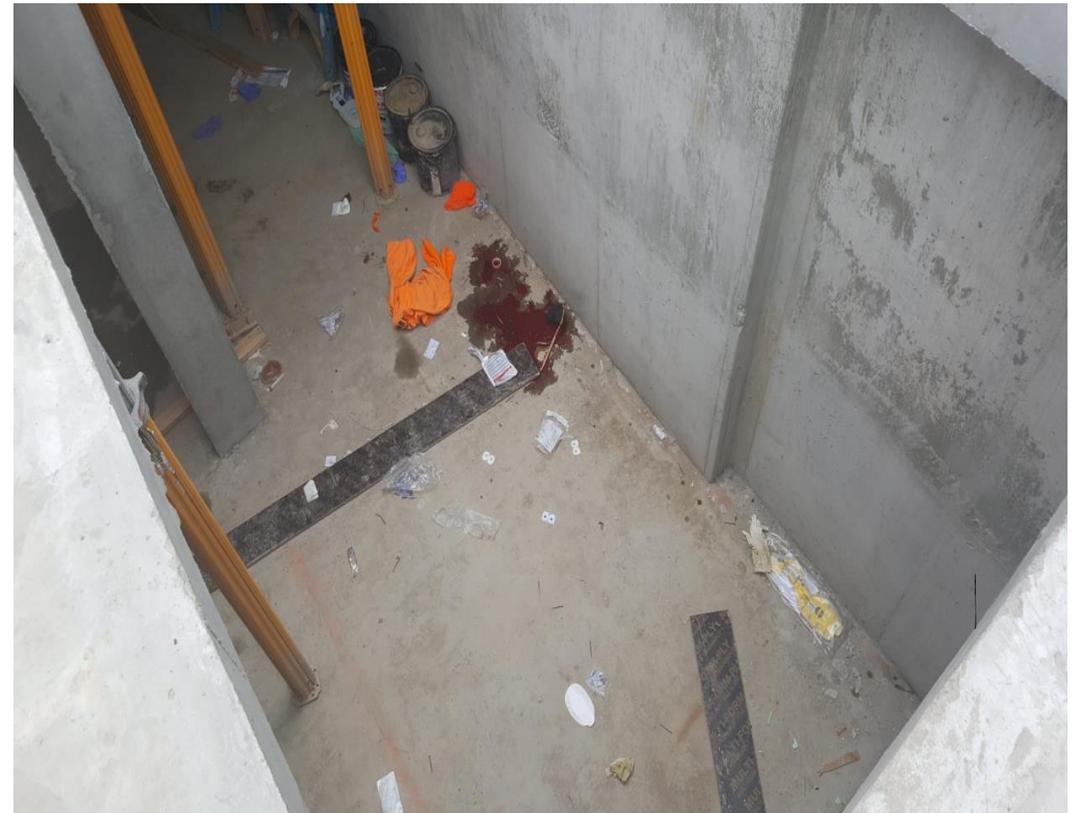
- The worker fell nine feet through the shaft to the cellar floor and suffered a critical injury.

- The worker was preparing to commence masonry work around a stair shaft when he removed the guard rails from the edges of the shaft.
- There were no safety measures in place consisting of a Controlled Access Zone (CAZ) or effective fall protection for performing a leading-edge operation, and the worker was not using a safety harness or an anchor point.

- Shall install guardrails when working on an elevated surface greater than 6 ft.

- Daily Pre-Shift Meeting & Toolbox to review work and identify dangers for the tasks.
- Install guardrails when openings are created.
- In lieu of guardrails, a CAZ should be set up, and tie-offs should be provided.
- Ensure workers are wearing appropriate PPE when on-site.
- Ensure all workers are aware of openings with signage and other indicators.

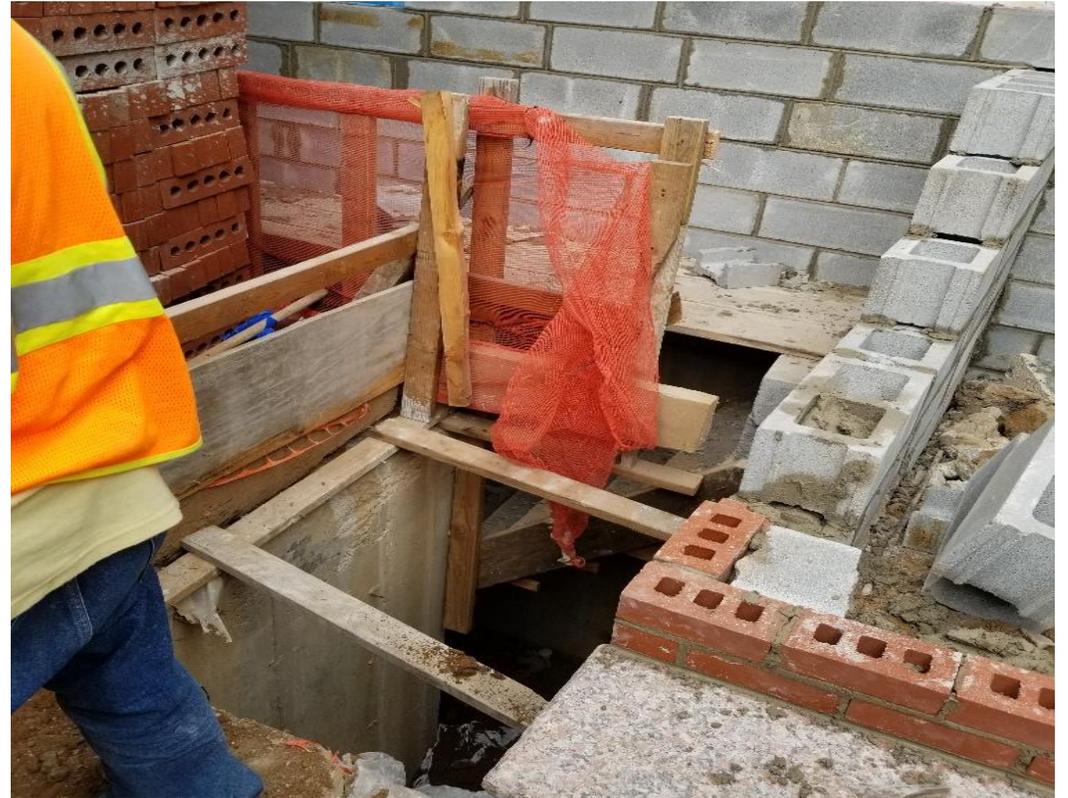
Failure to institute/maintain safety equipment measures or temporary construction – No Guardrails.

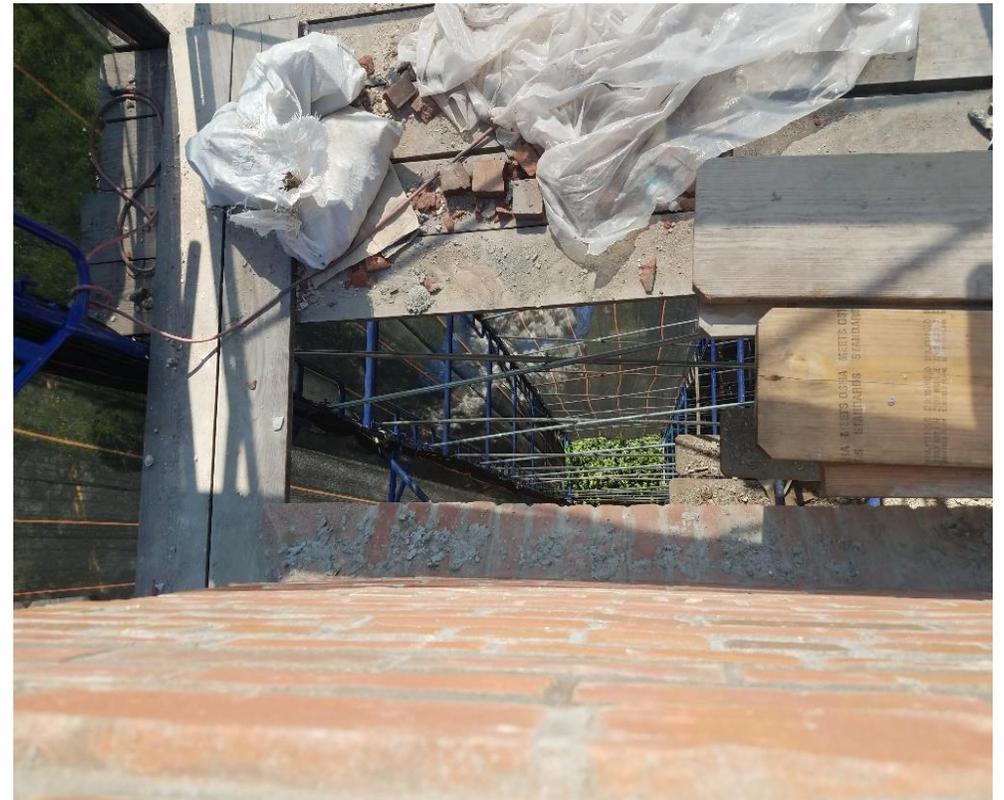
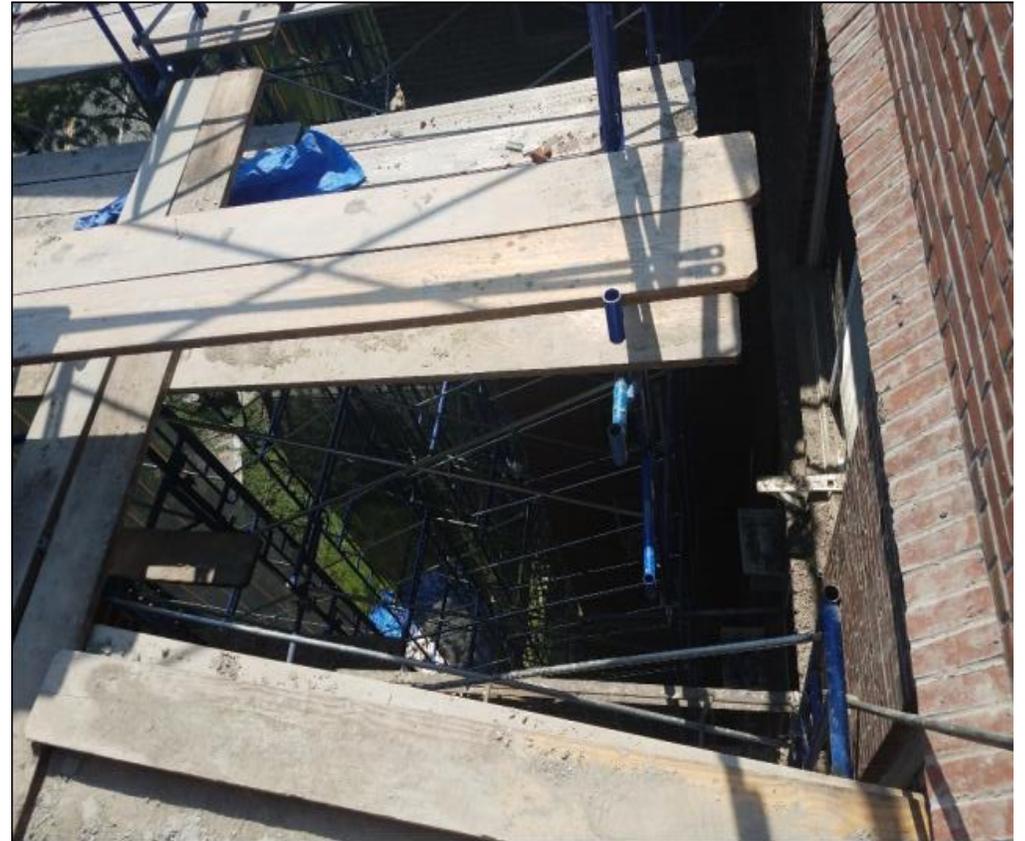
Failure to Follow Approved Drawings – 4%

- Queens- September 2019
- Worker on the roof of a three-story building was working on a scaffold to perform parapet work when the worker fell in between the scaffold and the façade and landed on the lawn area.
- The worker's right leg and both hands were broken.
- The worker was taken to the emergency room but was not in critical condition.

- The scaffold and sidewalk shed permits were valid with the design drawings at the site.
- Design drawings were not referenced or followed during the construction of the scaffolding.
- No life-lines present at the site.
- There were no guardrails on the scaffolding.
- There were a number of missing planks.

- Daily Pre-Shift Meeting & Toolbox to review work and identify dangers for the tasks.
- Always construct scaffolding and other structures according to approved drawings.
- Ensure fall protection measures are in place.
 - Install guard rails when working on an elevated surface of six ft or greater.
 - Workers are wearing appropriate PPE.

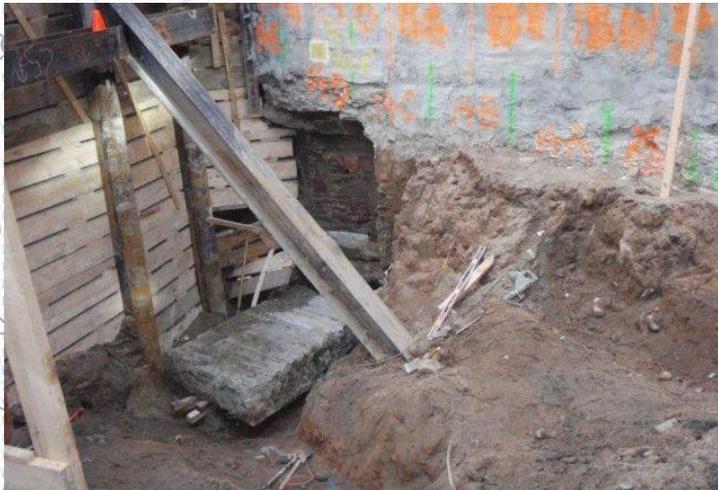
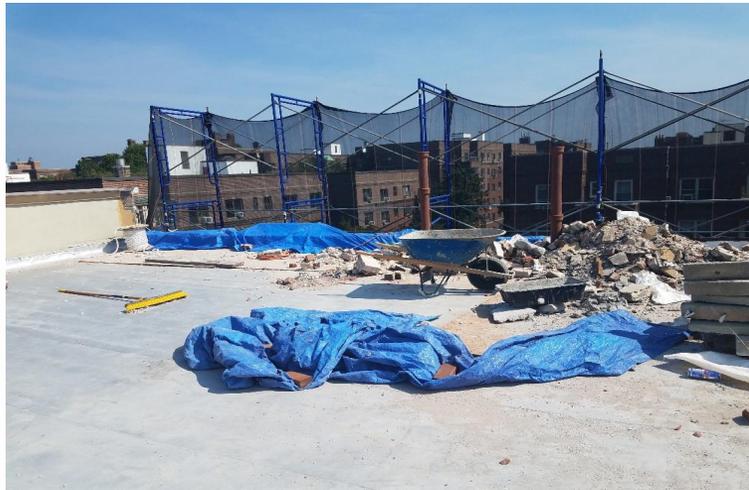
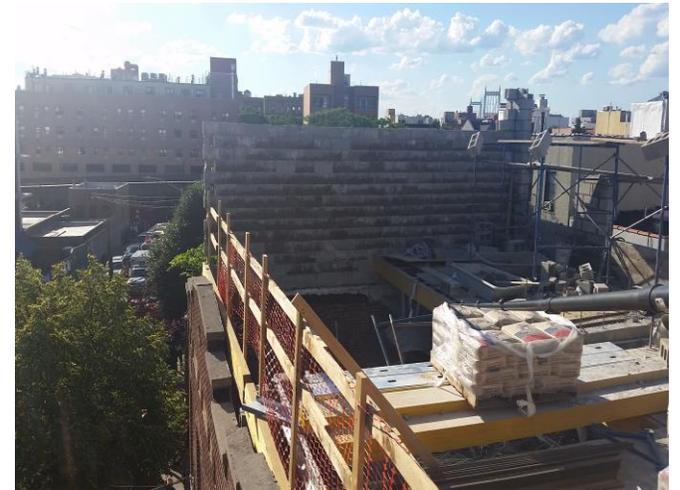
Section of Code: 28-105.12.2

Work does not conform to approved construction documents and/or approved amendments.

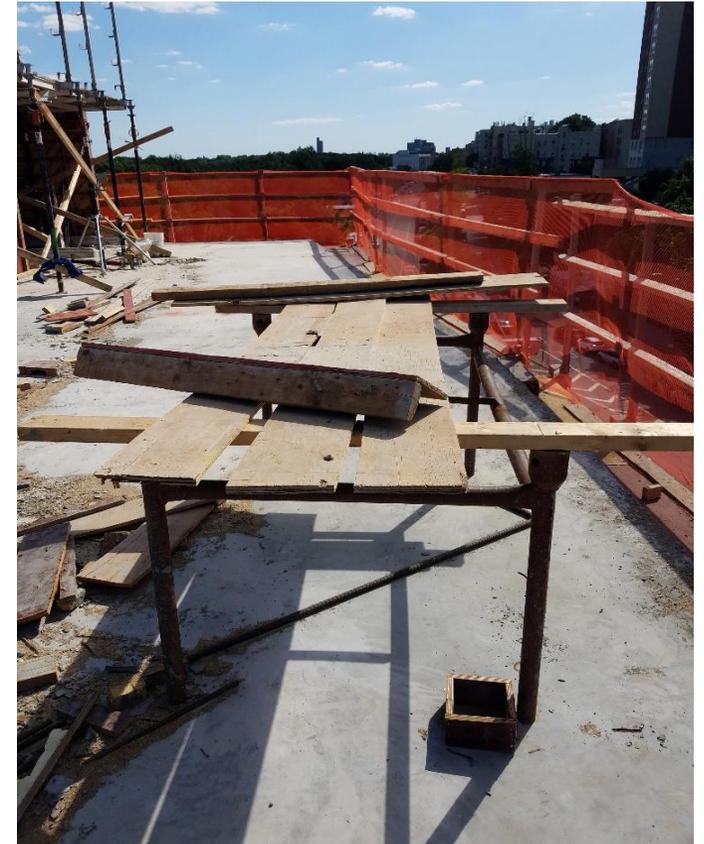
- Worker was cutting the plywood on a table that was set up improperly.
- Worker was not trained on the proper use of the saw.

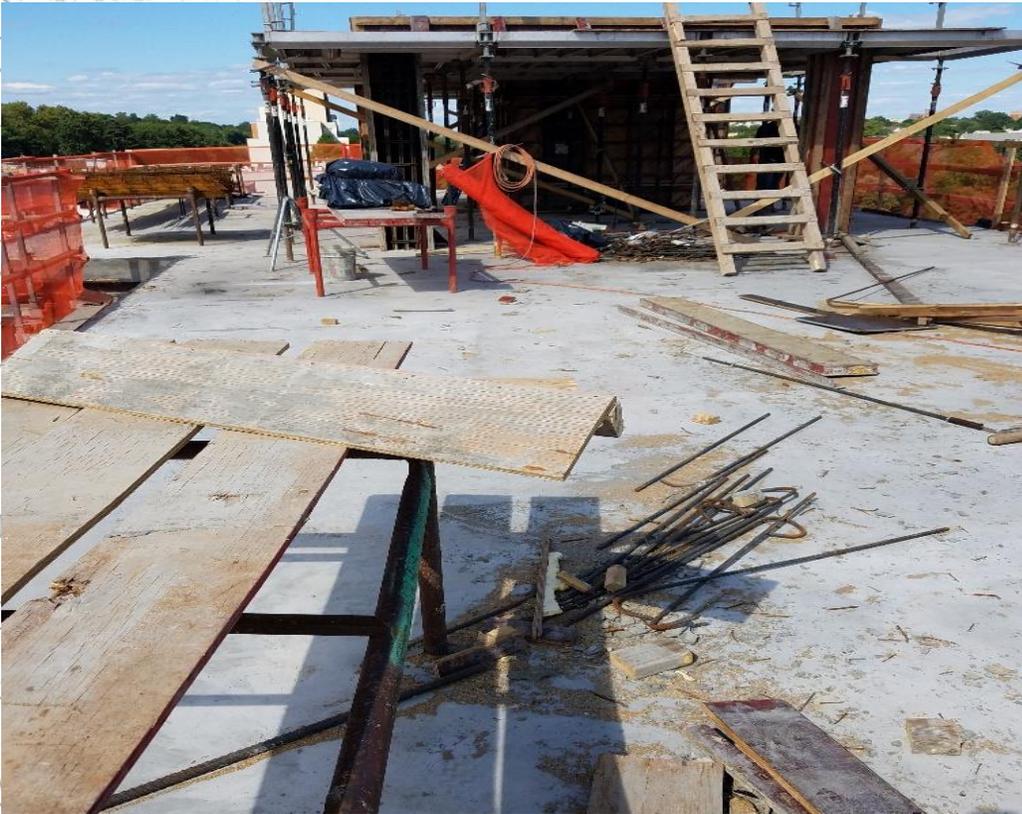
- Daily Pre-Shift Meeting & Toolbox Talk to review work and identify dangers for the tasks.
- Always train workers on the proper use of machinery and equipment before allowing them to operate the equipment.

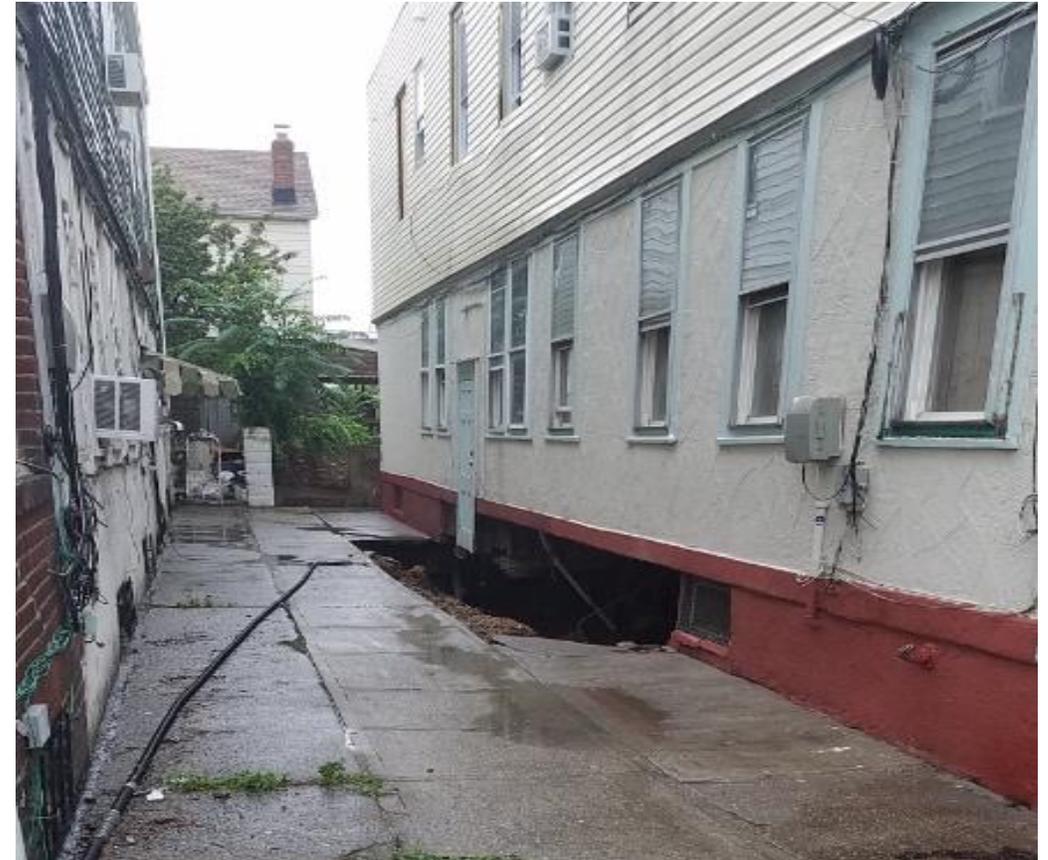
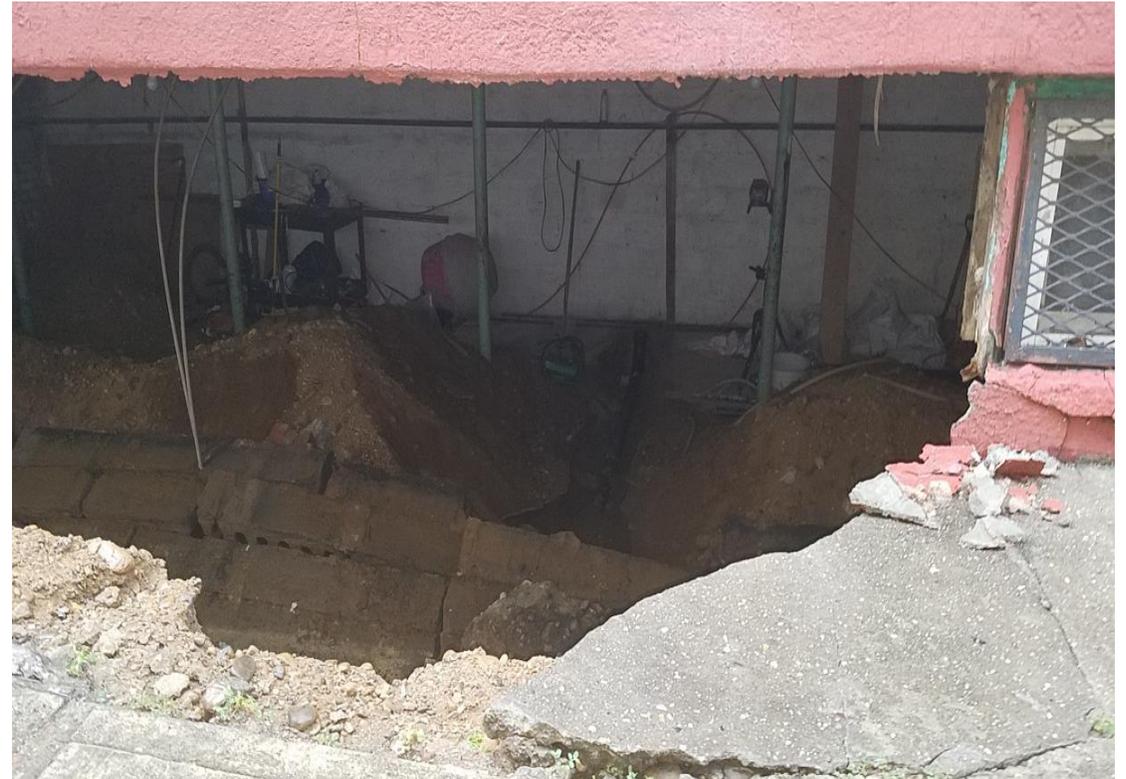
- Queens – July 2020
- The gut renovation took place without permits.
- Foundation walls collapsed.
- Collapse affected two other buildings in the vicinity; a full vacate order was issued to all three properties.

- Work was being performed without a permit.
- Did not verify the structural stability of structure prior to work.
- Lack of shoring and bracing of the existing wall.

- Ensure working with a DOB issued permit.
- Reapply for a permit prior to expiration.
- If the scope of work changes, obtain a new permit.
- Verify structural stability prior to commencement of work.

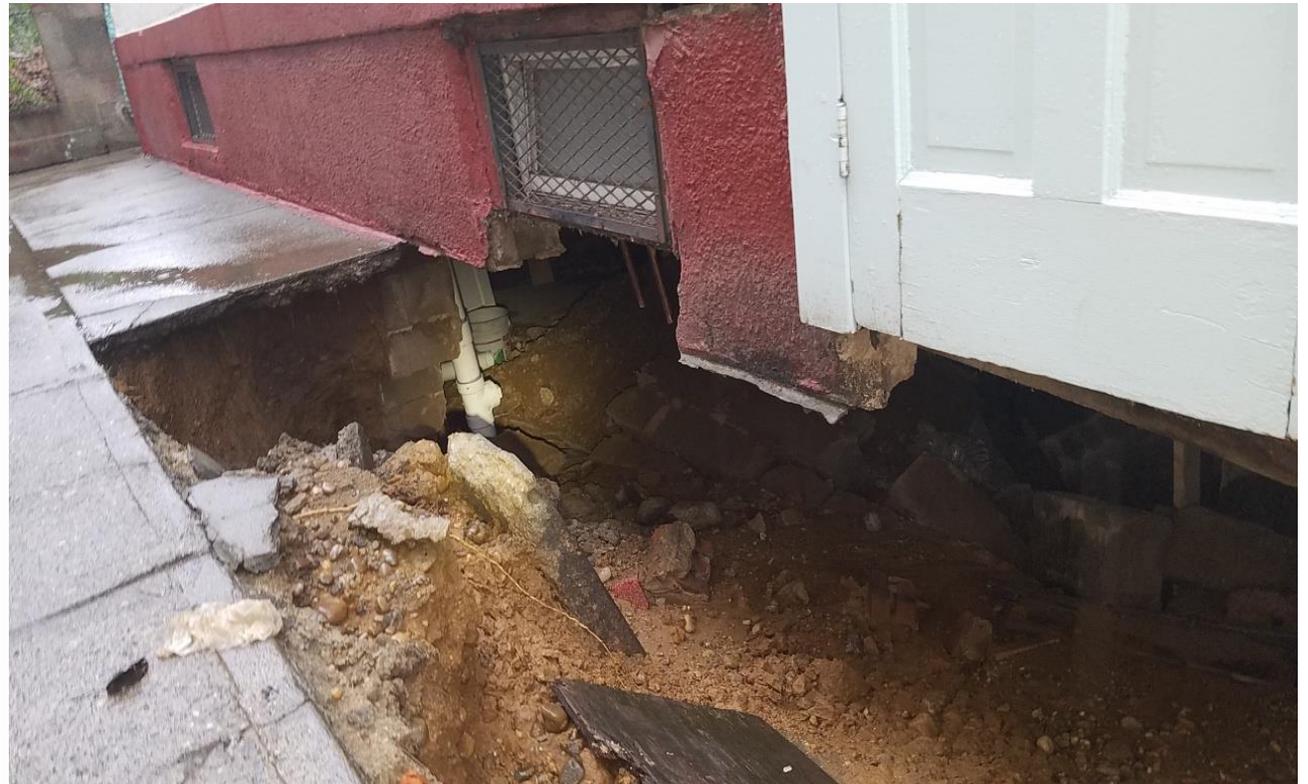
Work Without a Permit

- Work should only take place when appropriately permitted.
