**Thornton  
Tomasetti**

*FISP Recommendations Report:*  
**A Review of the New York  
City Façade Inspection  
& Safety Program**

**December 10, 2025**

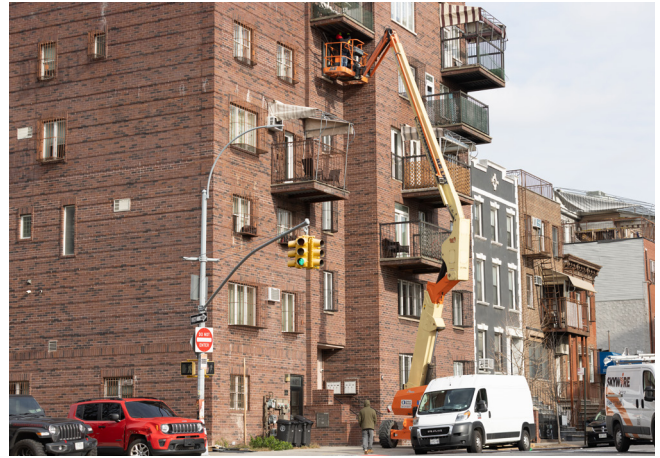
A boom lift is used to gain access to a façade in NYC.

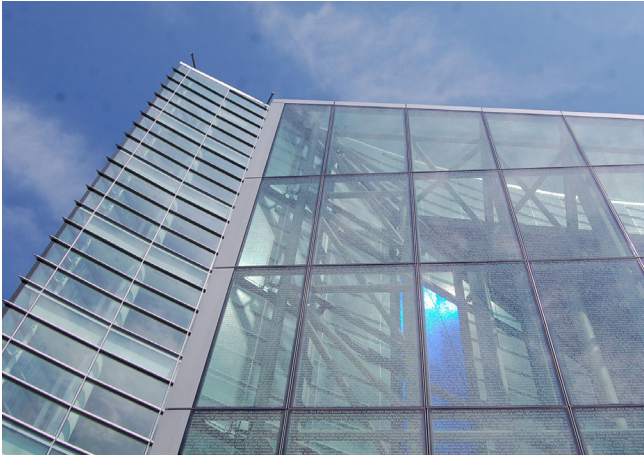
A glass curtain wall façade.

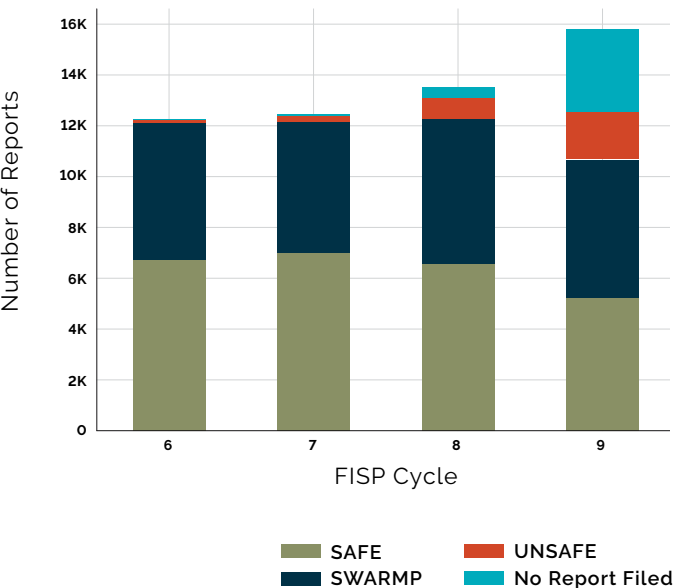
Figure 5: Initial Report Status by Cycle (TR6 Data on 10/9/24, Source: DOB)

For the approximately 13,000 buildings that filed initial reports in Cycle 9. Fifteen percent of buildings for which reports were filed are categorized as UNSAFE. Between Cycles 6 and 9, the number of buildings filed as SAFE has generally declined, while the number filed as UNSAFE has increased. Among the buildings for which an Initial report was filed, the percentage filed as UNSAFE increased from 6% to 15% between Cycle 8 and Cycle 9.

Among all buildings at the time of this analysis (October 2024), including those with “No Report Filed” (NRF) status, the percentage of Initial reports filed as UNSAFE increased from 6% to 12%. Note that the actual total number of filings in Cycle 9 is higher due to reports received by DOB after our analysis of the data.

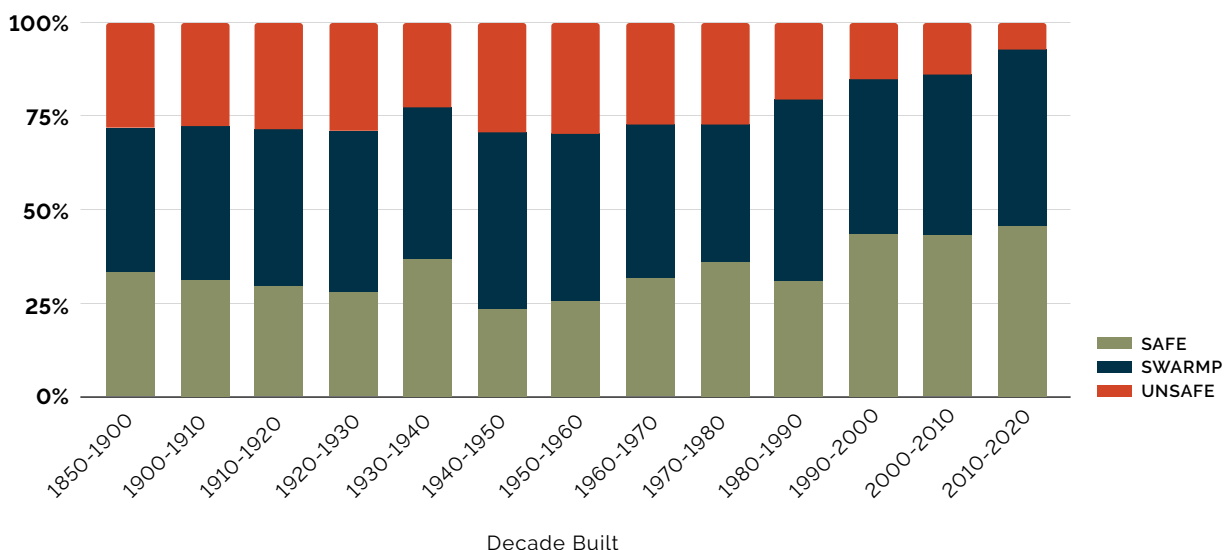
Figure 8: Report Status by Building Age, Percentage (Cycle 9)

Trends in filing status by age brackets mirror the trend for FISP buildings overall. However, when we examine the data more closely, further conclusions can be drawn about the relationship between age and status.
