# DETERIORATION OF CONSTRUCTION MATERIALS IN NYC

DAN ESCHENASY, PE, F.SEI, SECB  
*Chief Structural Engineer*

This presentation will provide a historical perspective of construction material deterioration caused by climate conditions and design practices in New York City. The presentation includes an overview of basic material science, Code-related requirements, along with an explanation of conditions that led to the deterioration of stone, wood, brick concrete and steel and historic methods of protection.

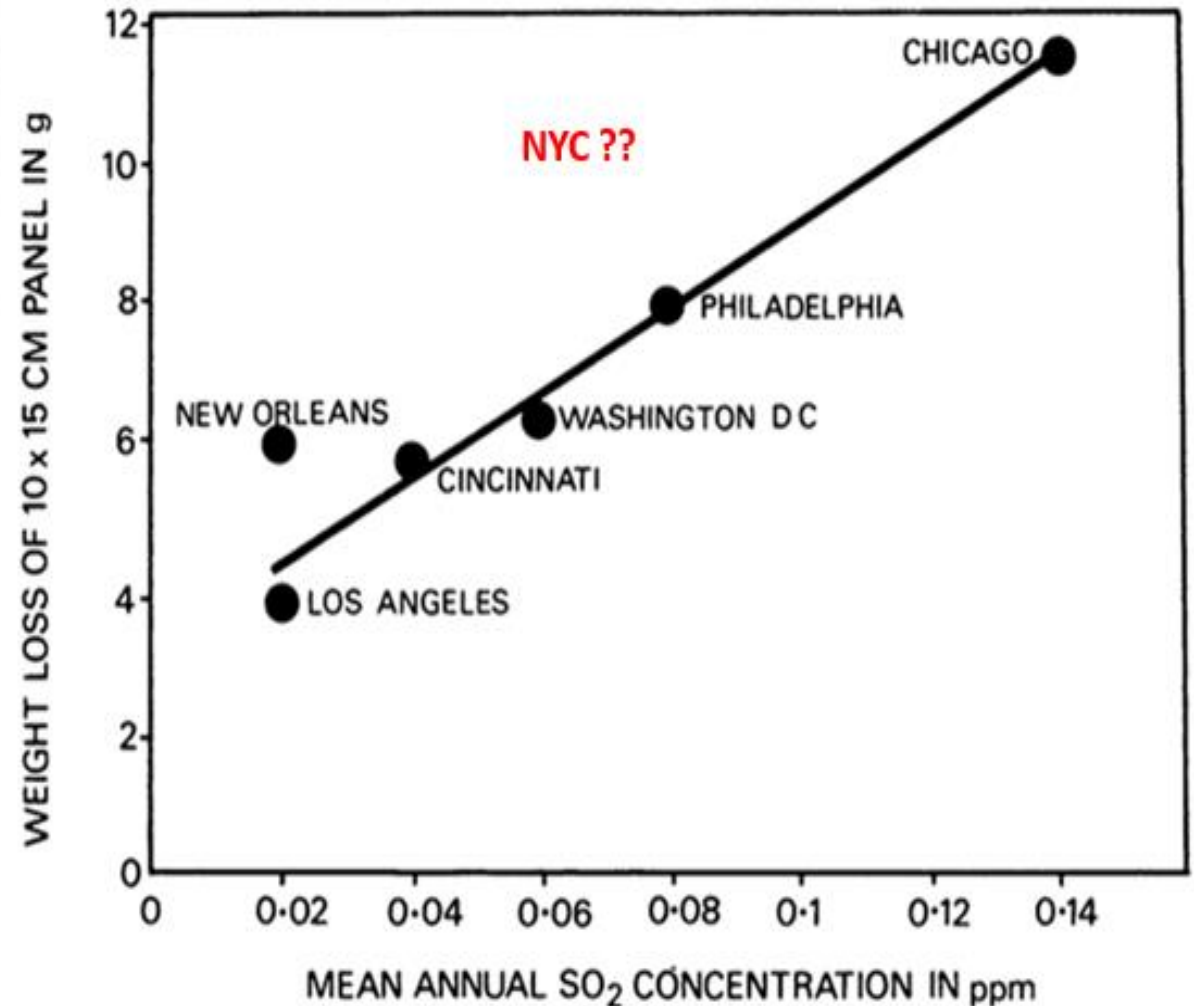
Effects of sulfur dioxide and acid precipitation on metals and anti-rust painted steel

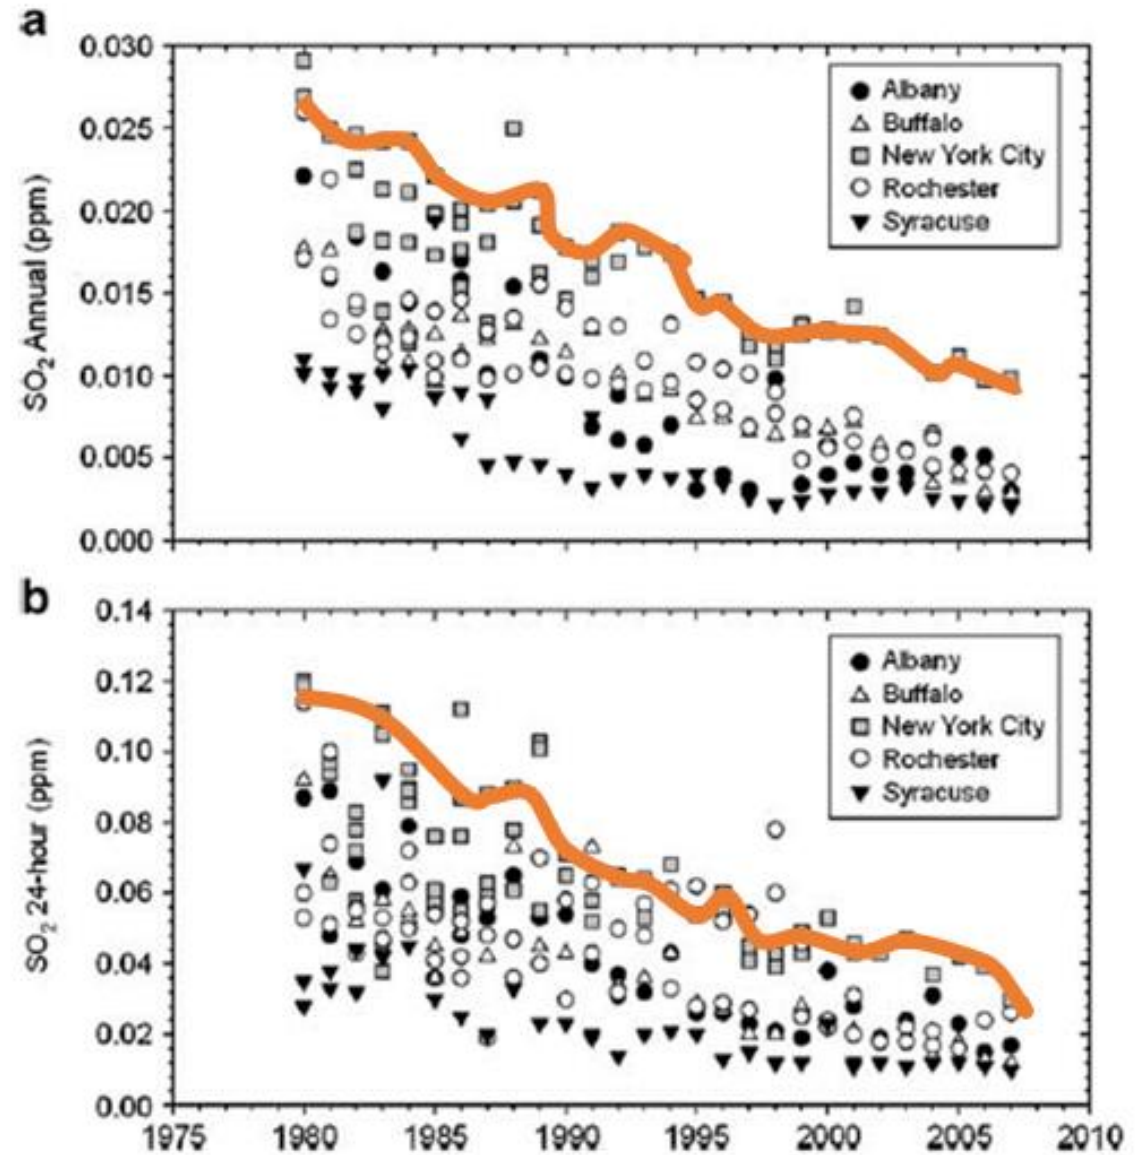
A – Annual

B – Average 24hrs

New York City

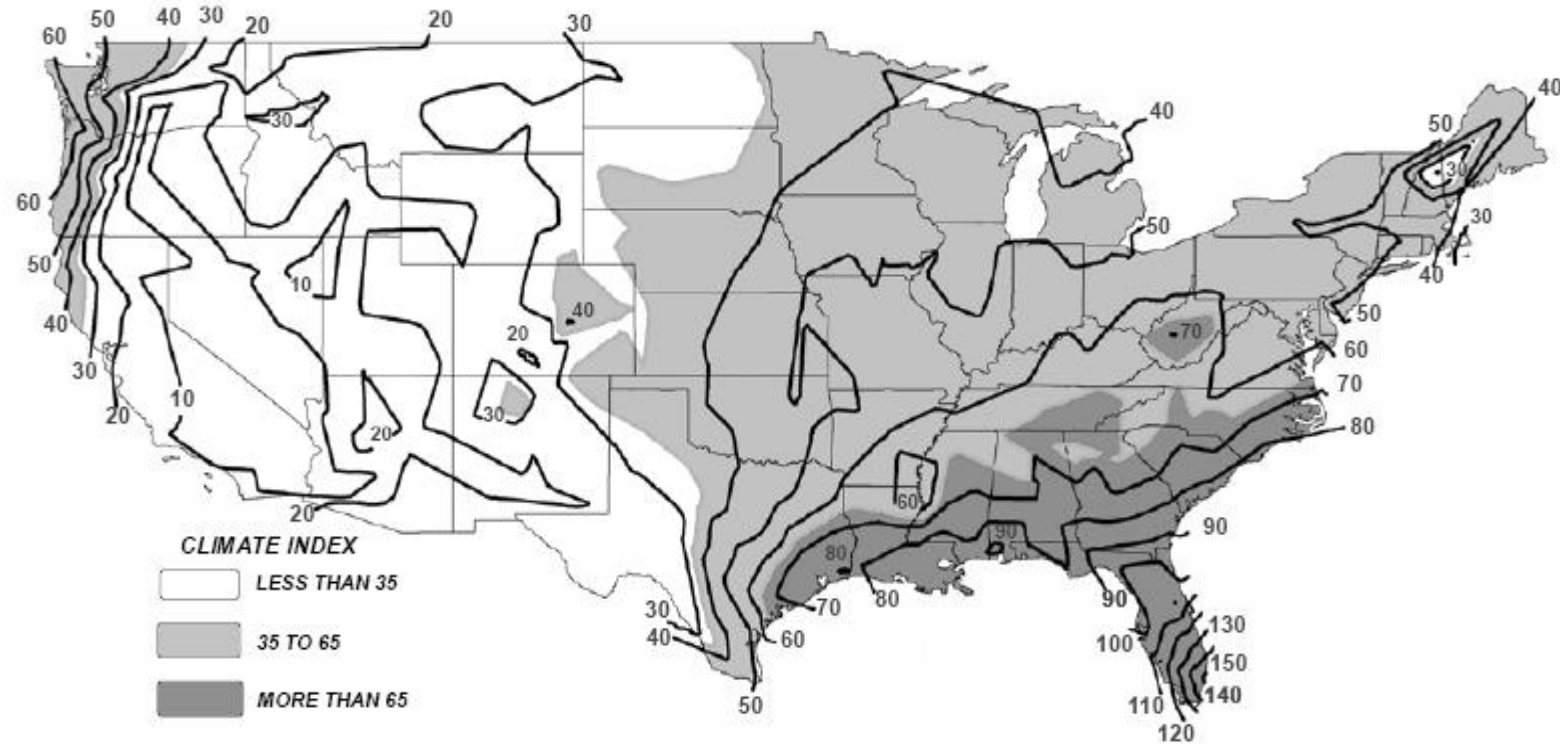
Figure 2. Revised climate index map for decay hazard based on data for the period 1971–2000. Higher index values indicate greater decay hazard.

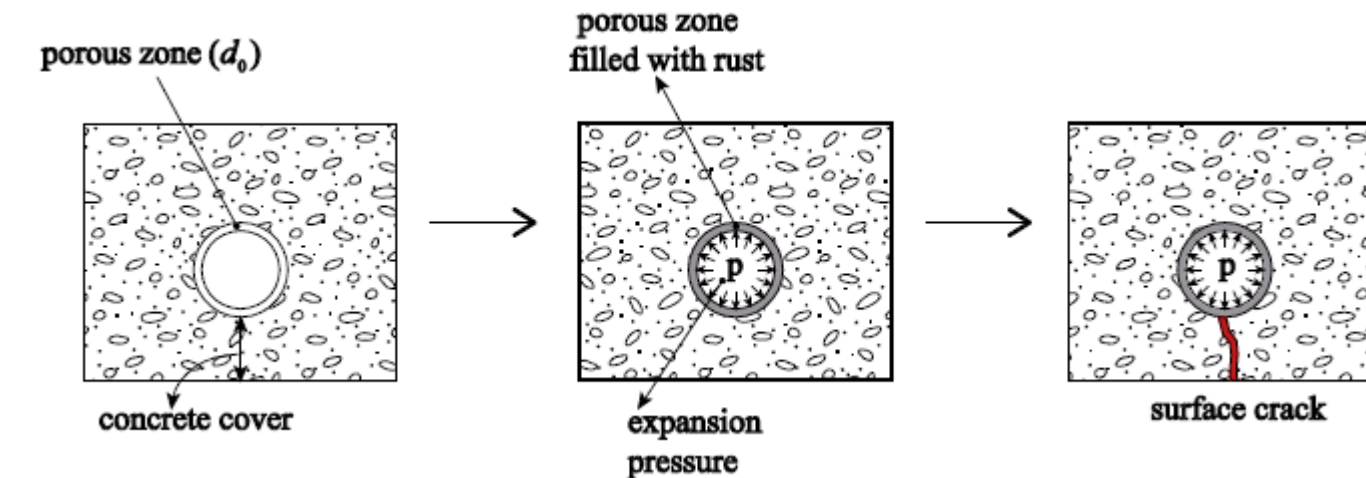
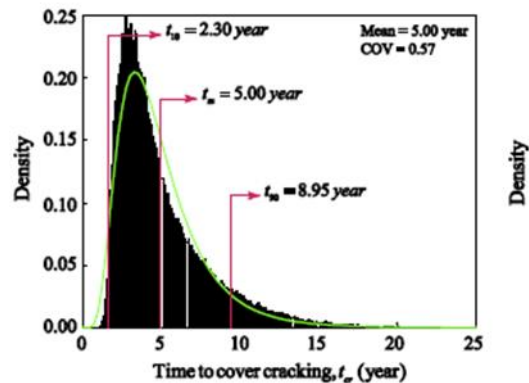
Carbon dioxide reacts to form carbonic acid and it is transported into concrete pores, leading CARBONATION. Carbonation starts at the outside and proceeds to the inside of a component. At the same time, the pH of the alkaline pore water decreases. When the carbonation front reaching the steel reinforcement causes the loss of the steel's protective alkaline layers; as a consequence the steel starts rusting. Rust causes a volume increase, so that resulting tension inside the cement paste may lead to cracking, blistering and spalling of the surface.

TIME TO COVER CRACKING

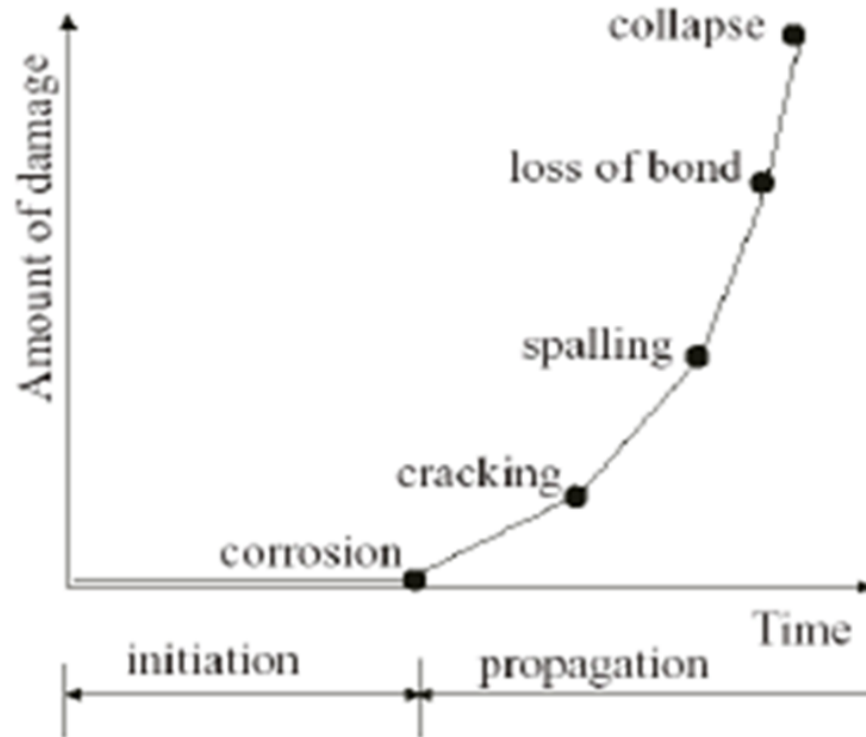
## 2 PHASES

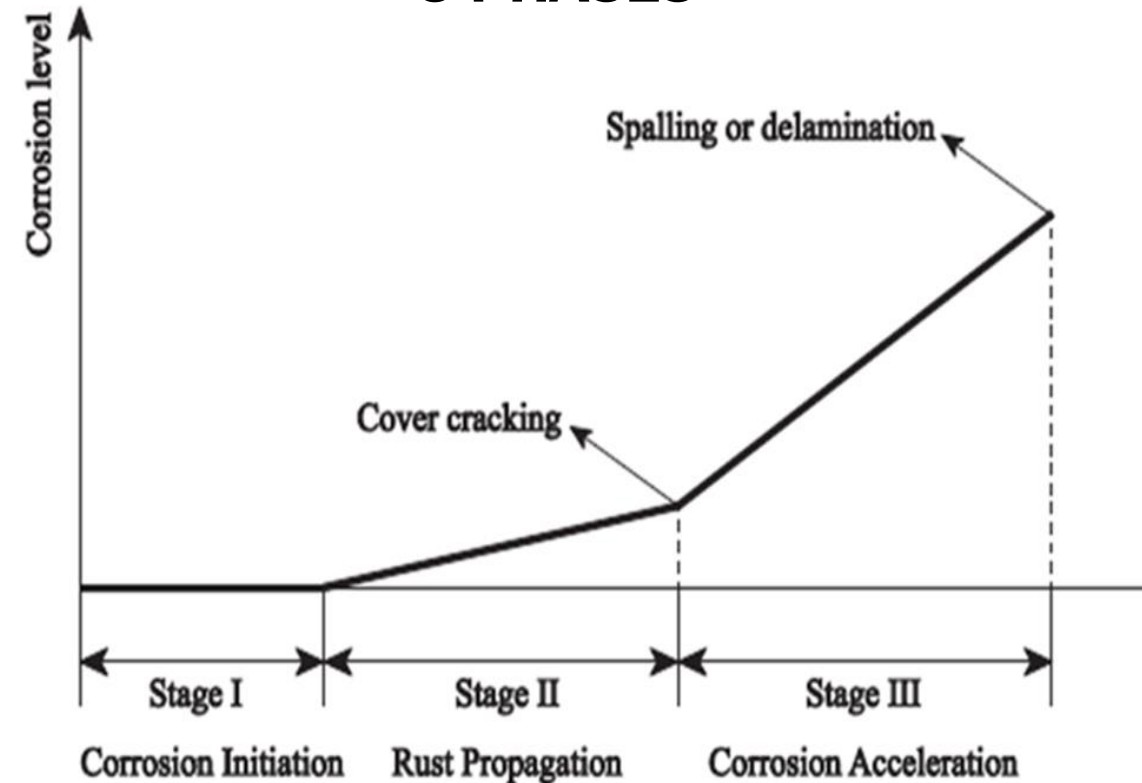
## 3 PHASES

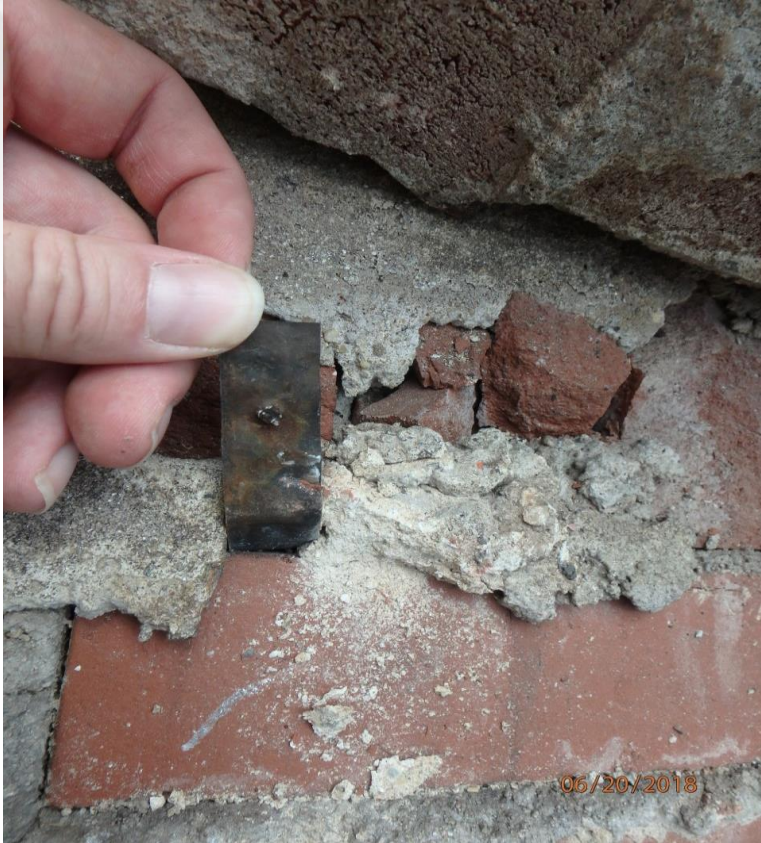
## Life Expectancy

- BIA - 6 year for ties and 20-30 anchors
- ACI - 7 years embedded ties and 16 years for not embedded
- Cover PROPERTIES
