**Staten Island University Hospital  
Environmental Screening for  
South Campus Resiliency Project  
375 Seguine Avenue  
Staten Island, New York 10309**

Environmental Assessment  
Determination and Compliance  
Findings for HUD-assisted Project  
24 CFR Part 58

April 5, 2016  
Revised August 25, 2016

Staten Island University Hospital - South Campus Upgrades

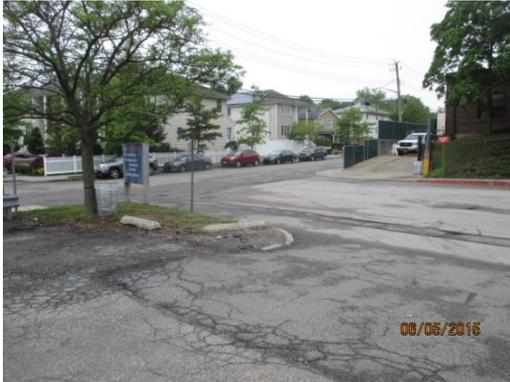
**Photo #1** View of ambulance driveway entrance looking southwest towards Melville Street

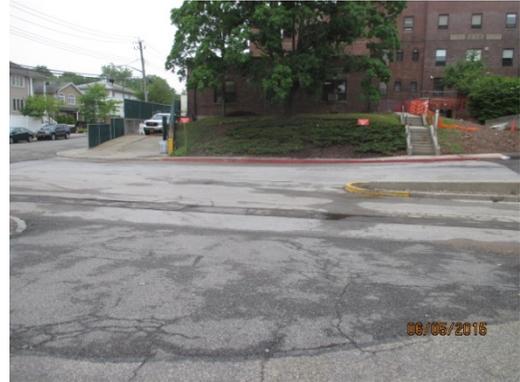
**Photo #2** View of ambulance driveway entrance looking west towards hospital

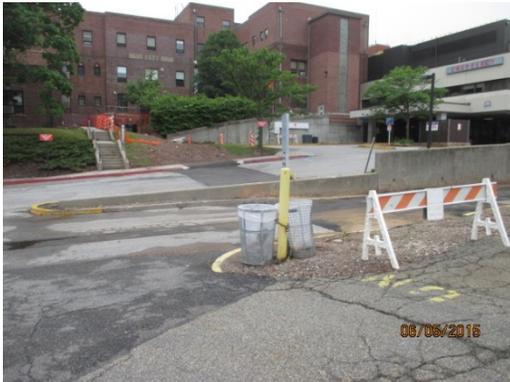
**Photo #3** View of ambulance driveway and Central Utility Plant access road looking northwest towards hospital

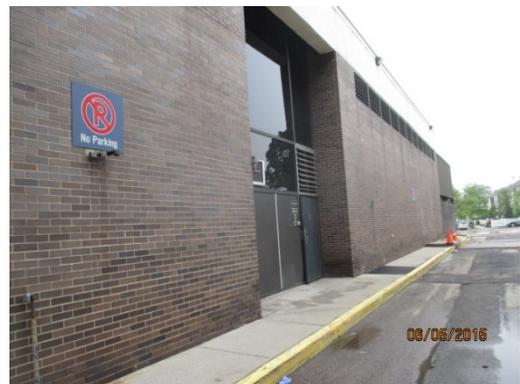
**Photo #6** View of west side of Central Utility Plant

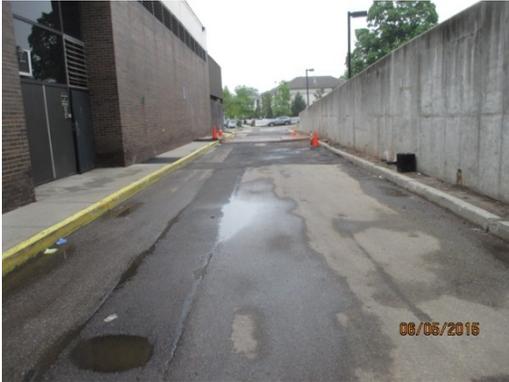
**Photo #7** View of Central Utility Plant access road looking south towards Melville St.

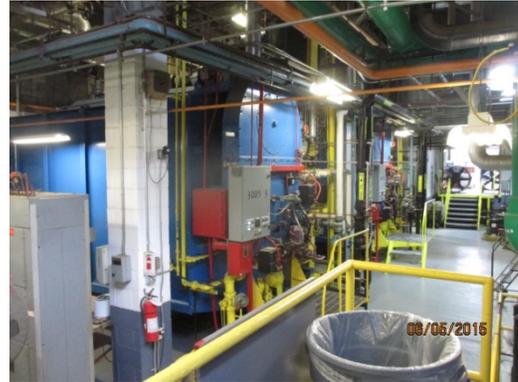
**Photo #8** View of existing boilers in Central Utility Plant

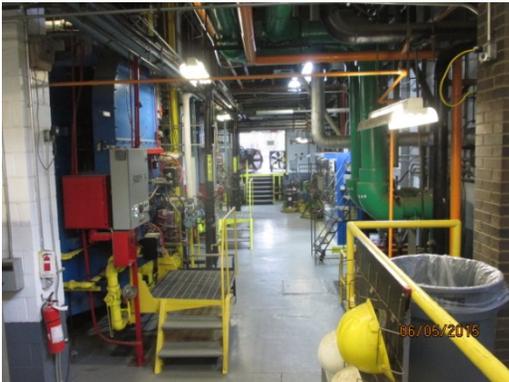
**Photo #9** Alternative view of existing boilers in Central Utility Plant

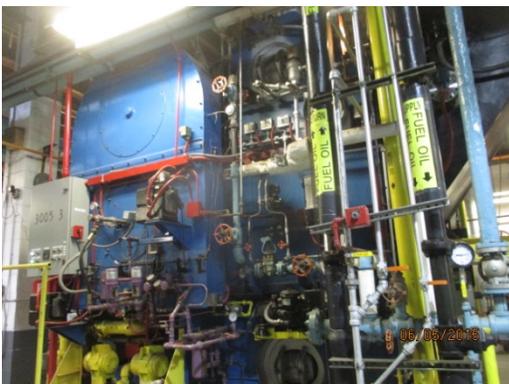
**Photo #11** View of existing boiler (2)

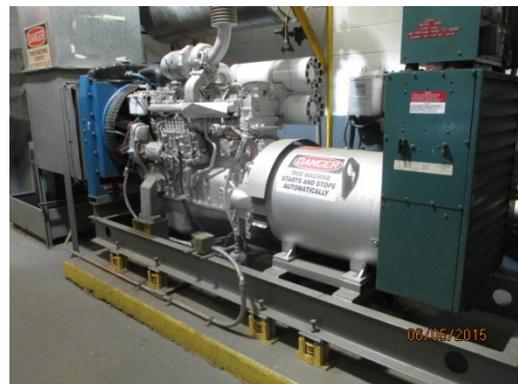
**Photo #12** View of generator to be removed

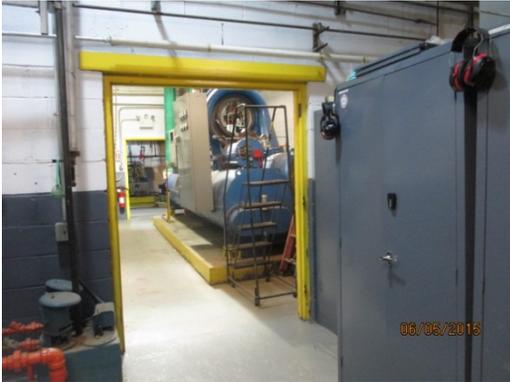
Photo #13 View of proposed location of third boiler

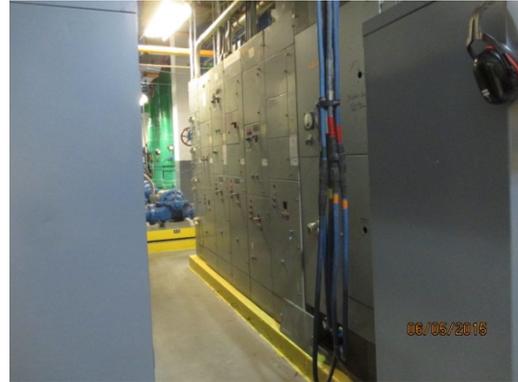
Photo #14 Existing electrical switchgear and panels

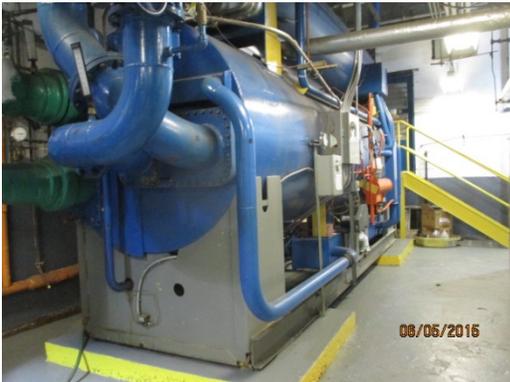
Photo #15 View of chiller to be refurbished

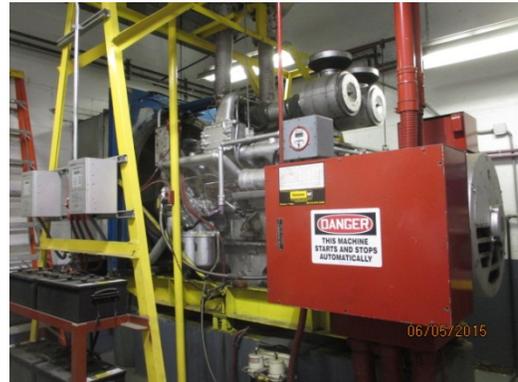
Photo #16 View of generator to be replaced

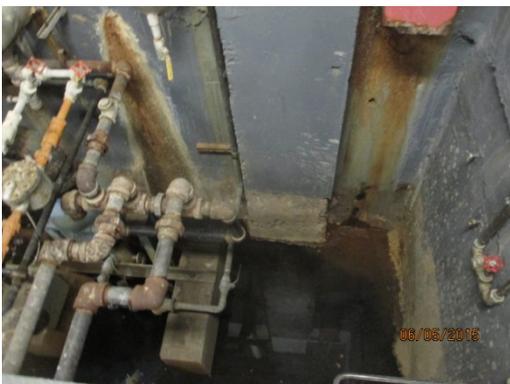
Photo #17 View of existing sump/proposed pump intake location

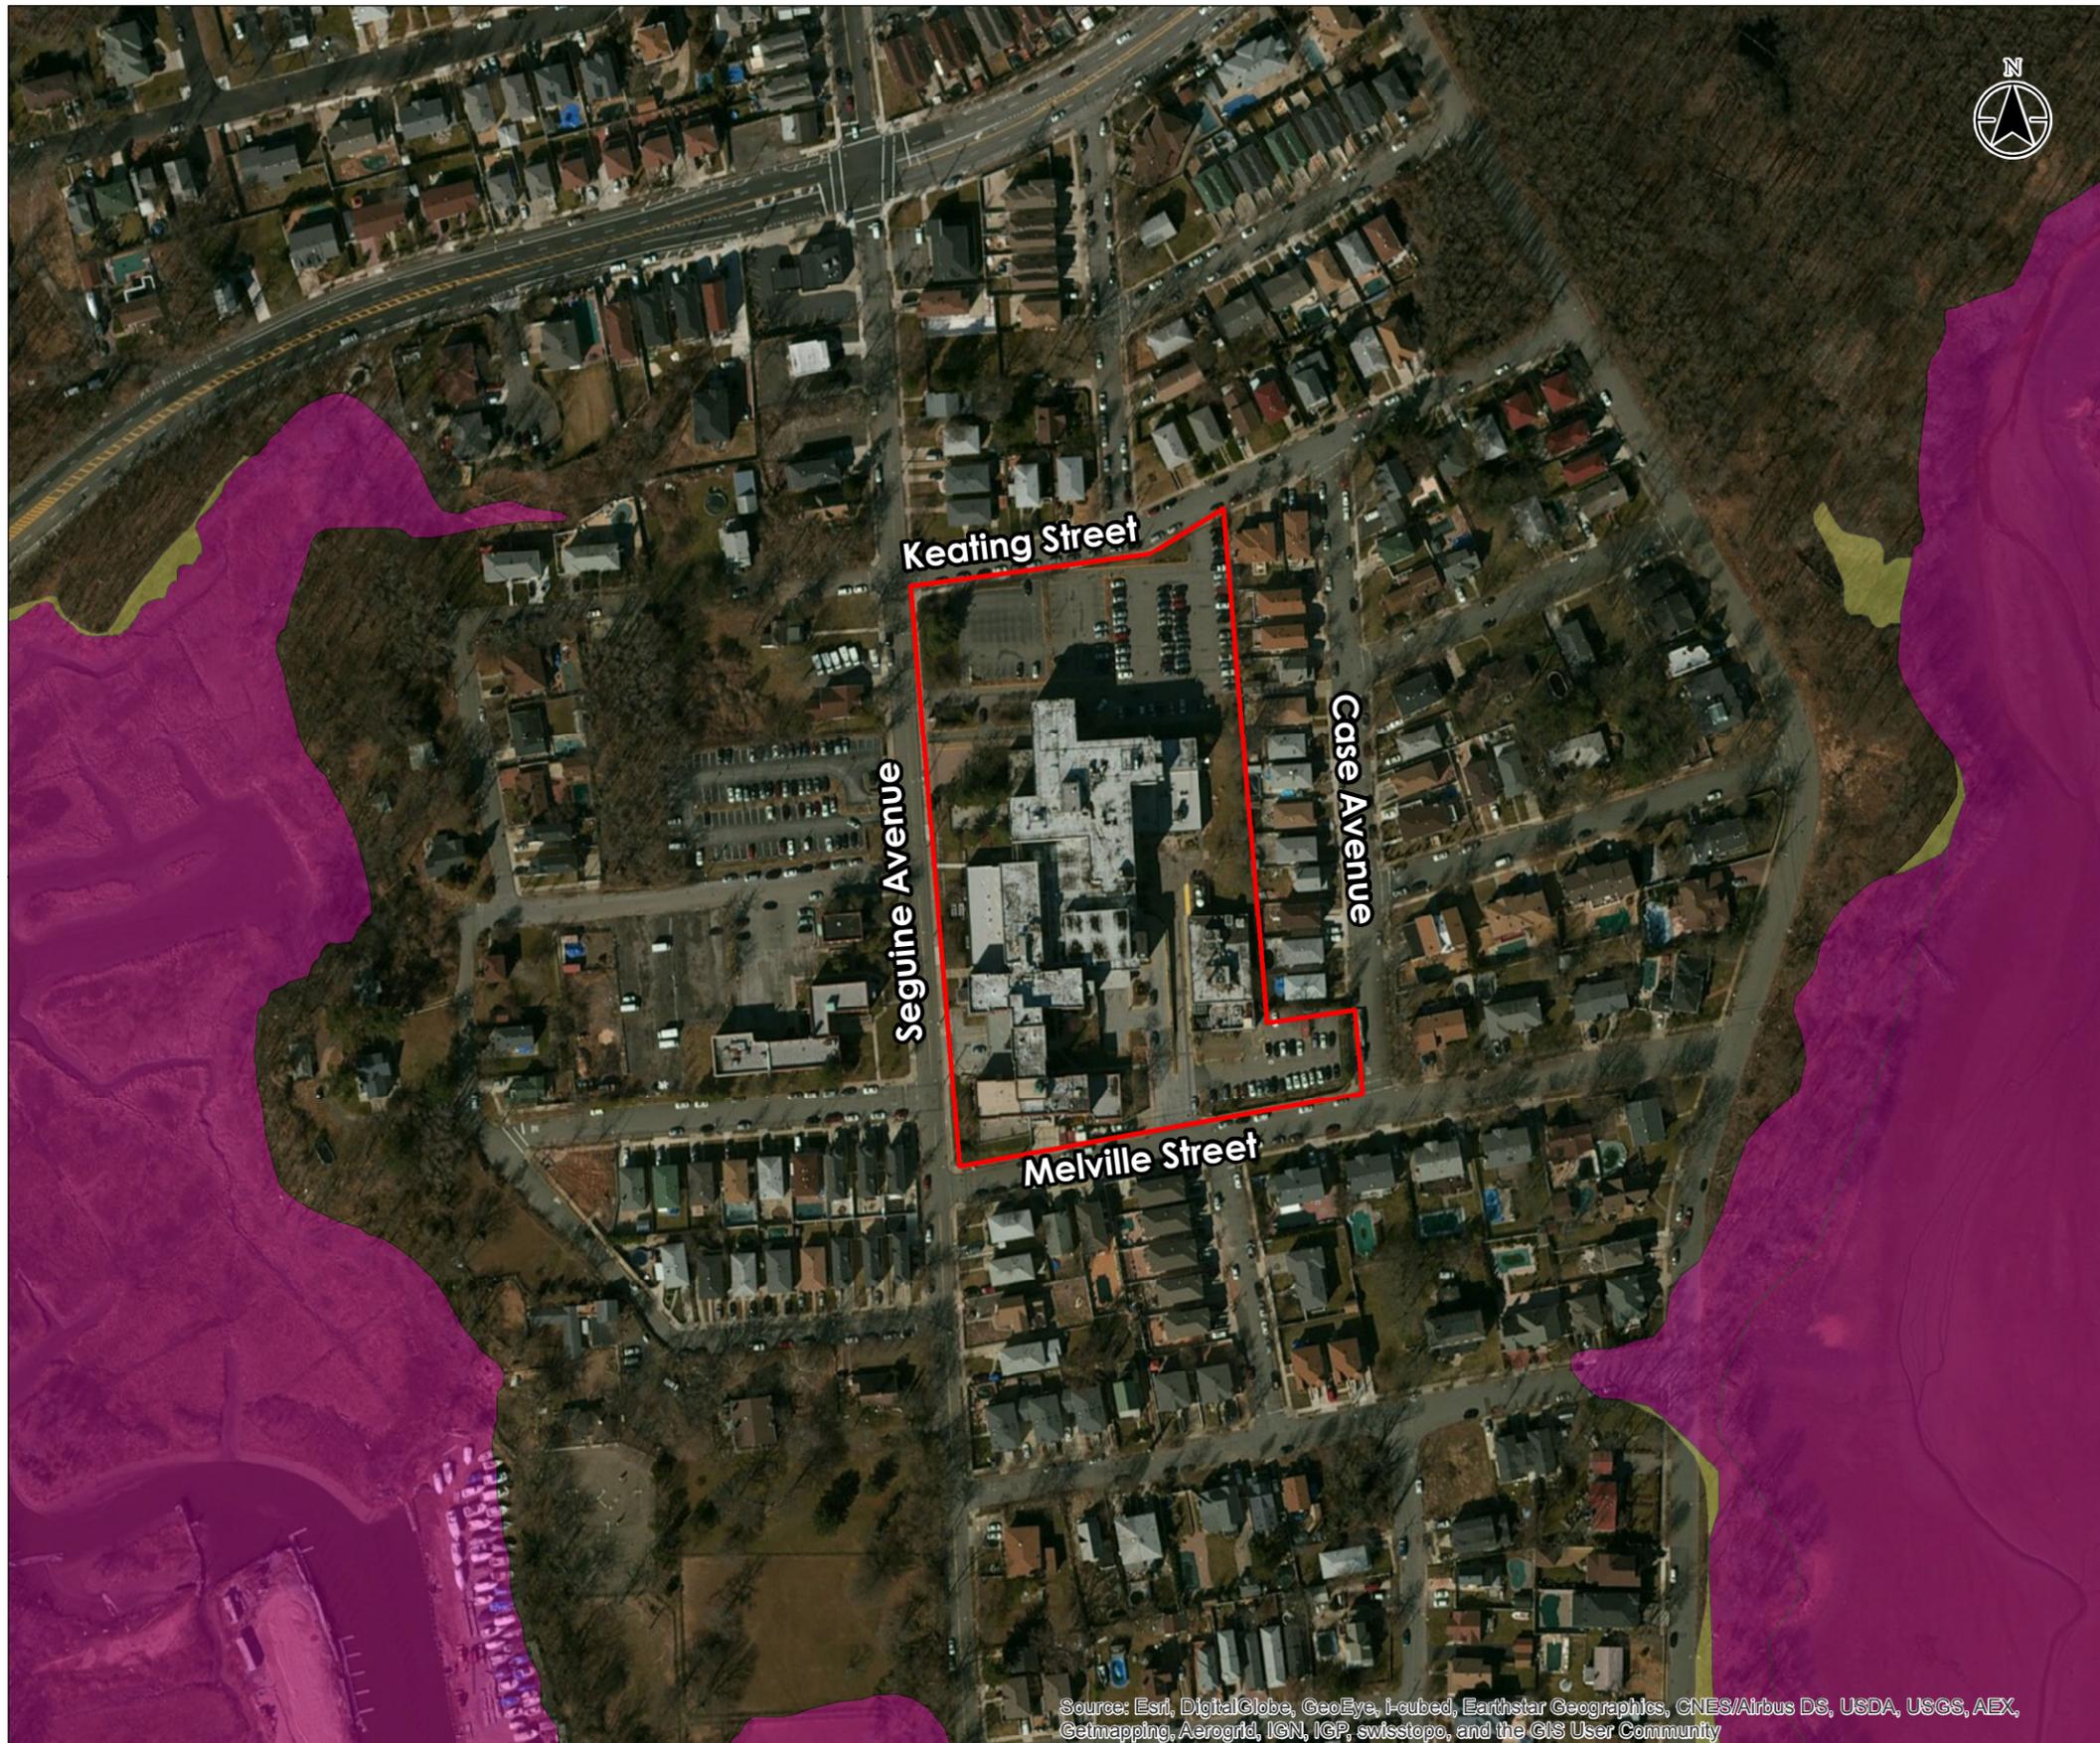
- Staten Island University Hospital - South Campus
- 100-year flood zone
- 500-year flood zone

- Notes**
1. Coordinate System: NAD 1983 StatePlane New York Long Island FIPS 3104 Feet
  2. Data published by the Federal Emergency Management Agency (FEMA) on 9/5/2007 and obtained from msc.fema.gov
  3. FIRM panel = 3604970314F, dated 9/5/2007

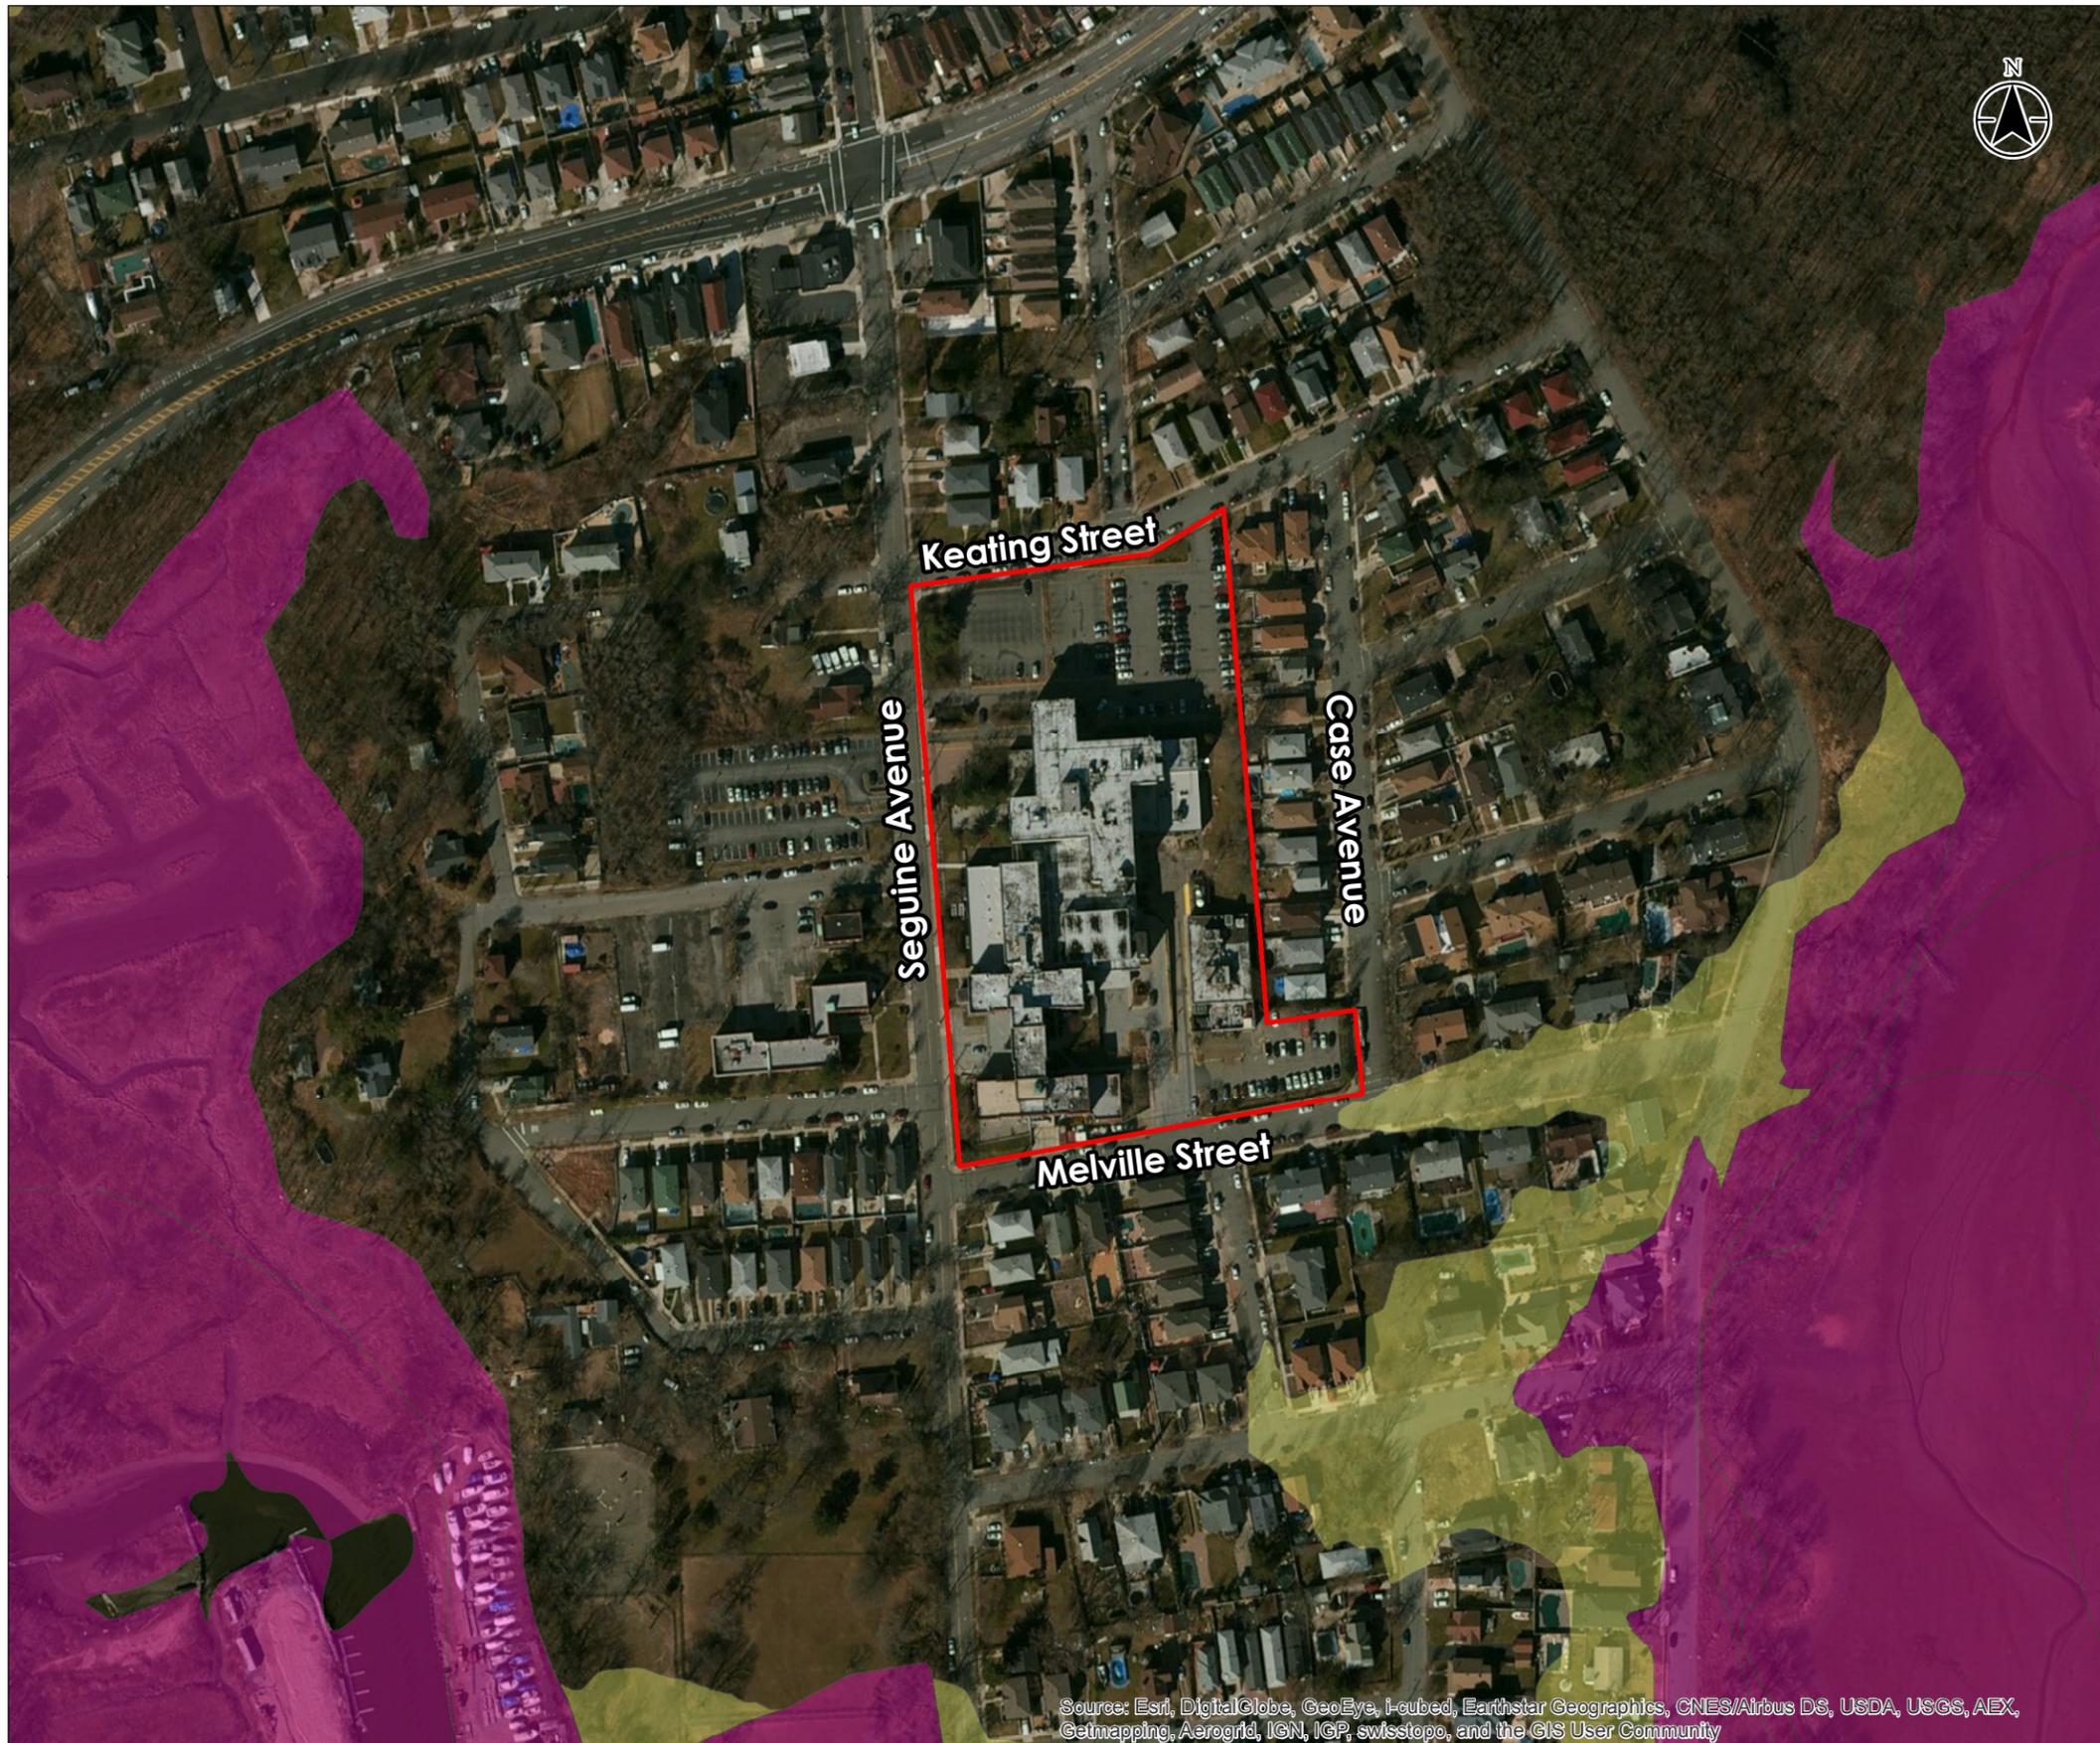
- Staten Island University Hospital - South Campus
- 100-year flood zone
- 500-year flood zone

- Notes**
1. Coordinate System: NAD 1983 StatePlane New York Long Island FIPS 3104 Feet
  2. Data published by the Federal Emergency Management Agency (FEMA) on 12/5/2013 and obtained from msc.fema.gov
  3. FIRM panel = 3604970329G, dated 12/5/2013

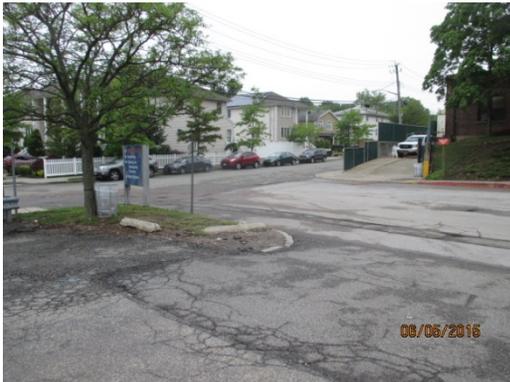
**Photo #1** View of ambulance driveway entrance looking southwest towards Melville Street

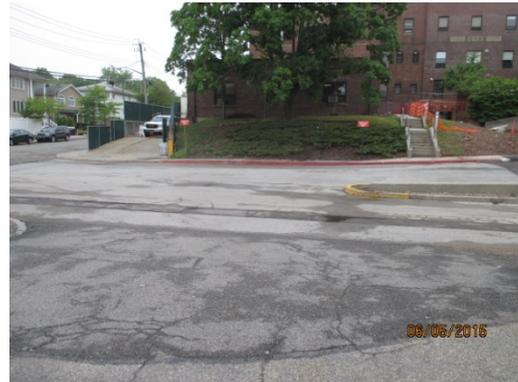
**Photo #2** View of ambulance driveway entrance looking west towards hospital

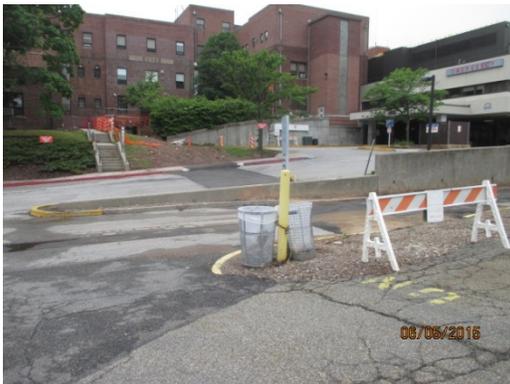
**Photo #3** View of ambulance driveway and Central Utility Plant access road looking northwest towards hospital

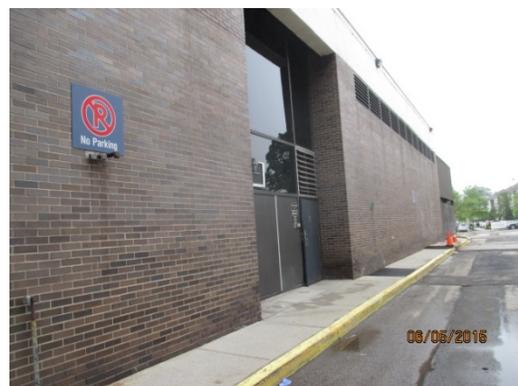
**Photo #6** View of west side of Central Utility Plant

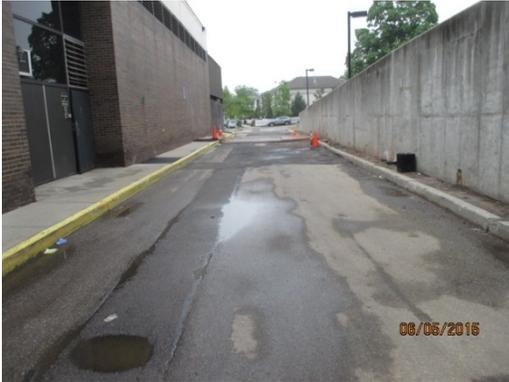
**Photo #7** View of Central Utility Plant access road looking south towards Melville St.

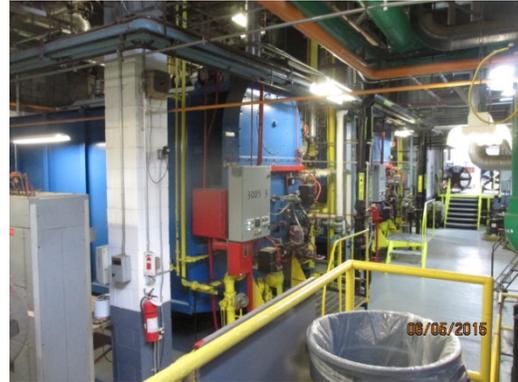
**Photo #8** View of existing boilers in Central Utility Plant

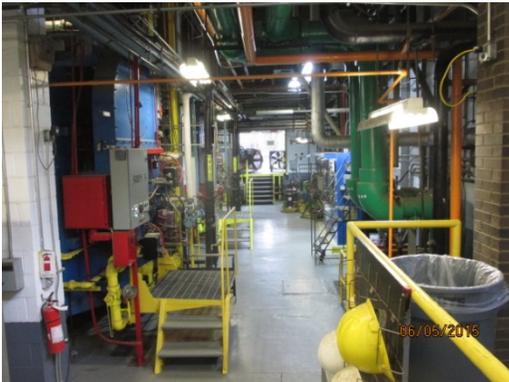
**Photo #9** Alternative view of existing boilers in Central Utility Plant

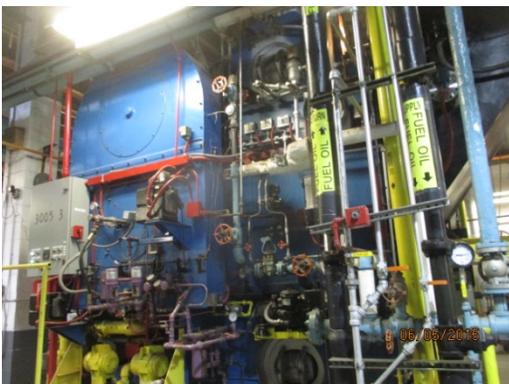
**Photo #11** View of existing boiler (2)

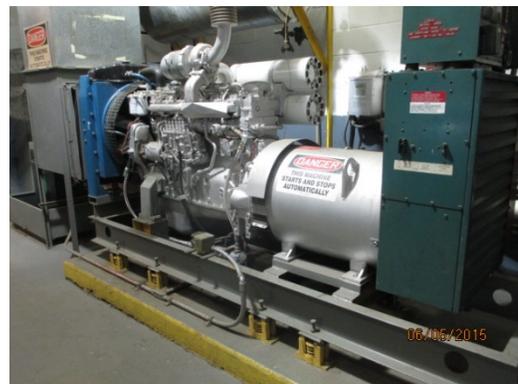
**Photo #12** View of generator to be removed

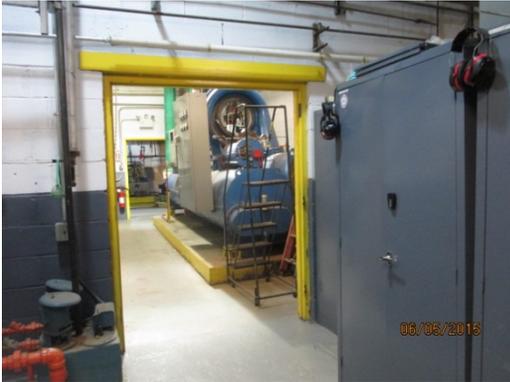
**Photo #13** View of proposed location of third boiler

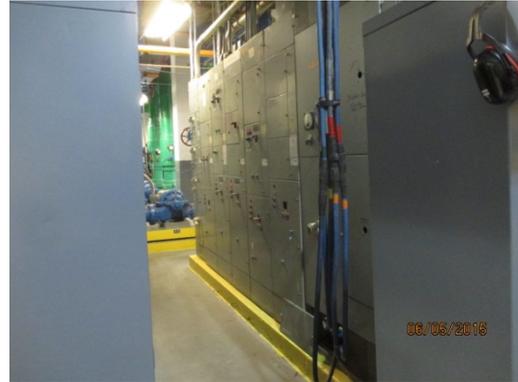
**Photo #14** Existing electrical switchgear and panels

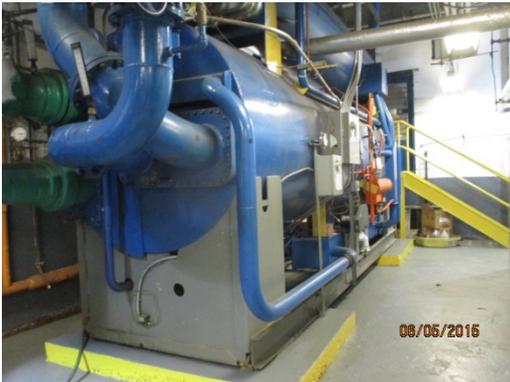
**Photo #15** View of chiller to be refurbished

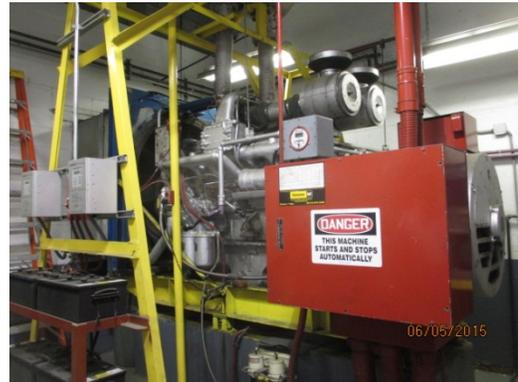
**Photo #16** View of generator to be replaced

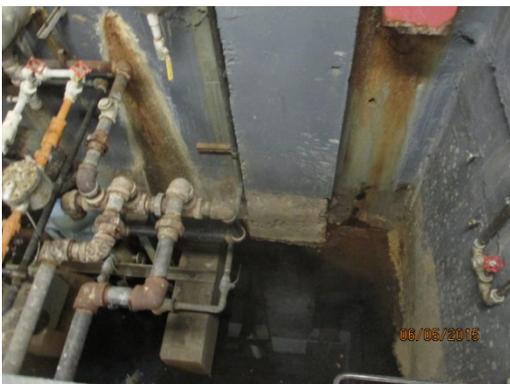
**Photo #17** View of existing sump/proposed pump intake location
