# 6/18/25 Broad Channel Civic Association

## HWQ1182SD – East 6<sup>th</sup> Rd Capital Project Scope Development Study

## HWQ1182SD: East 6th Rd CPSD Study

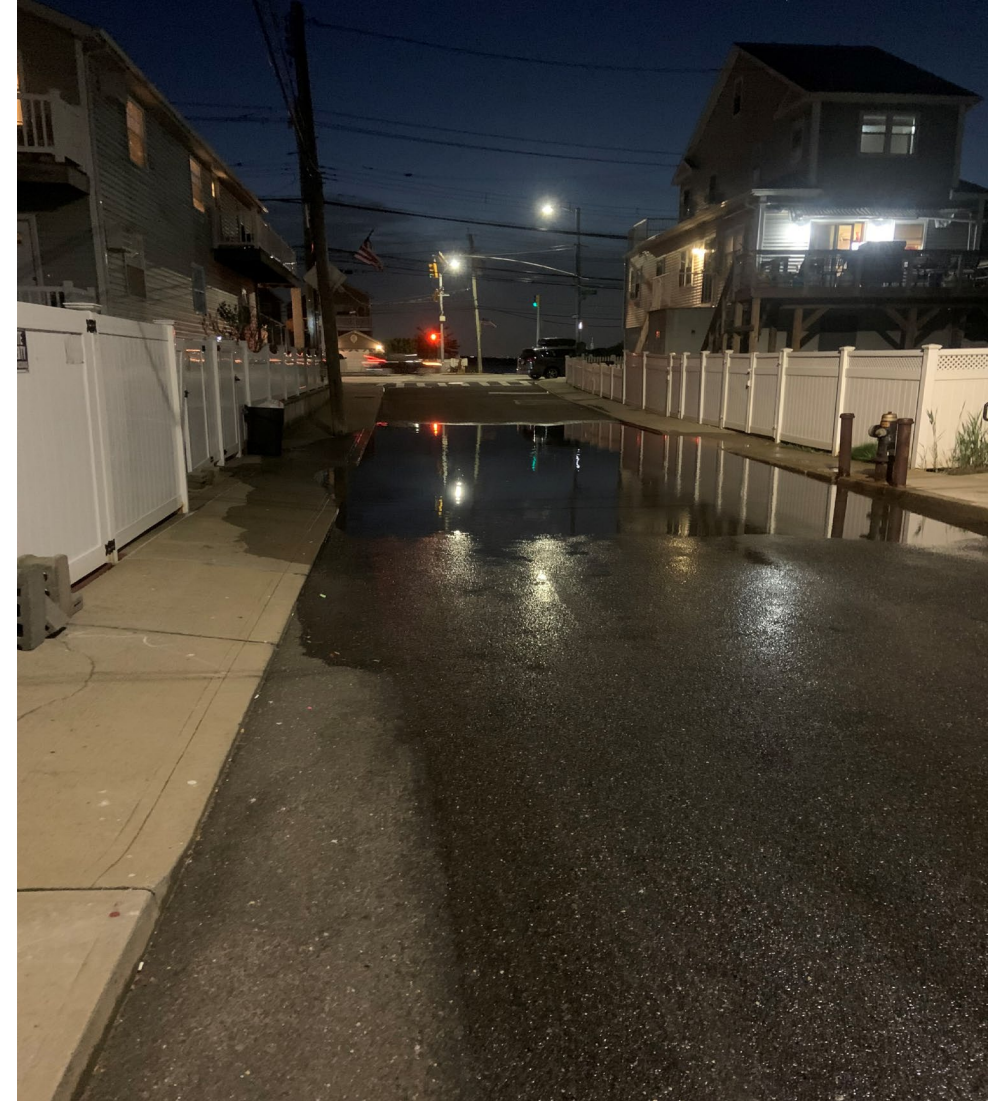
## 1) Tidal surcharge from Jamaica Bay:

- Minimum overflows at tidal elevations above El. 2.73
  - Gauge data suggests 230 occurrences on average a year
- Field observation of flooding at approximately elevation El. 3.5
  - Gauge data suggests 92 occurrences on average a year

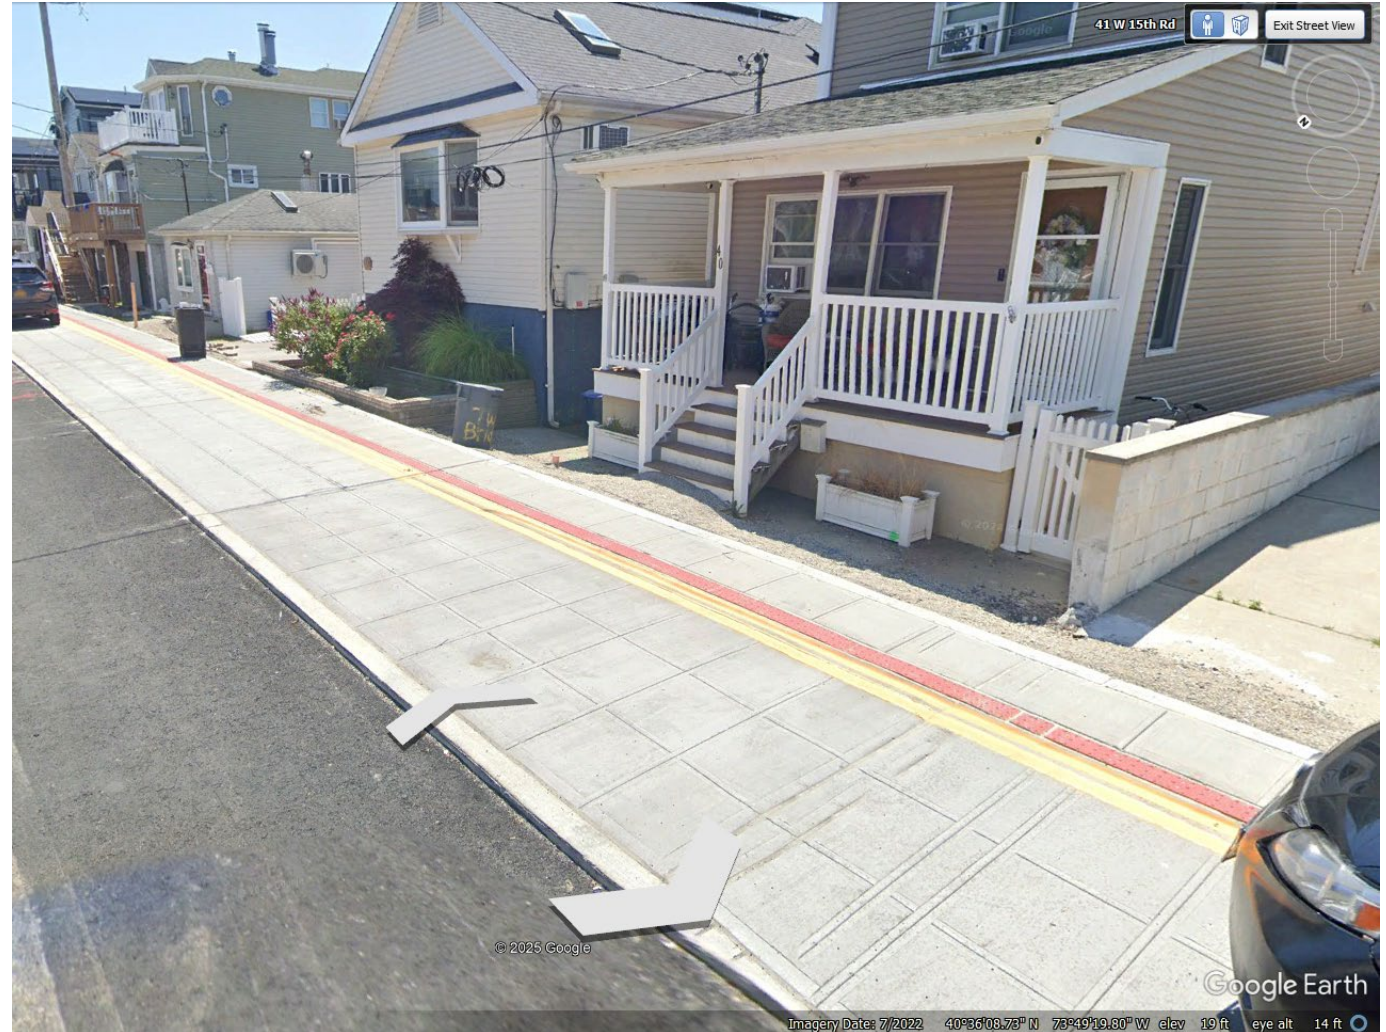
Elsewhere in Broad Channel, streets were raised to El. 5.4 (4.9 for W 14<sup>th</sup> Rd) to mitigate flooding

- W 14<sup>th</sup> Street was raised 1.4' from 3.5
- W 15<sup>th</sup> Street was raised 1.6' from 3.8
- W 16<sup>th</sup> Street was raised 1.2' from 4.2
- W 17<sup>th</sup> Street was raised 1.5' from 3.9

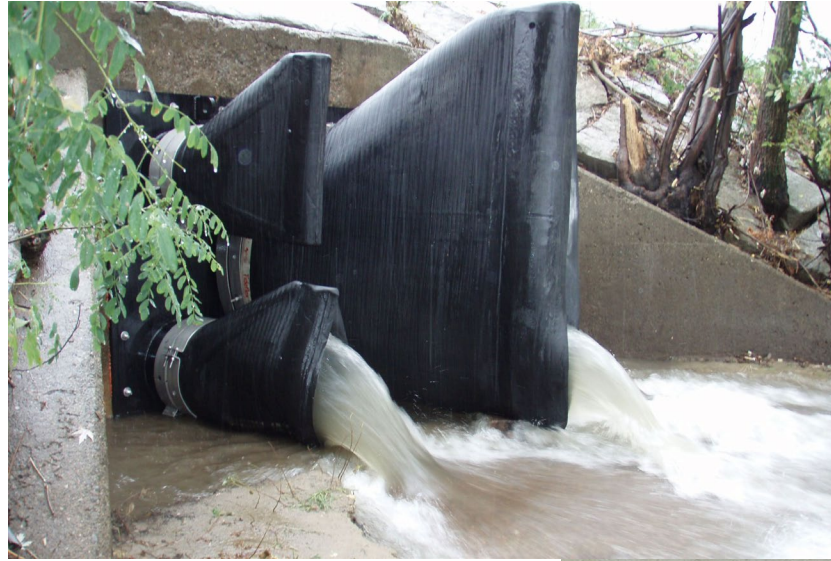
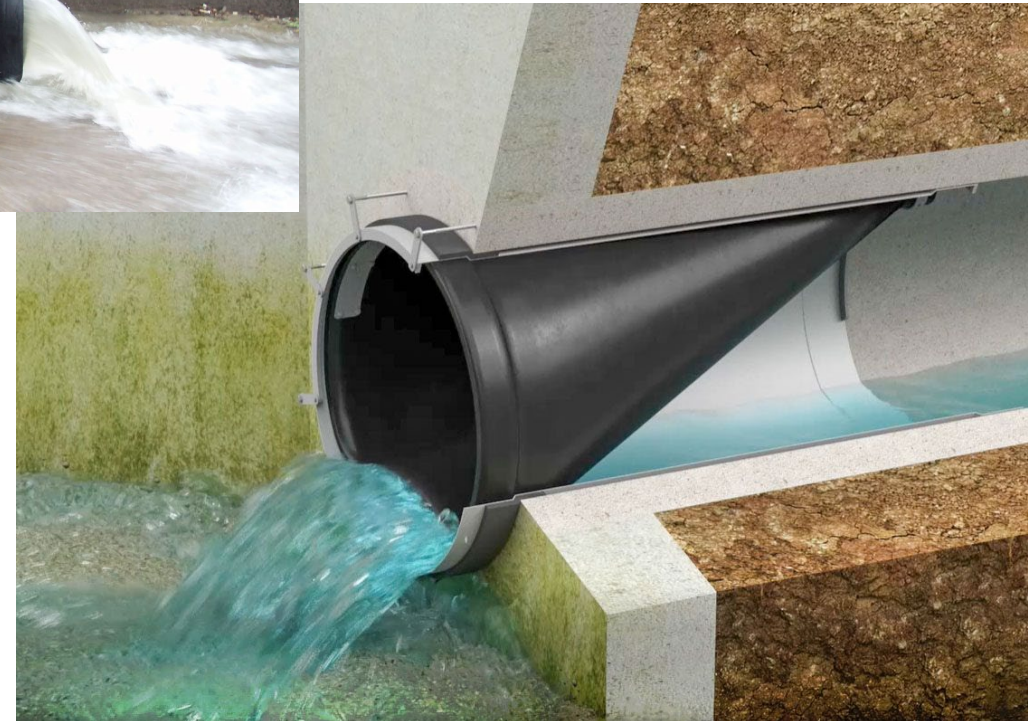
# Alternatives – Tide Valve

- Prevent water from outside the drainage system from backing up into it
- Can be installed on the outfall or further up in the system inside a manhole
- Decreases efficiency of existing drainage system during rainfall events
- Can be designed and implemented in a shorter timeframe than other alternatives

| | <b>Tidal<br/>Surcharging</b> | <b>Rainfall<br/>Surcharging</b> | <b>Wetland<br/>Overland Flow</b> | <b>Notes</b> |
|---|---|---|---|---|
| <b>Tide Valve</b> | Improve | Worsen | No effect | Can be designed and constructed quickly |

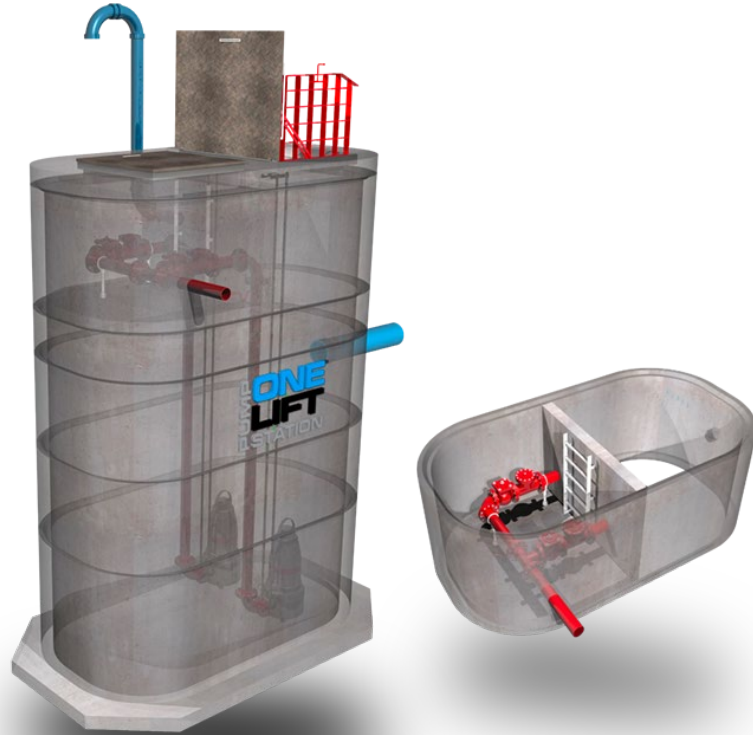
# Alternatives – Pump Station

- Remove water from a drainage system through mechanical means.
- Requires standing/pooling water to trigger the pump.
- Would require additional measure to prevent tide from backing up into the pump station, otherwise would run continuously.
- Would not mitigate overland flooding from the wetlands. Only would drain the area faster once tide recedes.
- Small scale ones could be installed within manhole drainage structures.
- Requires long term maintenance.

| | <b>Tidal<br/>Surcharging</b> | <b>Rainfall<br/>Surcharging</b> | <b>Wetland<br/>Overland Flow</b> | <b>Notes</b> |
|---|---|---|---|---|
| <b>Pump Station</b> | No effect | Improved | No Effect | Can be installed in manhole structures resulting in smaller/limited construction impacts |

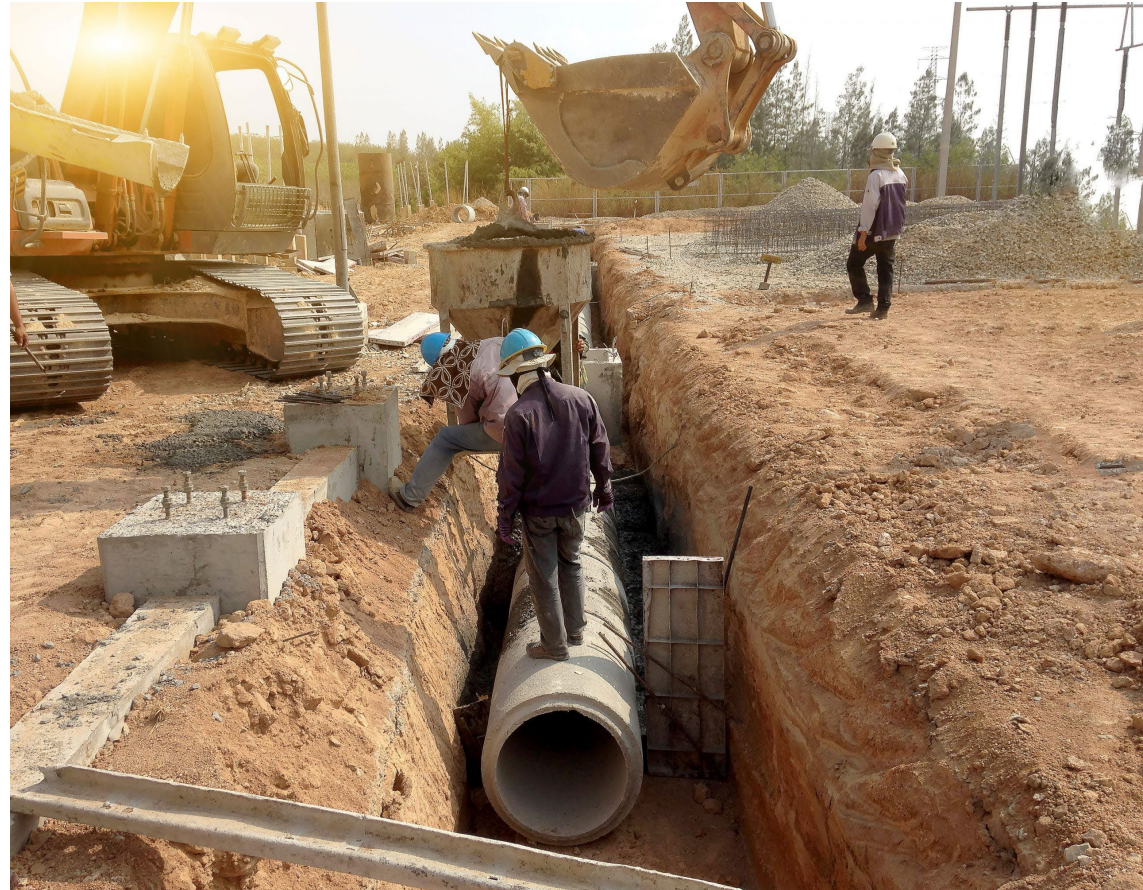
# Alternatives – Pipe System Upgrade

- Reconstruct the existing drainage system to meet NYDEP Design requirements
- Would mitigate flooding from rainfall events
- Would require additional improvements such as tide valves to address tidal surcharge
- Limited future resiliency due to overland flow from wetland.
- Would result in long term construction impacts through the neighborhood.

| | <b>Tidal<br/>Surcharging</b> | <b>Rainfall<br/>Surcharging</b> | <b>Wetland<br/>Overland Flow</b> | <b>Notes</b> |
|---|---|---|---|---|
| <b>Pipe System Upgrade</b> | No effect | Improved | No Effect | Longer design and construction durations with limited future resiliency due to overland flow from wetland |

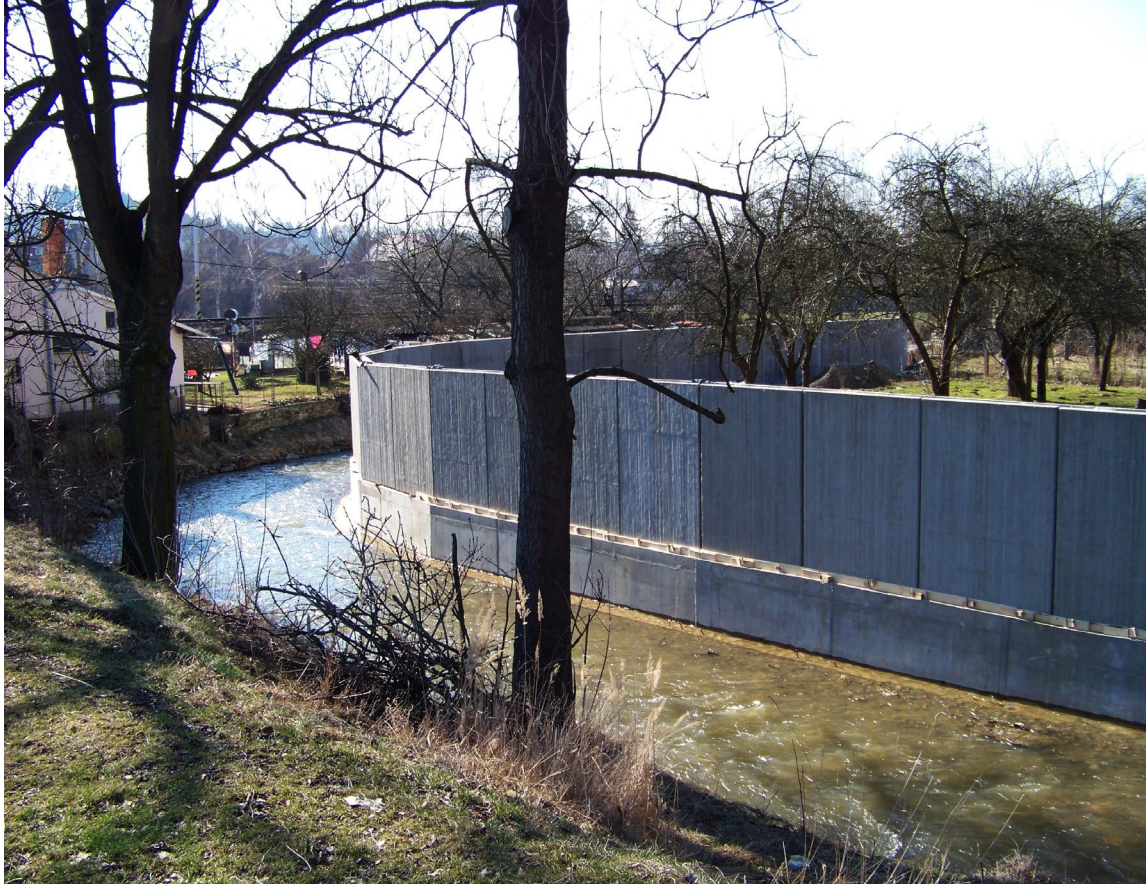
# Alternatives – Flood Wall

- Construct flood wall between E 6<sup>th</sup> Rd. properties and the National Parks Service wetland.
- Would mitigate flooding from overland flow.
- Would require additional improvements such as tide valves to address tidal surcharge.
- Would not mitigate rainfall flooding.
- Significant property acquisitions and permitting expected.
- Would require construction access through private properties or significant wetland impacts.

| | <b>Tidal<br/>Surcharging</b> | <b>Rainfall<br/>Surcharging</b> | <b>Wetland<br/>Overland Flow</b> | <b>Notes</b> |
|---|---|---|---|---|
| <b>Flood Wall</b> | No effect | No Effect | Improved | Regulatory permitting and property acquisitions would be required. |

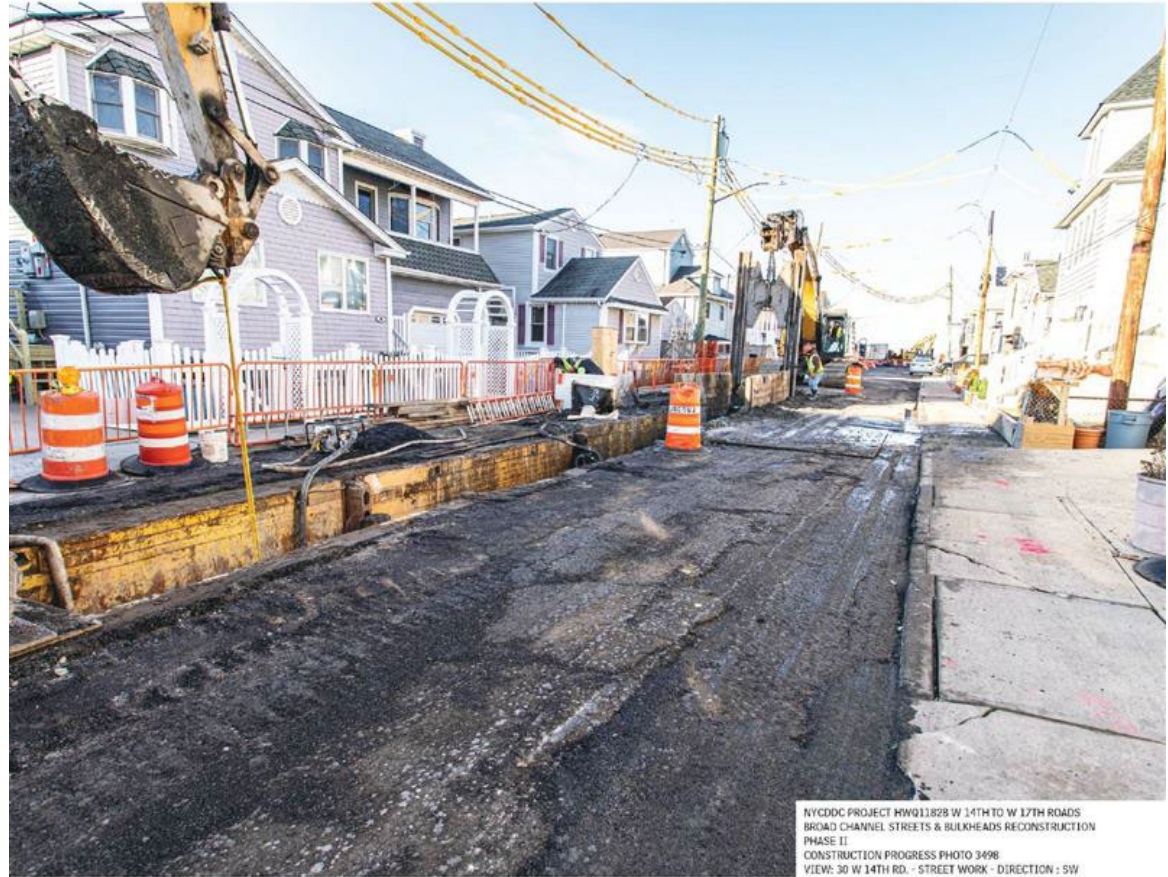
# Alternatives – Street Raising

- Reconstruct and raise the streets similar to West Side Street raising projects
- Would mitigate flooding from overland flow to the roadway.
- Would mitigate tidal surcharge from the drainage system by raising the road.
- Could be integrated with stormwater system upgrades to address rainfall flooding
- Significant long term construction impacts through the neighborhood.
- May impact private properties requiring improvements outside of the right of way.

| | <b>Tidal<br/>Surcharging</b> | <b>Rainfall<br/>Surcharging</b> | <b>Wetland<br/>Overland Flow</b> | <b>Notes</b> |
|---|---|---|---|---|
| <b>Street Raising</b> | Improved | Improved | Improved | As a standalone measure, it can exacerbate flooding onto private properties. Property modifications to accommodate new roadway elevations can mitigate flooding issue from a new roadway. |
