The QUIETeD Methodology of Crumbling Infrastructure – An IT Approach

MOT Capstone - Final Presentation

12/19/2022

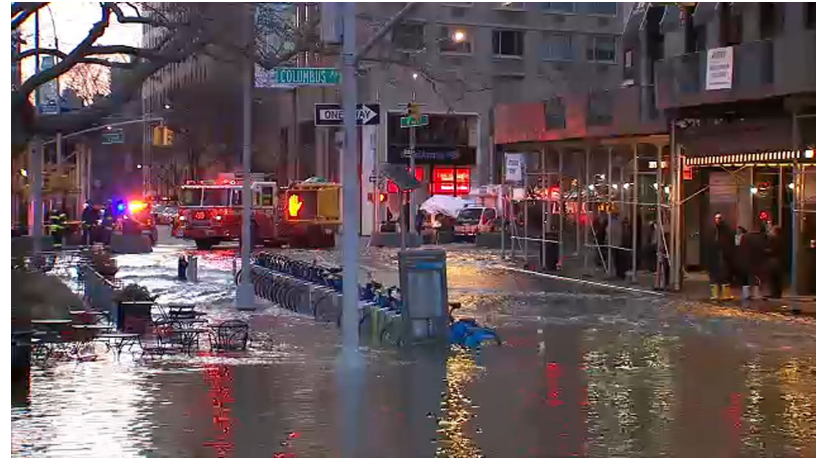
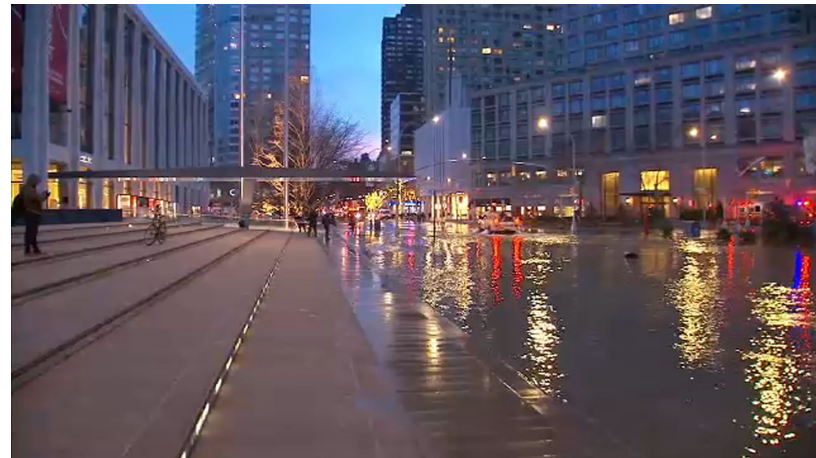
According to the news: Broadway southbound (66th - 58th) closed for at least a few days, the northbound side remained open.

- The dramatic water main break directly affected the whole related area for at least 2 days, and the influence would last 4 days for Broadway
- Neighbouring streets take responsibility of exceed capacity (e.g. Central Park Ave had 94.9% increase in traffic vol) but usually could quickly adjust and led the traffic back to “normal”
- People are more likely to select the nearest substituted road as the second choice if the repair would take at least 2 days
- Considering the classification of impacted area, the major affected groups are the neighboring residents and local retailers

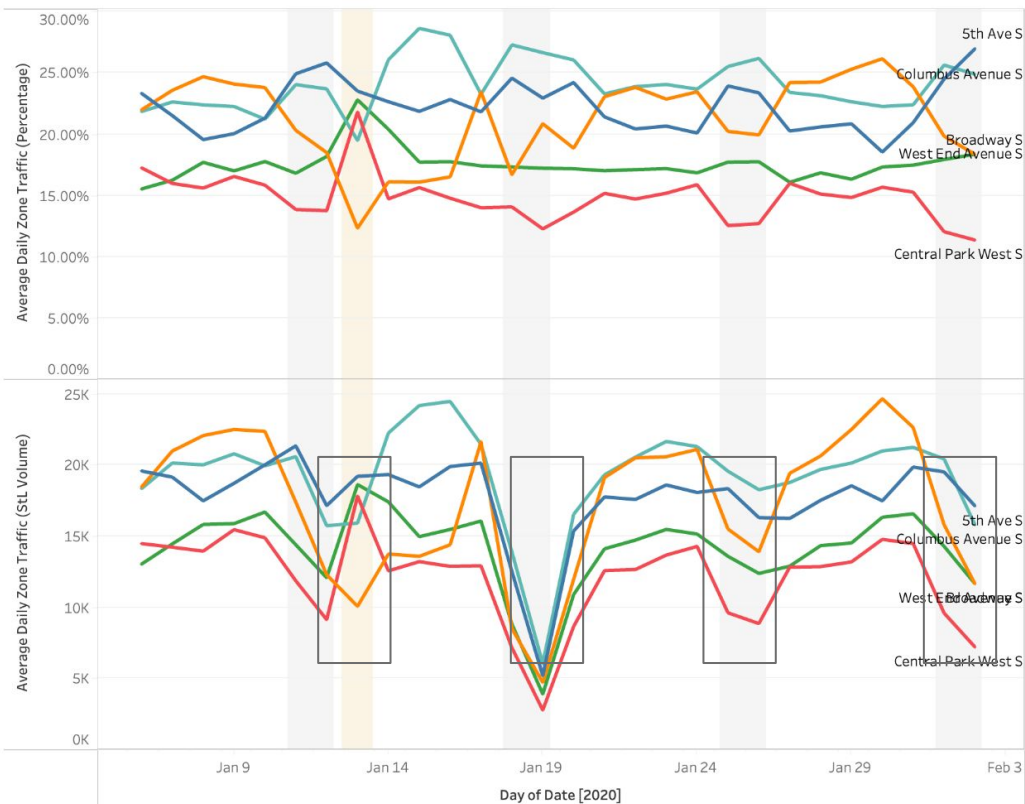
Whole Period

33.5% and 17.7% drop on Jan 13 for Broadway and Columbus Ave, but the volume did not change much (-18% and 1.1%)

- Volume for all selected routes:

seasonality

Monday – Highest, Weekends – Lowest

- The water main break led the traffic volume on Broadway drop instead ¹³

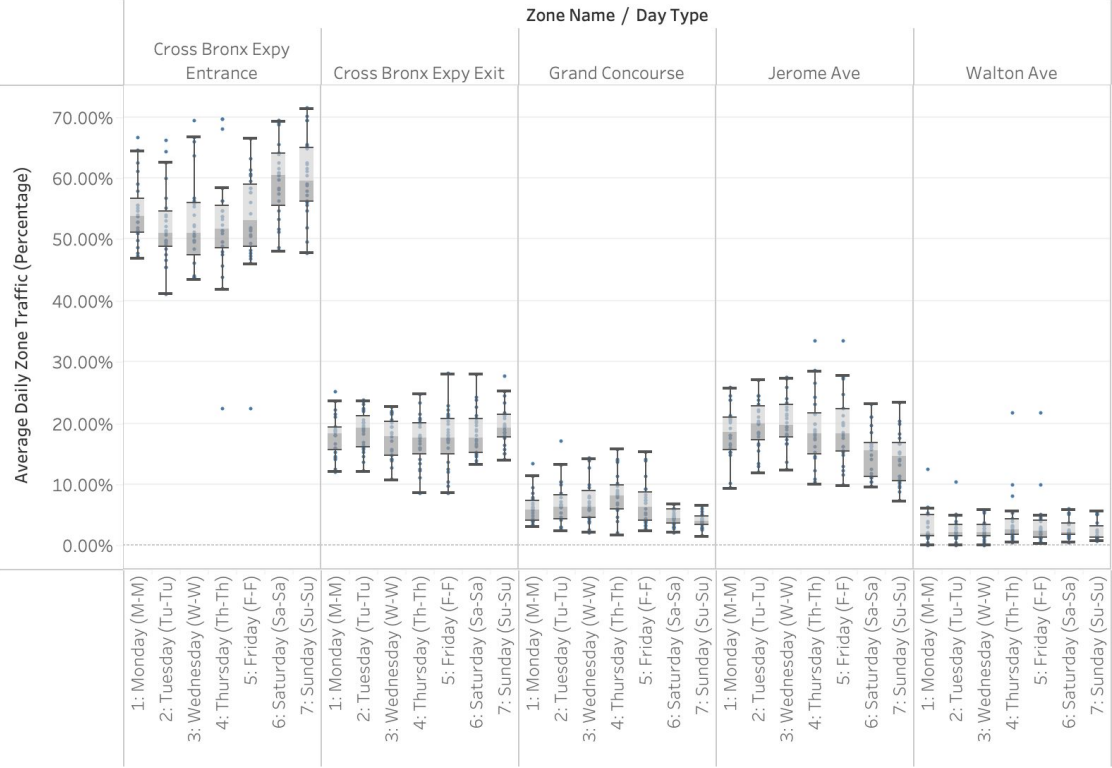
Boxplot

Longer effect on Cross Bronx Expressway Entrance, Cross Bronx Expressway Exit and Jerome Ave.

Neighbouring streets could quickly adjust, the impact was less likely to last for several days.
