Use of 3D Ground Modeling in Managing Ground Risks

From planning to asset management and operations

June 5, 2025

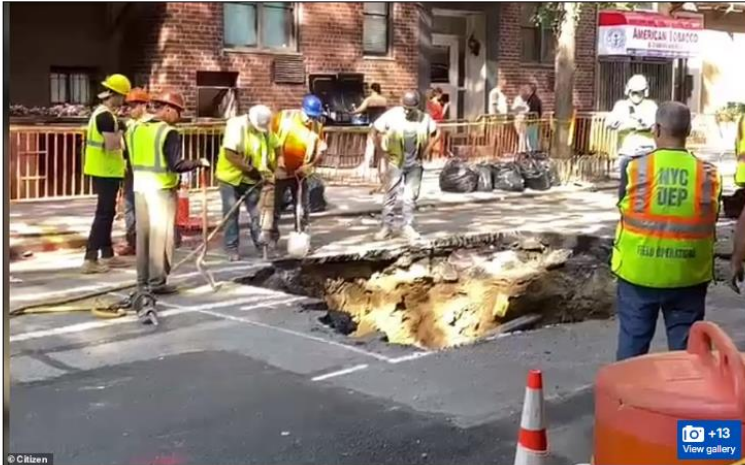
The Department of Environmental Protection responds to a massive 20-foot sinkhole that opened up in the middle of an Upper East Side street on Thursday at East 89th Street and York Ave

Ground Collapse / Sinkhole

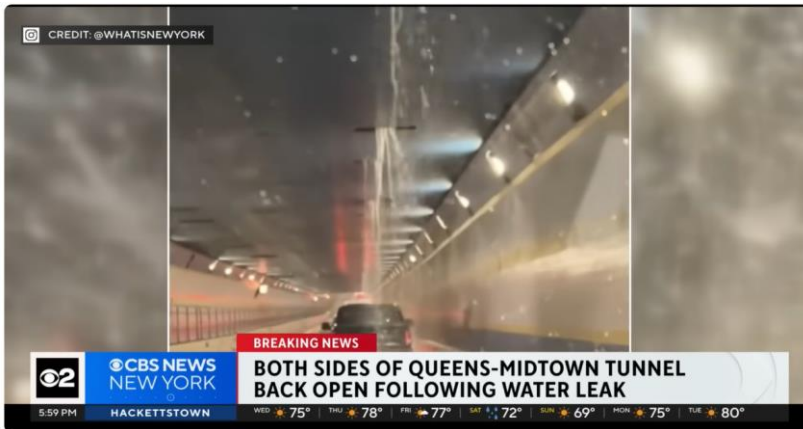
Damage to Utility & Structure

Barge 'drifted 50 feet' down East River before drilling hole in Queens-Midtown Tunnel

The northbound tunnel is reopened for two-way traffic.

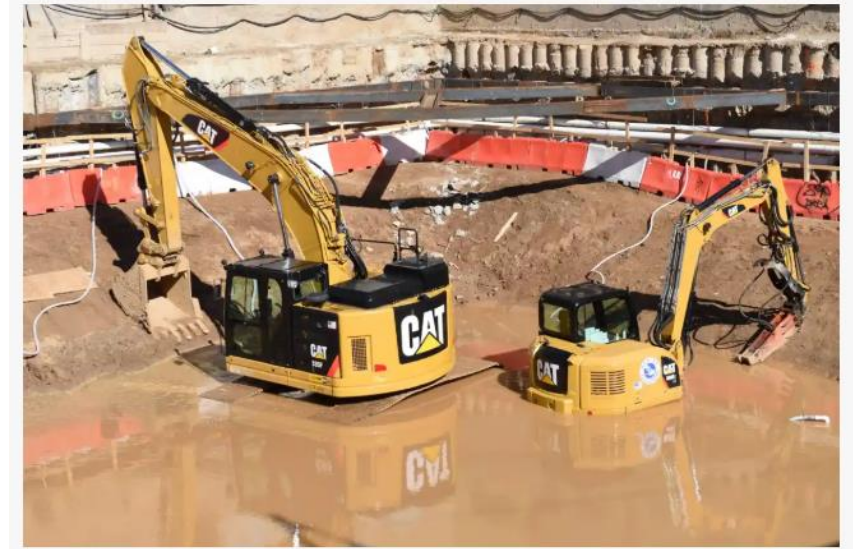
A 24 inch water main broke early this morning on North 6th Street and Driggs Avenue, flooding basements and a construction site, while causing the street near the L train construction to crack and undermine. (Photo by Todd Maisel)

Flooding

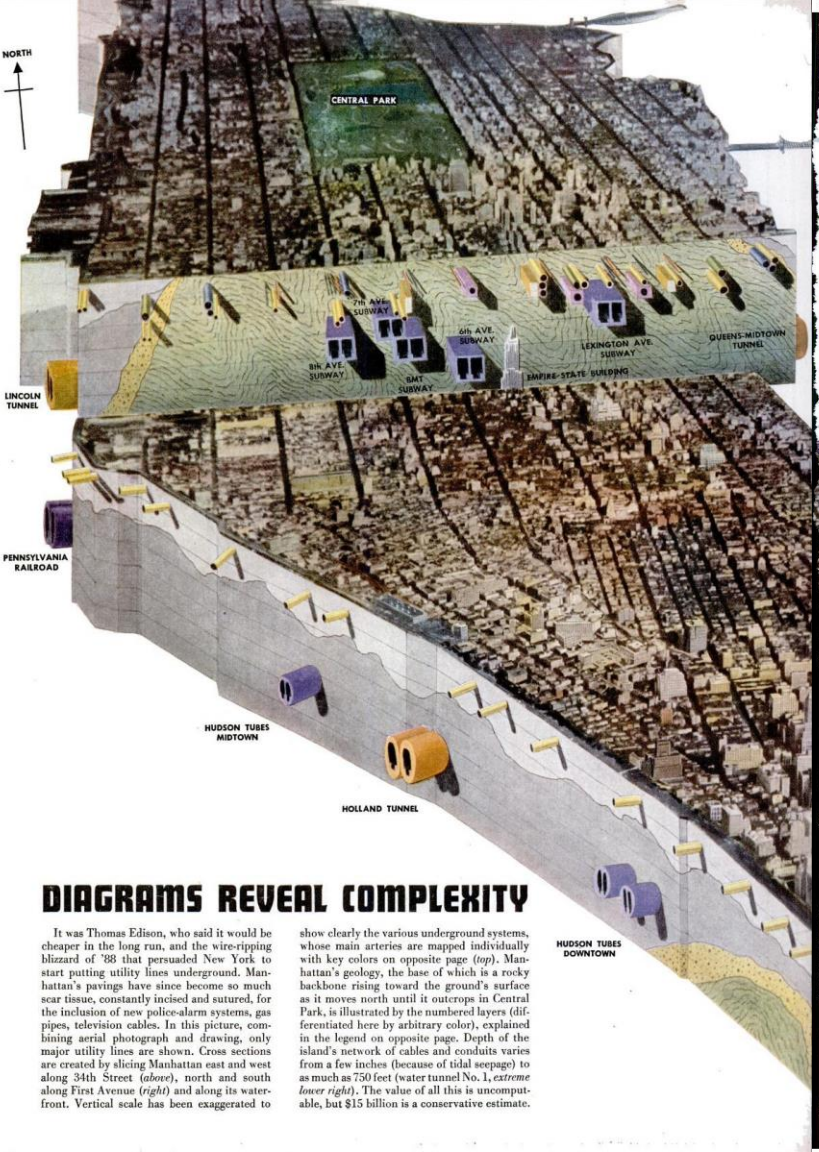
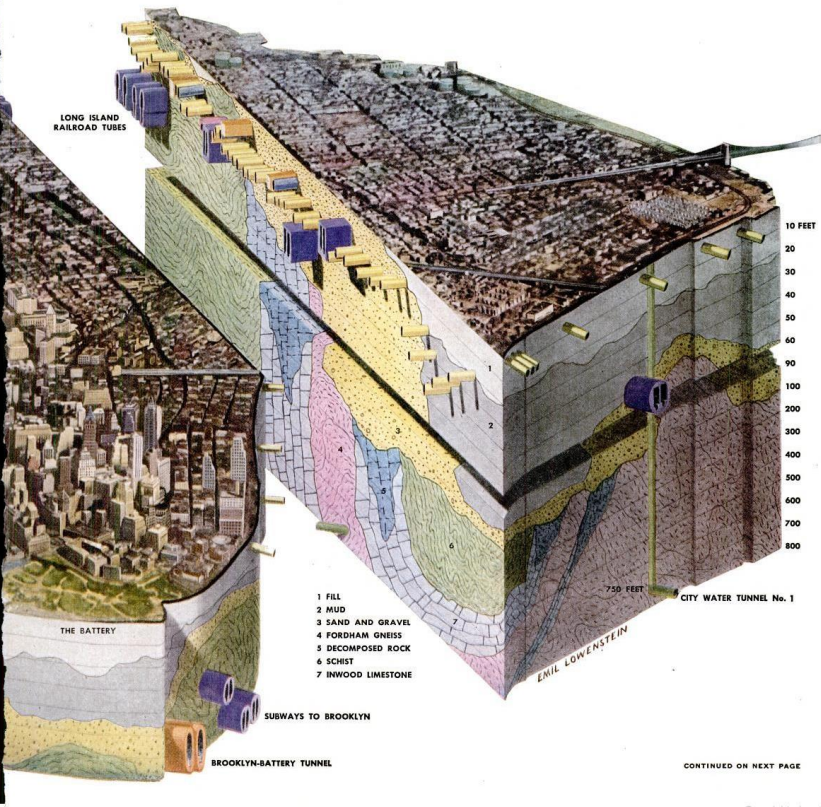
DIAGRAMS REVEAL COMPLEXITY

It was Thomas Edison, who said it would be cheaper in the long run, and the wire-ripping blizzard of '88 that persuaded New York to start putting utility lines underground. Manhattan's pavings have since become so much scar tissue, constantly incised and sutured, for the inclusion of new police-alarm systems, gas pipes, television cables. In this picture, combining aerial photograph and drawing, only major utility lines are shown. Cross sections are created by slicing Manhattan east and west along 34th Street (above), north and south along First Avenue (right) and along its waterfront. Vertical scale has been exaggerated to

show clearly the various underground systems, whose main arteries are mapped individually with key colors on opposite page (top). Manhattan's geology, the base of which is a rocky backbone rising toward the ground's surface as it moves north until it outcrops in Central Park, is illustrated by the numbered layers (differentiated here by arbitrary color), explained in the legend on opposite page. Depth of the island's network of cables and conduits varies from a few inches (because of tidal seepage) to as much as 750 feet (water tunnel No. 1, extreme lower right). The value of all this is uncomputable, but \$15 billion is a conservative estimate.

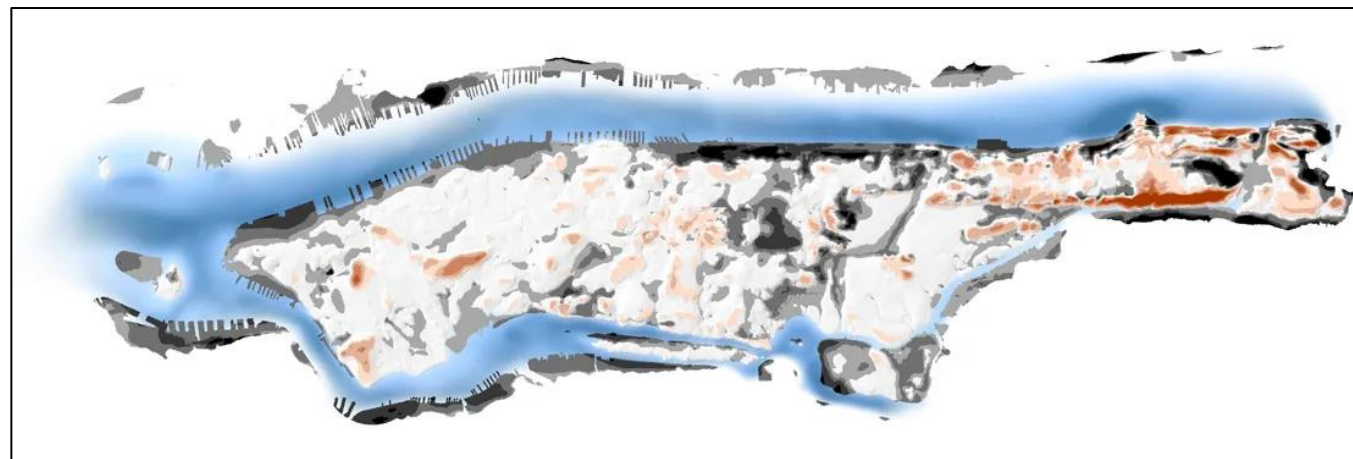
Groundwater Table Map

Coastline & Elevation Changes (1609 to Present)

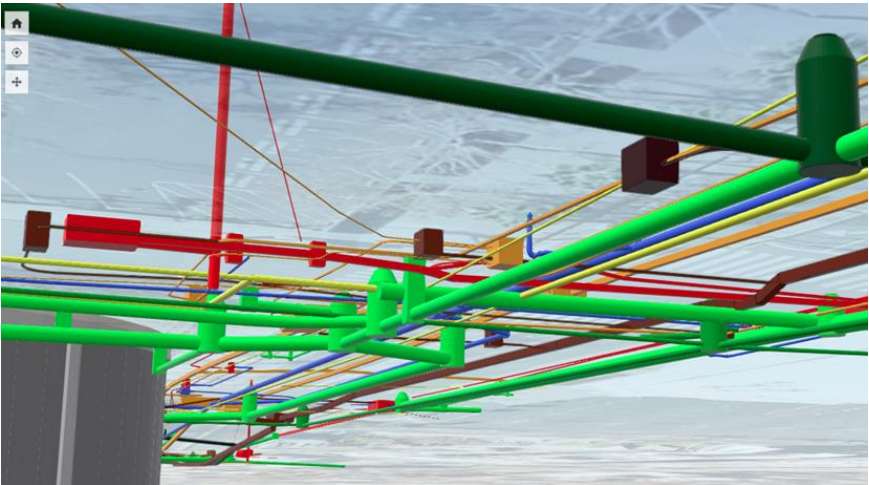
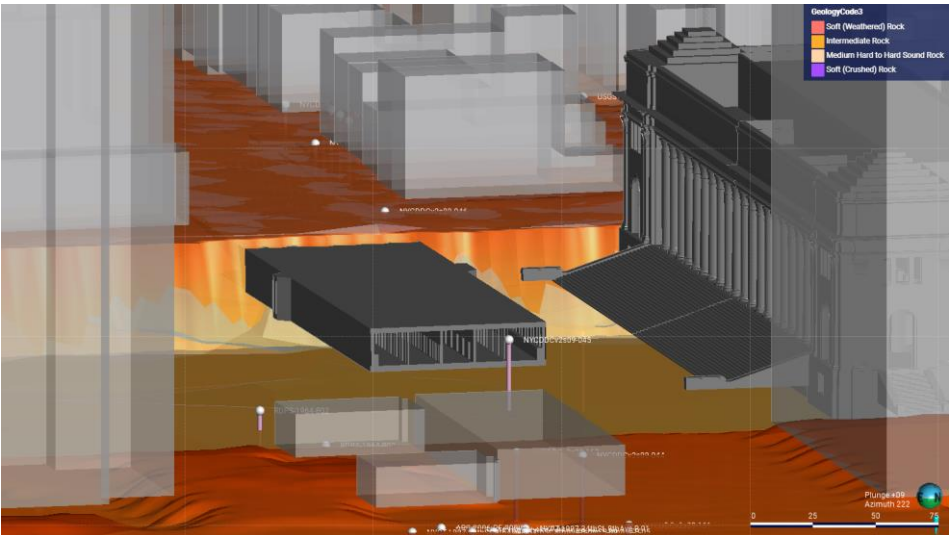
3D Ground Model including underground assets and proposed alignments

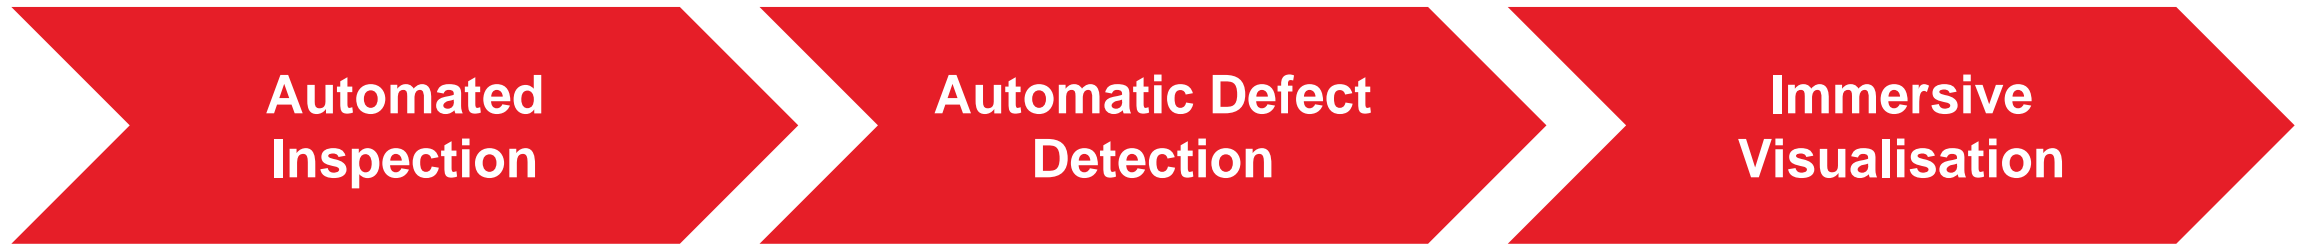
End-to-end automated inspection for asset management

Survey, Specification and Build

- UAV (Drones), UGV (e.g. robot dog)
- Mobile: maintenance vehicle integrated / bespoke loco mounted
 - Fixed: Integrated onto fixed infrastructure e.g. maintenance rails

AI and Machine Learning

- Defects detection (e.g. water ingress, spalling, cracking)
- Change detection (e.g. temporal progression and defect growth)
- Inventorying: (e.g. FLS signage, MEP equipment cataloguing)

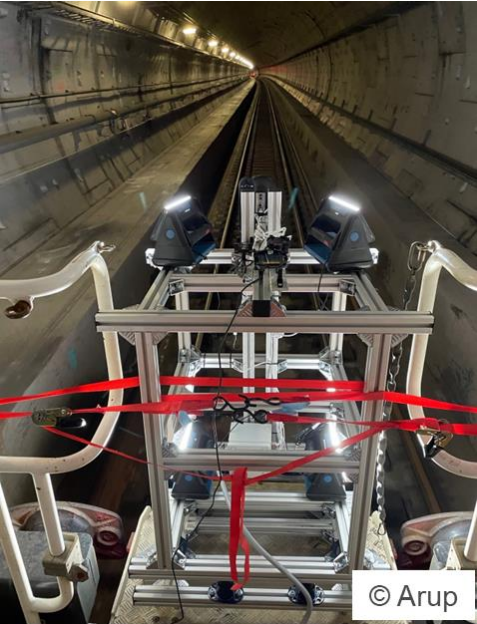
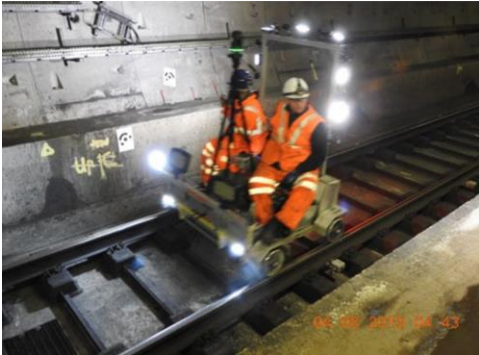
Large Diameter Tunnels

Bespoke modular data capturing system

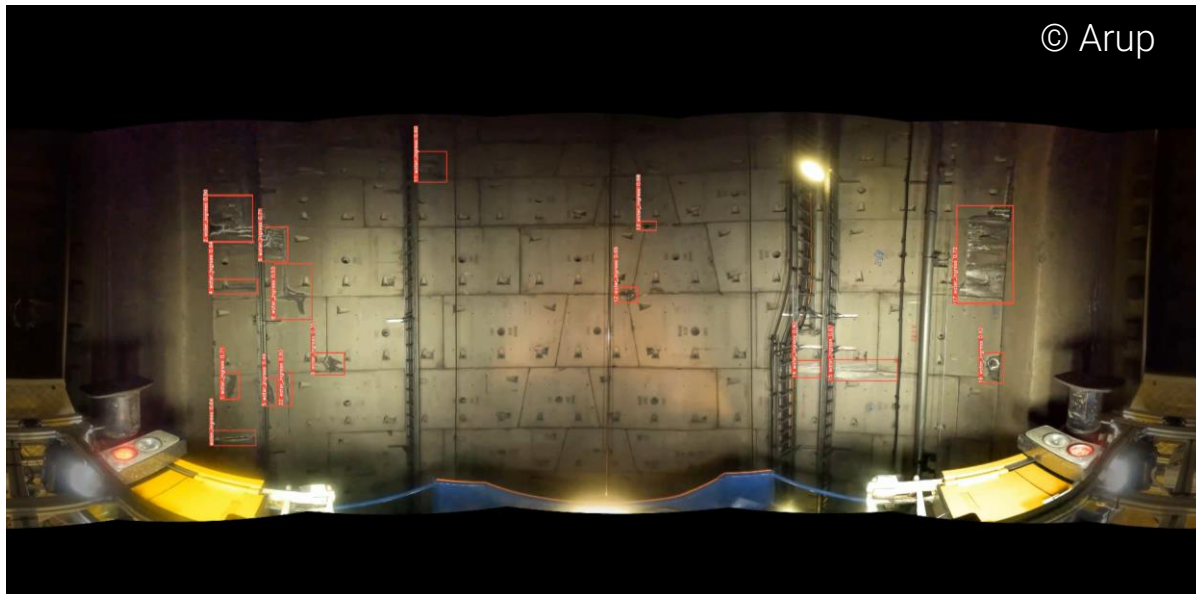
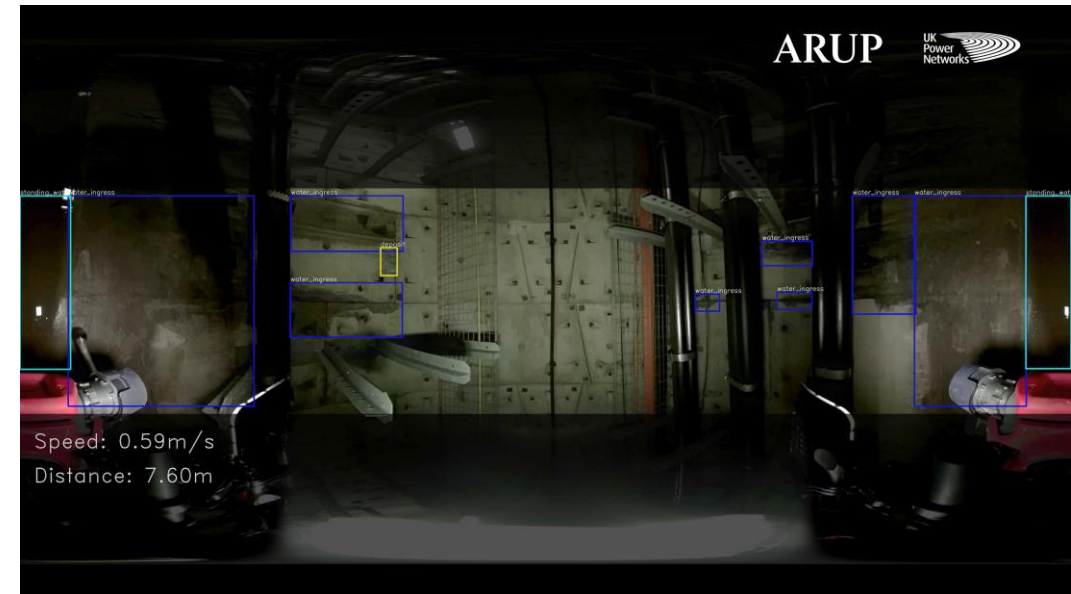
Defect Detection in Tunnels

Automatic Defect Detection

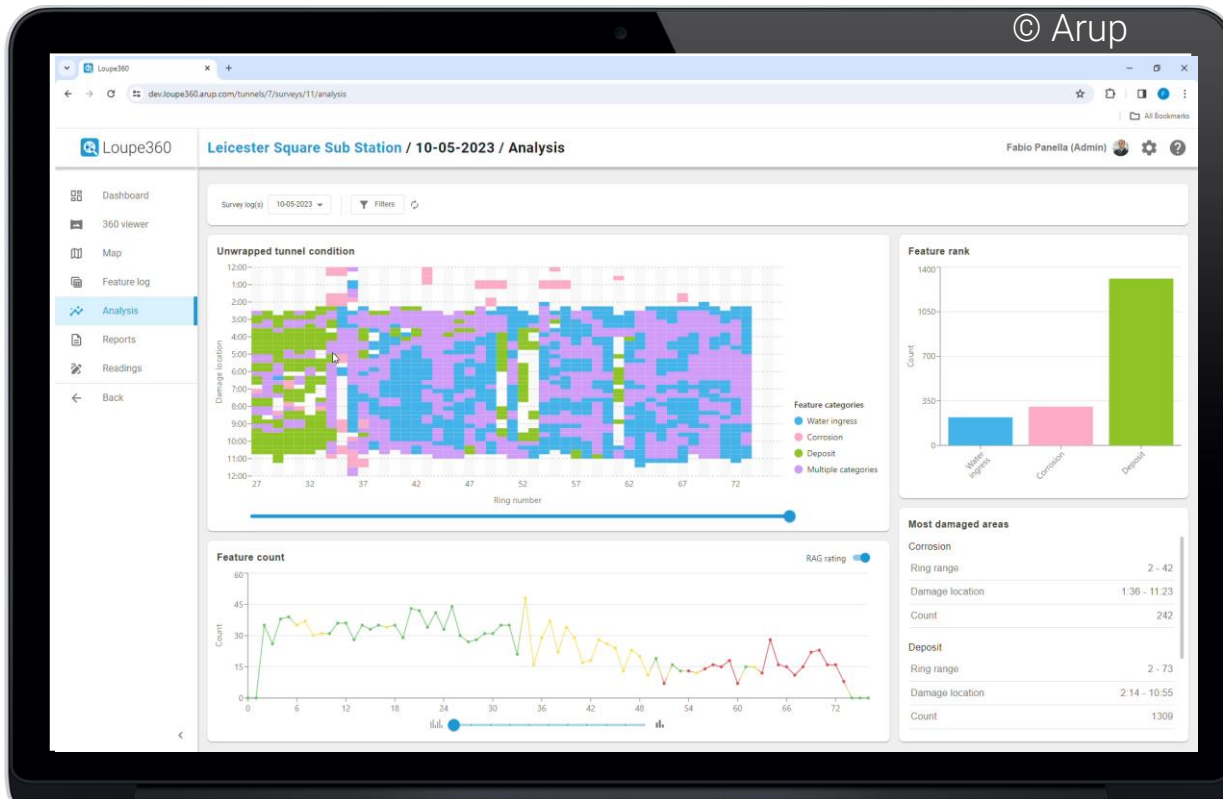
The data is visualised in a web-based dashboard. Easy to interpret visuals accurately describe the asset conditions. Automated reporting is also available to match the client's standards.

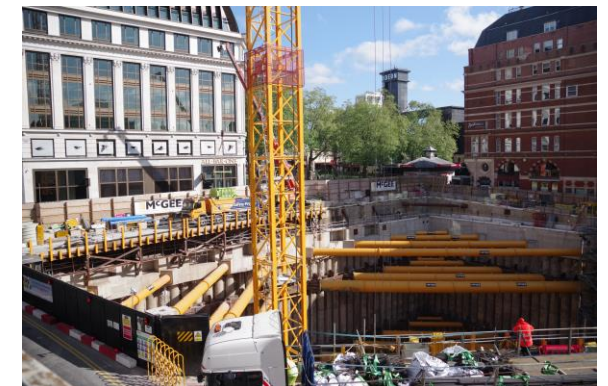
Asset protection role from nearby construction

- Comprehensive before-and-after comparisons depicting any alterations or damages incurred during construction periods.
- Ultimately, the benefits of continuous visual inspection lie in its ability to act as an indispensable guardian, preserving the longevity and functionality of tunnels amidst the dynamic challenges posed by neighbouring construction endeavours.

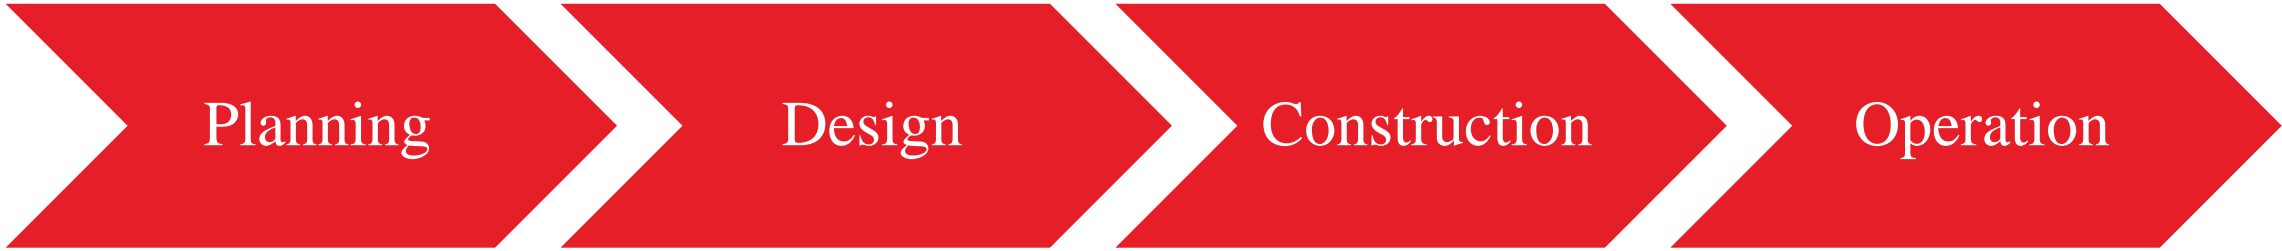
Unifying Data Approach

Existing Data Collection

- Desk Study Data
- Field Inspection Data

Ground Model & Interpretation

- Ground Investigation Data
- Existing Condition Monitoring Data
- Geotechnical Interpretation Information
- Design Information

Construction Model

- Construction Data
- Construction Ground Condition Data
- Construction Instrumentation & Monitoring Data
- As-built Information

Asset Management & Maintenance

- Asset Inventory
- Routine Operational Data
- Maintenance Inspection Data
