**FINAL SUPPLEMENTAL ENVIRONMENTAL IMPACT STATEMENT FOR THE
CROTON WATER TREATMENT PLANT
AT THE HARLEM RIVER SITE**

7.13. HAZARDOUS MATERIALS

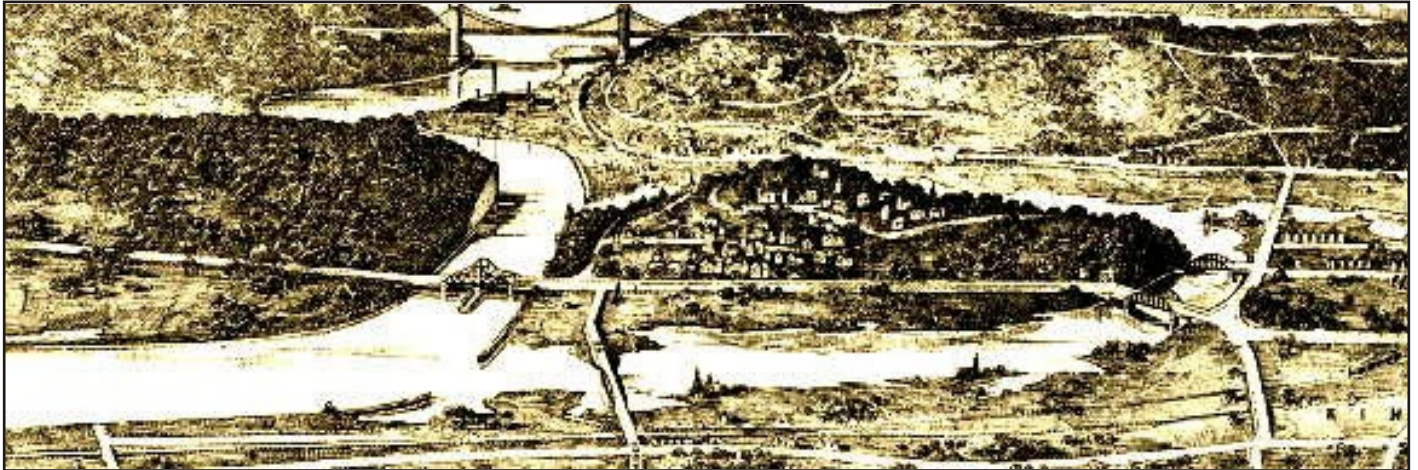
**1895 Artistic Rendering
Harlem River Site**

1890s. The artist's rendering depicting the Harlem River and the northern portion of the water treatment plant site is believed to represent the area in 1895 shortly after the U.S. Ship Canal was constructed thus connecting the Harlem and Hudson Rivers and separating the Marble Hill neighborhood from the rest of Manhattan. No development is noted on or near the water treatment plant site. The 1897 topographic map depicts the railroad tracks adjacent to the shoreline of the Harlem River and illustrates very little landmass between the tracks and the Harlem River. Both figures suggest that the land area, which is now the water treatment plant site, had not been filled in to its current shoreline and contour.

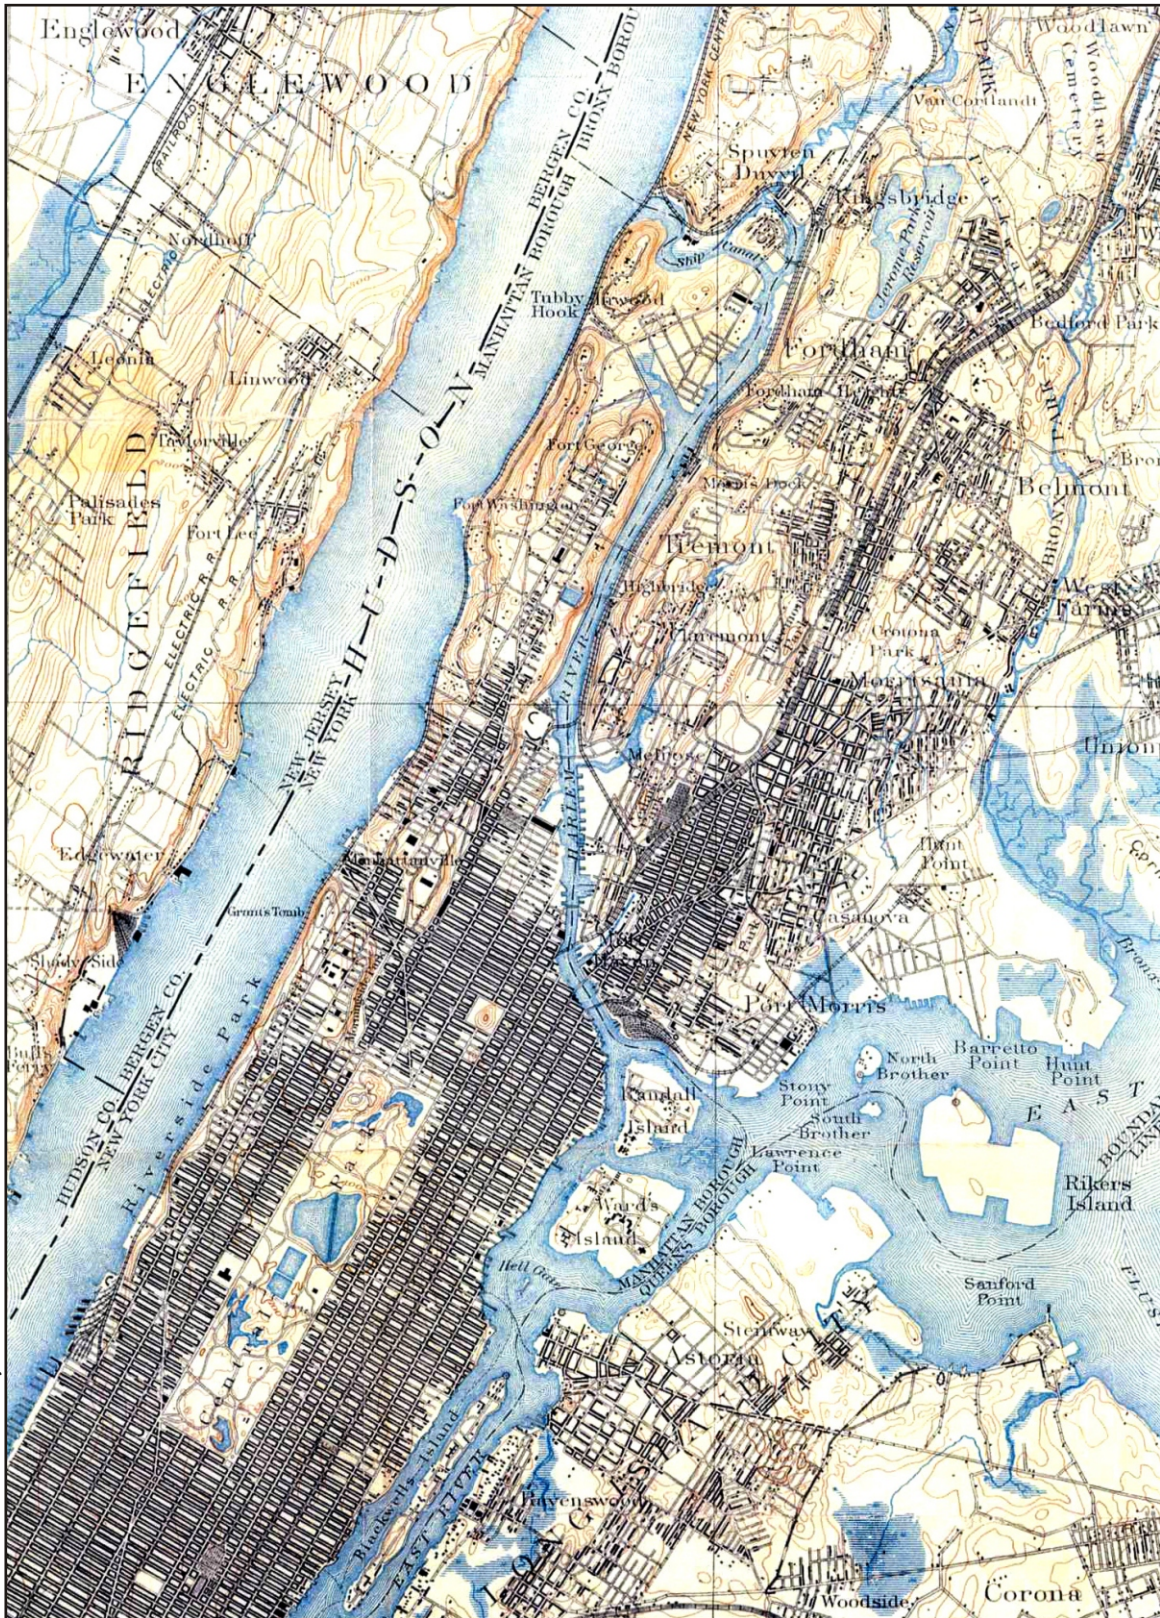
1897 Topographic Map
Harlem River Site

In addition to the aerial photographs, an artist's rendering (Figure 7.13-1) believed to depict the area in 1895 was reviewed. It showed the northern portion of the water treatment plant site after the dredging and construction of the U.S. Ship Canal (i.e., Harlem River) was completed. In addition, an 1897 topographic map prepared by the U.S. Coast and Geodetic Survey (Figure 7.13-2) provides insight to the shoreline configuration shortly after the canal was completed.

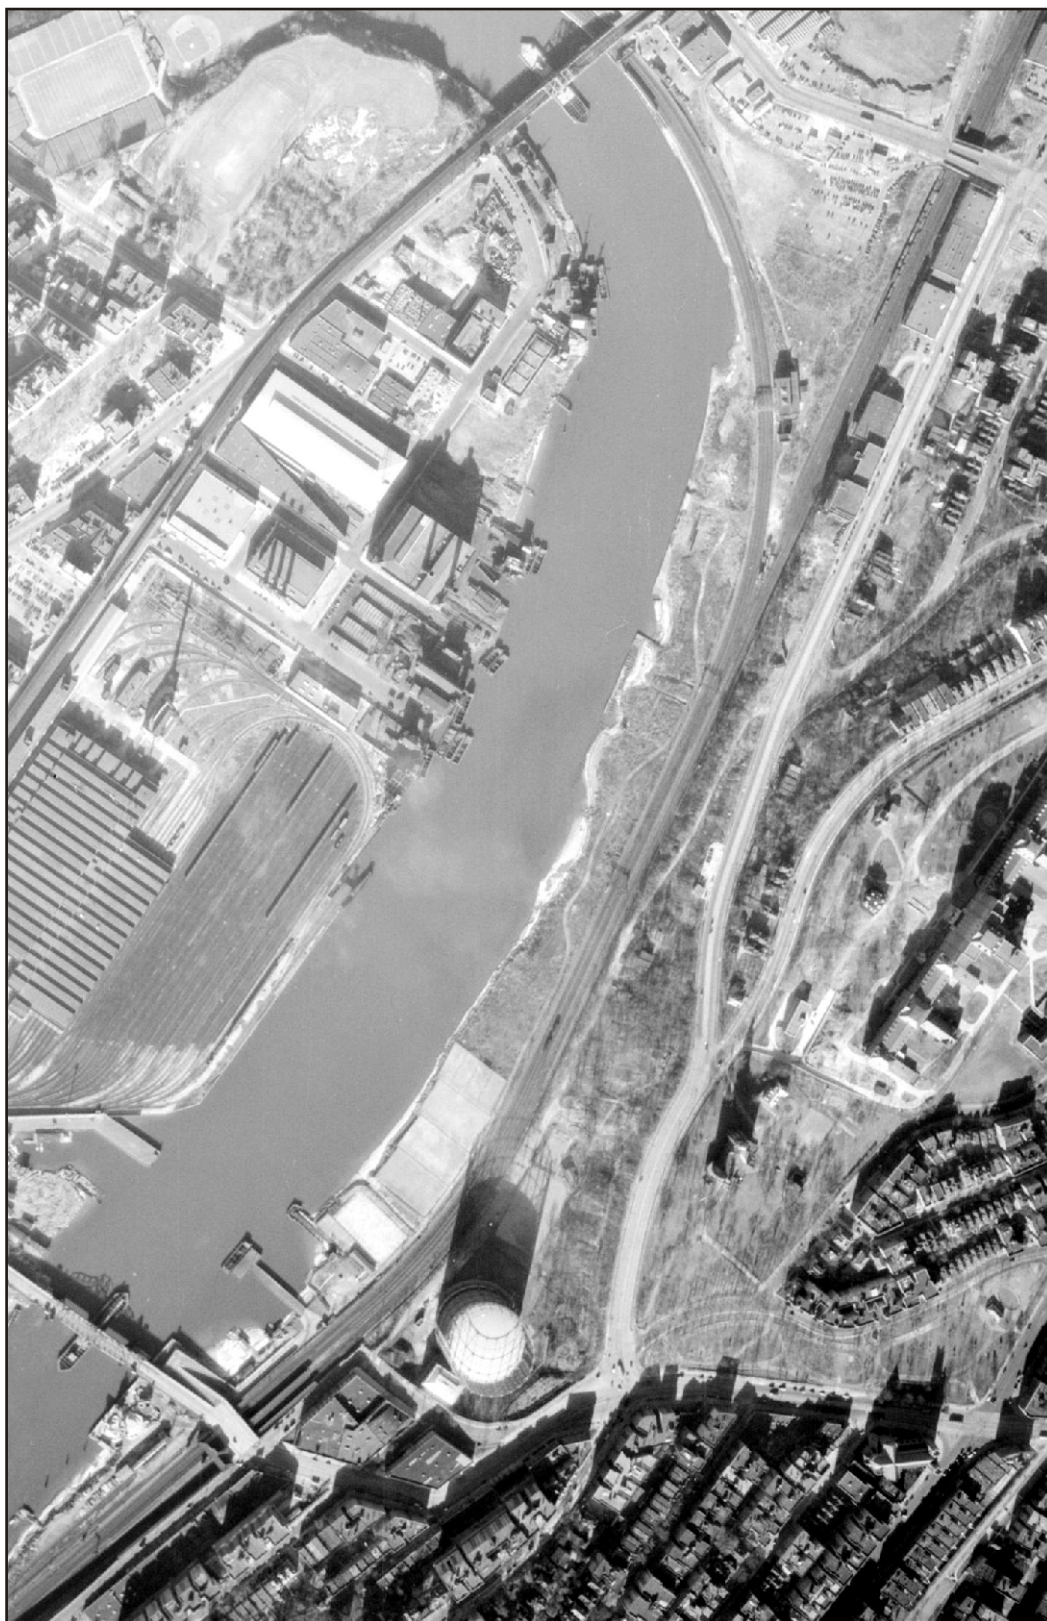
**1941 Aerial Photograph
Harlem River Site**

Few, if any, land uses on the water treatment plant site evident in the 1941 photograph may have resulted in the release of hazardous materials or wastes to the environment. Depending on the nature of the industrial operations at the facility south of the University Heights Bridge, residues from fuel spills or ash may remain. In addition, activities associated with the operation of the gasholder east of the water treatment plant site may have resulted in the release of contaminants (e.g., semi-volatile organic compounds), which could have potentially infiltrated the groundwater and migrated toward the water treatment plant site.

The historical aerial photographs that were reviewed were taken on January 8, 1941 (Figure 7.13-3), February 23, 1954 (Figure 7.13-4), April 13, 1954 (Figure 7.13-5), undated late 1950s (Figure 7.13-6), June 16, 1960 (Figure 7.13-7), and two undated photographs taken in the 1990s (Figure 7.13-8 and Figure 7.13-9). Significant observations derived from these figures follow.

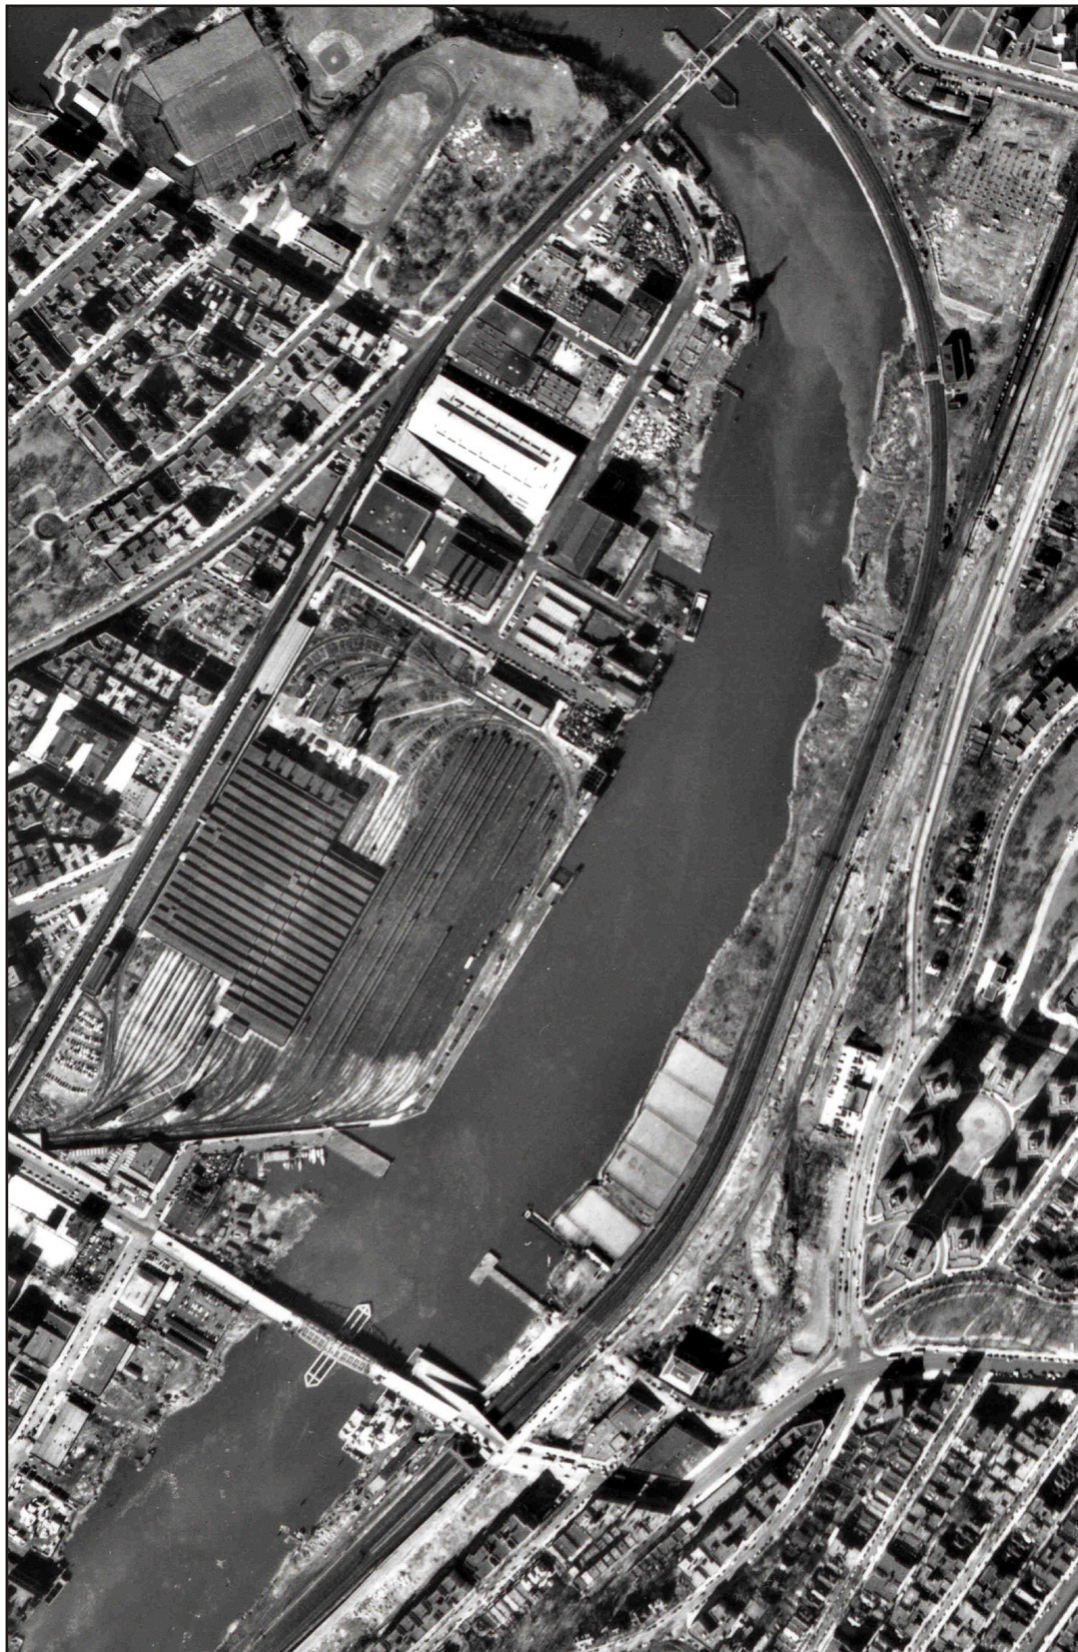
**February 1954 Aerial Photograph
Harlem River Site**

1954. Two aerial photographs were reviewed showing the Harlem River Site area in 1954. In general, both 1954 photos depict conditions similar to those seen in 1941, although excavation, grading, and building demolition are in progress for the construction of the Major Deegan Expressway. The February 1954 photo depicts a wastewater discharge plume (possibly muddy stormwater) entering the river from what appears to be an outfall structure west of the Putman and Hudson Division railroad track split and north of the water treatment plant site. The spit of land and marina visible in the 1941 photograph have been removed and, in its place, a more prominent pier or dock has been constructed.

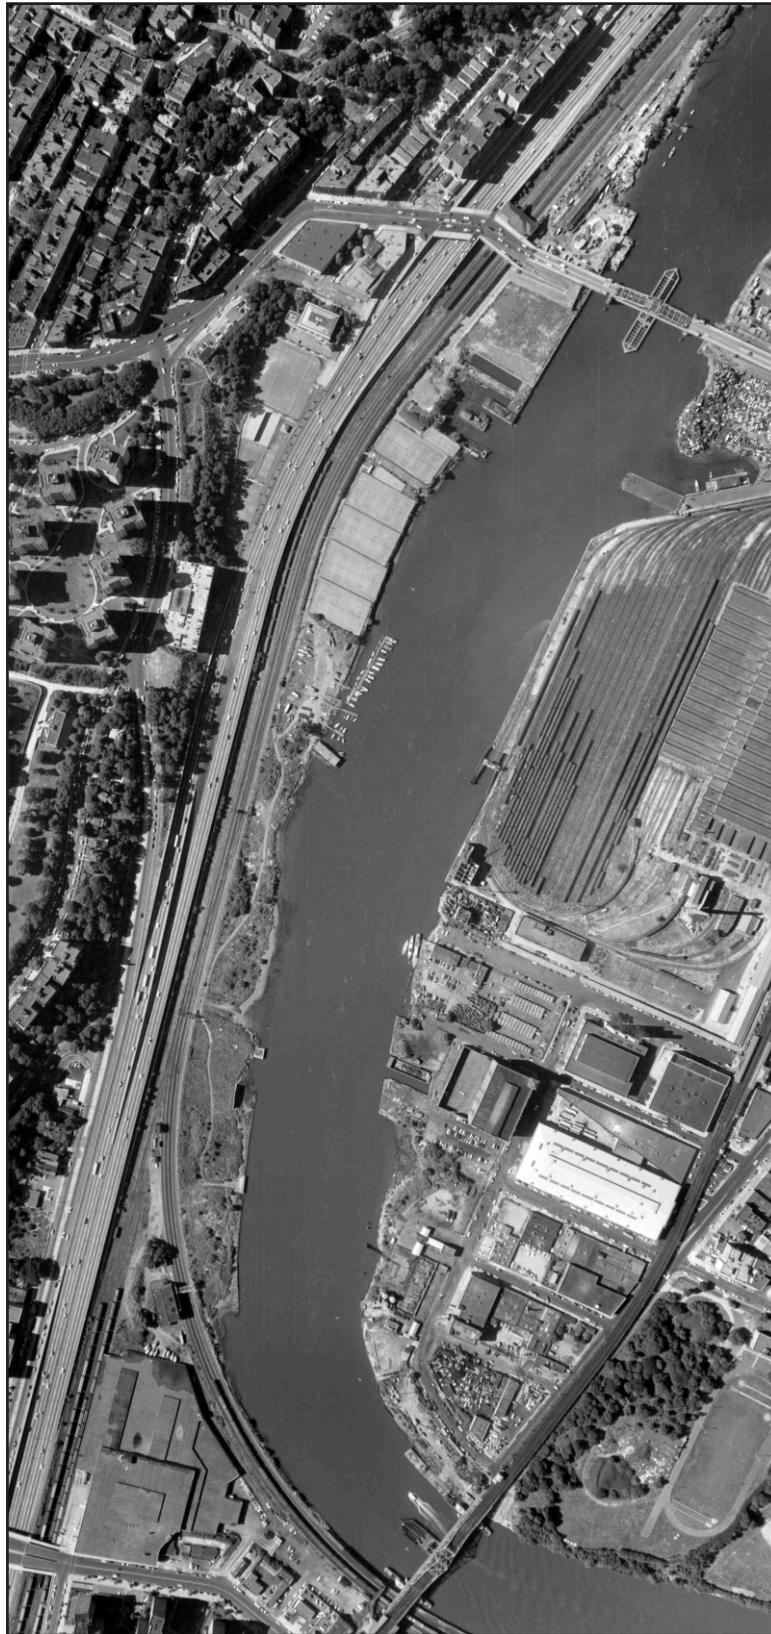
**1960 Aerial Photograph
Harlem River Site**

1960. The 1960 aerial photograph depicts conditions similar to those shown in previous photos, including the wastewater discharge outfall (i.e., stormwater) and a pier/dock structure southwest of the railroad track split. Consistent with previous photos, there is minimal evidence of activity on the northern portion of the water treatment plant site. A new marina, piers, small boats, and a moored barge are visible north of the five rectangular plots (presumed to be athletic fields or tennis courts). The rectangular plots, an adjacent building, and a small pier remain as previously observed. The cove south of the small pier contains a rectangular object, which may be an anchored or grounded barge. The Landing Road Pier is present with a vessel moored to its northern side. The cove on the southern side of the pier has been mostly filled in, leaving a small rectangular pool and bulkhead adjacent to the pier. The sand and gravel distribution facility south of the bridge continued to be in operation. The Major Deegan Expressway had been completed and was in service.

Through 1960, there appear to be few, if any, activities or operations on the water treatment plant site that may have resulted in the release of hazardous materials or wastes to the environment. However, it is likely that petroleum tanks may have been associated with the marina north of the rectangular plots, the building south of the plots, and the industrial facility south of the bridge, any of which may have had spills or other releases to the environment.

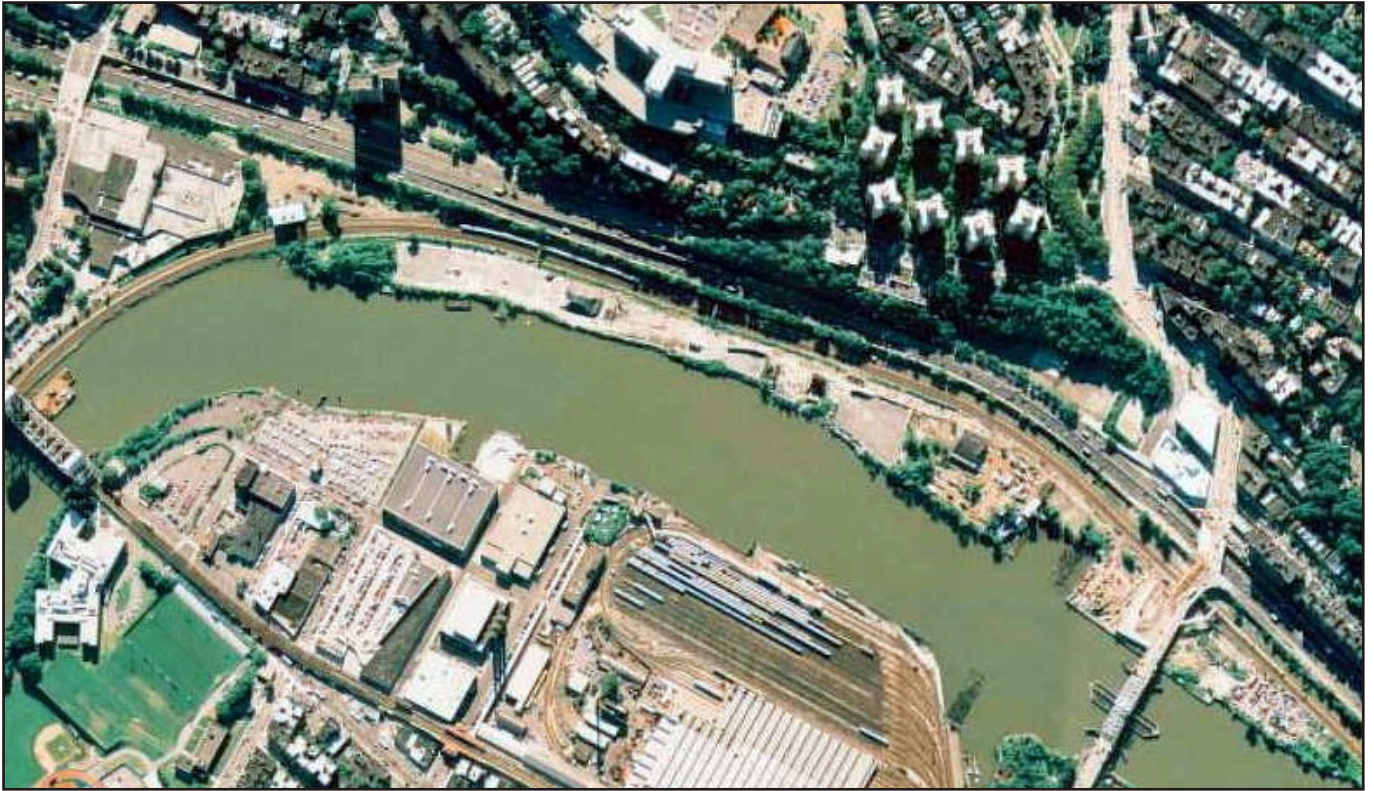
Figure 7.13-8

Sometime after 1960, the property occupied by the building supply distributor was filled in, extending the shoreline to the U.S. Pier and Bulkhead Line and roughly equivalent to the end of the small pier. The Landing Road Pier is still visible but has deteriorated significantly. The filled-in area immediately north of the University Heights Bridge appears to be used as a

materials and equipment storage area. The former facility south of the bridge, believed to have been used for sand and gravel distribution is no longer present and has been replaced by a vehicle storage lot.

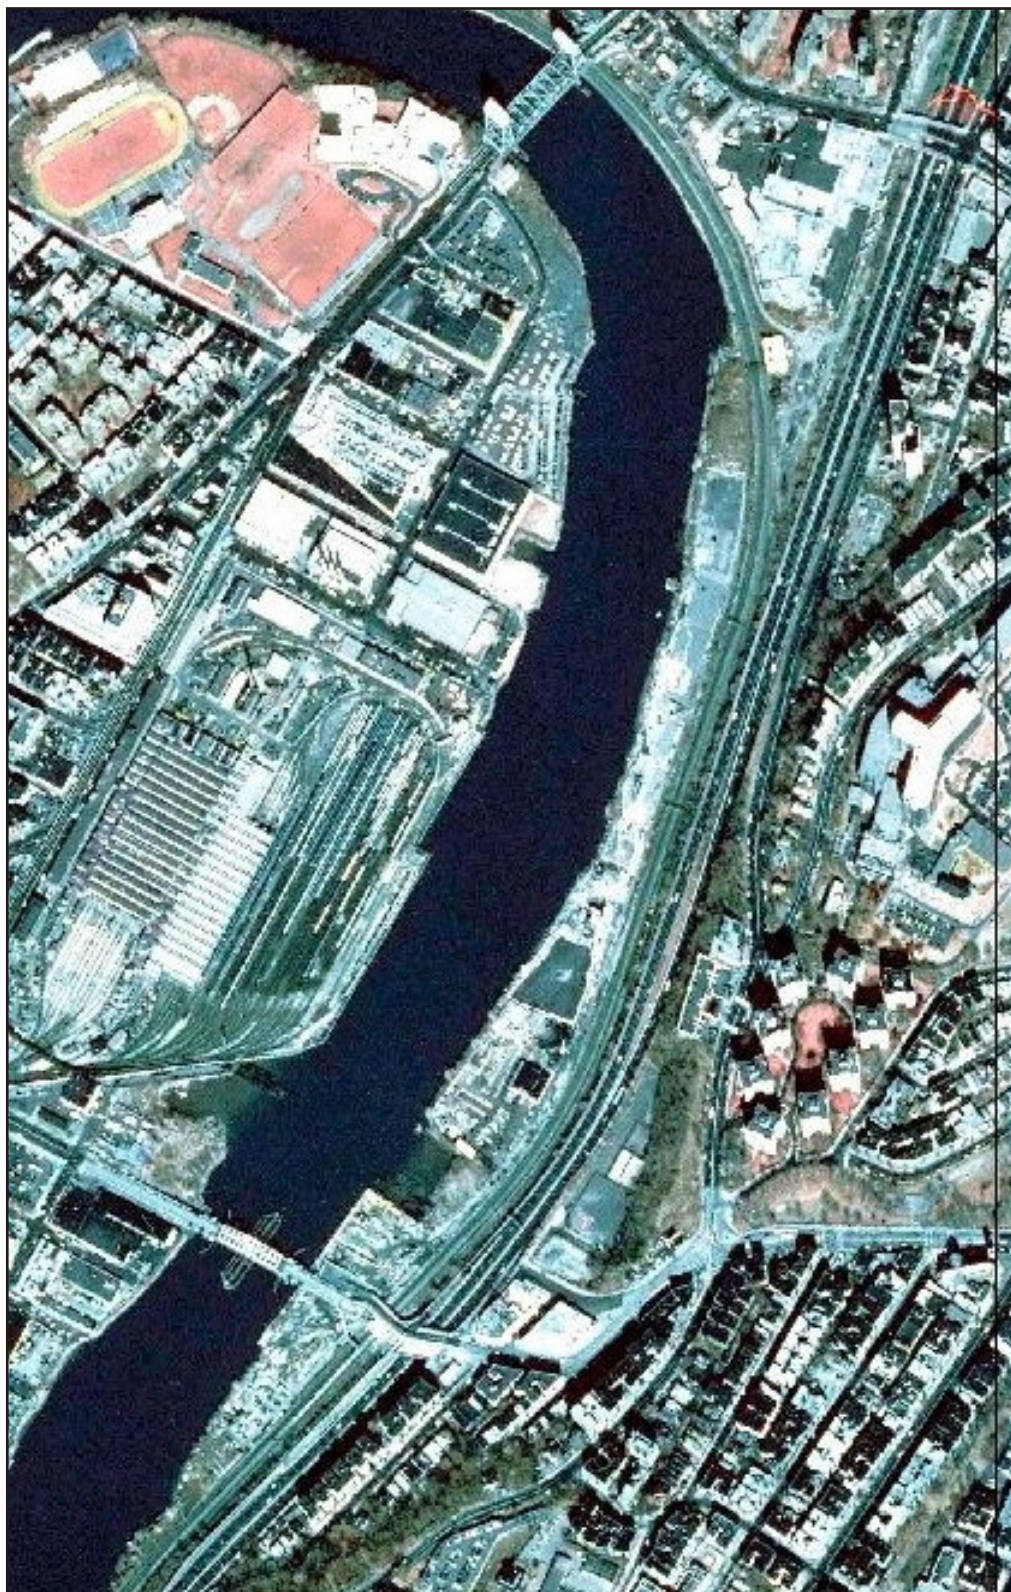
**1990s Aerial Photograph
Harlem River Site**
