## ***Chapter 9: Proposed Catskill Aqueduct Repair and Rehabilitation***

This chapter of the ~~Final Draft~~ Environmental Impact Statement (~~E~~DEIS) evaluates the proposed Catskill Aqueduct Repair and Rehabilitation (repair and rehabilitation) that would occur as part of Upstate Water Supply Resiliency. It provides background on the purpose and need for the repair and rehabilitation, describes the proposed activities and schedule for the repair and rehabilitation, and presents the environmental impact assessments for applicable impact categories.

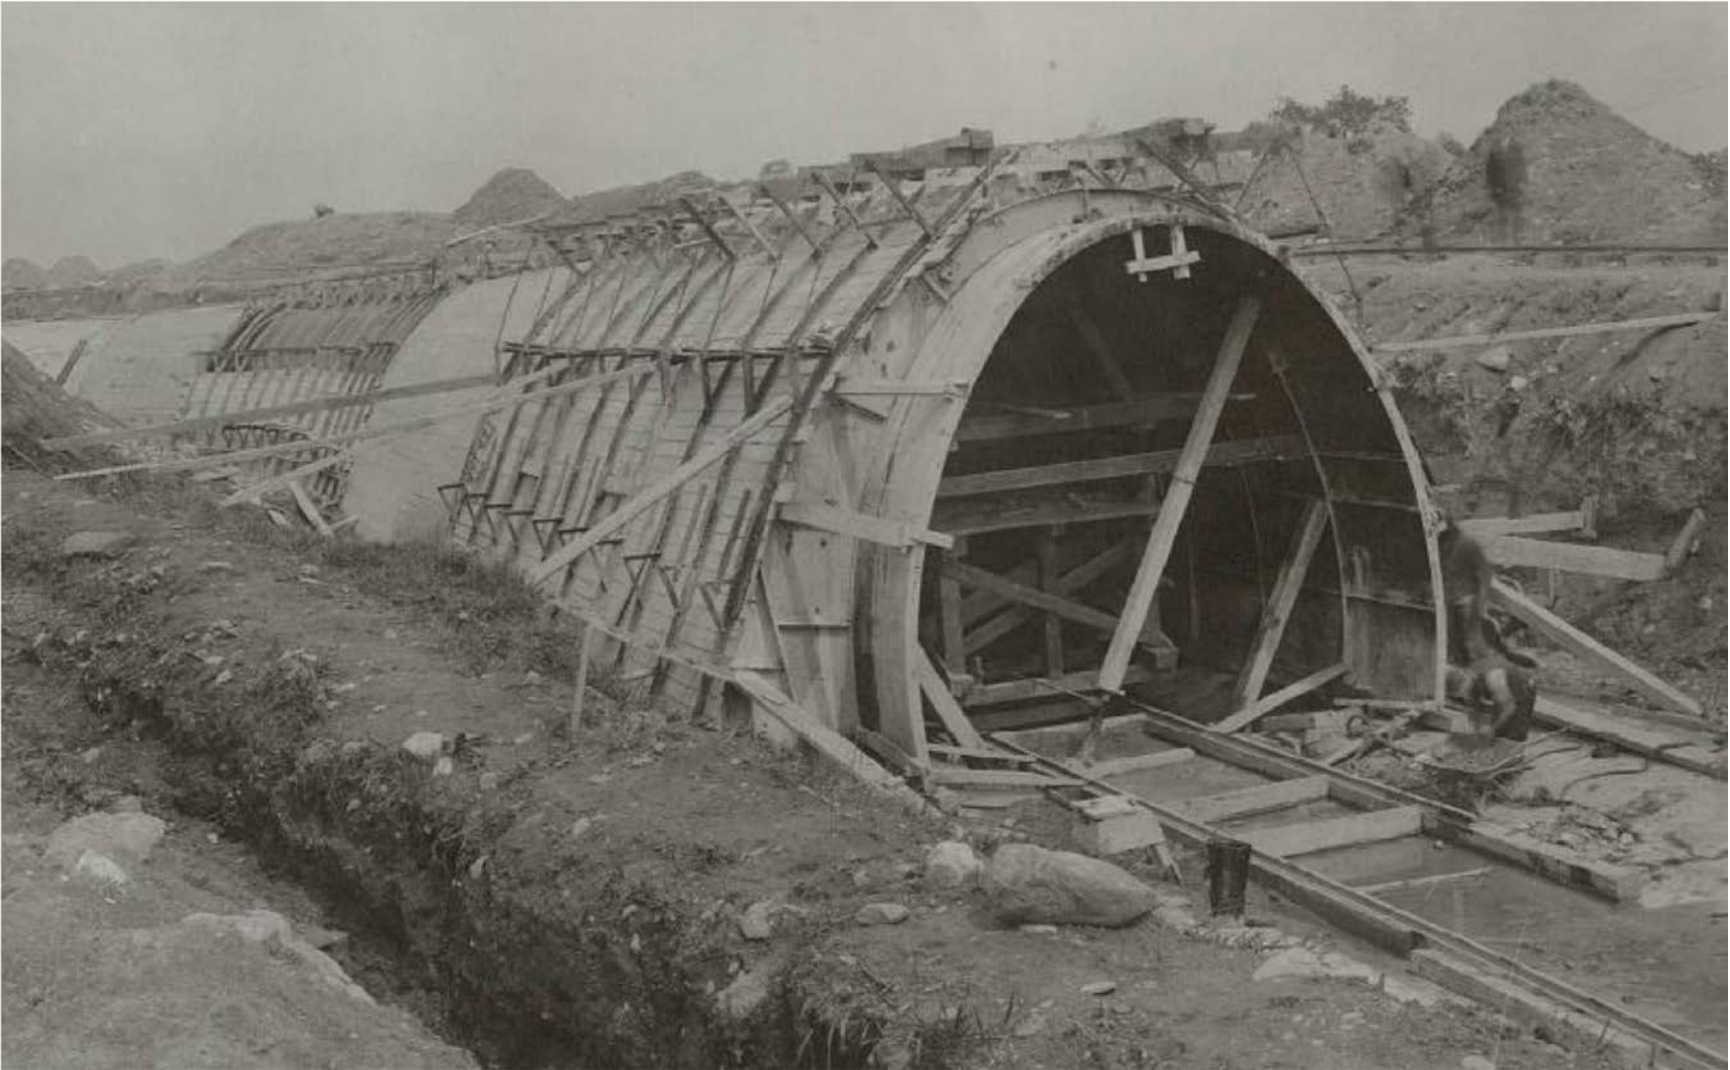
**Figure 9.2-6: Historic Photograph of the Peekskill Cut-and-Cover Tunnel, May 12, 1910**

**Figure 9.2-6** is a historic photograph showing construction of the Peekskill Cut-and-Cover Tunnel with steel forms erected and ready for casting the concrete arch. Within the cut-and-cover tunnel segments, there is a gap or headspace between the water surface and the top of the tunnel under most conditions to ensure the water is able to flow freely. In some locations where the aqueduct crosses streams or drainage channels, culverts were installed as part of the original contract with sluice gates for drainage. The sluice gates, when opened, allow the aqueduct to be drained into adjacent streams or drainage channels. However, many of these sluice gates have never been used to drain the aqueduct.

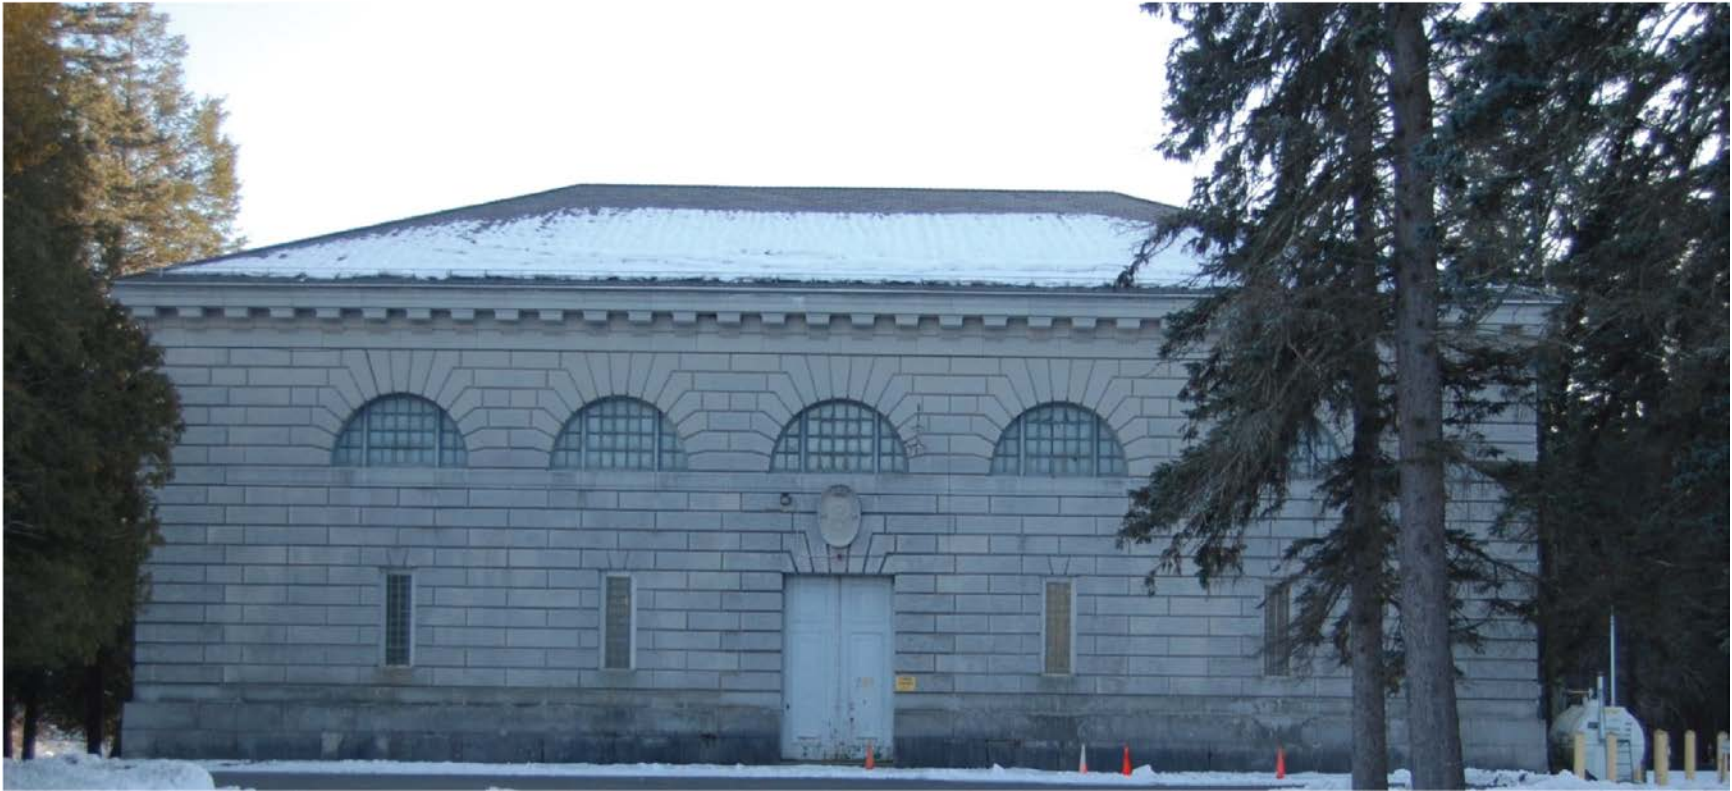
**Figure 9.2-8: Chlorination Facility at the Ashokan Screen Chamber**

Sodium hypochlorite or chlorine dioxide would be introduced into the aqueduct via the new chlorination facility located in the existing Ashokan Screen Chamber. The chemical feed system within the chlorination facility has been carefully designed by DEP to dose sodium hypochlorite or chlorine dioxide, respectively, under two operating conditions:

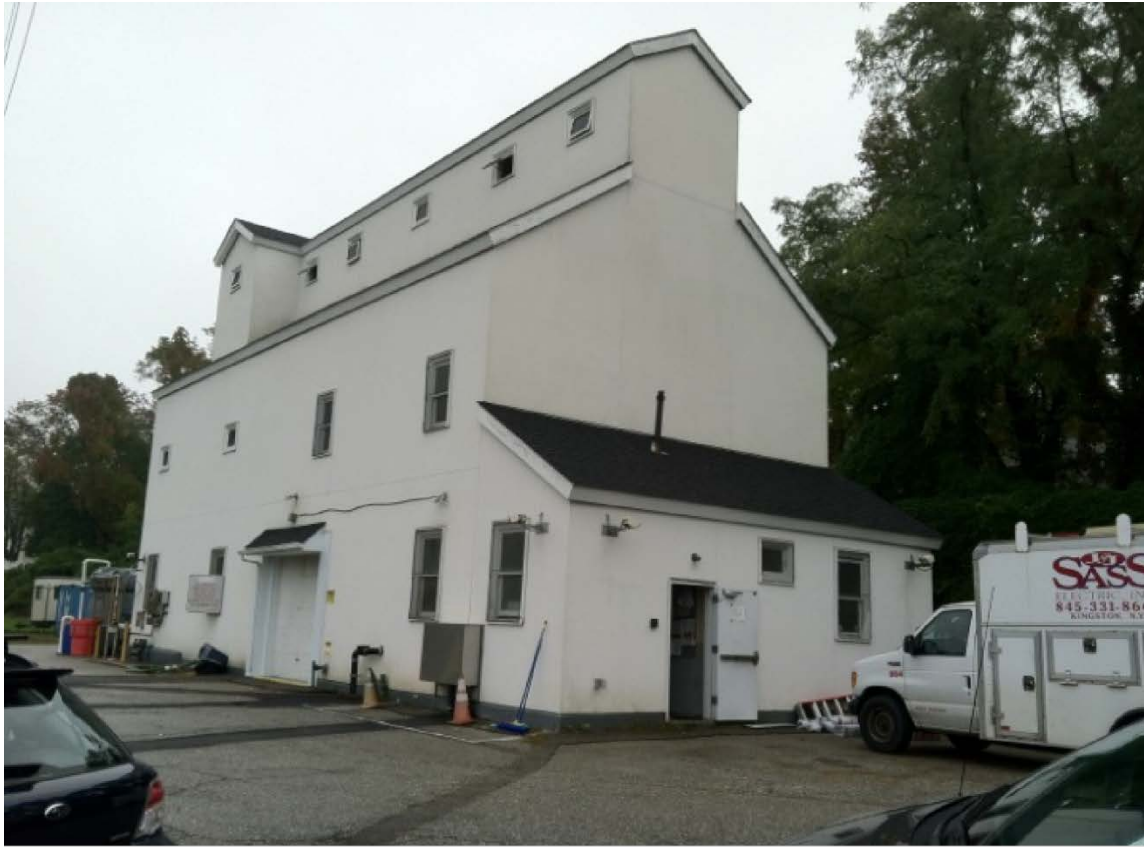
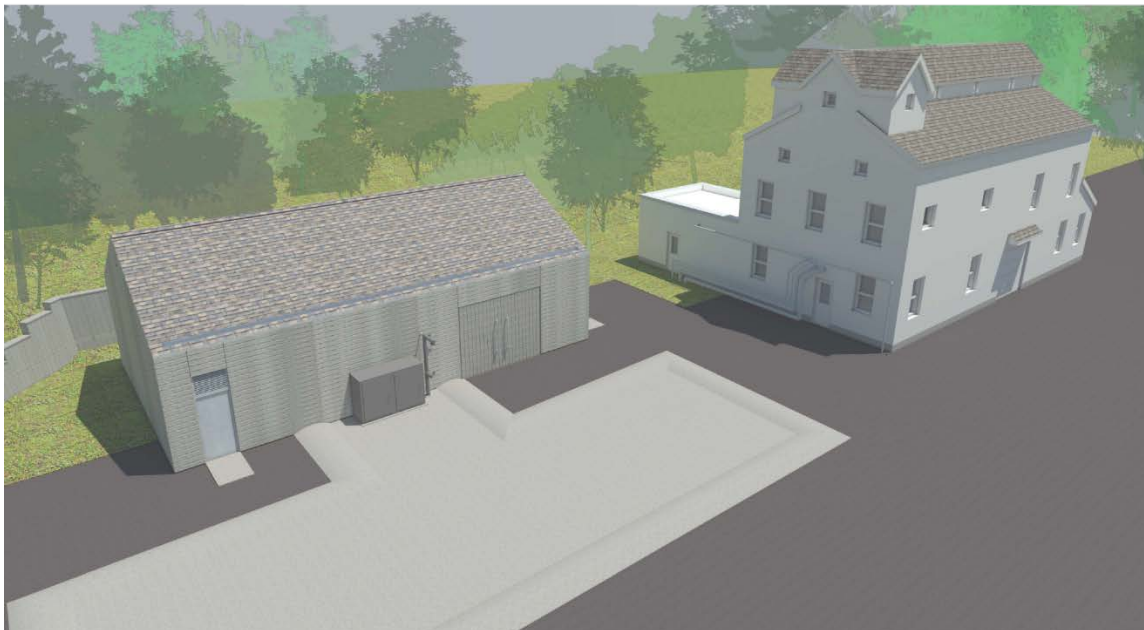
**Figure 9.2-9: Dechlorination Facility at the Pleasantville Alum Plant**

Existing

Proposed

In addition to installation of the dechlorination facility at this location, the repair and rehabilitation would include construction of chemical system upgrades within Pleasantville Alum

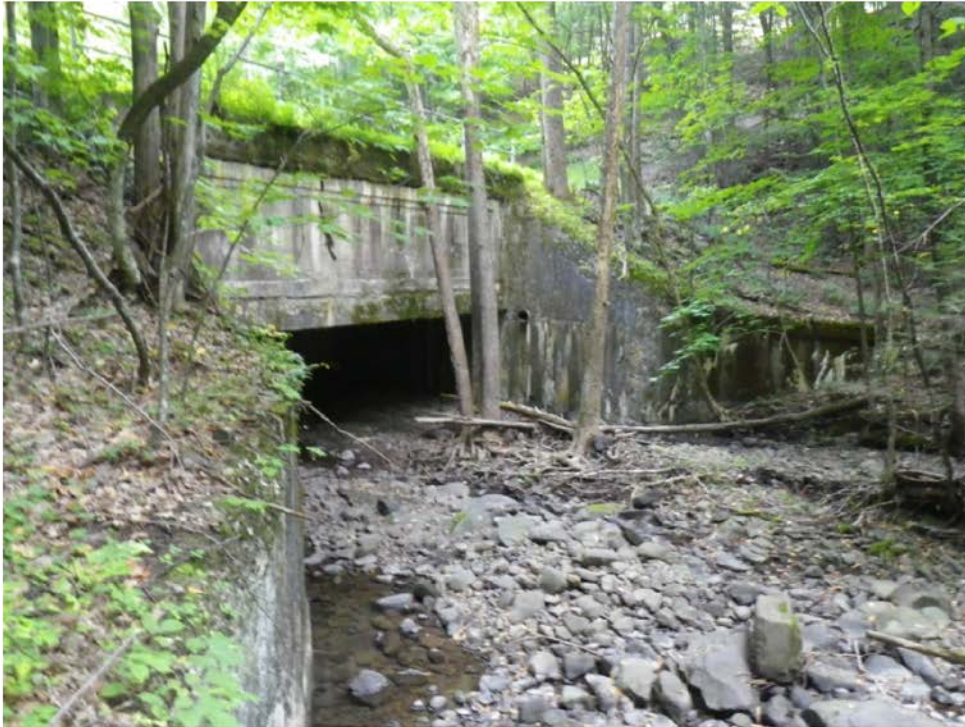
**Figure 9.2-12: Bridge Repair**

The Catskill Aqueduct crosses streams via bridge structures (see **Figure 9.2-12**). As part of the repair and rehabilitation, internal and external repairs would be conducted to repair structural defects on the Tongore, Poor Farm Arch, Foundry Brook, and Indian Brook bridges to improve their structural integrity and, in turn, extend their longevity. Bridge repair work would entail visually identifying and sounding deteriorated concrete and patching with concrete mortar.

Structural elements such as rebar and steel beams would be inspected for damage. If found to be badly corroded, replacement sections would be spliced in or sections would be reinforced. Surface defects such as cracks, spalls, and gouges on the bridge abutments would be patched with repair concrete.

Typical Siphon Bridge Structure

Typical Bridge Section
