Parks

Morningside Park 114th, 116th and 122nd Street Staircases Reconstruction

Public Design Commission Public Review
November 18, 2024
Laura Drawbaugh RLA, NYC Parks

- Make stairs safer and ADA compliant.
- Manage stormwater to prevent flooding.

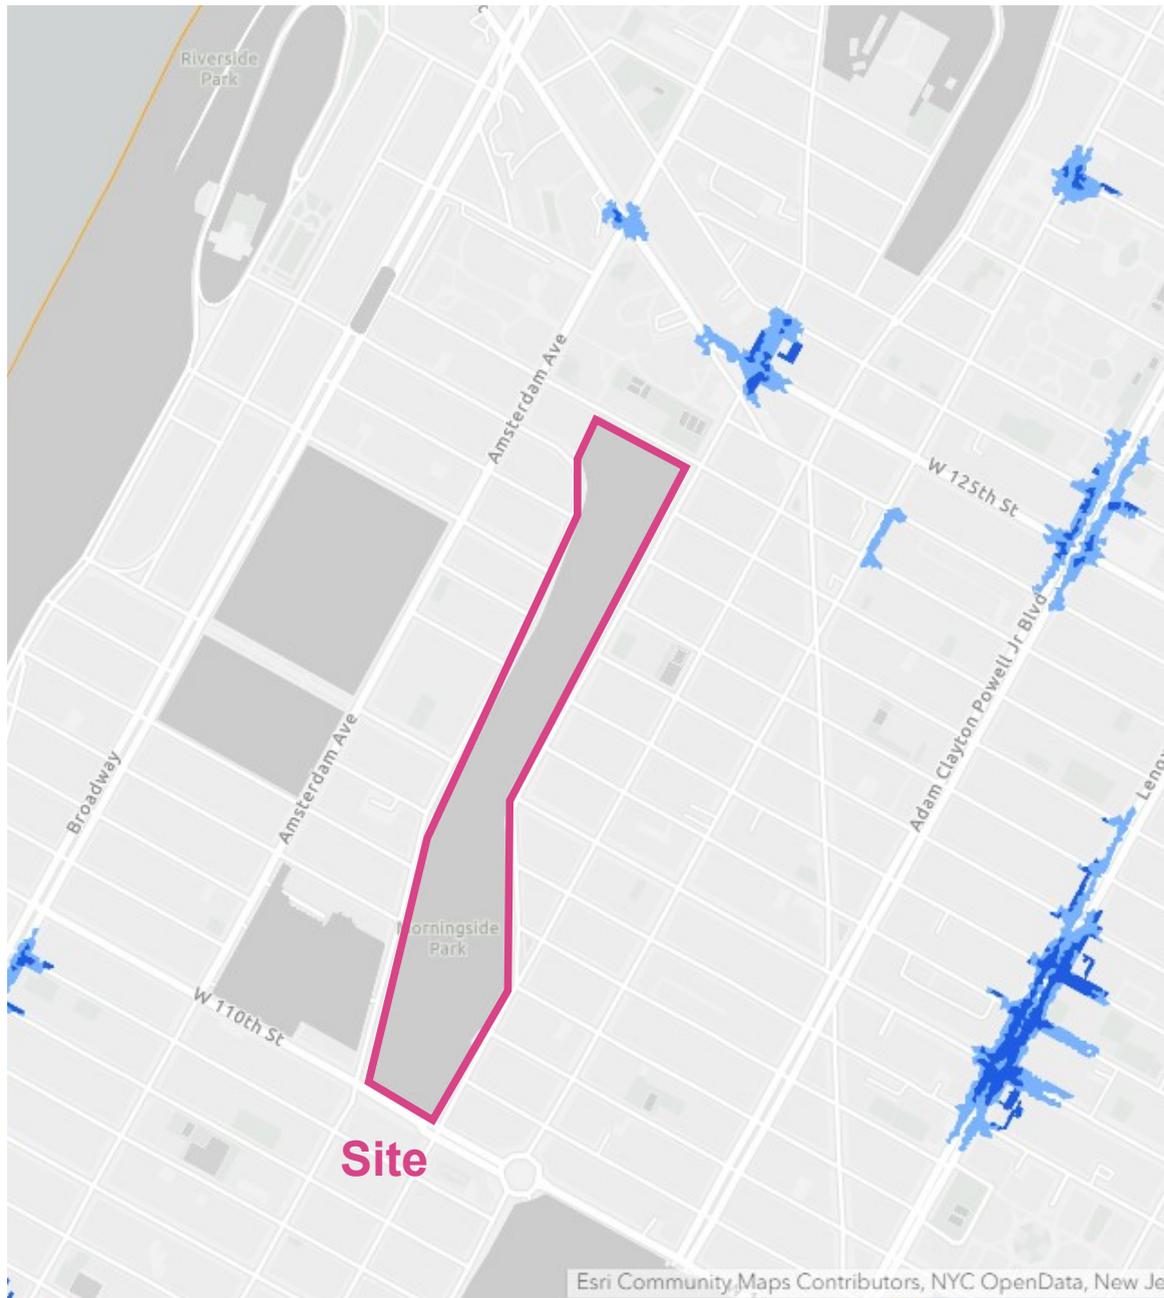
Moderate Flooding (10-year storm)

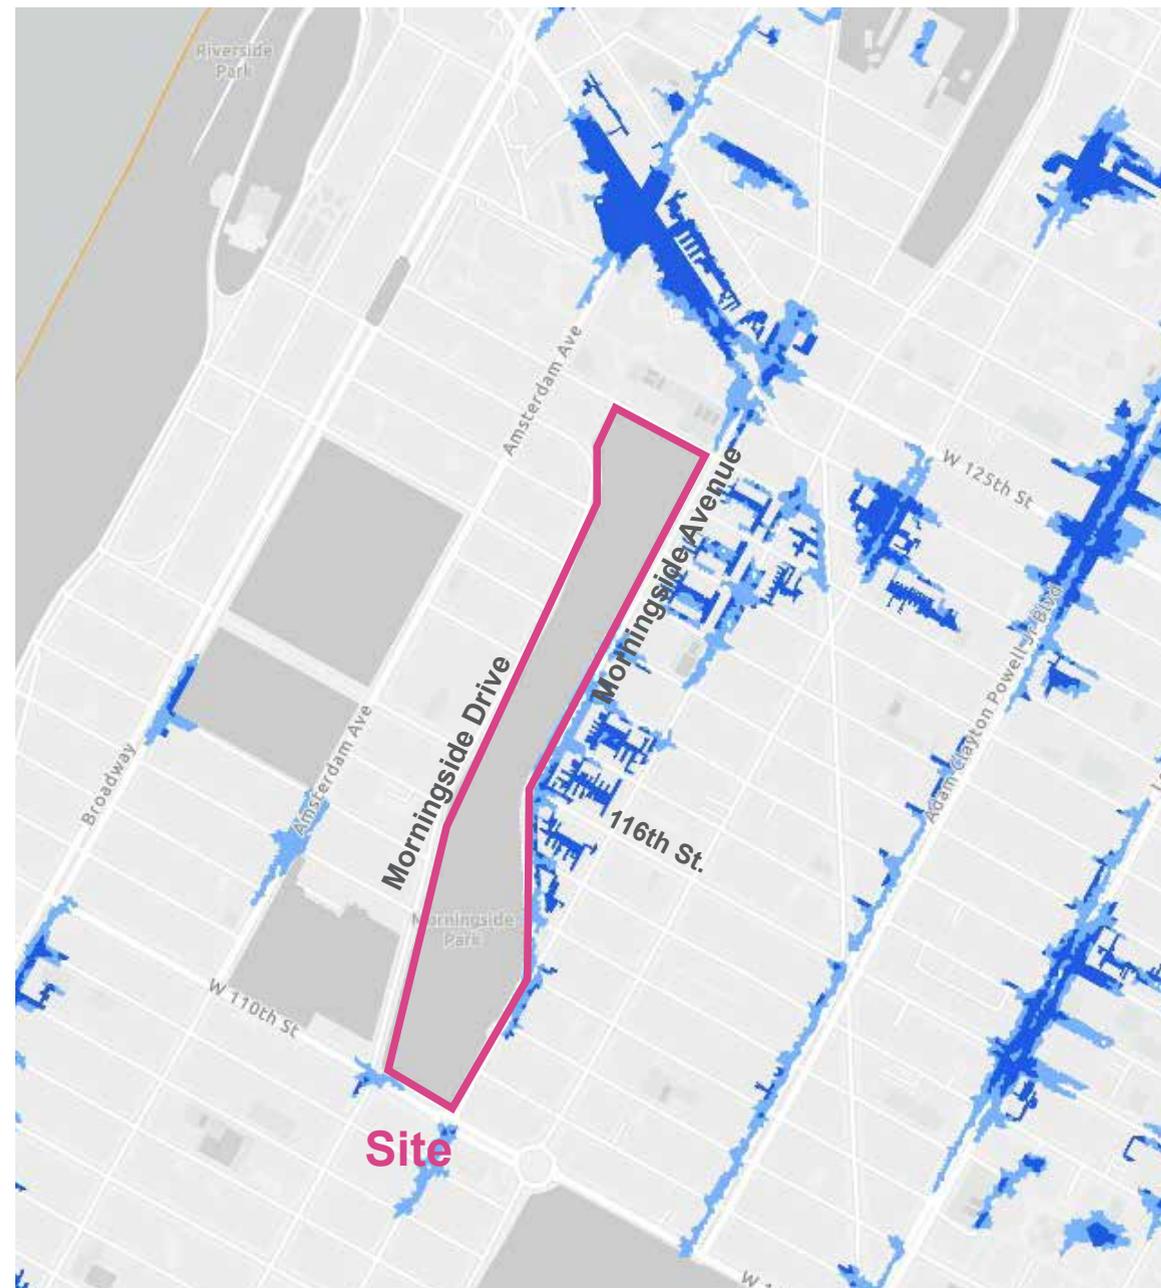
Extreme Flooding (100-year storm)
Runoff to the east to Morningside Avenue is from park interior, not Morningside Drive

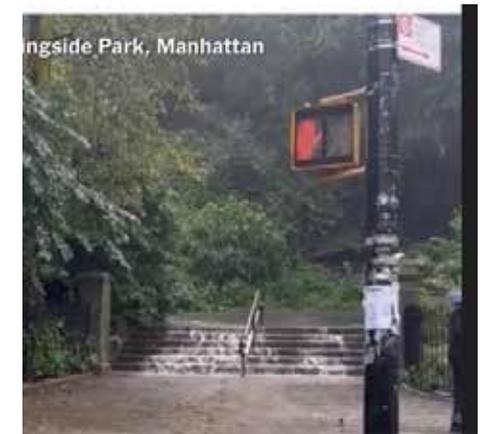
September 29, 2023
stormwater runoff down the escarpment and stairs at 116th St. vicinity

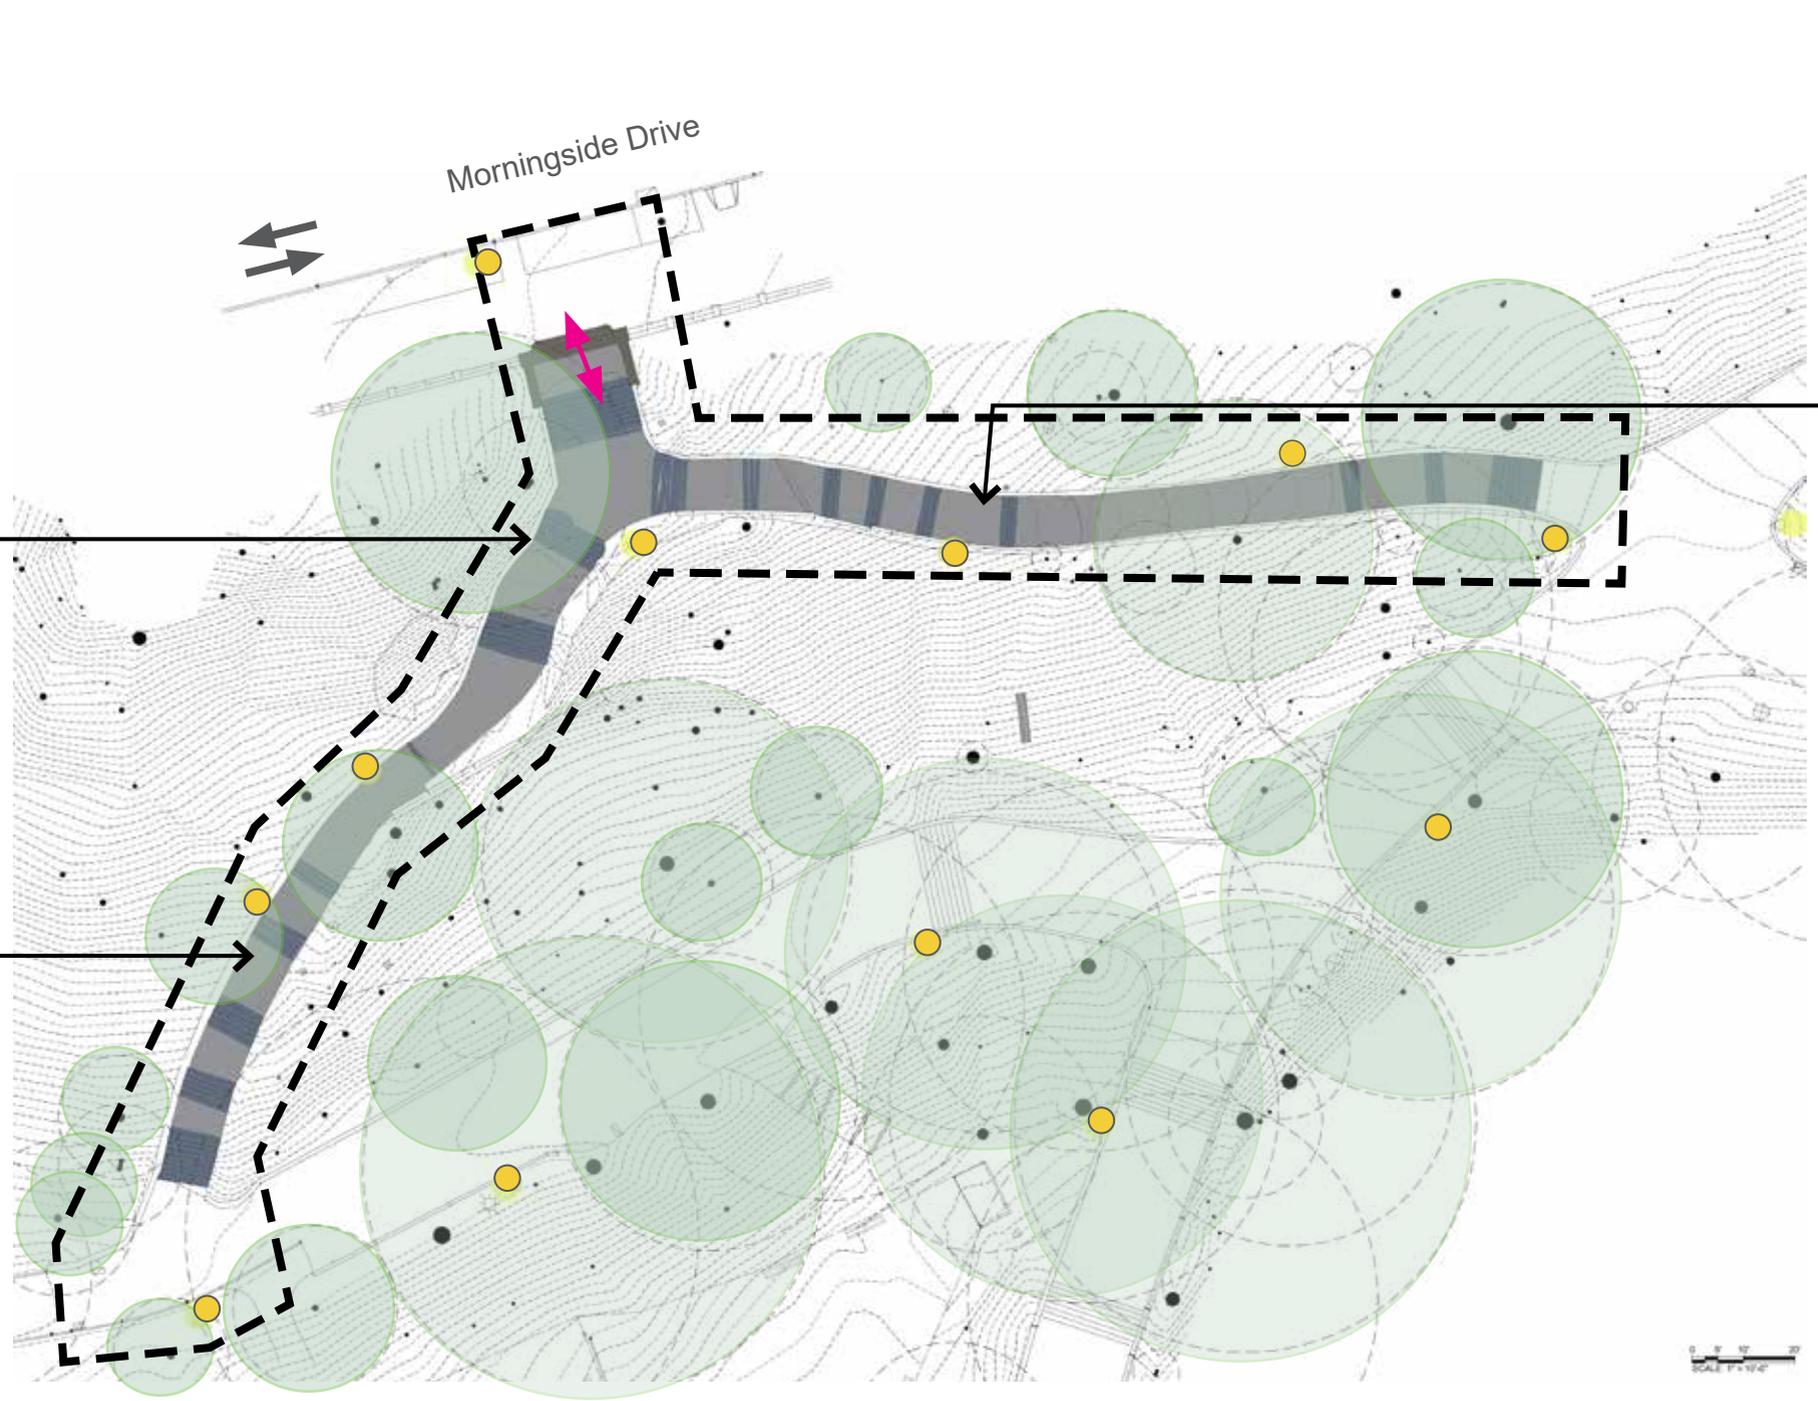
Morningside Park | A. 114th Street Stairs , Existing Conditions

Bluestone treads
Asphalt landings
Carved boulder cheekwalls
Rustic schist ashlar cheekwall
Mis-aligned treads

Bluestone treads
Asphalt landings
Carved boulder cheekwalls
Mis-aligned treads

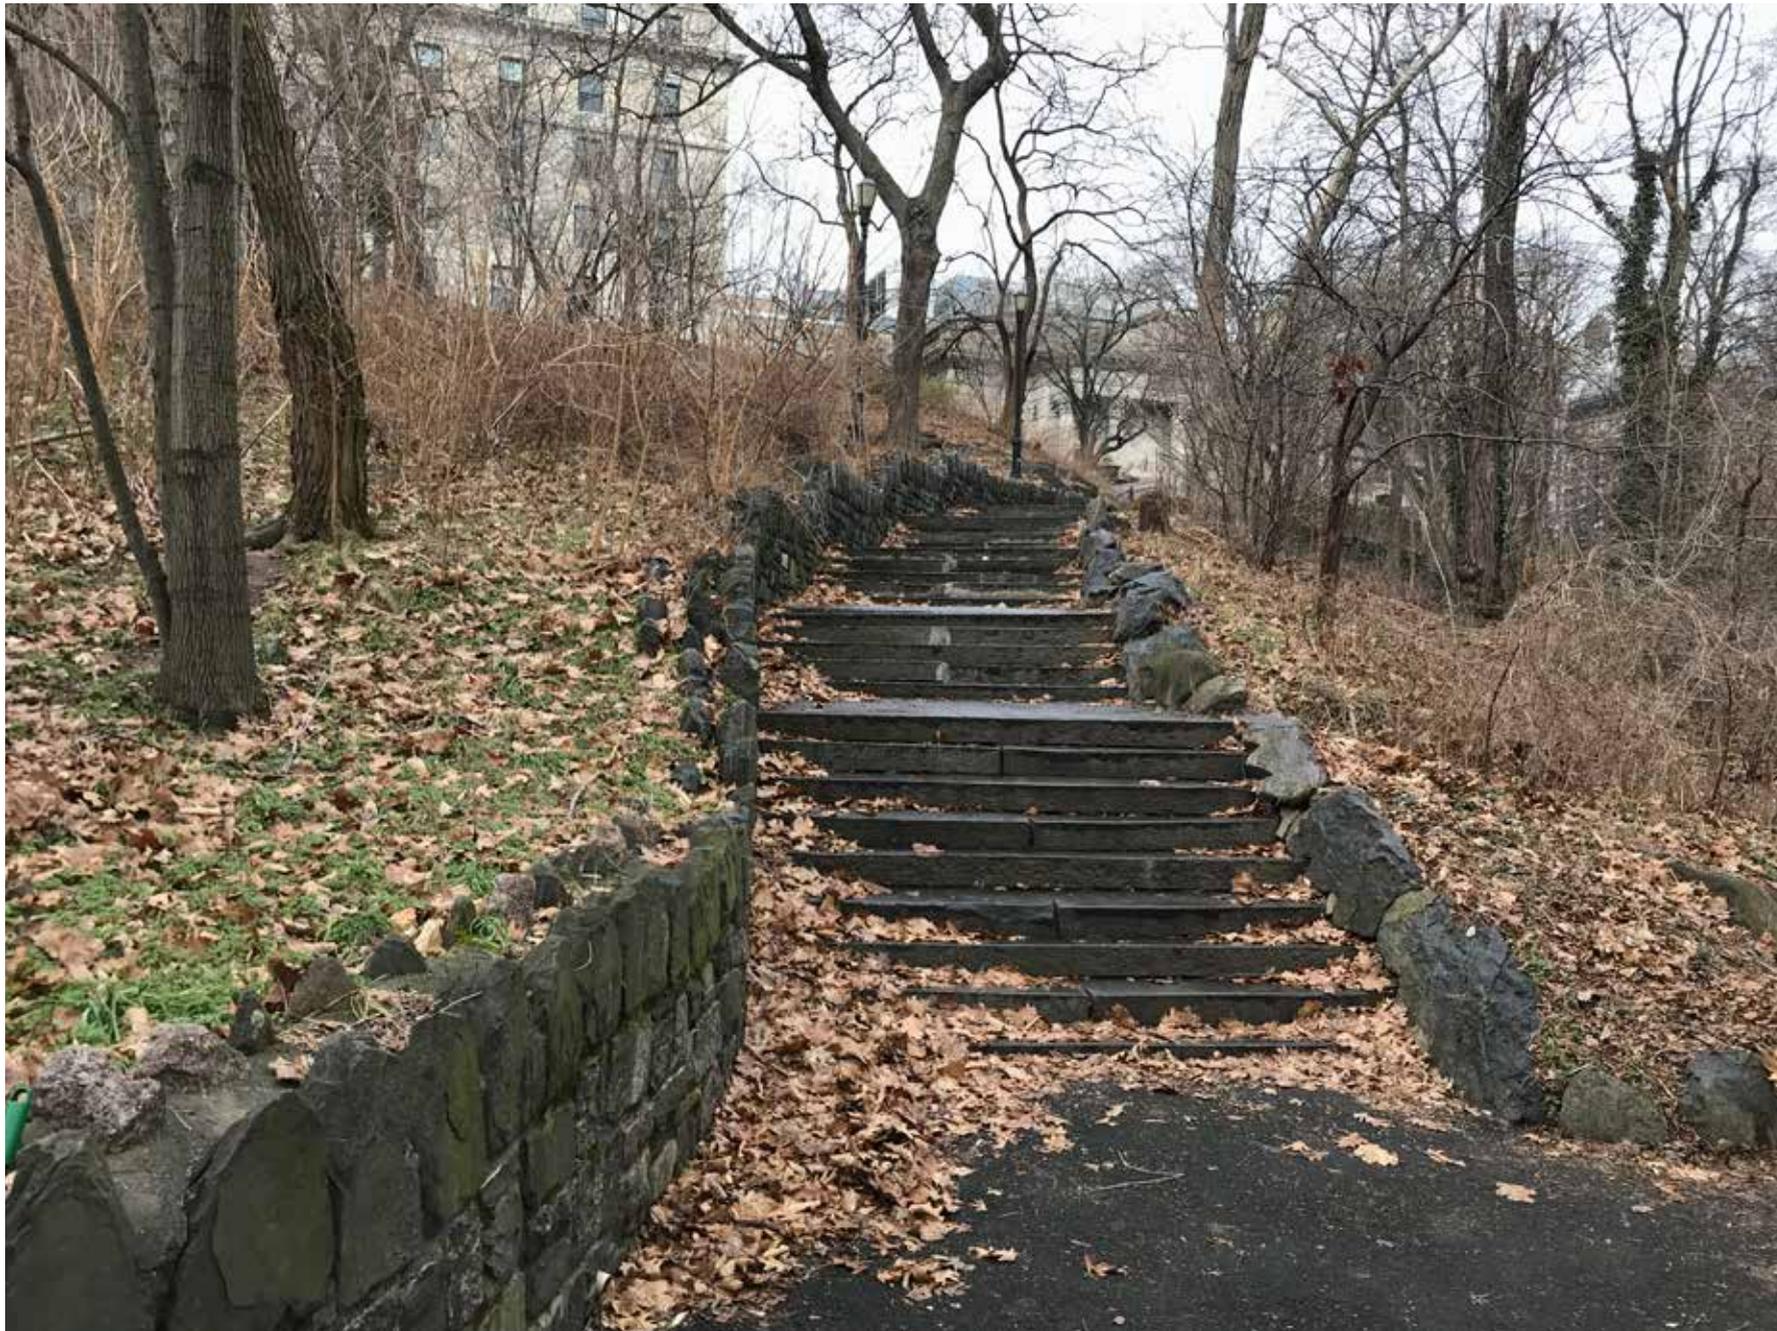
South stairs, toothed retaining wall and carved boulder cheekwall

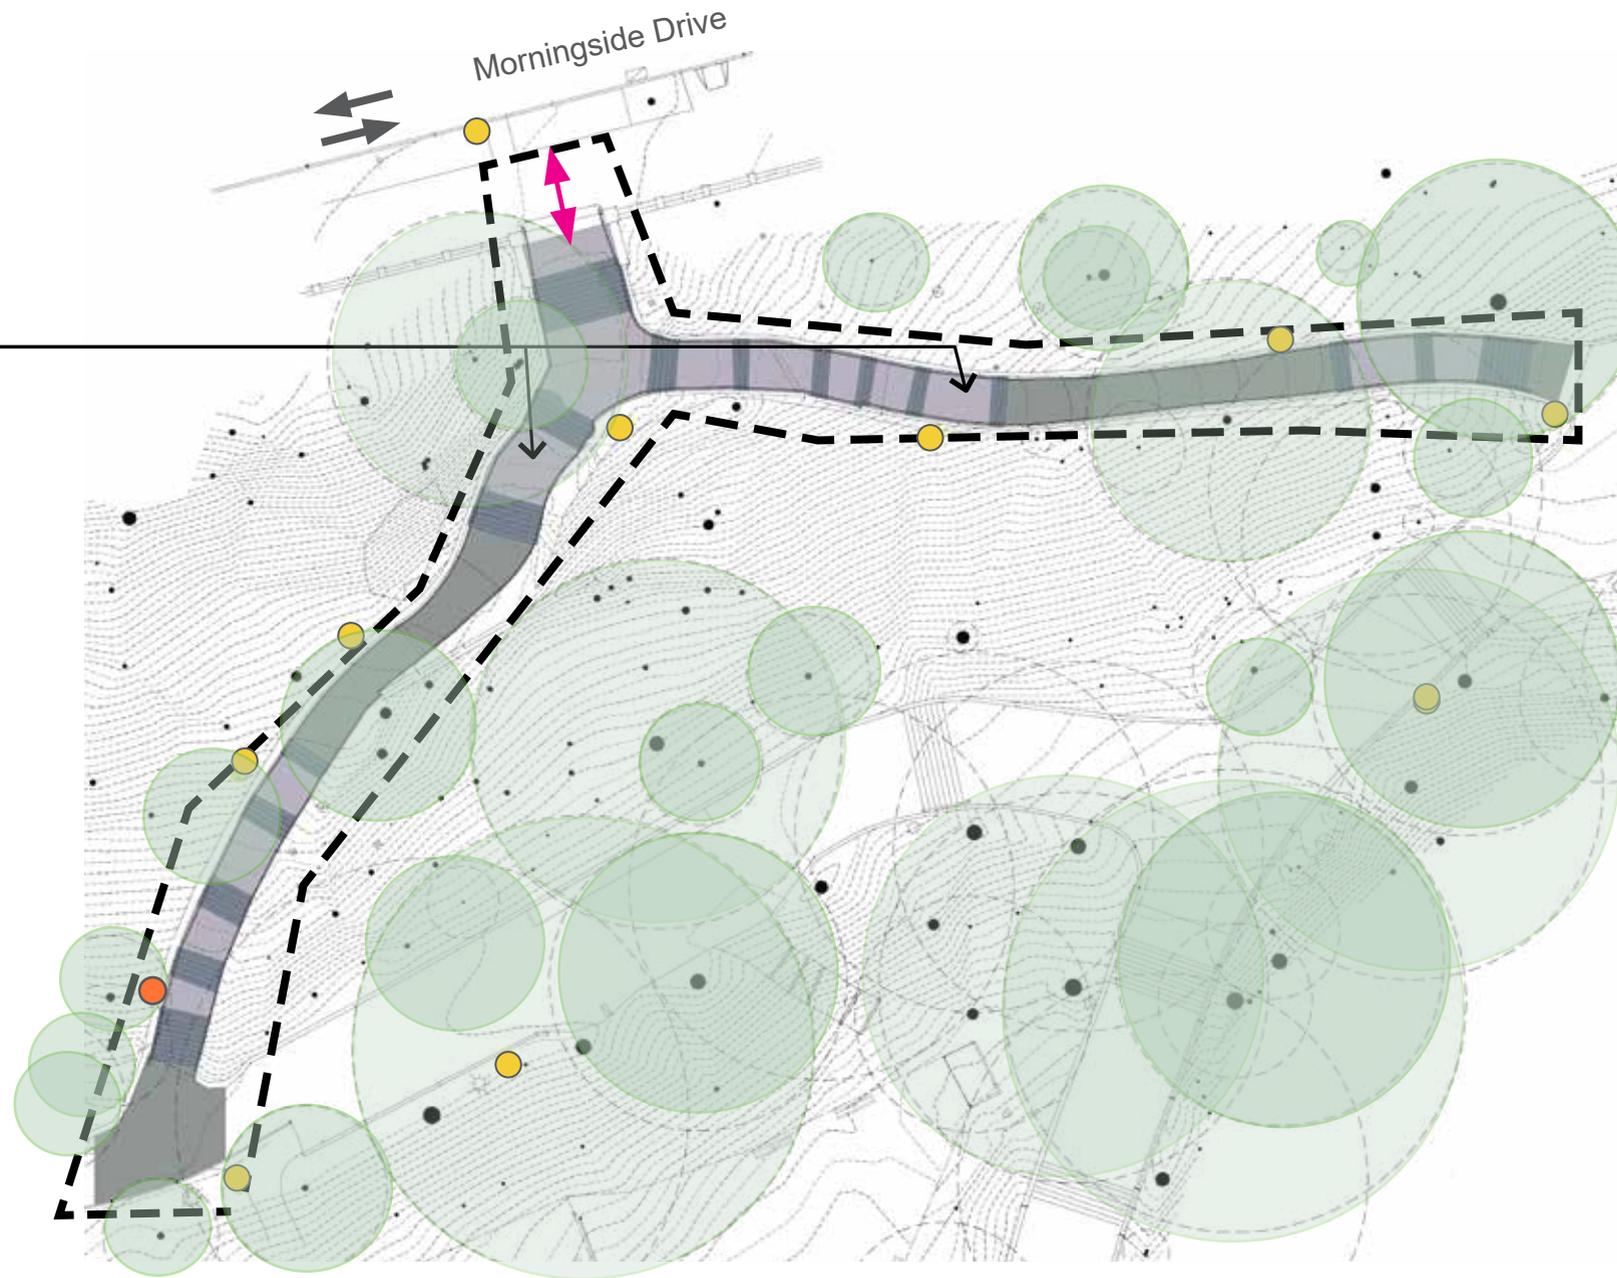
Morningside Park | A. 114th St. Stairs, Proposed Reconstruction

Add handrails on both sides

Remove and reset boulder
cheekwalls with drainage
material

Repoint ashlar cheekwall

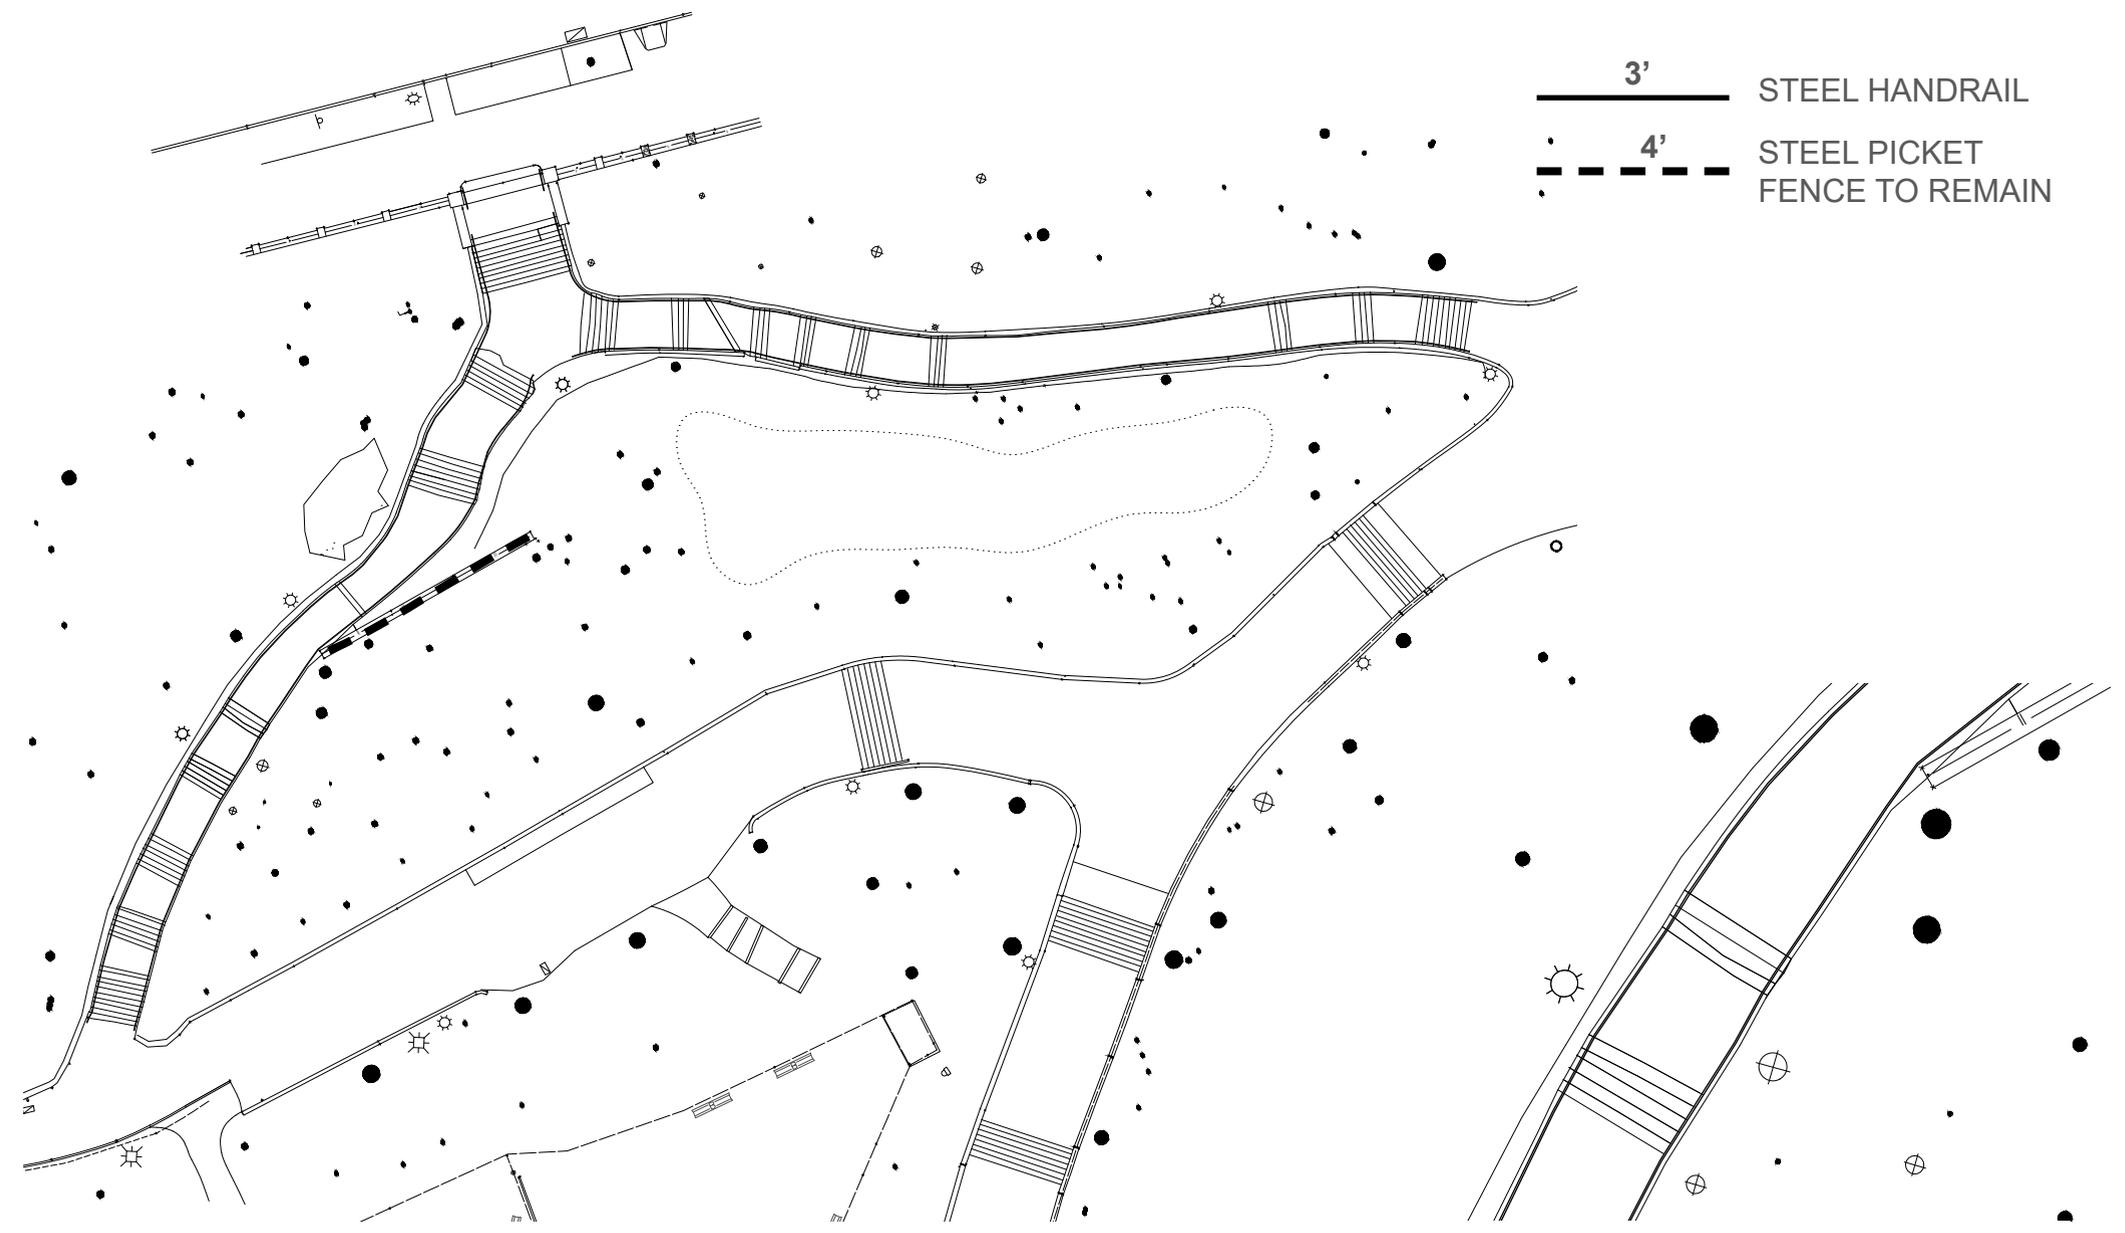
Morningside Park | A. 114th St. Proposed Fence Diagram

3' STEEL HANDRAIL
4' STEEL PICKET FENCE TO REMAIN

TYPICAL CLOSE-UP

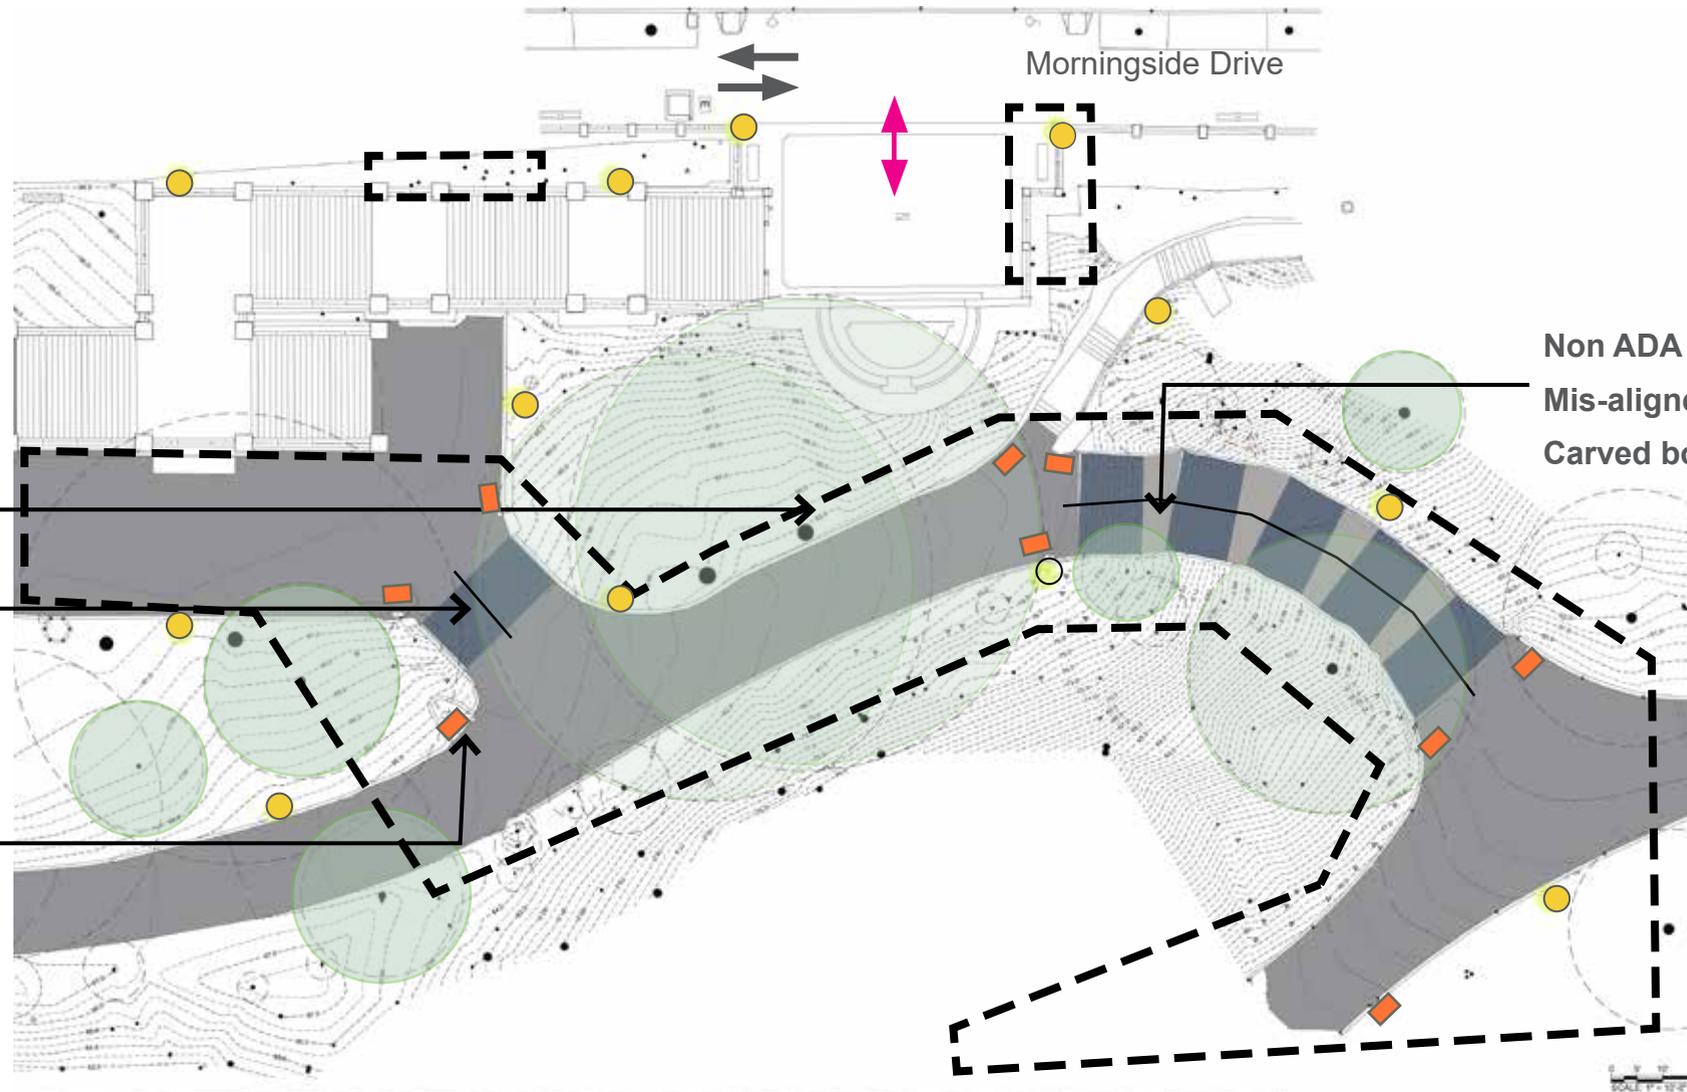
Morningside Park | B. 116th Street Stairs, Existing Conditions

Stormwater runoff from retaining wall weep holes

Non ADA Handrails

Mis-aligned bluestone treads

Exposed pipe creates flooding on path and stairs and street

Non ADA handrails

Carved boulder cheekwalls

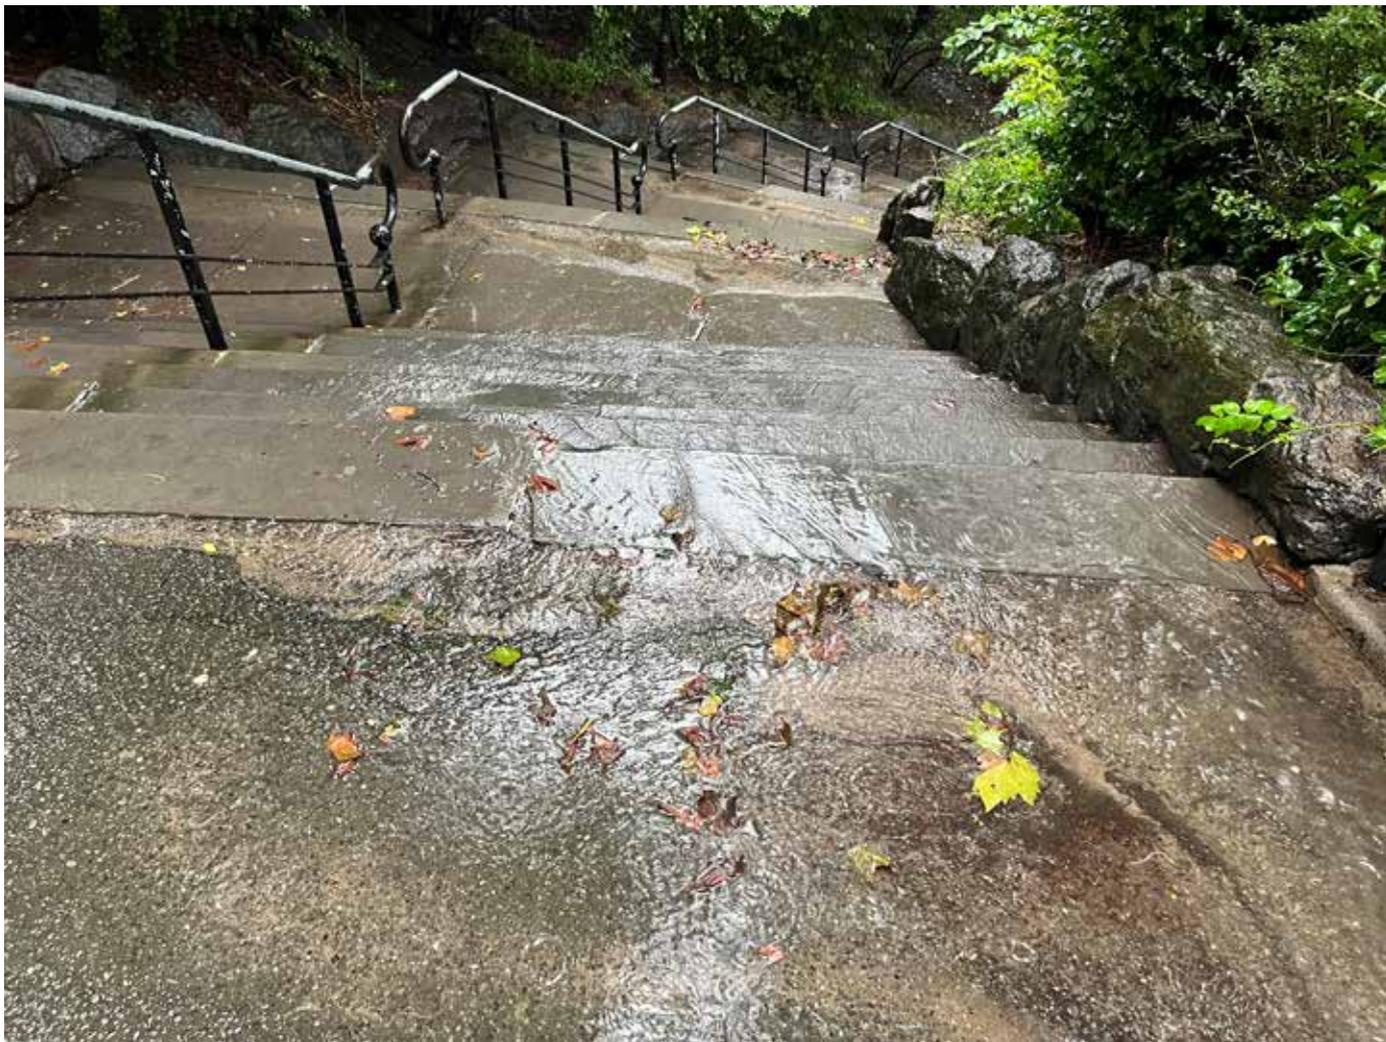
Top of stairs -stormwater from higher elevations and groundwater create flooding

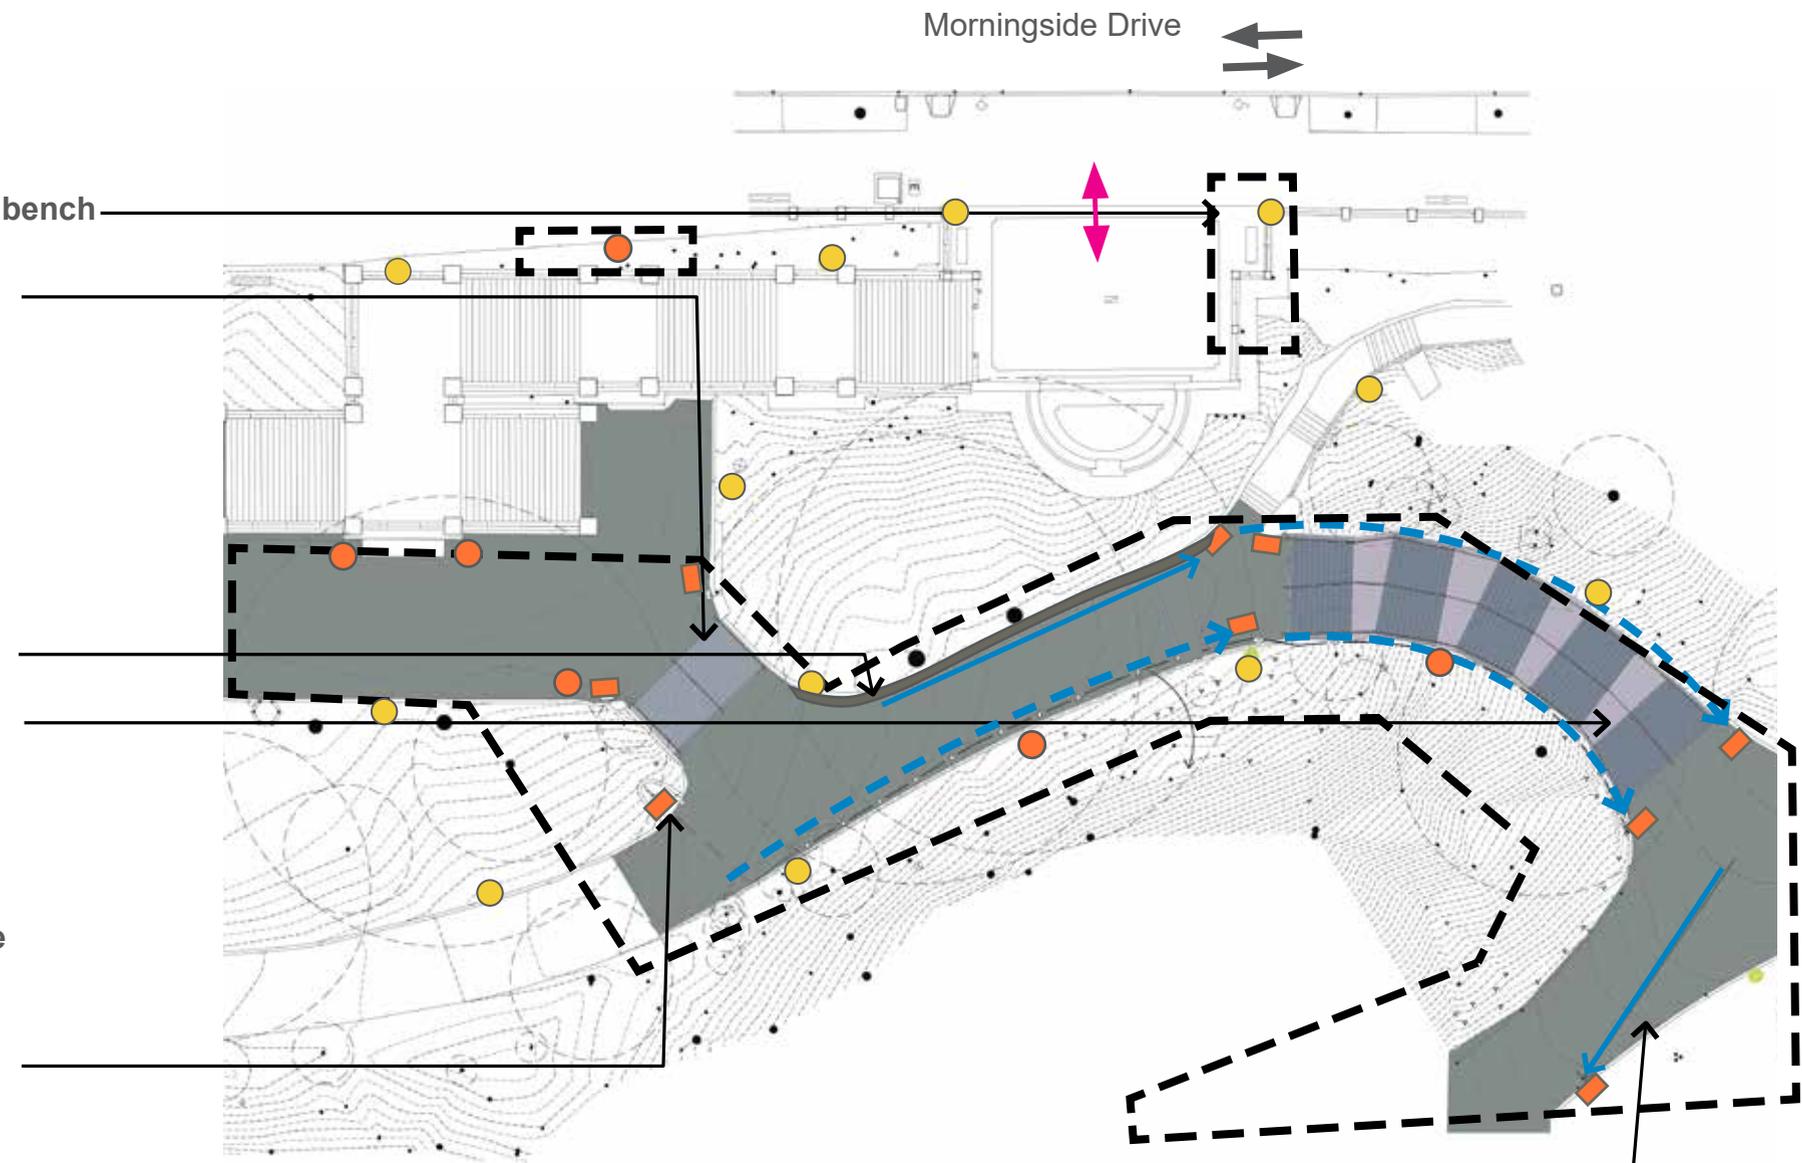
Morningside Park | B. 116th Street Stairs, Proposed Reconstruction

- Reset light and pedestal, coping, bench
- Remove existing non-ADA handrails
- New ADA compliant "Central Park" handrails-center and both sides
- New granite block swale for surface drainage
- Remove existing non-ADA handrails
- New ADA compliant "Central Park" handrails-center and both sides
- Remove and reset existing boulder cheekwalls with drainage materials
- Reconstruct drainage of birdbath with dome grate to prevent overflow
- Regrade asphalt path to existing catch basin

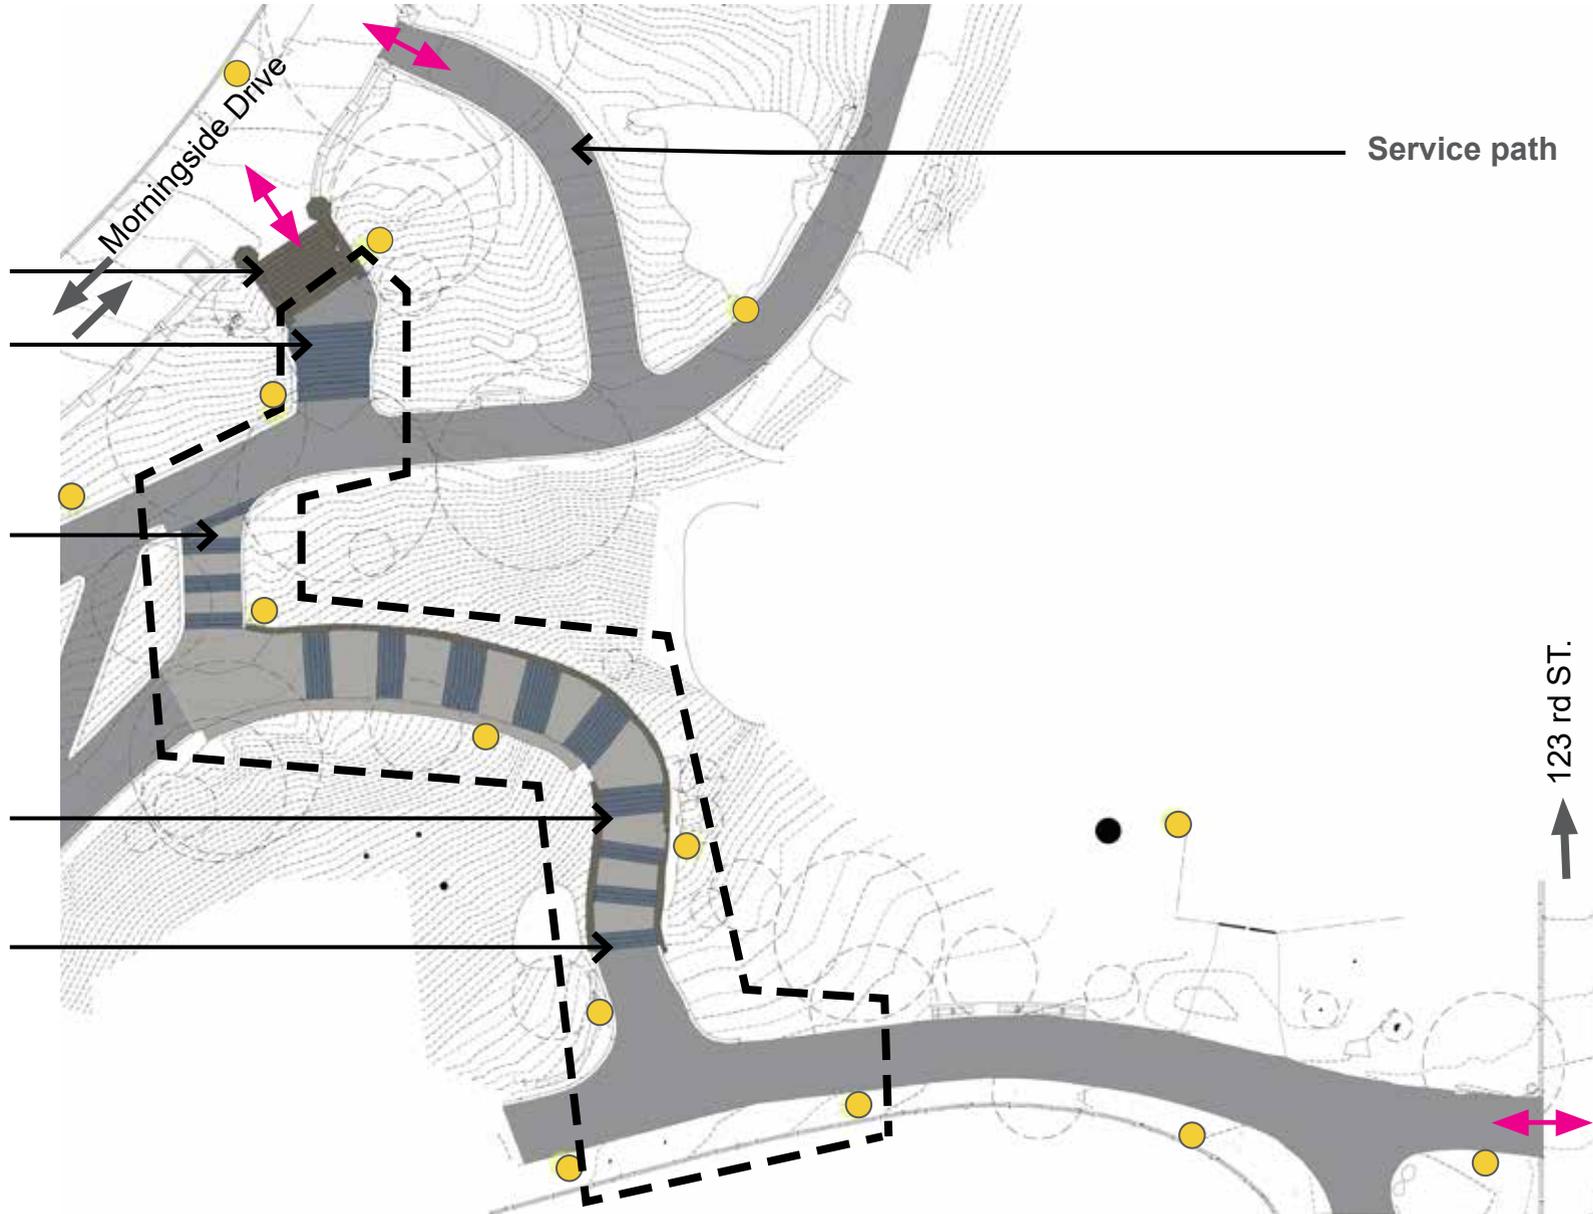
Morningside Park | C. 122nd Street Stairs-Existing Conditions

- Granite stairs-good condition
- No handrails
- Misaligned bluestone treads
- No handrails
- Asphalt landing
- Carved boulder cheekwalls
- Misaligned bluestone treads
- No handrails
- Concrete landings
- Concrete cheekwalls in poor condition
- Misaligned bluestone treads
- Pipe handrail in poor condition
- Concrete landings in poor condition
- Concrete swale in poor condition
- Granite block cheekwalls, disintegrating

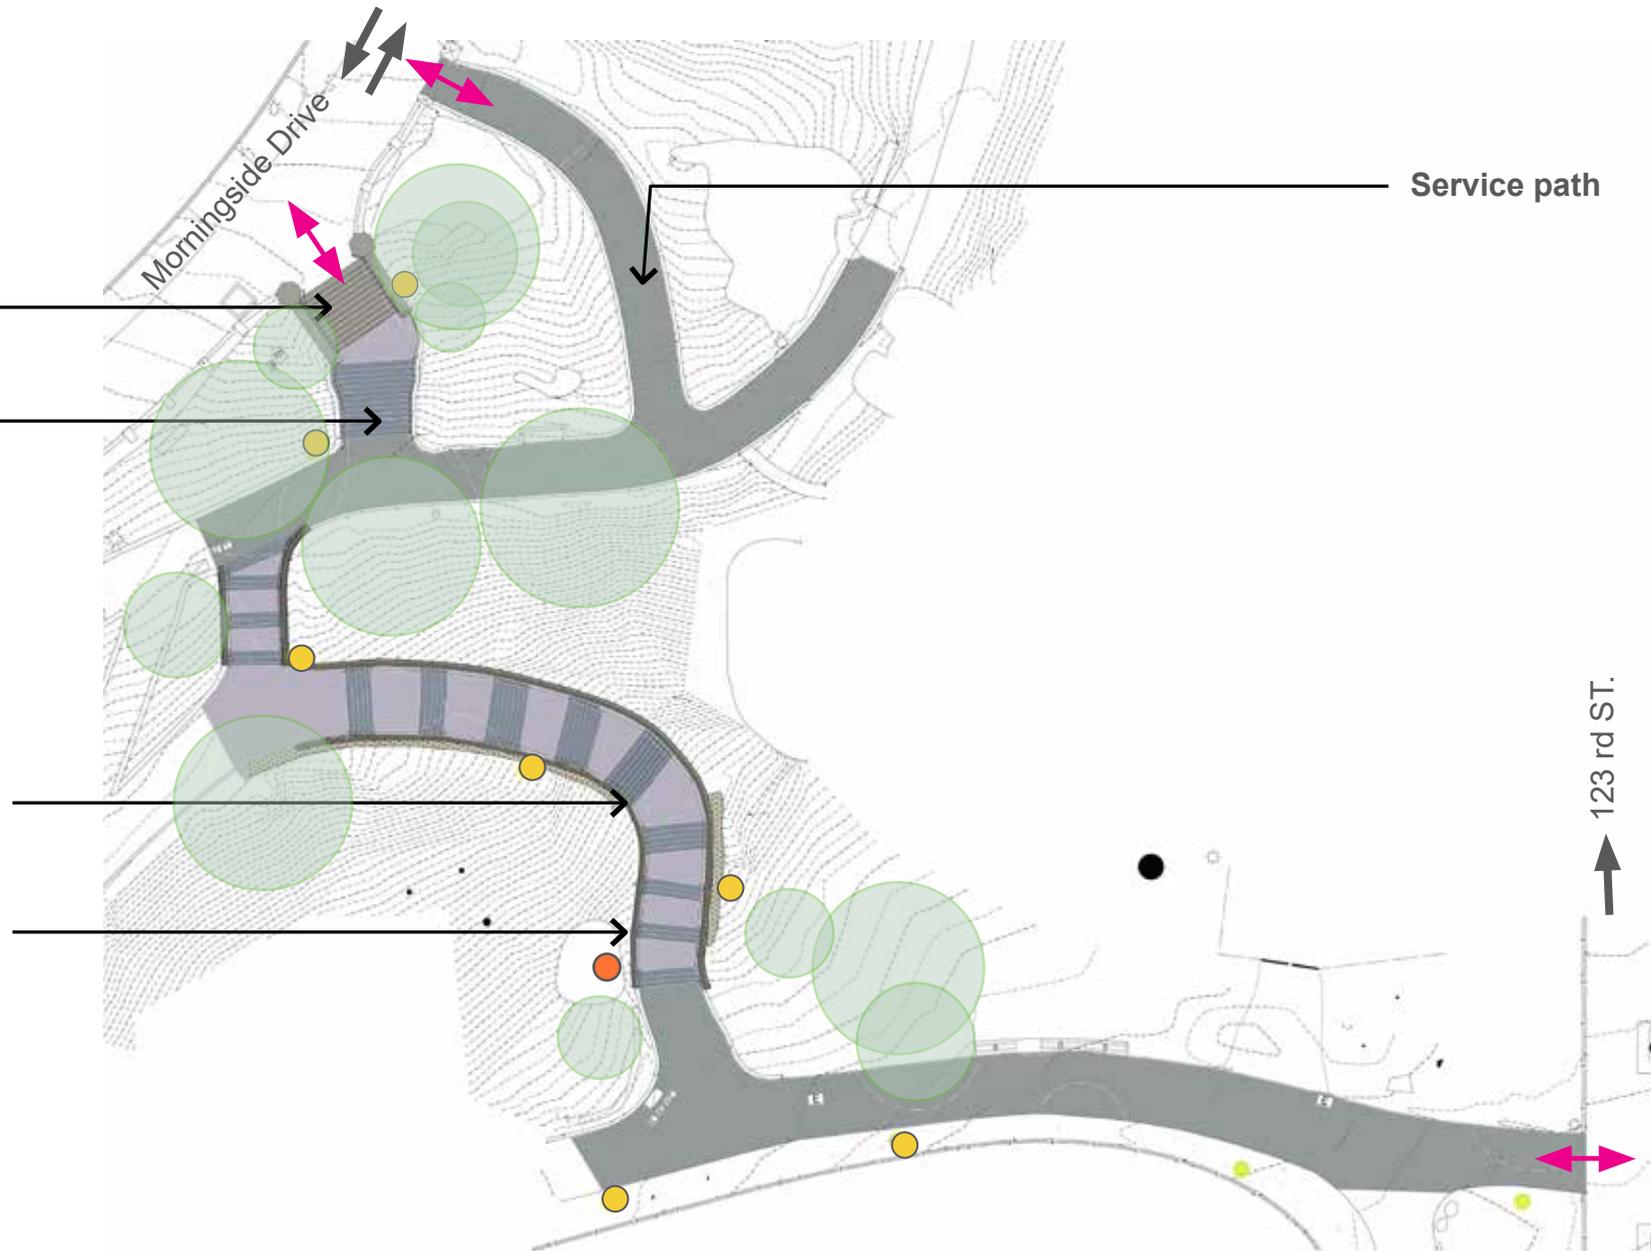
Morningside Park | C. 122nd Street Stairs , Proposed Reconstruction

Granite stairs to remain
Add handrails

Add handrails
Reset carved boulder cheekwalls

Remove concrete swale- reconstruct as granite block swale

Add handrails
Remove granite block cheek walls- reconstruct as granite schist veneer cheekwalls
