Parks

Morningside Park 114th, 116th and 122nd Street Staircases Reconstruction

Public Design Commission Public Review
November 18, 2024
Laura Drawbaugh RLA, NYC Parks

- Make stairs safer and ADA compliant.
- Manage stormwater to prevent flooding.

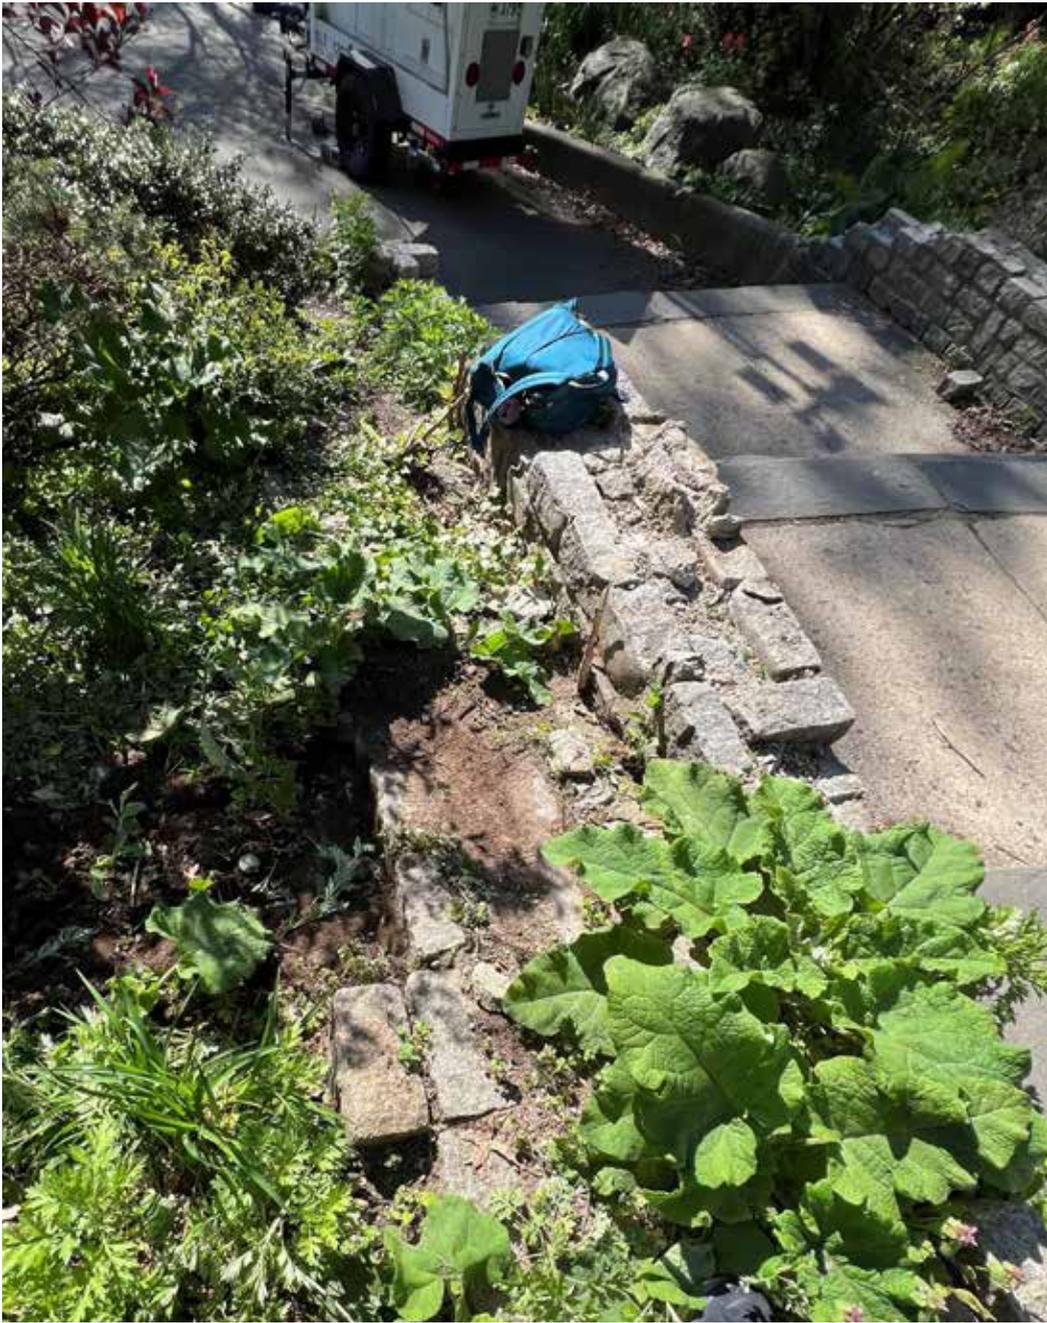
Overgrown swale on the left. 1966 cheekwall was built on top of pre-1964 cheekwall wall but also overlapping the treads, narrowing the stairways.

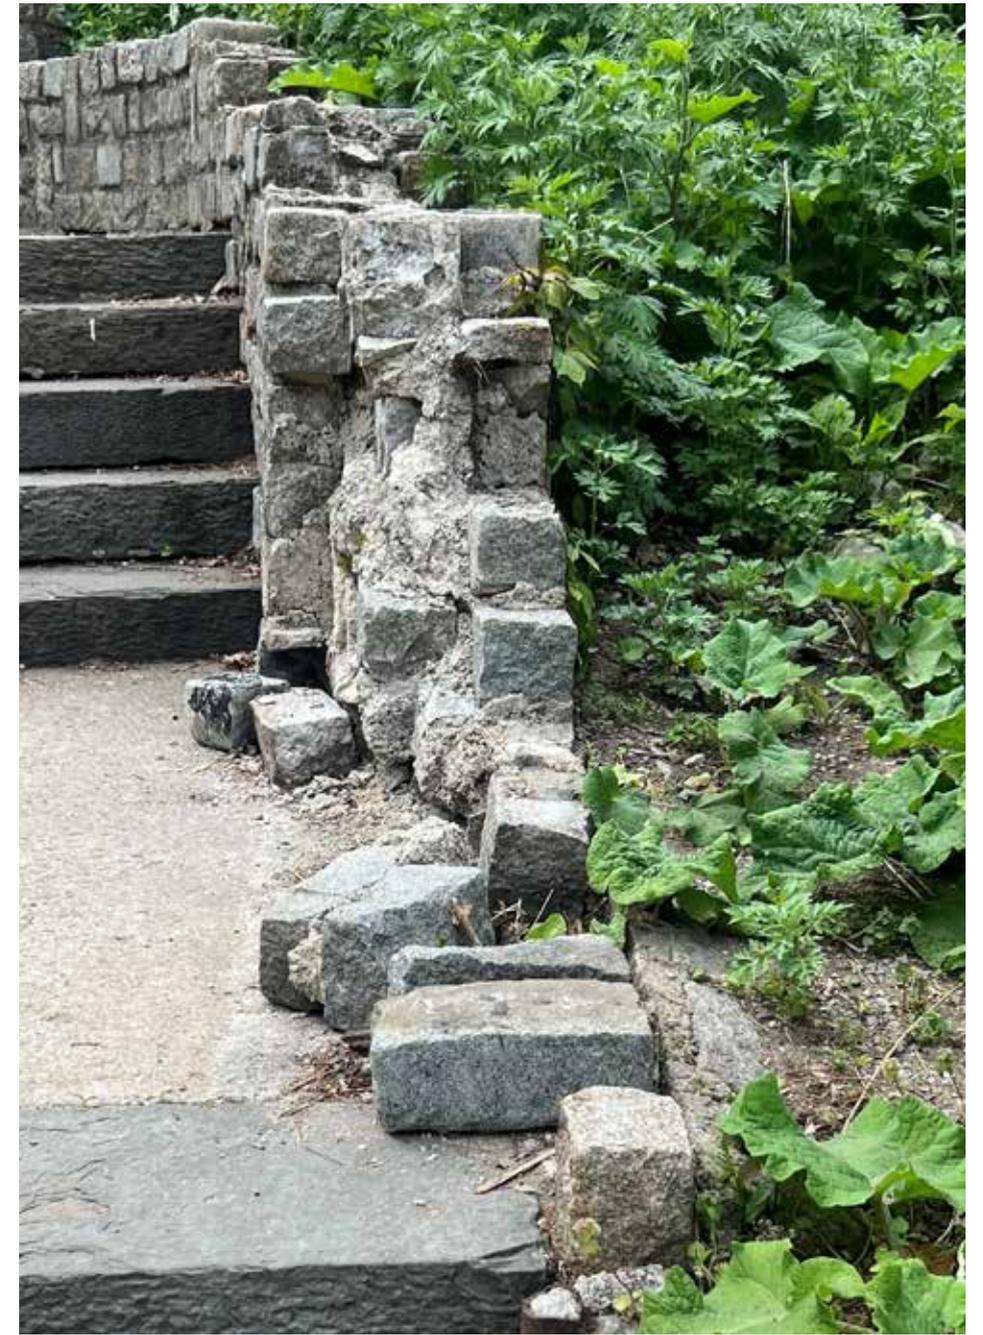
1966 wall overlaps treads by 1-3 granite blocks. Existing wall is 16" wide. No coping allows water in the joints. Lack of coping and poor base is causing granite blocks to separate.

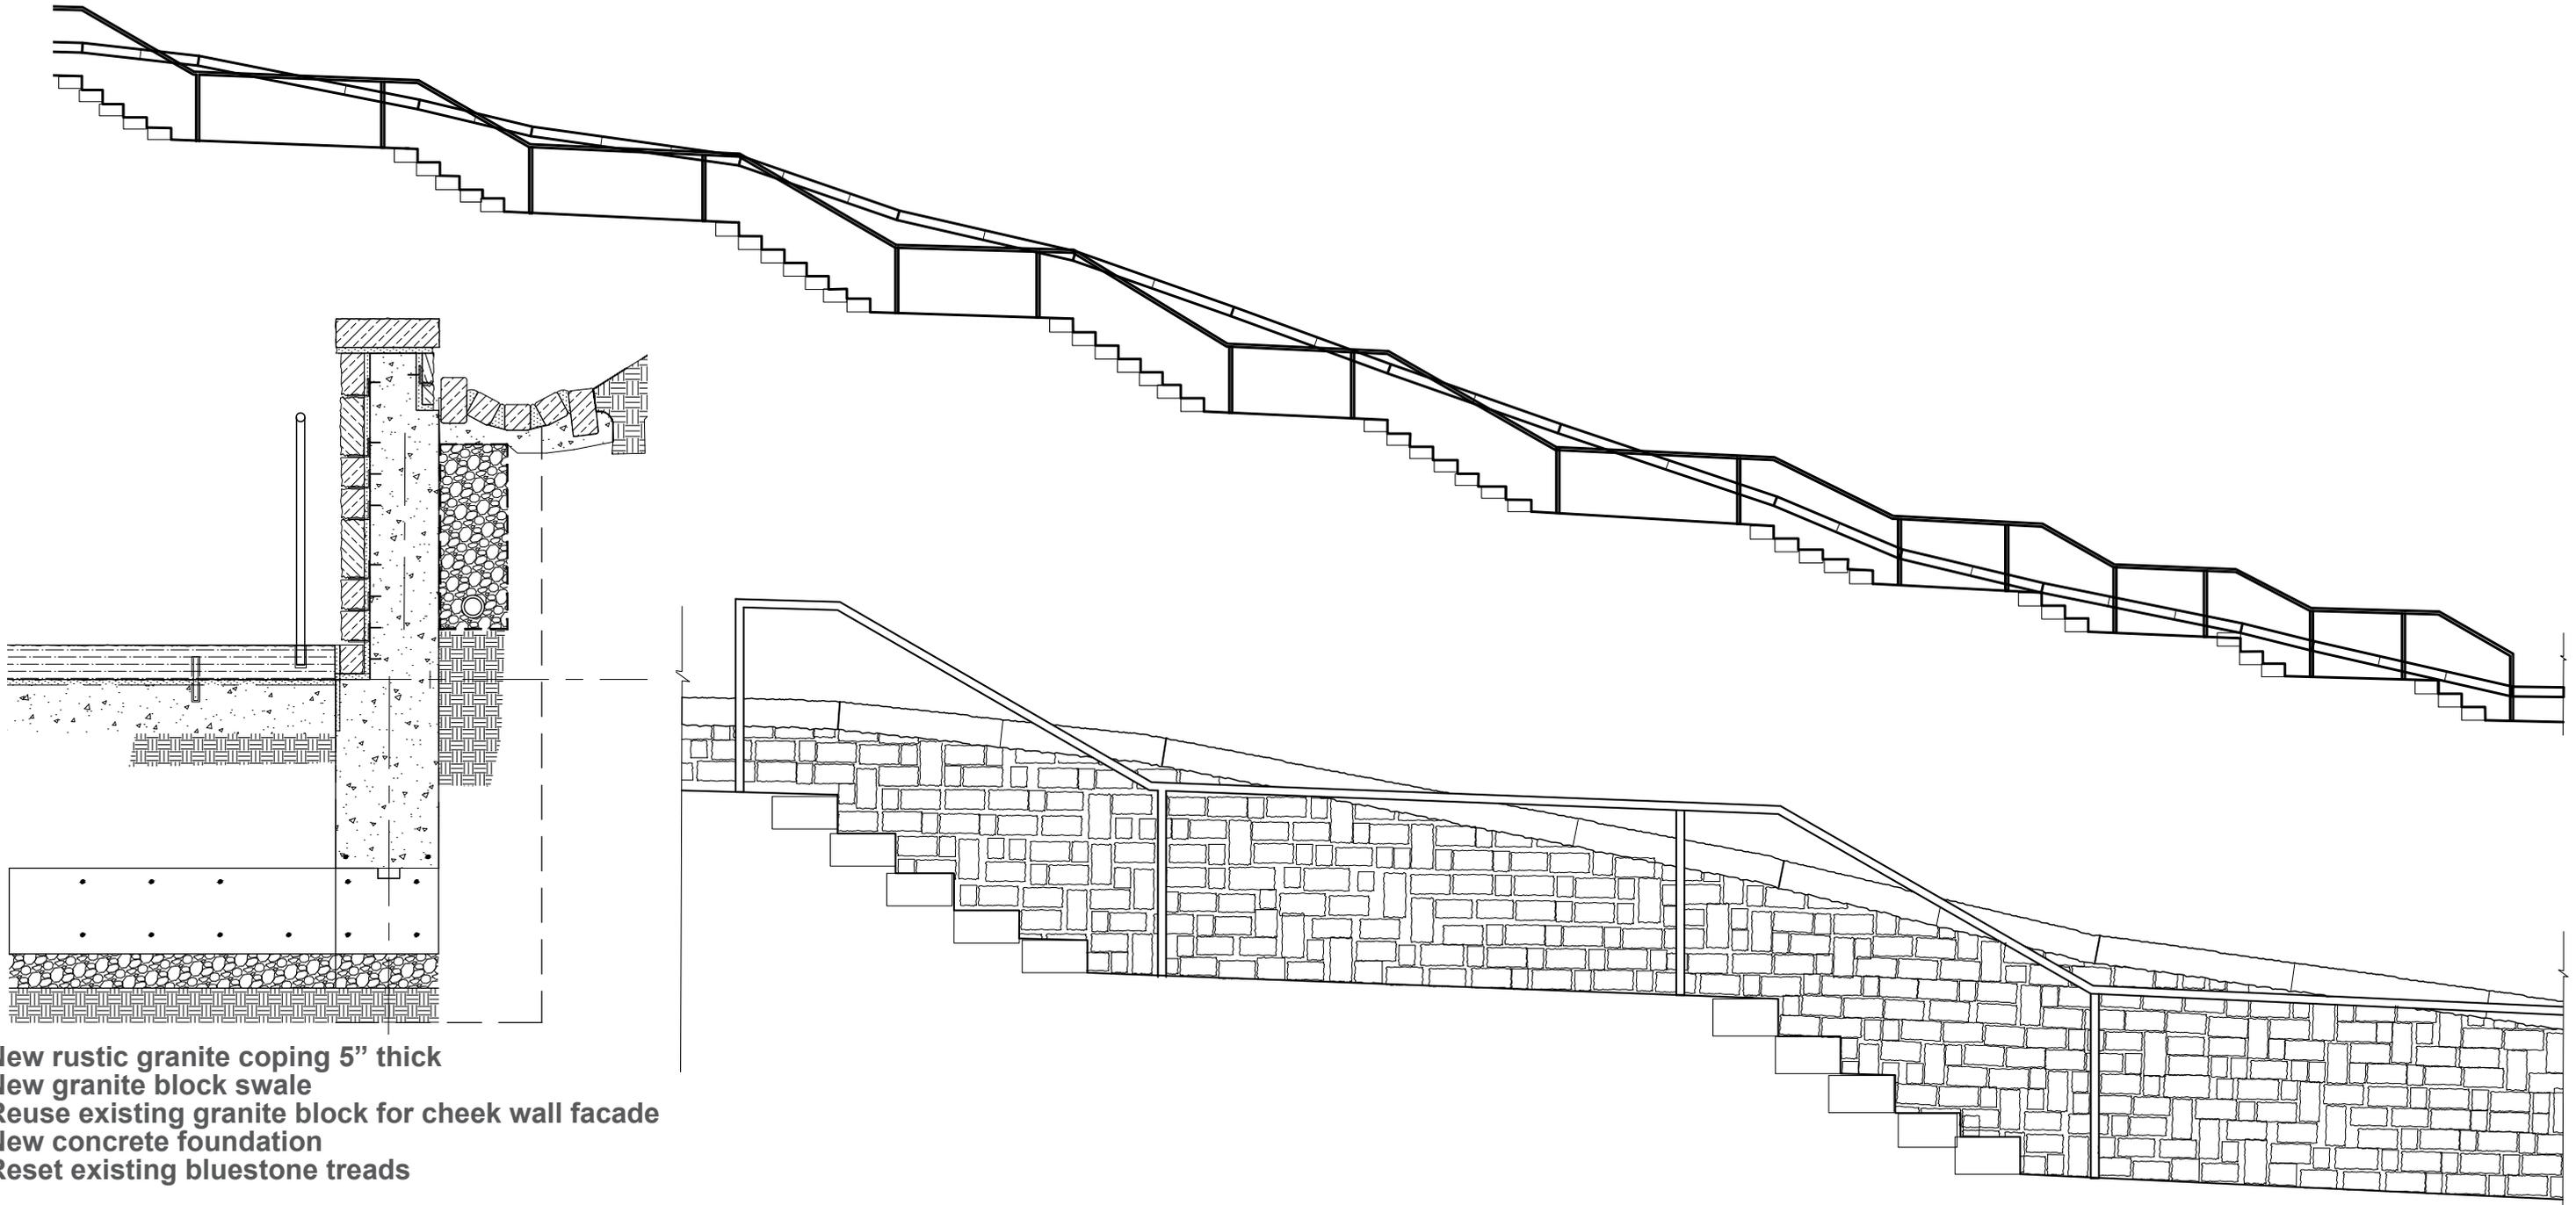
Morningside Park | C. 122nd Street Stairs-North proposed section and elevation

New rustic granite coping 5" thick
New granite block swale
Reuse existing granite block for cheek wall facade
New concrete foundation
Reset existing bluestone treads

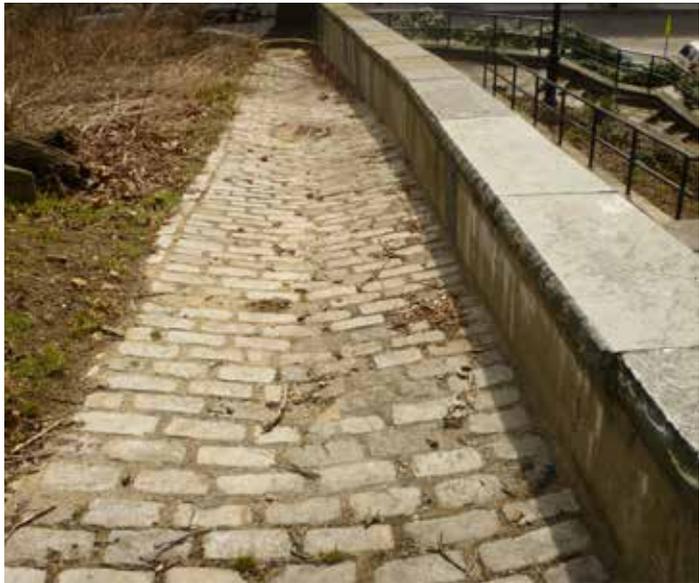
Granite block swale

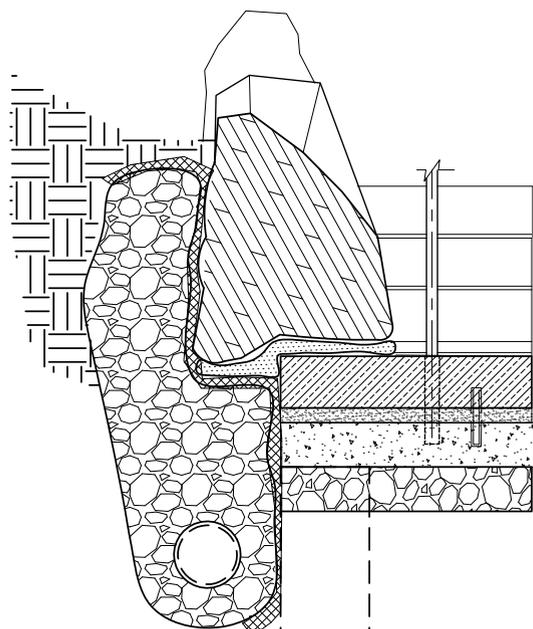
Remove and reset boulder cheekwalls with drainage material and perforated pipe- connect to existing park drainage system

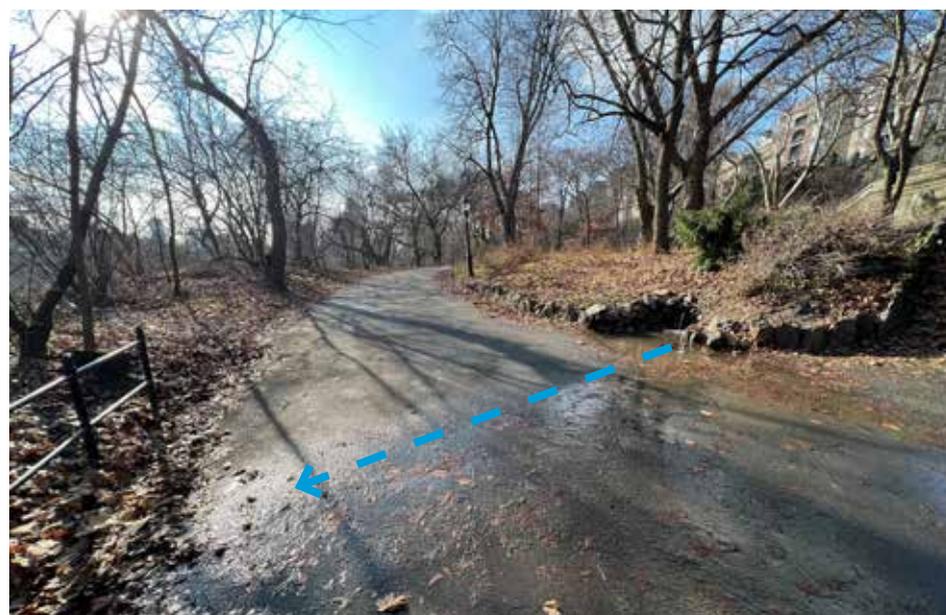
Add new dome grate with drainage connection, connect to existing park drainage system-see next page

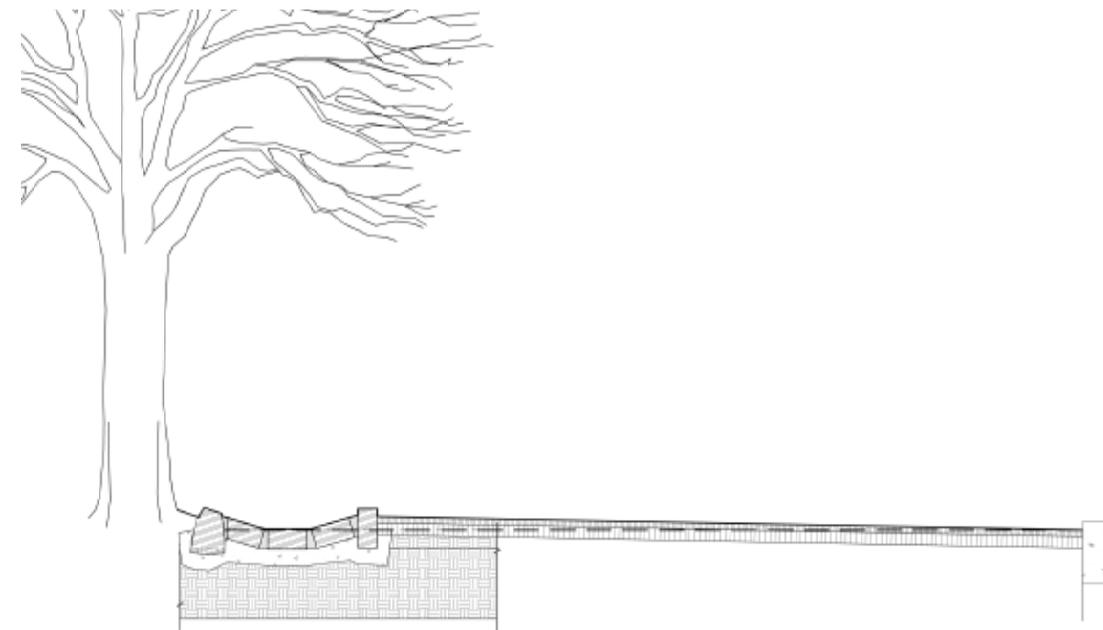
Add new granite block swale-3'-2" wide, with raised edge- connect to existing park drainage system. Raise west grade slightly to protect tree roots
Existing path width: 17'-8"
Proposed path width: 14'-8"

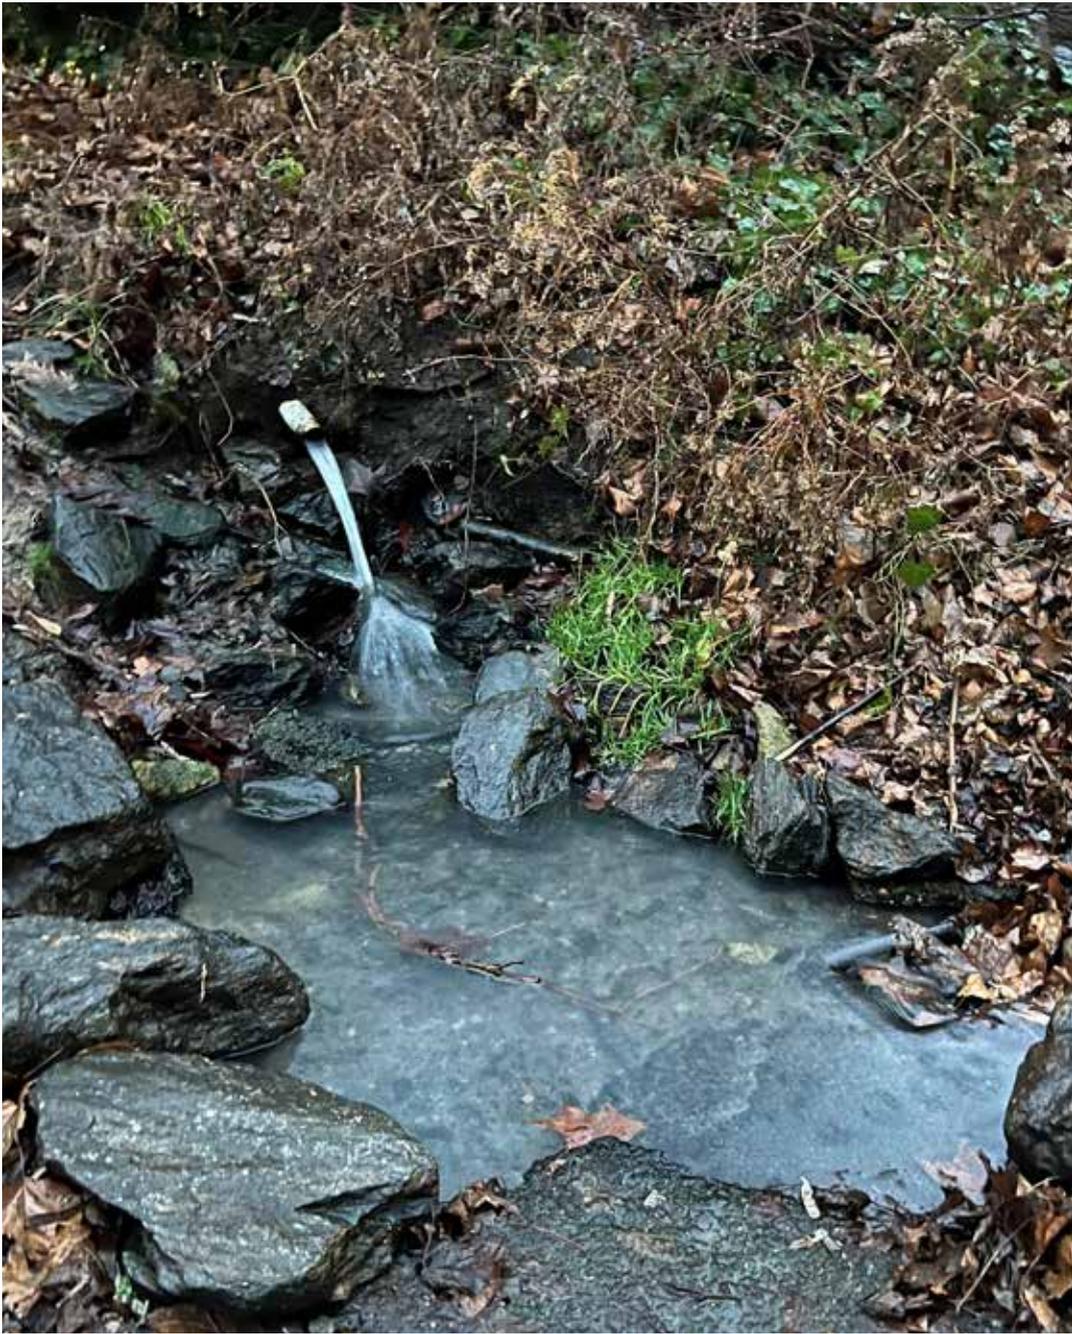
Existing condition: Exposed pipe in depressed area overflows due to clogged drop inlet. Excess water damages the stairs.

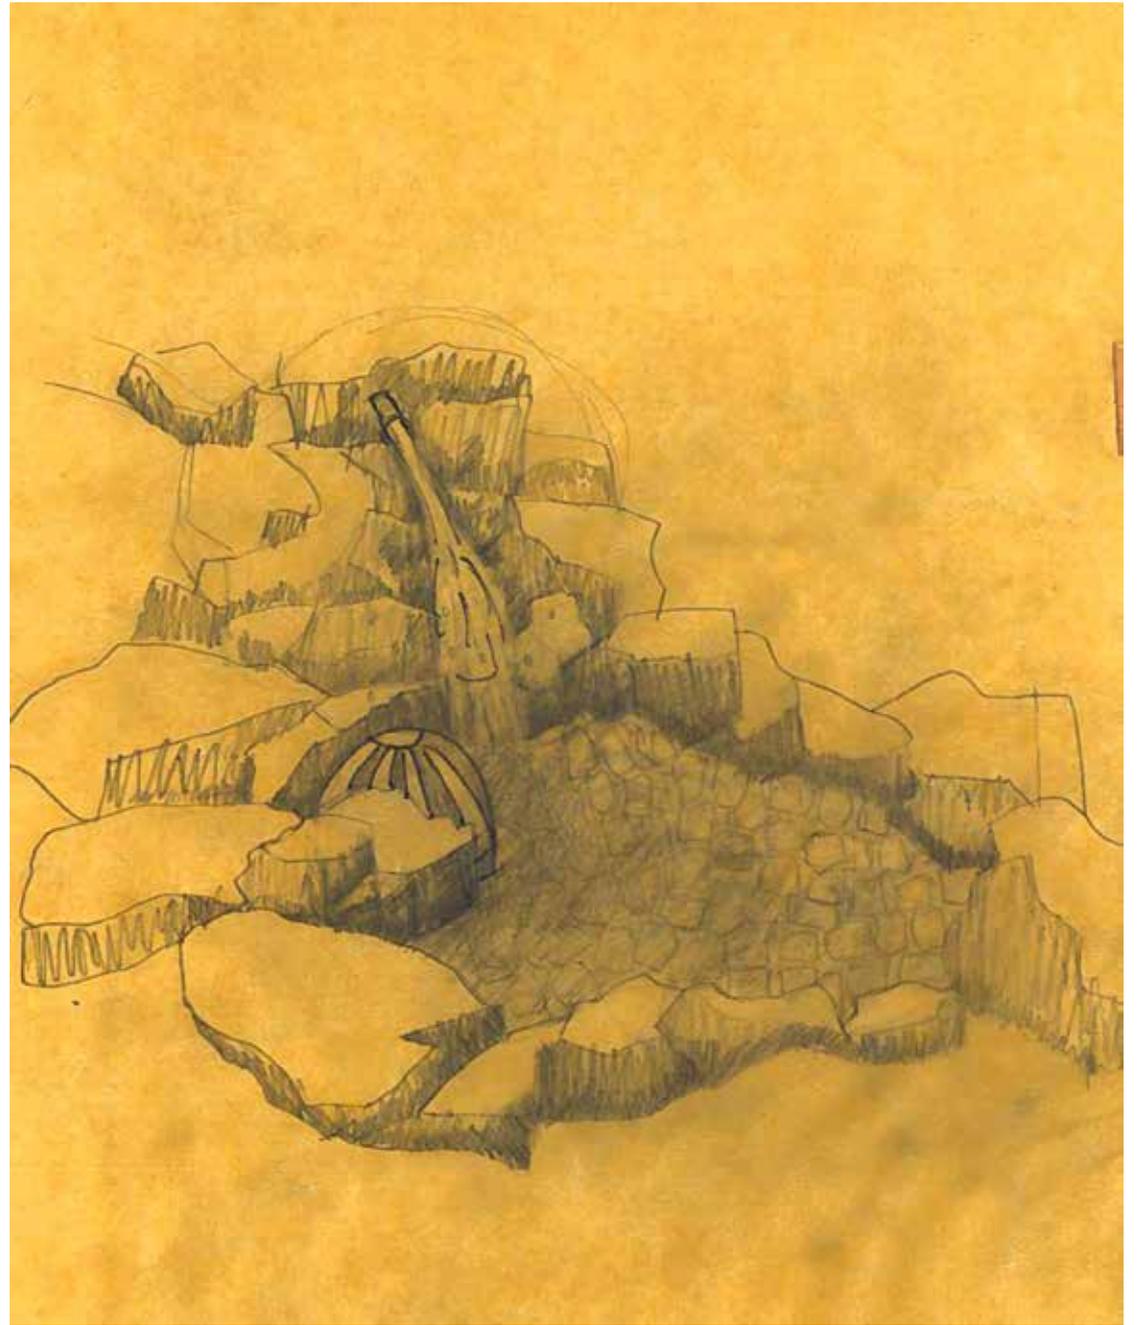
Proposed: Reconstruct drainage of depressed area with dome grate to prevent overflow. Line basin with mortared granite setts.

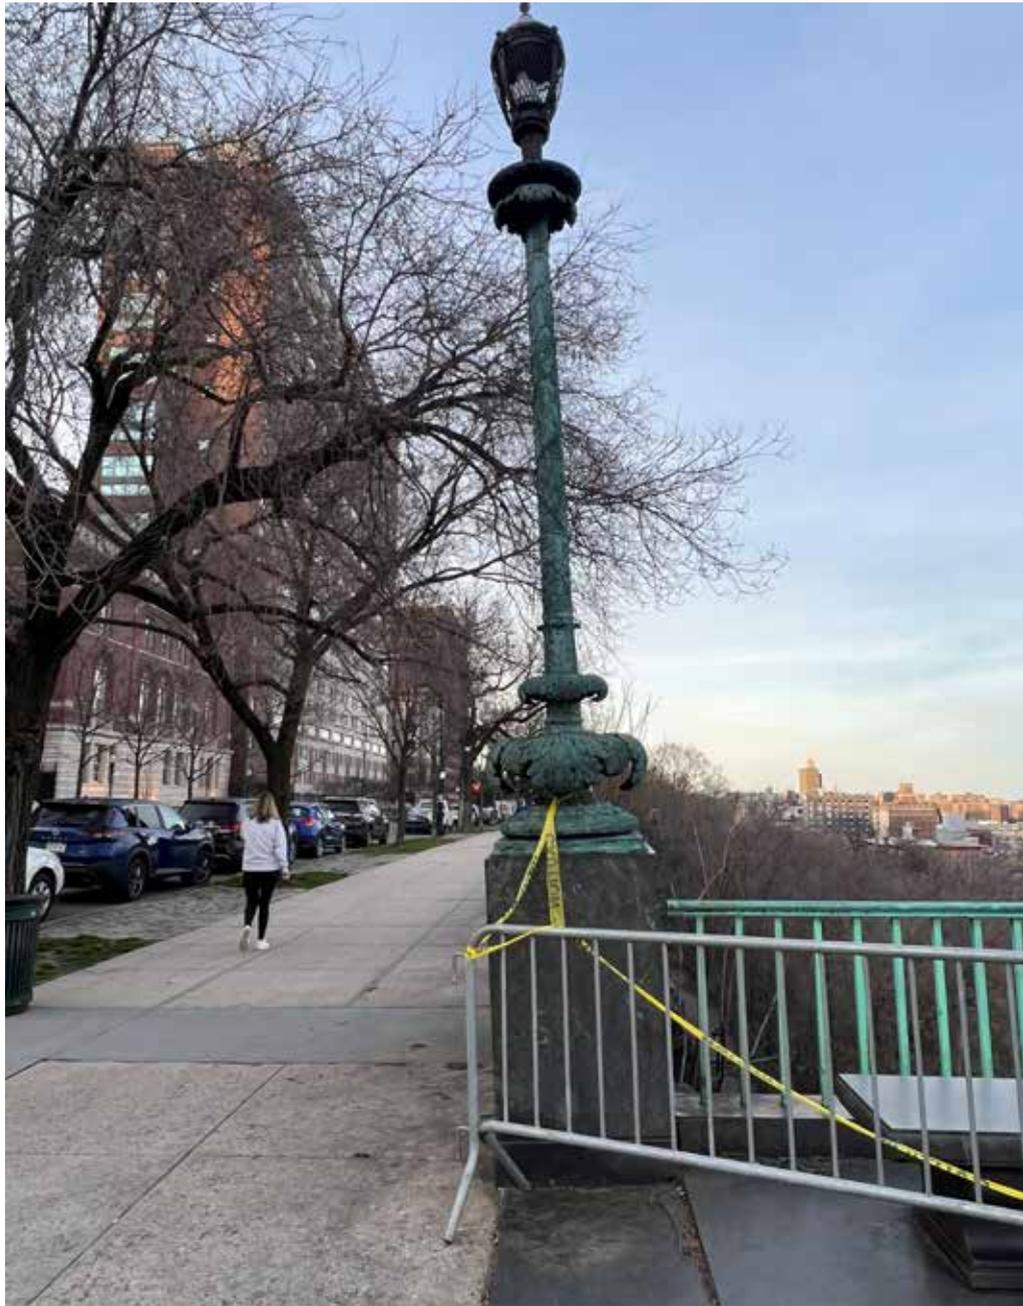
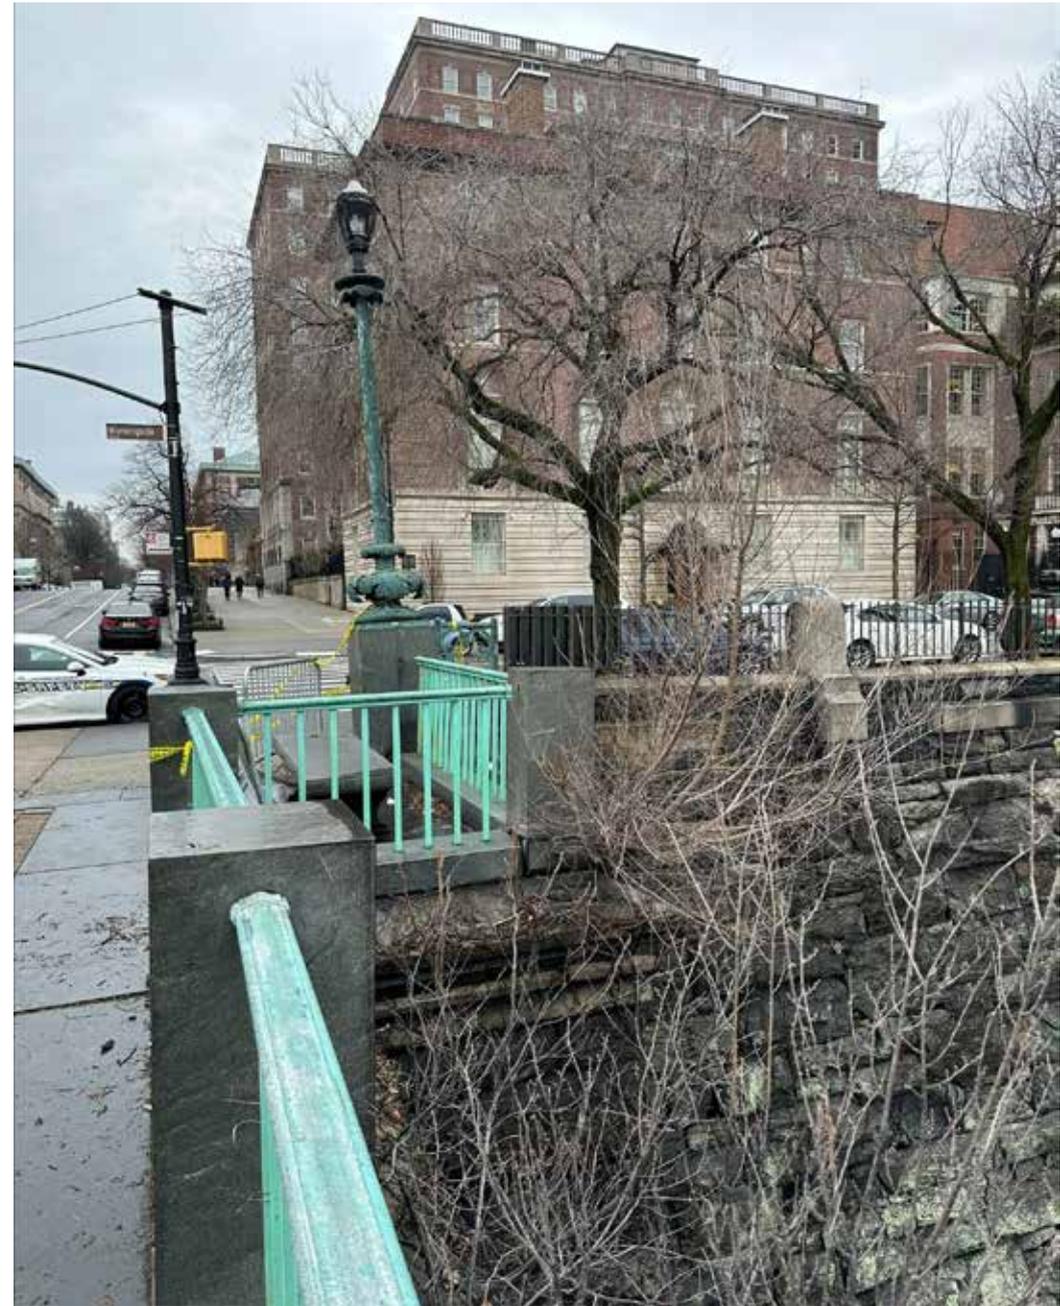
Leaning historic light and pedestal:
Remove and reset pedestal and light pole, re-attach railing to removed and reset granite posts, remove and reset schist coping dislodged by roots, remove and reset granite curb
