DASNY (No. 371410)  
Staten Island Family Court Complex  
Bridging Consultant Services

PDC Conceptual Presentation  
18 August 2025

# Staten Island Family Court Complex

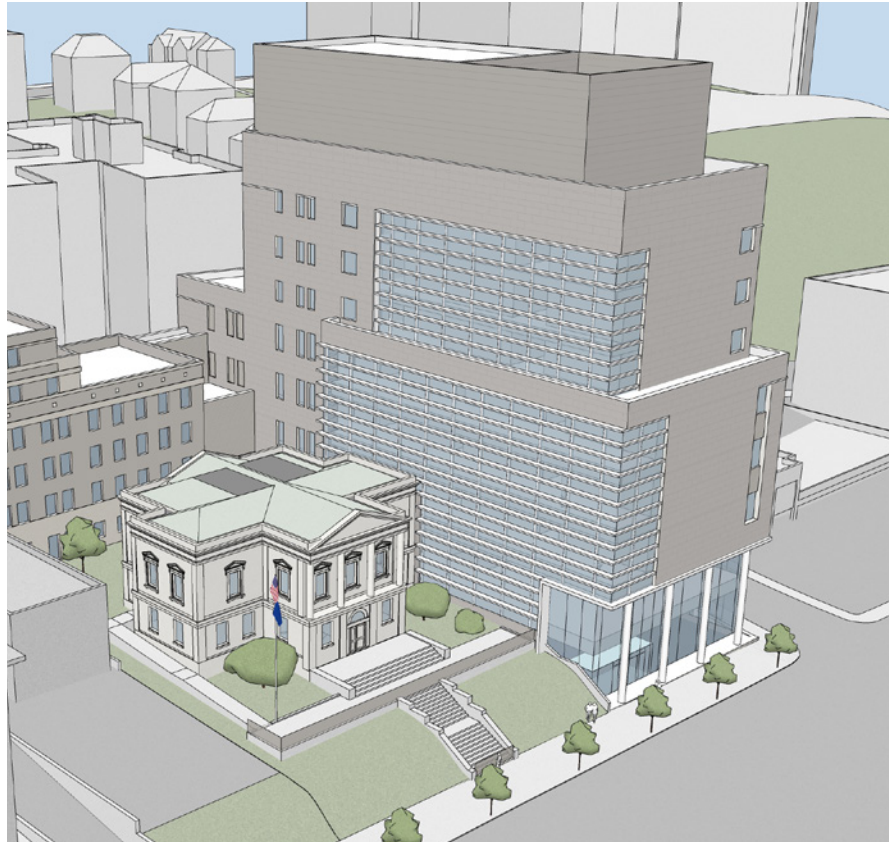
No Plaza  
Stair and Berm

- New Family Courthouse entrance and lobby is in 10 Hamilton.
- Historic courthouse stairs and yard must be fenced off to maintain secure perimeter and prevent public trying to approach the former main entrance.

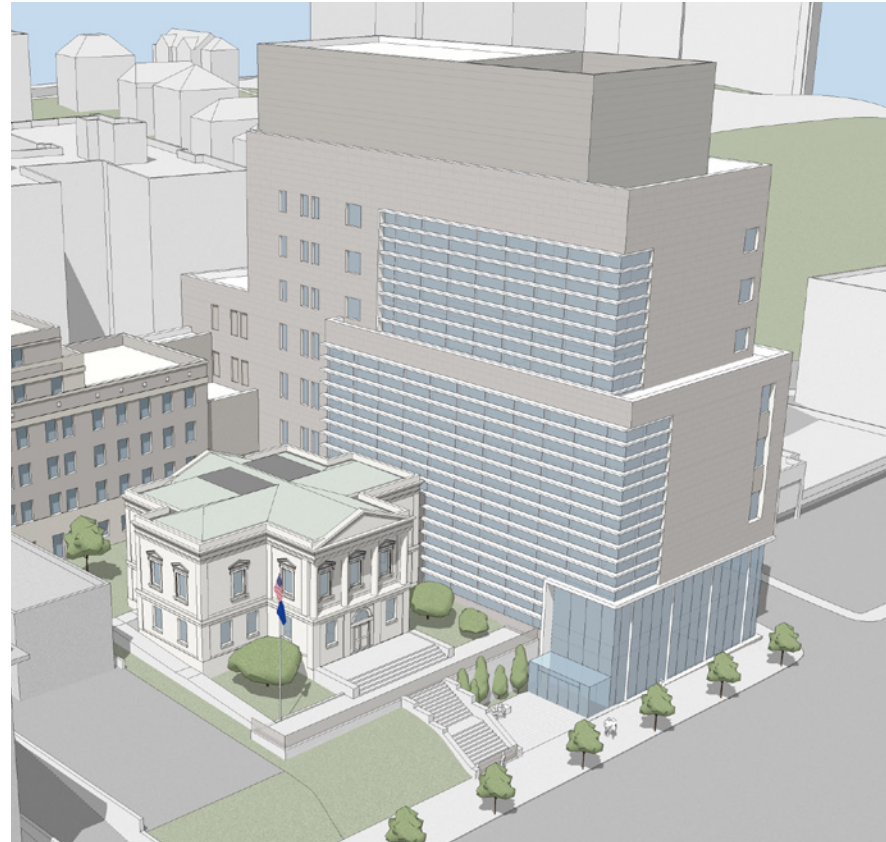
Small Plaza  
Stair and Partial Berm

- Berm is partially excavated to create small public plaza and entry to the building along Richmond Terrace.
- Historic courthouse stairs and yard remain inaccessible.
- Historic grand stair adjacent to the small new entry plaza creates confusion as to which is the primary entrance.

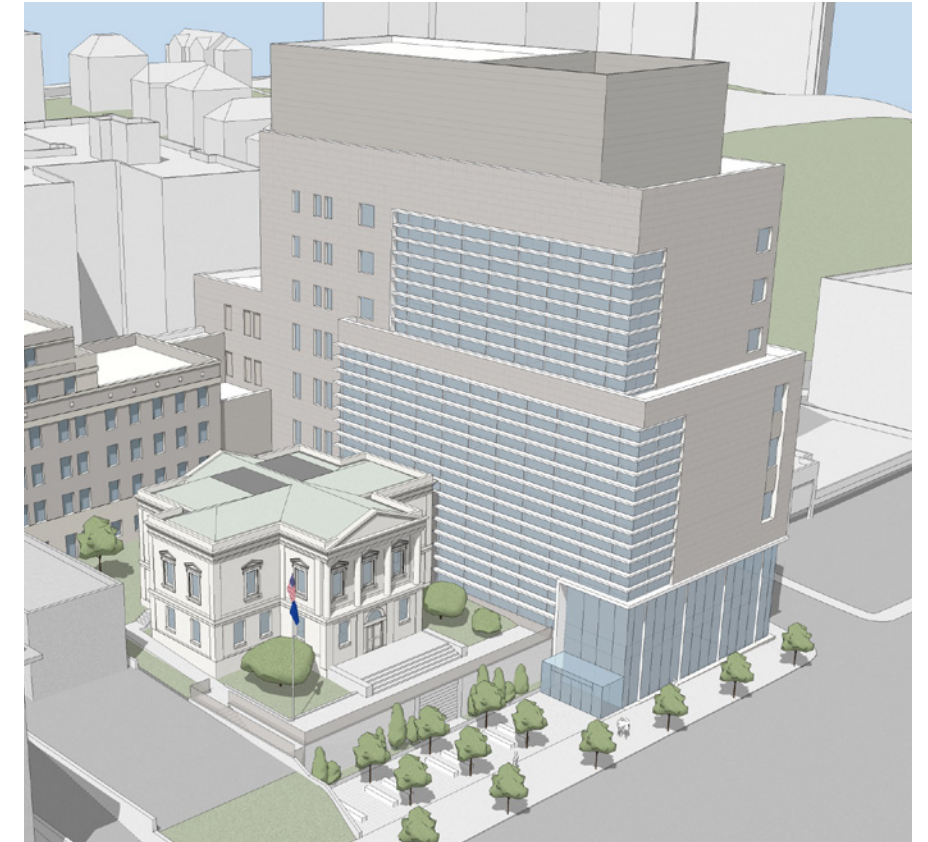
Large Plaza  
Remove Stair and Berm

- Stair and berm are removed to create open and welcoming public plaza for the court and community.
- Public entrance is clearly visible and entrance plaza is proportionate to the size of the courthouse and lobby.
- Retaining wall provides a secure perimeter while not obstructing views of the historic courthouse.

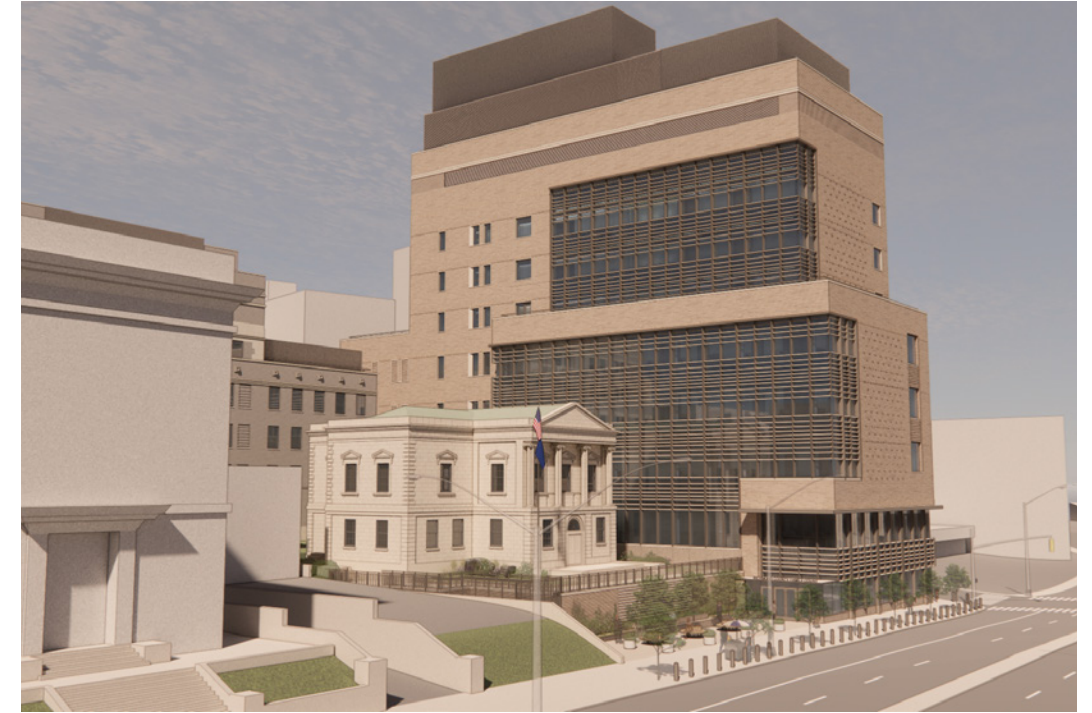
## South Facade

- Restore existing terracotta facade
- New high performance sash windows with applied muntins to match historic profiles.

- Repair, repoint, and restore existing brick masonry, stone, and coping.
- New high performance fixed casement windows with applied muntins to match historic profiles.
- New custom exterior doors with high performance IGUs and decorative grille to match historic profiles.

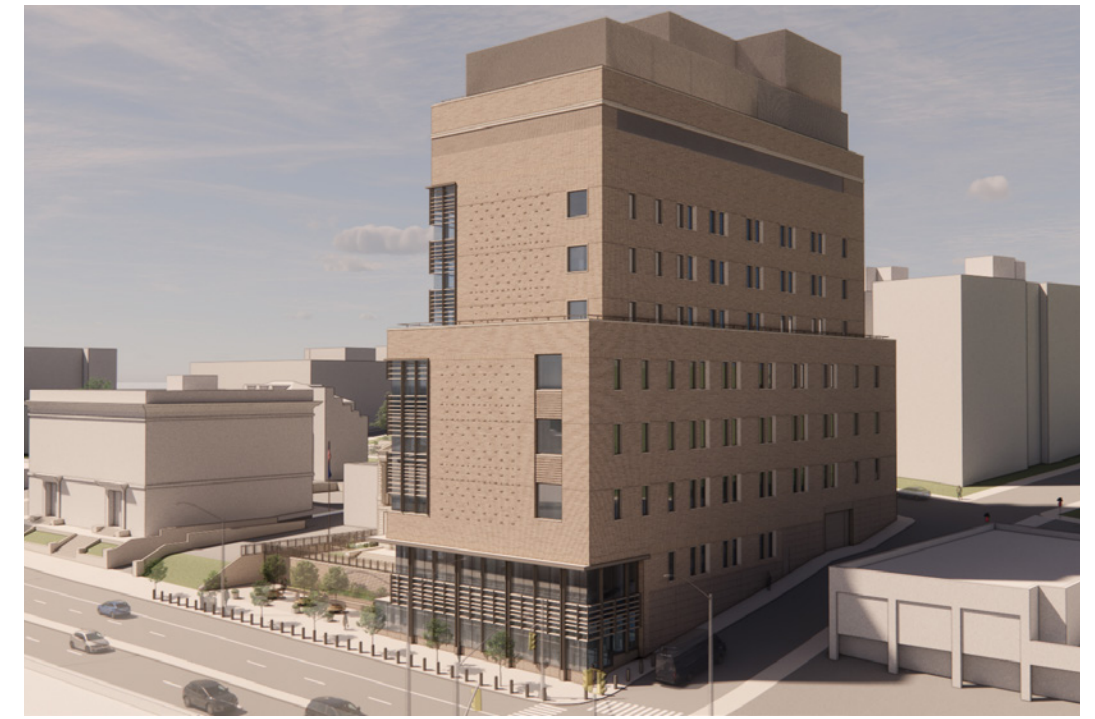
## East Facade

- Restore existing terracotta facade
- New high performance sash windows with applied muntins to match historic profiles.

- Repair, repoint, and restore existing brick masonry, stone, and coping.
- New high performance fixed casement windows with applied muntins to match historic profiles.
- New custom exterior doors with high performance IGUs and decorative grille to match historic profiles.

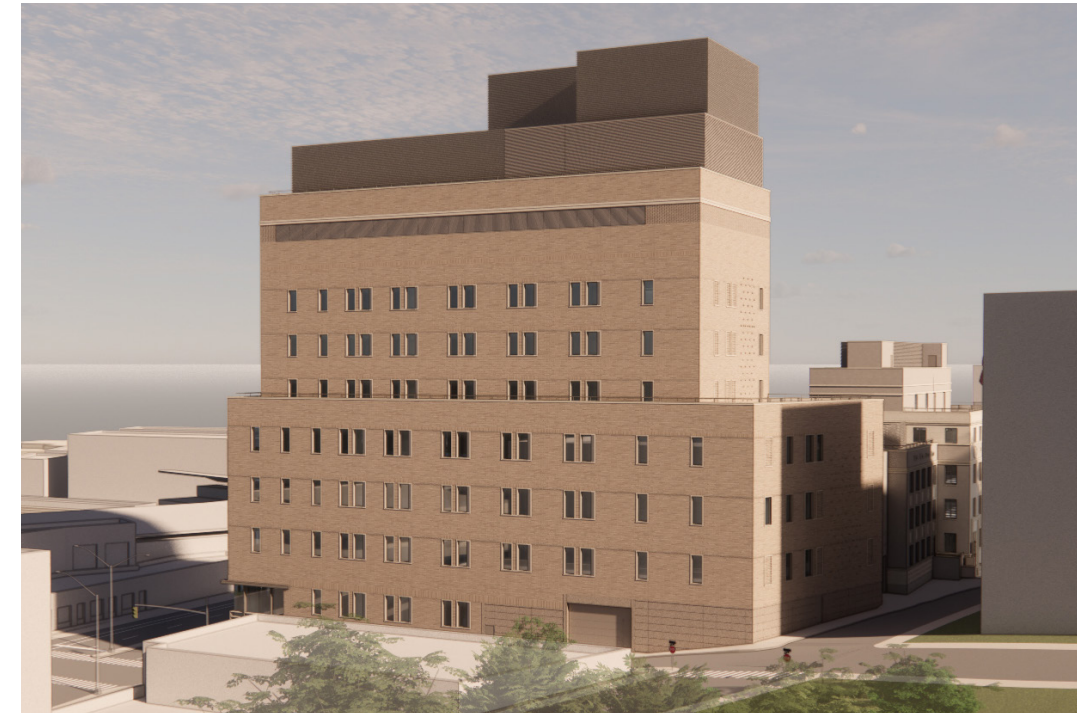
## North Facade

- Restore existing terracotta facade
- New high performance sash windows with applied muntins to match historic profiles.

- Repair, repoint, and restore existing brick masonry, stone, and coping.
- New high performance fixed casement windows with applied muntins to match historic profiles.
- New custom exterior doors with high performance IGUs and decorative grille to match historic profiles.

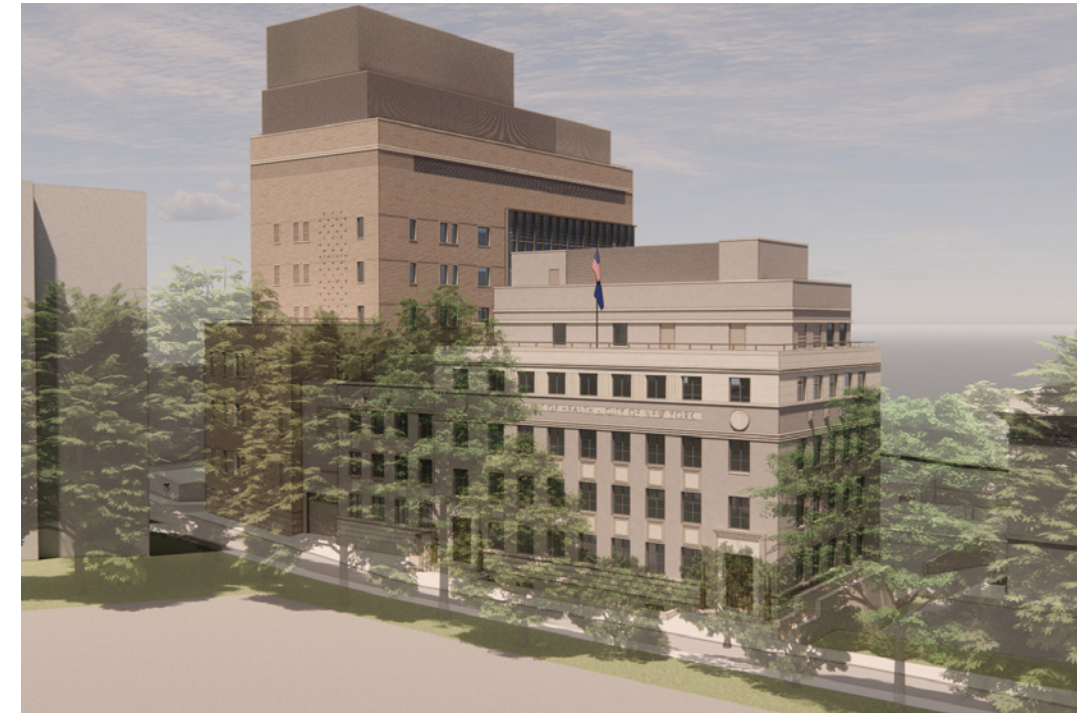
## West Facade

- Restore existing terracotta facade
- New high performance sash windows with applied muntins to match historic profiles.

- Repair, repoint, and restore existing brick masonry, stone, and coping.
- New high performance fixed casement windows with applied muntins to match historic profiles.
- New custom exterior doors with high performance IGUs and decorative grille to match historic profiles.

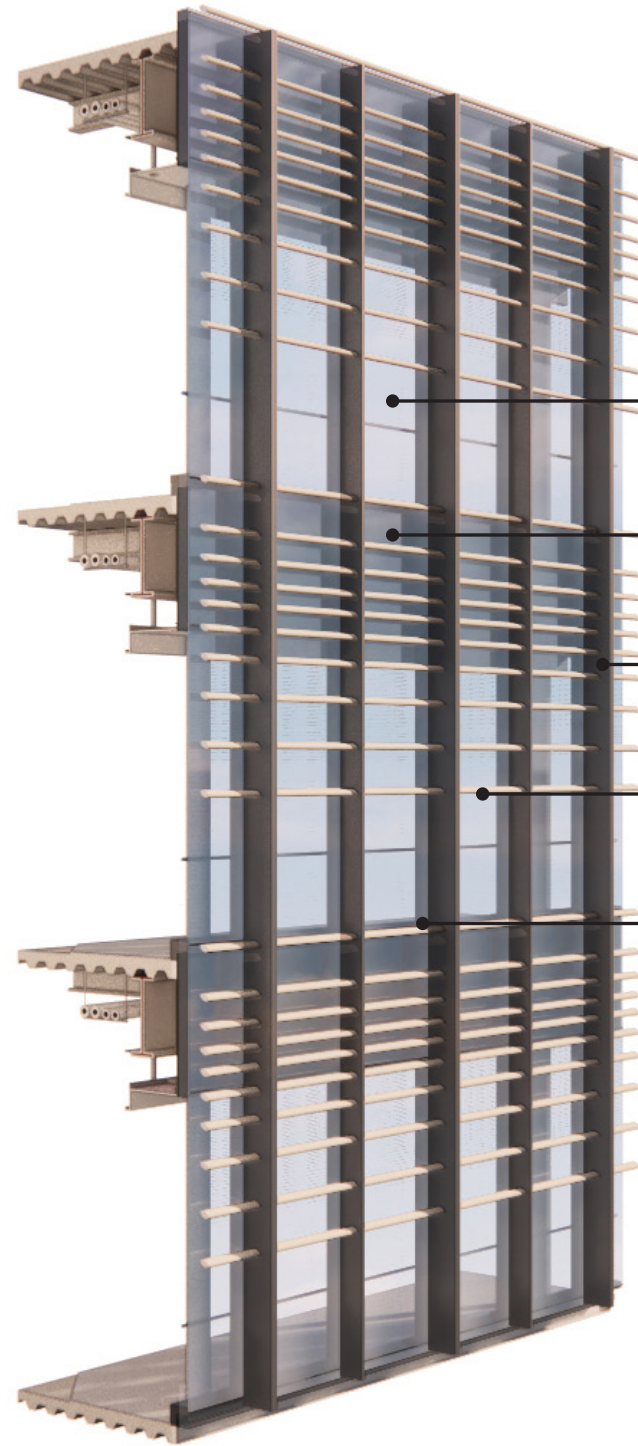
*INSULATED GLASS UNIT*

*GLAZED SPANDREL PANEL*

*VERTICAL FIN SUNSHADE  
ALUMINUM EXTRUSION IN BRONZE FINISH*

*HORIZONTAL SUNSHADE  
ALUMINUM EXTRUSION IN*

*REINFORCED MULLION*
