Appendix F1
Natural Resources Survey

MEMORANDUM

Re: SANDRESM1 East Side Coastal Resiliency Project:
Natural Resources Shoreline Survey

Photo Location Map and Photo Log

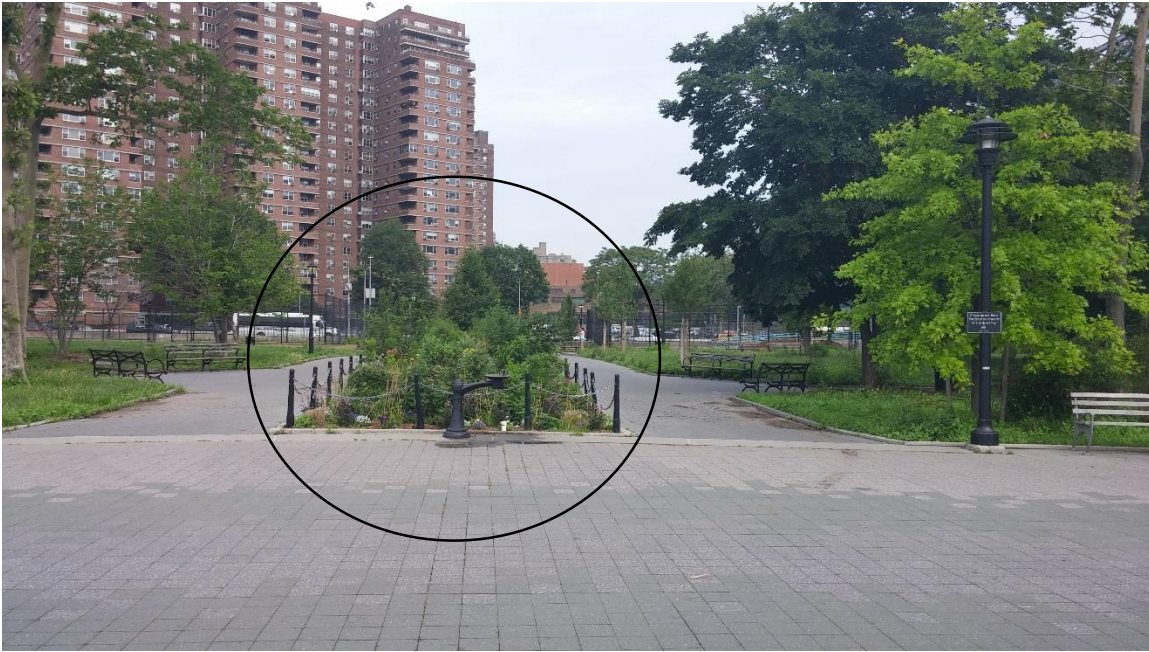
Photo 2 – Healthy landscaped bed of mostly ornamentals in East River Park. Several dragonflies observed at this location. Photo taken facing west.

The vegetation documented throughout the surveys consisted primarily of landscaped planted beds in East River Park. These beds were lined with mulch and contained some native species, such as seaside goldenrod (*Solidago sempervirens*) and joe-pye-weed (*Eupatorium maculatum*), that provide habitat and foraging opportunities for pollinators. The majority of the vegetation in these beds consisted of ornamental plants (Photo 3). An invasive species, common reed (*Phragmites australis*), was also present in small, young stands in several beds. Most of these landscaped beds contained large areas of mulch, a sparse herbaceous layer and an evenly spaced shrub layer (Photo 4). Trees were present in most landscaped beds and included species such as swamp white oak (*Quercus bicolor*), London plan tree (*Platanus x acerifolia*), and red oak (*Quercus rubra*). The majority of the landscaped beds that lined the waterfront pathway are consistent with these attributes. The plants in these beds appeared healthy and well maintained. Other locations in the interior of the park such as south of the Williamsburg Bridge and adjacent to the basketball courts contained landscaped beds that were also composed of mostly ornamentals in excellent health and robust in size (Photo 2).

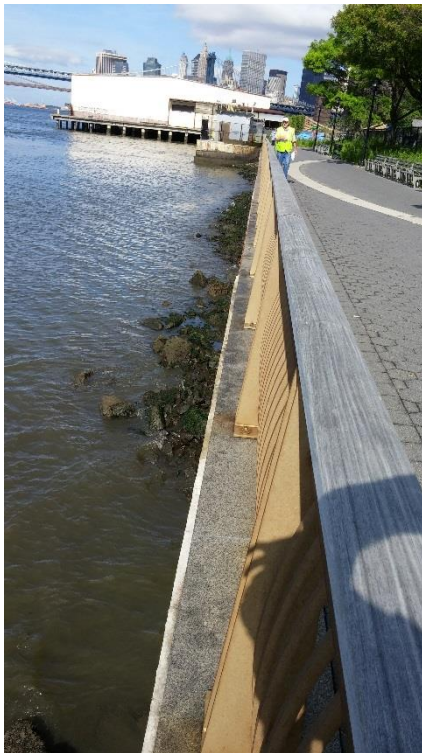
Photo 5 –Exposed intertidal rock with small areas of sand and gravel along bulkhead north of Pier 42 at low tide. Flooded at high tide. Photo taken facing west.

Starting at Pier 42 and extending several hundred feet north (Photo 5), the edge of the riprap shoreline was evident during low tide. During wave ebbs, small areas of gravel and sand substrate were temporarily exposed. Wave energy at this location was high (Photo 6). Some of the riprap in this area contained green algae (*Ulva* spp.) and rockweed (*Ascophyllum* spp.). Barnacles (insert scientific name) were also observed on the exposed bulkhead surface below the water line. No other invertebrates or plants, and no fish were observed in this area. (Said already)

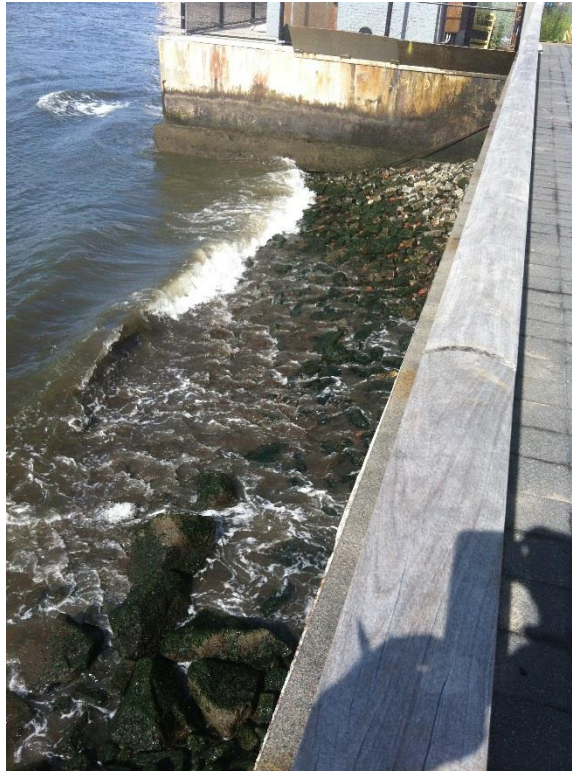
Photo 6 – High wave energy and intertidal substrate of rock and sand located north of Pier 42 at low tide. Rocks contained some submerged aquatic vegetation consisting of rockweed and green algae. Photo taken facing southwest.

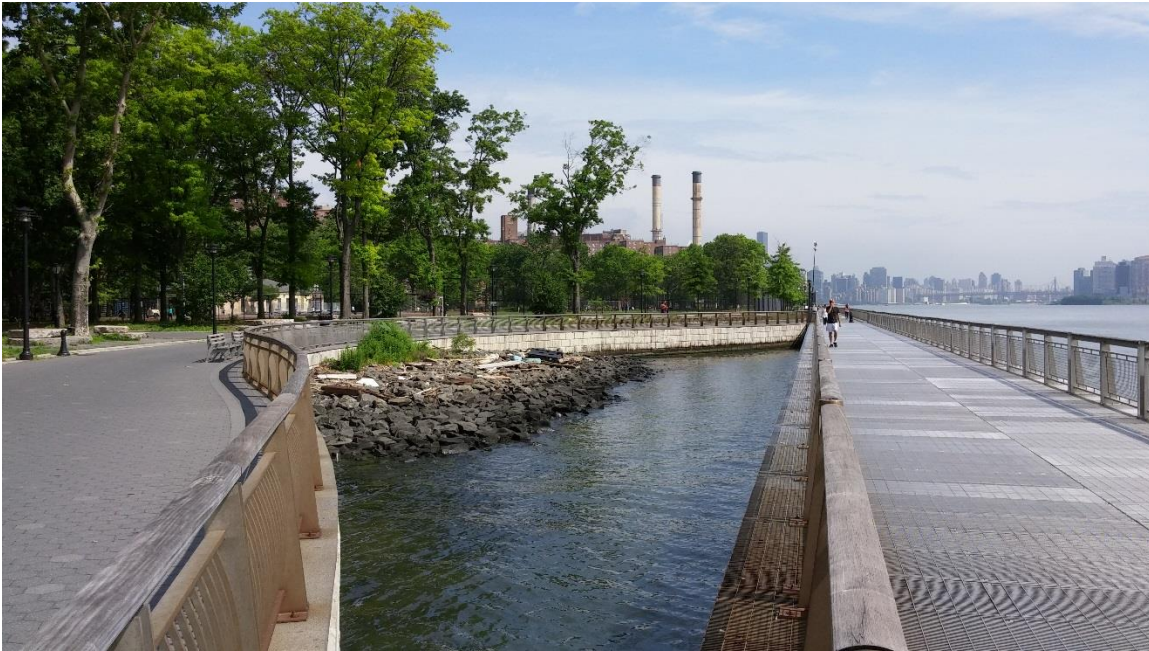
Photo 8 – Riprap cove feature in East River Park, between East 4th Street and East 5th Street. High tide. Upland vegetation located at highest point. Photo taken facing north.

Two constructed coves are present in East River Park north of the Williamsburg Bridge. These coves are hardened and have a large riprap embankment (Photo 8). At low tide, no substrate type other than riprap was observed (Photo 10). On the lowest riprap, green algae and rockweed were observed (Photo 10). On the highest elevation where high tides do not reach, some upland vegetation was observed including sunflower (*Helianthus* spp.), mugwort (*Artemisia vulgaris*), rye-grass (*Lolium* spp.), narrow-leaved plantain (*Plantago lanceolata*), morning glory (*Ipomoea* spp.), and a honey-locust seeding (*Gleditsia triacanthos*). No other invertebrates or plants, and no fish were observed in this area.

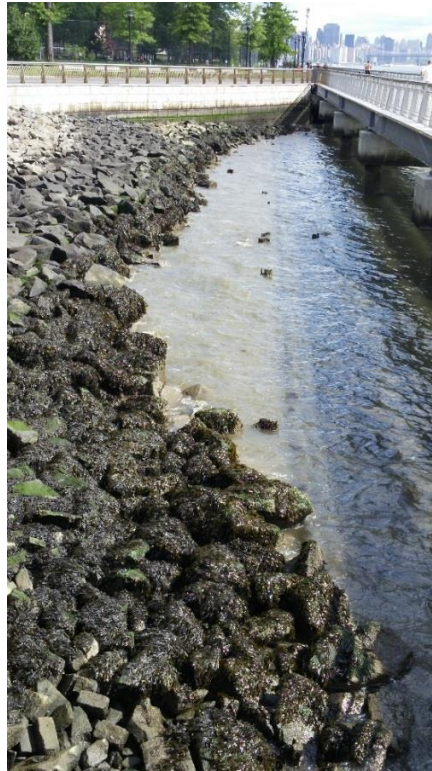
Photo 10 – Riprap cove feature in East River Park, between Rivington Street and Stanton Street. Low tide. Photo taken of Plot 2, facing north.

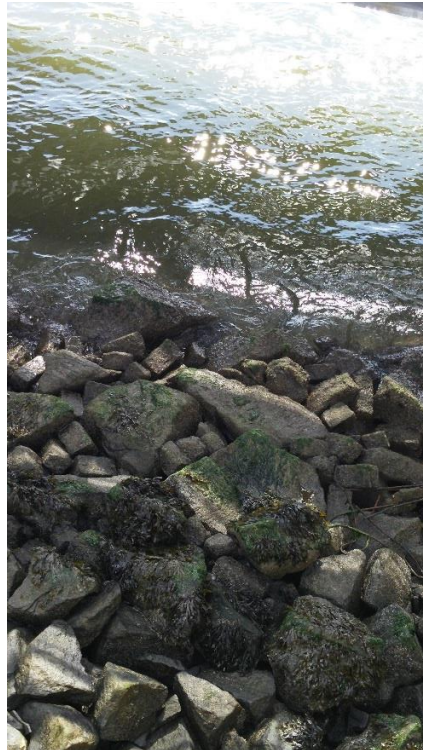
Photo 11 – Green algae and rockweed present on rocks exposed during low tide at riprap coves. Photo taken facing east.

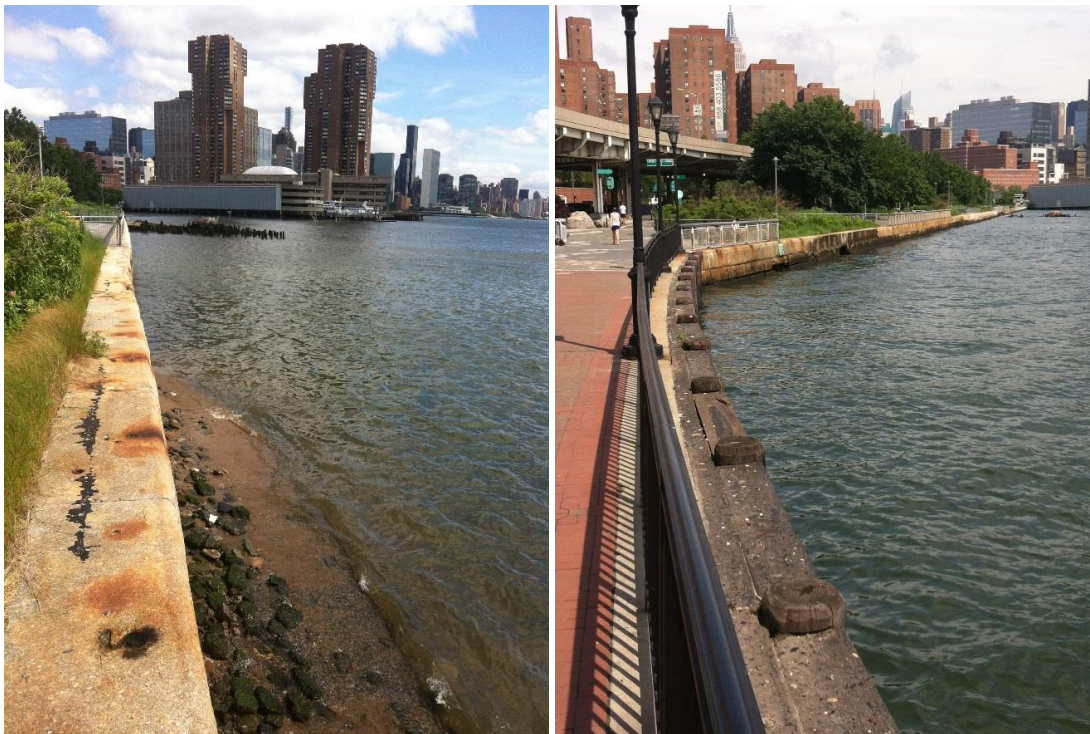
Photo 13 – Rock, gravel, and sand intertidal substrate at Stuyvesant Cove Park at low tide. No exposed substrate at high tide. Photo taken facing north.

At Stuyvesant Cove Park, a strip of sand, gravel, and rock intertidal substrate was observed (Photo 13). The strip was approximately 50 feet long and 3 feet wide. Green algae and rockweed were also observed on the rocks. Wave energy at this site was high. Additional sandy substrate could be seen through the shallow water, indicating that at a lower low tide there would be more substrate exposed. No shellfish, invertebrates, or fish were observed in this area.

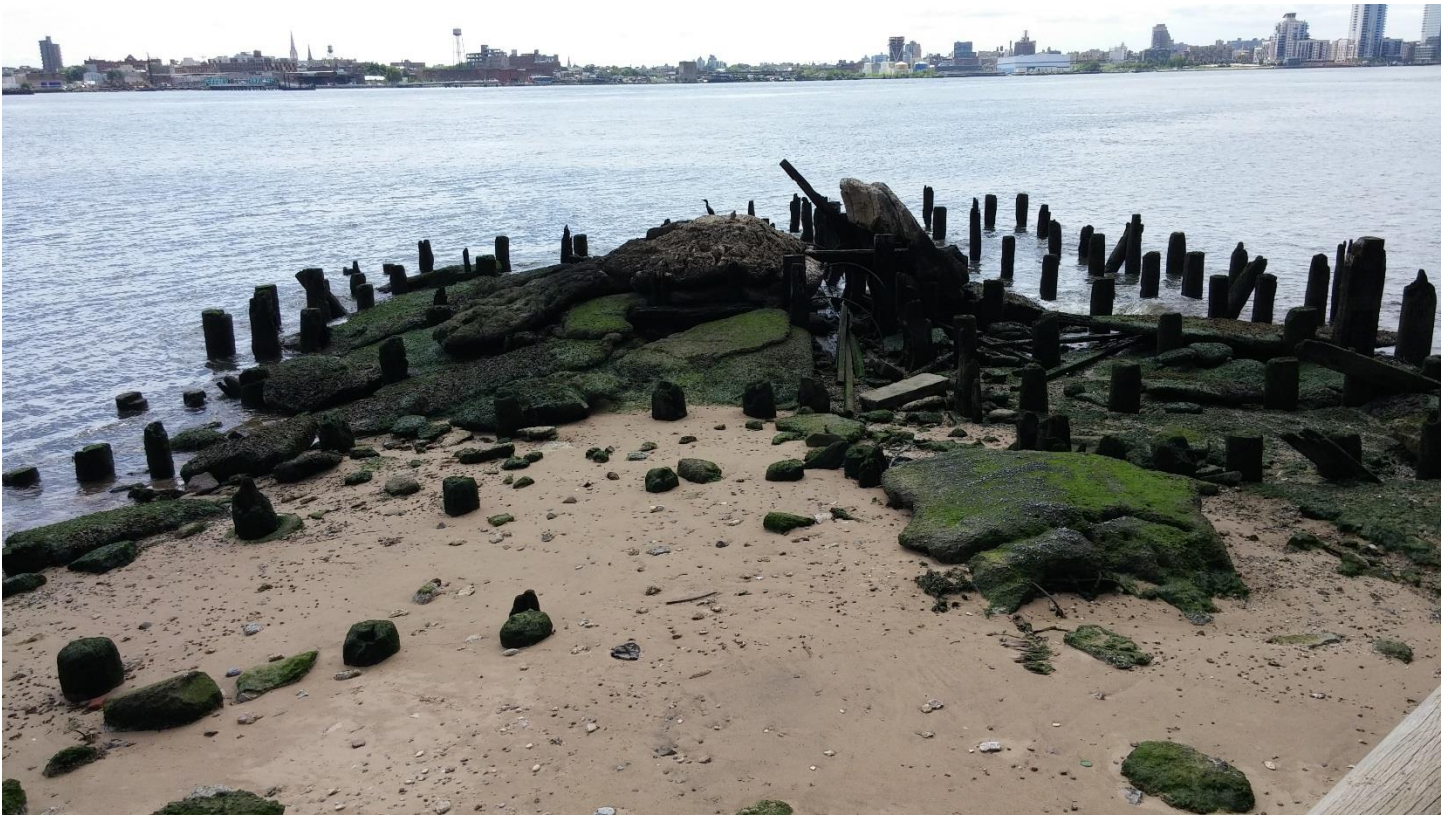
Photo 16 – Intertidal sand flat associated with remains of derelict dock/pier. Photo taken facing southeast.

At Stuyvesant Cove Park, the remains of a dock or small pier structure were observed at both high and low tide. At high tide, mostly concrete and wood pilings were visible, with some substrate exposed closest to the bulkhead and under shallow water extending out from the bulkhead (Photo 17). At low tide, an intertidal flat was exposed (Photo 16). This flat consisted of a sandy area at its northern half and concrete, pilings, and debris in the southern half. A pipe structure extending from the bulkhead had associated signage indicating it to be a combined sewer outfall (Outfall #NCM-048). Wave energy at the edges of the flat was high; however, the intertidal area is large enough to potentially provide refuge from tidal influence during periods of low tide. The pilings were being used as perching habitat for Double-crested Cormorants (*Phalacrocorax auritus*) and Ring-billed Gulls (*Larus delawarensis*) (Photo 15). Green algae and rockweed were observed on the large rocks and concrete slabs. Numerous birds were observed foraging on the benthic substrate and among the seaweed, indicating aquatic invertebrates likely present. No shellfish or fish were observed in this area.

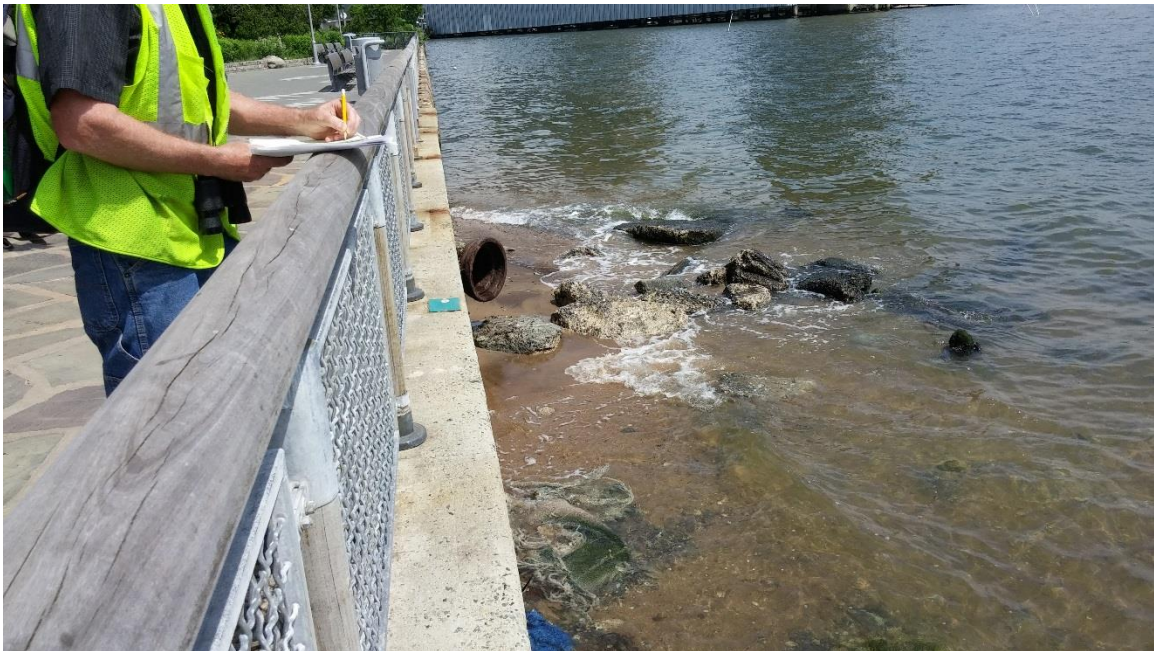
Photo 17 – Intertidal sand flat and in Stuyvesant Cove Park at high tide. Photo taken facing north.
