Appendix F1
Natural Resources Survey

Re: SANDRESM1 East Side Coastal Resiliency Project:
Natural Resources Shoreline Survey

Shoreline Survey Results Memorandum

Photo Location Map and Photo Log

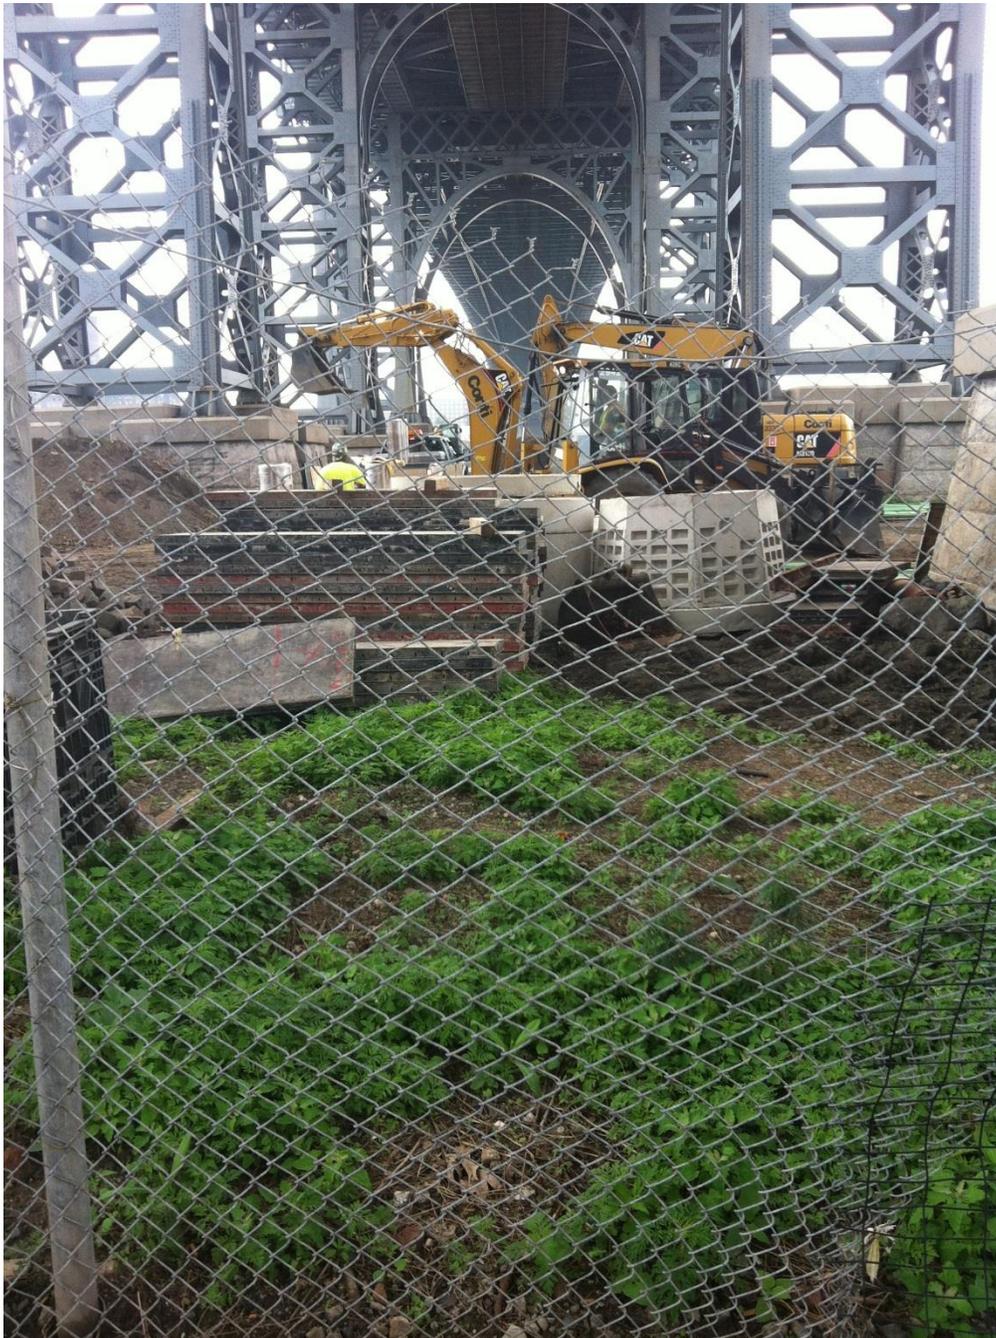
Photo 1 – Active construction underneath the Williamsburg Bridge. Photo taken facing southeast.

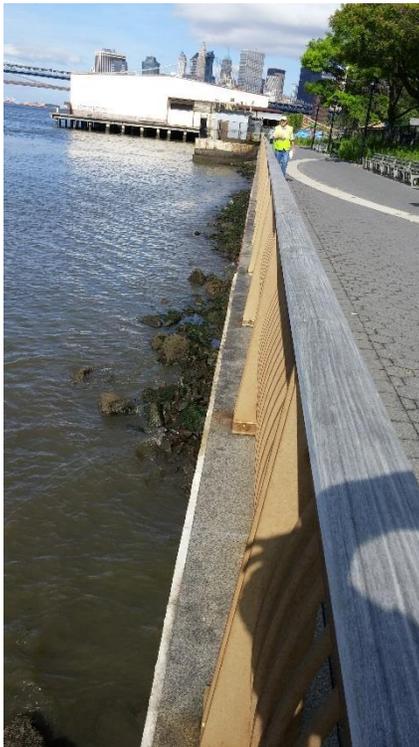
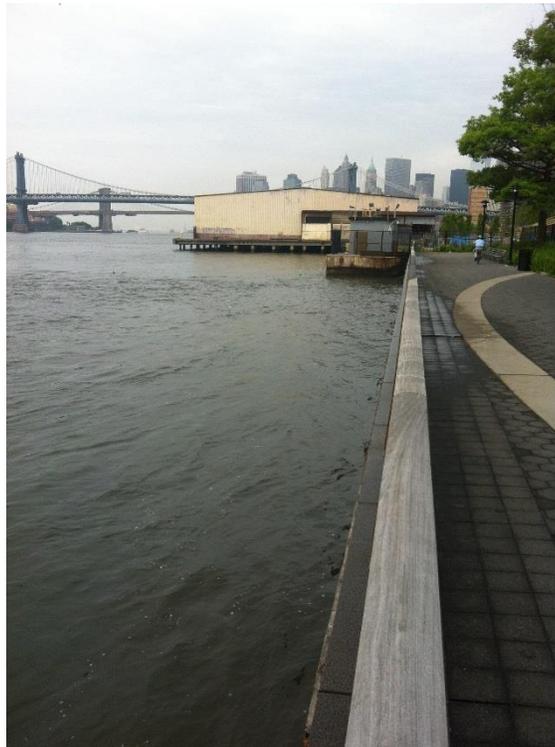
Photo 5 –Exposed intertidal rock with small areas of sand and gravel along bulkhead north of Pier 42 at low tide. Flooded at high tide. Photo taken facing west.

Starting at Pier 42 and extending several hundred feet north (Photo 5), the edge of the riprap shoreline was evident during low tide. During wave ebbs, small areas of gravel and sand substrate were temporarily exposed. Wave energy at this location was high (Photo 6). Some of the riprap in this area contained green algae (*Ulva* spp.) and rockweed (*Ascophyllum* spp.). Barnacles (insert scientific name) were also observed on the exposed bulkhead surface below the water line. No other invertebrates or plants, and no fish were observed in this area. (Said already)

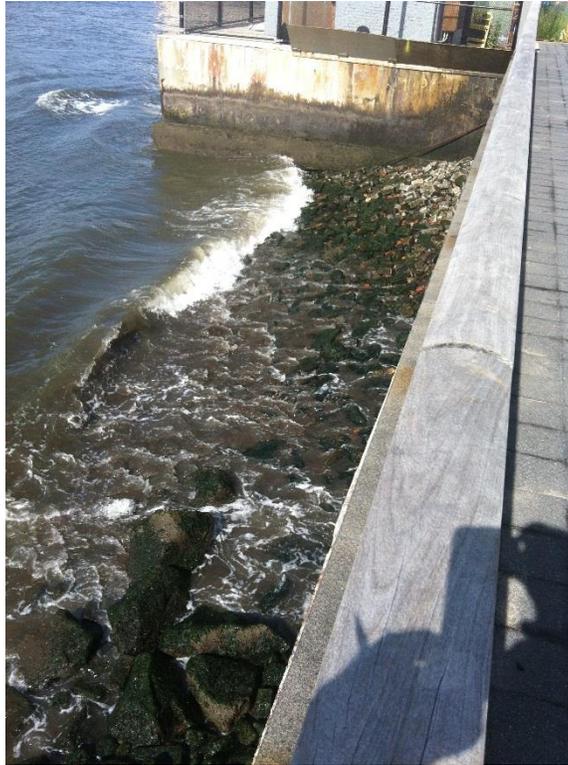
Photo 6 – High wave energy and intertidal substrate of rock and sand located north of Pier 42 at low tide. Rocks contained some submerged aquatic vegetation consisting of rockweed and green algae. Photo taken facing southwest.

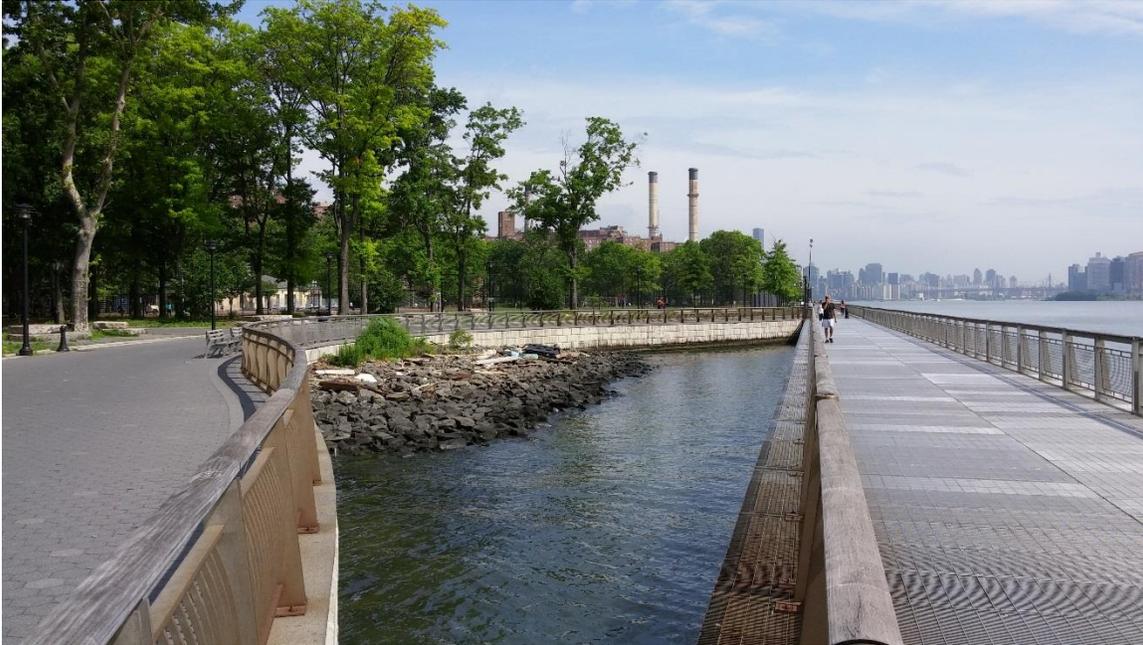
Photo 8 – Riprap cove feature in East River Park, between East 4th Street and East 5th Street. High tide. Upland vegetation located at highest point. Photo taken facing north.

Two constructed coves are present in East River Park north of the Williamsburg Bridge. These coves are hardened and have a large riprap embankment (Photo 8). At low tide, no substrate type other than riprap was observed (Photo 10). On the lowest riprap, green algae and rockweed were observed (Photo 10). On the highest elevation where high tides do not reach, some upland vegetation was observed including sunflower (*Helianthus* spp.), mugwort (*Artemisia vulgaris*), rye-grass (*Lolium* spp.), narrow-leaved plantain (*Plantago lanceolata*), morning glory (*Ipomoea* spp.), and a honey-locust seeding (*Gleditsia triacanthos*). No other invertebrates or plants, and no fish were observed in this area.

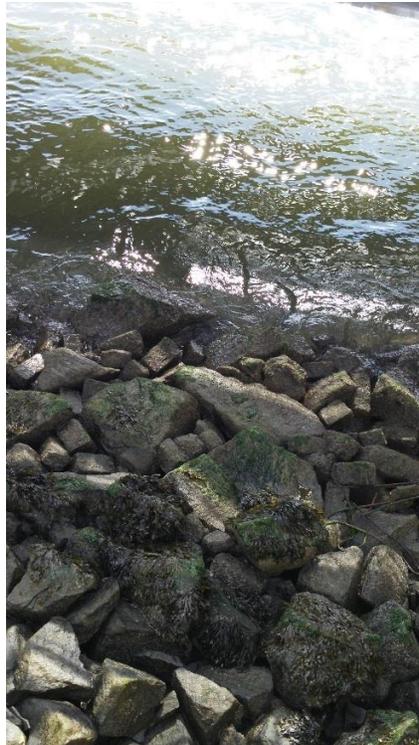
Photo 11 – Green algae and rockweed present on rocks exposed during low tide at riprap coves. Photo taken facing east.

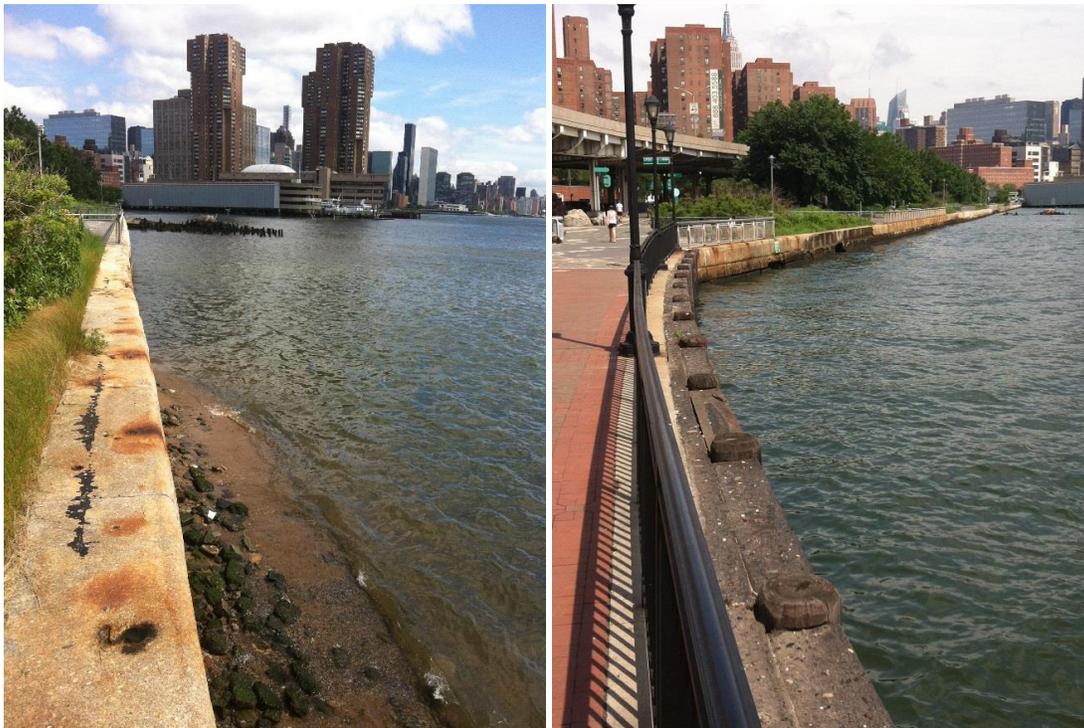
Photo 13 – Rock, gravel, and sand intertidal substrate at Stuyvesant Cove Park at low tide. No exposed substrate at high tide. Photo taken facing north.

At Stuyvesant Cove Park, a strip of sand, gravel, and rock intertidal substrate was observed (Photo 13). The strip was approximately 50 feet long and 3 feet wide. Green algae and rockweed were also observed on the rocks. Wave energy at this site was high. Additional sandy substrate could be seen through the shallow water, indicating that at a lower low tide there would be more substrate exposed. No shellfish, invertebrates, or fish were observed in this area.

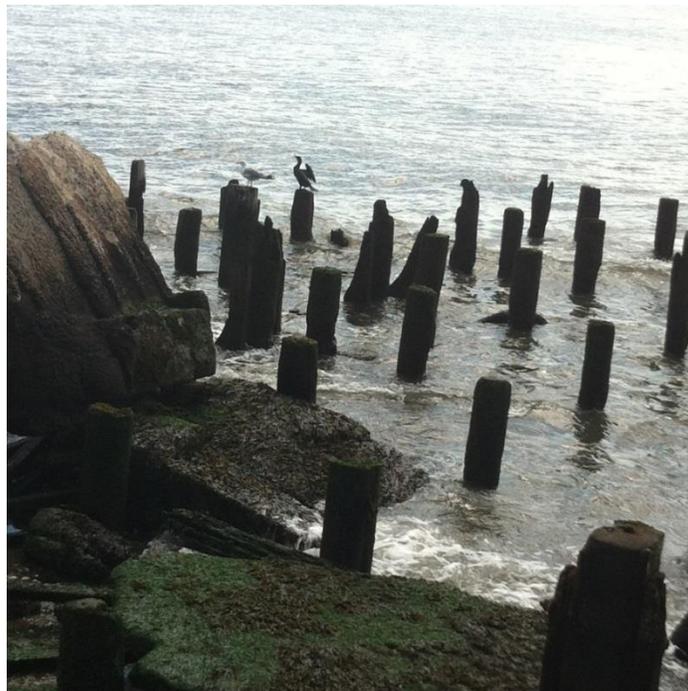
Photo 15 – Birds perching on pilings from derelict dock/pier. Photo taken facing east.

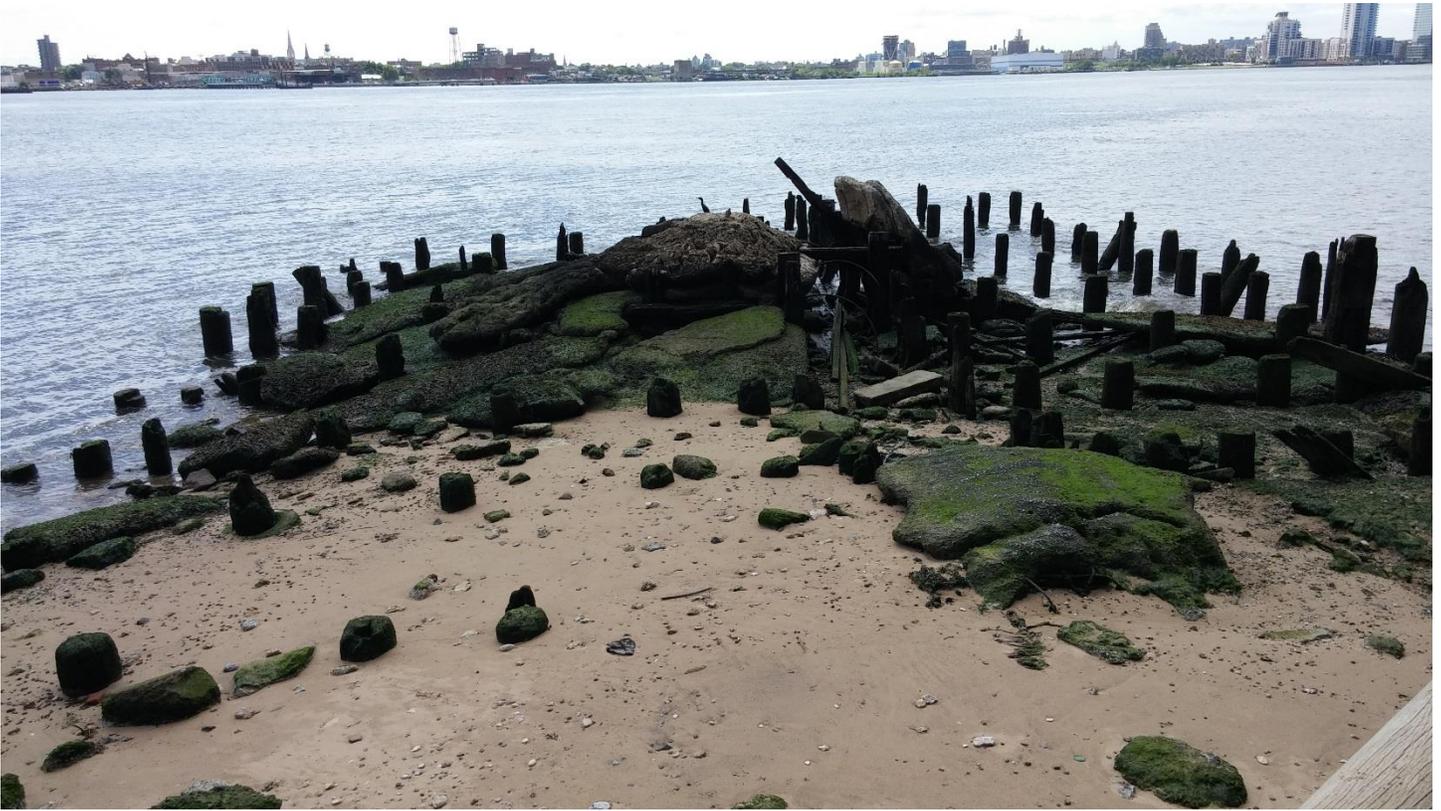
Photo 16 – Intertidal sand flat associated with remains of derelict dock/pier. Photo taken facing southeast.

At Stuyvesant Cove Park, the remains of a dock or small pier structure were observed at both high and low tide. At high tide, mostly concrete and wood pilings were visible, with some substrate exposed closest to the bulkhead and under shallow water extending out from the bulkhead (Photo 17). At low tide, an intertidal flat was exposed (Photo 16). This flat consisted of a sandy area at its northern half and concrete, pilings, and debris in the southern half. A pipe structure extending from the bulkhead had associated signage indicating it to be a combined sewer outfall (Outfall #NCM-048). Wave energy at the edges of the flat was high; however, the intertidal area is large enough to potentially provide refuge from tidal influence during periods of low tide. The pilings were being used as perching habitat for Double-crested Cormorants (*Phalacrocorax auritus*) and Ring-billed Gulls (*Larus delawarensis*) (Photo 15). Green algae and rockweed were observed on the large rocks and concrete slabs. Numerous birds were observed foraging on the benthic substrate and among the seaweed, indicating aquatic invertebrates likely present. No shellfish or fish were observed in this area.

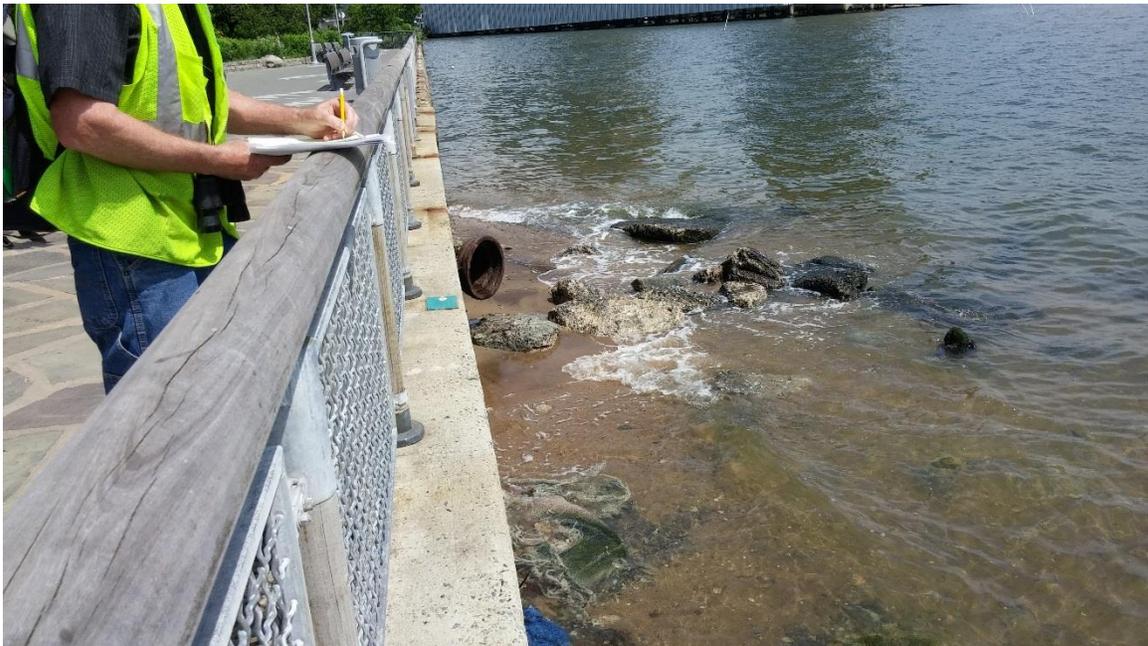
Photo 17 – Intertidal sand flat and in Stuyvesant Cove Park at high tide. Photo taken facing north.
