# PROPOSED IMPROVEMENTS

IN THE MATTER OF REPLACING EXISTING WINDOW AT 151 Central Park West, APT. 1W, NEW YORK, NY 10023

**MANDIGO** Residence

151 Central Park West, Apt. 1W

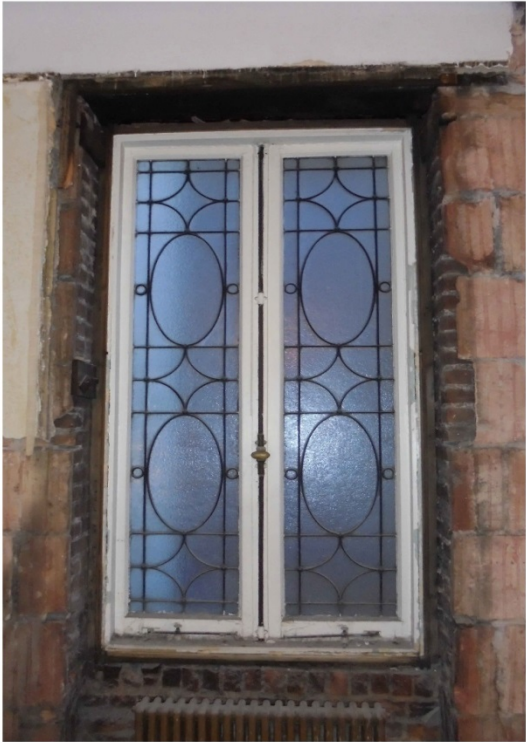
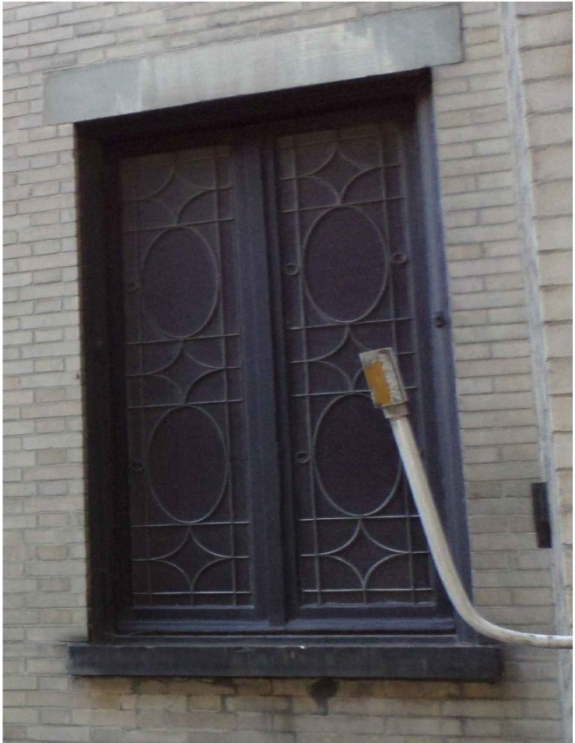
EXISTING & PROPOSED WINDOW ELEVATION

EXISTING WINDOW CONDITION - EXTERIOR VIEW

PROPOSED WINDOWS FASTEN WITHIN EXISTING MASONRY OPENINGS

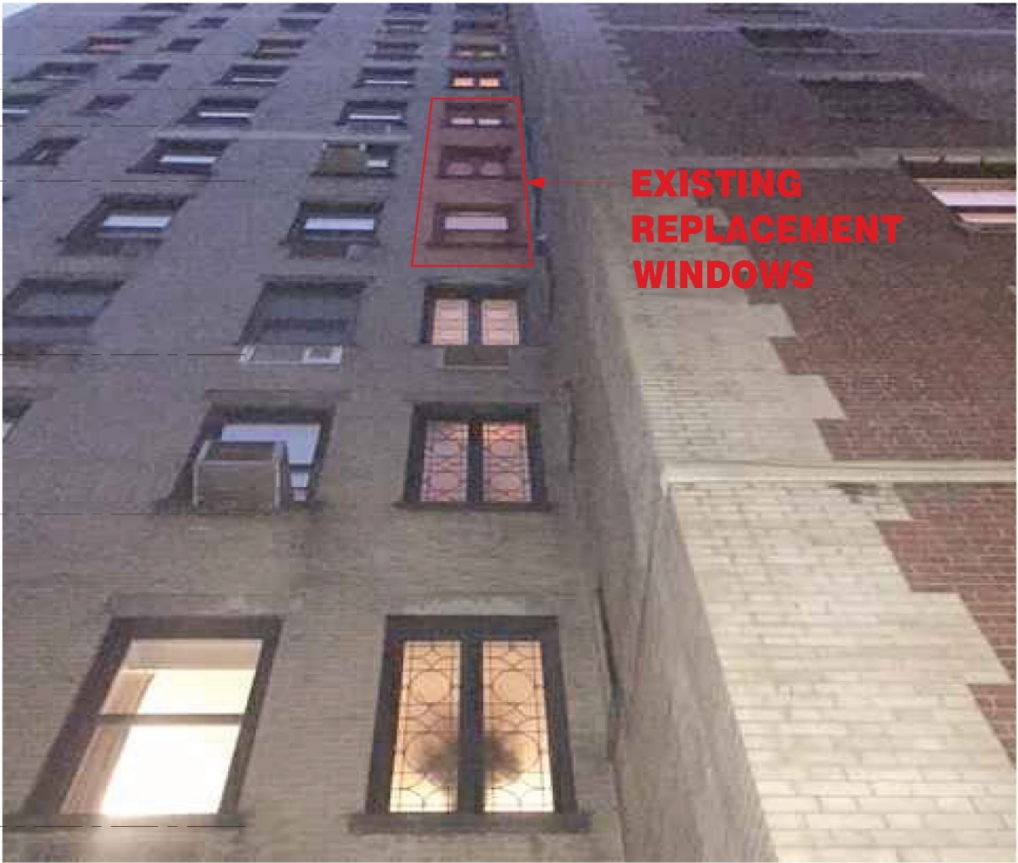
Existing Partial Building West Facade Courtyard

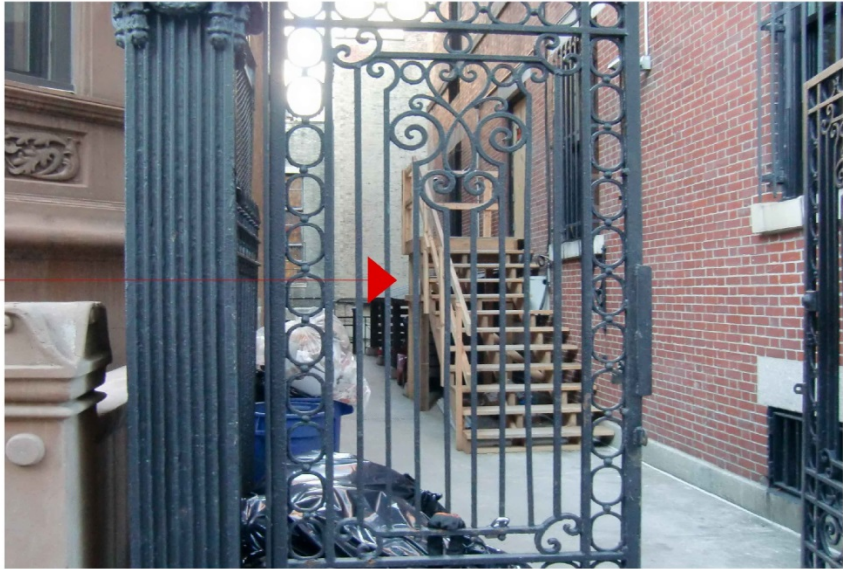
WINDOW LOCATION  
BEHIND STAIR

West 75th St. Service Entrance

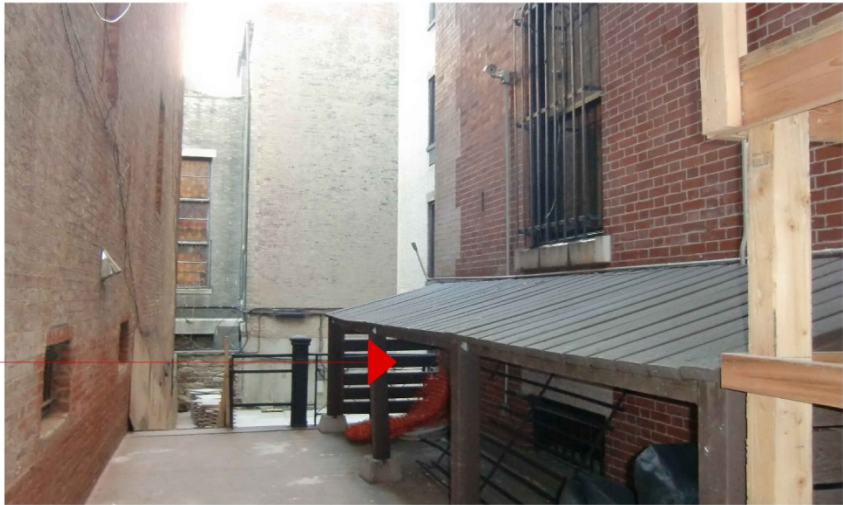
WINDOW LOCATION  
BEHIND CORNER

West Facade Courtyard Corridor at Service Area

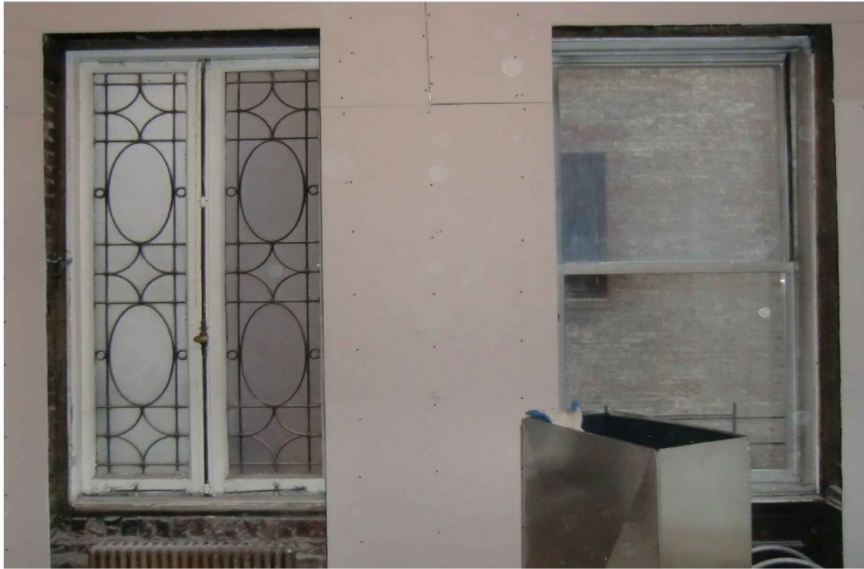
Window Interior View. Window Design For Interior Decoration Purpose.

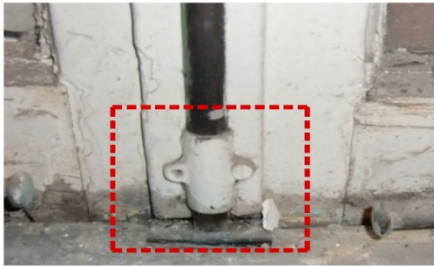
Window Interior View Close-Ups:

- The window shows signs of rot at the sill.
- It is missing a bolt stay at the top.
- The window is very hard to get open and even harder to close properly, consequently it is very drafty and not energy efficient.
- The Cremorne bolt is difficult to engage because it is warped. It does not fit through the top bracket to close and consequently that bracket was discarded a long time ago. This means the window cannot be secured at the head adding to the draftiness
- The leaded glass is cracked in at least 3 places.
- The glass is very thin monolithic glass and allows cold air to come right through

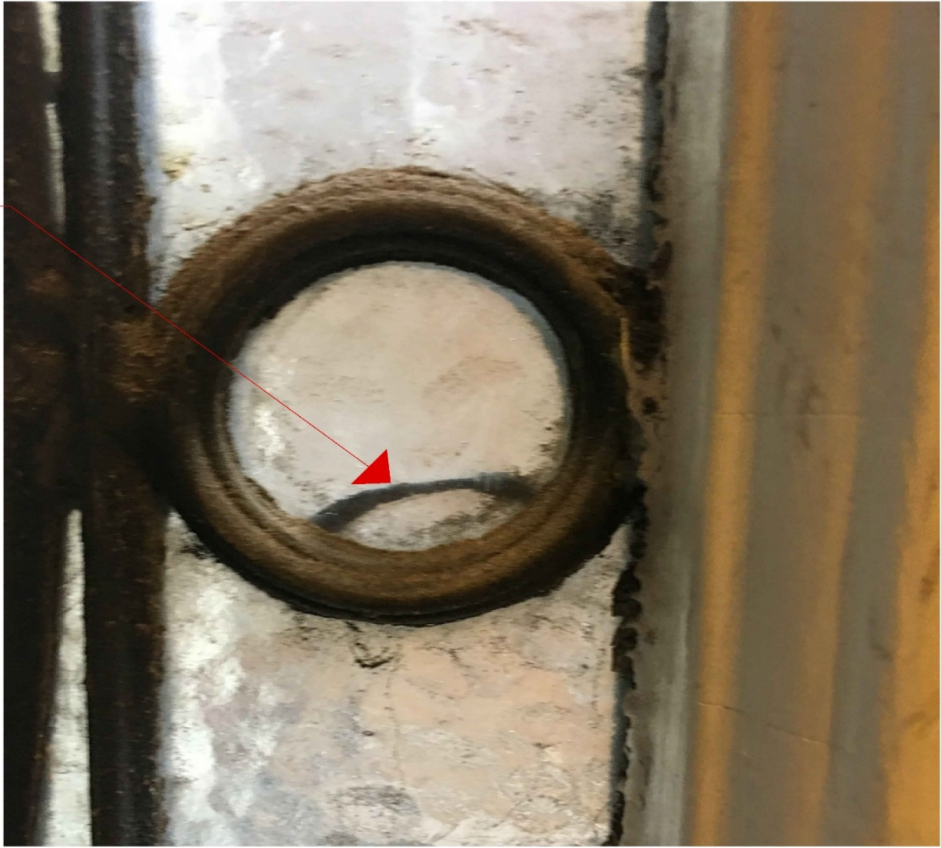
Window Close-Up

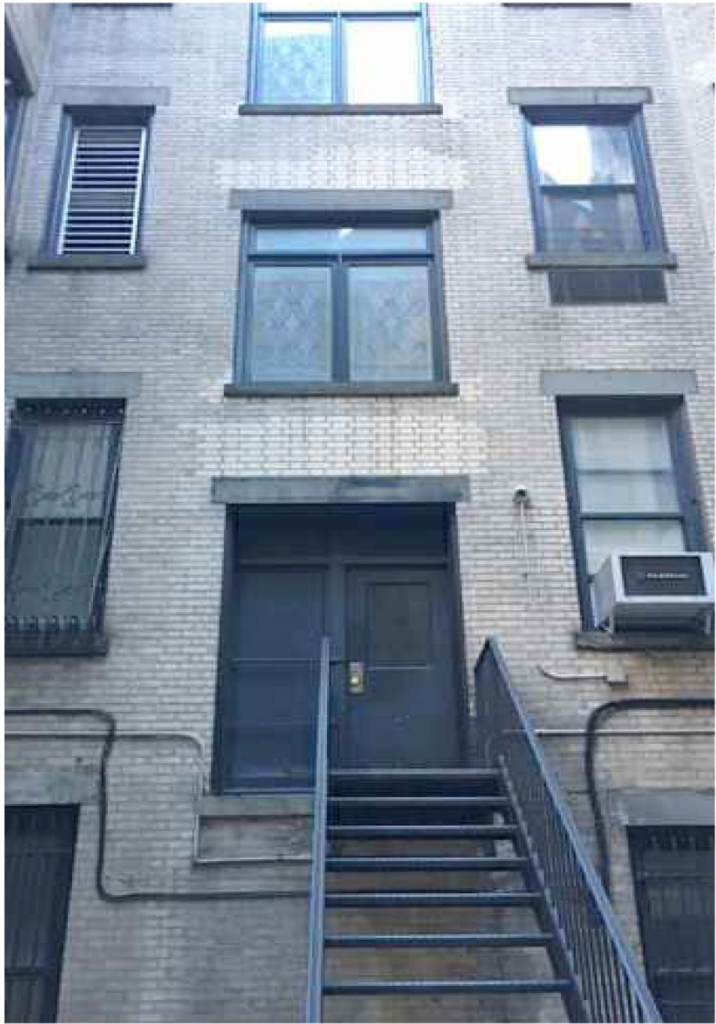
STAIRWELL EXTERIOR

LEADED GLASS WINDOWS REMAINING INTACT IN VISIBLE  
AREAS OF 151 CENTRAL PARK WEST

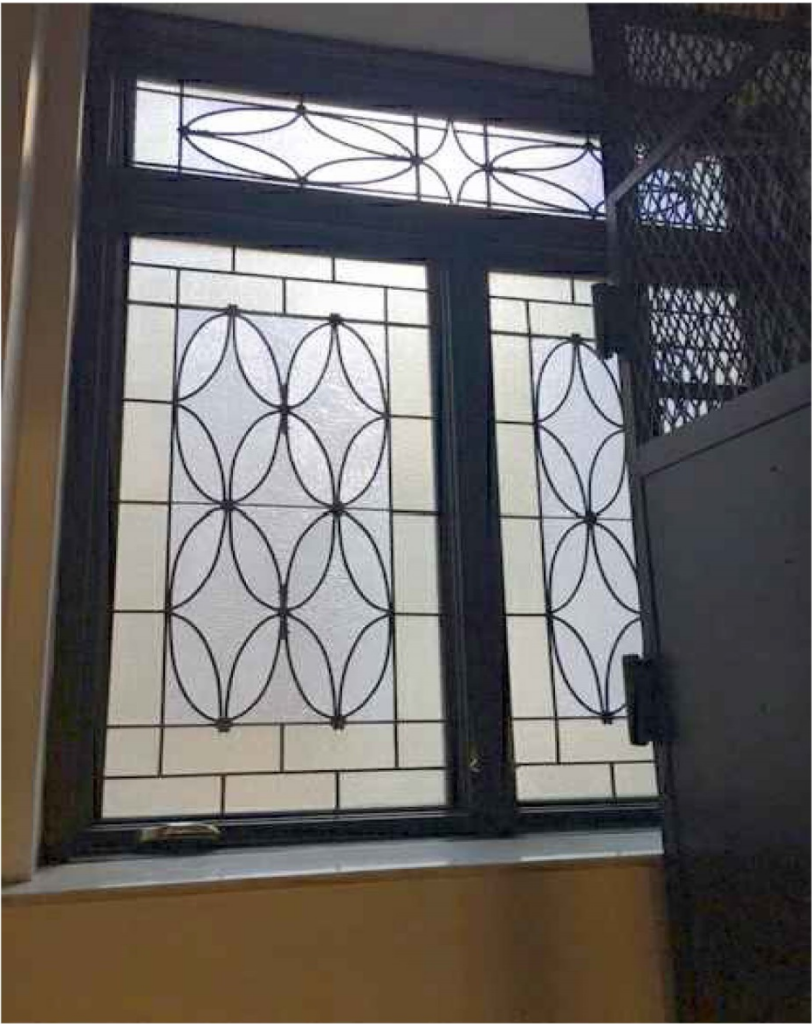
STAIRWELL INTERIOR

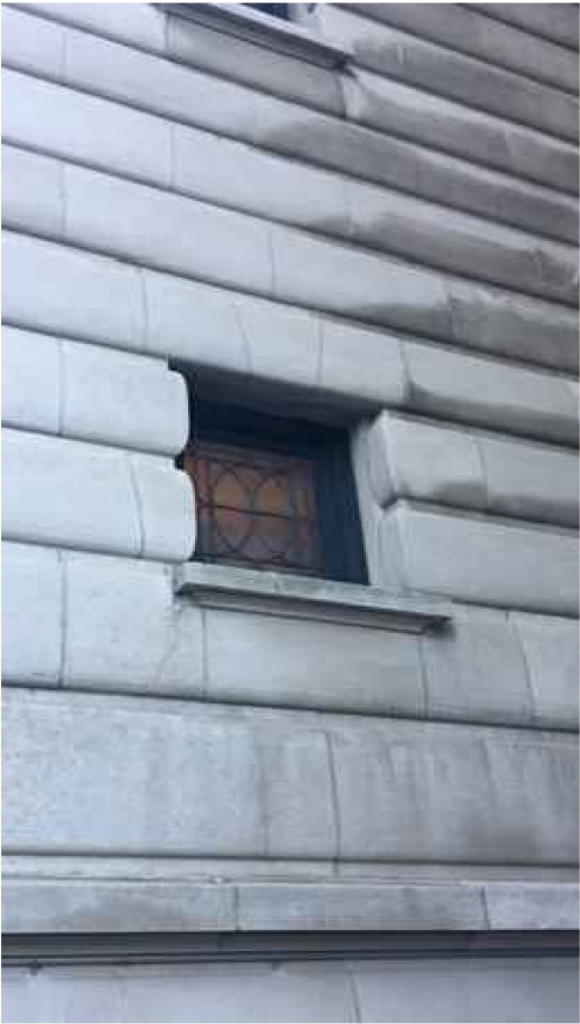
WINDOW REMAINING IN OWNERS APARTMENT
