The Rehabilitation of Brooklyn Bridge - Approach Arches, Towers,
Ramp Substructures, and Miscellaneous Repairs
New York City Department of Transportation - Division of Bridges

New York City Landmarks Preservation Commission Review
Contract No. BRC270D
June 29, 2018

General Scope of Work - Manhattan Approach

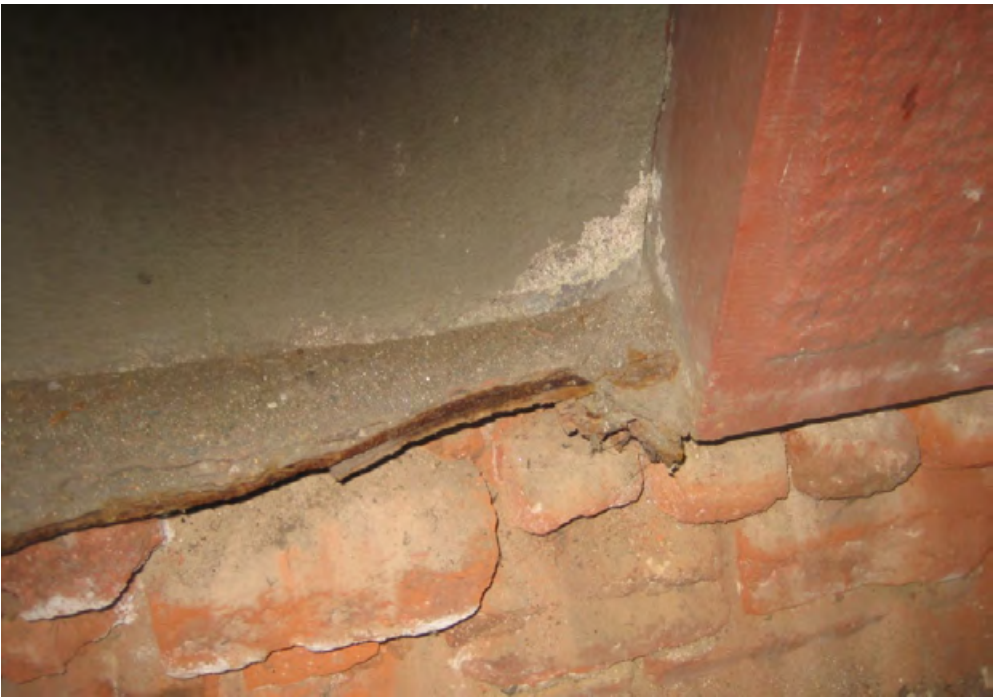
1 - Crumbling Brick Window Sill

“Generally, the fire-hardened surface of the bricks and the mortar joints has deteriorated over the 125 plus years of life of the bridge, exposing the softer interior of the bricks. Since it is exposed, the softer brick interior erodes and easily falls off as dust...Humidity in the arch block interiors is likely a major contributing factor to the degradation of the brick surfaces”
