**Landmarks Preservation Commission Presentation**

**Empire State Dairy**  
2840 Atlantic Avenue, Brooklyn

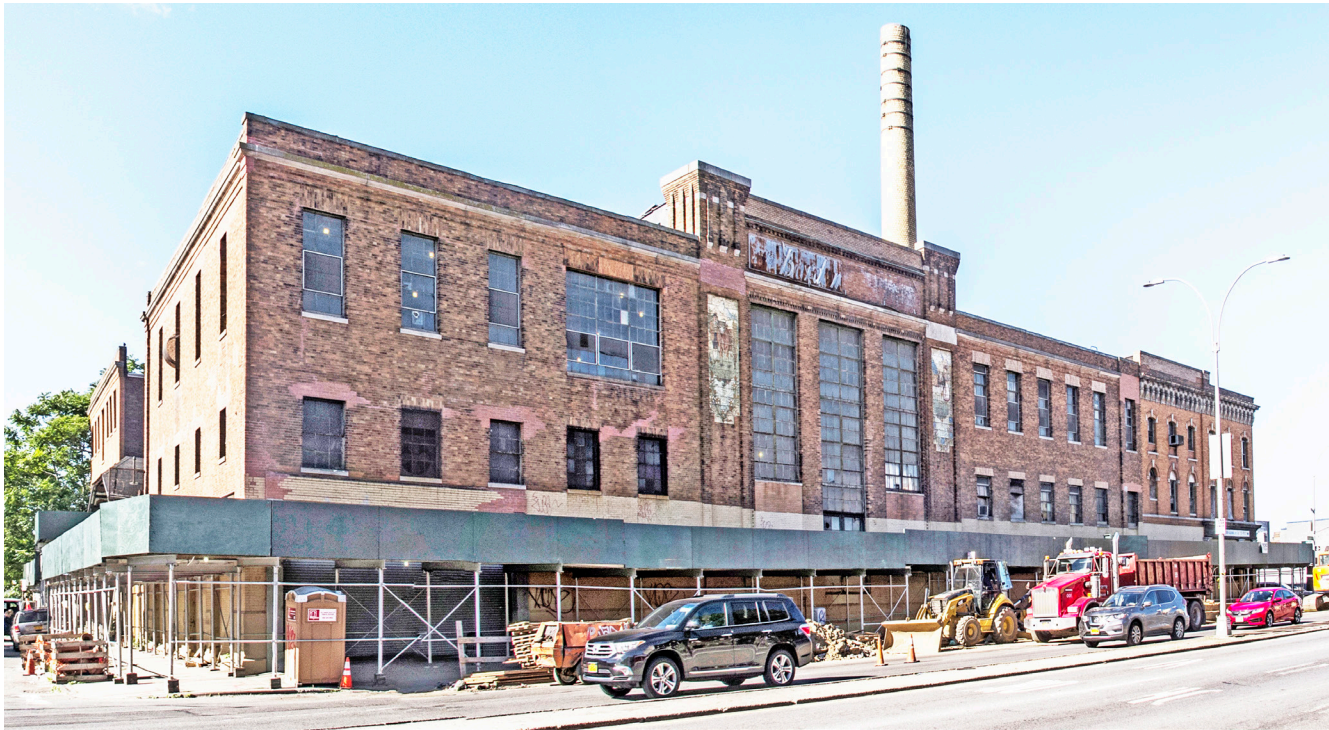
A. View from Atlantic Avenue Looking at North Facade

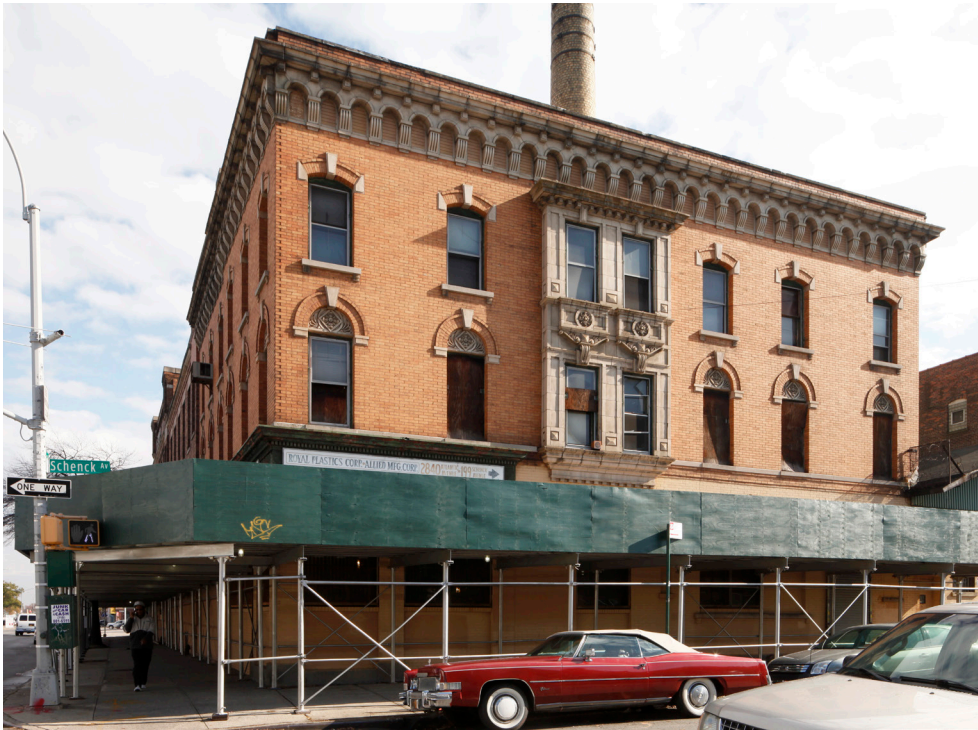
B. West Facade View (Landmarked Portion on the Left)

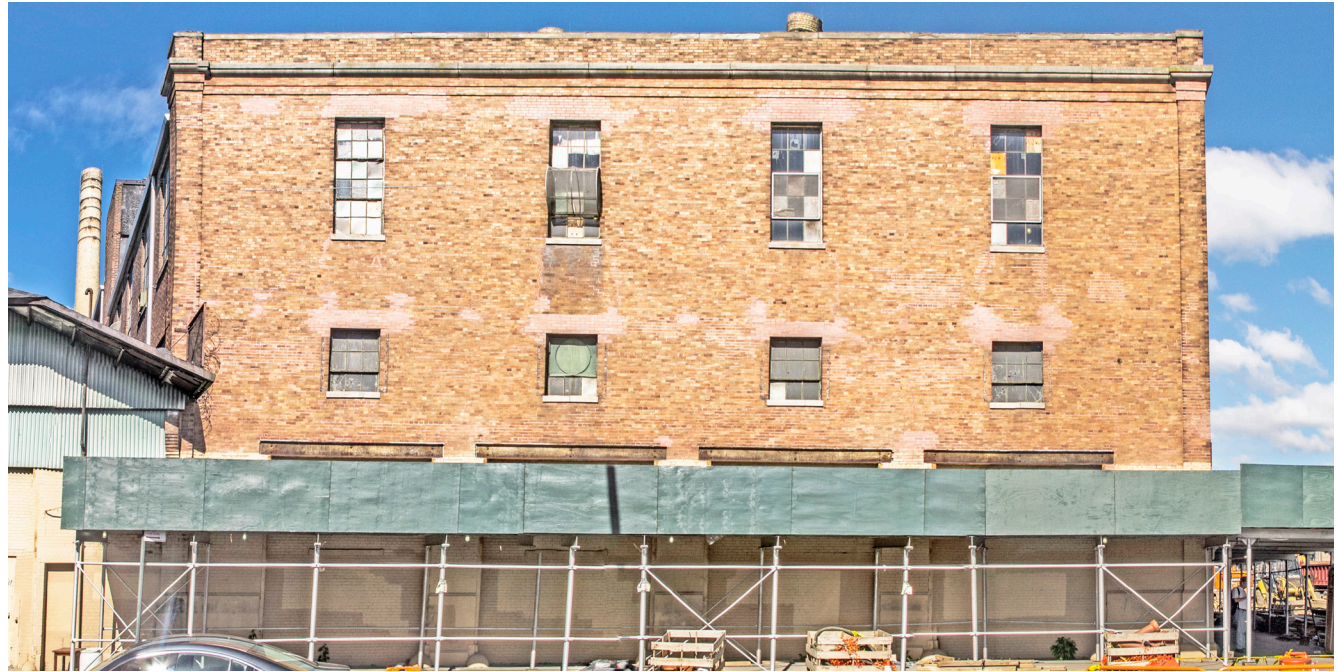
C. East Facade

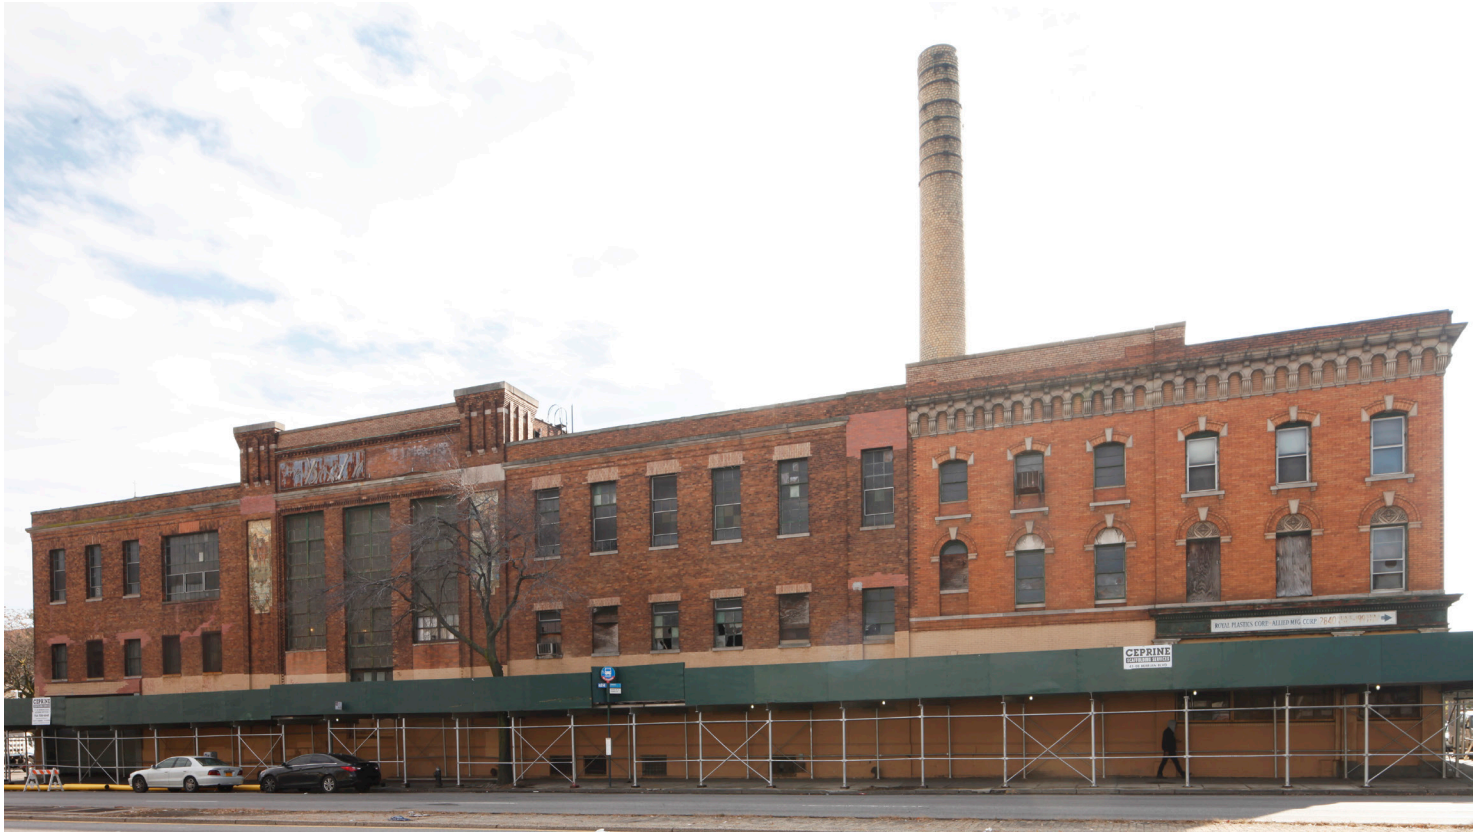
A. Overall View of Landmarked Building from Atlantic Ave

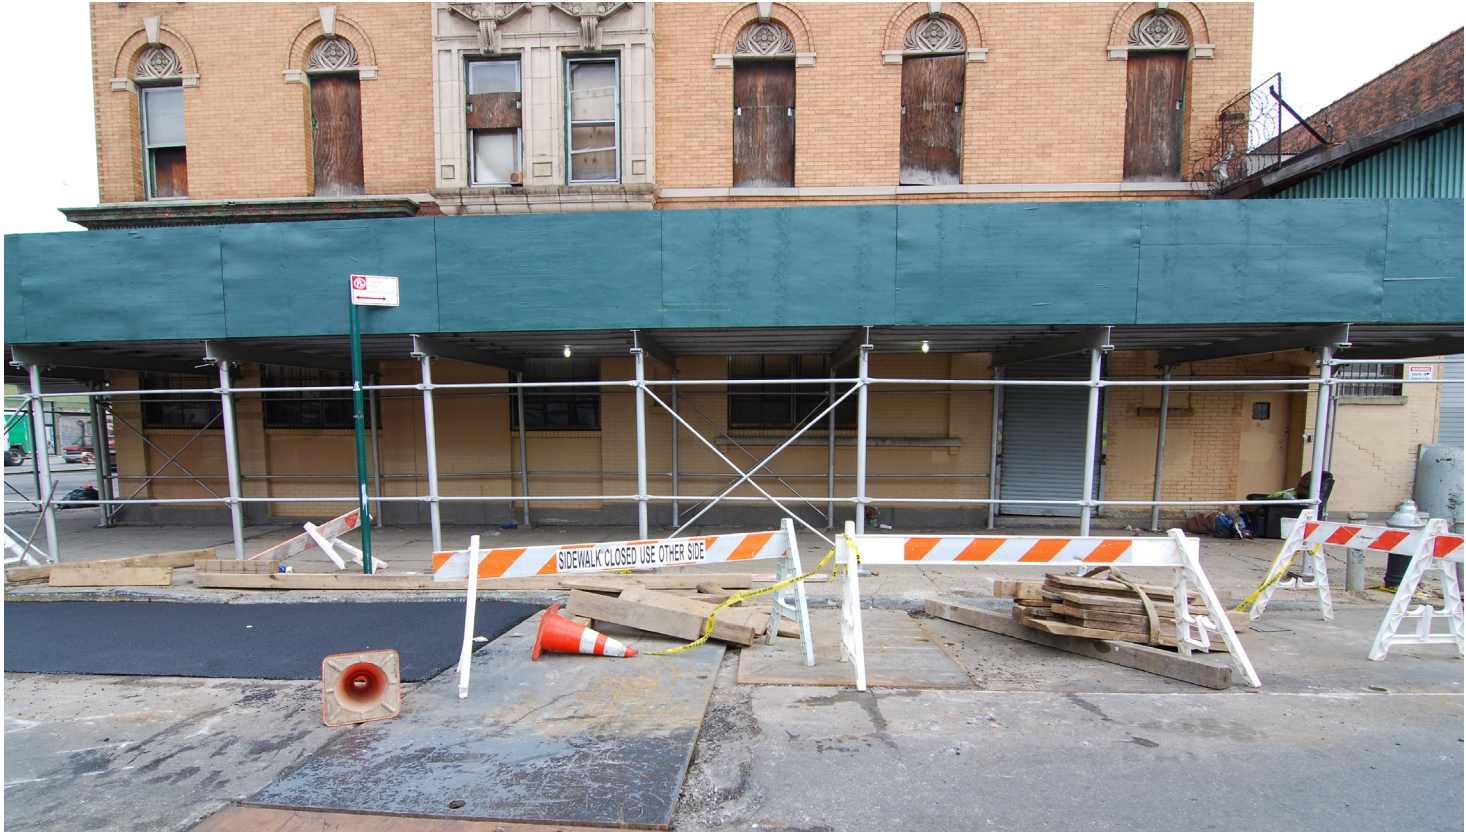
B. Infill at Base of Building on Scheck Street

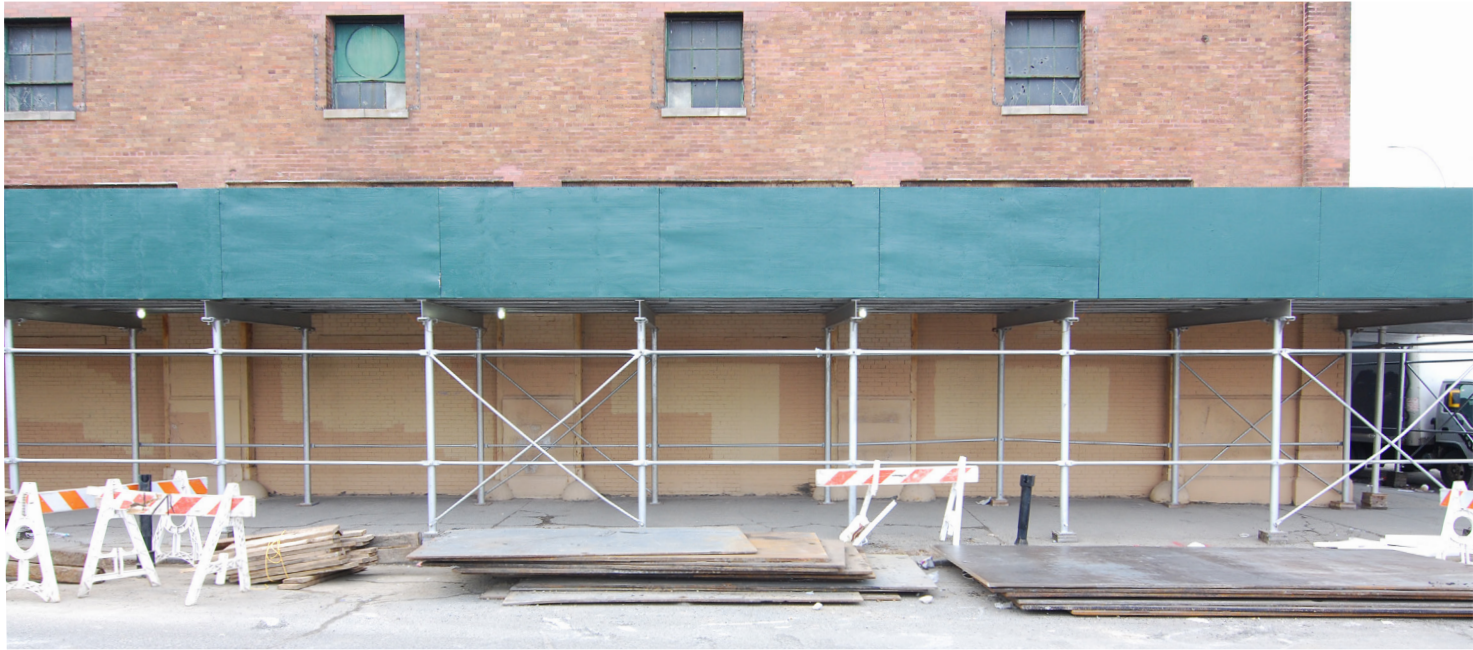
C. Infill at Base of Building on Barbey Street

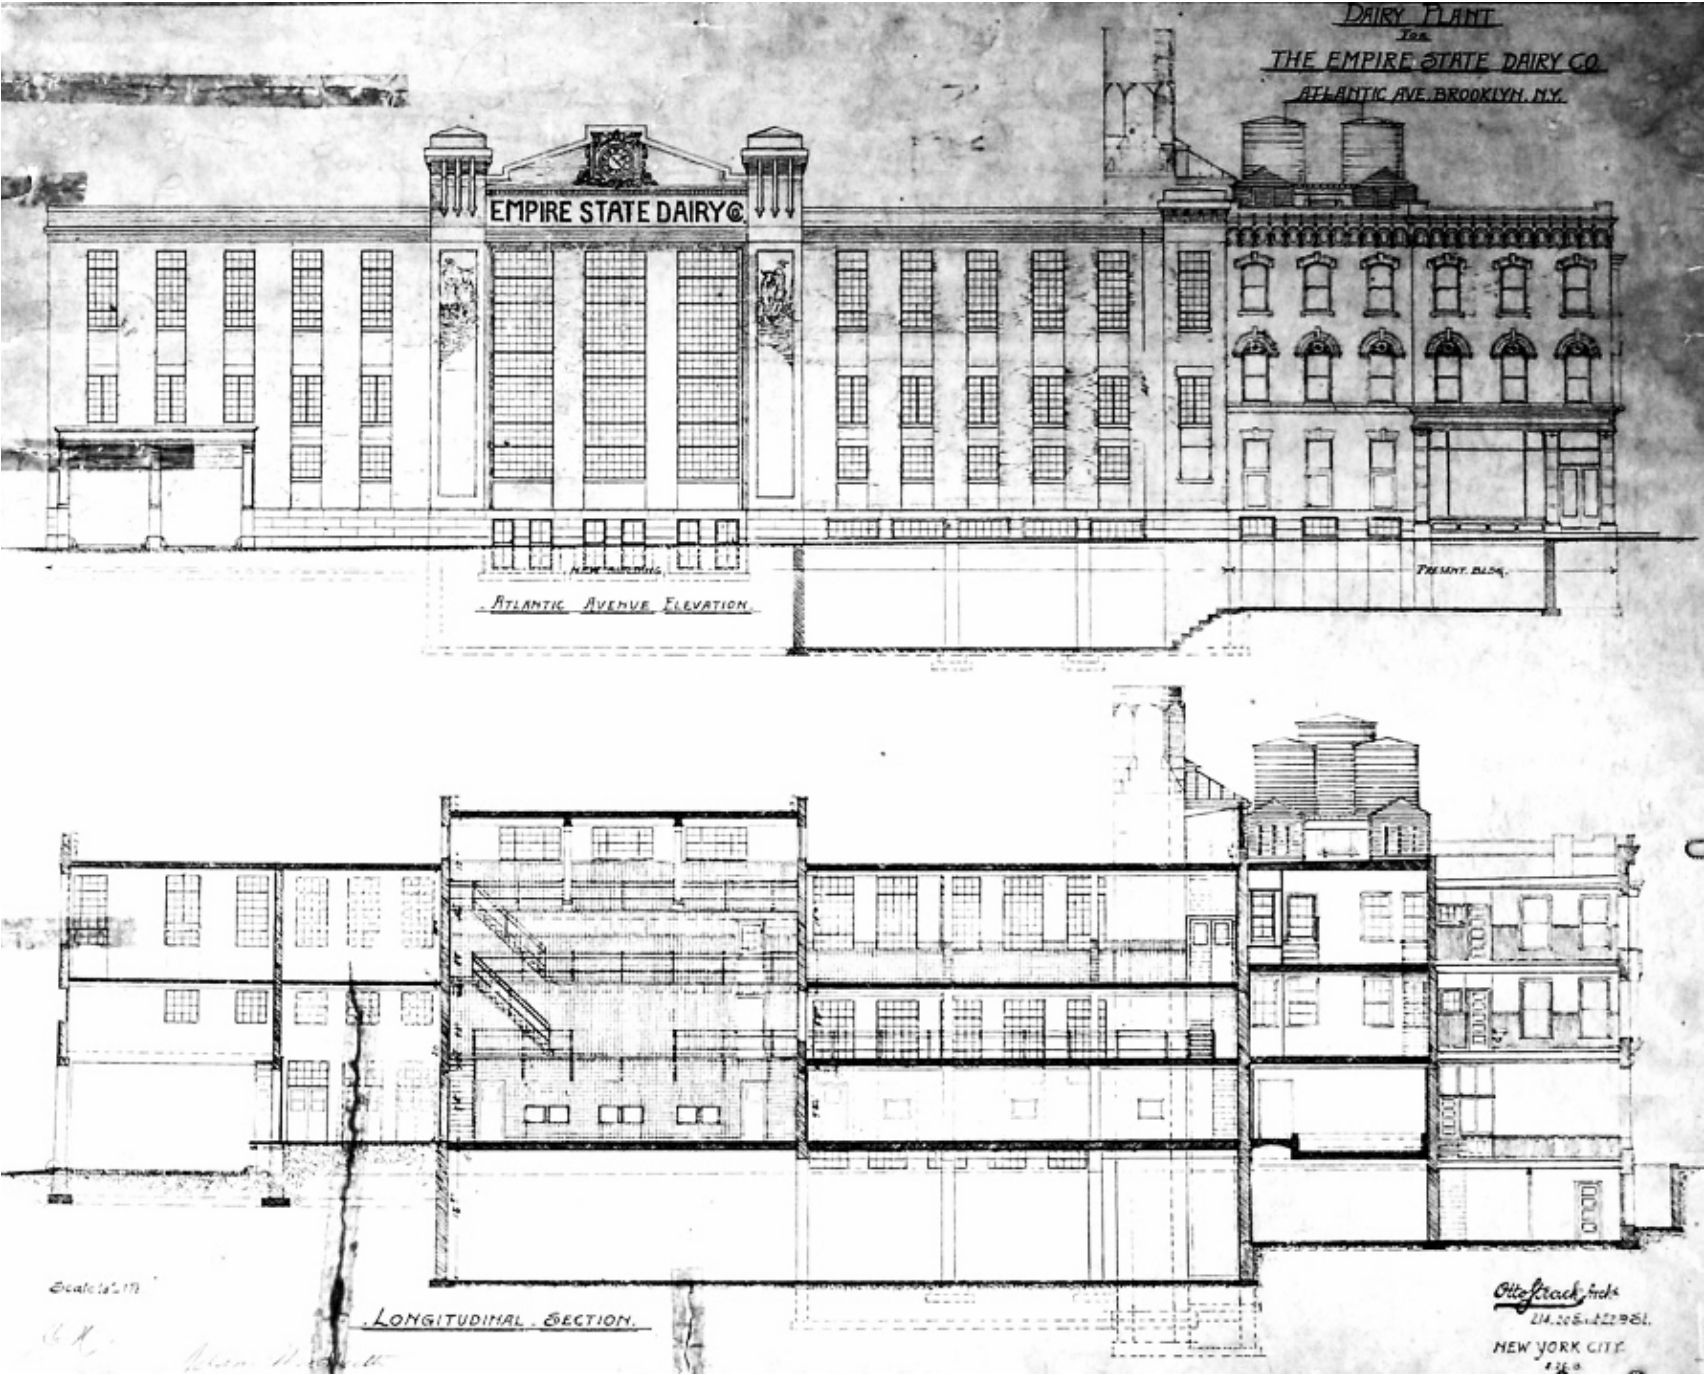
Above: North Elevation Along Atlantic Ave  
Below: Building Section Looking South,

Building Drawings, 1913

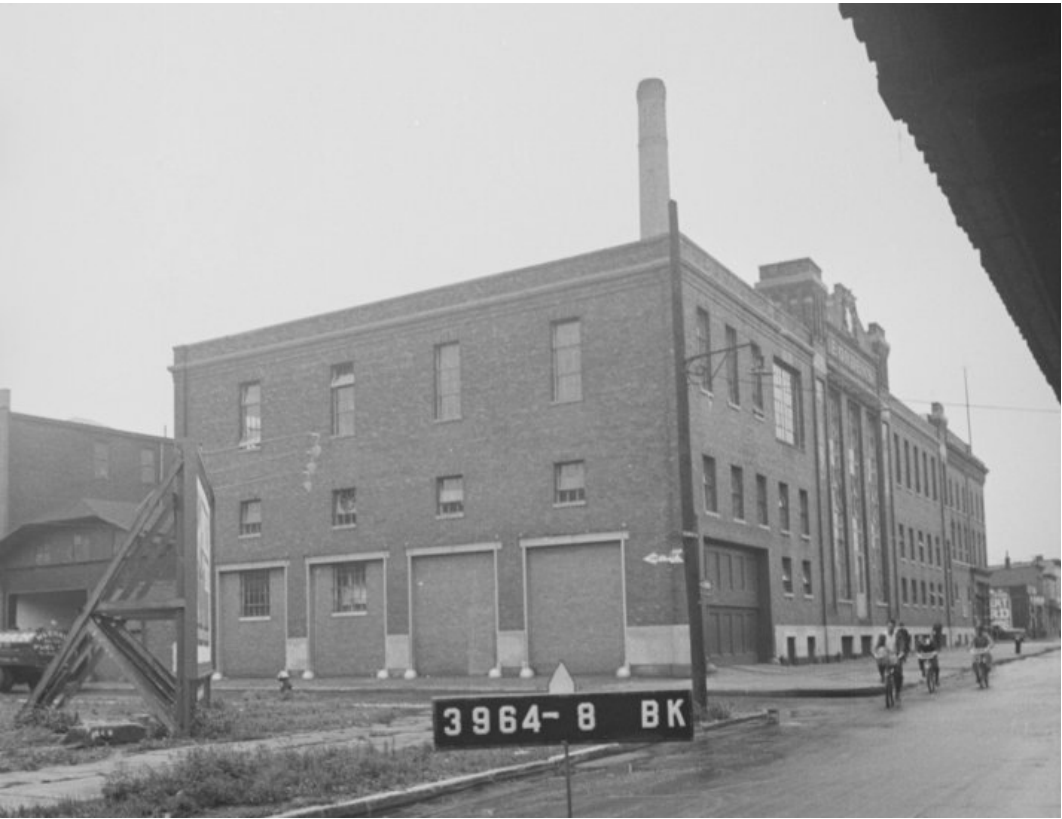
Historic Photo at Corner of Atlantic Avenue and Barbey Street, 1940

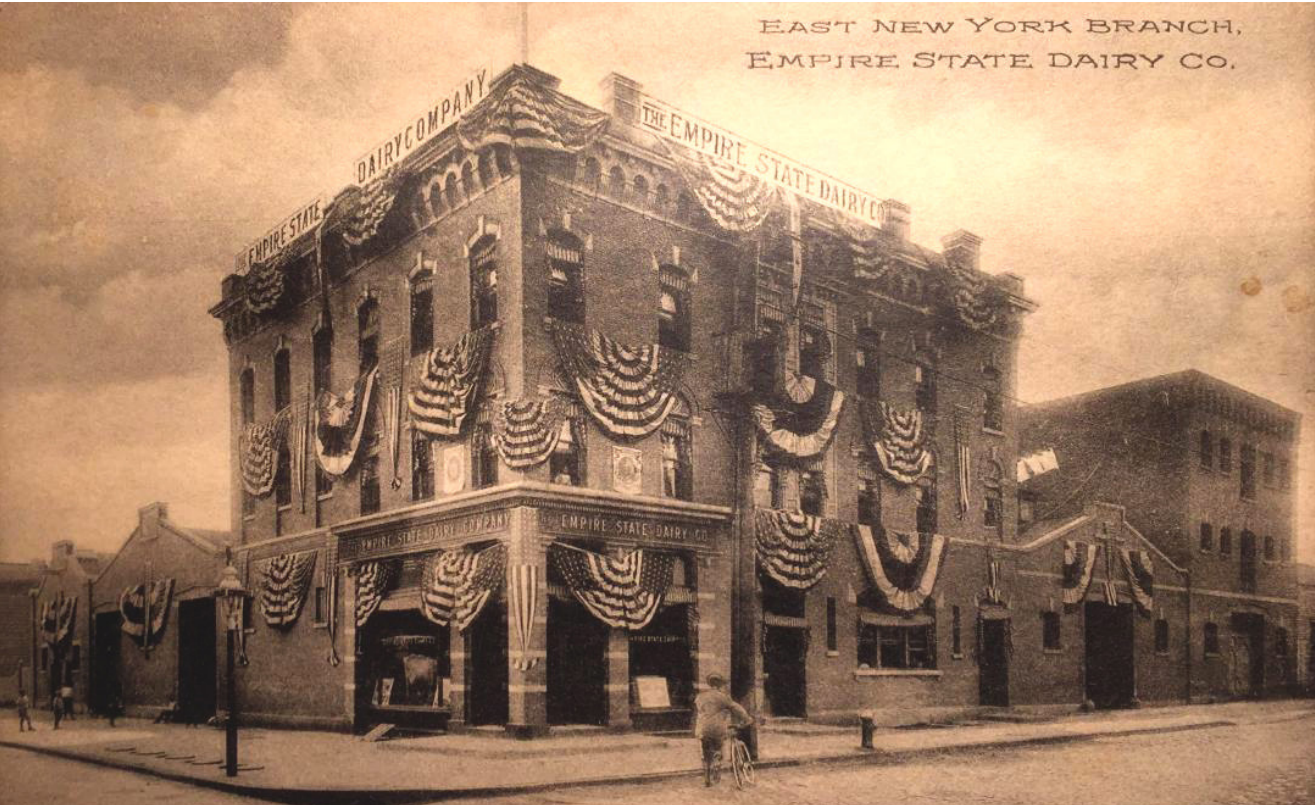
Historic Photo at Corner of Atlantic Avenue and Schenck Avenue, 1907

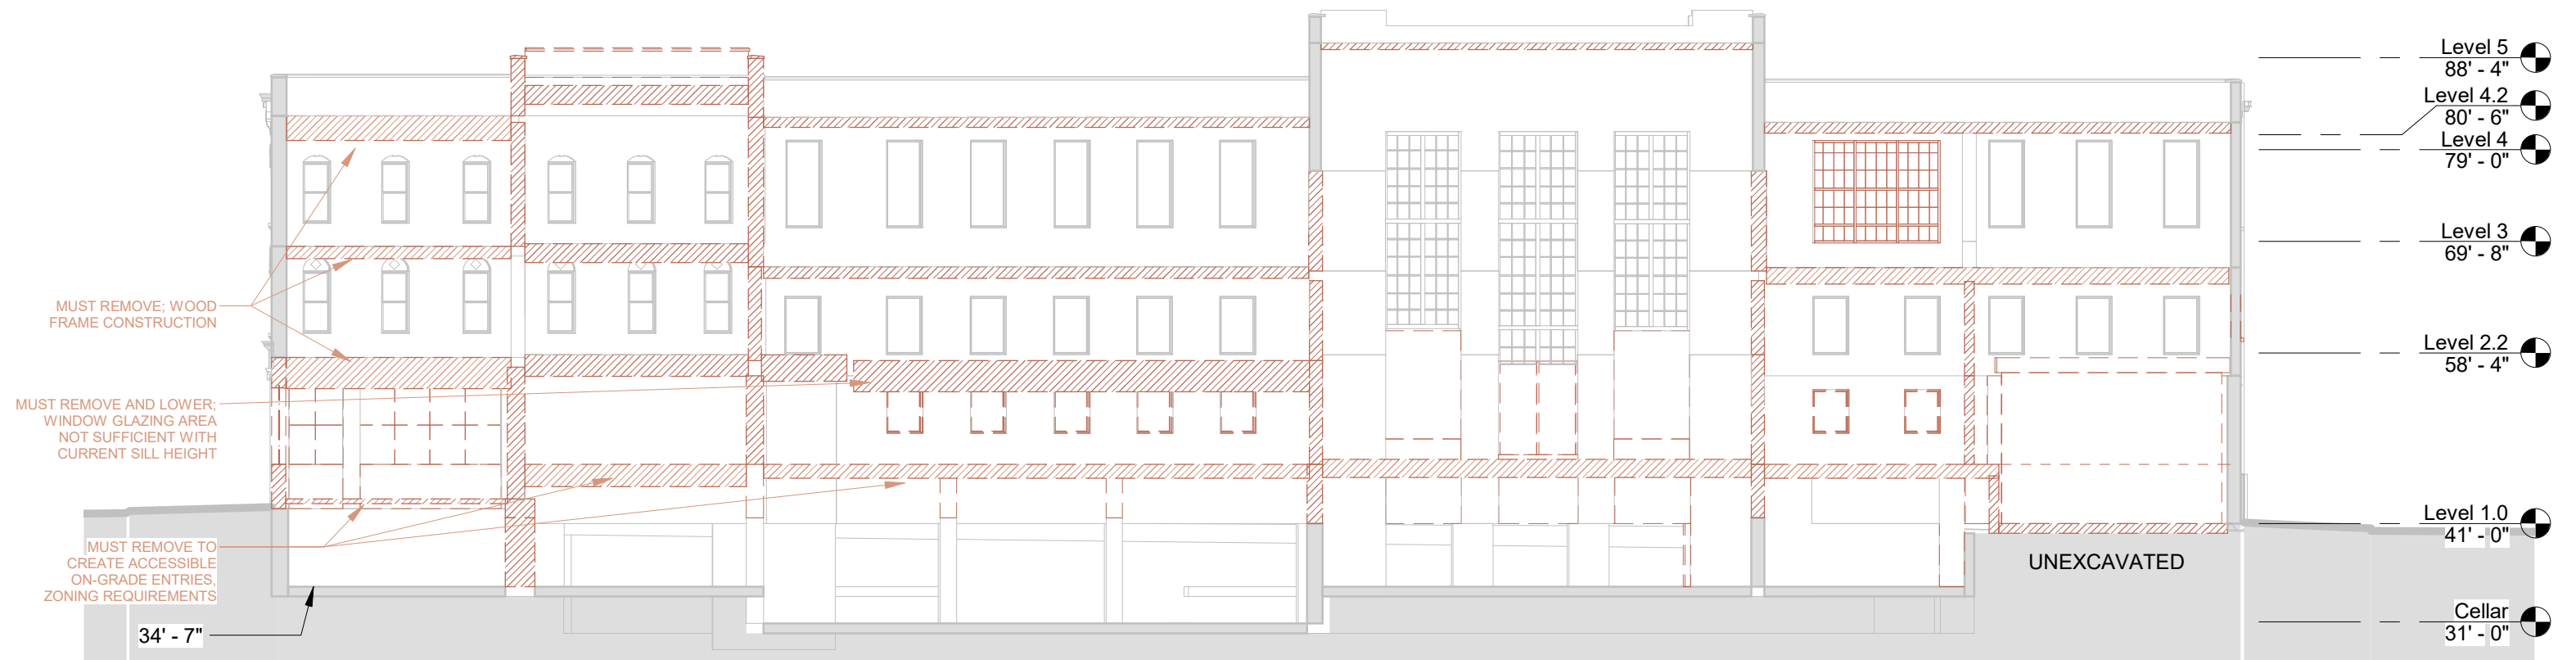
**EXISTING + DEMO - SECTION 1 LOOKING NORTH**

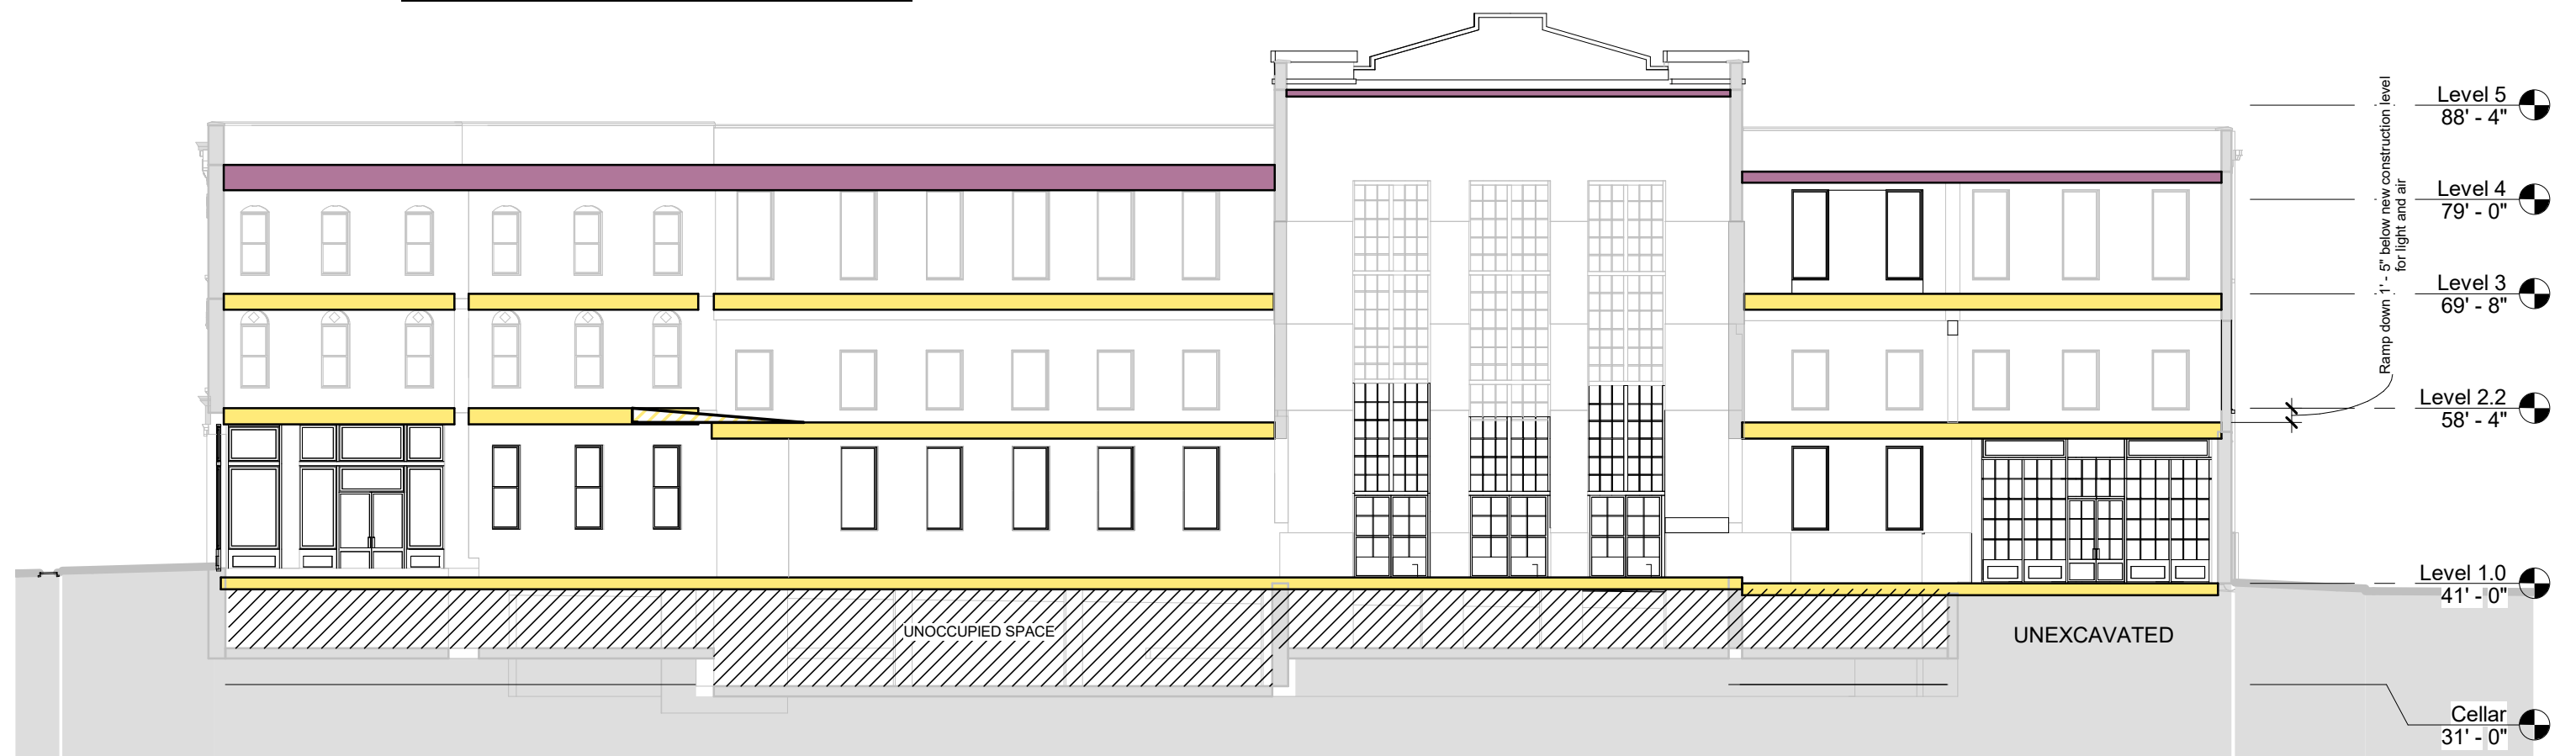
**NEW CONSTRUCTION - SECTION 1 LOOKING NORTH**

- FLOORS TO BE REMOVED
- EX'G ROOF TO BE REPLACED
- NEW FLOORS WITH EMBEDDED STRUCTURE
- NEW ROOF

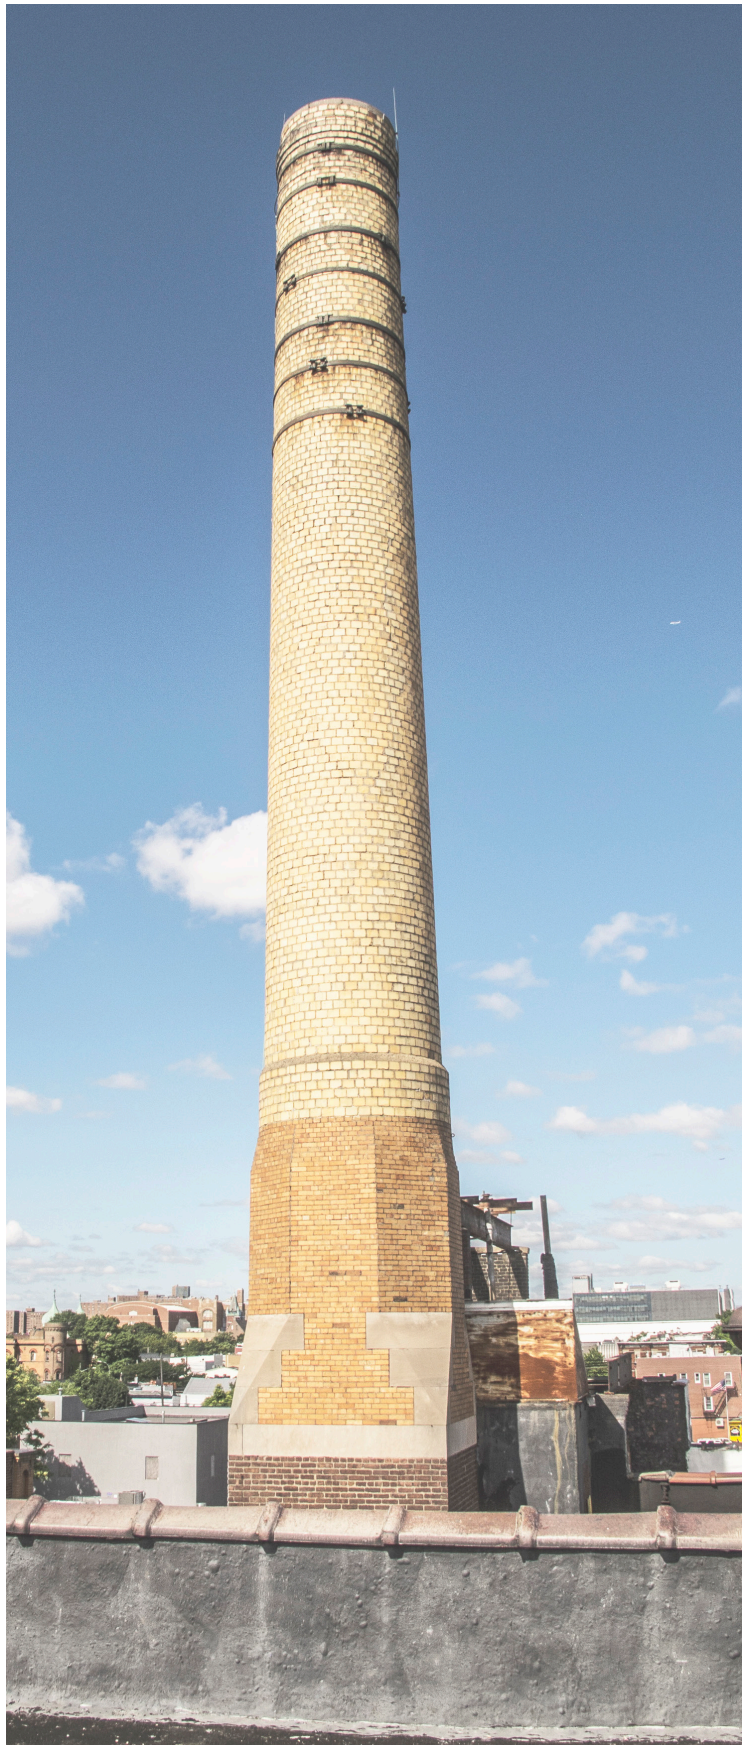
A. Existing Chimney from Roof

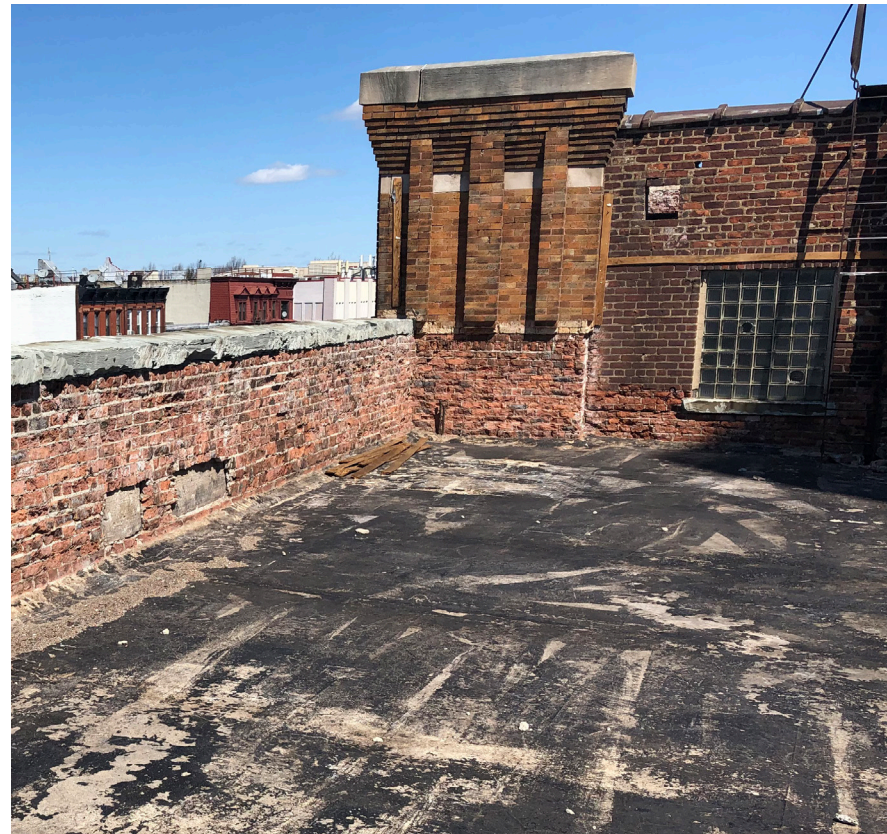
B. View from Roof Looking NE towards Main Entry

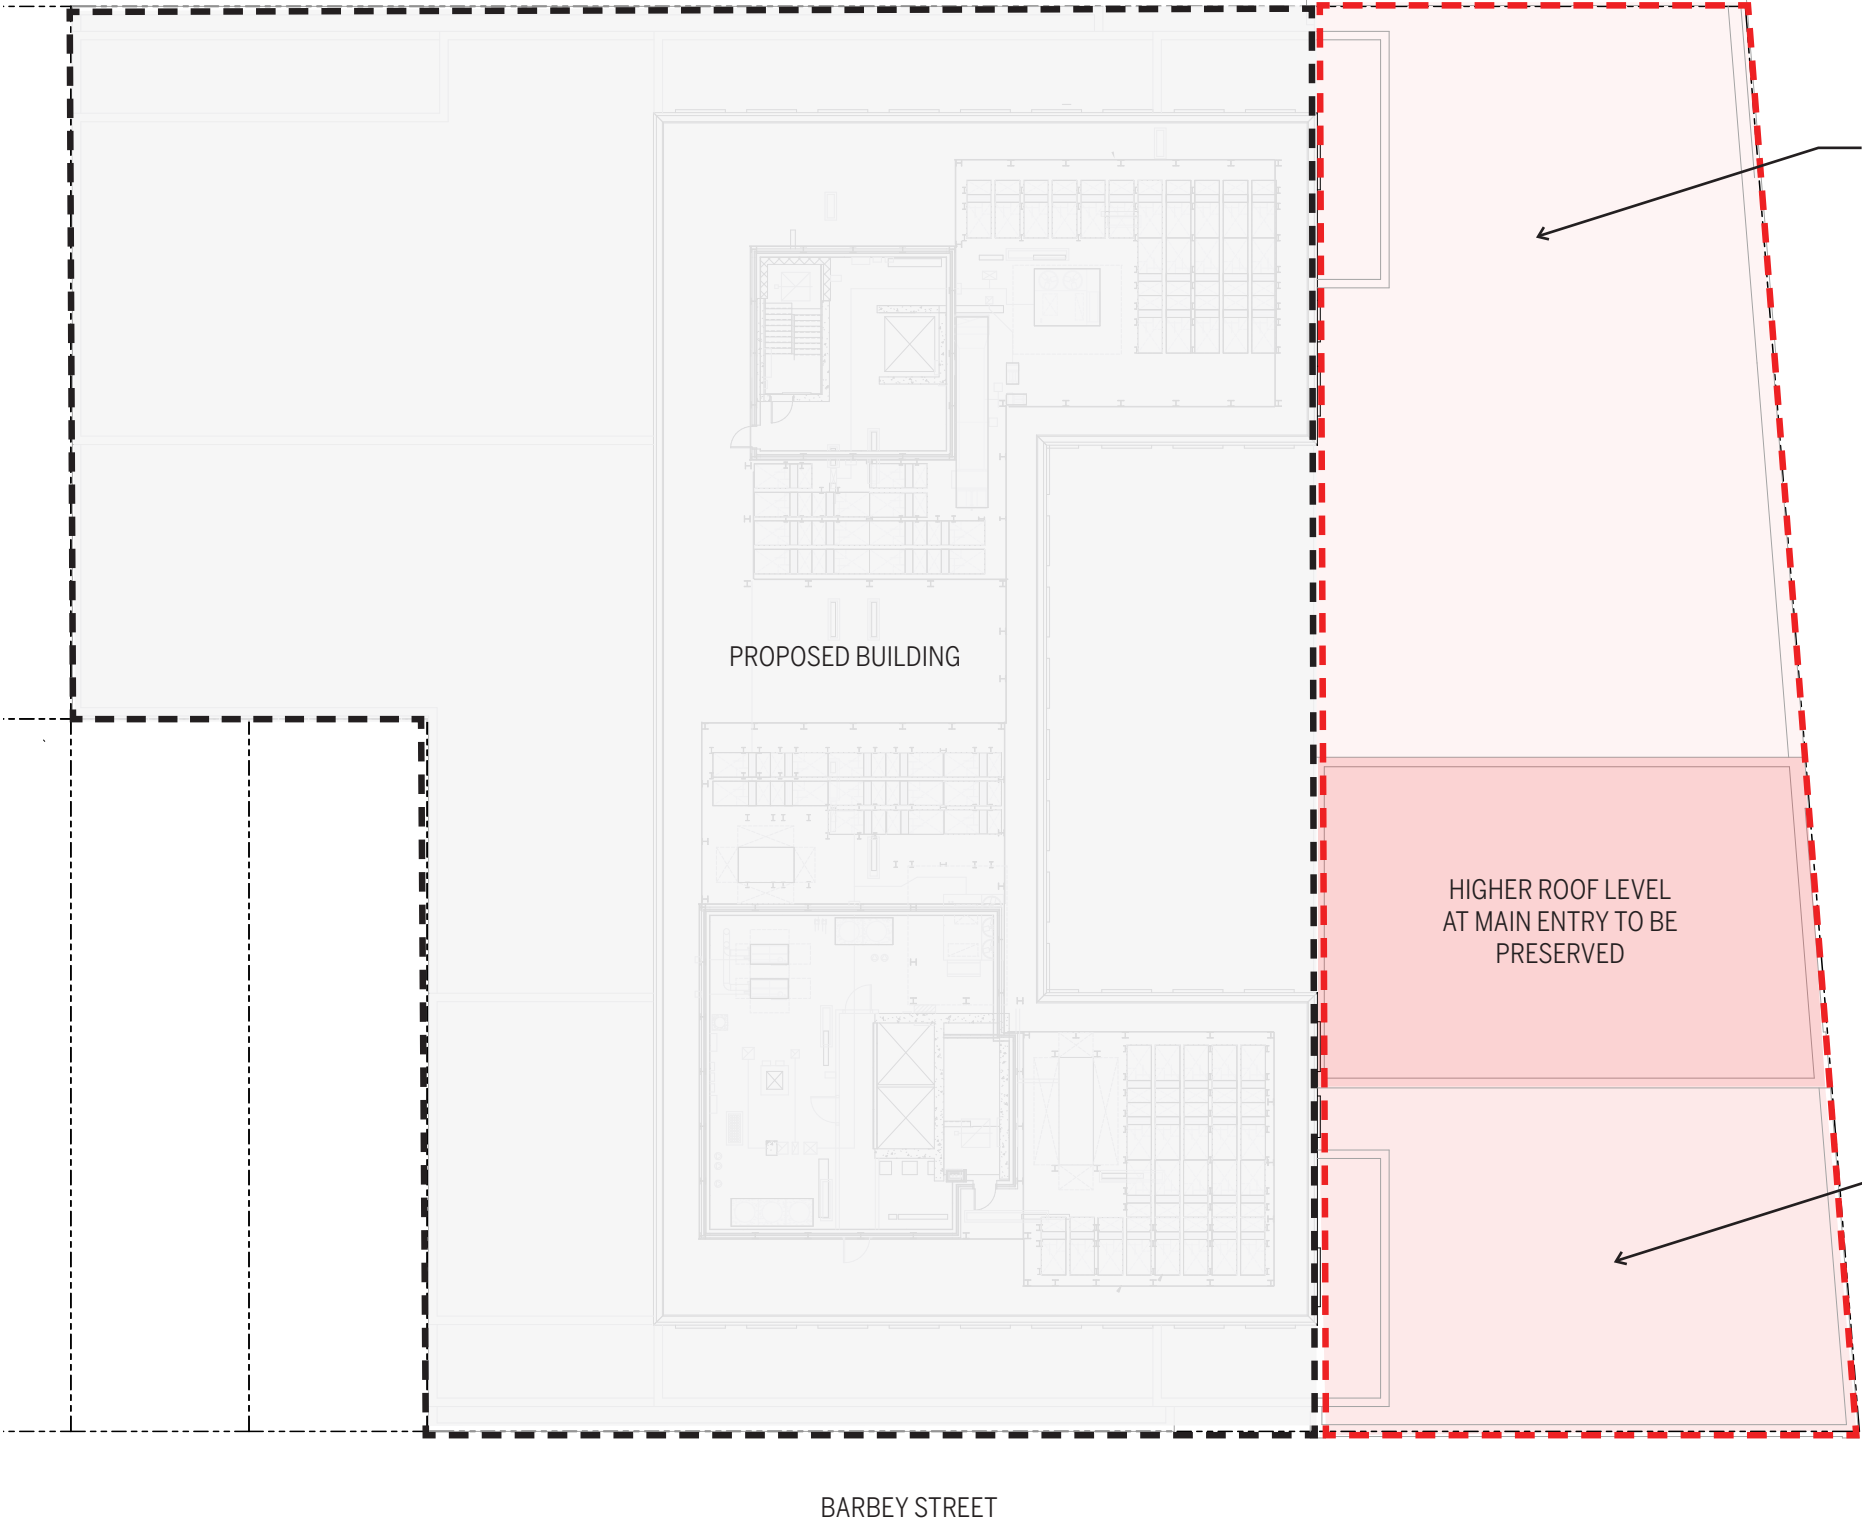
Proposed Roof Plan

THREE PORTIONS OF ROOF  
TO BE RECONSTRUCTED AT  
SAME LEVEL; ASSOCIATED  
PARAPETS TO BE  
PRESERVED

HIGHER ROOF LEVEL  
AT MAIN ENTRY TO BE  
PRESERVED

ROOF TO BE  
RECONSTRUCTED AS  
REQUIRED; PARAPETS TO  
BE PRESERVED

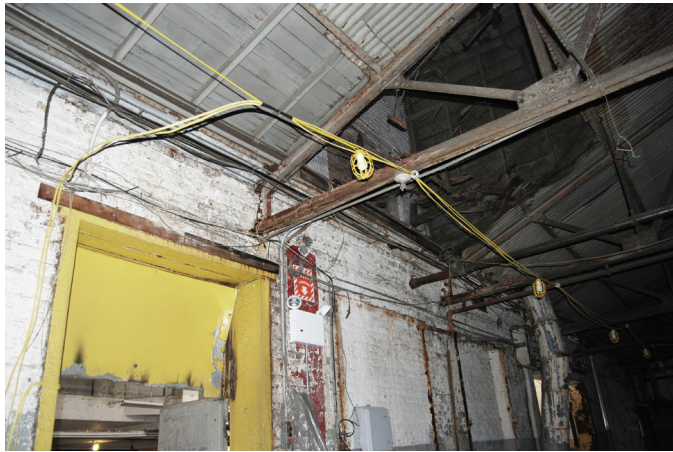
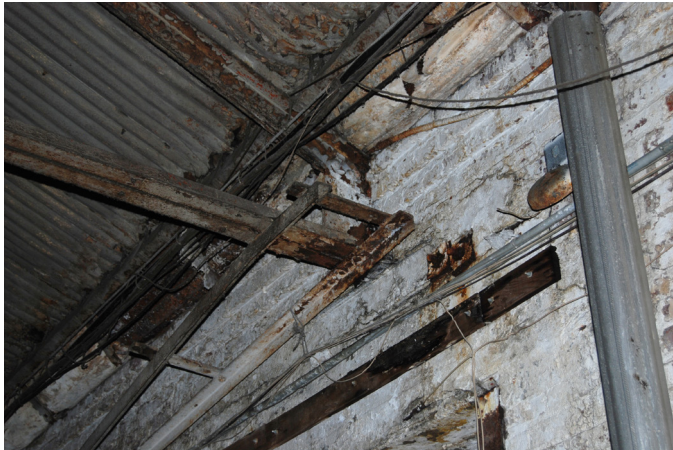
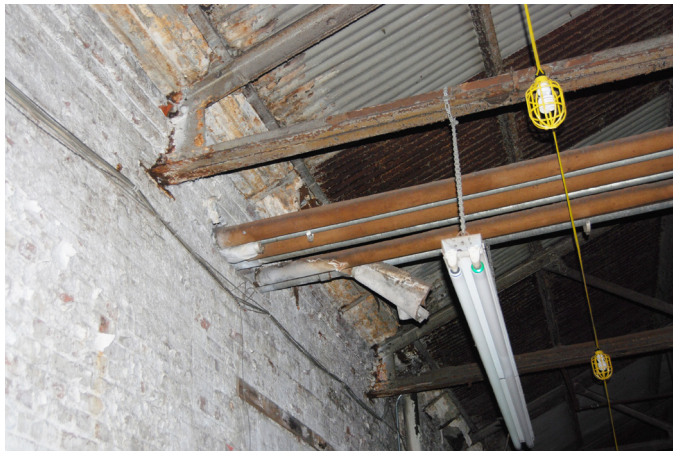
Existing Conditions Photos:  
Trusses at Shed Hitting Protected Structure

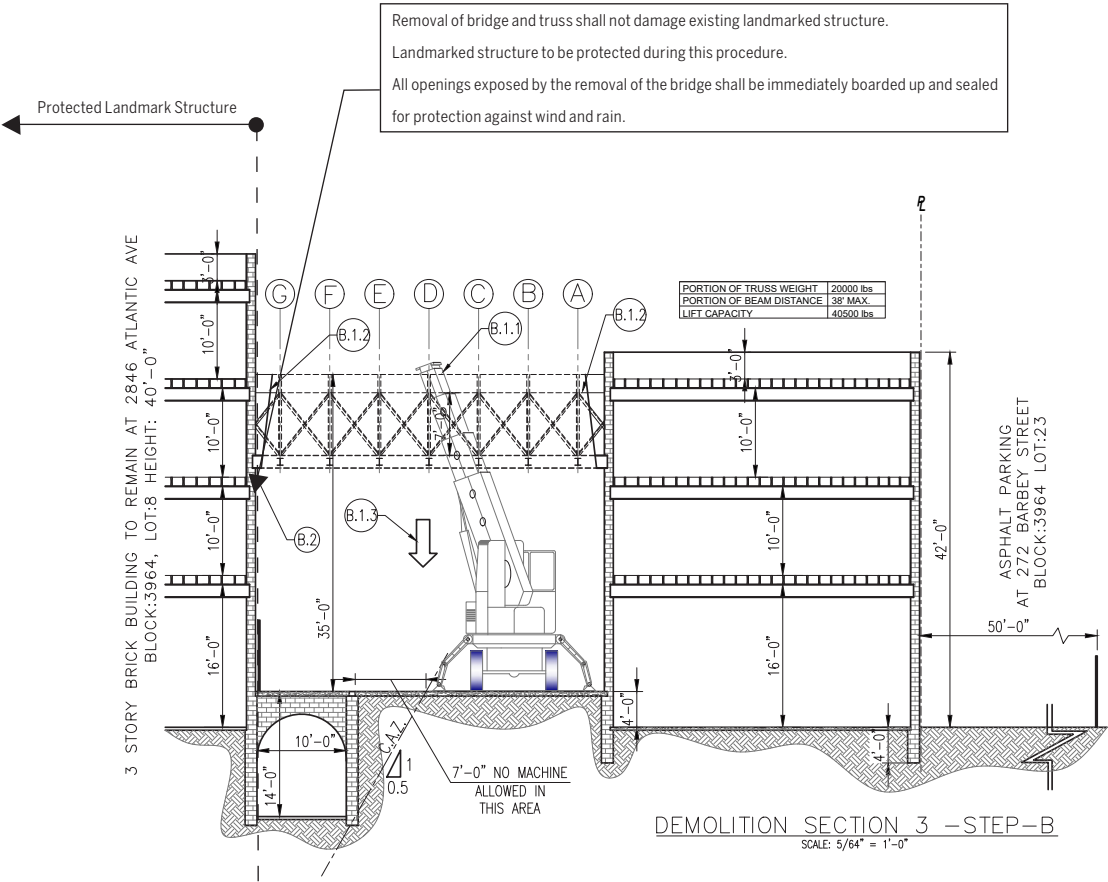
Demolition Plan Excerpts:  
Bridge Structures Hitting Protected Structure

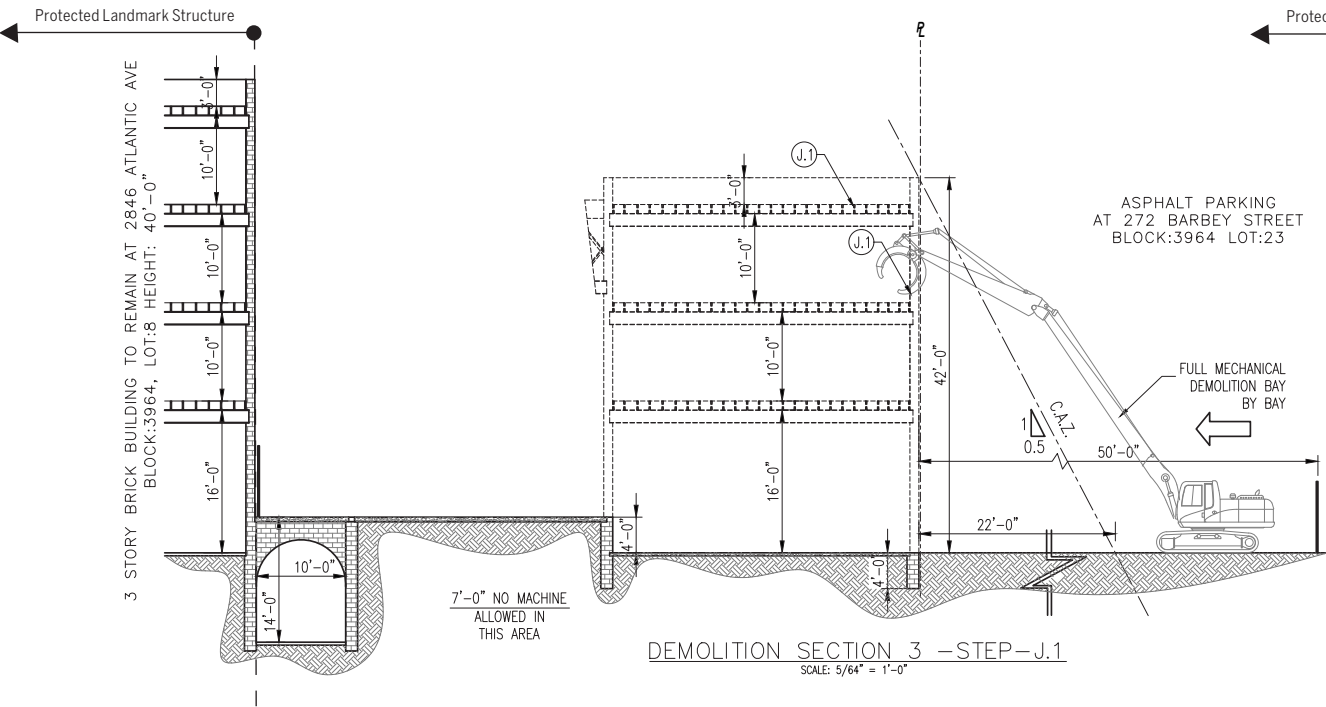
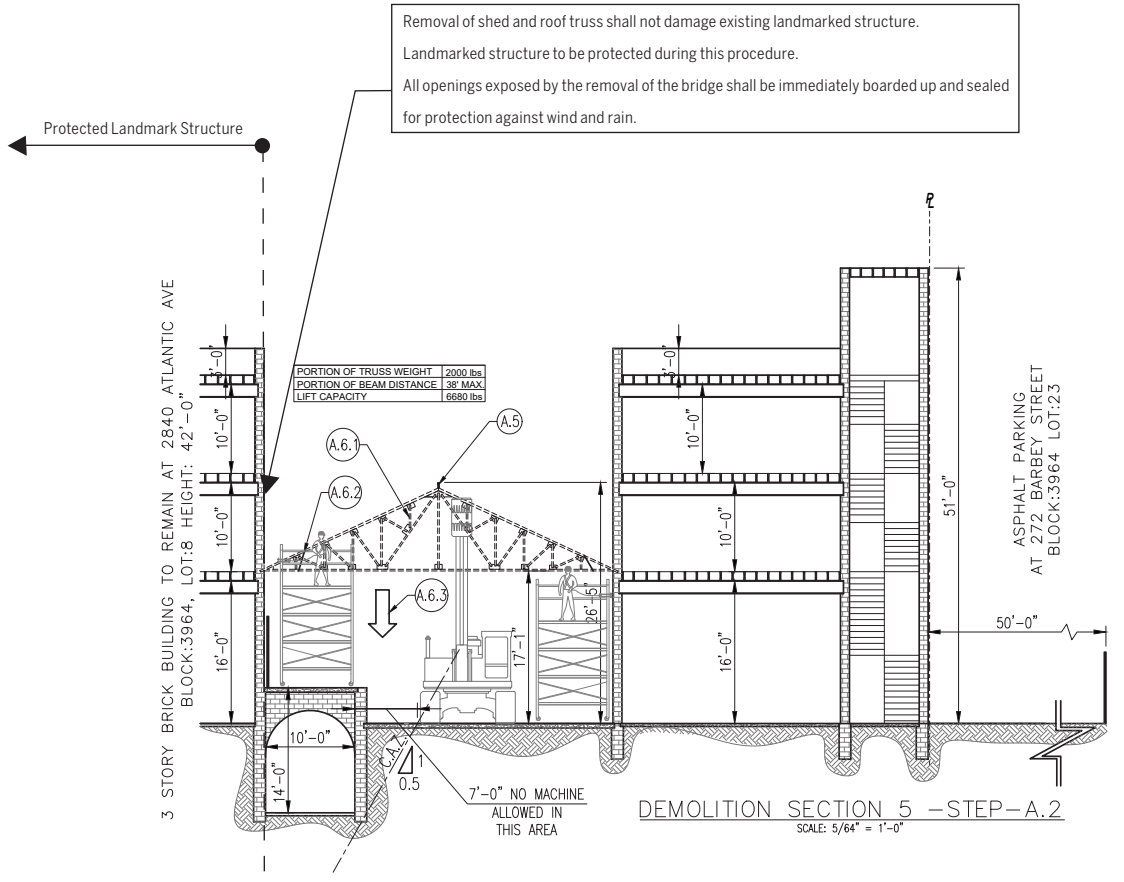
Demolition Plan Excerpts:  
Shed Structure Hitting Protected Structure
