**Landmarks Preservation Commission Presentation**

**Empire State Dairy**  
2840 Atlantic Avenue, Brooklyn

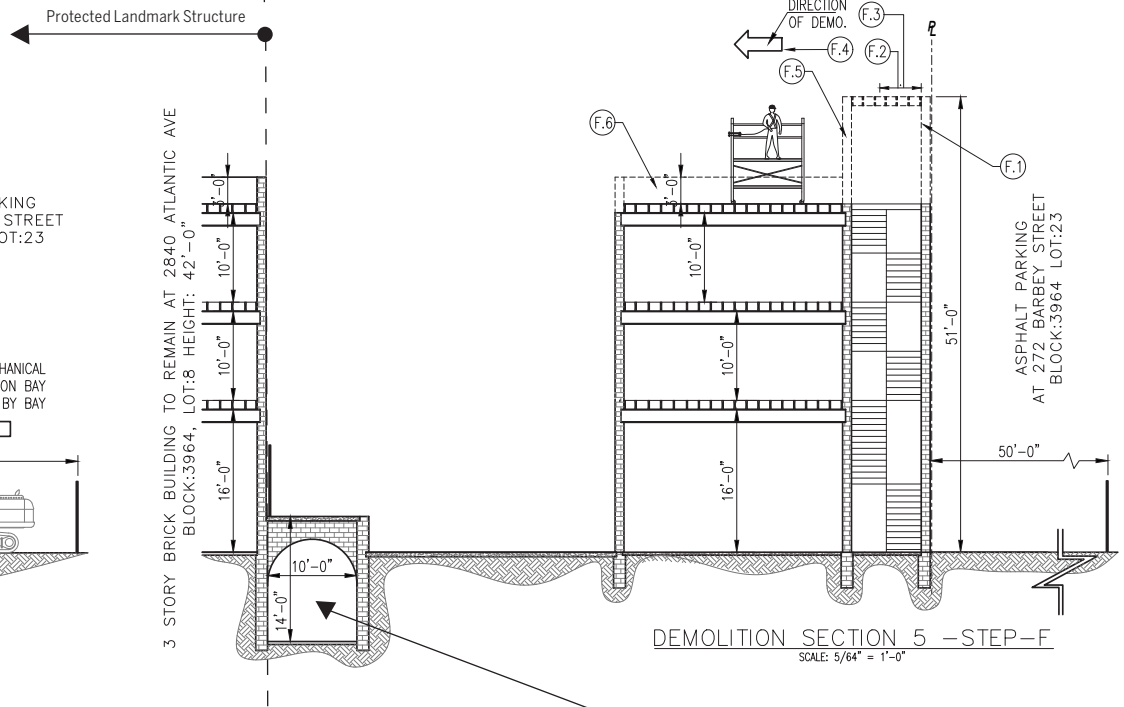
Concrete slab and masonry areaway to be removed at a later date. Landmarked structure to be protected during this procedure. Removal shall be coordinated with the structural engineer to ensure continued support and stability of south wall of protected landmarked building. All openings exposed by the removal of the areaway shall be immediately boarded up and sealed for protection against the wind and rain.
