4881 Broadway – Dyckman House – Individual Landmark Borough of Manhattan

New Addition, Restoration, and Accessibility Improvements

Dyckman Farmhouse Museum | Landmarks Preservation Commission, July 19, 2022

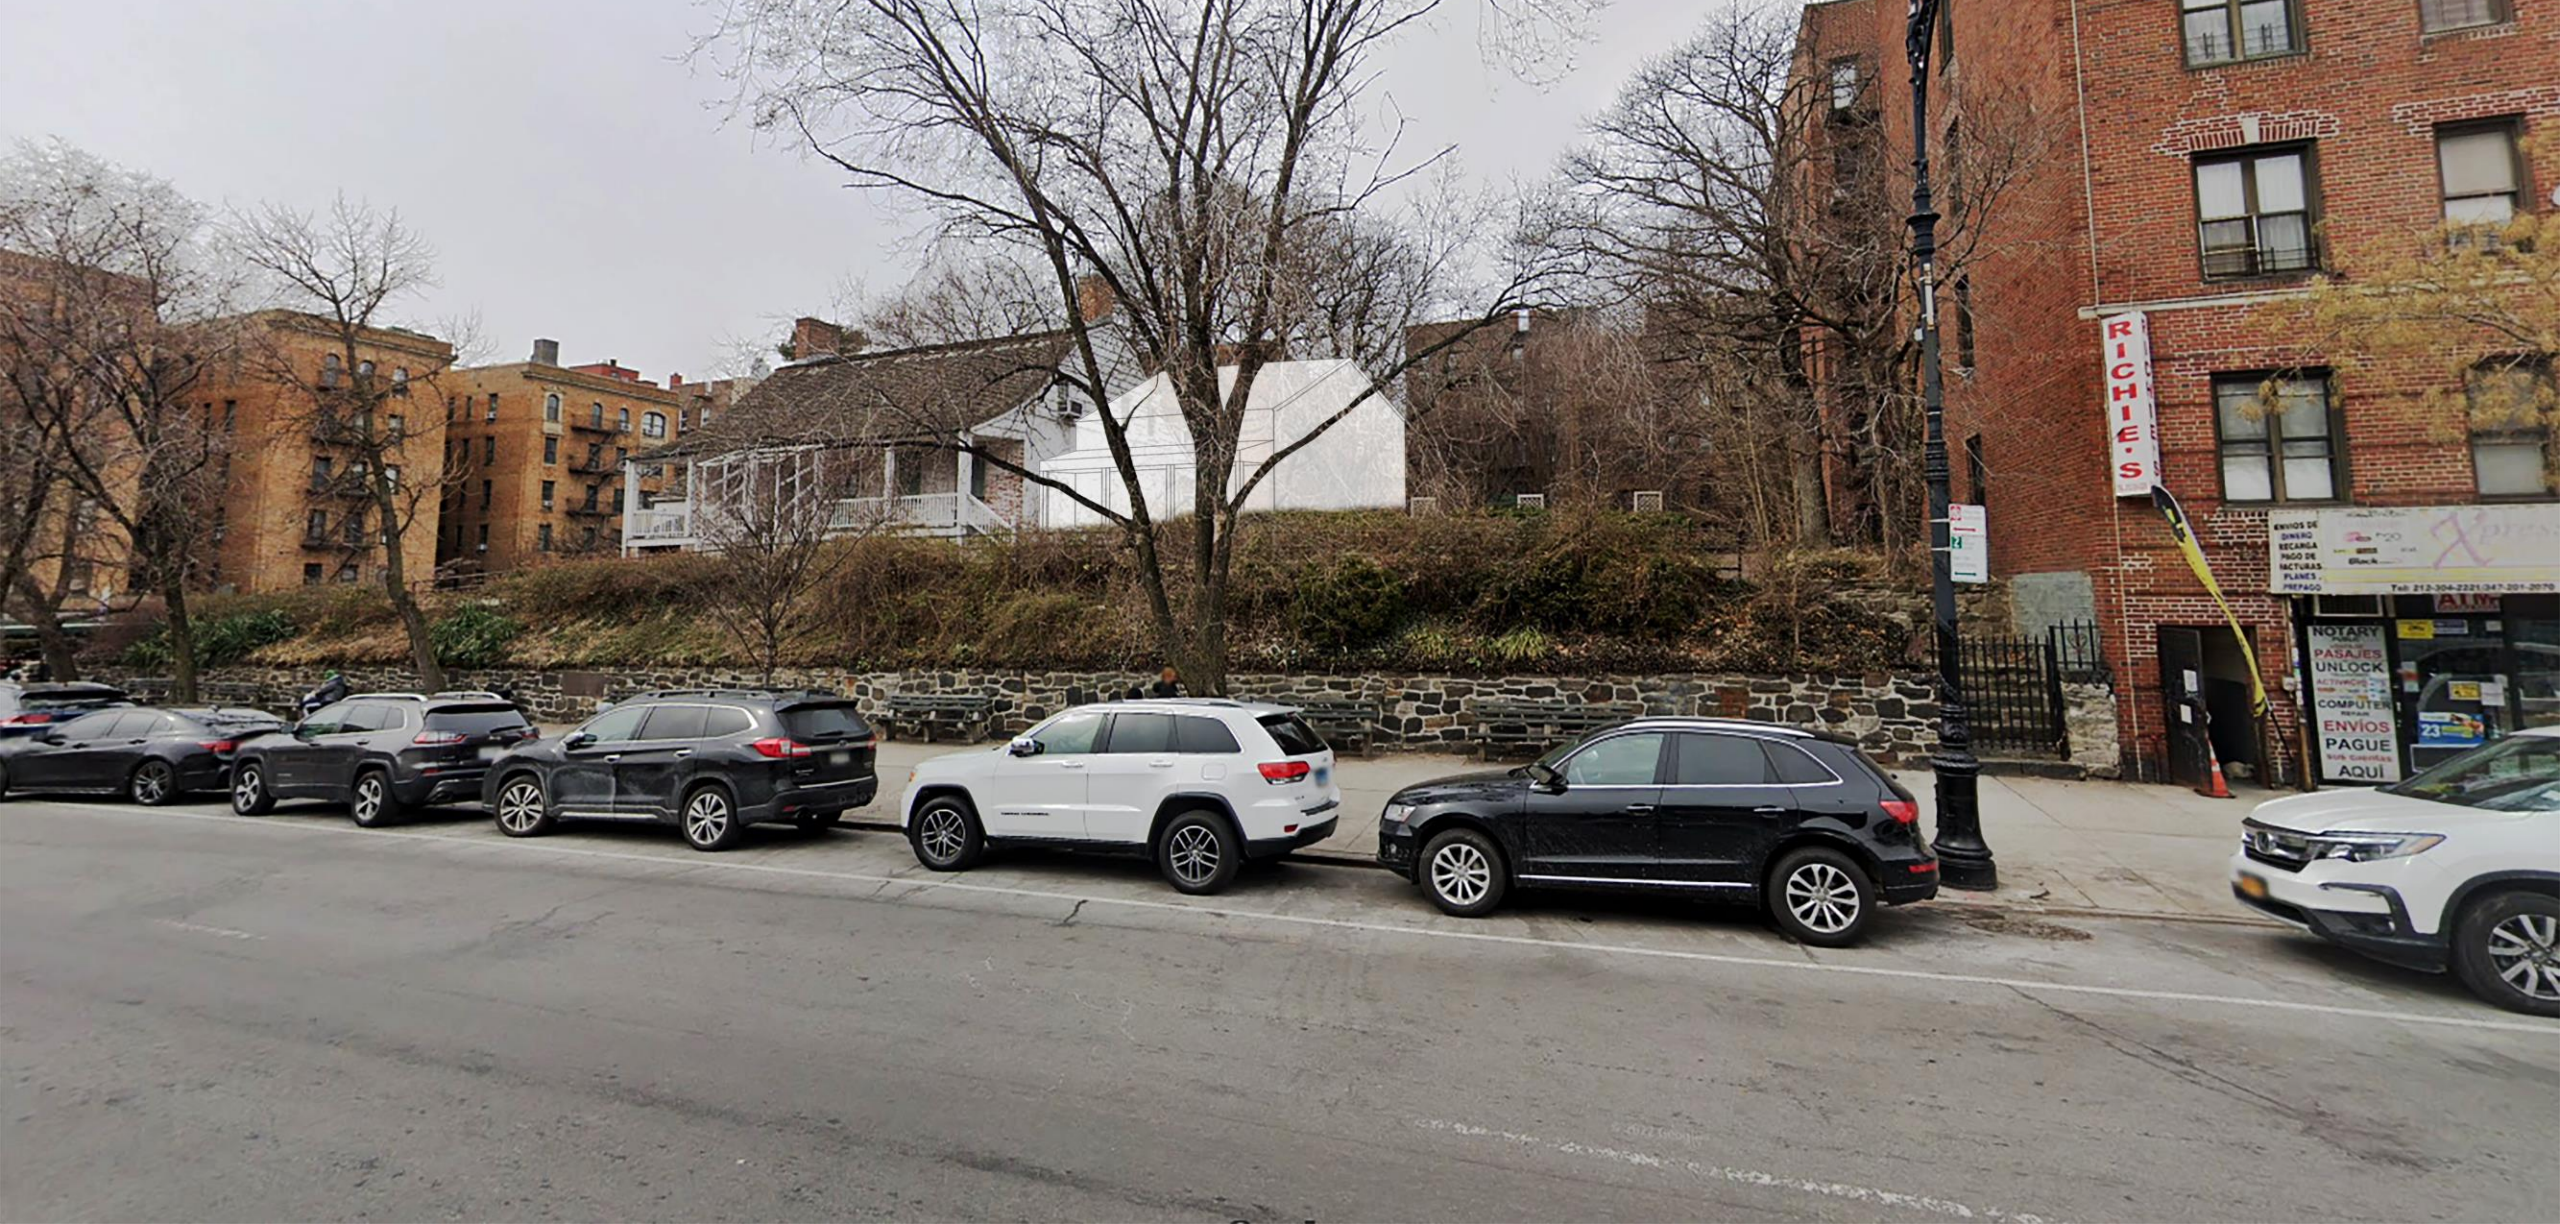
Historic House Trust of NYC
Dyckman Farmhouse Museum | Addition Massing Study

Legend

- - - - Outline of Historic Addition
- Proposed Door in New Connector
- Proposed form of New Connector in contact with the historic house
- Proposed Outline of New Addition

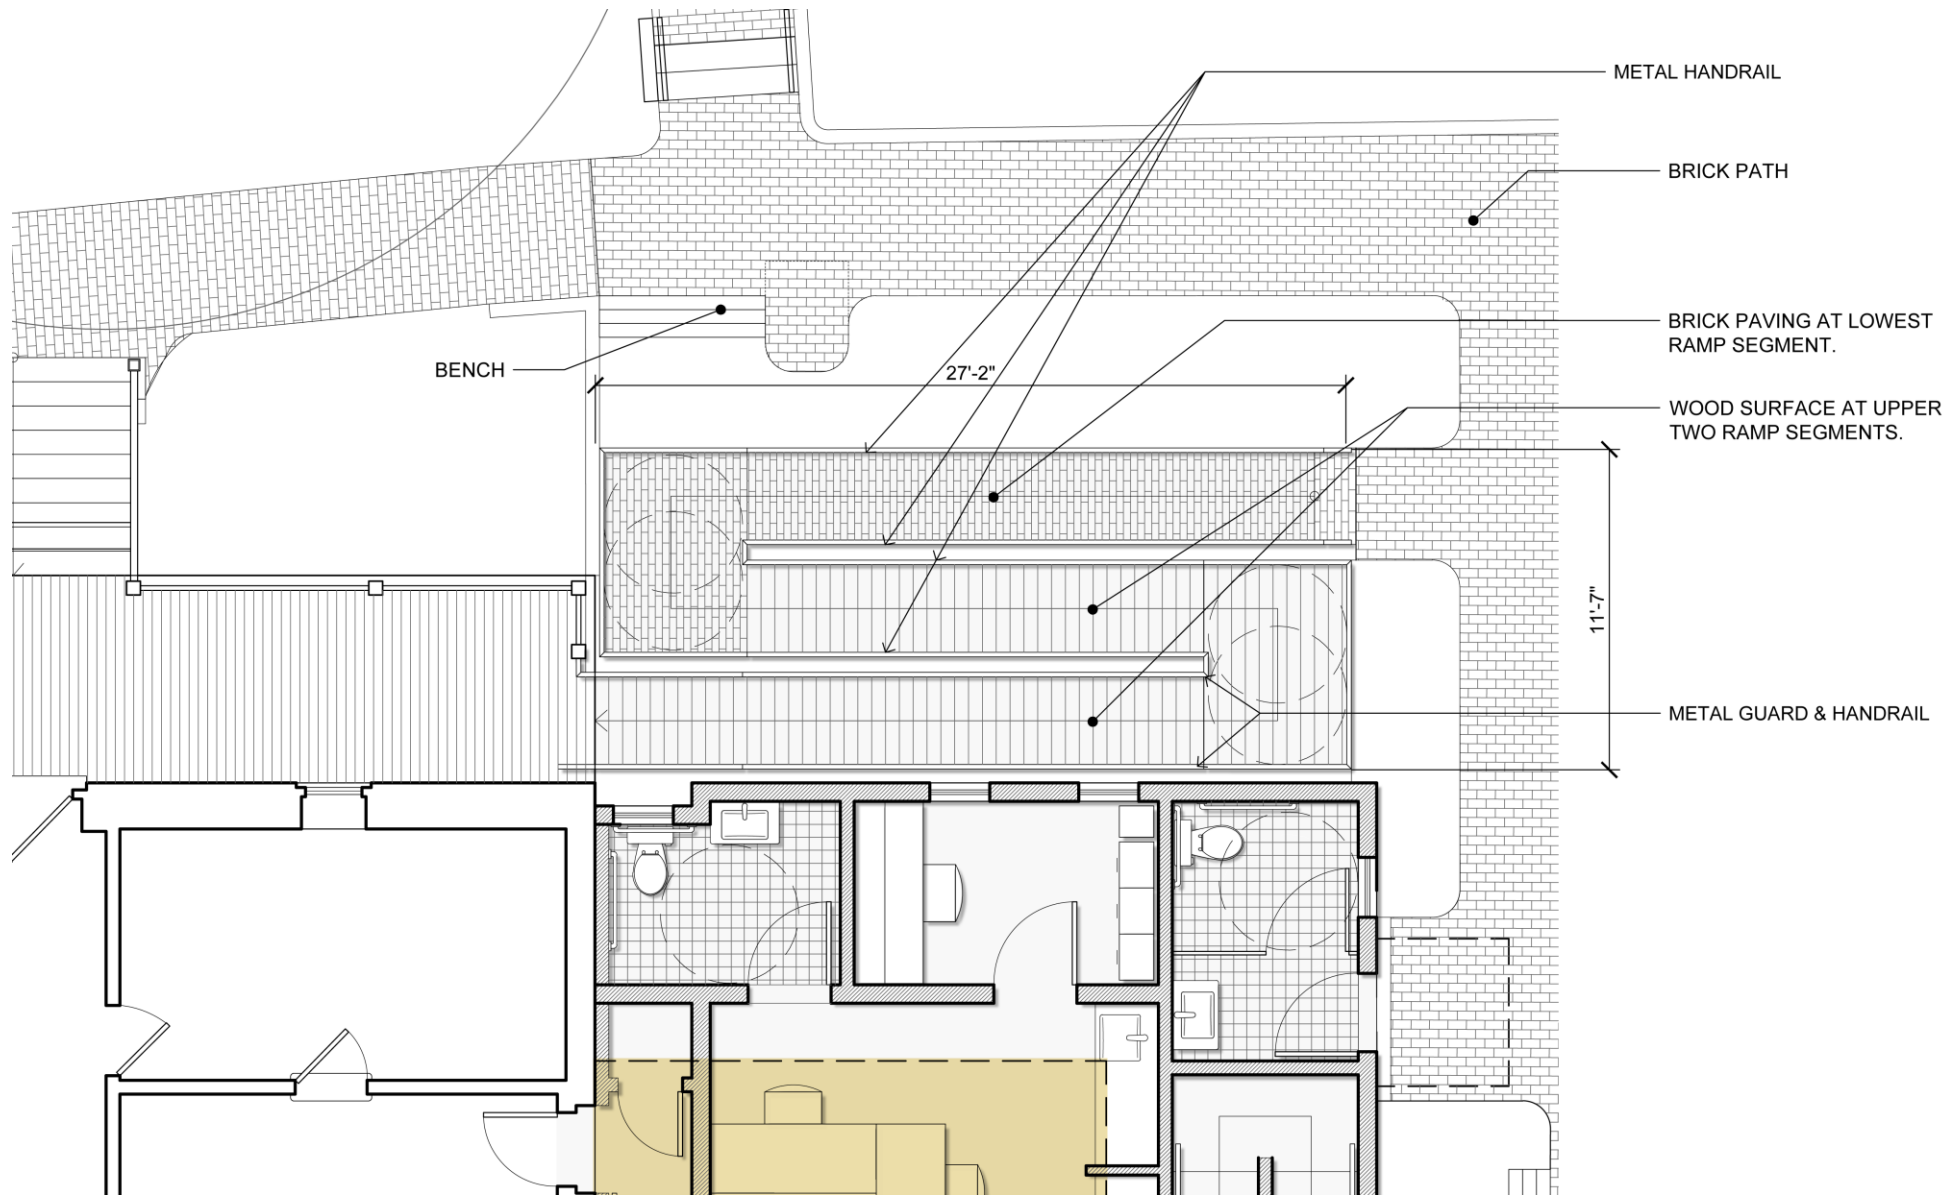
Dyckman Farmhouse Museum | Proposed Ramp for Barrier-Free Access to Main Floor Interior

Existing West Porch and Stairs

Proposed West Porch and Stairs

- METAL RAILINGS @ RAMP
- ALTERED RAILING SECTION
- RAISED DECK STRUCTURE
- NEW WOOD STEPS & RAILINGS

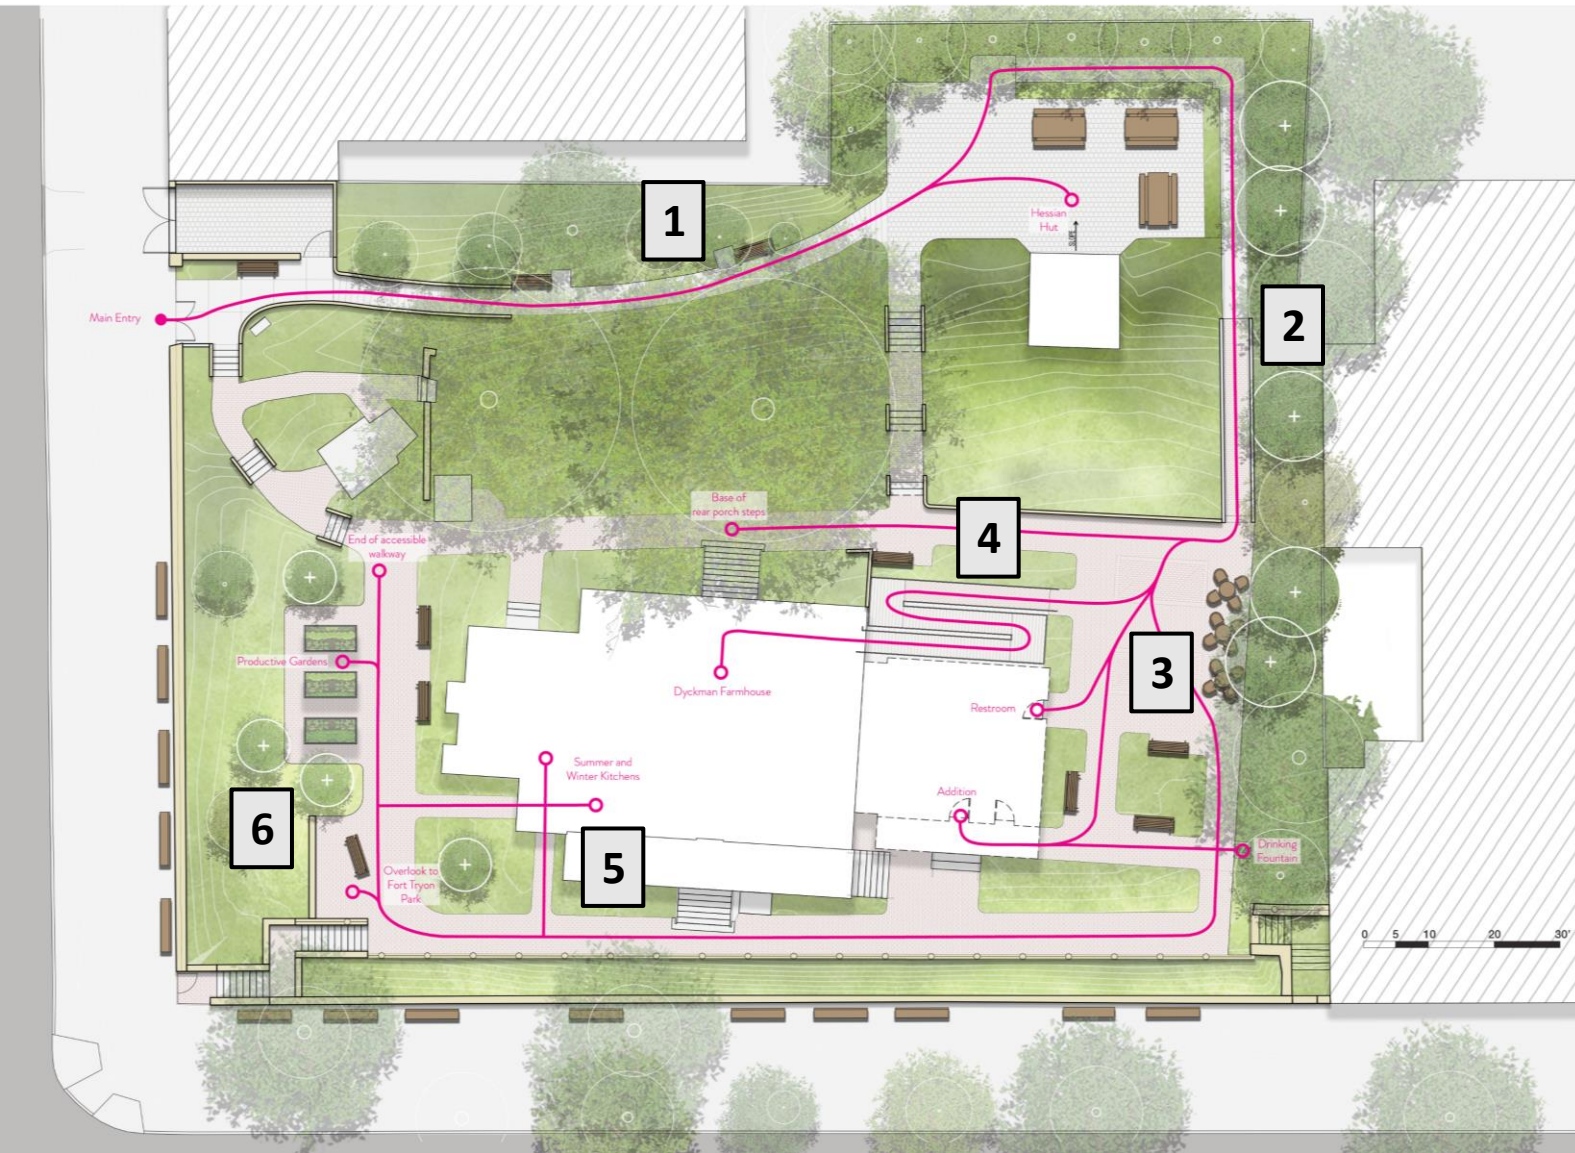
- New public entrance to park on 204th Street
- Enlarged and functional outdoor program areas with upgraded support facilities
- Rehabilitated paving and plantings
- Accessible route to entrance of farmhouse and all landscaped areas

1. Universal access from new park entrance to Hessian Hut program area
2. Constructed accessible ramp in landscape
3. Accessible route and plaza for expanded outdoor program, public toilet, and administrative offices
4. Constructed accessible ramp for access to west porch
5. Accessible route at front of farmhouse to basement interpretive rooms
6. Accessible route to distant vista and productive gardens

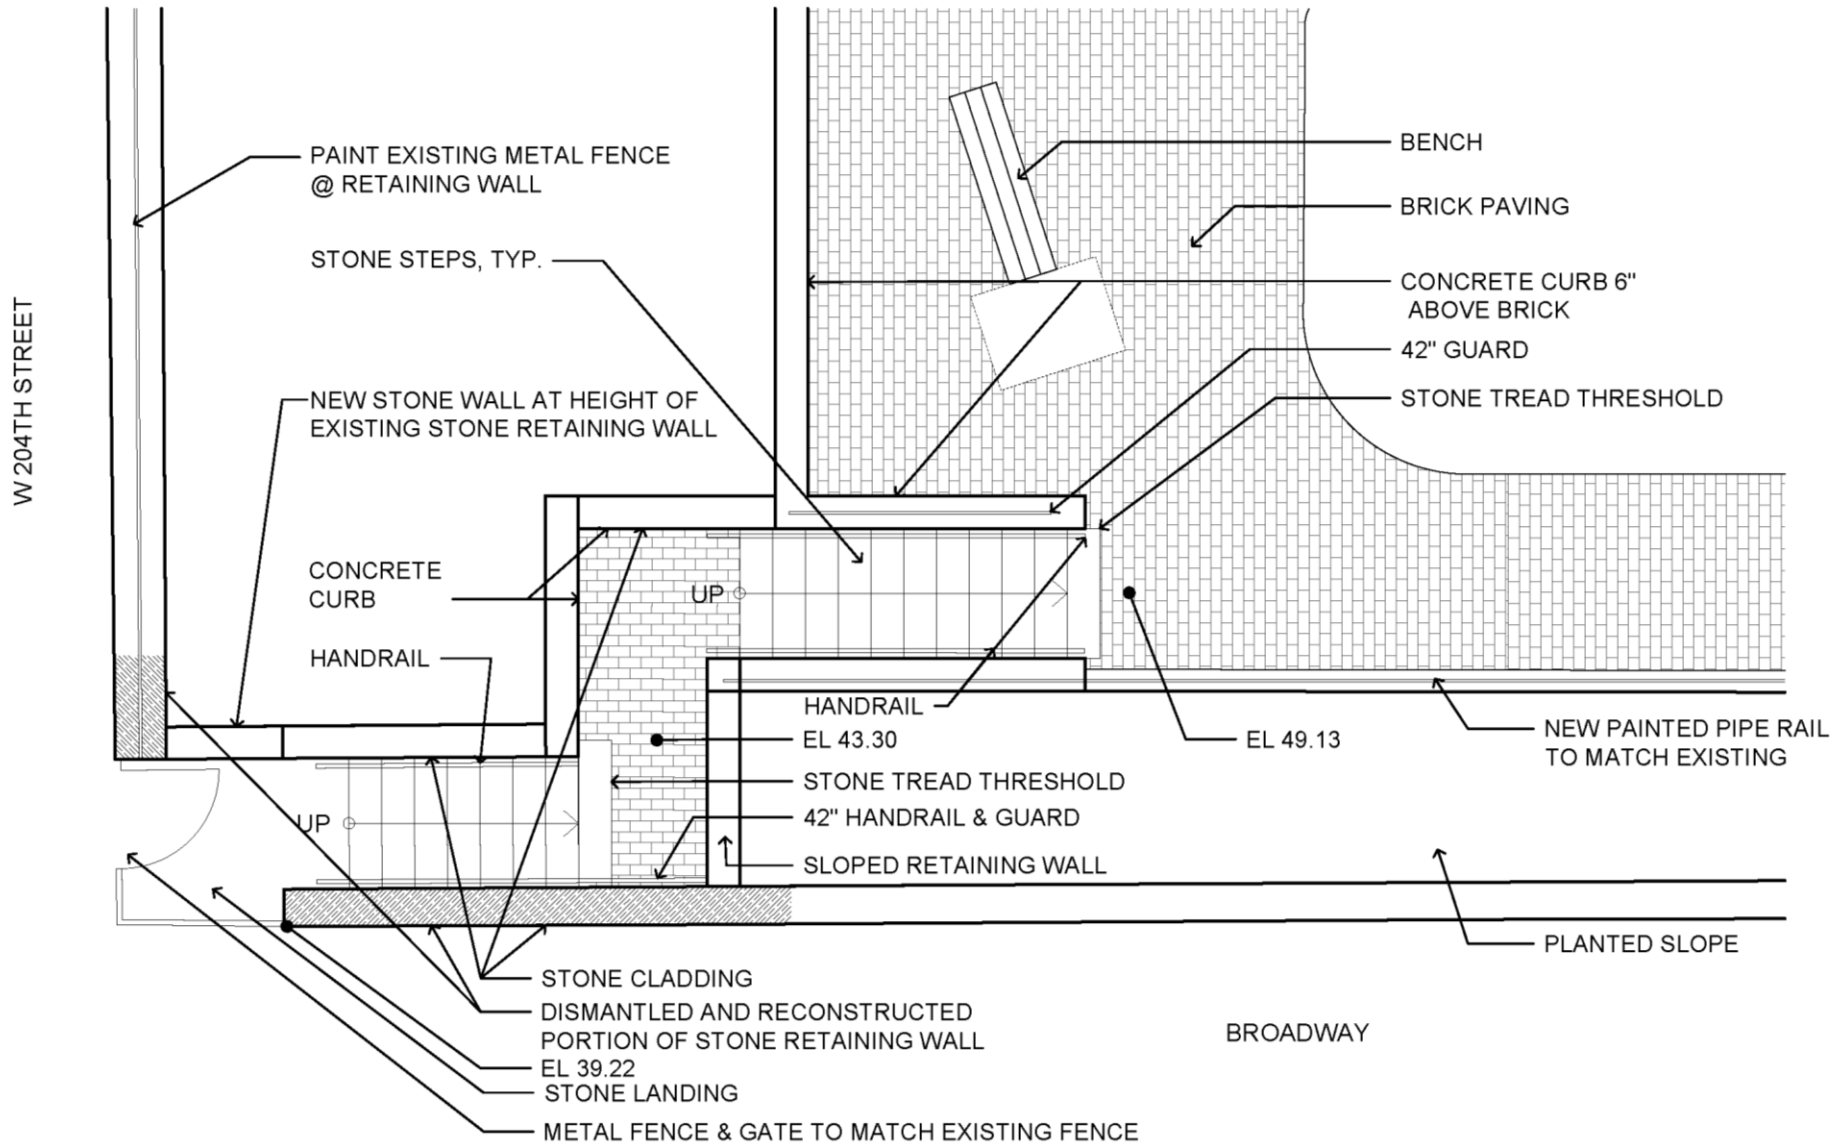
Dyckman Farmhouse Museum | Broadway and 204th Street Entrance – Proposed Plan

DISMANTLED AND RECONSTRUCTED PORTION OF STONE RETAINING WALL

PAINTED METAL GUARD W/MESH

PAINTED METAL GUARD RAIL & HANDRAIL WITH SAFETY MESH

STONE FACED WALL - RANDOM COURSE ASHLAR WITH SAME COLORS AS EXISTING WALL.

PAINTED PIPE RAIL TO MATCH EXISTING WITH SAFETY MESH

IRON FENCE TO MATCH EXISTING

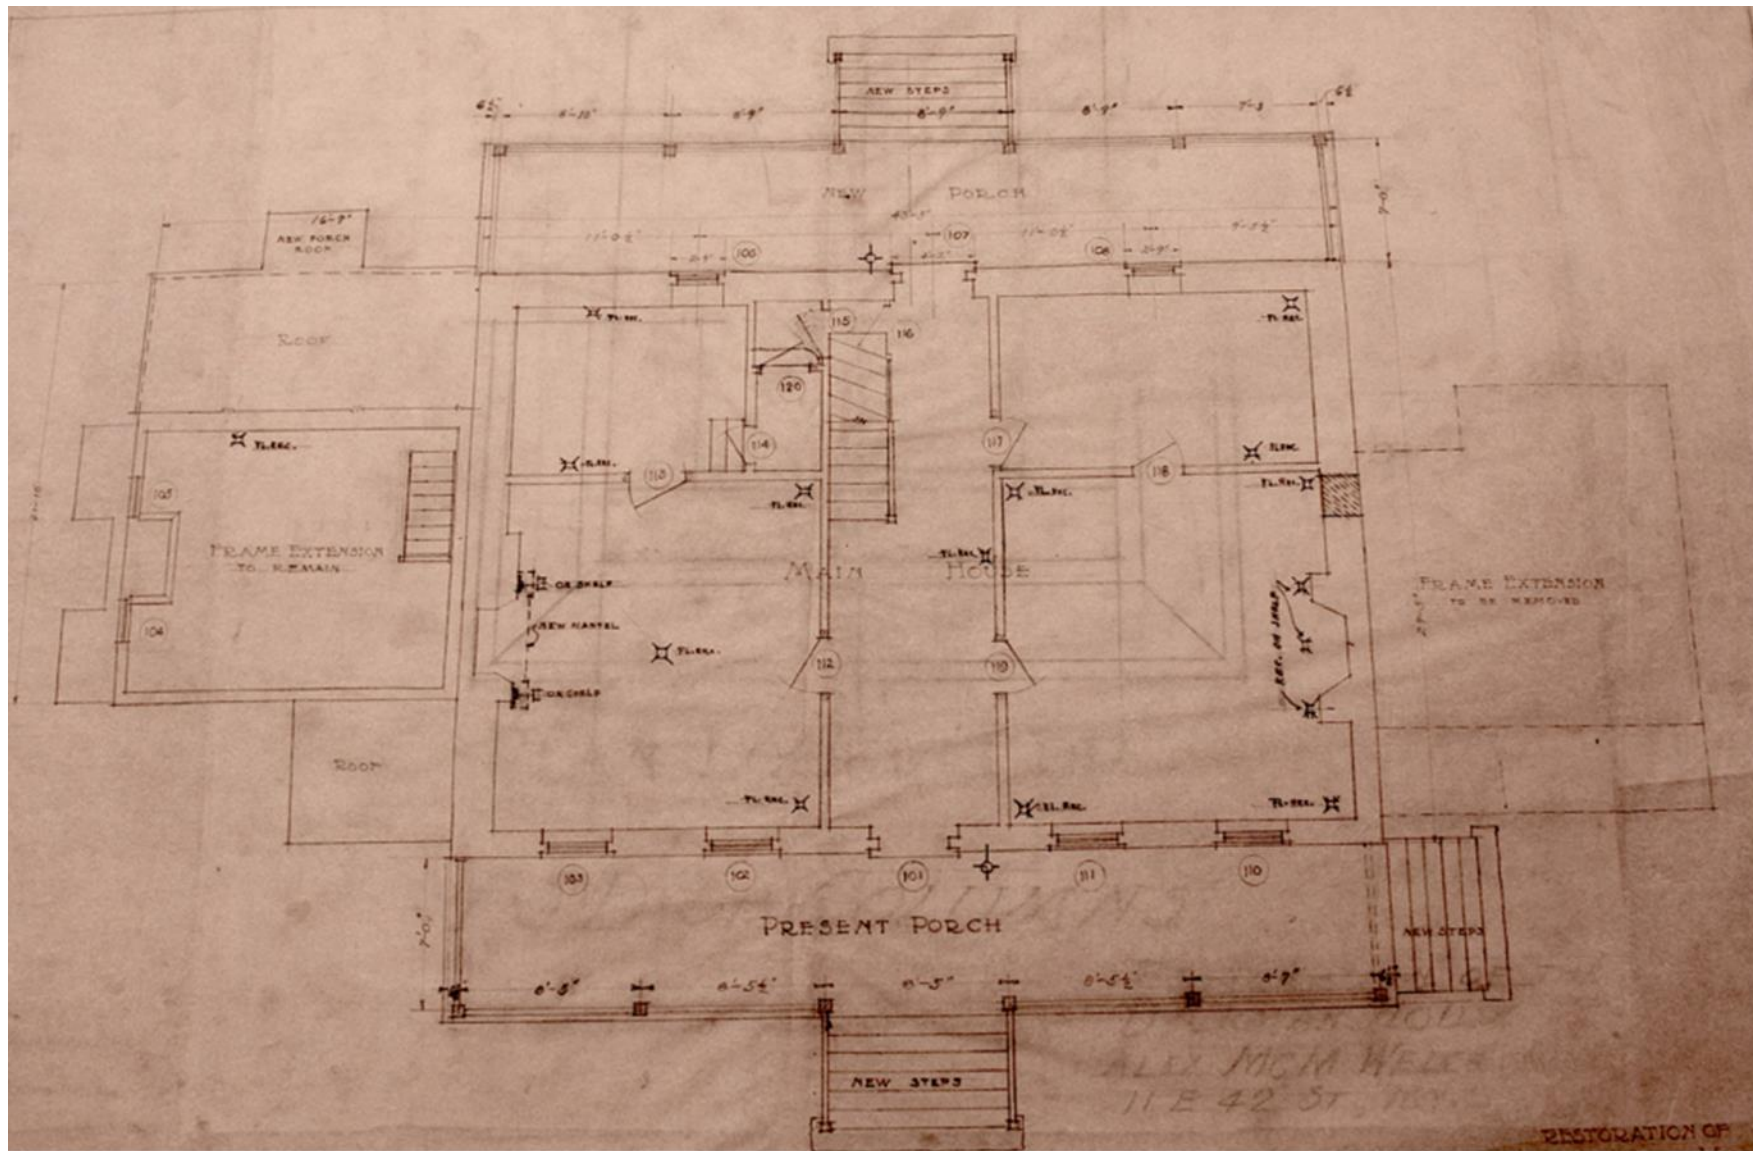
Alexander Macmillan Welch Preliminary Plan, 1915

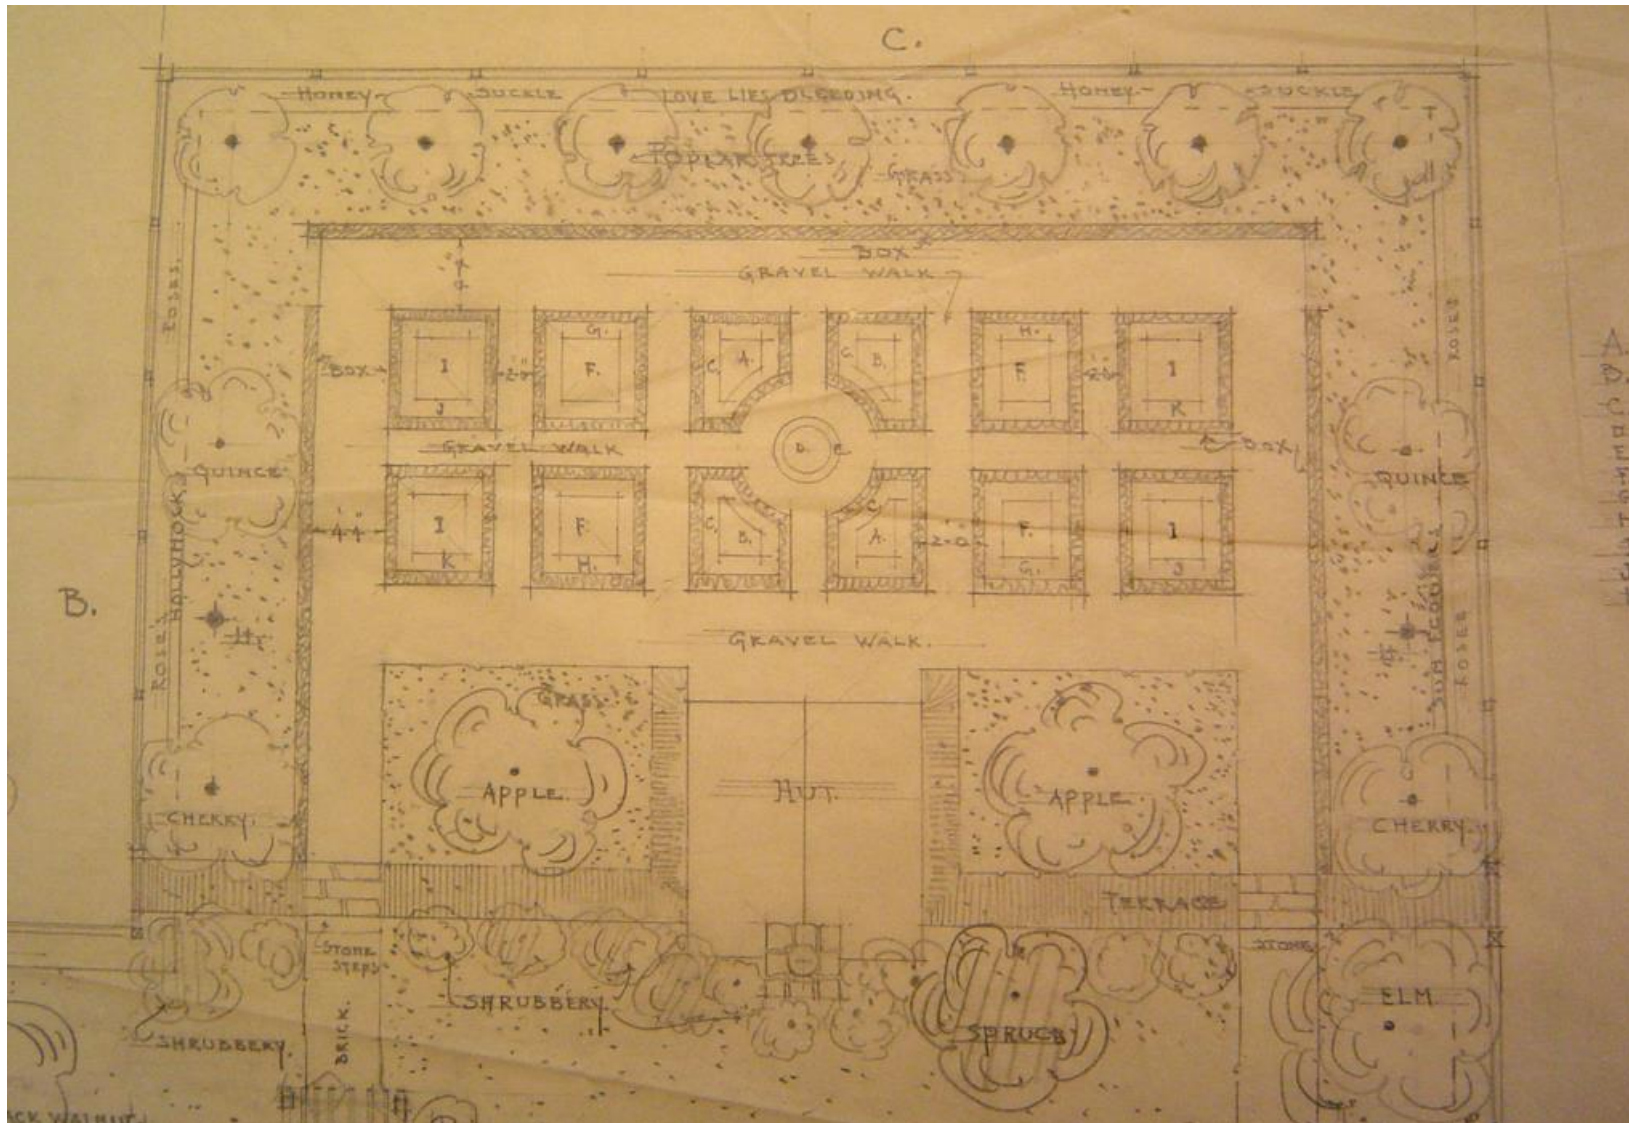
Preliminary Garden Plan at Hessian Hut, Alexander Macmillan Welch, 1915
