Preservation Department – Item 1, LPC-22-09135

**165-167 West 86th Street, aka 541 Amsterdam Avenue – West
Park Presbyterian Church – Individual Landmark
Borough of Manhattan**

Application for a Notice to Proceed to allow for Demolition on the Grounds of Hardship

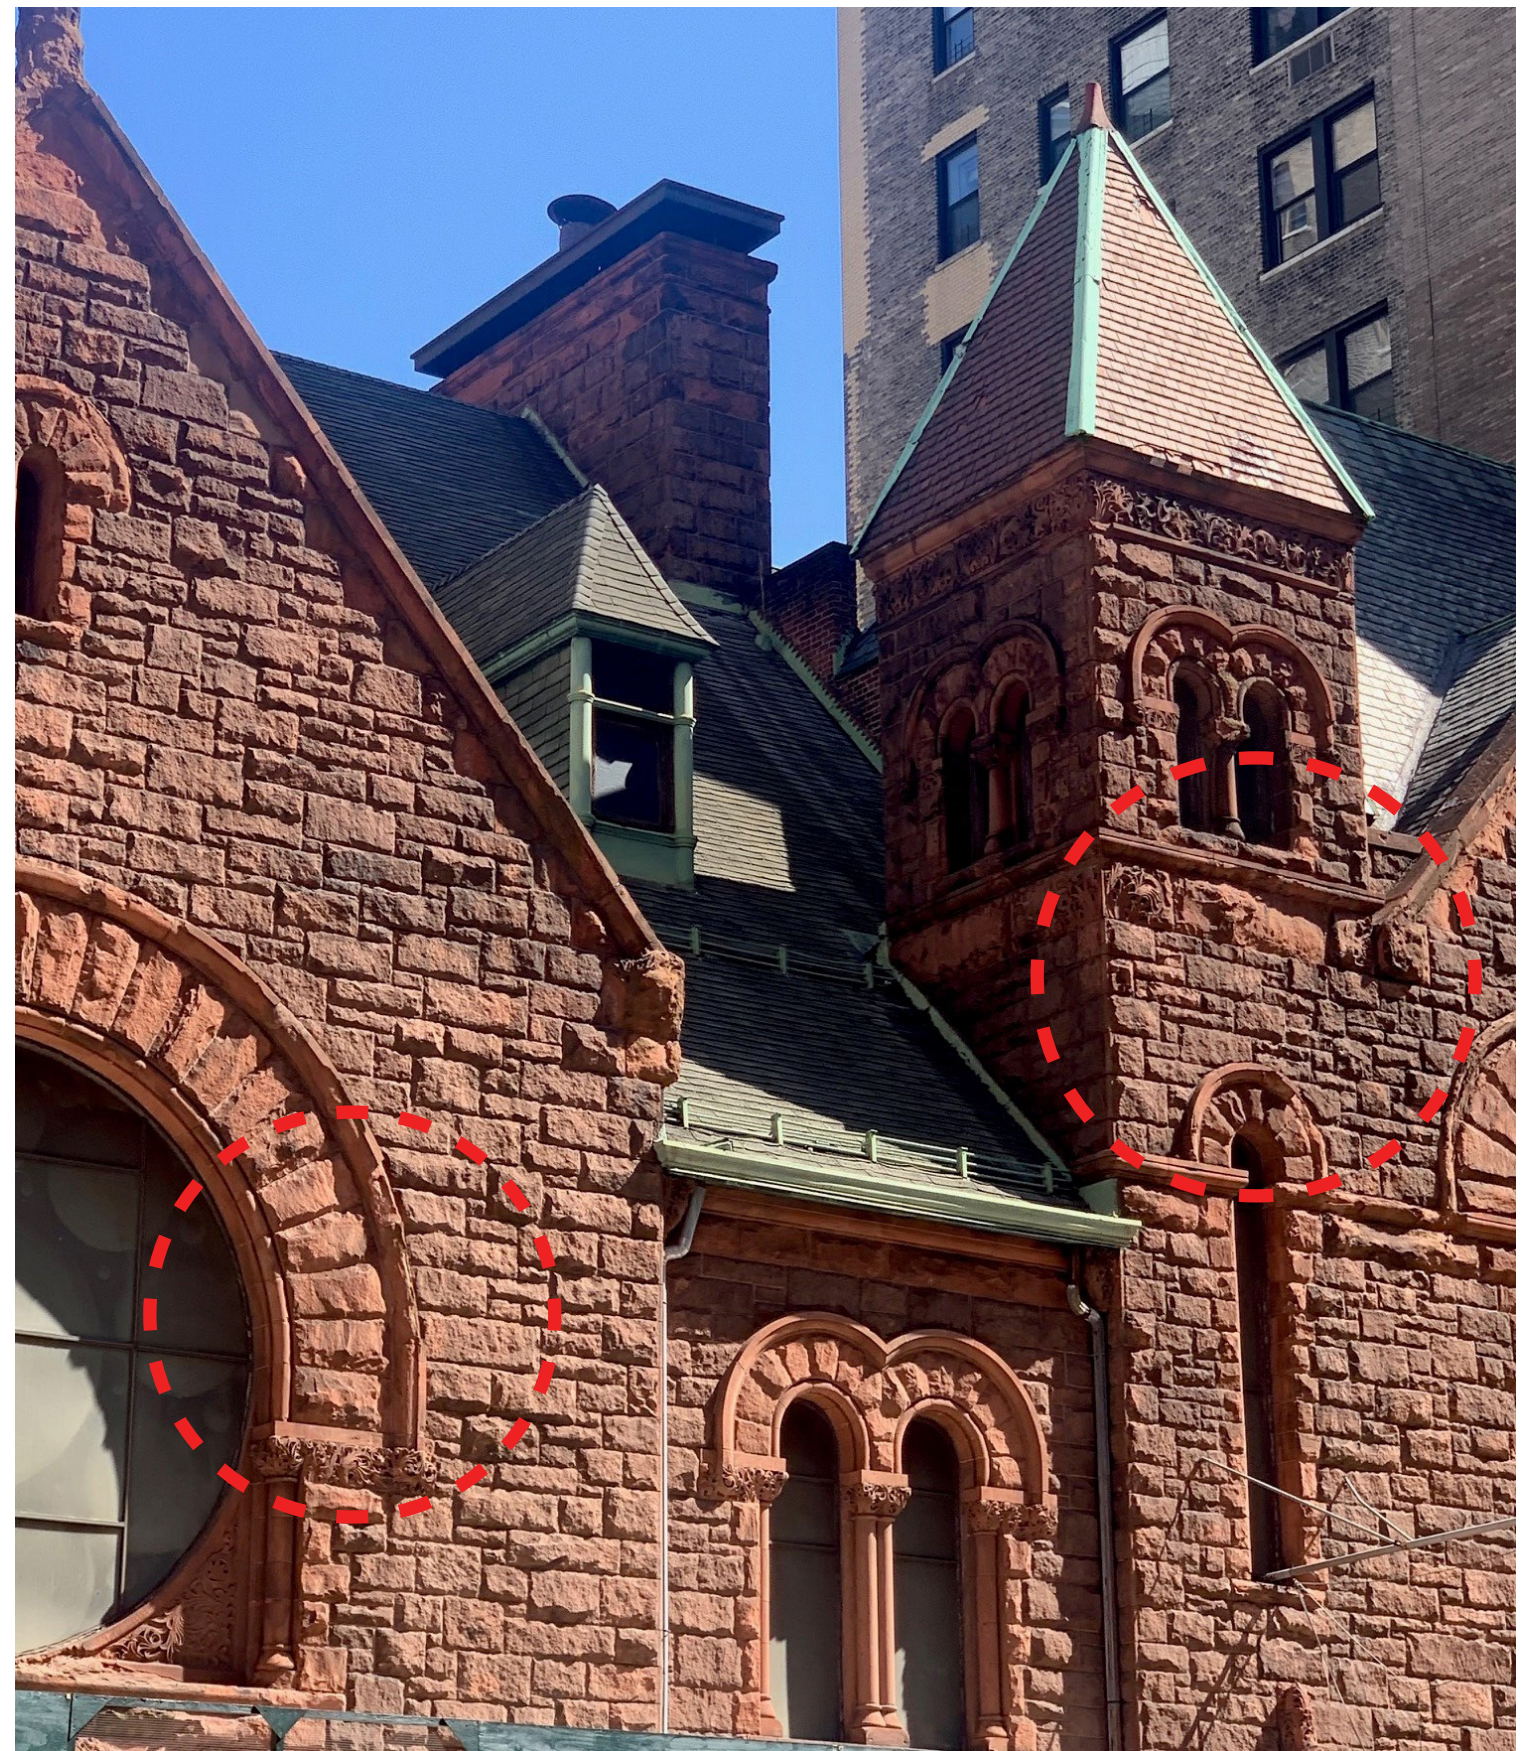
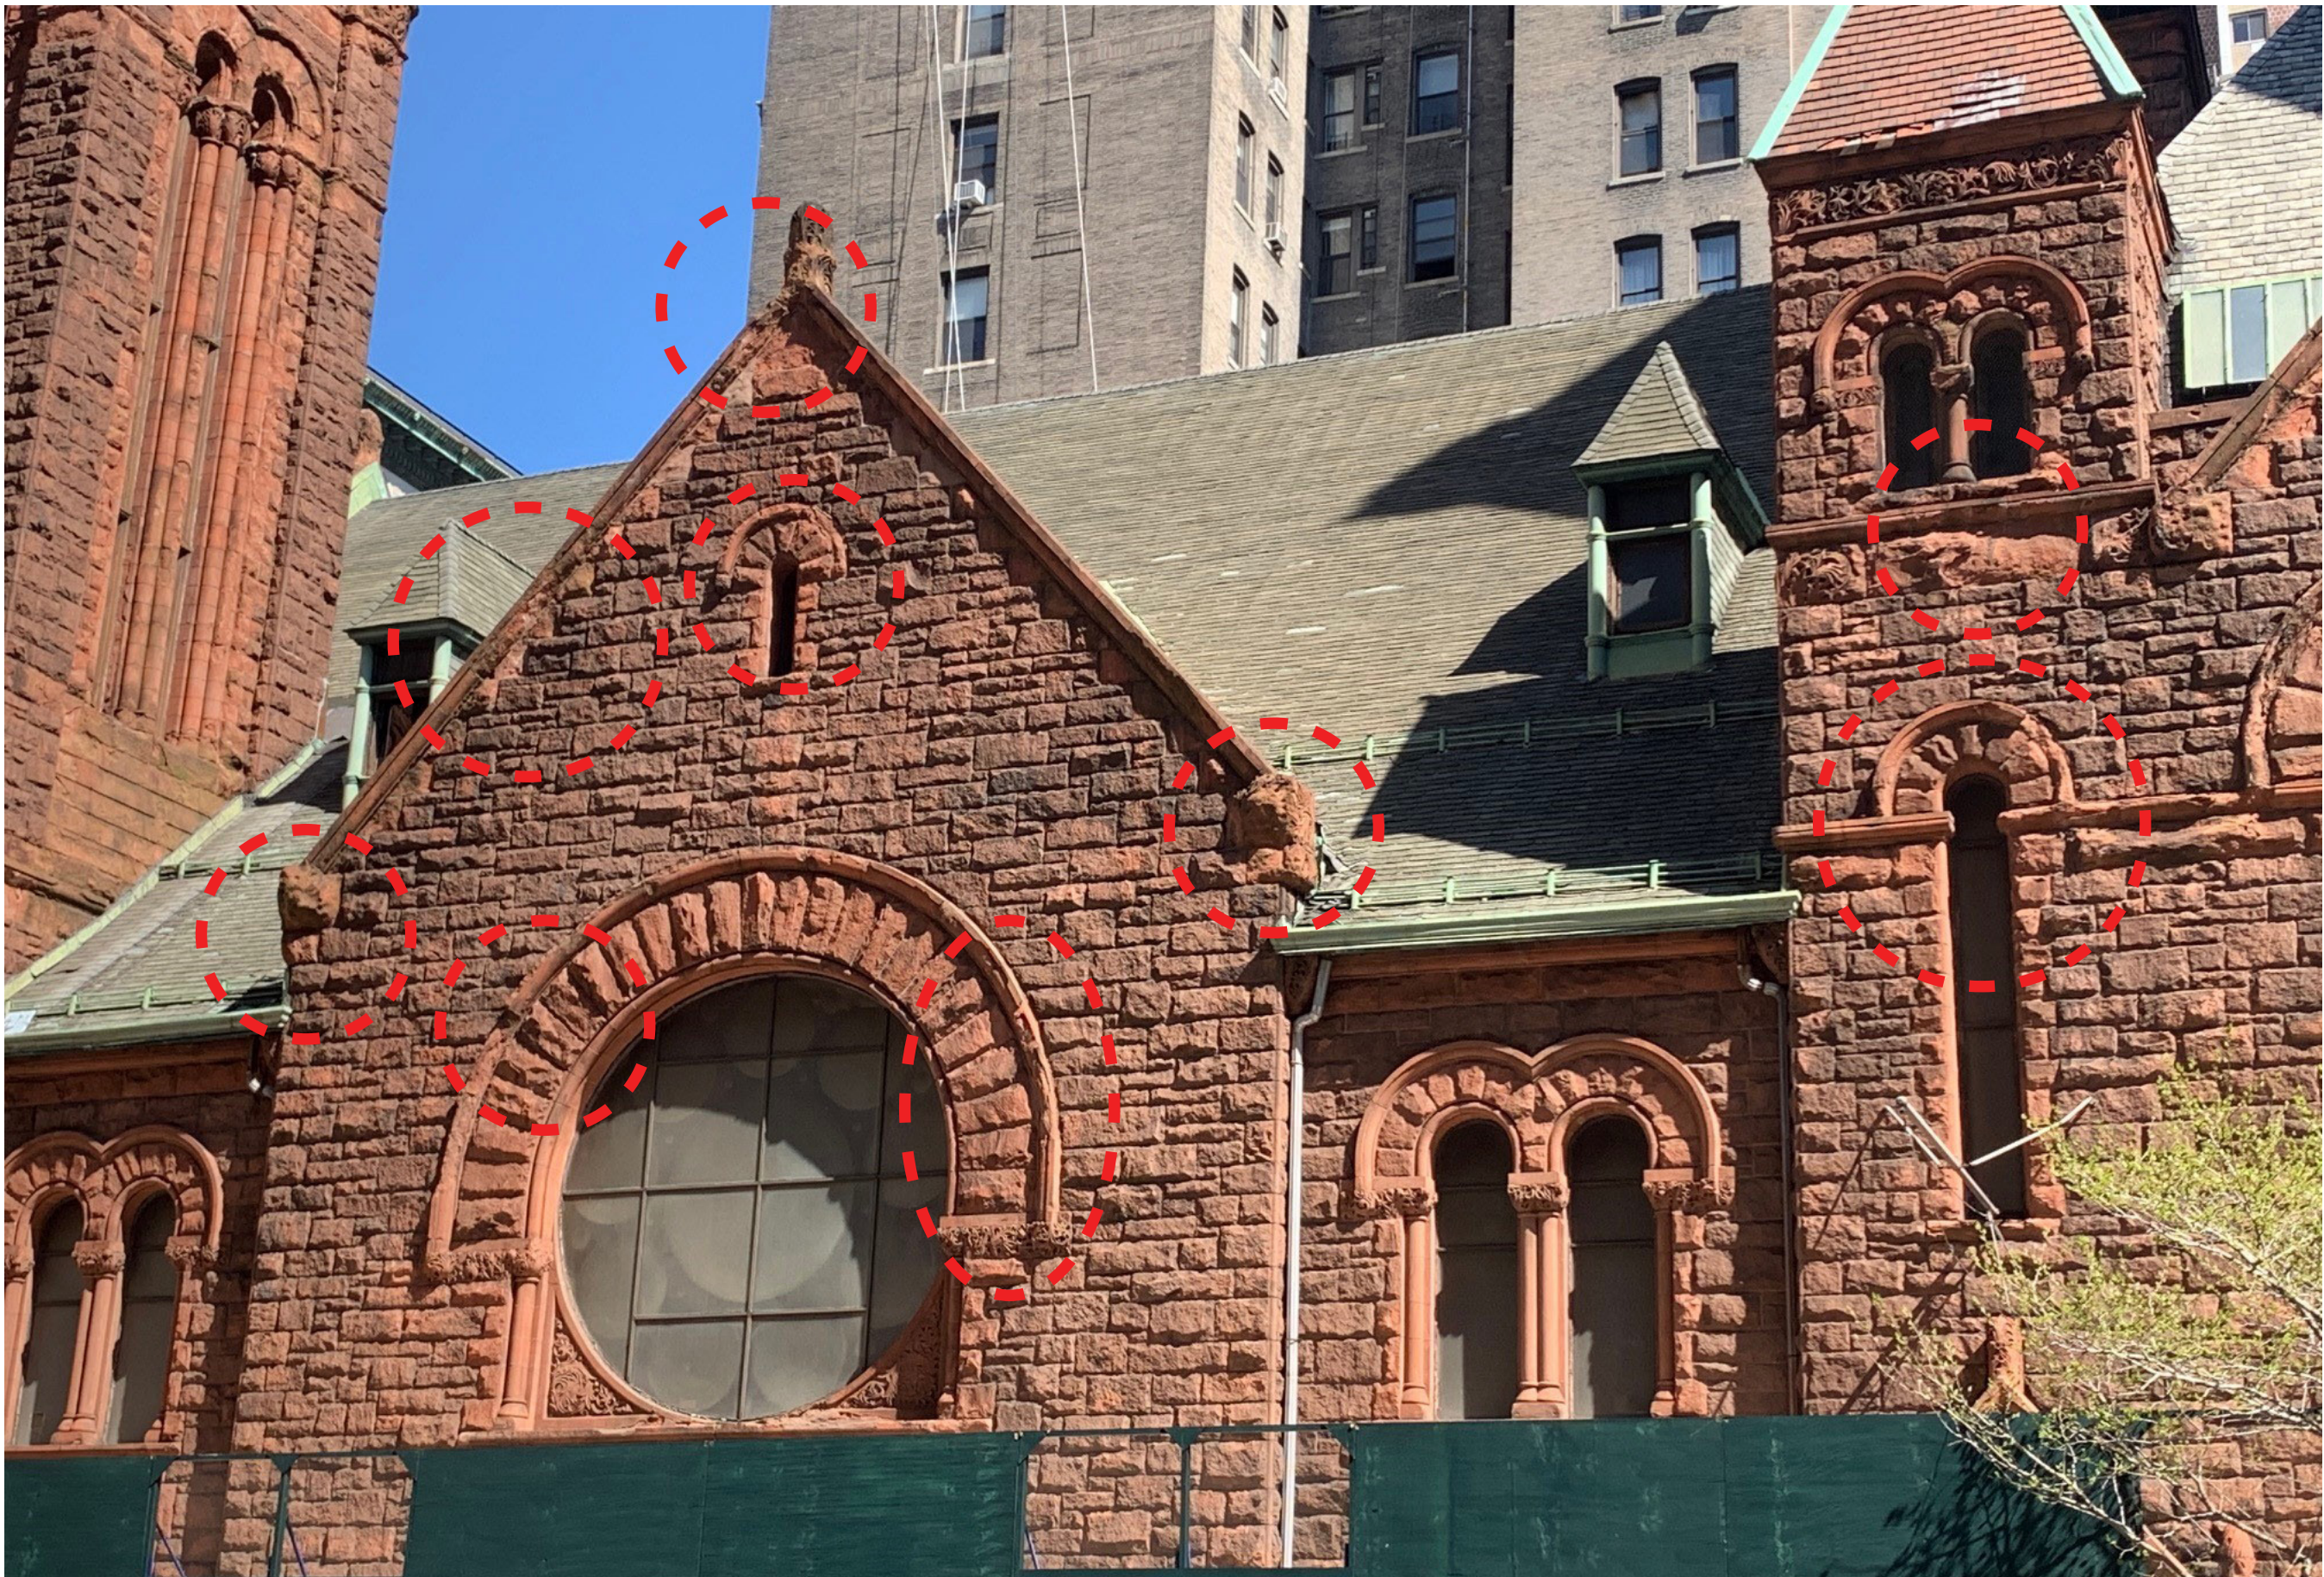
Existing Conditions

- Ornamental sandstone finial located at top of the West 86th Street Chapel façade at the end of the roof ridge beam is severely cracked and spalled.
- Extensive stone spalling, cracks, mortar deterioration and deteriorated windows noted throughout the building.
- Façade conditions are unsafe.
- Loose or unsafe material should be removed and the remaining masonry stabilized.

- DOB Violation #21-01507 (11/10/21) noted “sections of façade spalling severely” and “roof ridge ornamental masonry with large crack with a potential to detach and fall onto . . . public roadway.”
- DOB Violation # FEU10701XC (11/19/21) stated that “Exterior wall in state of disrepair, out of plumb and leaning” and that “the apex of the gable has displaced approximately 3”.
- DOB Summons #35644126R (01/24/22) for failure to secure building walls or appurtenances, noting that façade is spalling.

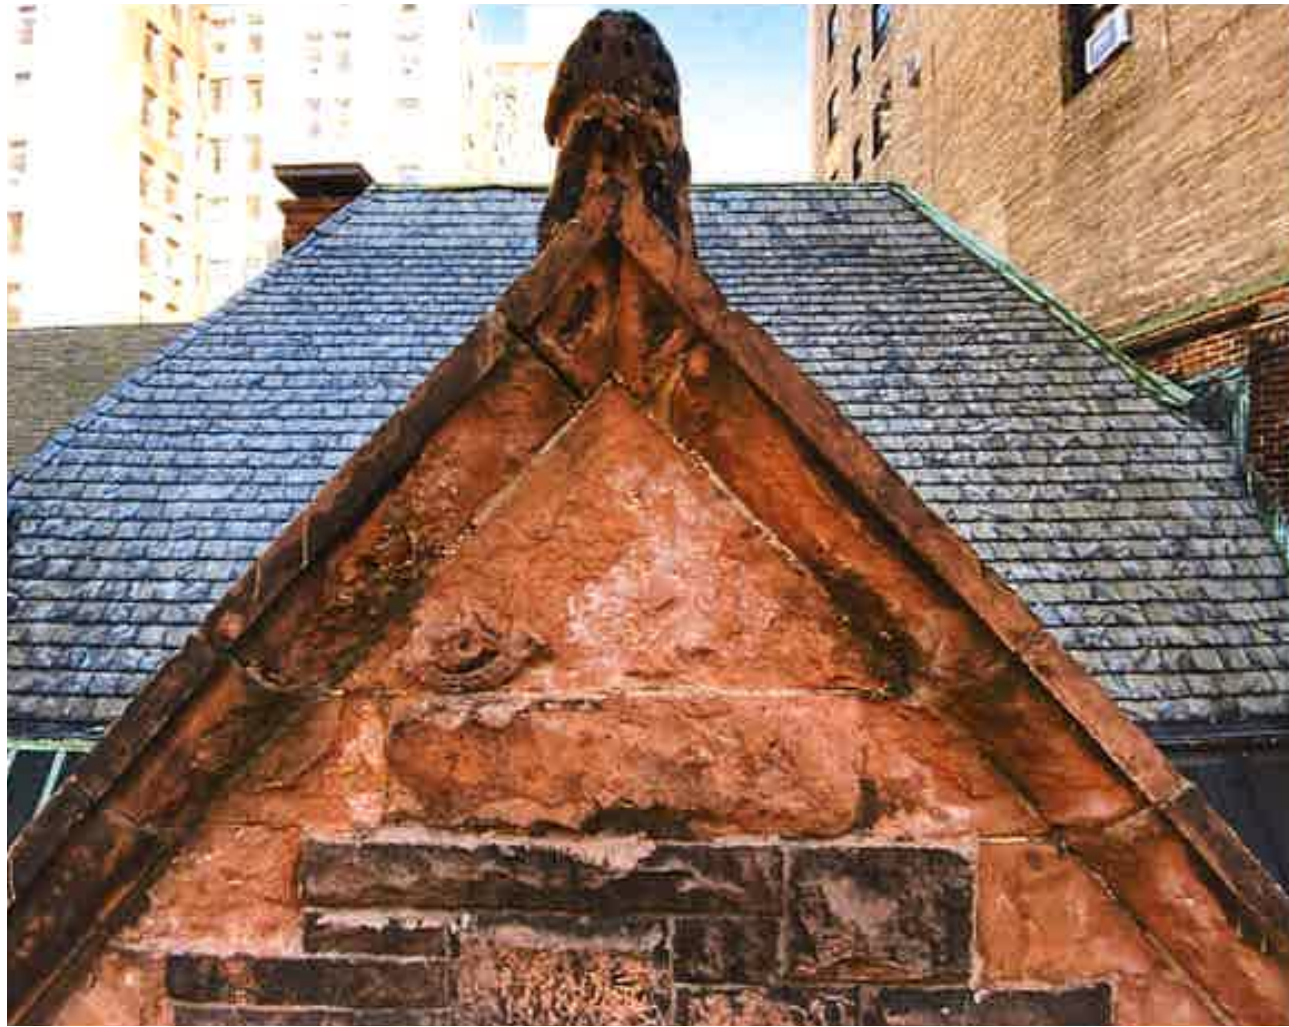
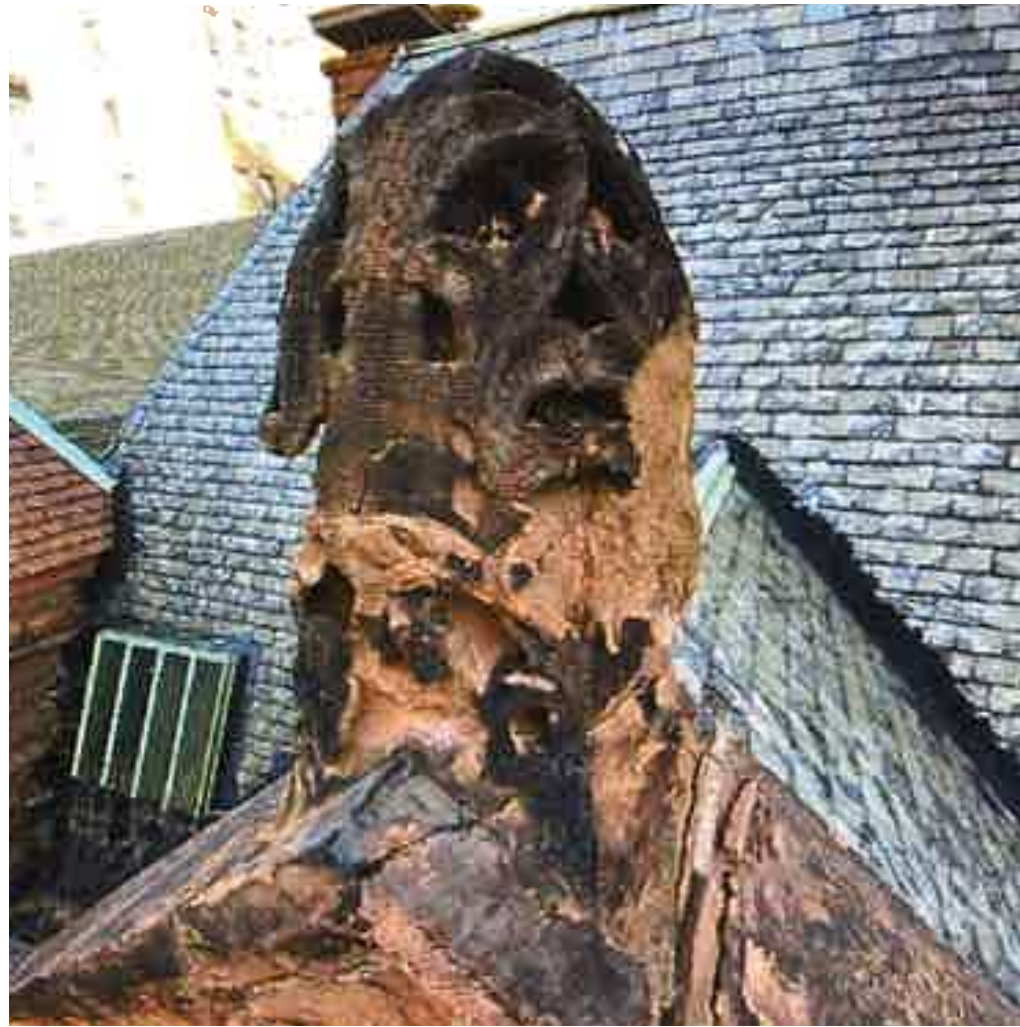
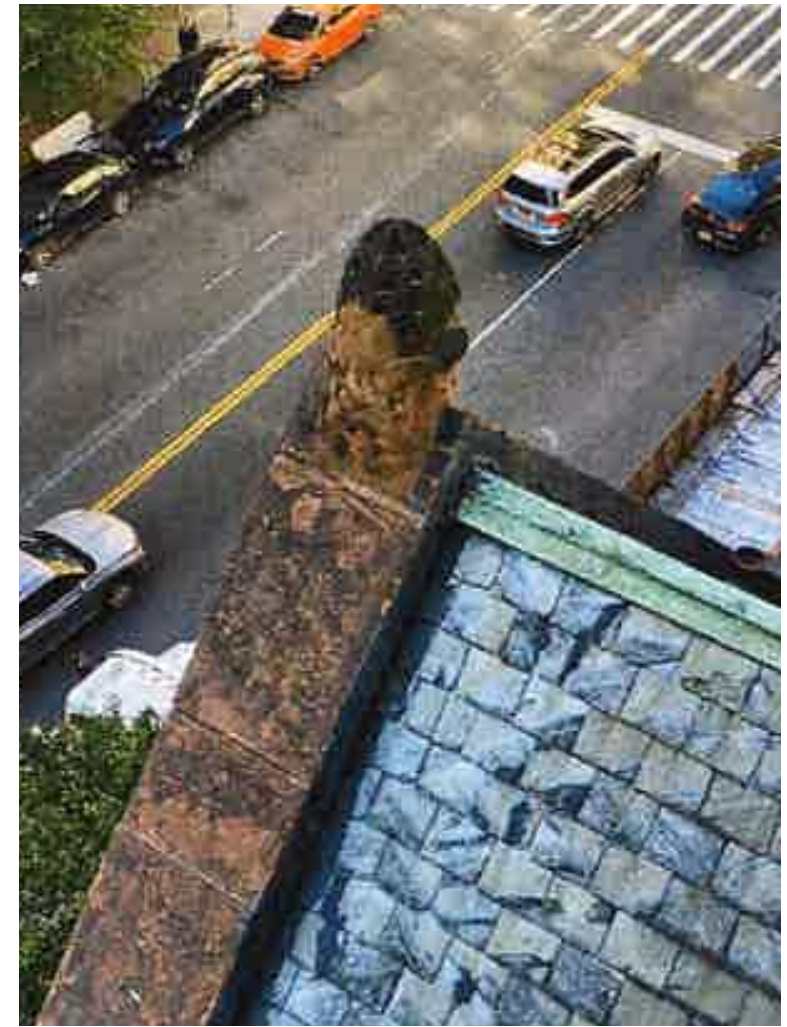
- Section of façade adjacent to 86th St. separated from roof by up to 4". Wall is not adequately braced against wind loads and roof and sanctuary ceilings are not adequately supported.
- Sandstone façades exhibit deterioration in varying degrees from minor to severe. Areas of cracked, hollow sounding and delaminated surface observed, Large spalls, voids pits and cracks observed throughout.

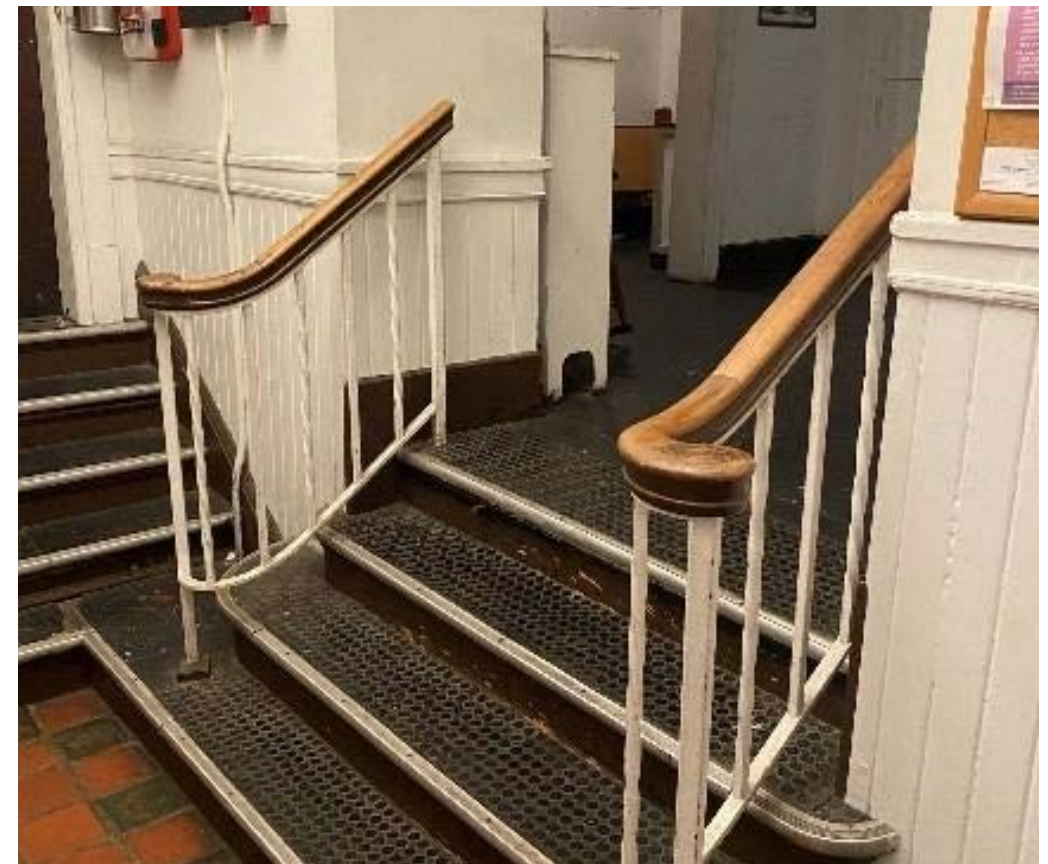
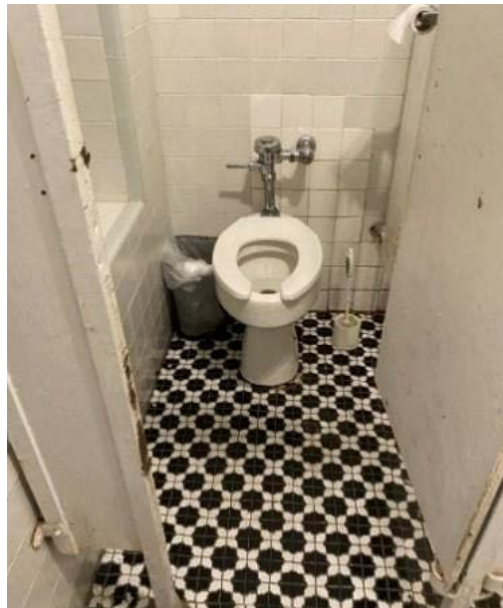
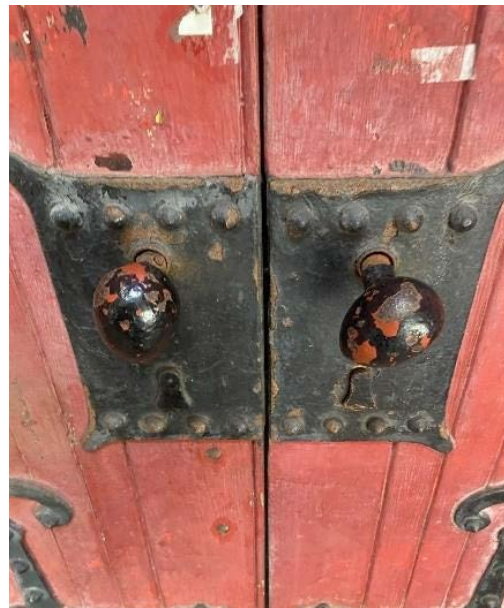
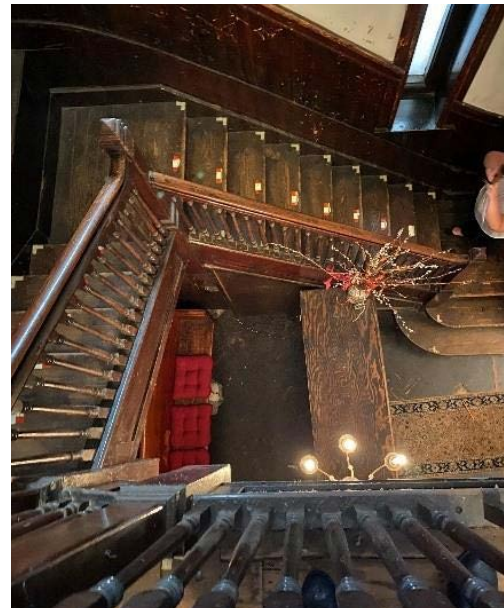
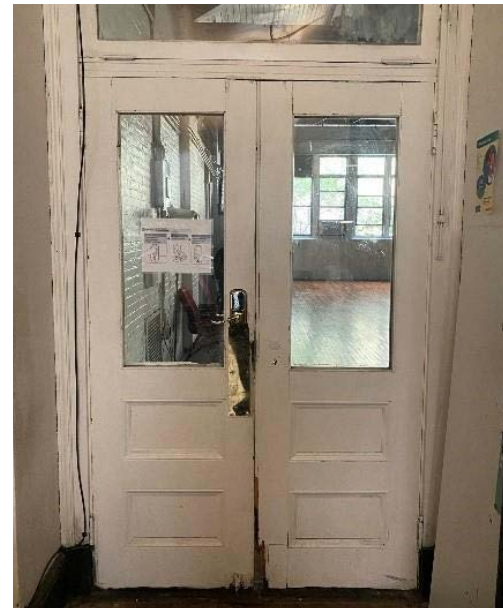
Accessibility *

- Amsterdam Avenue and West 86th Street entrances are not accessible.
- No accessible routes from sanctuary to any of the levels of the building including the balcony.
- No accessible restrooms.
- Interior doors, hardware and railings are non-compliant.

Note: Any new or altered element must be designed and constructed to meet 2010 ADA Standards. Change of dominant use and/or alteration costs in excess of 50% of the value of the building trigger a requirement for full ADA compliance.

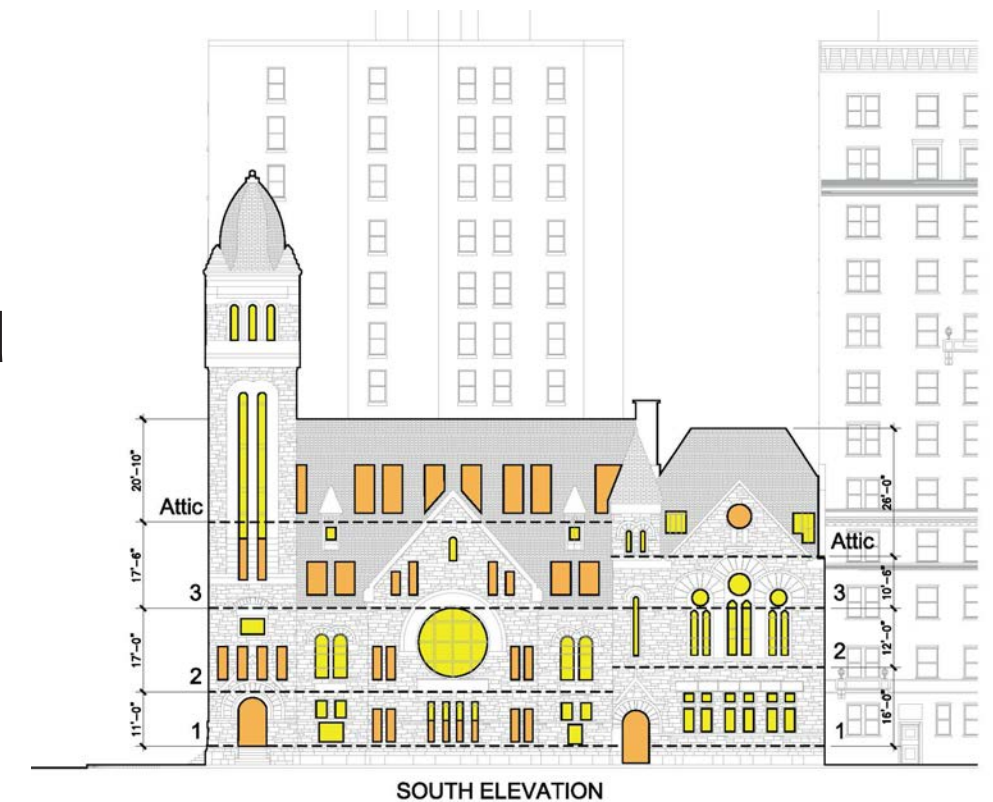
- Legend
- Legal Windows with limited openings
 - Proposed New Windows
 - Floors

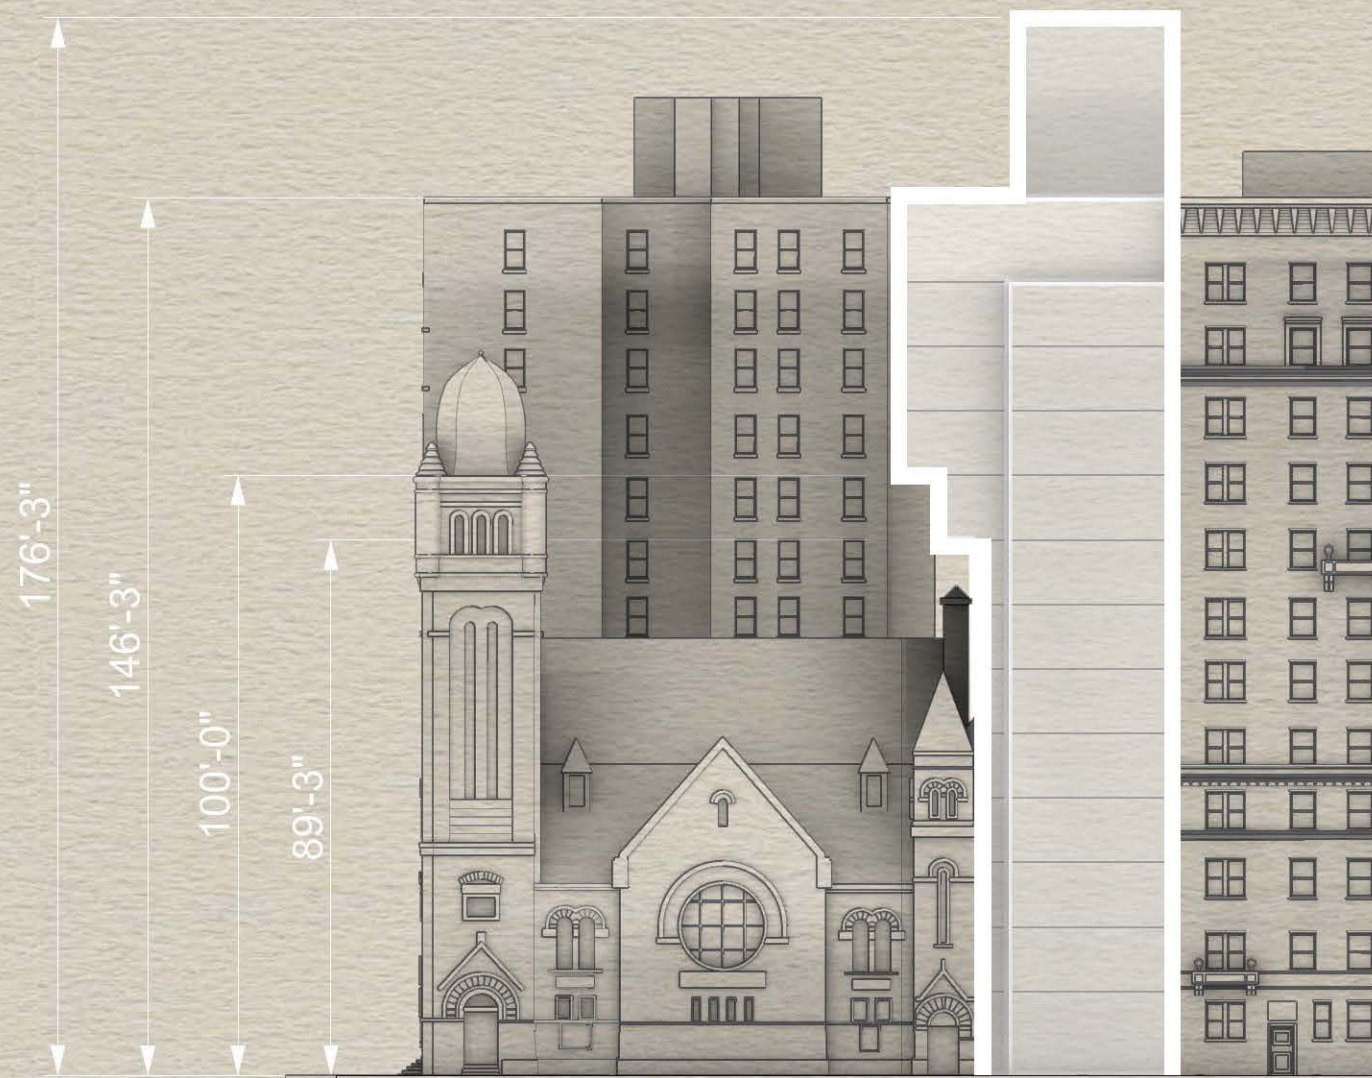
SOUTH ELEVATION

- Parish House demolished.
- New residential building constructed in its place and cantilevers over sanctuary.
- Sanctuary renovated and used as a community facility.
- New residential building would be costly and complex to construct and would yield small, inefficient floor plans.
- The Existing facade will most likely need to be completely replaced.
- Utilizes only a quarter of the site's allowable area.
