**4881 Broadway – Dyckman House – Individual Landmark
Borough of Manhattan**

New Addition, Restoration, and Accessibility Improvements at the Dyckman Farmhouse

4881 Broadway, New York, NY 10034 | Manhattan CB 12

Dyckman Farmhouse Museum | Landmarks Preservation Commission, December 6, 2022

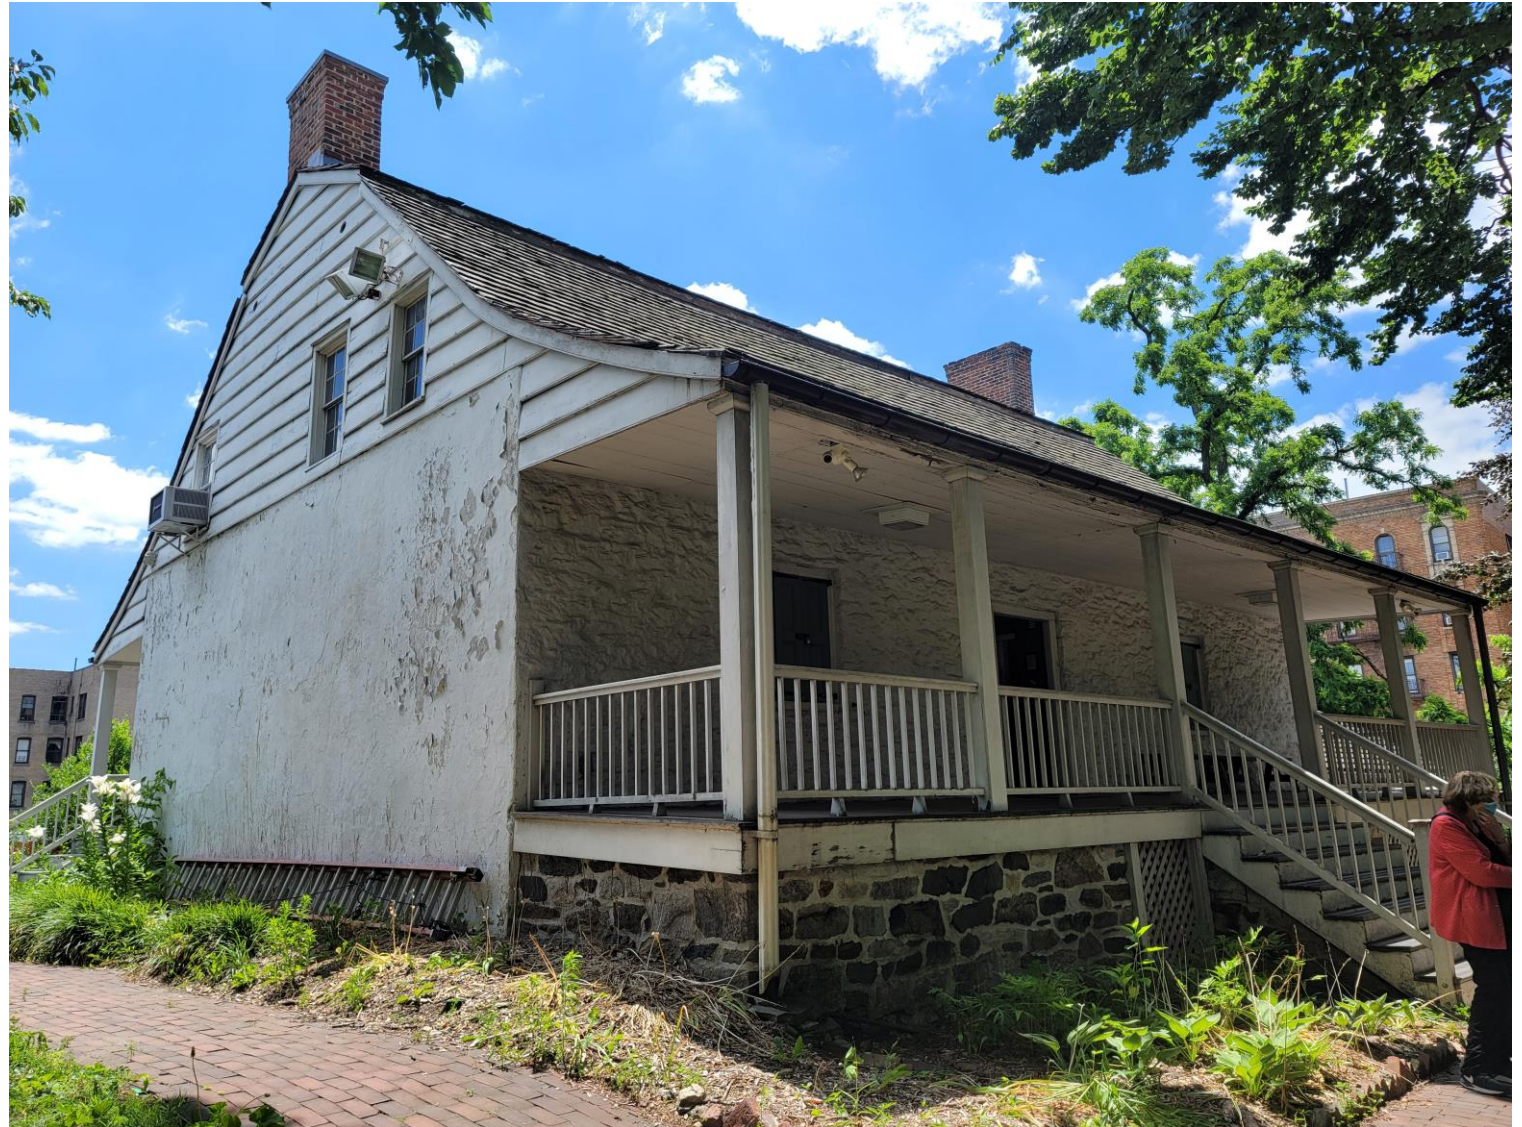
- The proposed addition and ramp are too large and overwhelm the historic house.
- The proposed standing seam roofing at the addition is not appropriate in the context of the historic building.

- Reduced addition footprint from 29' x 29' to 19' x 28'. Second floor reduced from 29' x 24' to 19' x 14'.
 - Caretaker to remain in south wing.
 - New addition for office space only.
- Reduced physical and visual impact of the ramp by combining ramp on grade with smallest elevated ramp; reduced length of required 42" guards.
- Revised roof materials to wood shingles on main addition roof, and painted flat-seam metal on low-slope porch and lean-to.

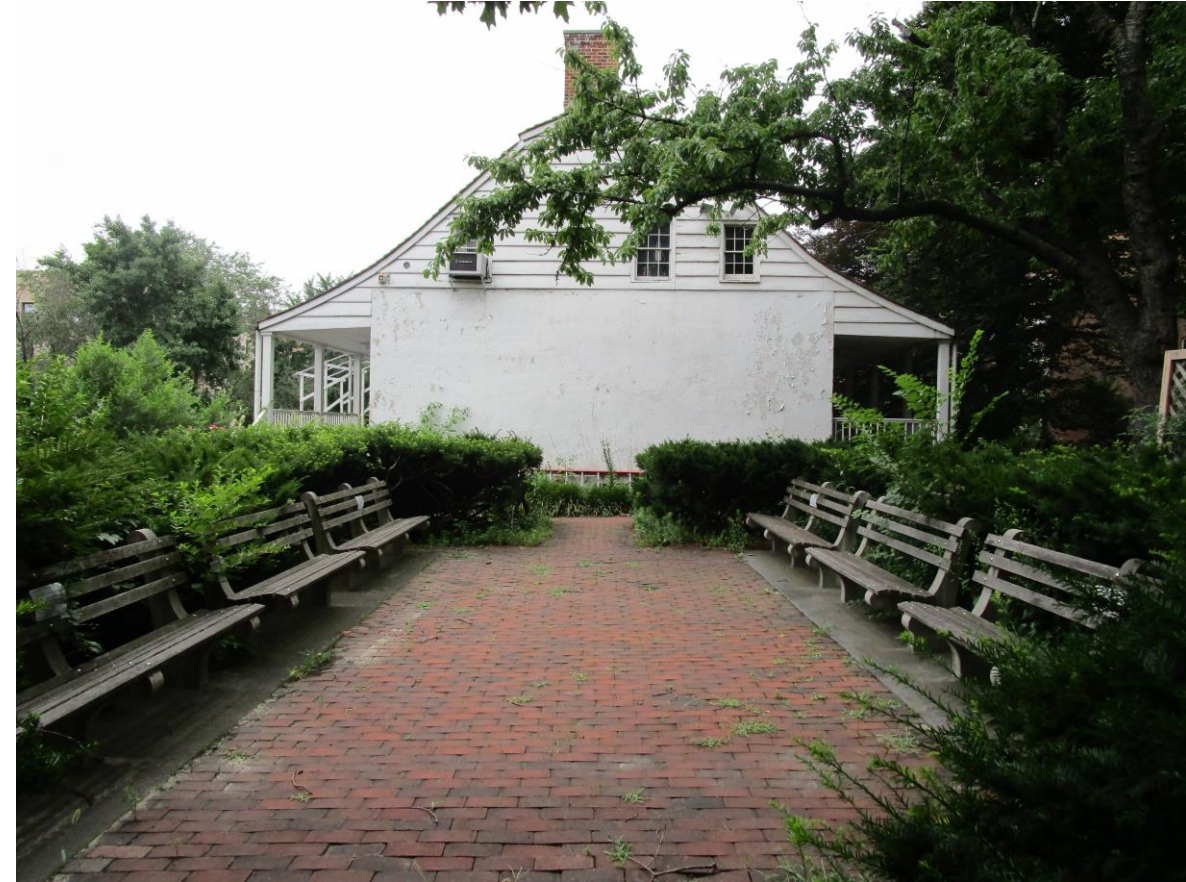
The amount of proposed new paving overall and curbs at stairs are unsympathetic to the character of the historic farmhouse site.

- Removed 800 sq. ft. of proposed paving north and south of house.
- Increased productive gardening/fruited trees area.
- Reduced curb width from 8” to 6” and cheekwalls from 8” to 4”.

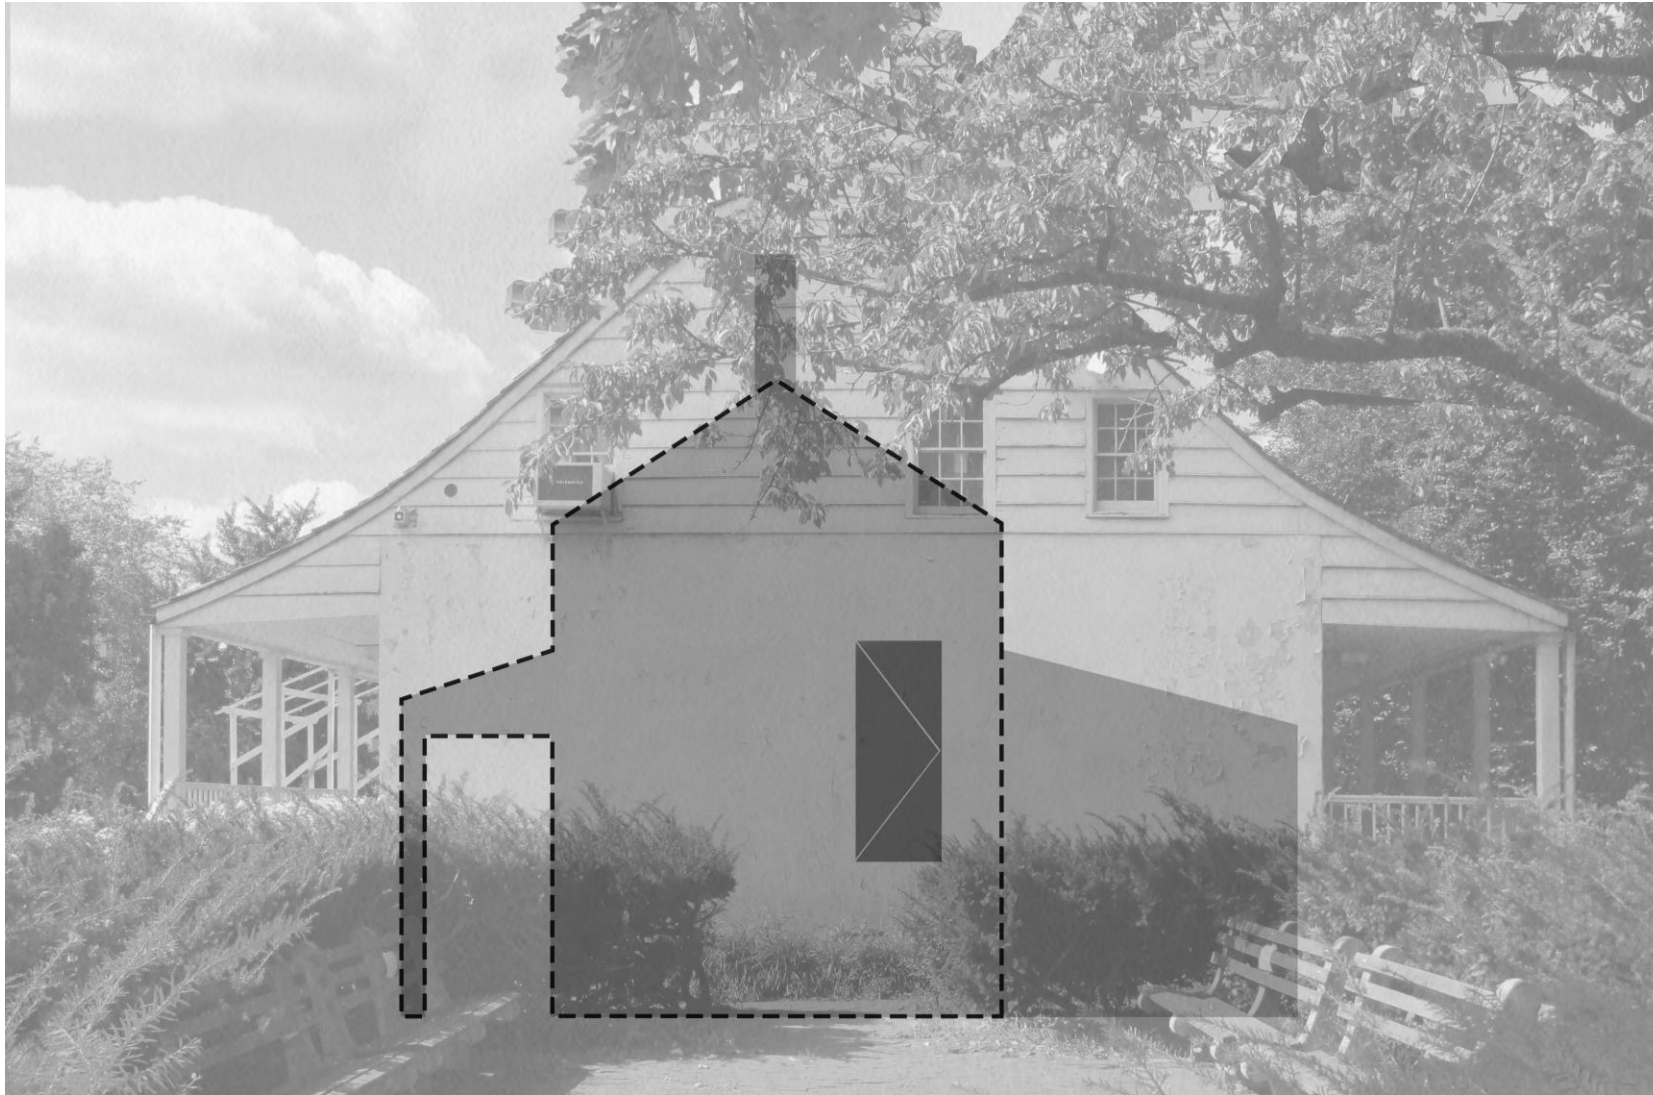
- **Dashed line** is the outline of the original north wing where the structure was attached to the main house
- **Gray shading** is the area where the new addition will be in contact with the main house
- **Black rectangle** shows the location of the previous connecting door, which will be reconstructed in its historic location.

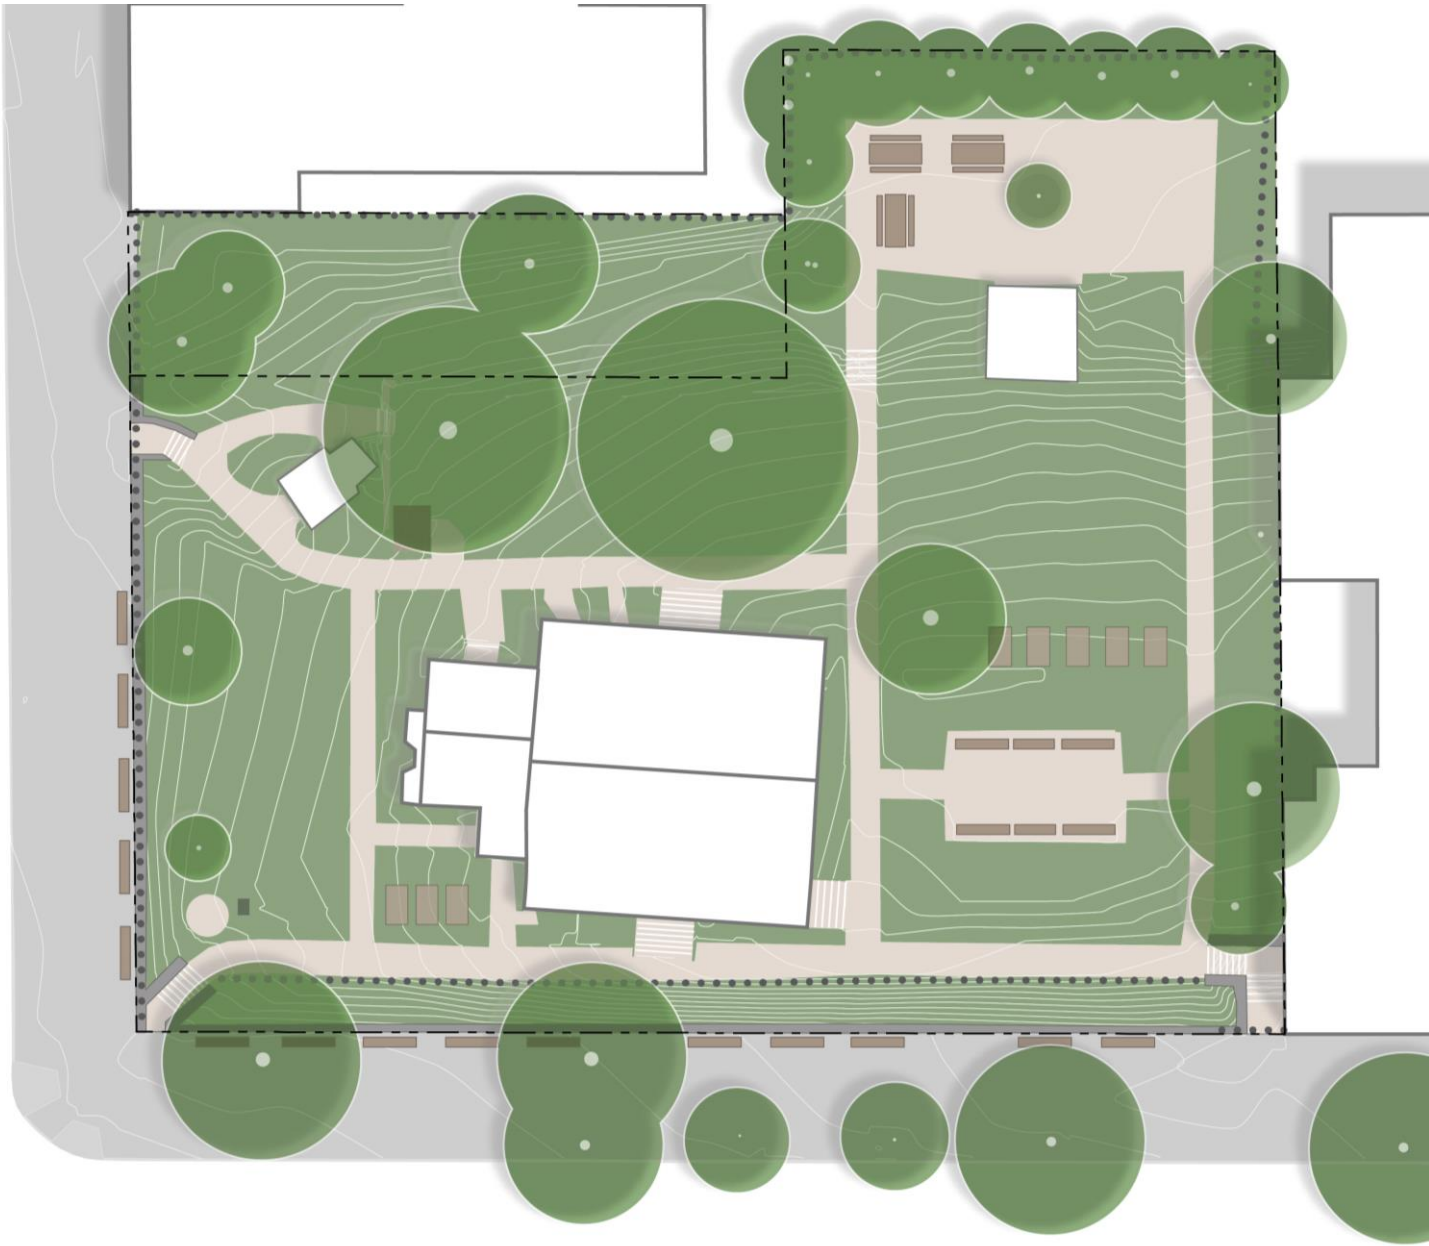
Challenges of the Site

- The entrance at W. 204th Street and Broadway is not barrier-free; the site is only accessible by flights of stairs due to change in grade, approximately 12’.
- There is no barrier-free access to the Museum, public restrooms, or Hessian Hut.
- Limited use of outdoor space for programs due to grade changes.
- Inadequate lighting, power, and water for outdoor events.
- Paving, stairs, railings, and fences are failing throughout the property.
- Plantings are overgrown.

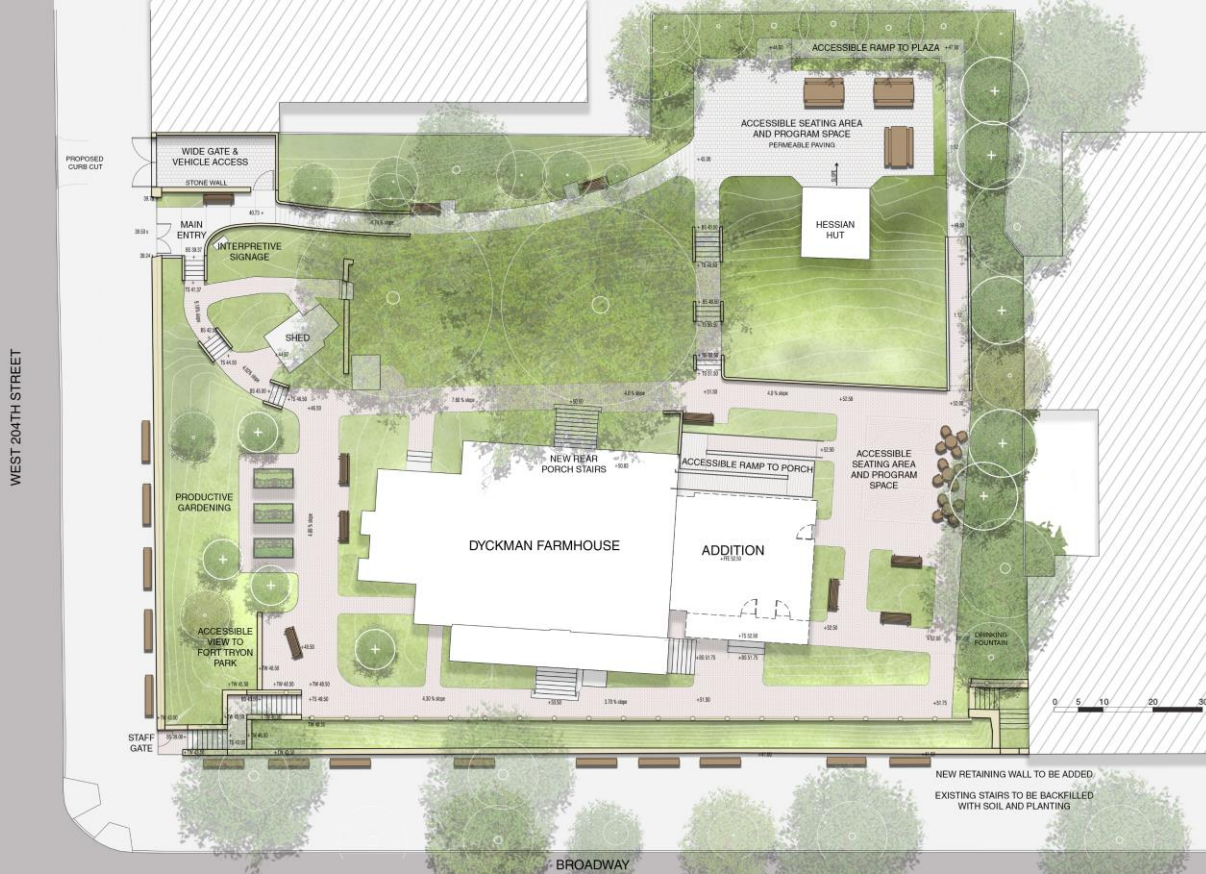
Previous Proposal

- New barrier-free public entrance to park on 204th Street
- Enlarged and functional outdoor program areas with upgraded support facilities
- Rehabilitated plantings
- New paving, including accessible and permeable paving
- Accessible route to Museum and all landscape program areas

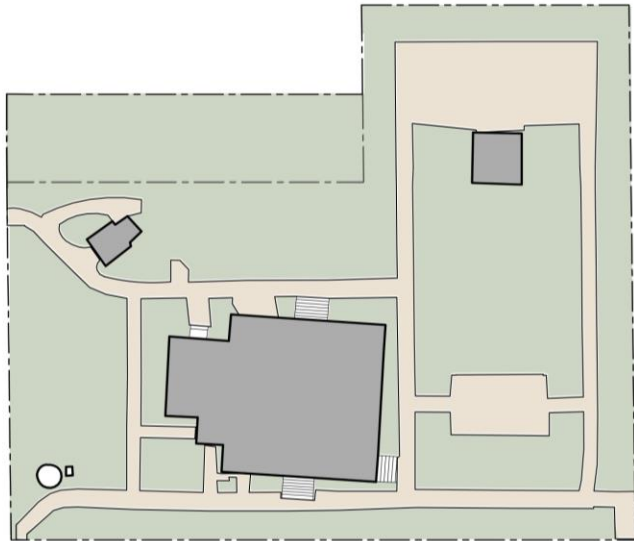
Existing Conditions
7,770 s.f. paving

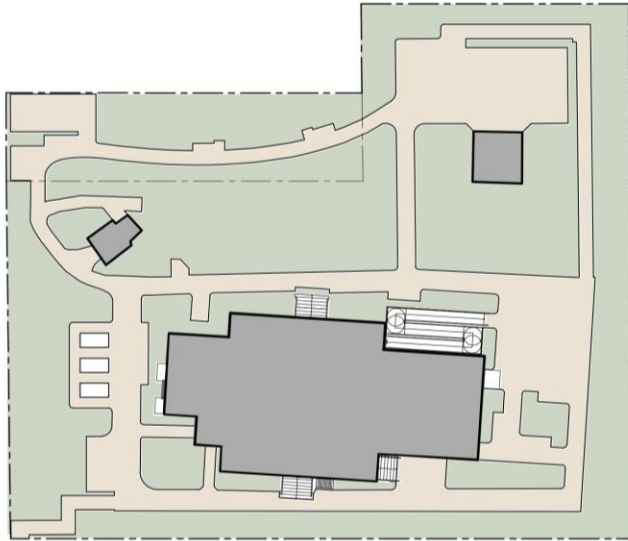
Previous Proposal
10,799 s.f. paving
Addition footprint 840 s.f.

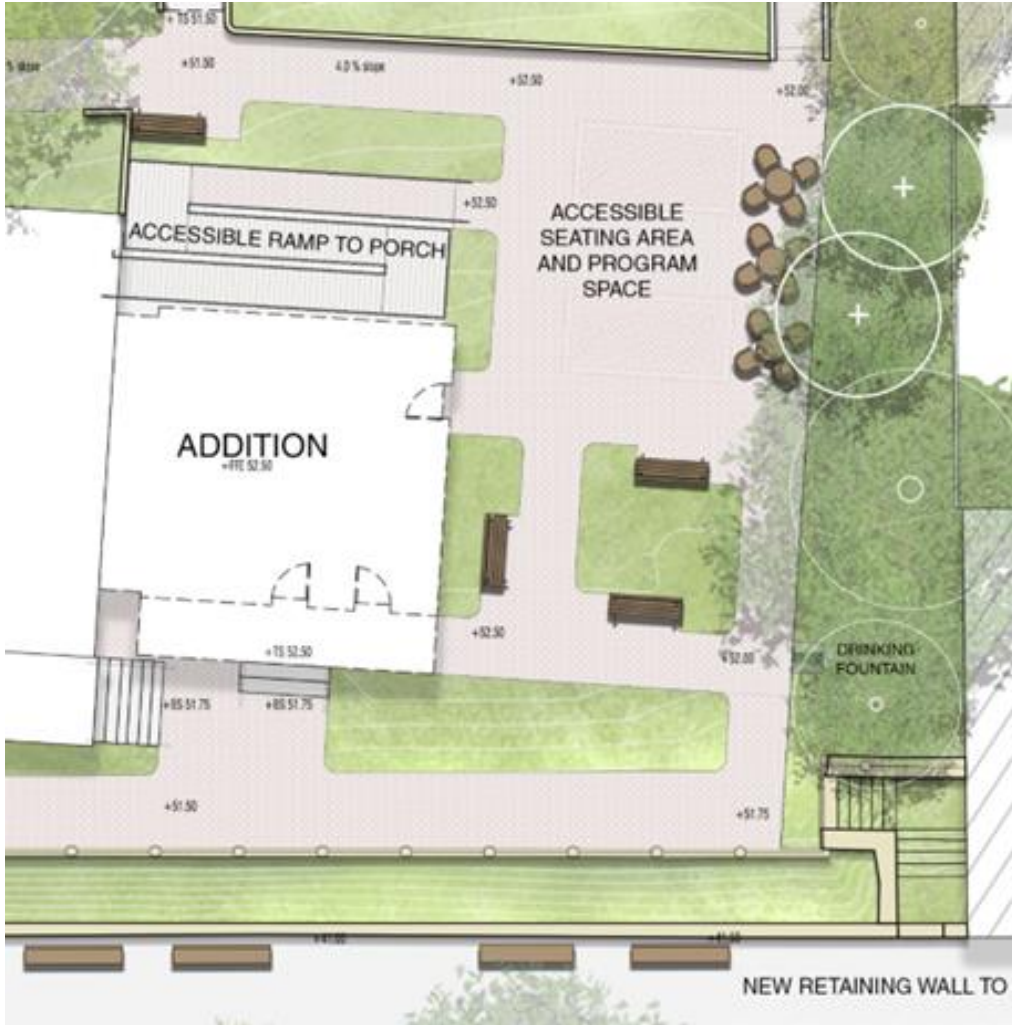
Current Proposal – Southeast Detail

- Enlarged garden plot with accessible bed at the west end
- Path to south of main house follows line of existing 1916 path
- Permeable paving around the garden plot
- Reduced paved area at overlook; bench relocated
- Benches removed at 204th Street

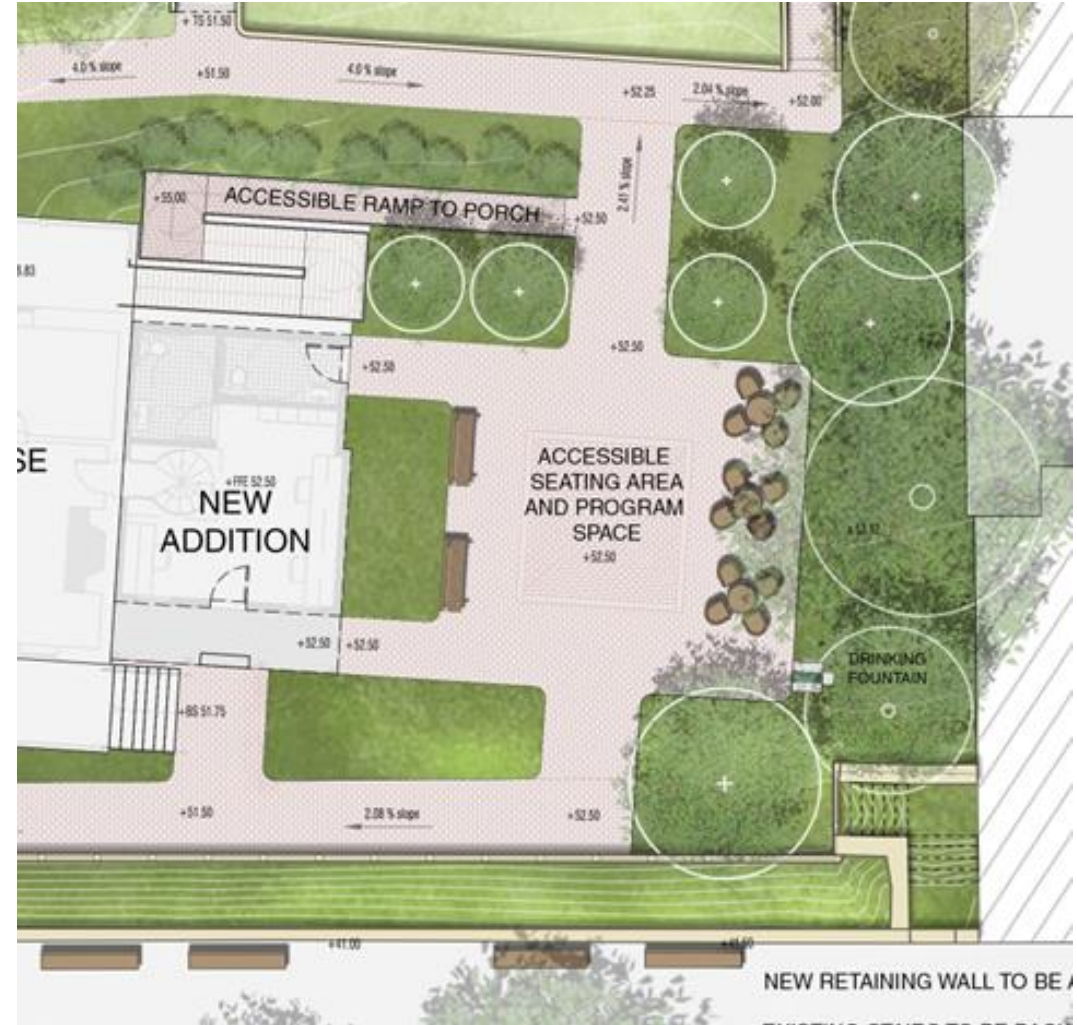
Current Proposal – Northeast Detail

- Reduced paved area
- Brick pattern similar to 1916 plan
- Additional trees at program space
- Use of ramp to define space

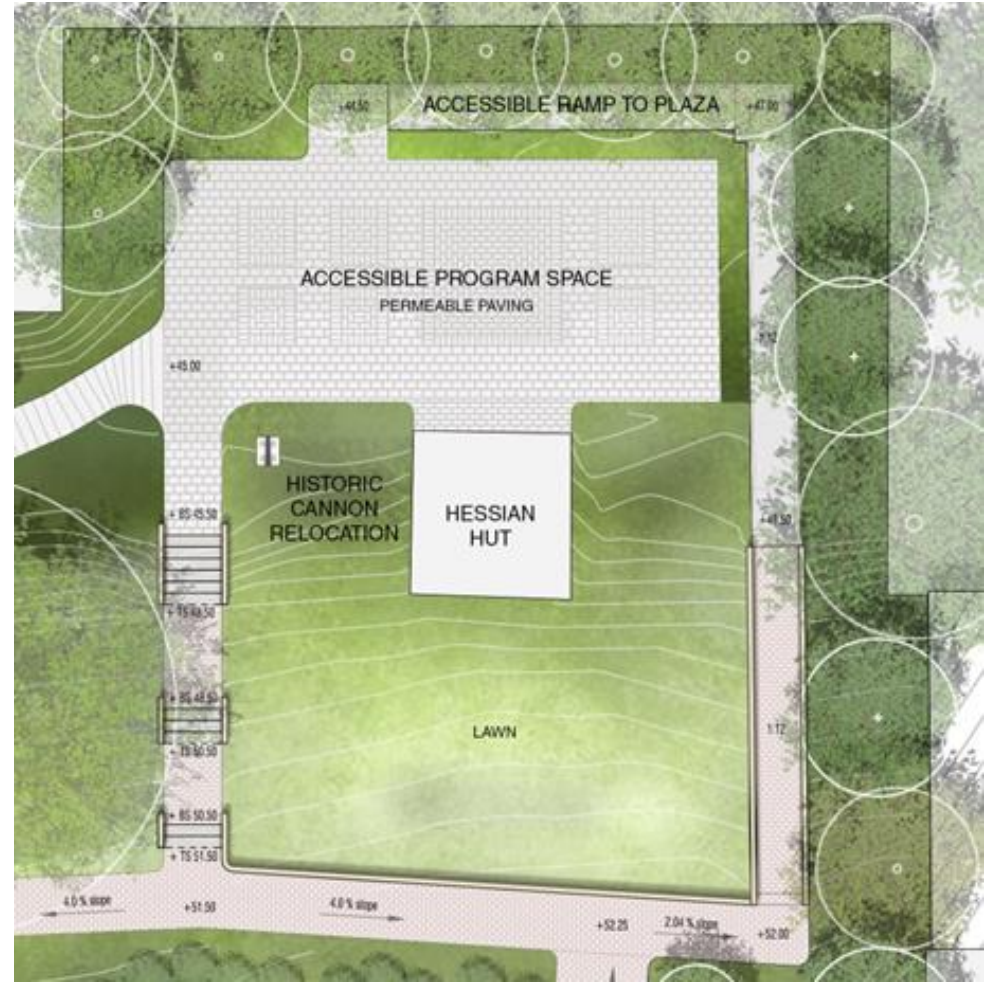
Current Proposal – Northwest Detail

- Move cannon back to its original location near the Hessian Hut
- Plan of 1916 garden recalled in paving pattern

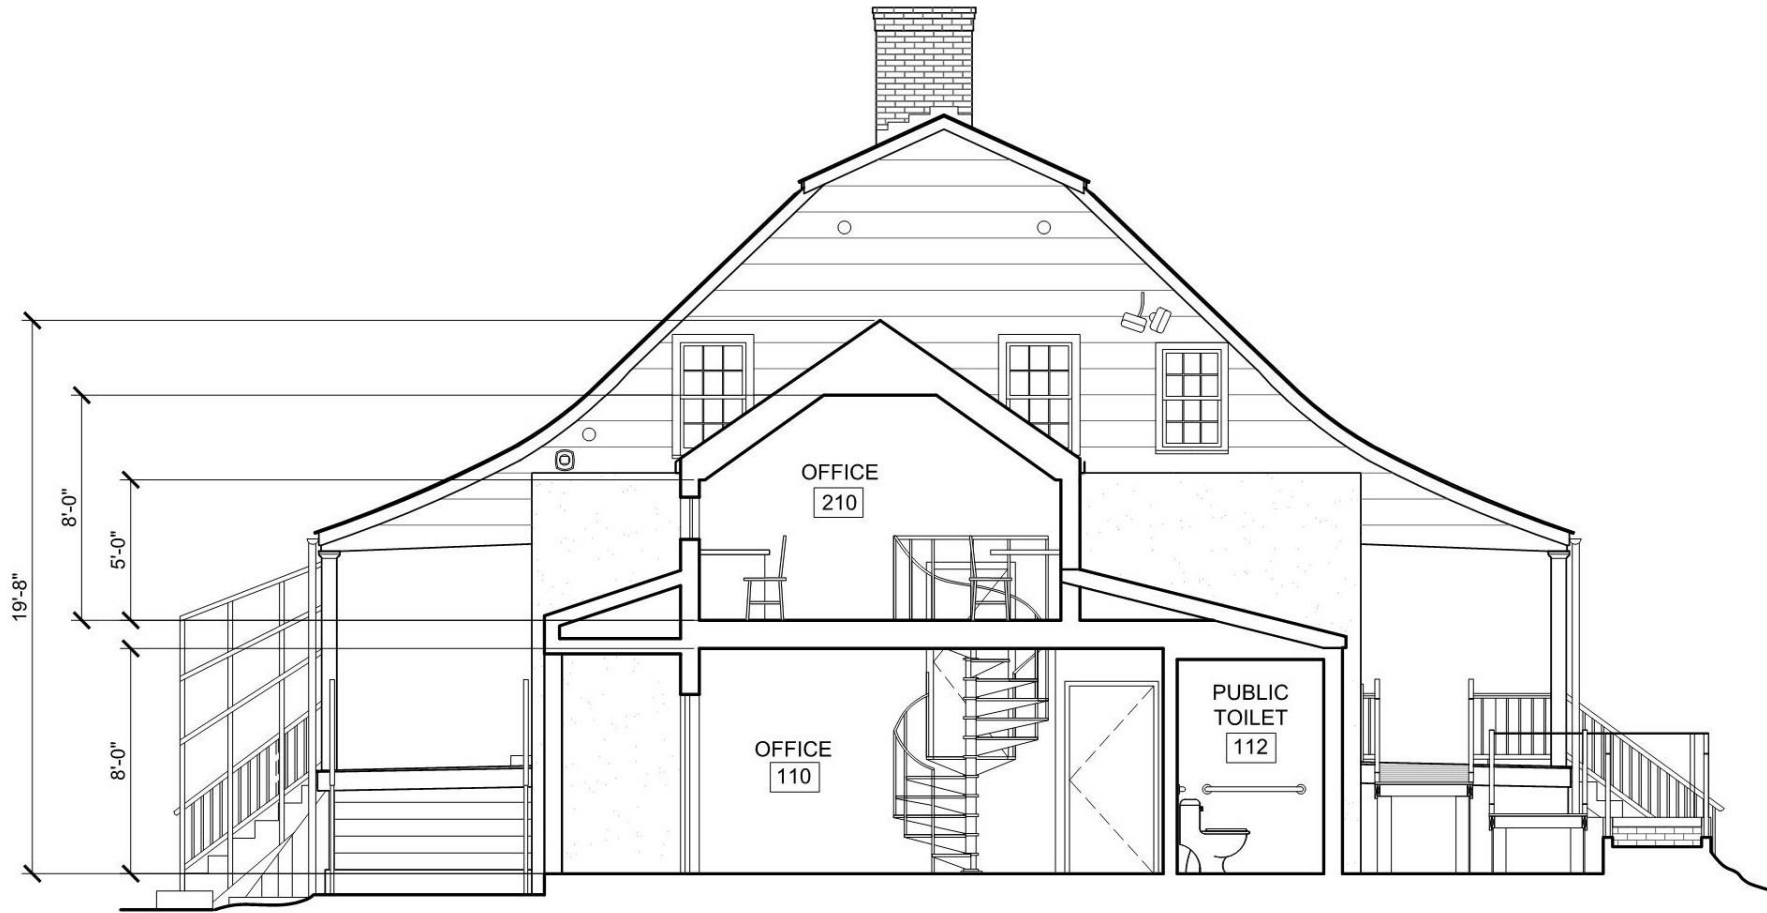
Historic House Trust of NYC
Dyckman Farmhouse Museum | Transverse Section at Addition – Current Proposal

- ATTIC FLOOR
- SECOND FLOOR
- ADDITION SECOND FLOOR
- FIRST FLOOR
- ADDITION FIRST FLOOR
- WINTER KITCHEN FLOOR

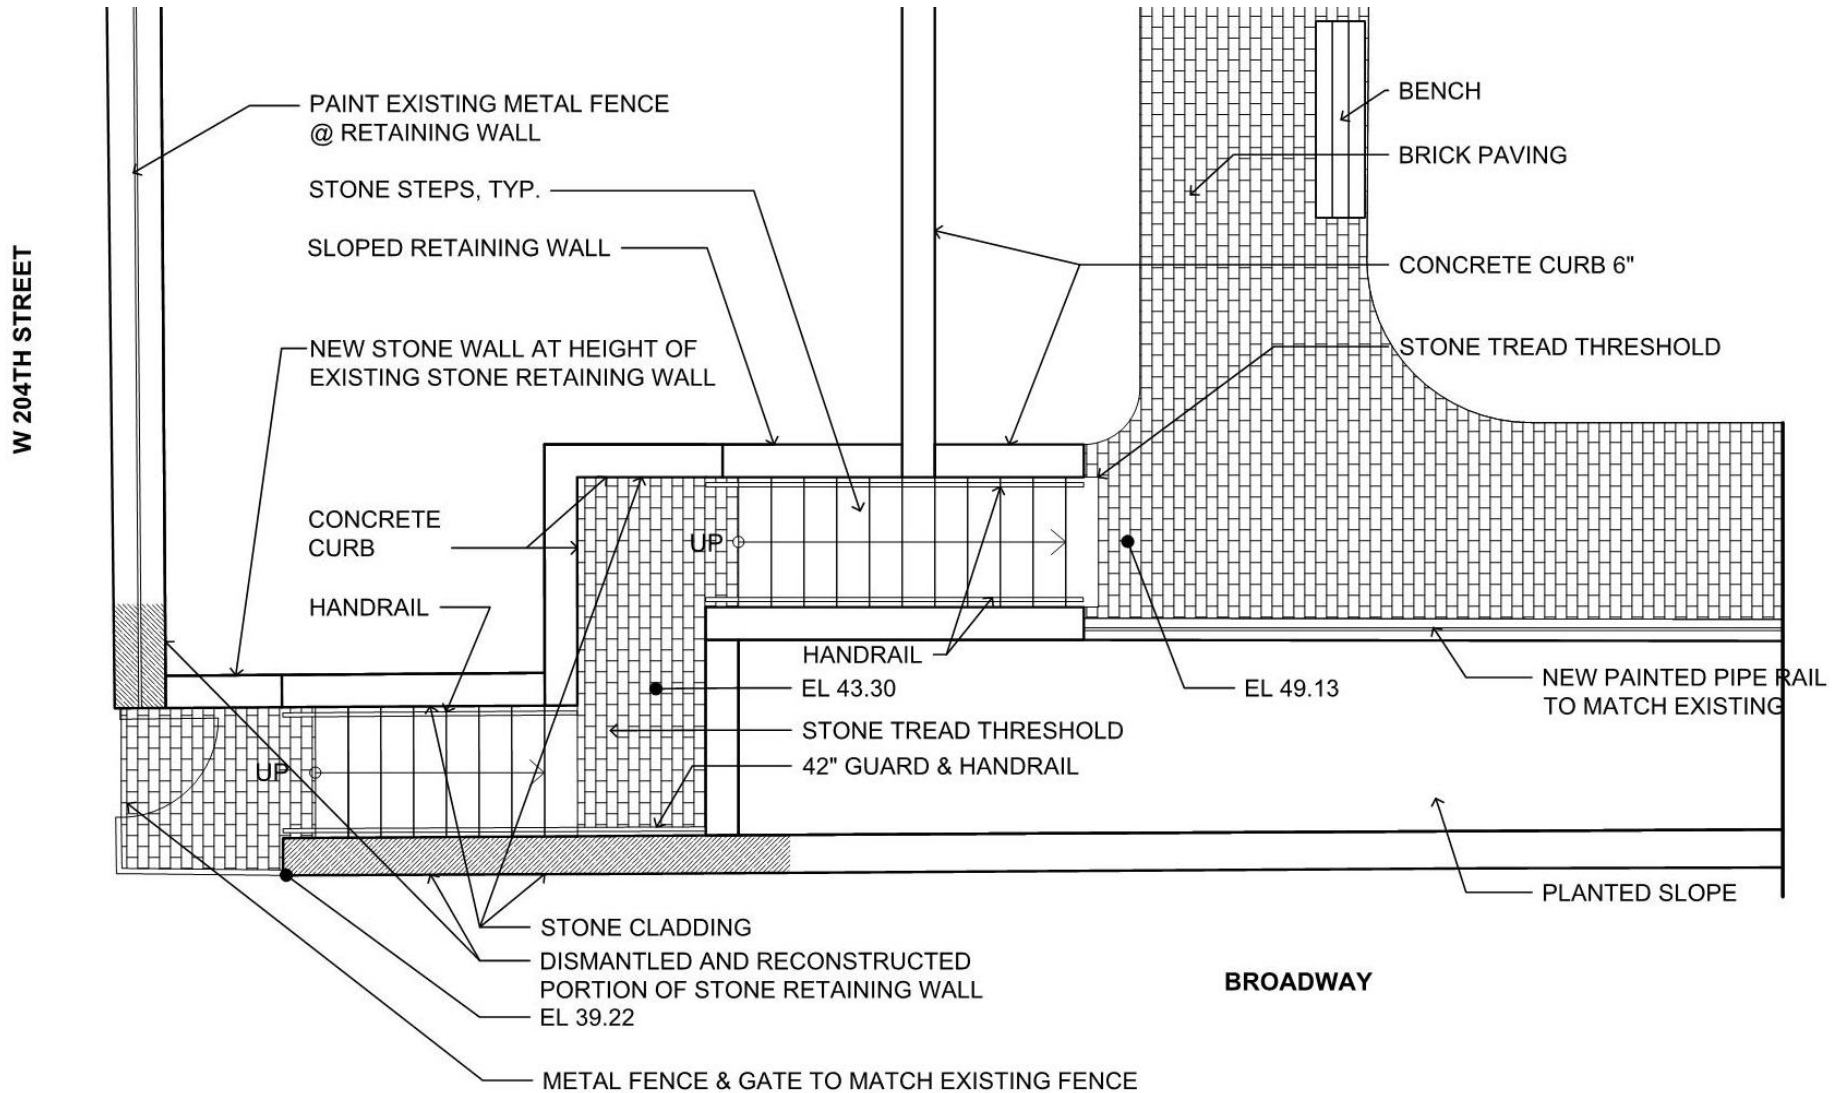
Dyckman Farmhouse Museum | Corner Entry Elevations – Current Proposal

DISMANTLED AND RECONSTRUCTED PORTION OF STONE RETAINING WALL

PAINTED METAL GUARD RAIL & HANDRAIL WITH SAFETY MESH

STONE FACED WALL - RANDOM COURSE ASHLAR WITH SAME COLORS AS EXISTING WALL.

PAINTED PIPE RAIL TO MATCH EXISTING WITH SAFETY MESH

PLANTED SLOPE

IRON FENCE TO MATCH EXISTING

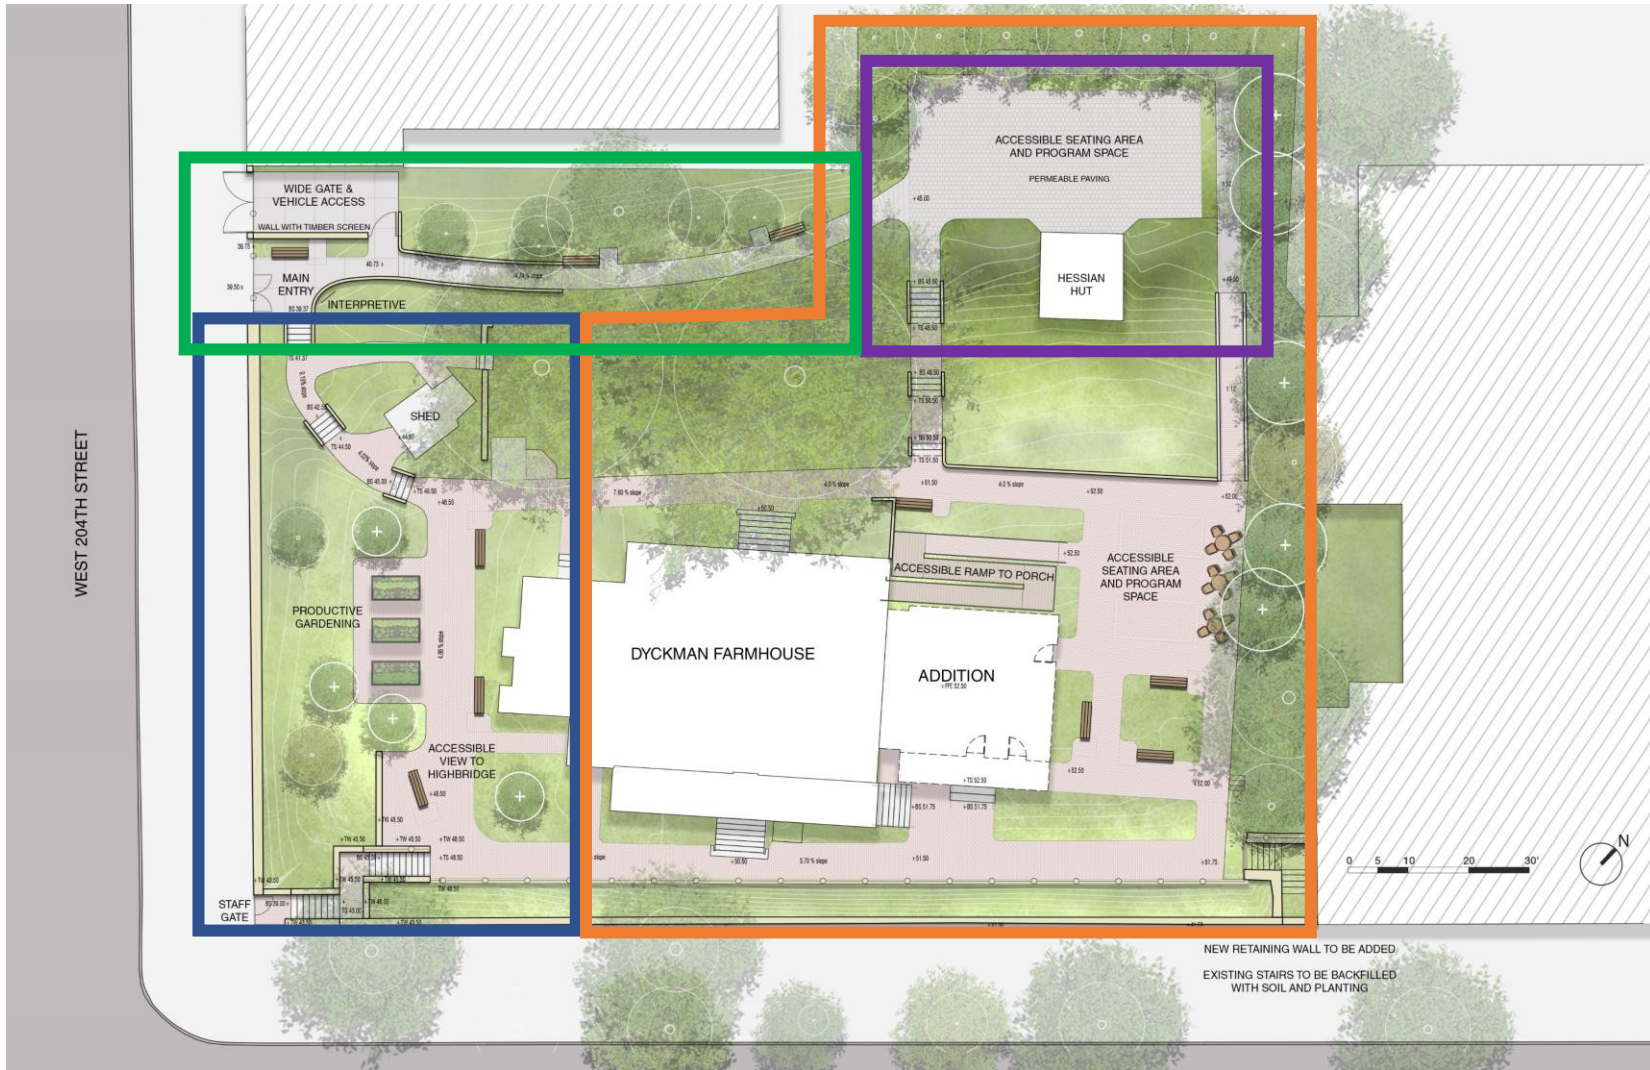
Farm Life Zone

- Related to 18th century farming and service functions
- Remaining view to Fort Tryon Park

Dyckman Park Zone

- Evolved 1916 landscape when property became a public park

Revolutionary War Zone

- Archaeologically reconstructed hut from Hessian encampment in upper Manhattan

Natural Zone

- Entrance path through a part of the site not previously developed
