Preservation Department – Item 7, LPC-23-05176

**130 Pitt Street – Hamilton Fish Park Play Center –
Individual Landmark
Borough of Manhattan**

Hamilton Fish Recreation Center Ramps

Landmarks Preservation Commission Presentation
January 24, 2023
Abokor Gulaid, NYC Parks

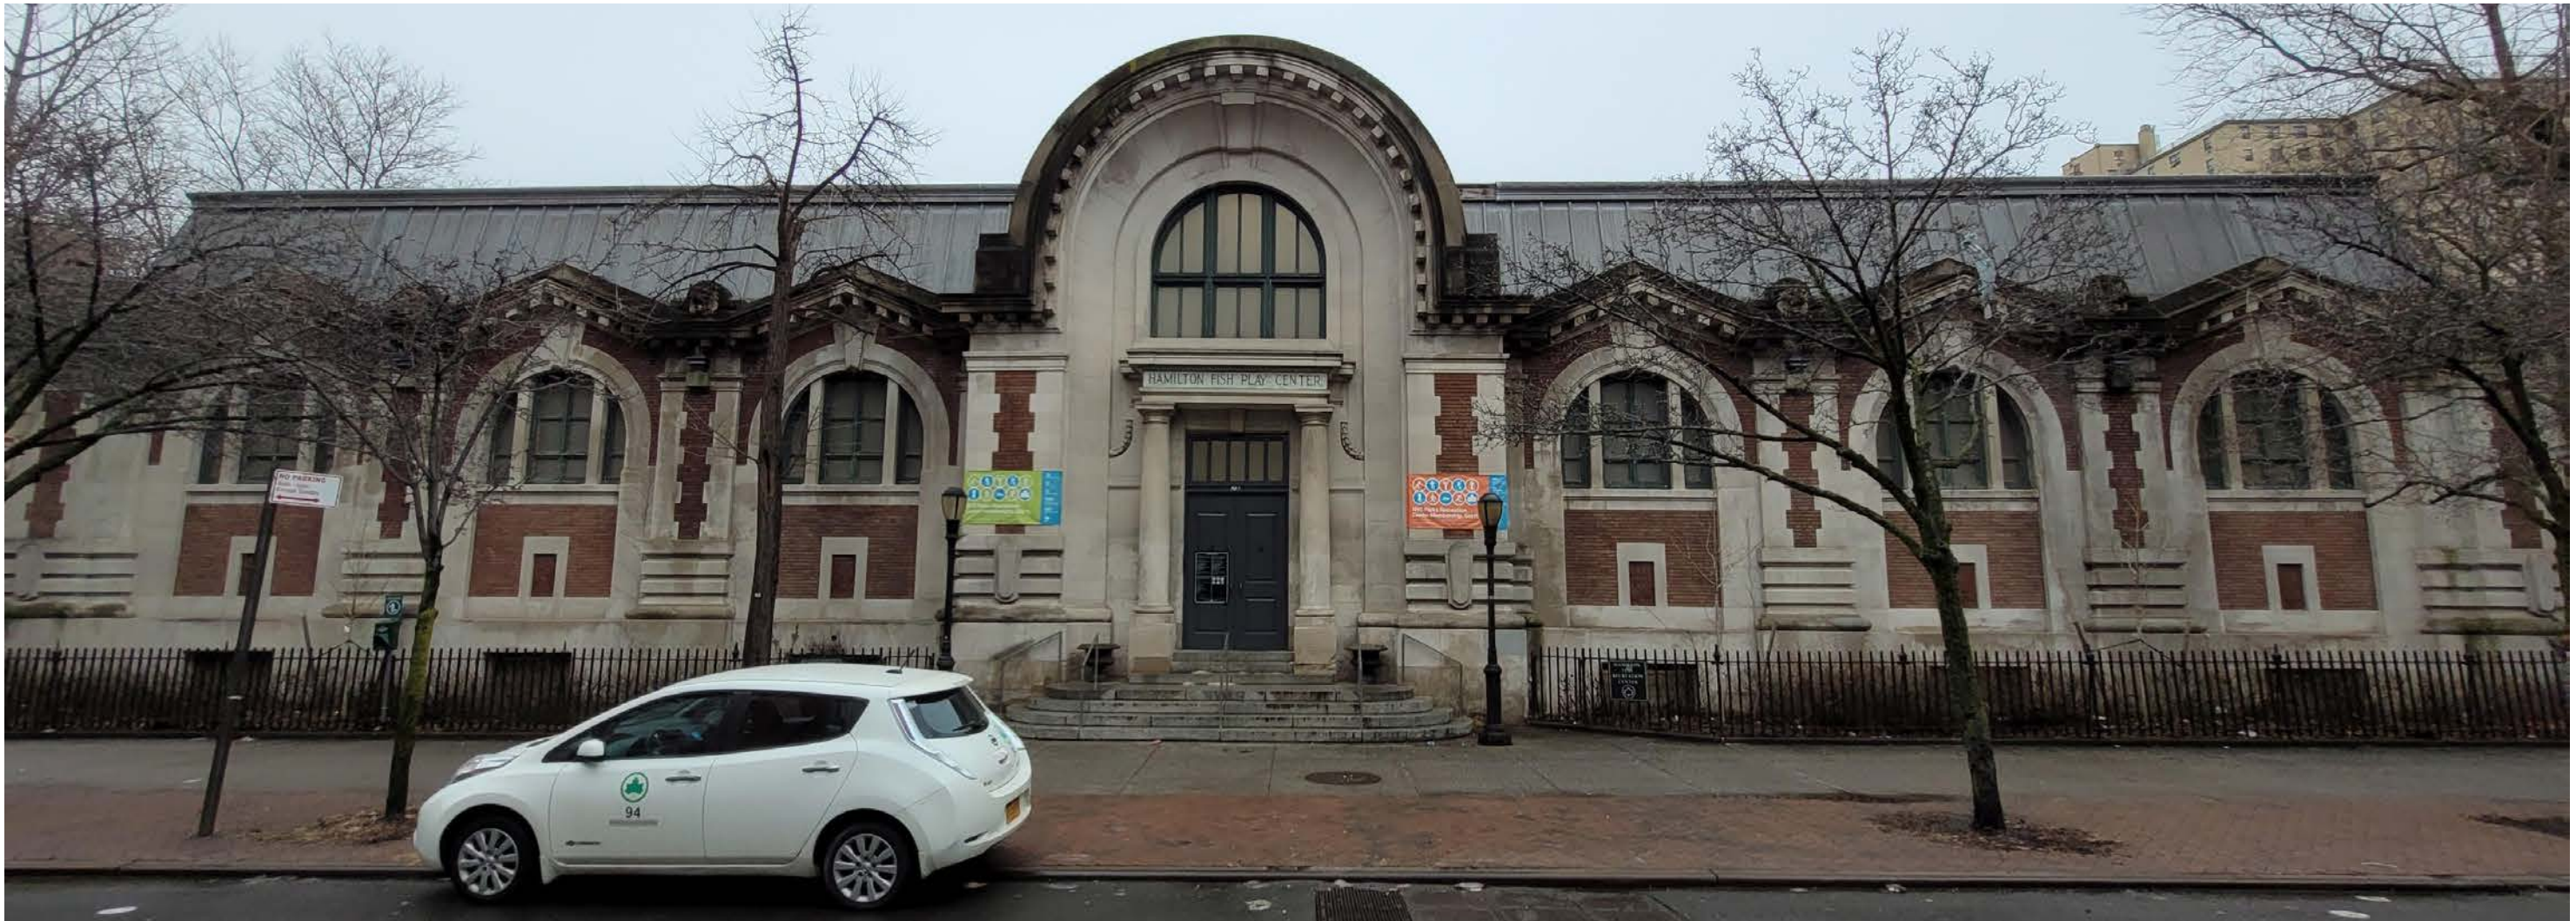
1 - Community Bldg. West Elevation and Street-Facing Entrance

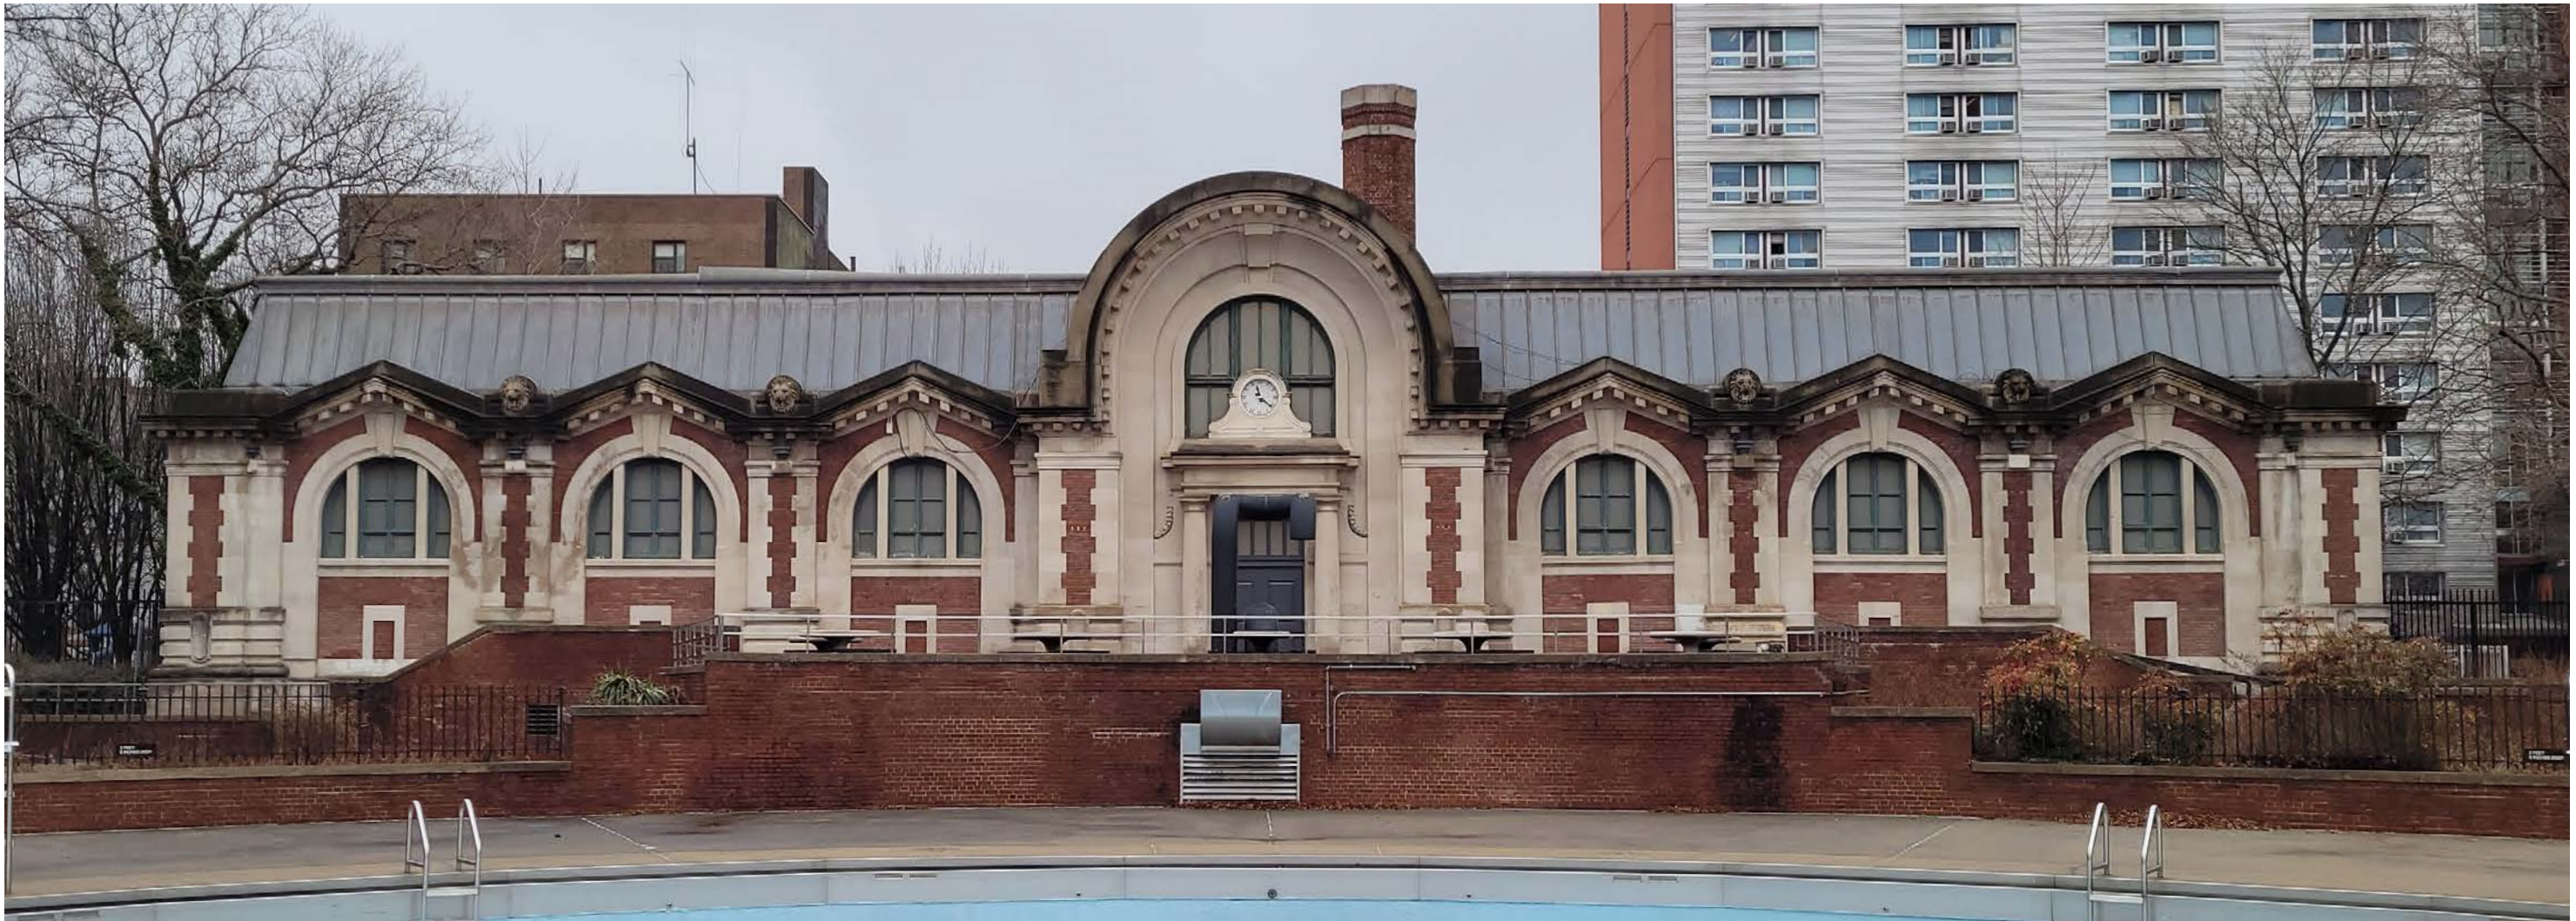
2 - Community Bldg. East Elevation and Park-Facing Entrance (from Pool Deck)

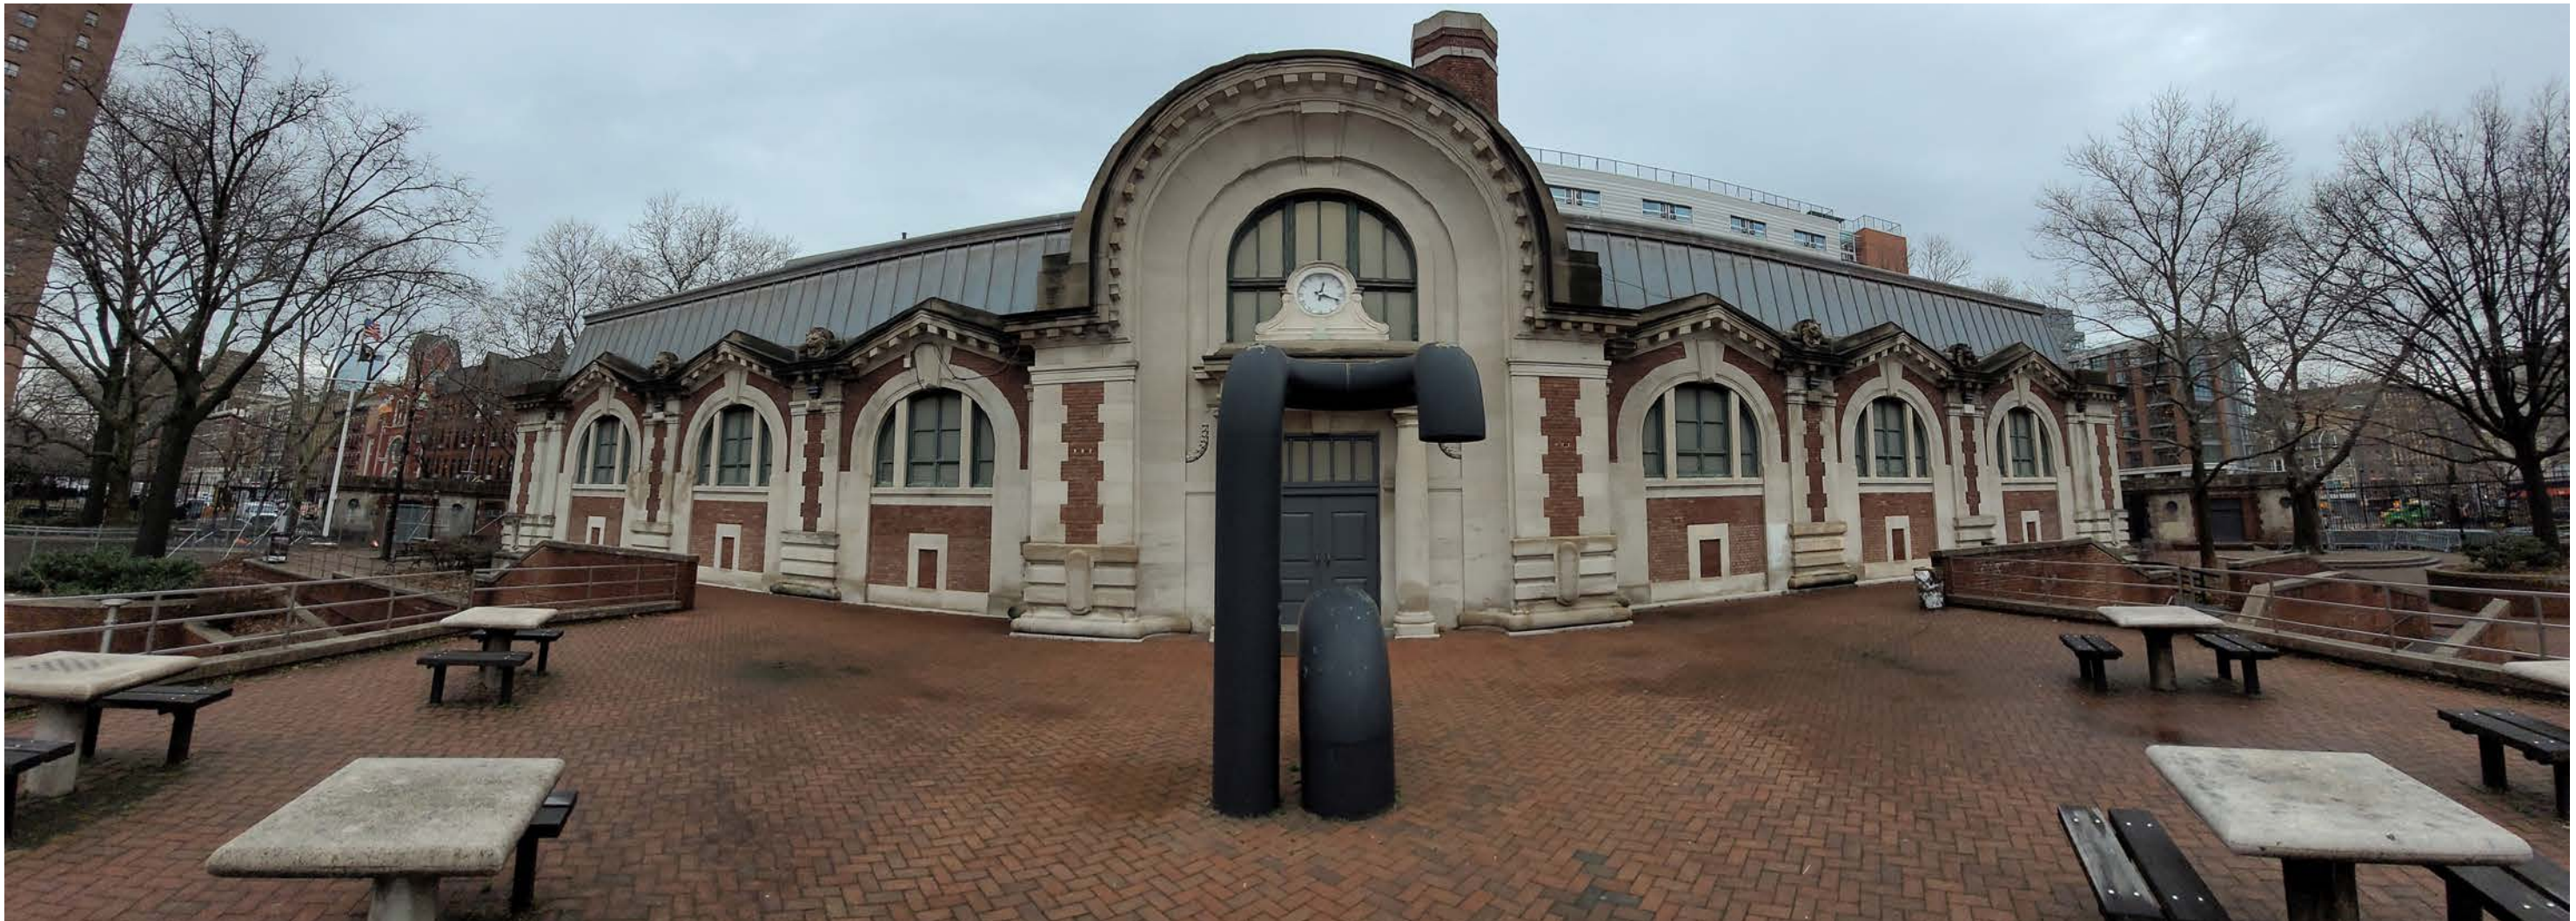
3 - Community Bldg. East Elevation (from Terrace)

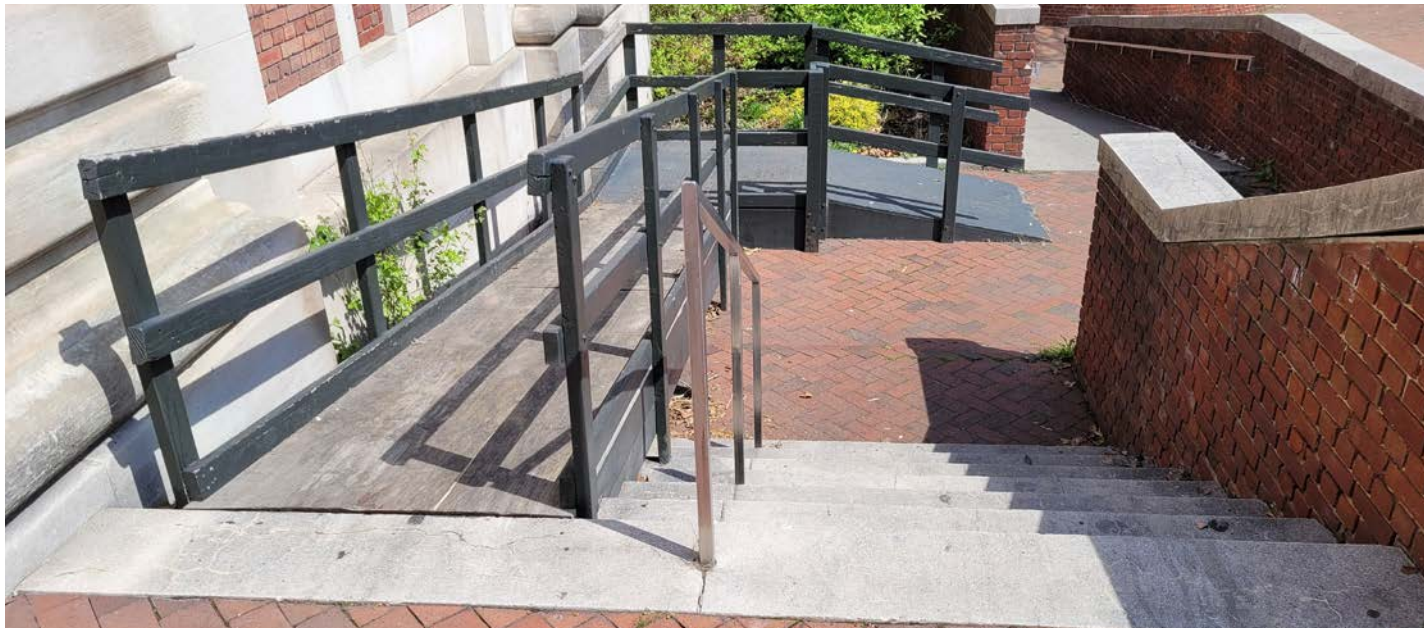
4 - Existing Non-Compliant Wood Ramp at North Stair

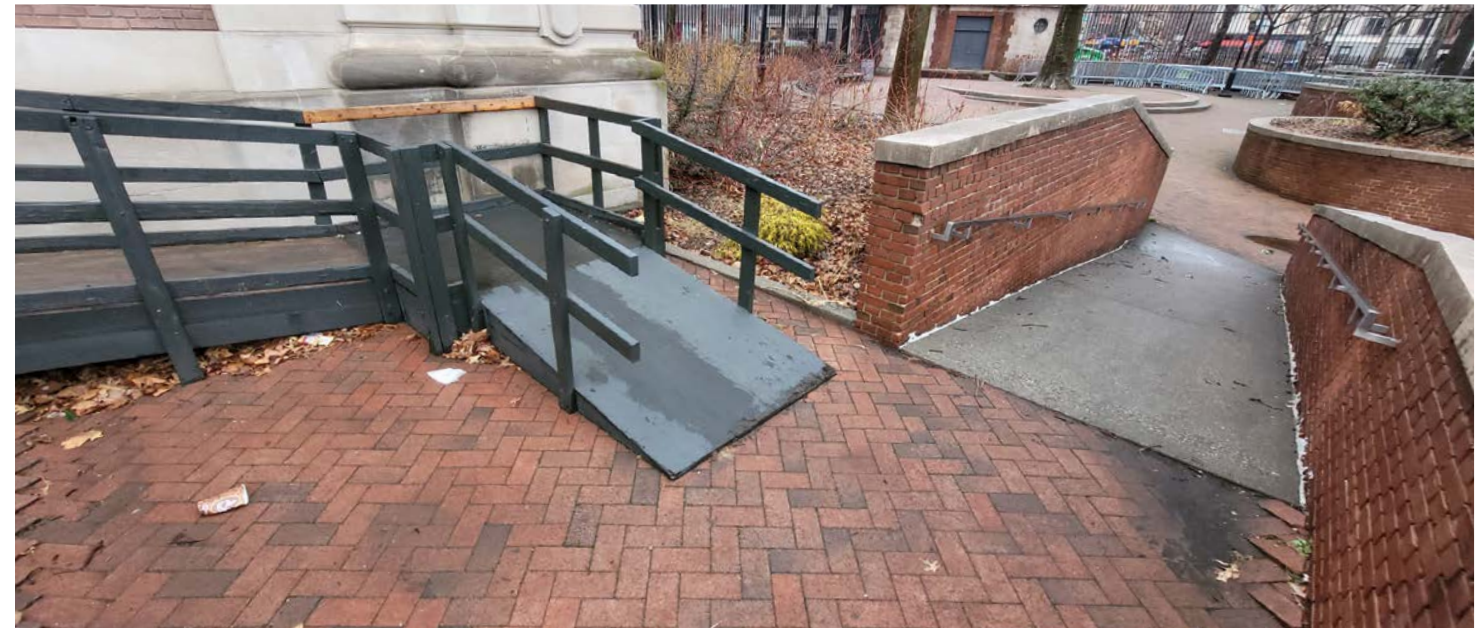
5 - Existing Non-Compliant Concrete Ramp at North Stair

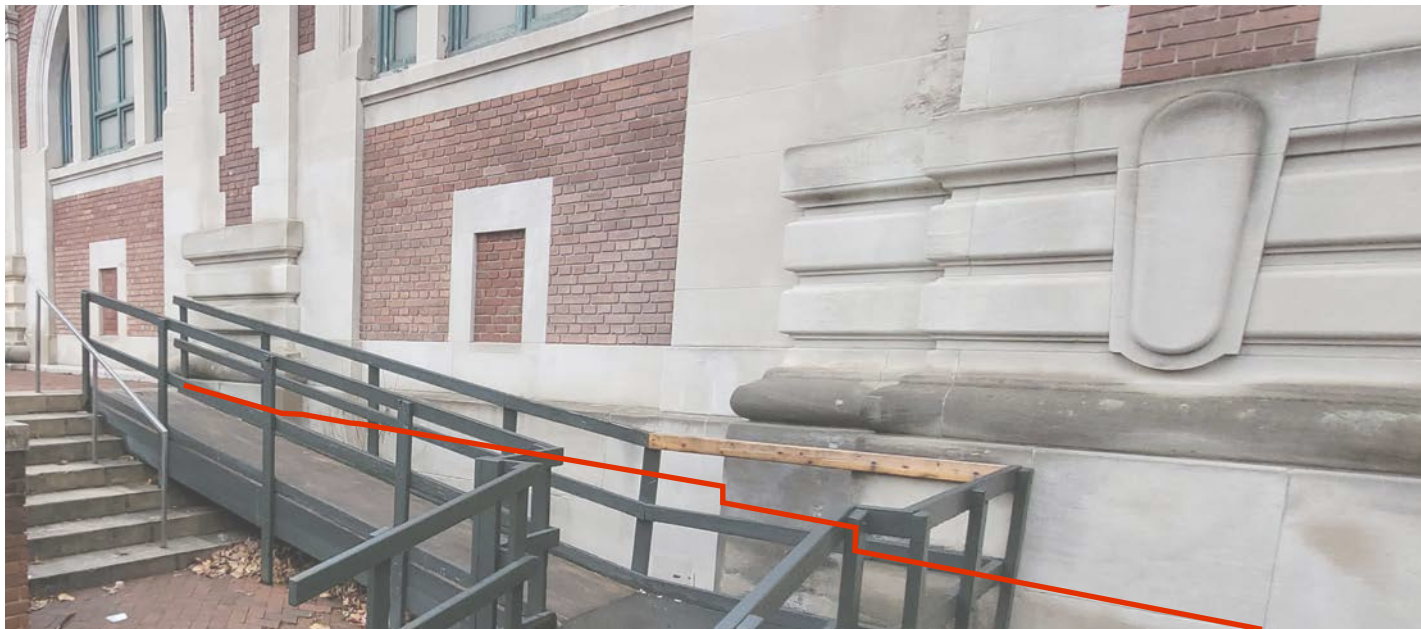
1 - Existing Freestanding Wood Ramp at North Stair

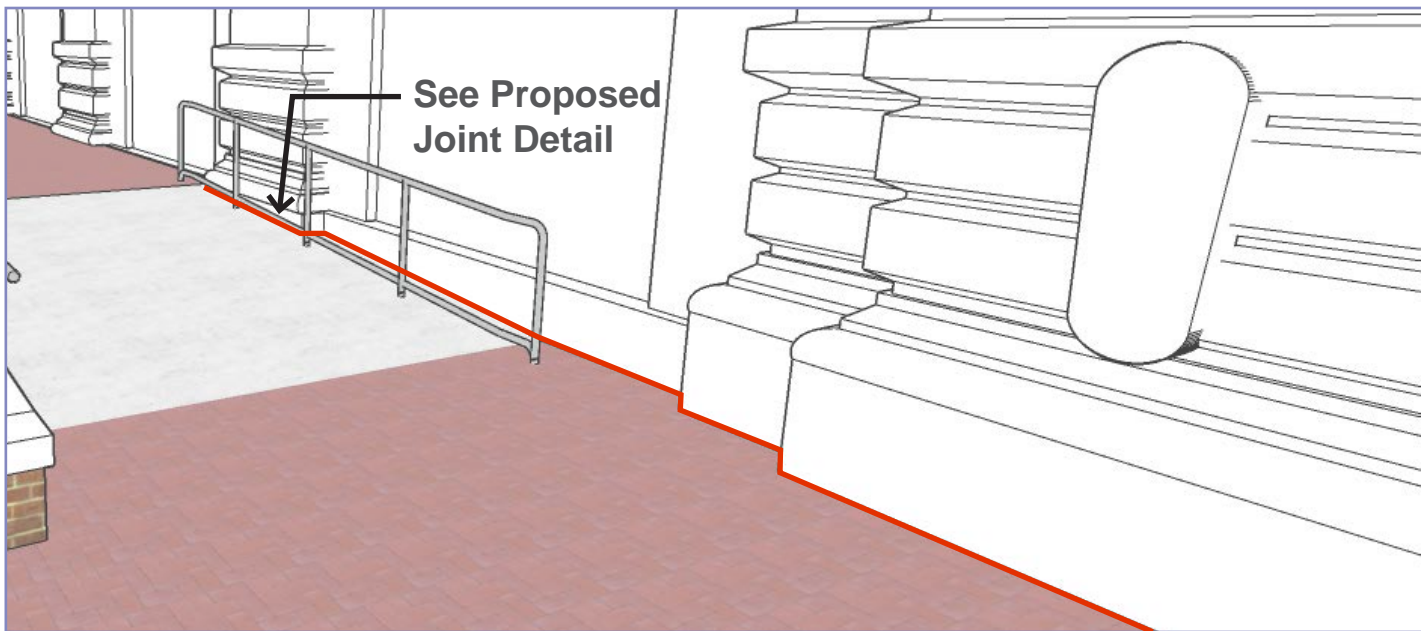
2 - Proposed Concrete Ramp at North Stair

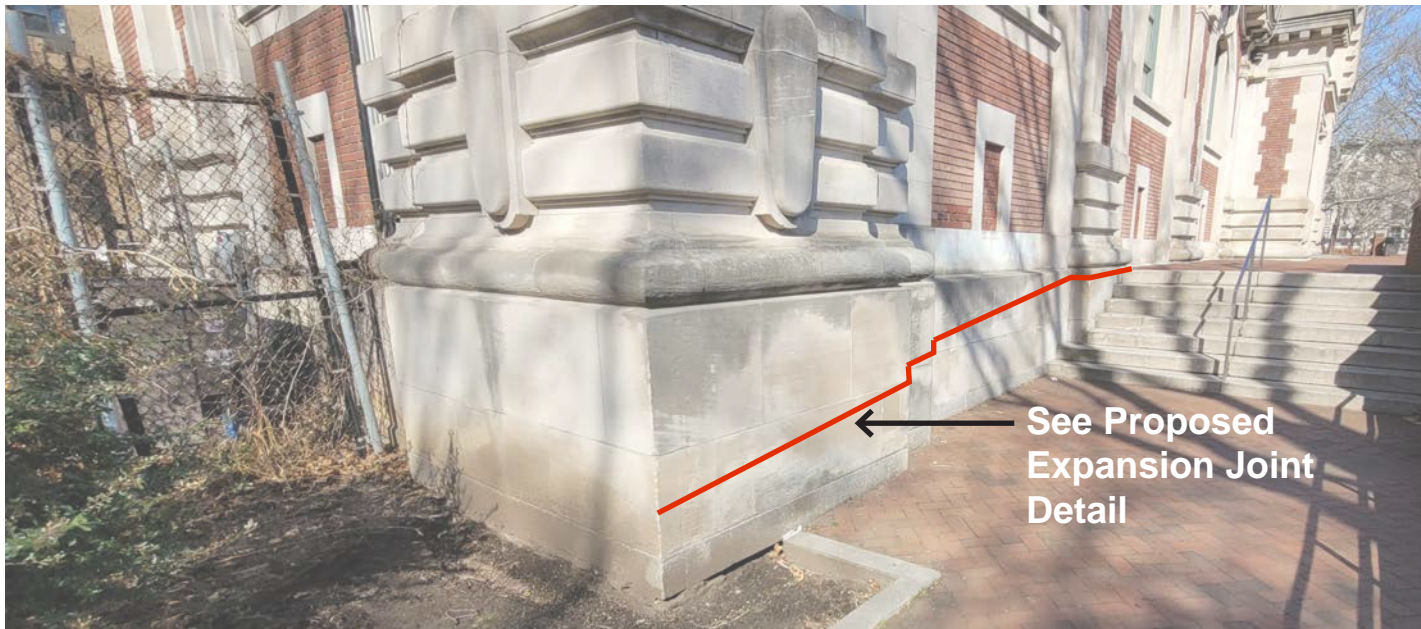
1 - Existing South Stair

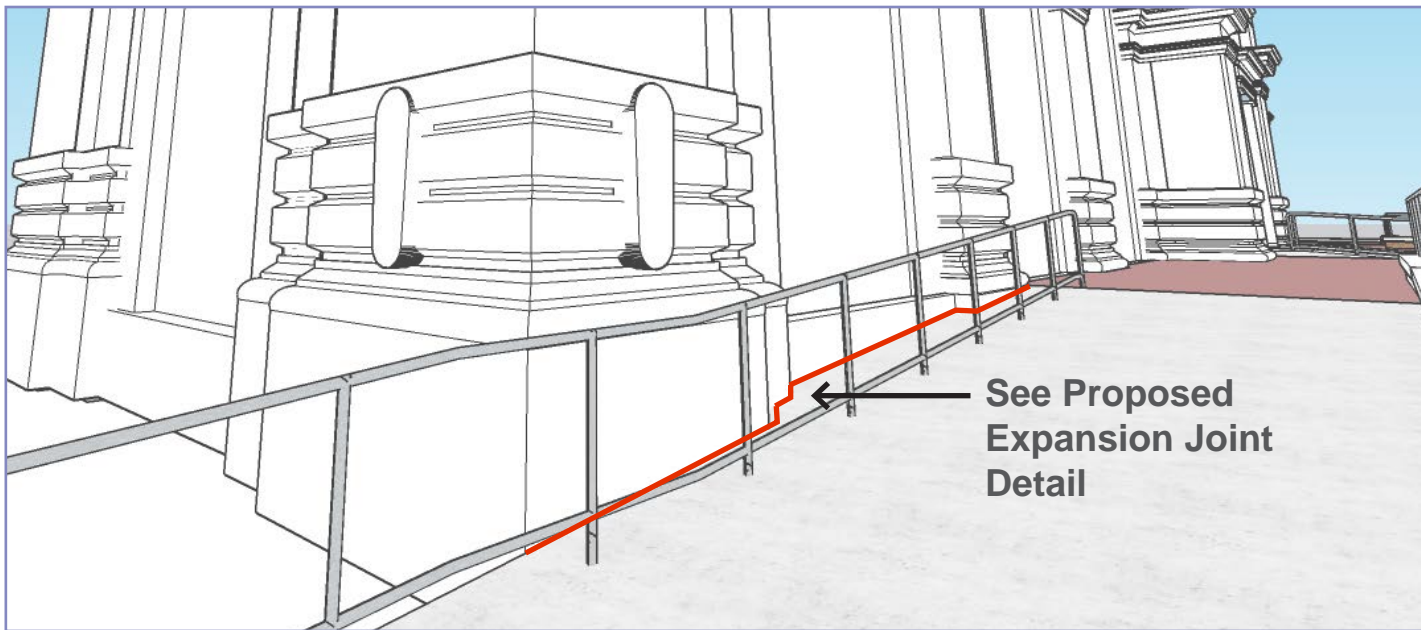
2 - Proposed Concrete Ramps and Landing at South Stair

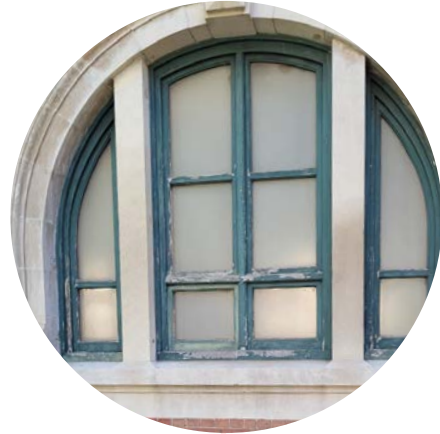
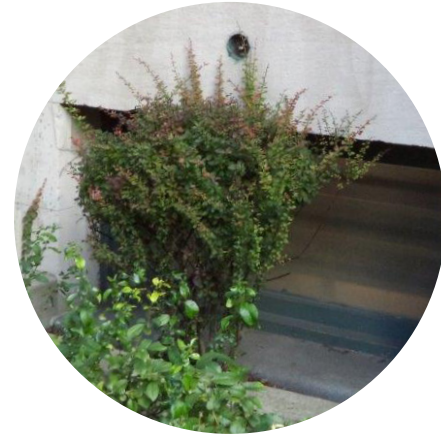
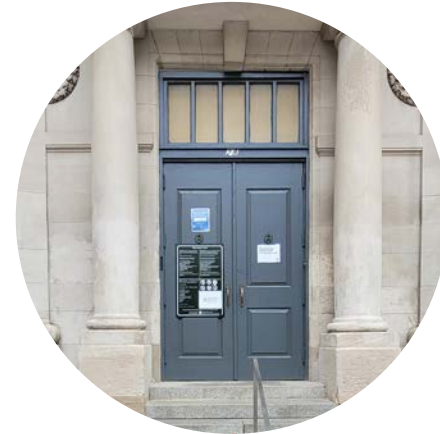
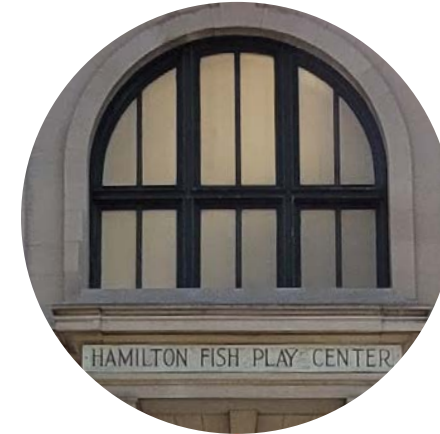
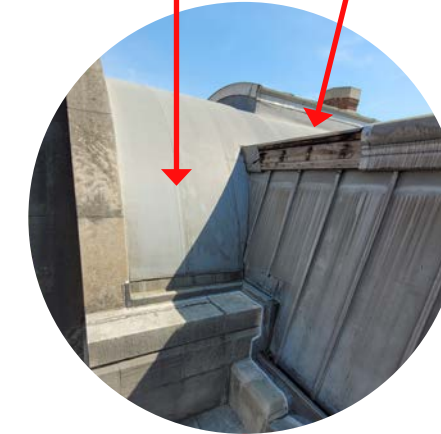
- Type 'A' deteriorated wood window sash and frames to be stripped and repainted to match existing color
Qty: 6 @ West Elevation

- Type 'C' deteriorated wood window sash and frames to be stripped and repainted to match existing color
Qty: 6 @ West Elevation

- Wood doors, door frames and transom window frames to be stripped and repainted to match existing color
Qty: 1 @ West Elevation

- Type 'B' deteriorated wood window sash and frames to be stripped and repainted to match existing color
Qty: 1 @ West Elevation

- Missing terne-coated stainless steel fascia panel to be replaced
- Roof Membrane to be restored

- Limestone gutter box to be replaced
- Terne-coated stainless steel gutter to be cleaned
- Spalled brick to be replaced

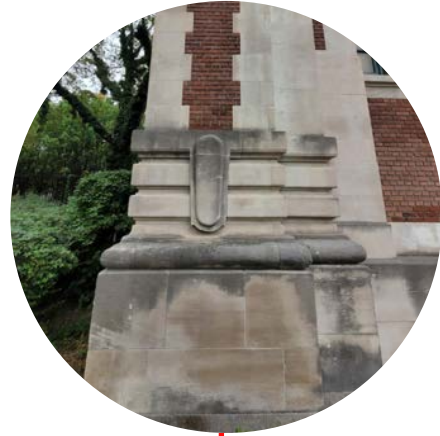
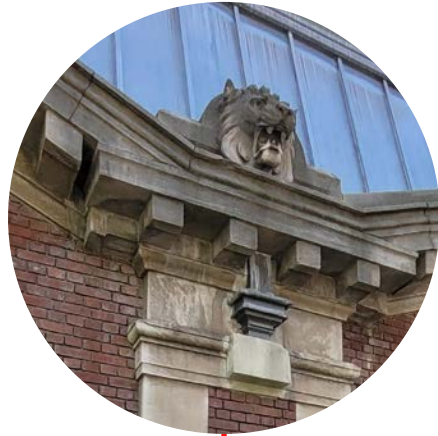
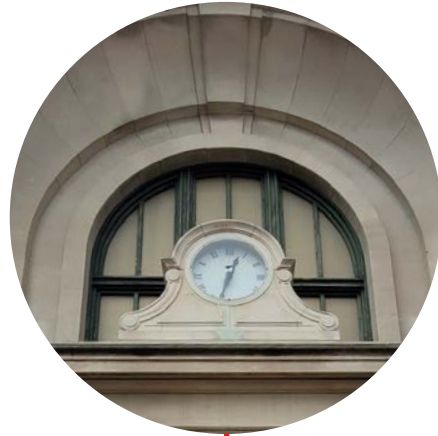
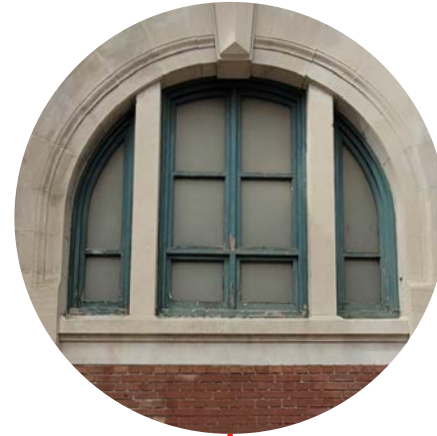
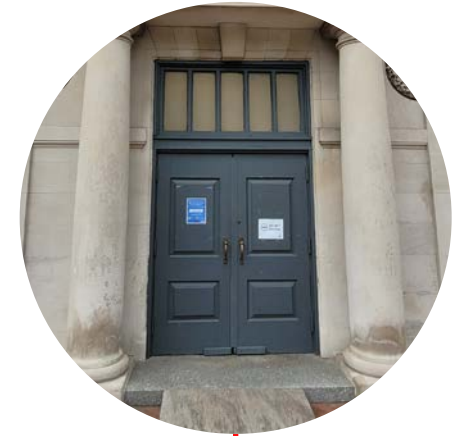
- Heavy surface discoloration/staining at limestone column base

- Stained limestone gargoyle and terne-coated stainless steel leader box to be cleaned
Qty: 4 @ East Elev

- Type 'B' deteriorated wood window sash and frames to be stripped and repainted to match existing color
Qty: 1 @ East Elevation

- Type 'A' deteriorated wood window sash and frames to be stripped and repainted to match existing color
Qty: 6 @ East Elevation

- Terne-coated stainless steel fascia to be cleaned
- Roof Membrane to be restored

- Wood doors, door frames and transom window frames to be stripped and repainted to match existing color
Qty: 1 @ East Elevation

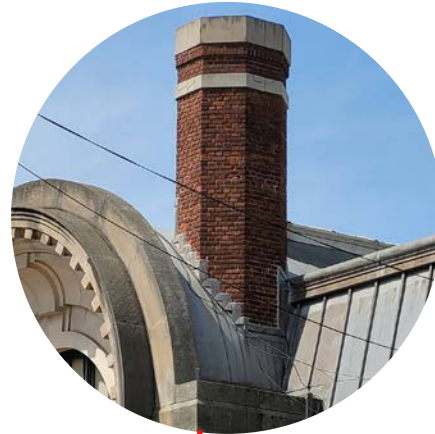
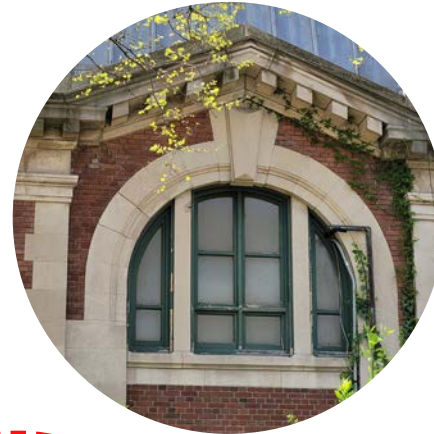
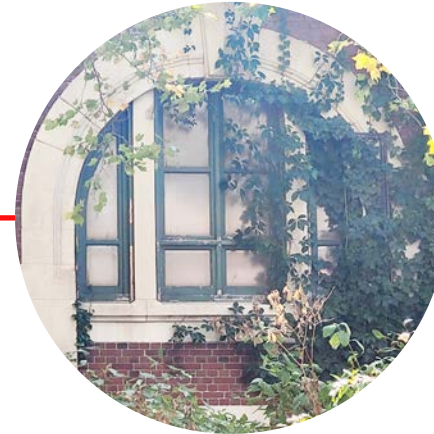
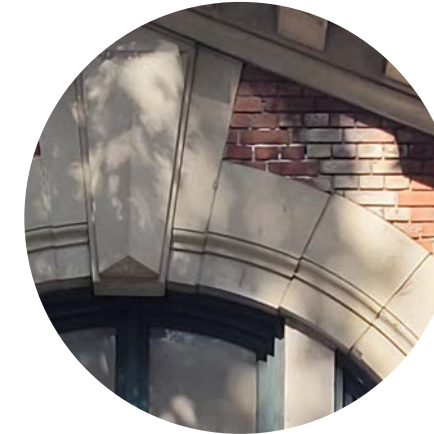
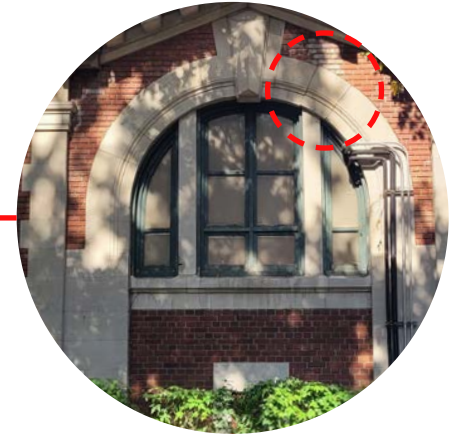
• Chimney brick and stone repointing, repair and replacement

• Type 'A' deteriorated wood window sash and frames to be stripped and repainted to match existing color
Qty: 1 @ North Elevation

• Heavy vegetation at window to be removed

• Displaced limestone voussoir above window

• Type 'A' deteriorated wood window sash and frames to be stripped and repainted to match existing color
Qty: 1 @ South Elevation

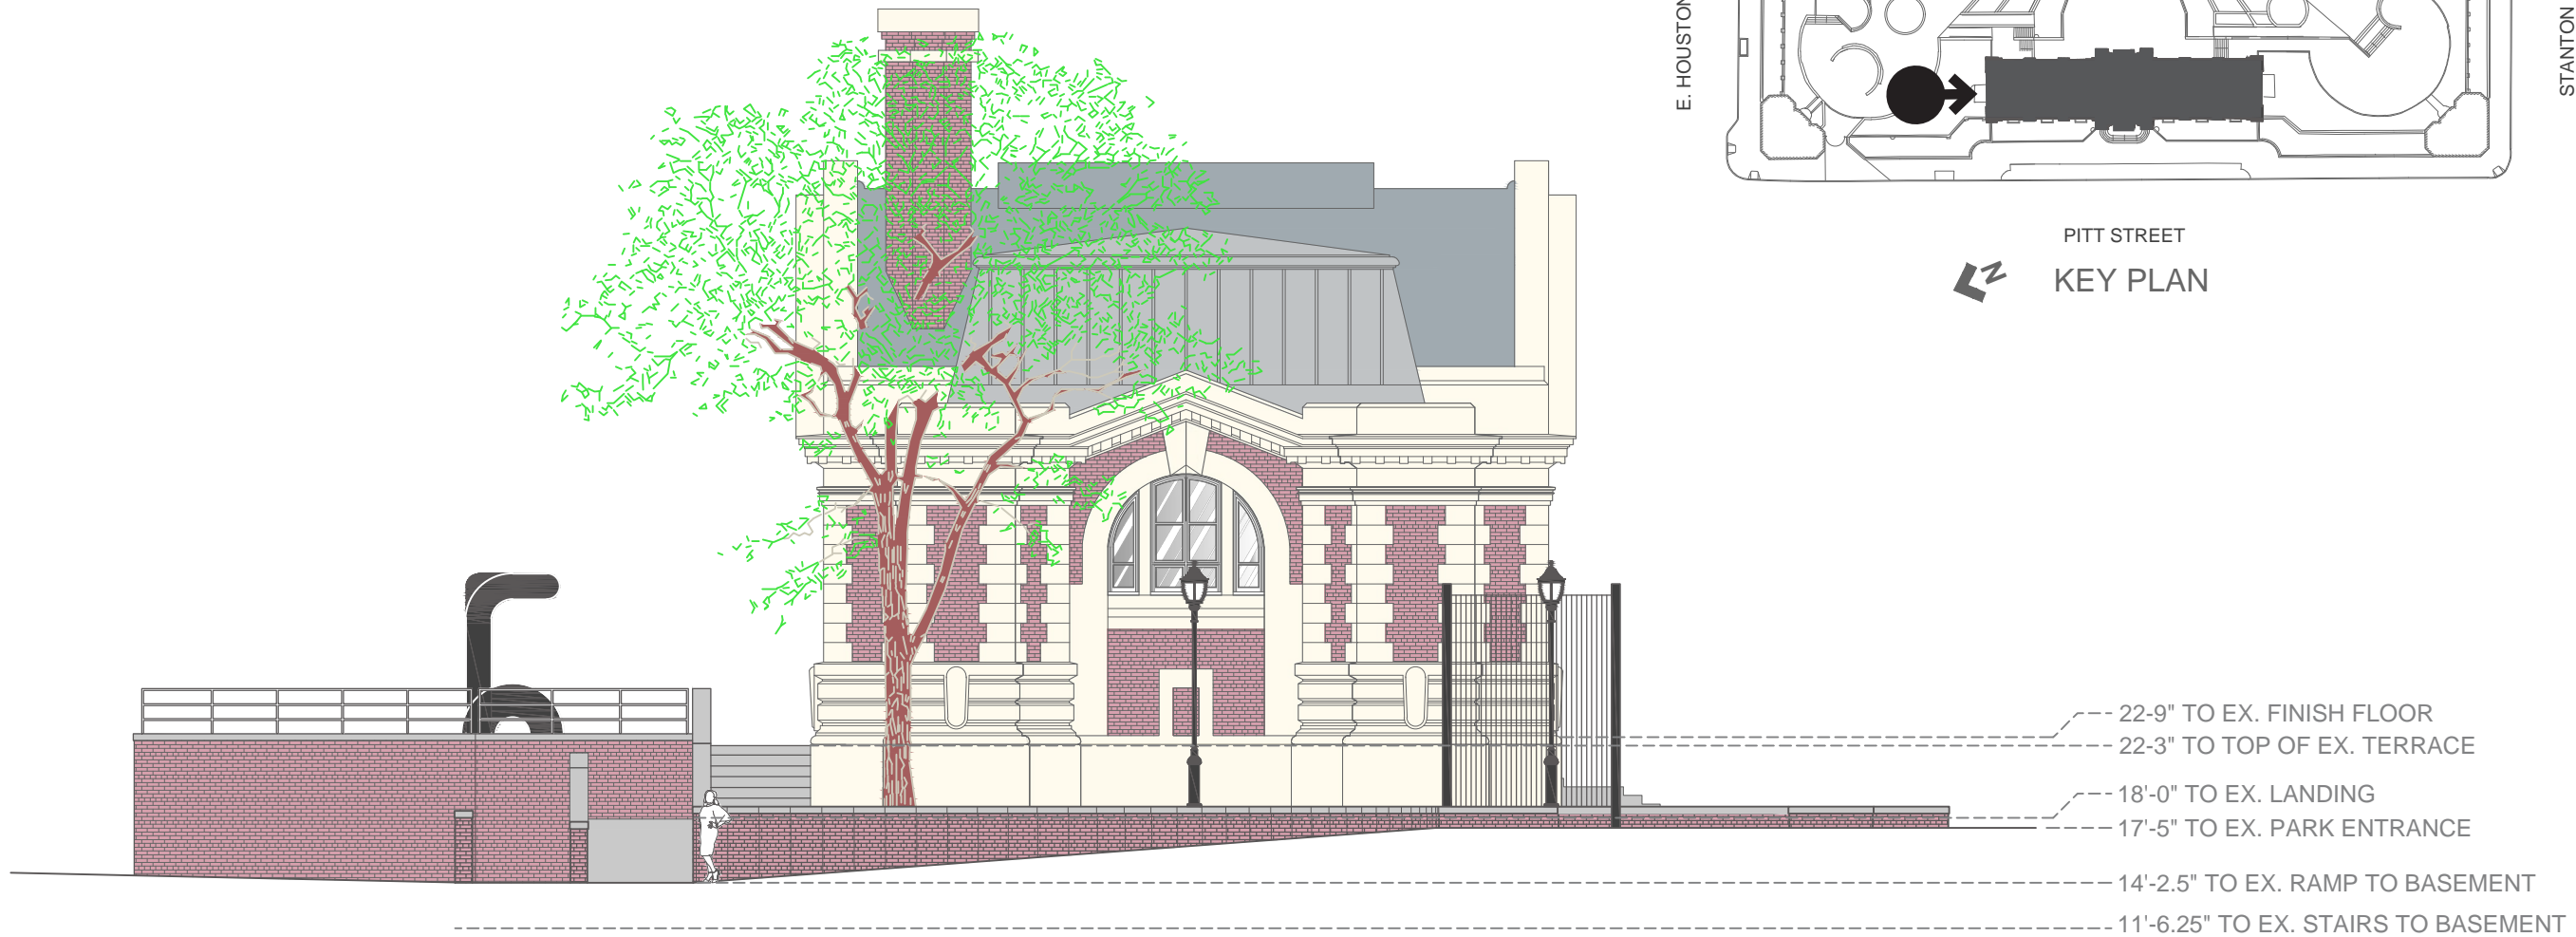
Hamilton Fish Recreation Center | Existing Exterior Elevation - Community Bldg. - North

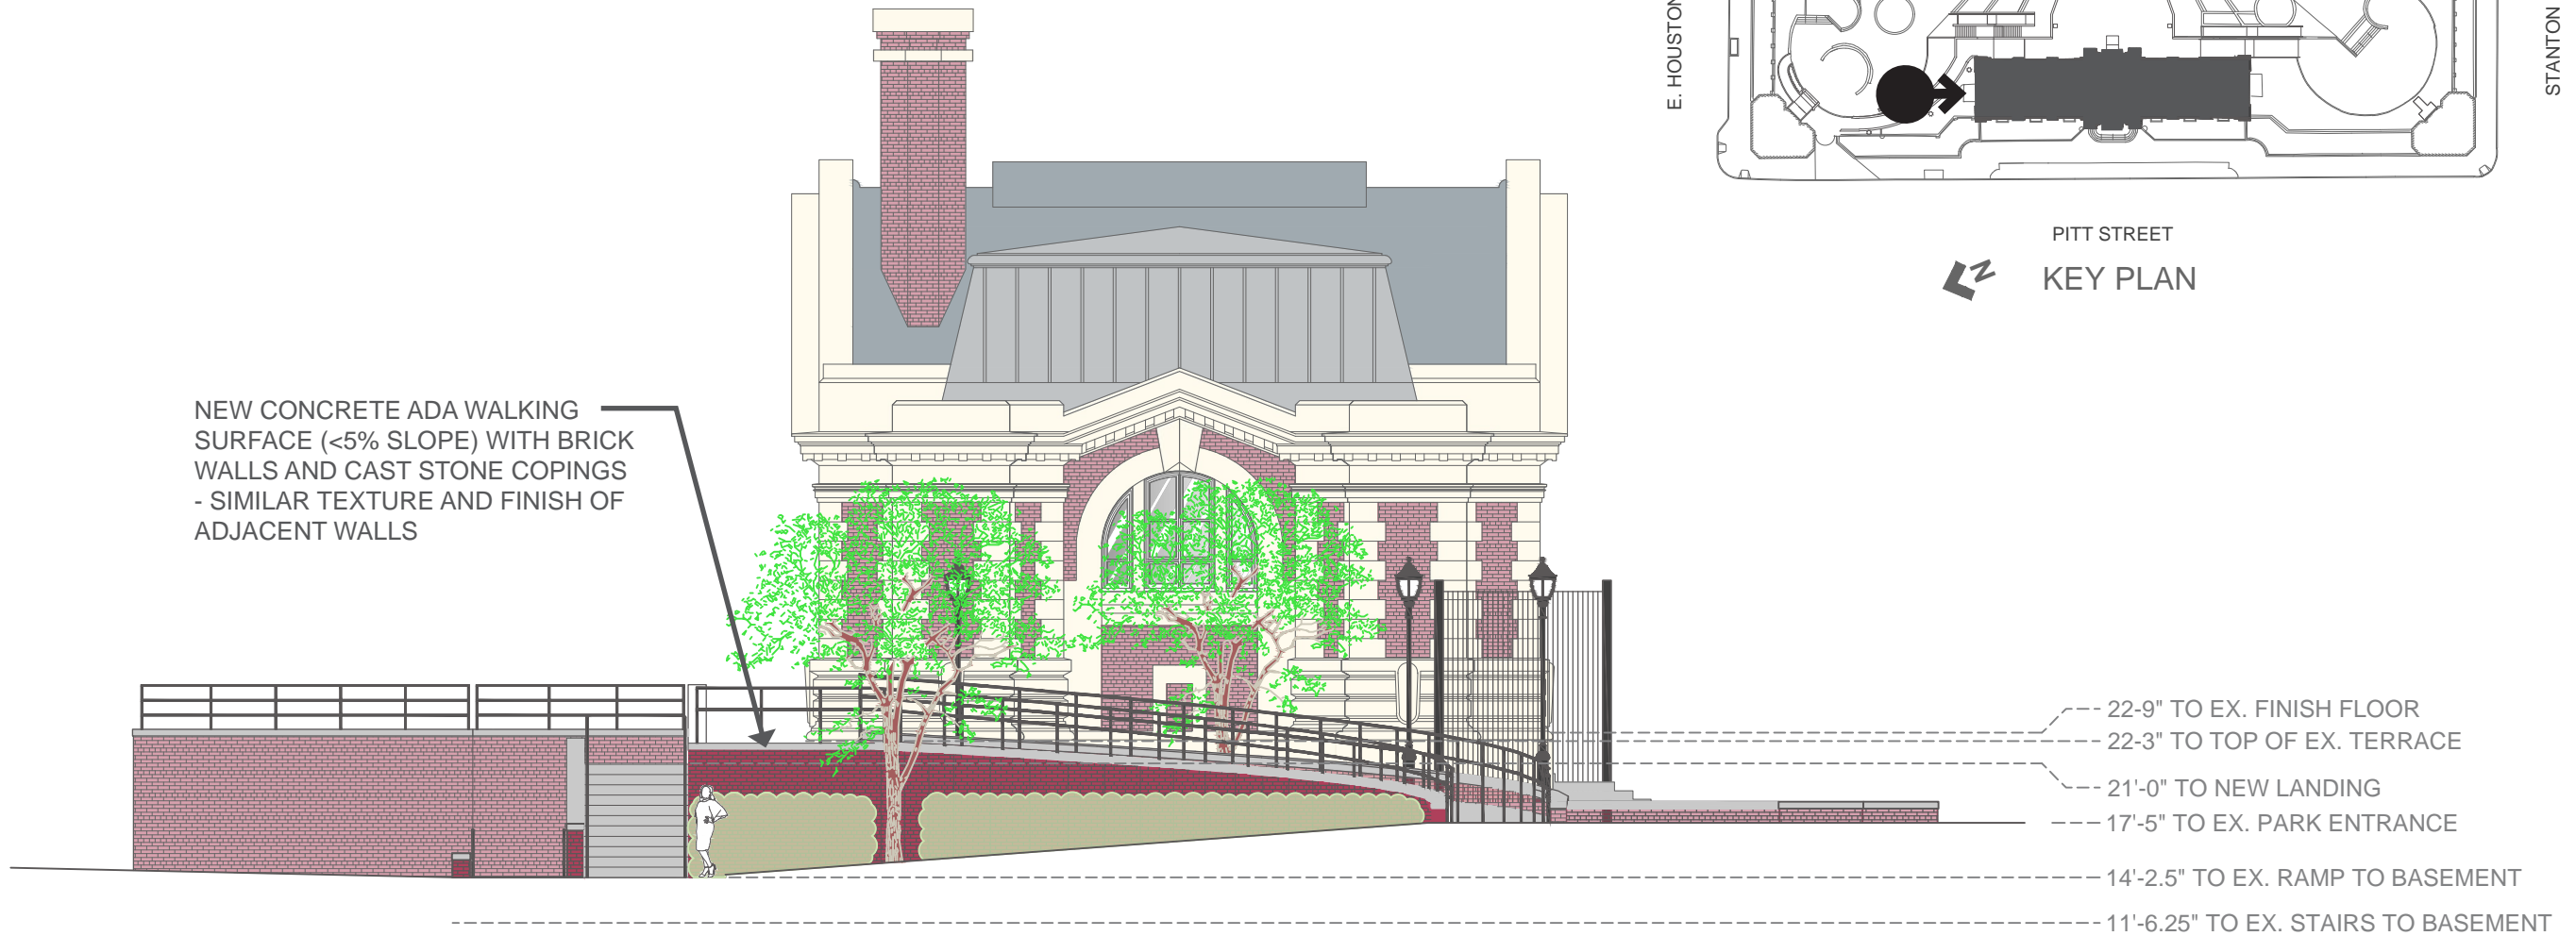
NEW CONCRETE ADA WALKING SURFACE (<5% SLOPE) WITH BRICK WALLS AND CAST STONE COPINGS - SIMILAR TEXTURE AND FINISH OF ADJACENT WALLS

Hamilton Fish Recreation Center | Proposed Exterior Elevation - Community Bldg. - North

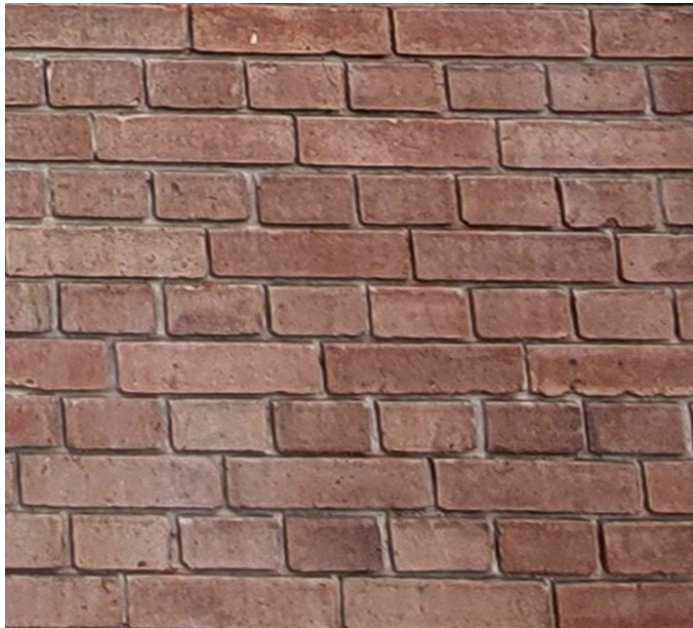
**Existing Facebrick
(English Bond)**

Replacement brick to match existing.
New mortar for reconstruction and re-pointing to match original.

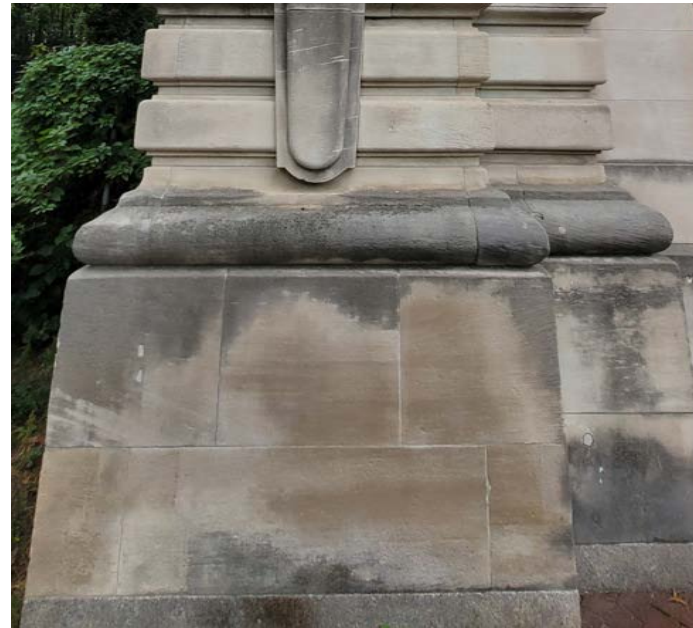
Existing Limestone

Existing limestone to be cleaned,
repaired, restored and replaced as
needed.

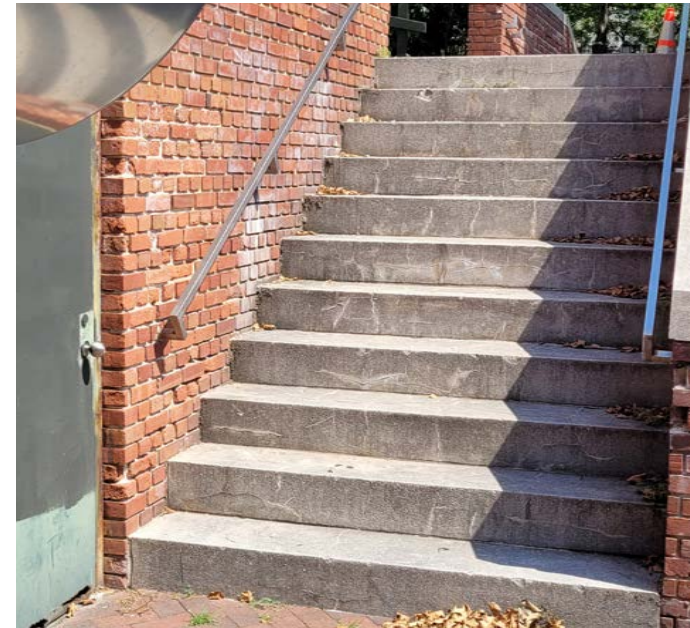
Existing Concrete Stairs

Replacement concrete stairs to match
existing.

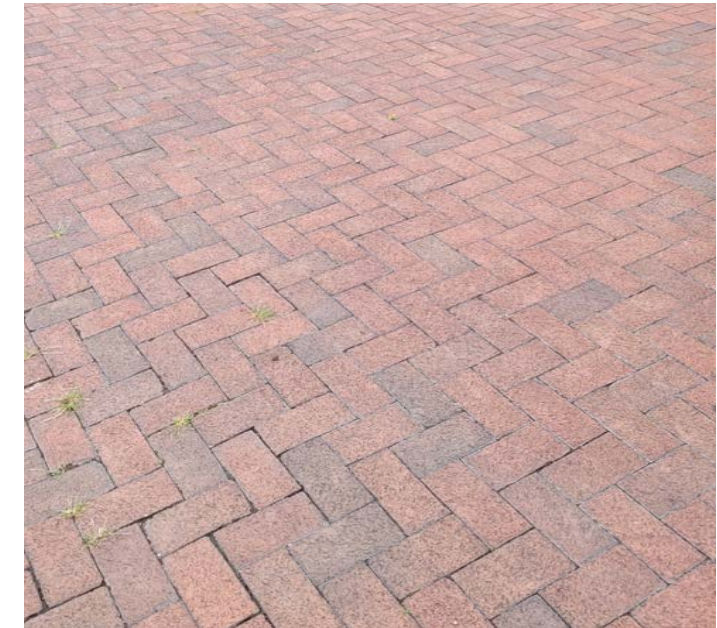
Existing Brick Pavers

Replacement brick to match existing.

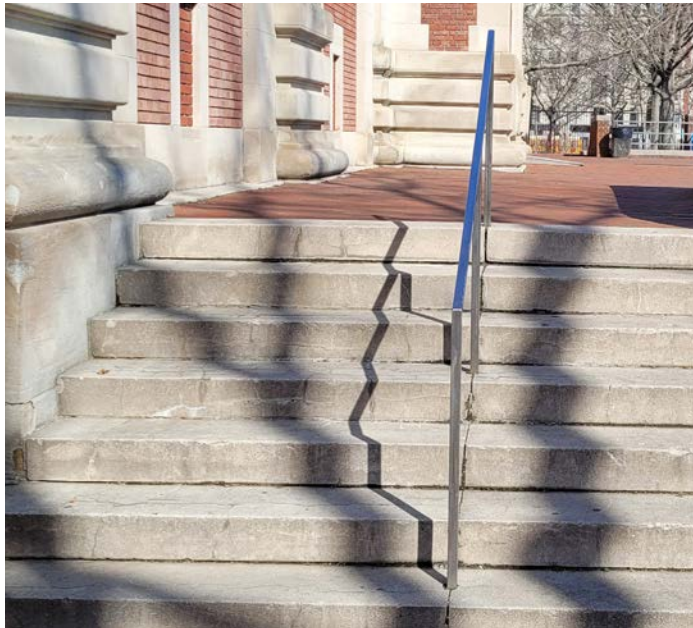
Existing Stainless Steel Handrails

Existing 1-1/4" stainless steel square tube handrails to be removed and replaced with code-compliant handrail.
