Preservation Department – Item 7, LPC-23-05176

**130 Pitt Street – Hamilton Fish Park Play Center –
Individual Landmark
Borough of Manhattan**

Hamilton Fish Recreation Center Ramps

Landmarks Preservation Commission Presentation
January 24, 2023
Abokor Gulaid, NYC Parks

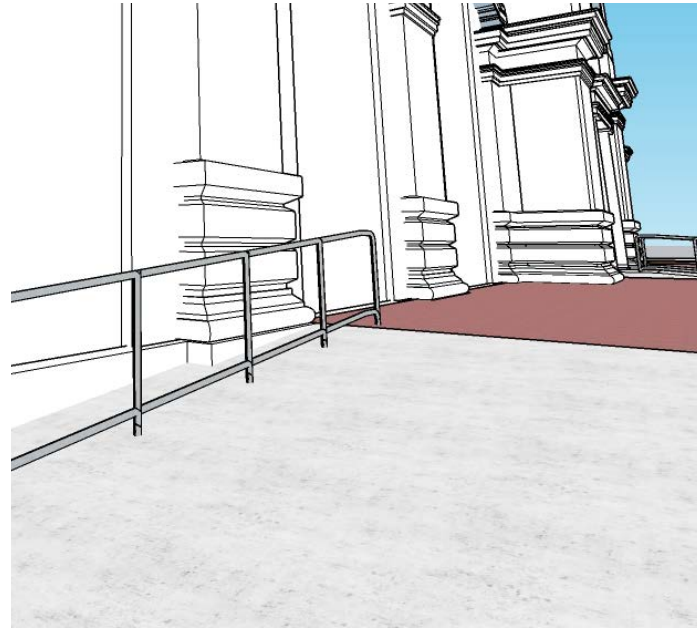
Replacement Stainless Steel Handrails

Replacement 1-1/2" diameter stainless steel handrails.

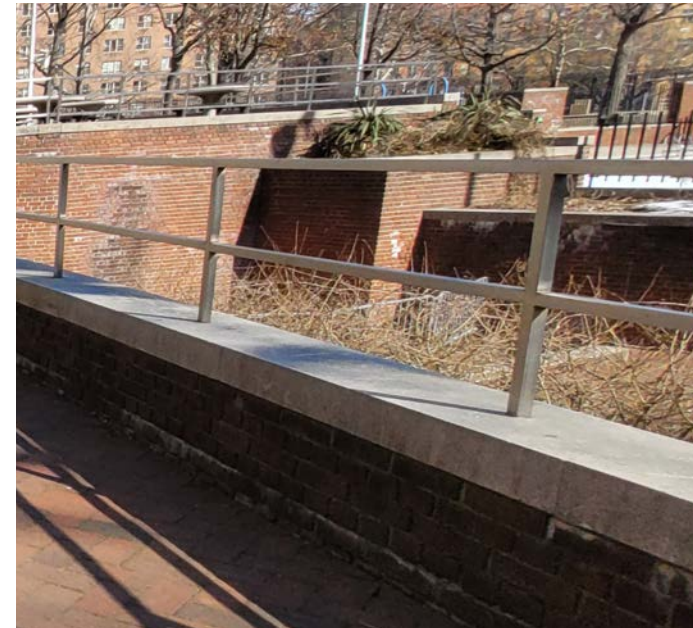
Existing Stainless Steel Guardrail on Parapet

Existing 1-1/4" stainless steel square tube guardrails to be removed and replaced with code-compliant guardrail.

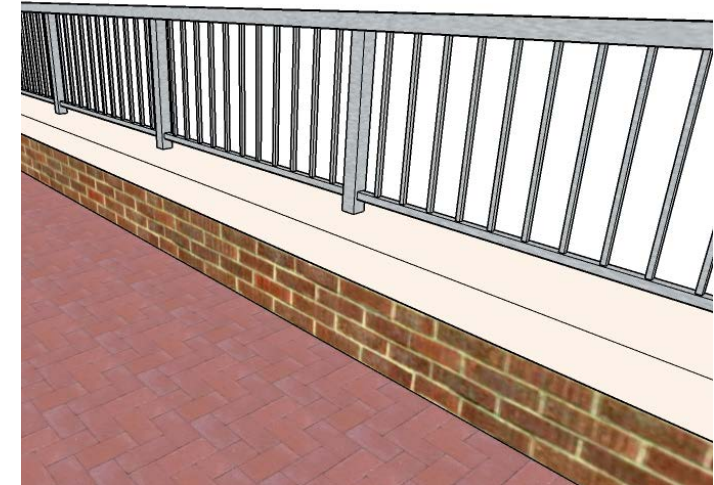
Replacement Stainless Steel Guardrail on Parapet

Replacement stainless steel guardrail.
- 2" sq. top rail
- 2" sq. vertical posts
- 1/2" sq. infill (pickets)

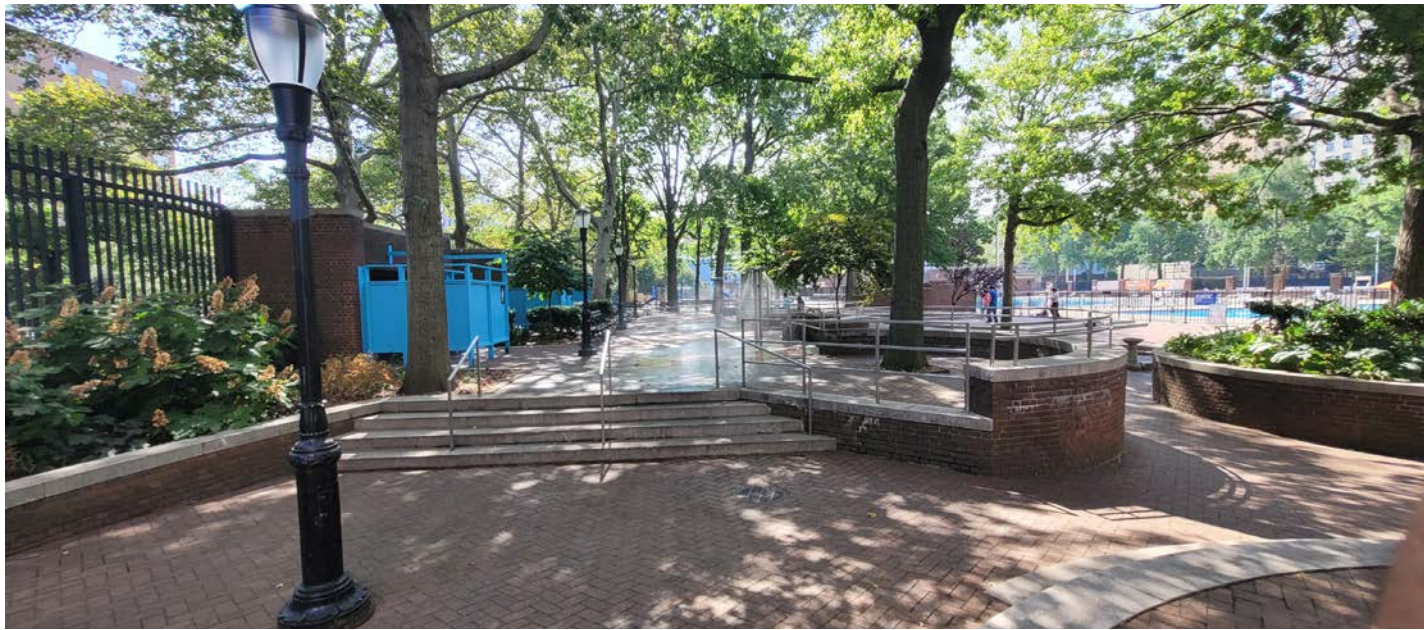
1 - Existing Stainless Steel Handrail and Guardrail near Playground

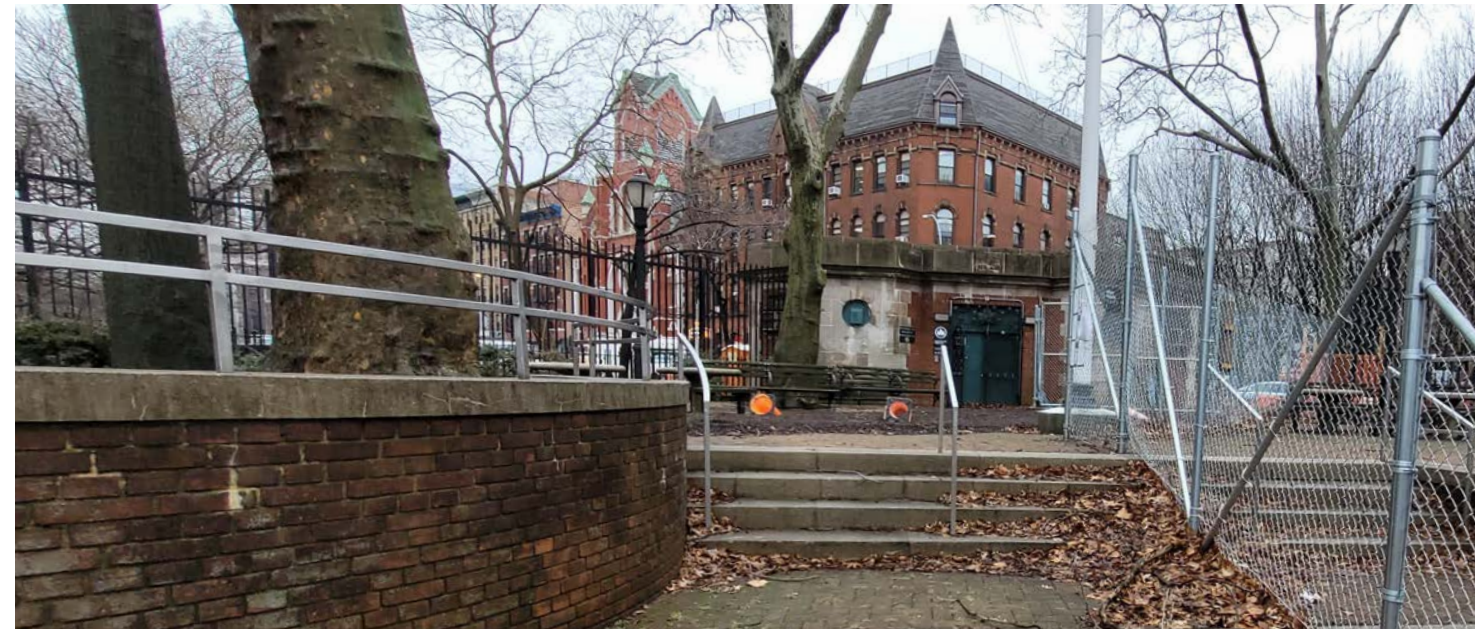
2 - Existing Stainless Steel Handrail and Guardrail near Stanton Street House
