Preservation Department – Item 9, LPC-22-08398

177 East 104th Street - 28th Police Precinct Station

Preservation/Renovation and Change of Use from Police Station to Community Facility:

Proposed: Hope Community Hall

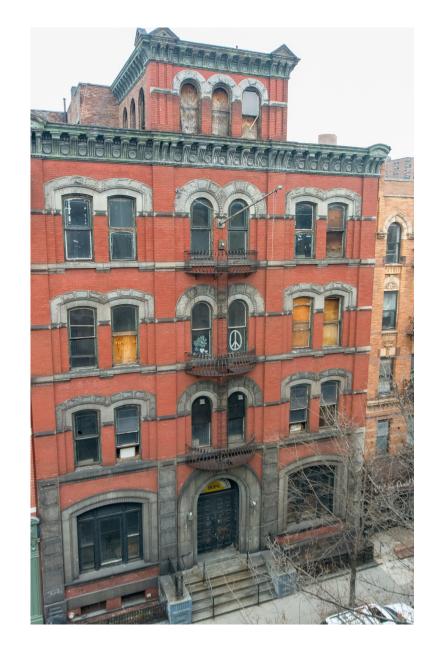
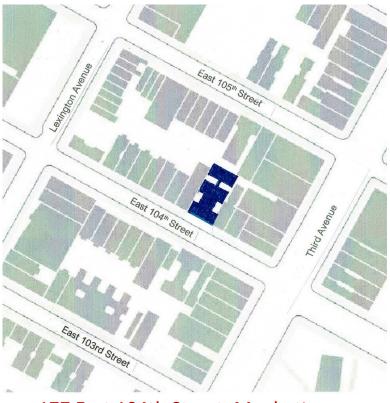
Current Photo and Plot Plan

177 East 104th Street, Manhattan

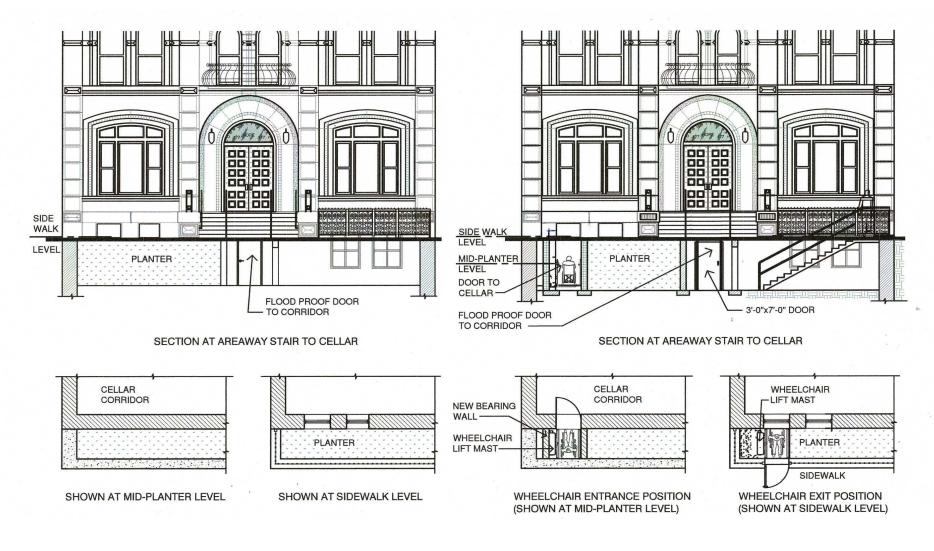
Wheelchair Lift as ADA Solution

EXISTING CONDITIONS

PROPOSED SOLUTION

- The five-story building currently has one stair and no elevator
- The new layout will include two new fire stairs and an elevator
- The site is landlocked and there is no rear access or exit
- The existing front entrance access includes six steps from the sidewalk to the first floor entrance doors (outside entrance to the cellar will be through a new sidewalk-to-cellar stair)
- The new wheelchair lift will be located at the westside planter at the cellar level until 'called' to the sidewalk level for use.

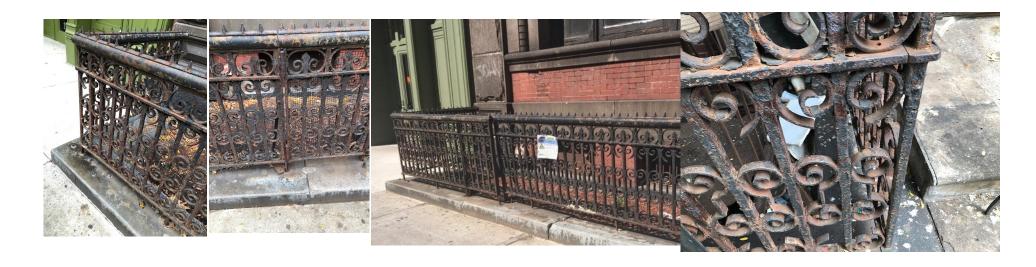
Fence Restoration and New Gate Creation

IRON FENCE AND STONE BASE RESTORATION SCOPE

- 1. The existing metal fence located at the building's front will be restored while any elements beyond repair are replaced with in-kind materials .
- 2. The metal fence will be removed from its existing stone base and cleaned of rust, dirt and other particles from the fence elements. New and existing fence members will be painted with appropriate paint in its historically identified color.
- 3. The existing stone bases will be removed, cleaned and reset, with no stone placed at the wheelchair entrance.
- 4. The contractor will rebuild the fences to accommodate the new fence gates—for the wheelchair lift and for the entrance to the cellar stair—via the gate at the top of the new eastside stair.
- 5. The new wheelchair lift entrance gate operator system will be coordinated with the wheelchair lift manufacturer and the building's electronic access program.

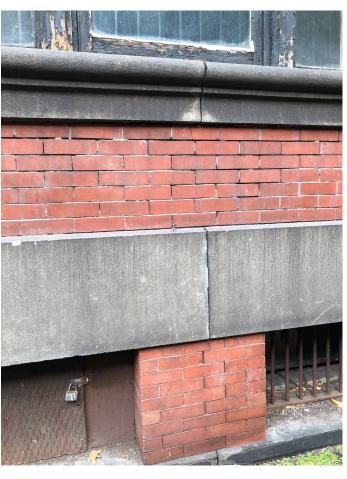
Wheelchair Lift Location Within West Areaway

Proposed location for new wheelchair lift pit between historic iron fence and cellar windows

Existing utility tunnel to street to be replaced with wheelchair lift

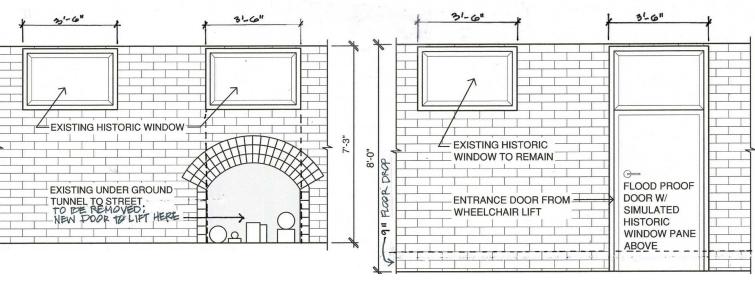
Interior Elevation of Partial Cellar — Existing

Corner of west planter in front of window which becomes the new door.

Interior Elevation of Partial Cellar - Proposed

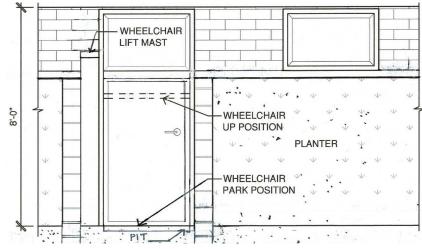
New Wheelchair Access for Building

Interior cellar wall where previous window and tunnel will be replaced with floodproof door (with built-in window). The wheelchair pit will be outside, while the corridor leads to the elevator on the cellar level

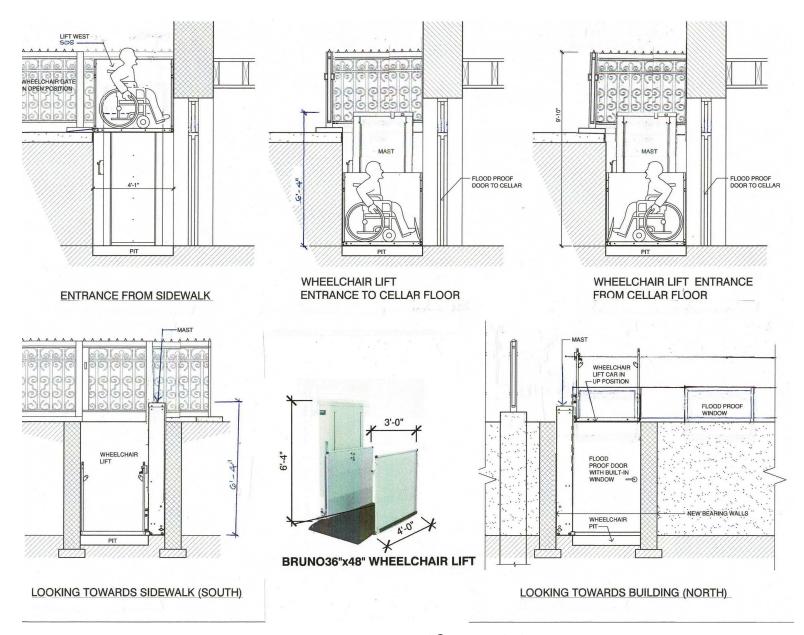
ADA Wheelchair Lift Positions

A 36" x 48" wheelchair lift is required to provide ADA/Wheelchair access to the building. The lift will travel from the sidewalk level to the Cellar floor level where a corridor connects with the building's elevator. The elevator is accessible to all floors.

The black wheelchair access door (the westside gate) will incorporate much of the existing wrought iron fencing which will be restored.

When not in use, the black wheelchair lift will rest at the cellar level six feet below. Only a portion of the wheelchair lift mast will be visible behind the wrought iron railing.

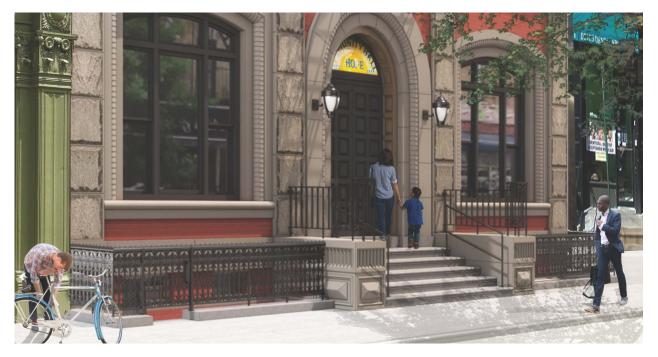
ADA/Wheelchair Access Lift

INCORPORATION OF WHEELCHAIR ACCESS INTO BUILDING FRONT SUMMARY
