Preservation Department – Item 6, LPC-23-09597

**177-179 East 73rd Street – 177-179 East 73rd Street Building –
Individual Landmark
Borough of Manhattan**

Persian Jewish Center of New York City

*Proposal to include a Synagogue -
177-179 East 73rd Street*

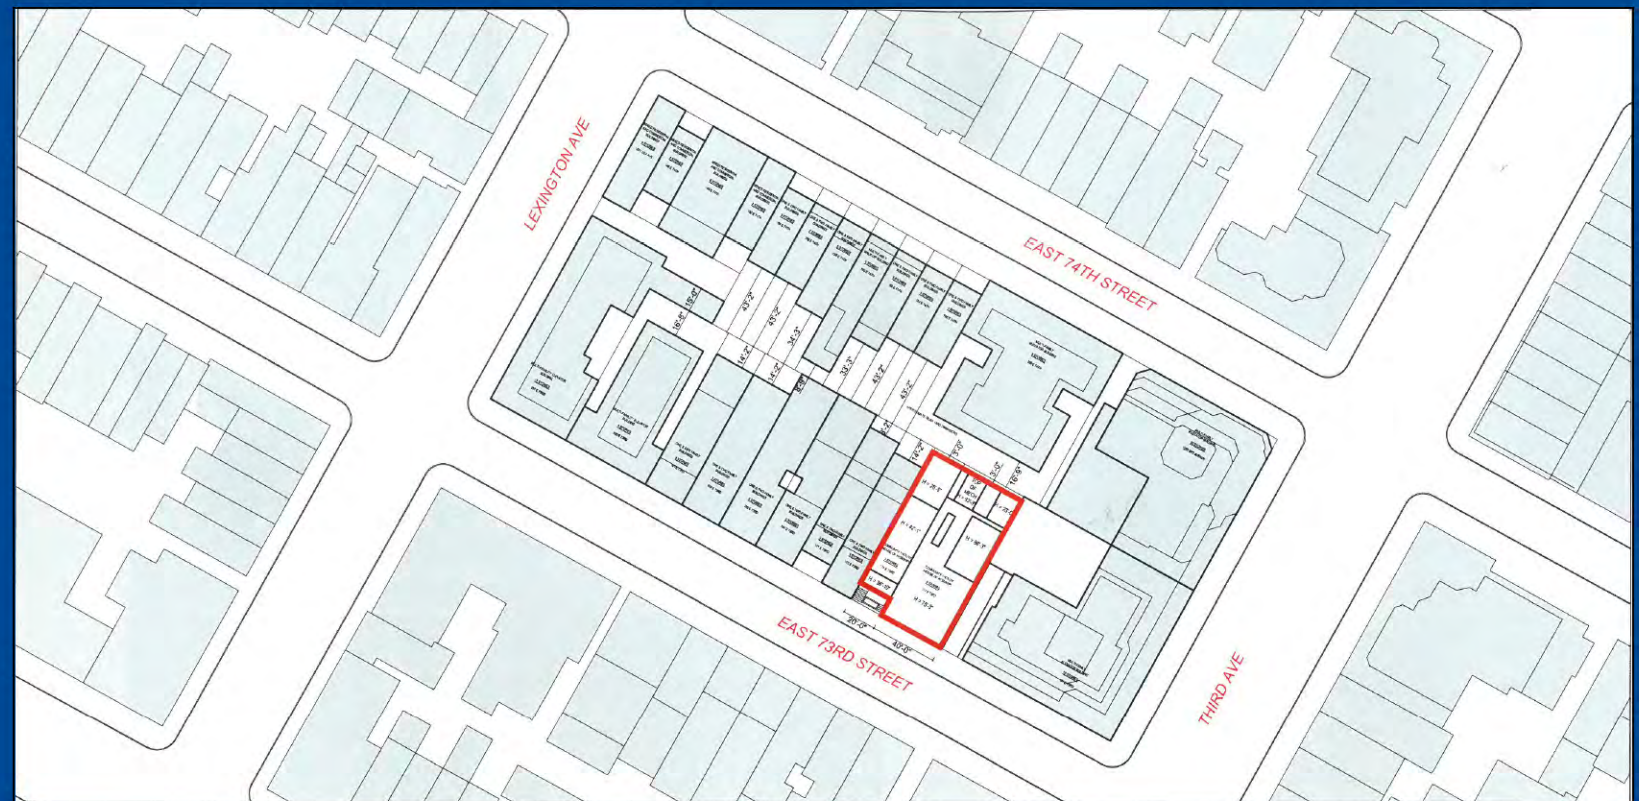
BLOCK PLAN DIAGRAM

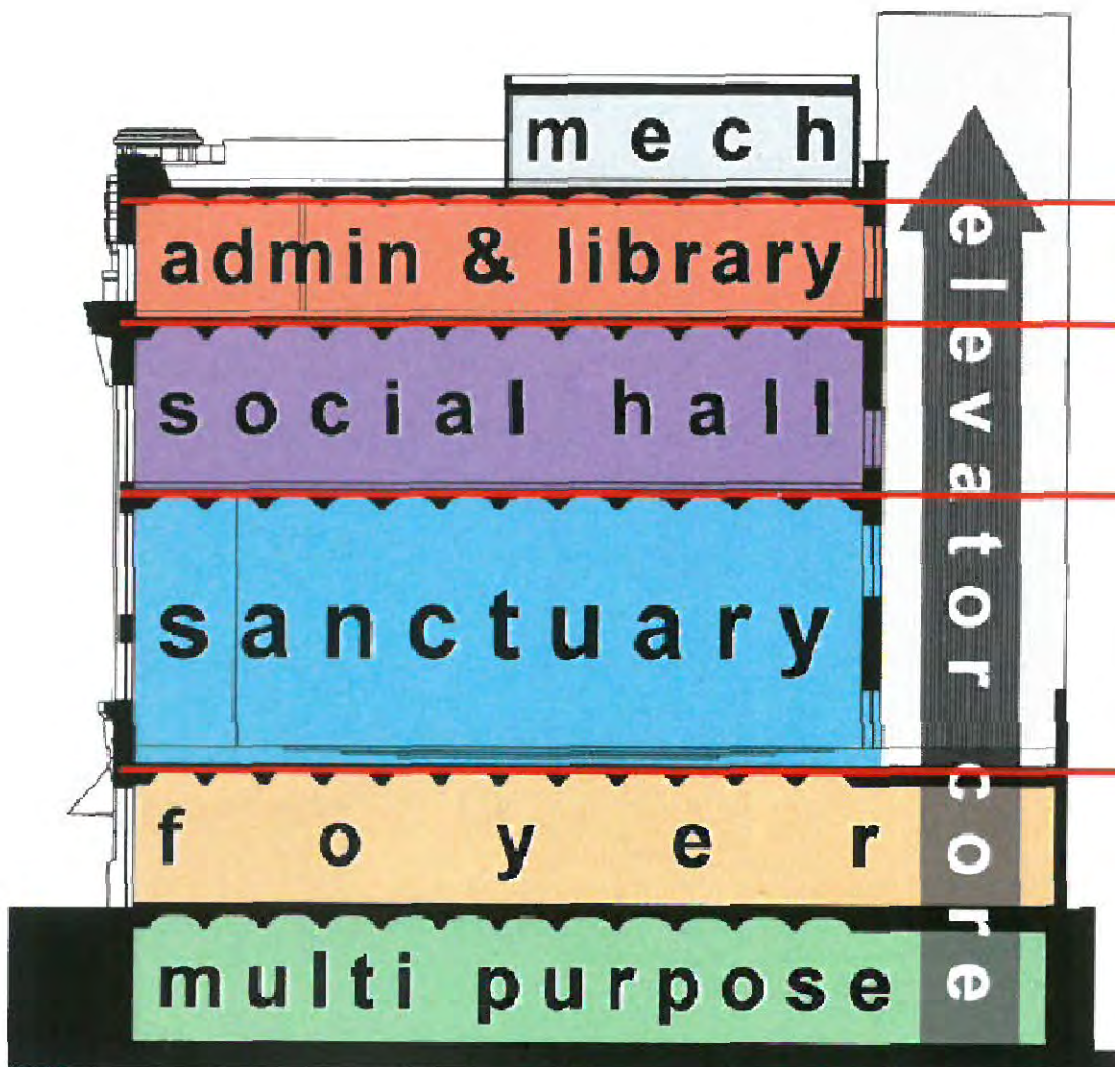
LPC APPROVED PROGRAM STACK

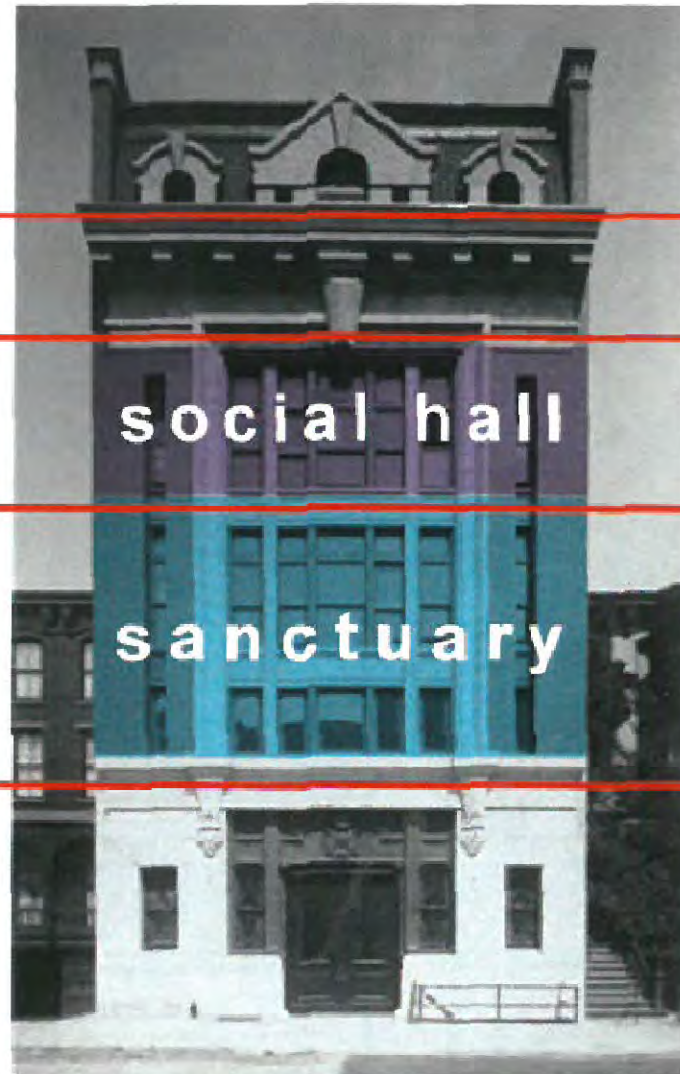
ALIGNMENT WITH SOUTH FACADE

The proposed program stack aligns the two main public programs - Sanctuary and Social Hall - with the grand window on the south facade.

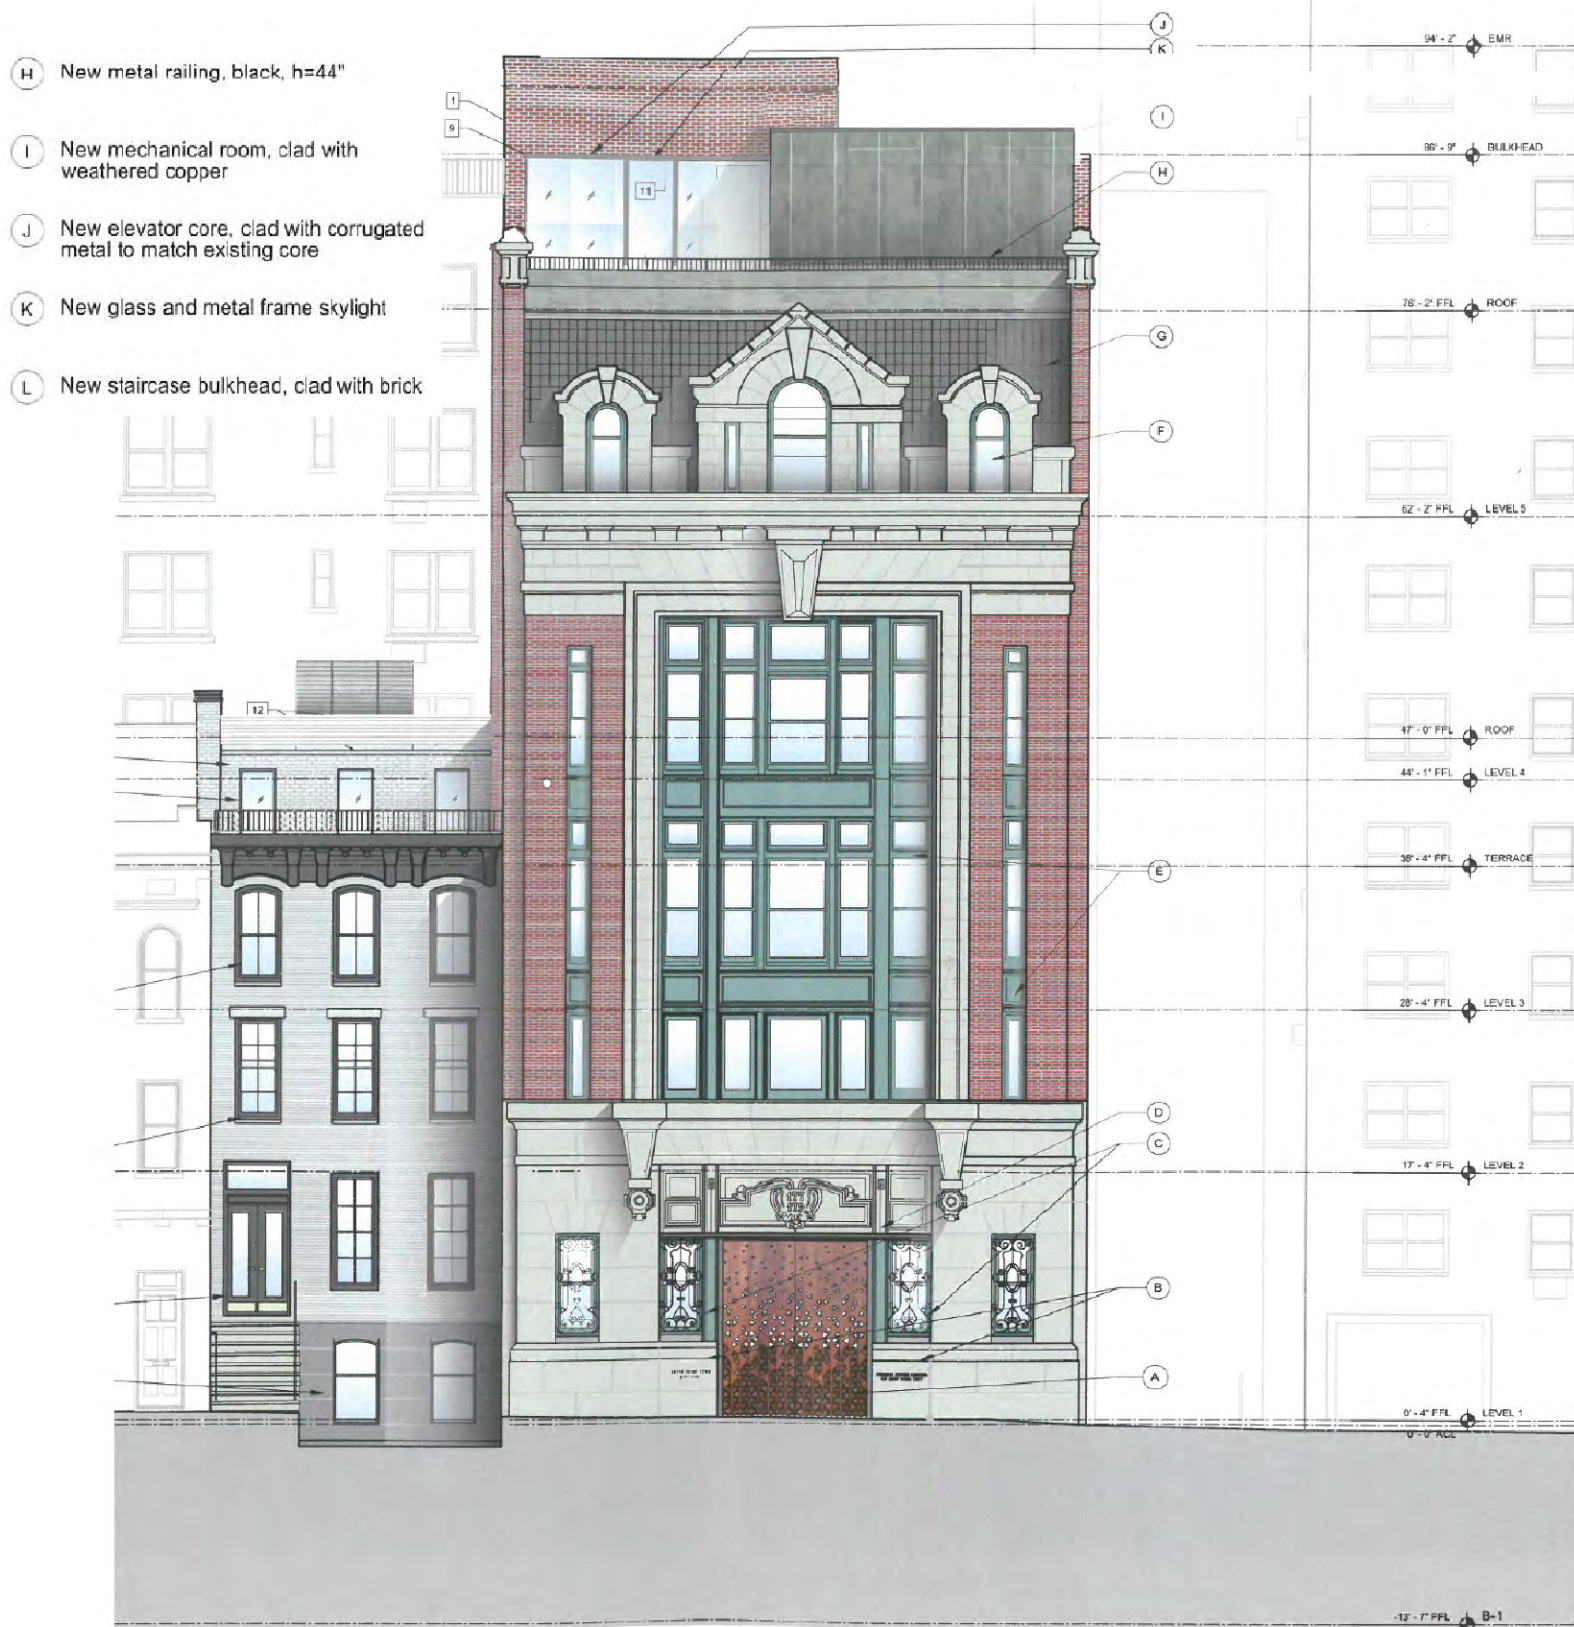
APPROVED

PROPOSED ELEVATION OF SOUTH FACADE

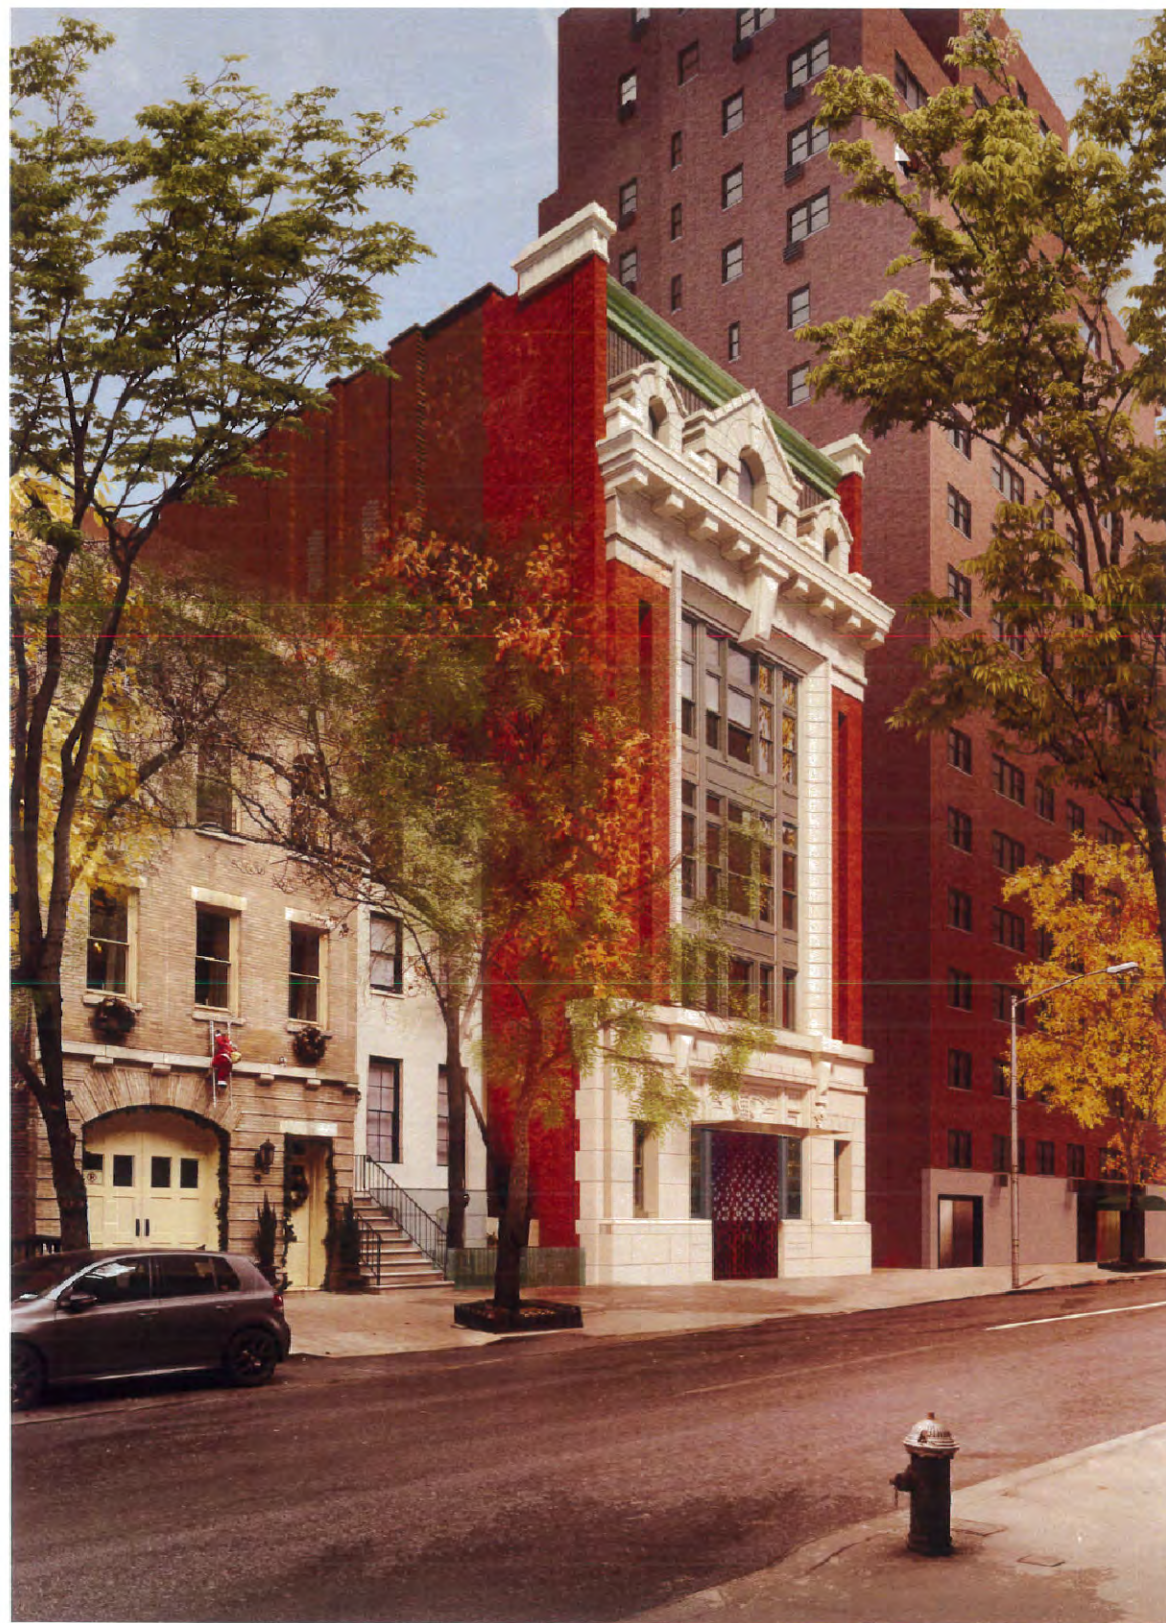
APPROVED

PROPOSED CONDITION OF WEST FACADE

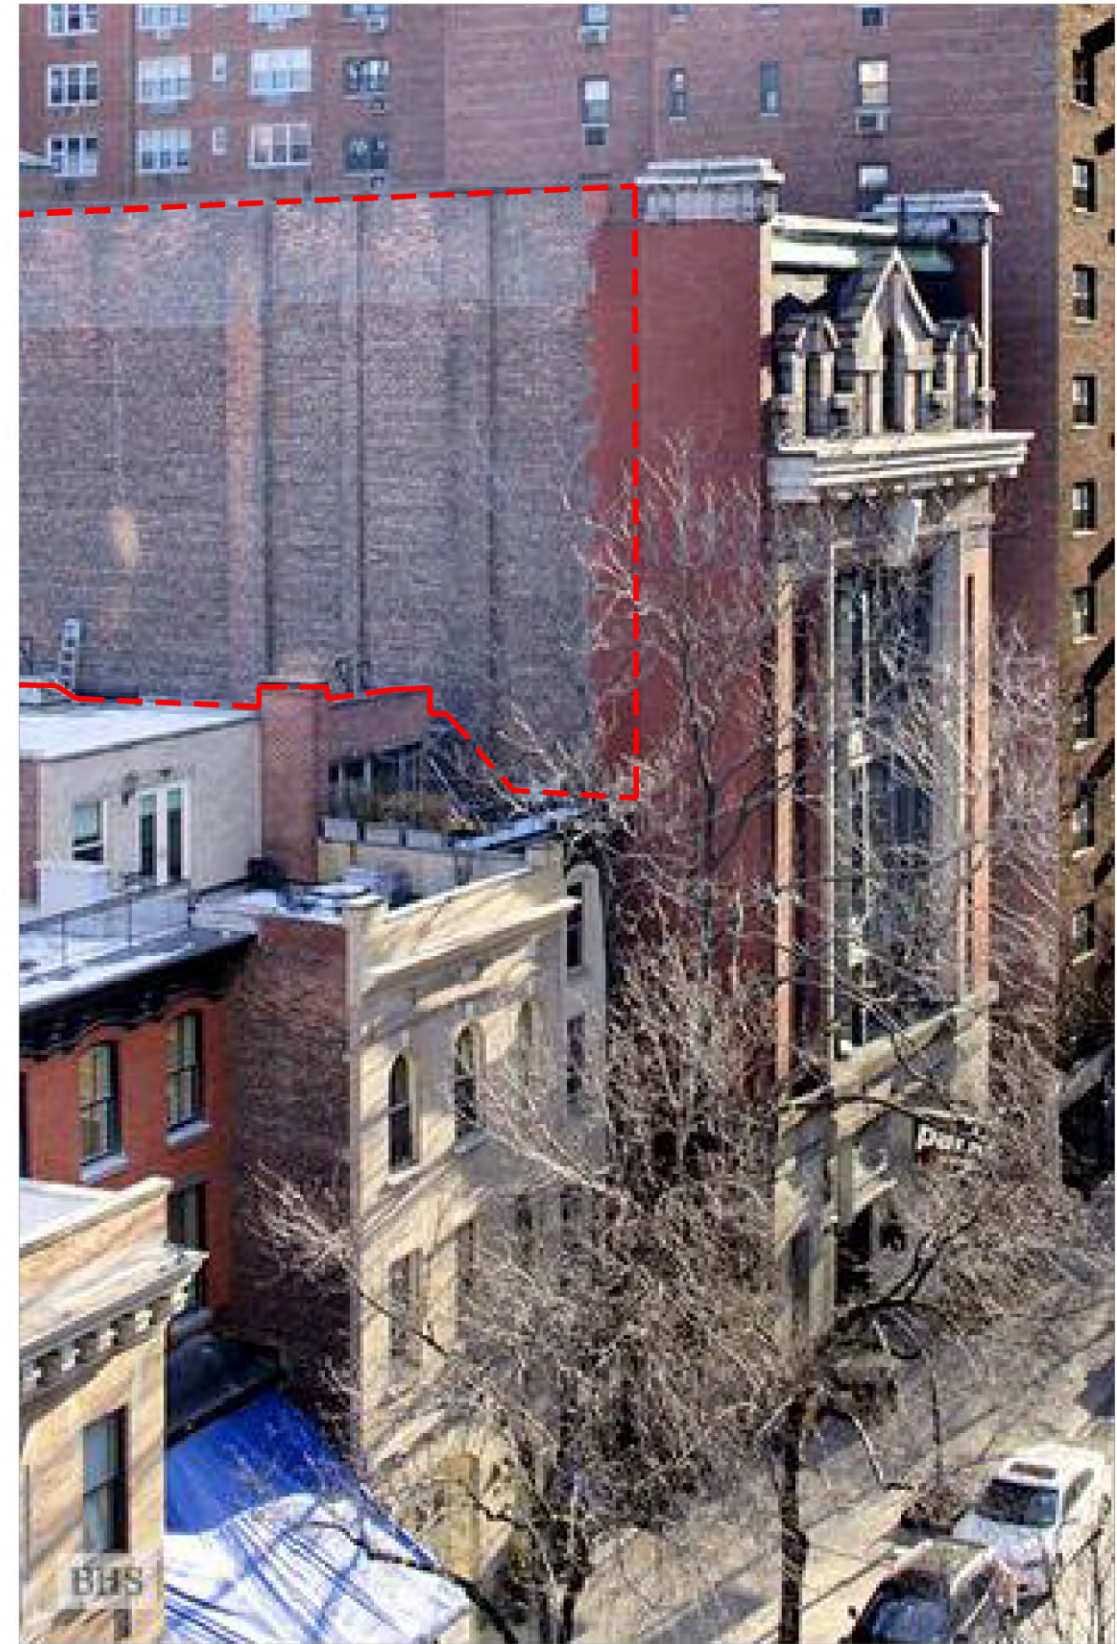
PROPOSED REMOVAL AND REPLACEMENT OF EXISTING BRICK FACADE

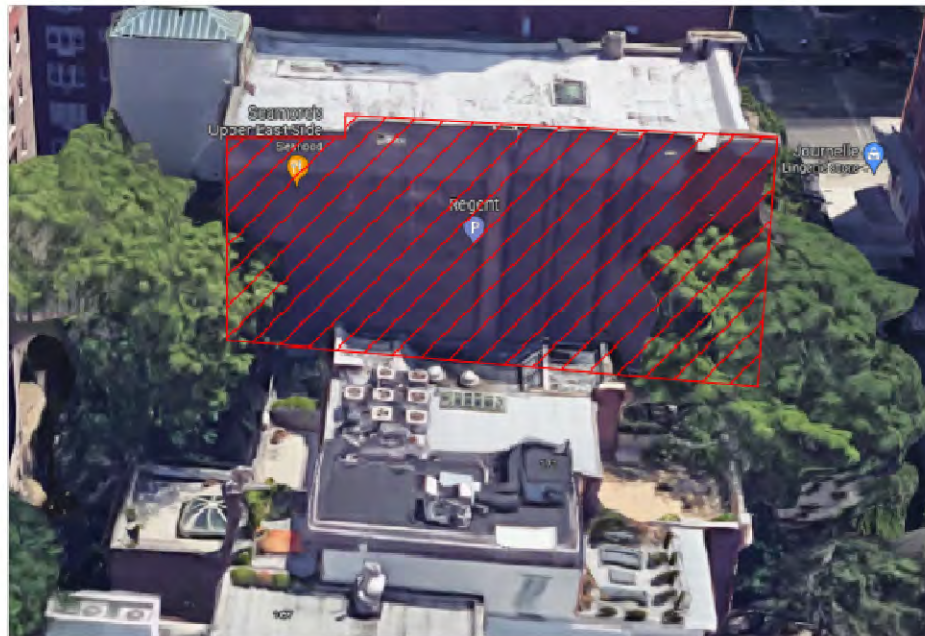
Area of Proposed Additional Demolition

Ancora concludes that due to the observed poor condition of the existing lot line masonry wall the preservation of the wall cannot be effectively accomplished as reflected in the current set of coordination drawings. Ancora presents the issues noted below for rational to propose full demolition of the entire height of the lot line masonry wall between 175 and 177 East 73rd Street.

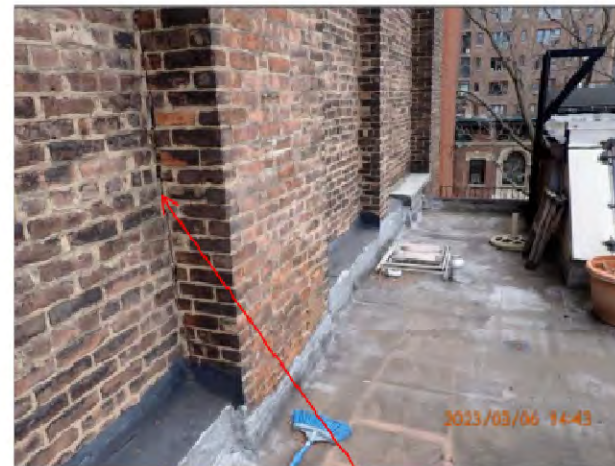
Noted Separation of chimney flue from masonry wall - Vertical Crack

The structural stability walkthrough revealed that internal structural construction and non-structural construction of 175 E 73rd St is in substandard conditions. The flooring throughout the building appears to be bulging from apparent water damage. Externally, the lot line party wall that joins 175 E 73rd St & 177 E 73rd St is showing signs of stress cracking vertically from the roof of 175 East 73rd Street vertically up the full height of the wall to the roof line of 177 East 73rd Street. The existing chimney flue along the same lot line has been observed to be separating from the wall and cracking has started to appear at the main joint connecting the flue back to the masonry wall.

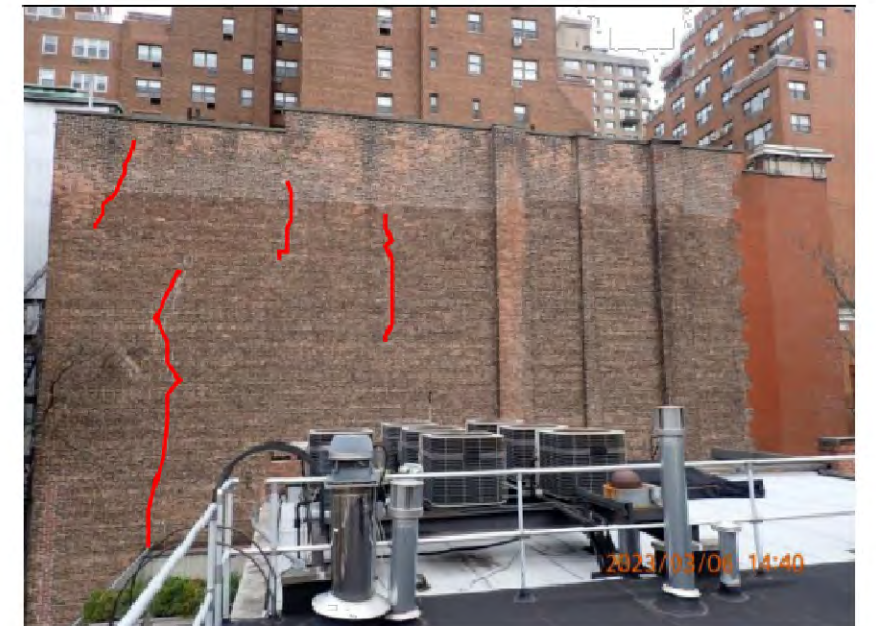
Typical Vertical Cracks in Existing Masonry Wall

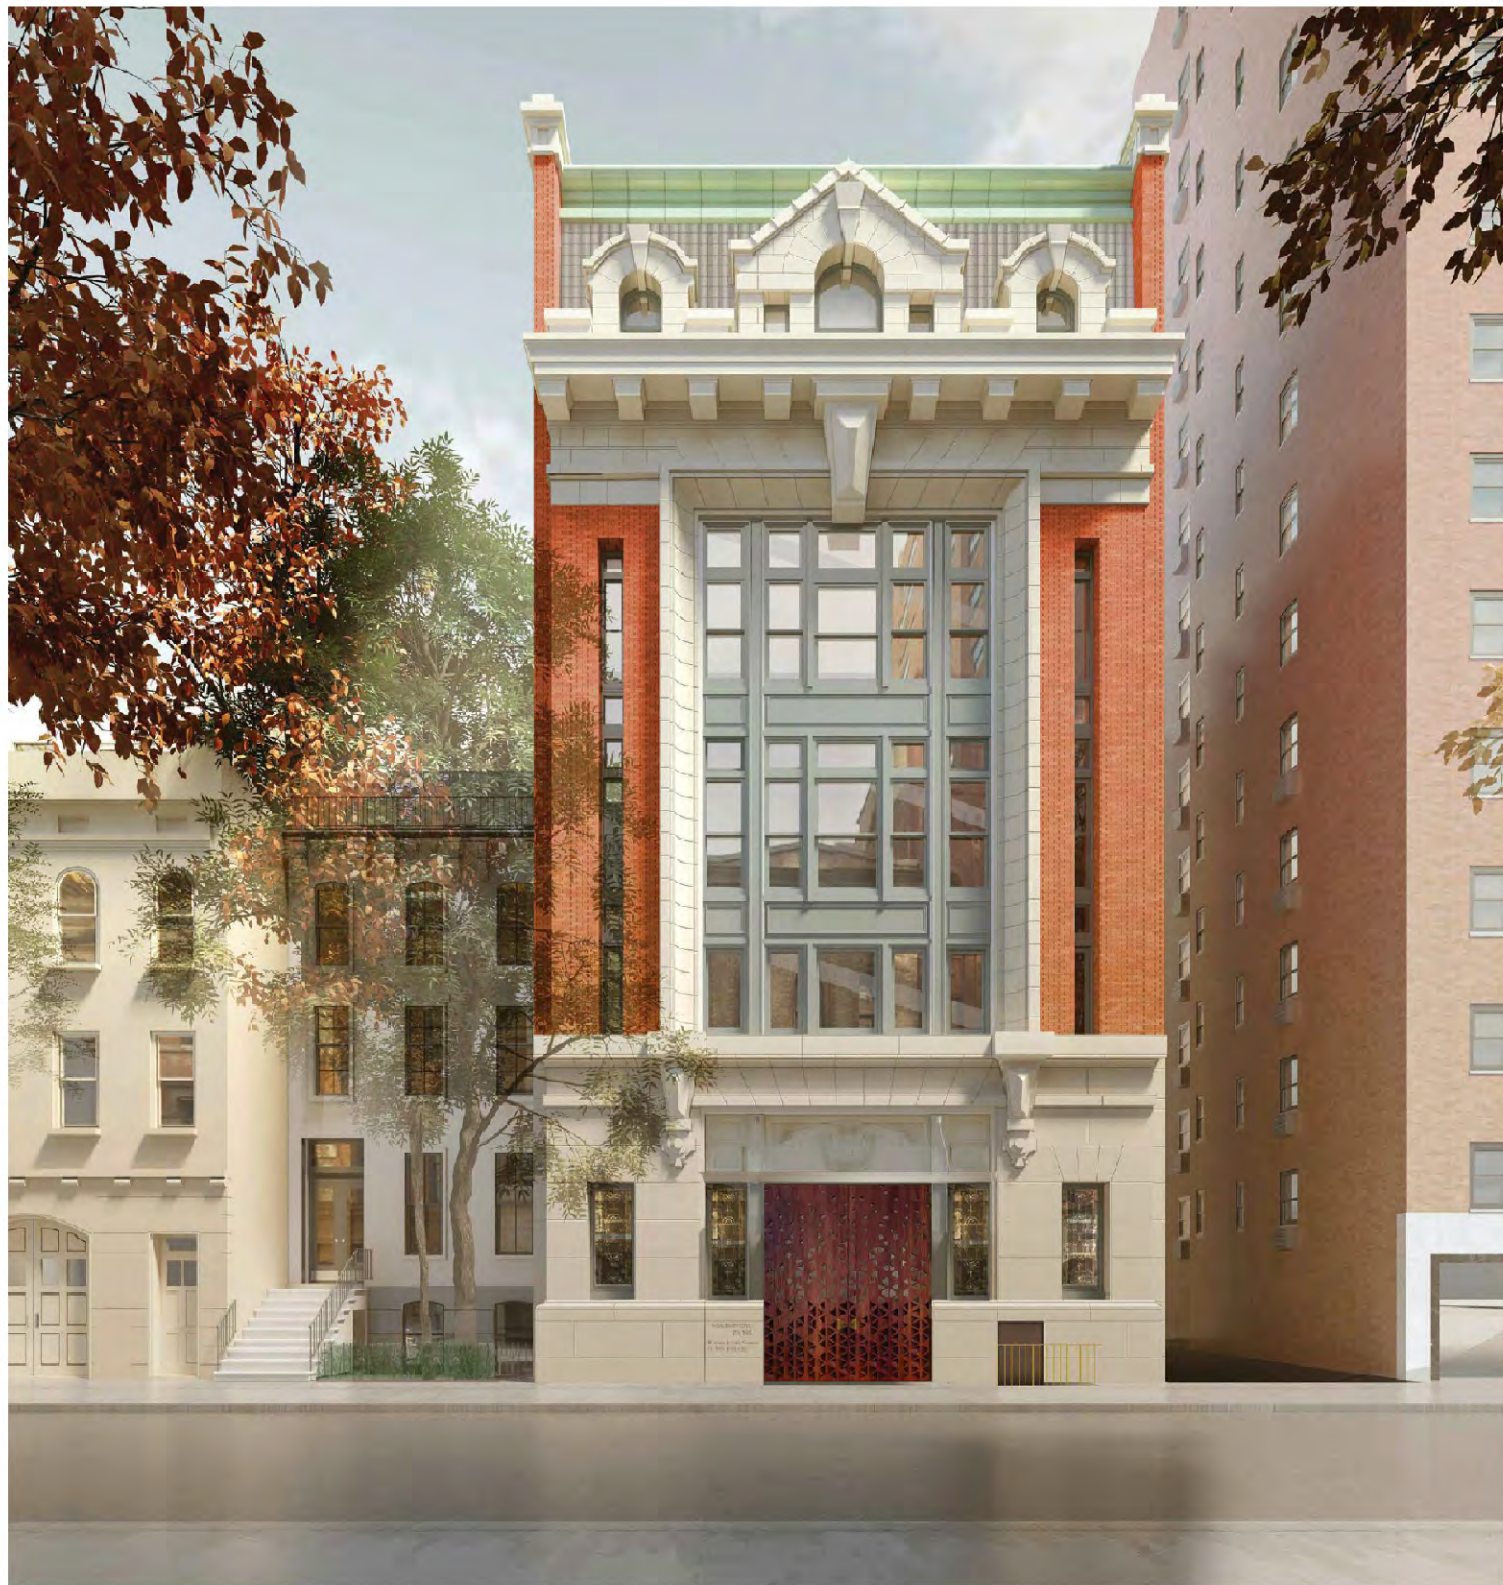
RENDERING OF SOUTH FACADE

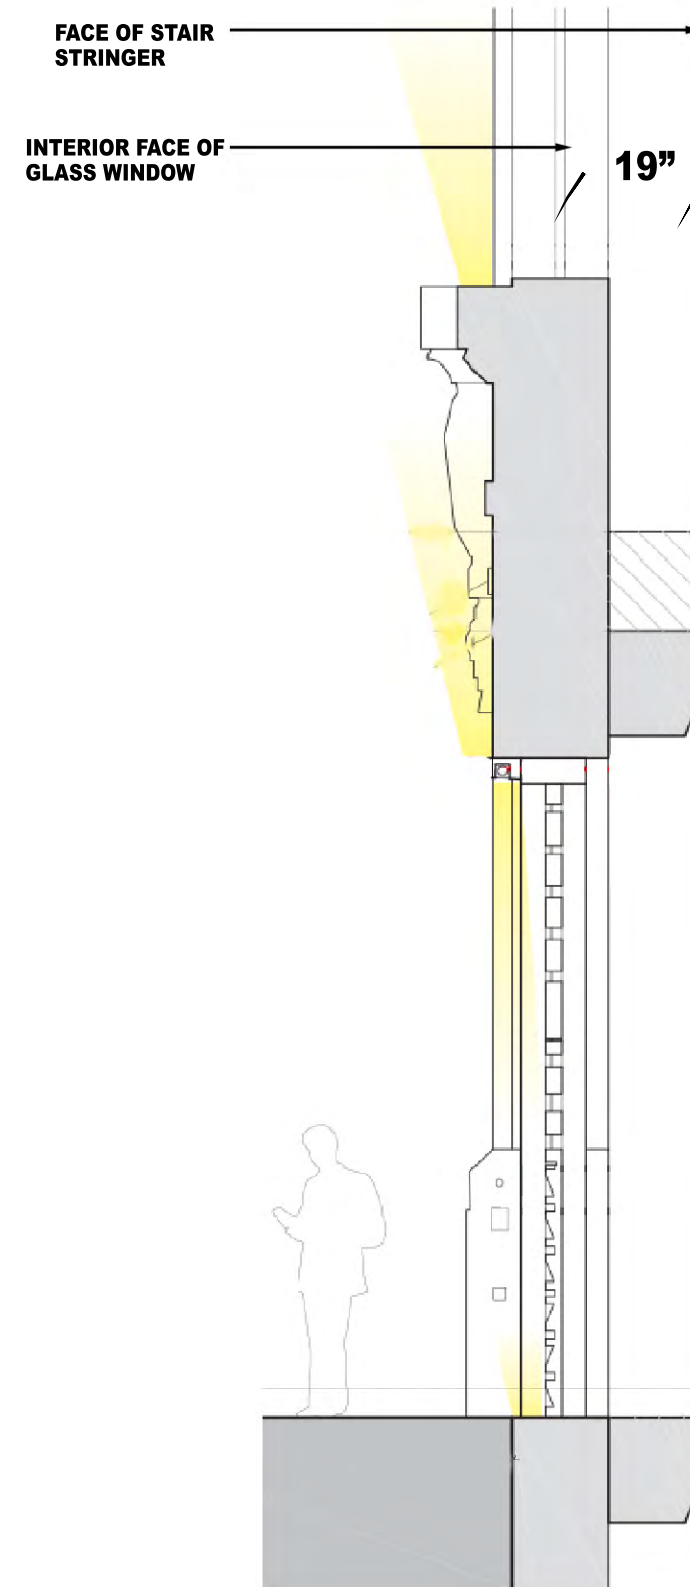
IMAGES OF EXISTING FACADE DETAILS

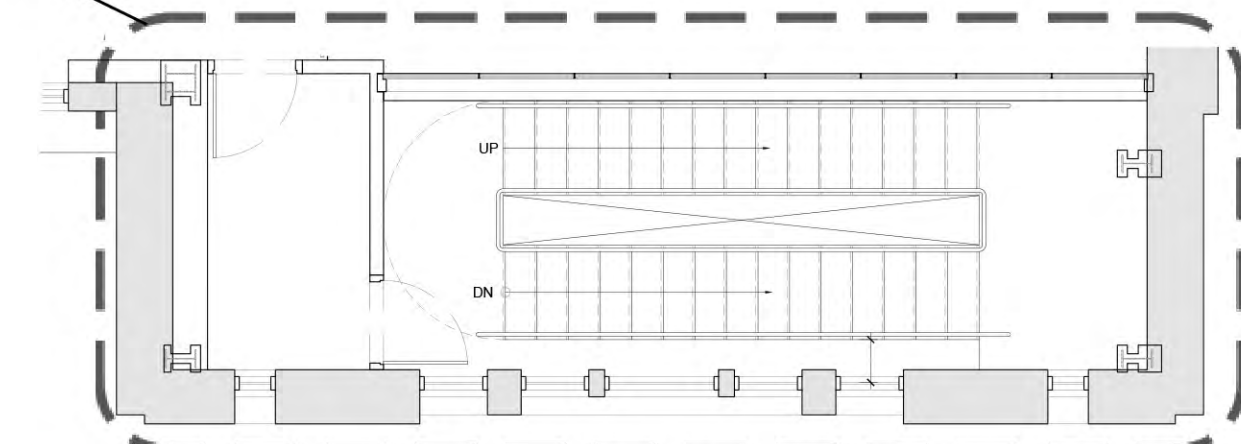
19'

- New Concrete Wall
- New Liner Wall
