Preservation Department – Item 8, LPC-23-08973

611 West 112th Street – Morningside Heights Historic District
Borough of Manhattan

SUBMISSION TO THE LANDMARKS PRESERVATION COMMISSION

BEYER
BLINDER
BELLE

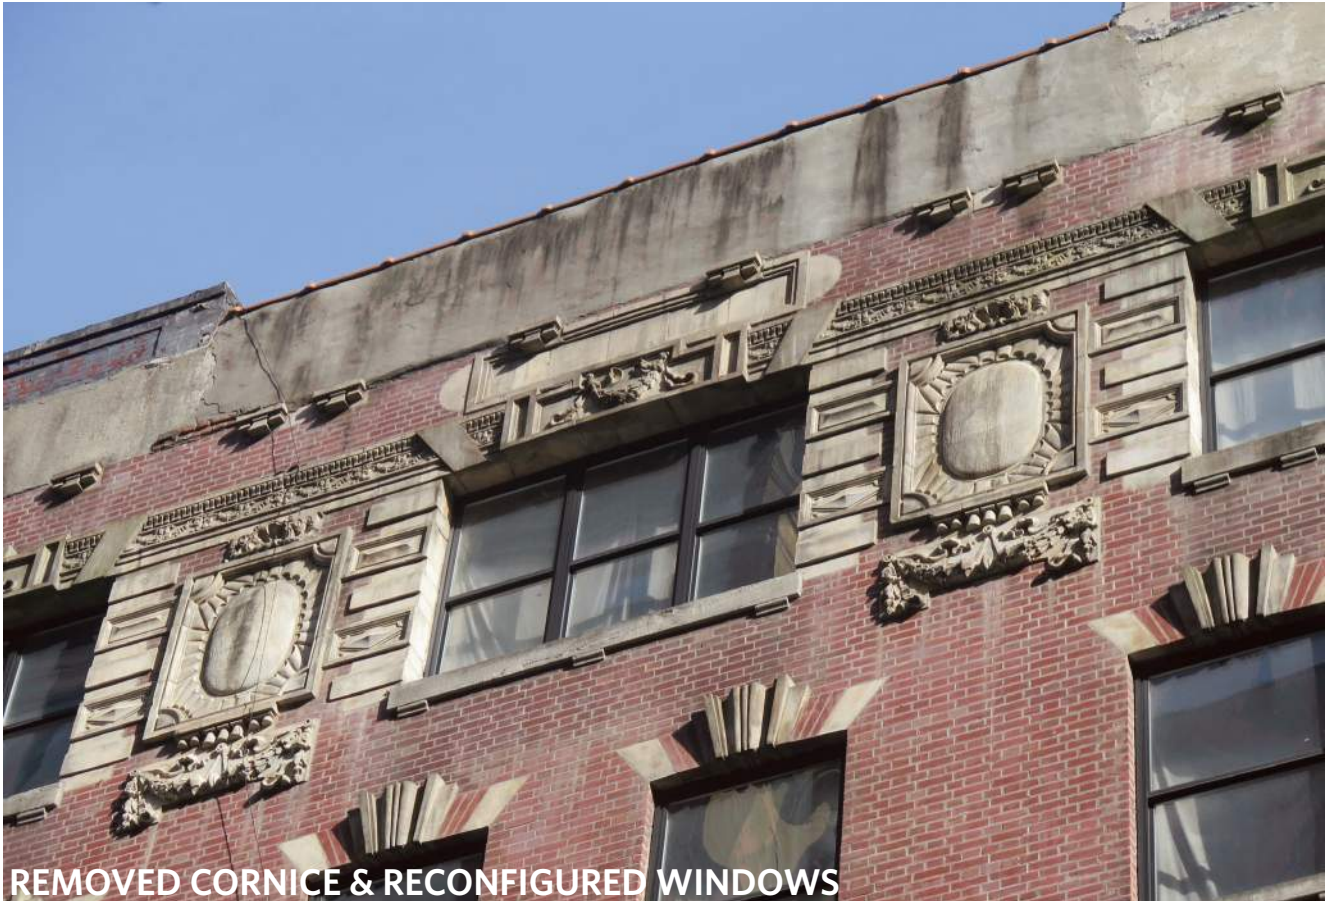
REMOVED CORNICE & RECONFIGURED WINDOWS

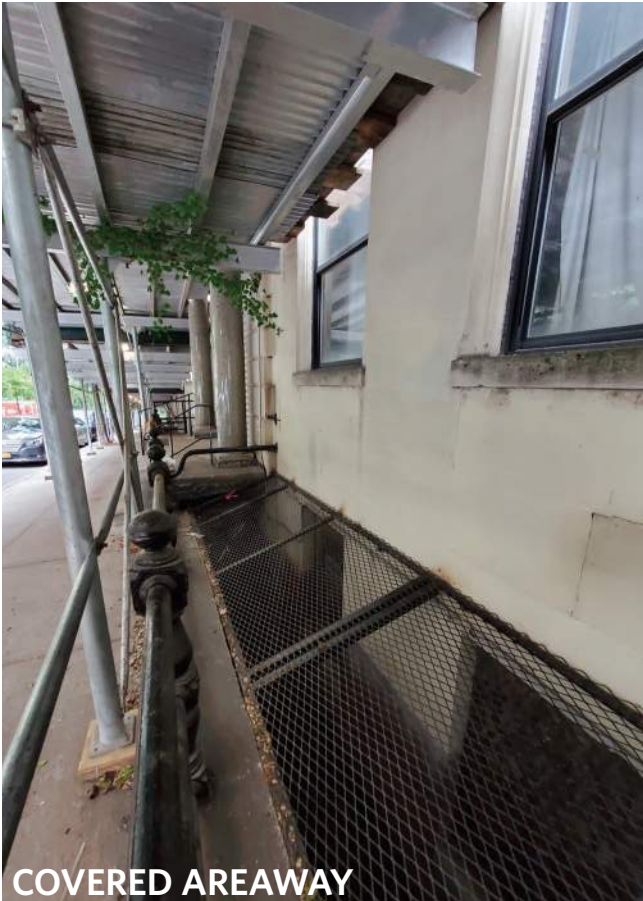
COVERED AREAWAY

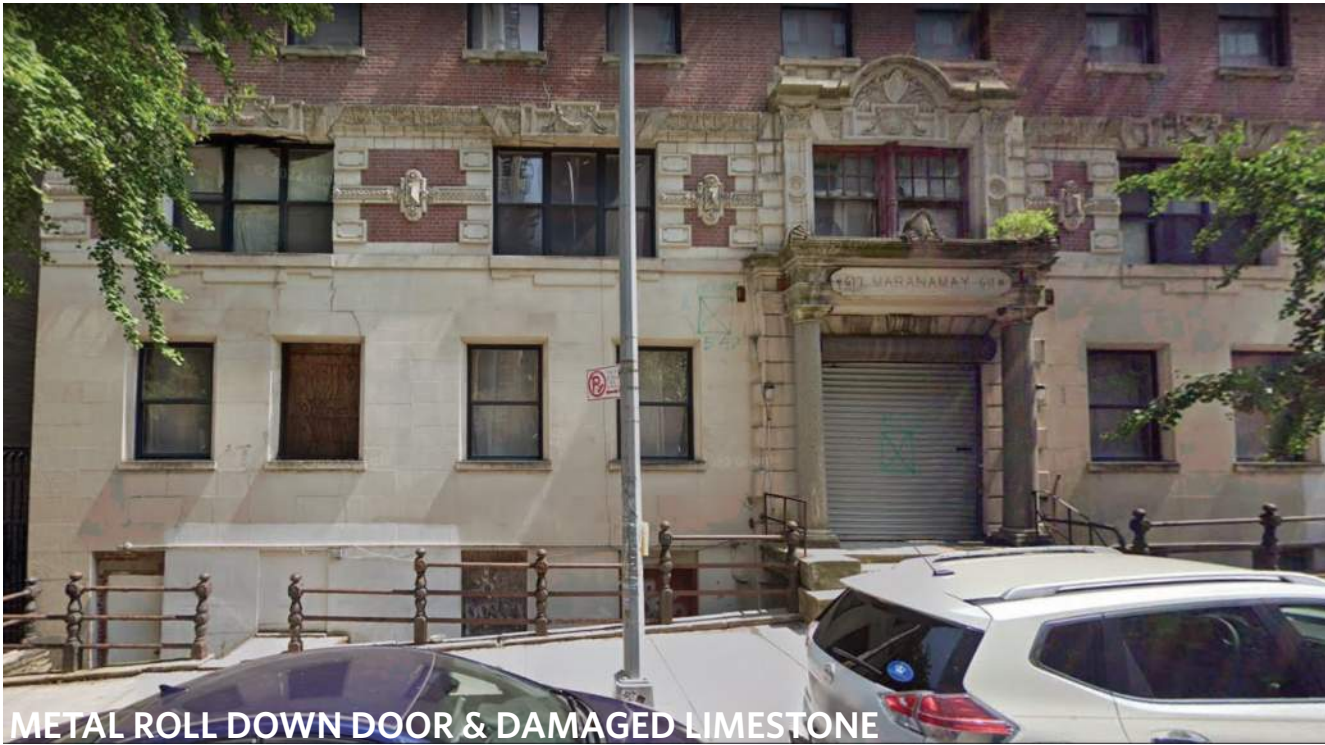
METAL ROLL DOWN DOOR & DAMAGED LIMESTONE

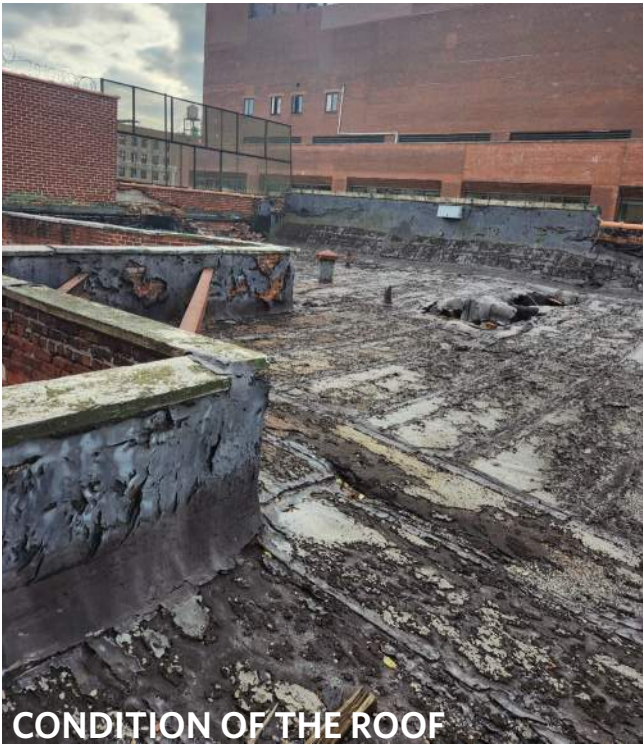
CONDITION OF THE ROOF

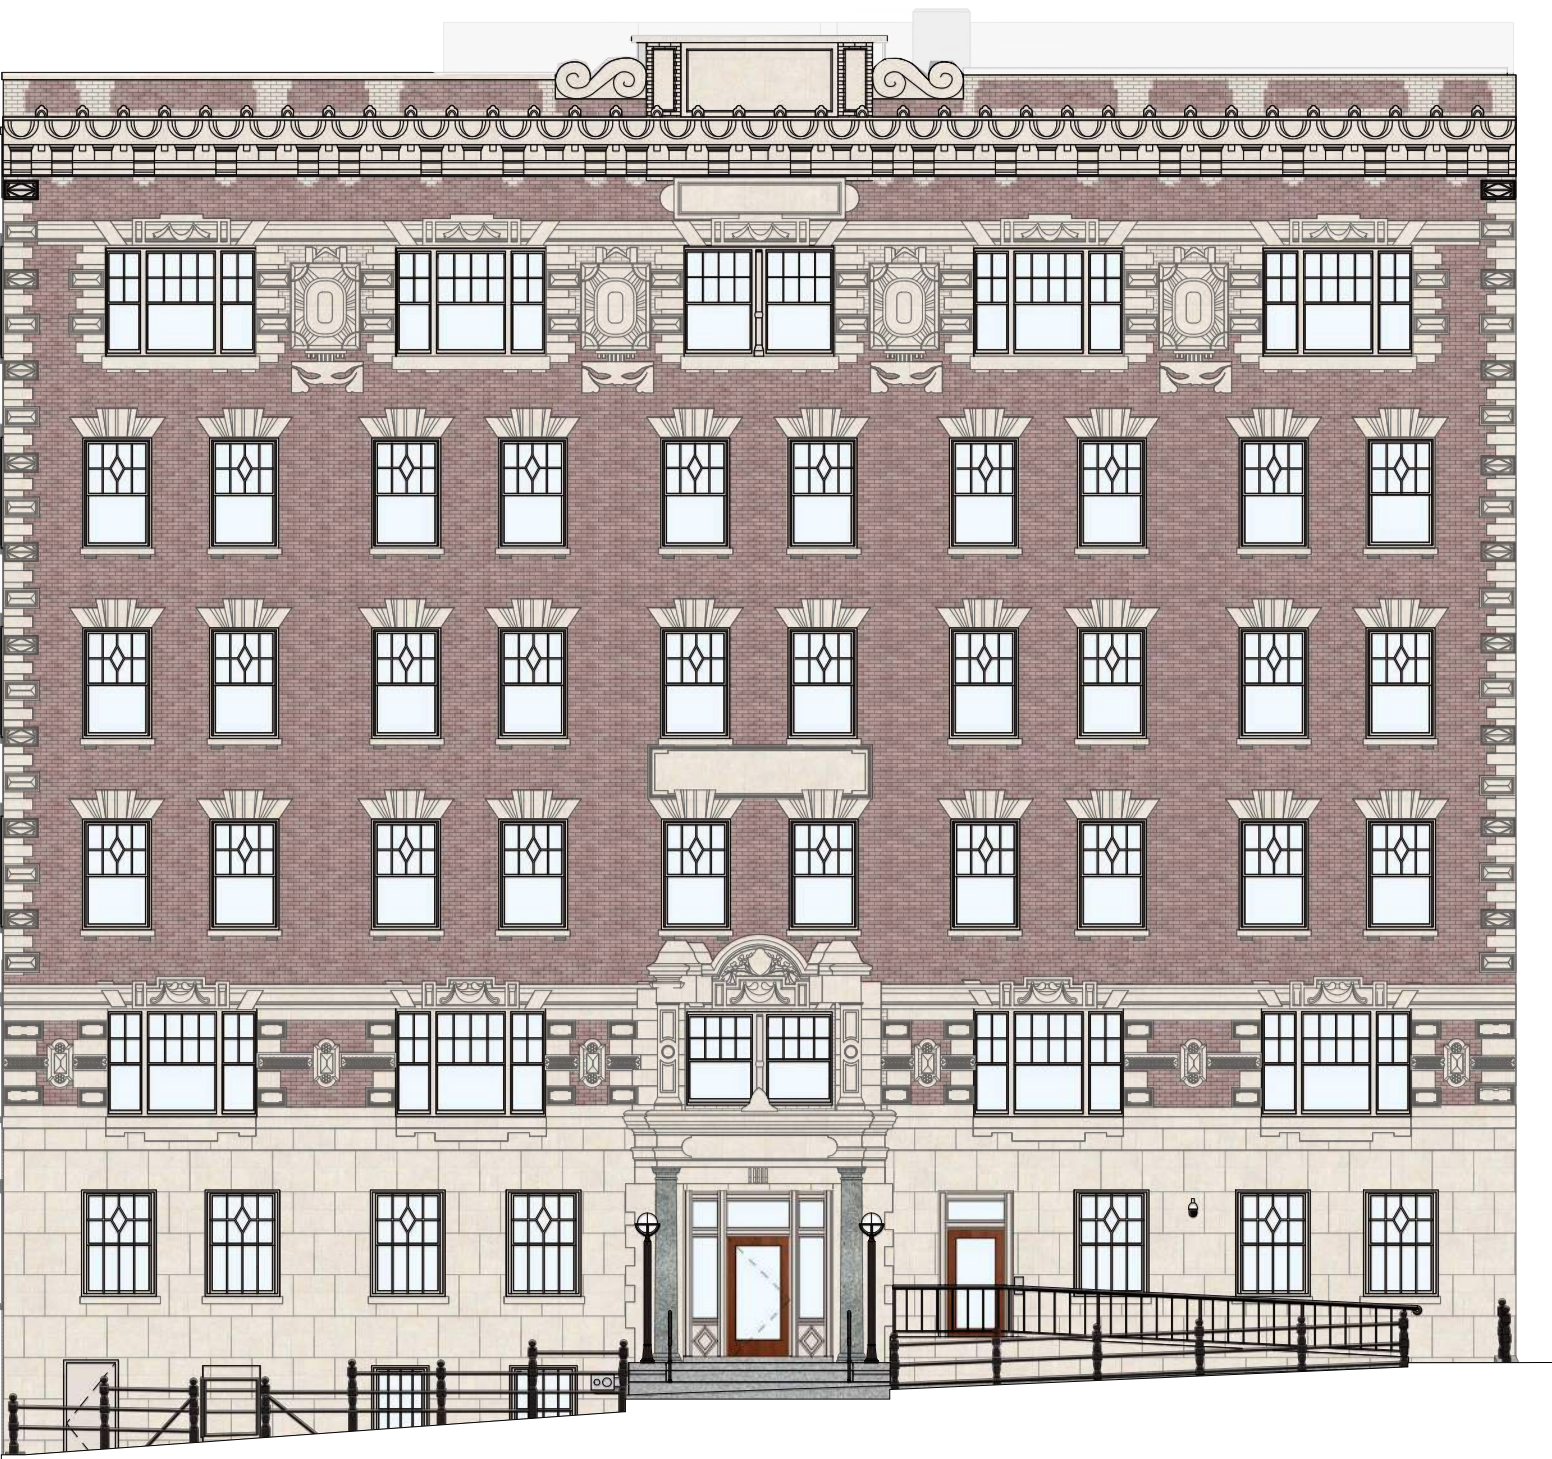
SOUTH ELEVATION PROPOSED OVERALL SCOPE:

- WINDOW REPLACEMENT
- CORNICE RE-CREATION
- MASONRY REPAIR
- ENTRANCE REPLACEMENT
- BARRIER FREE SLOPED WALKWAY

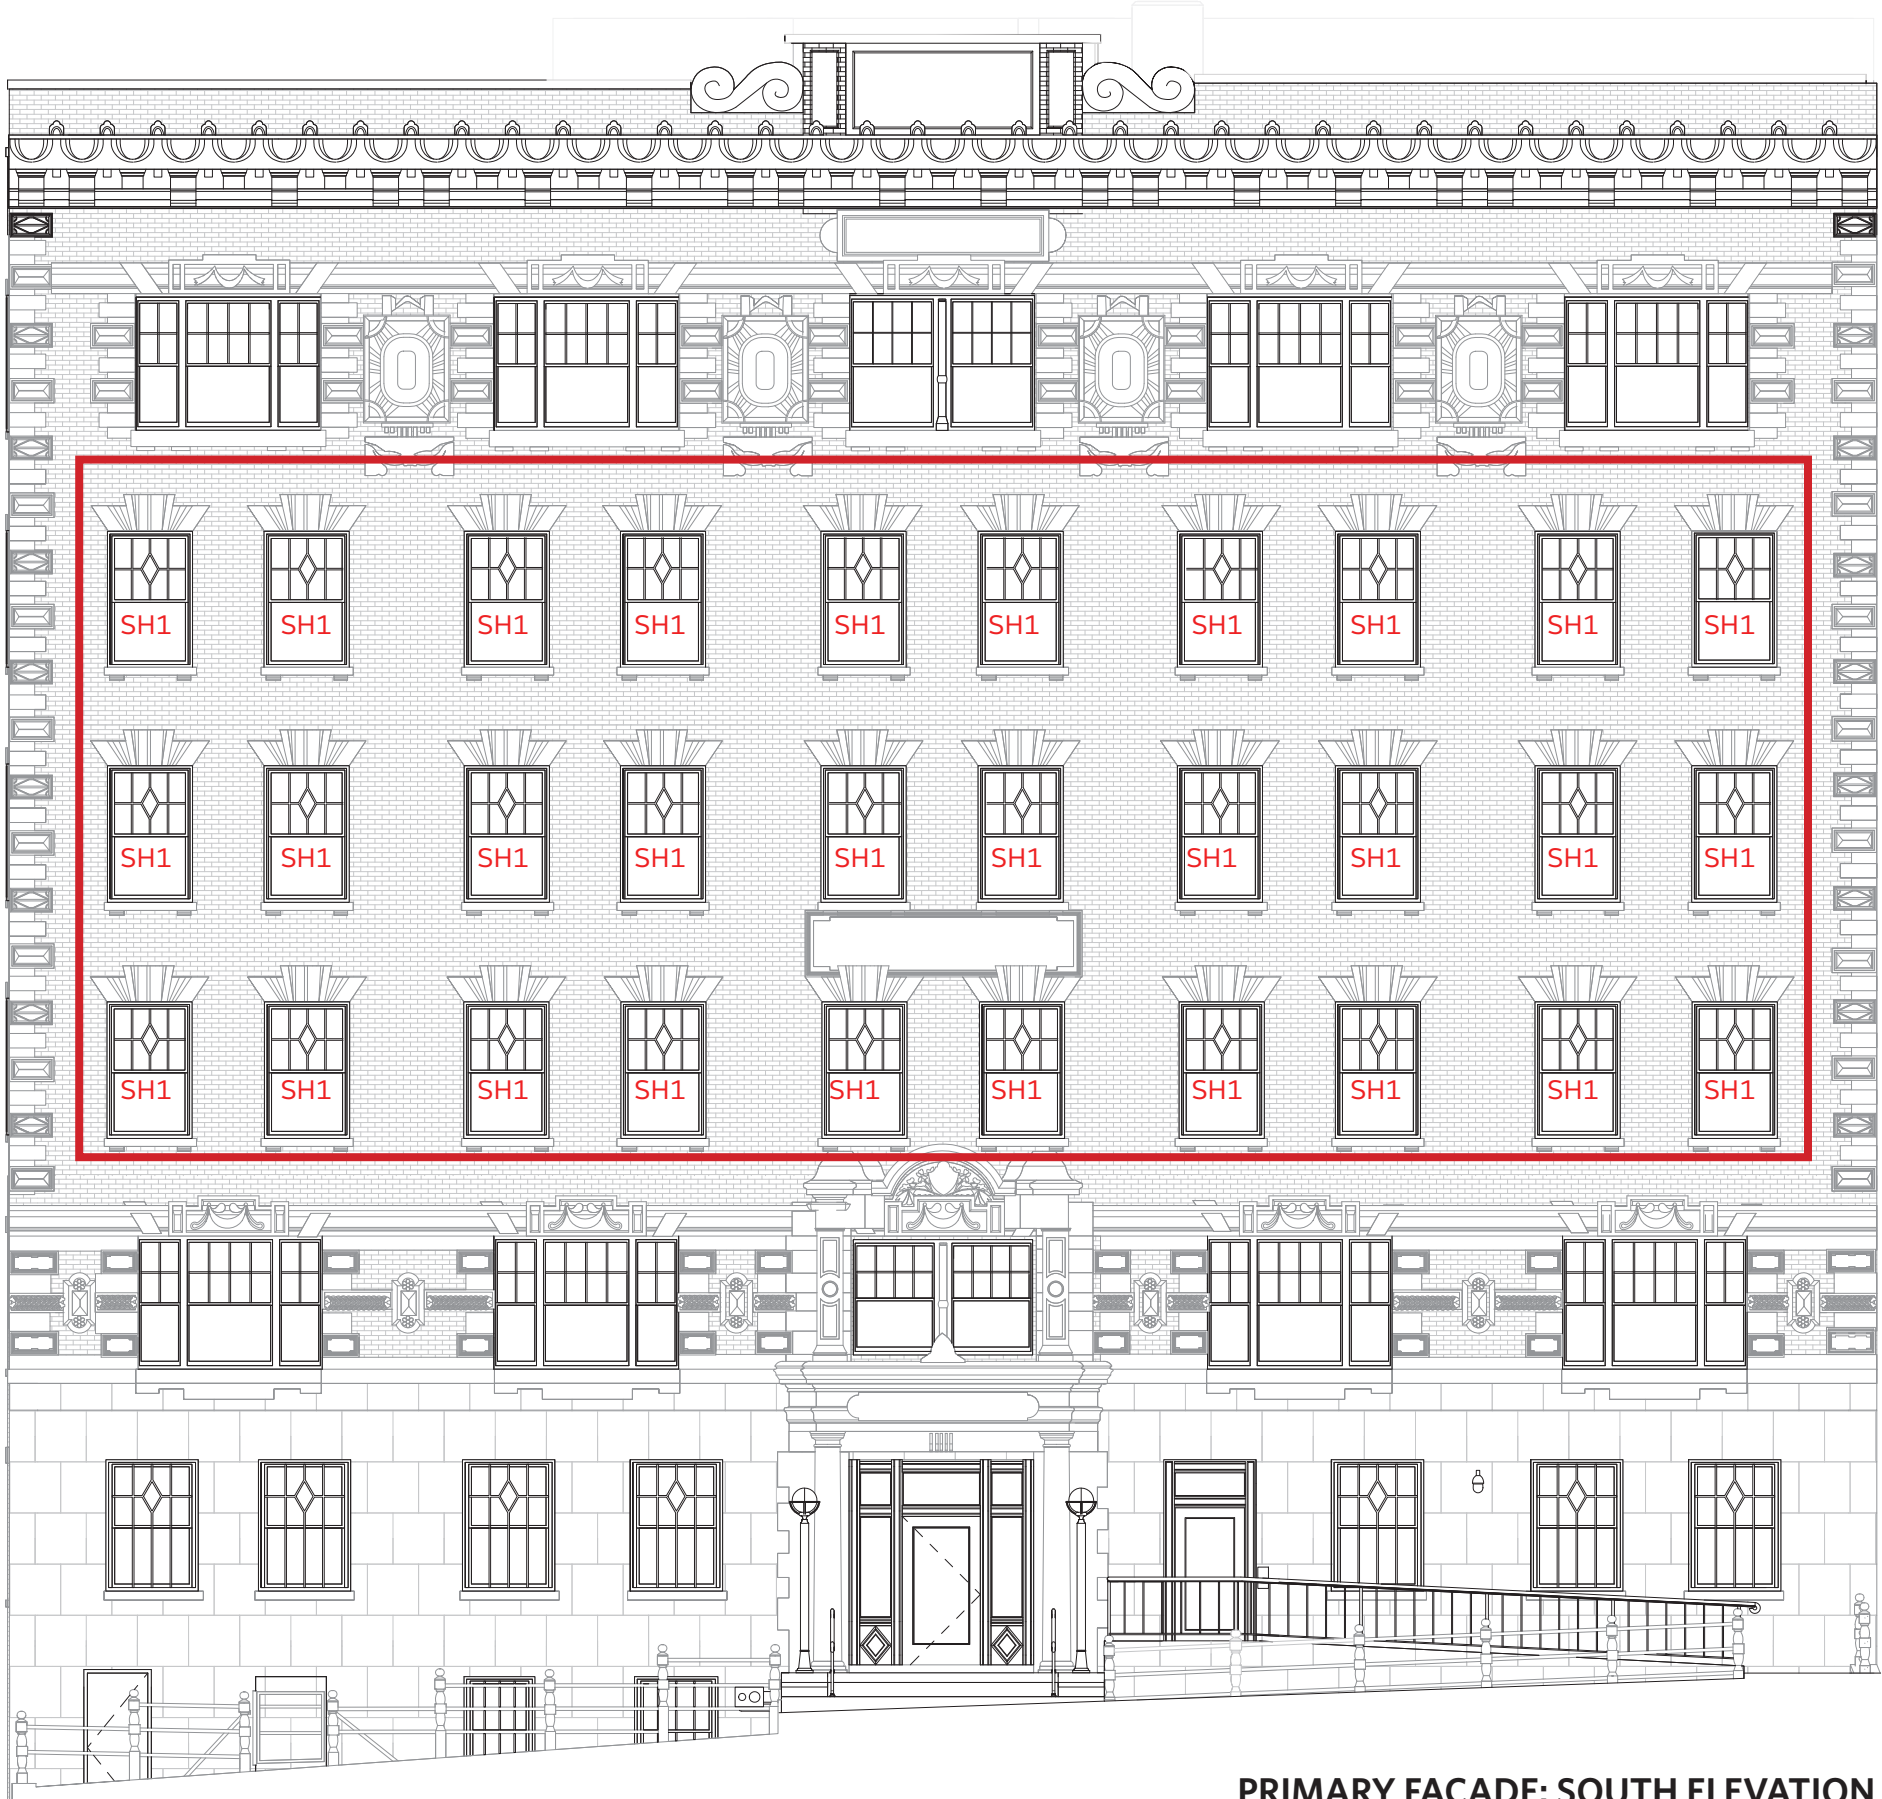
PRIMARY FACADE: SOUTH ELEVATION

- SINGLE HUNG
- ALUMINUM CLAD WOOD
- HISTORIC DIAMOND MUNTIN PATTERN USING PAINTED ALUMINUM SIMULATED DIVIDED LITE W/ SPACER BAR

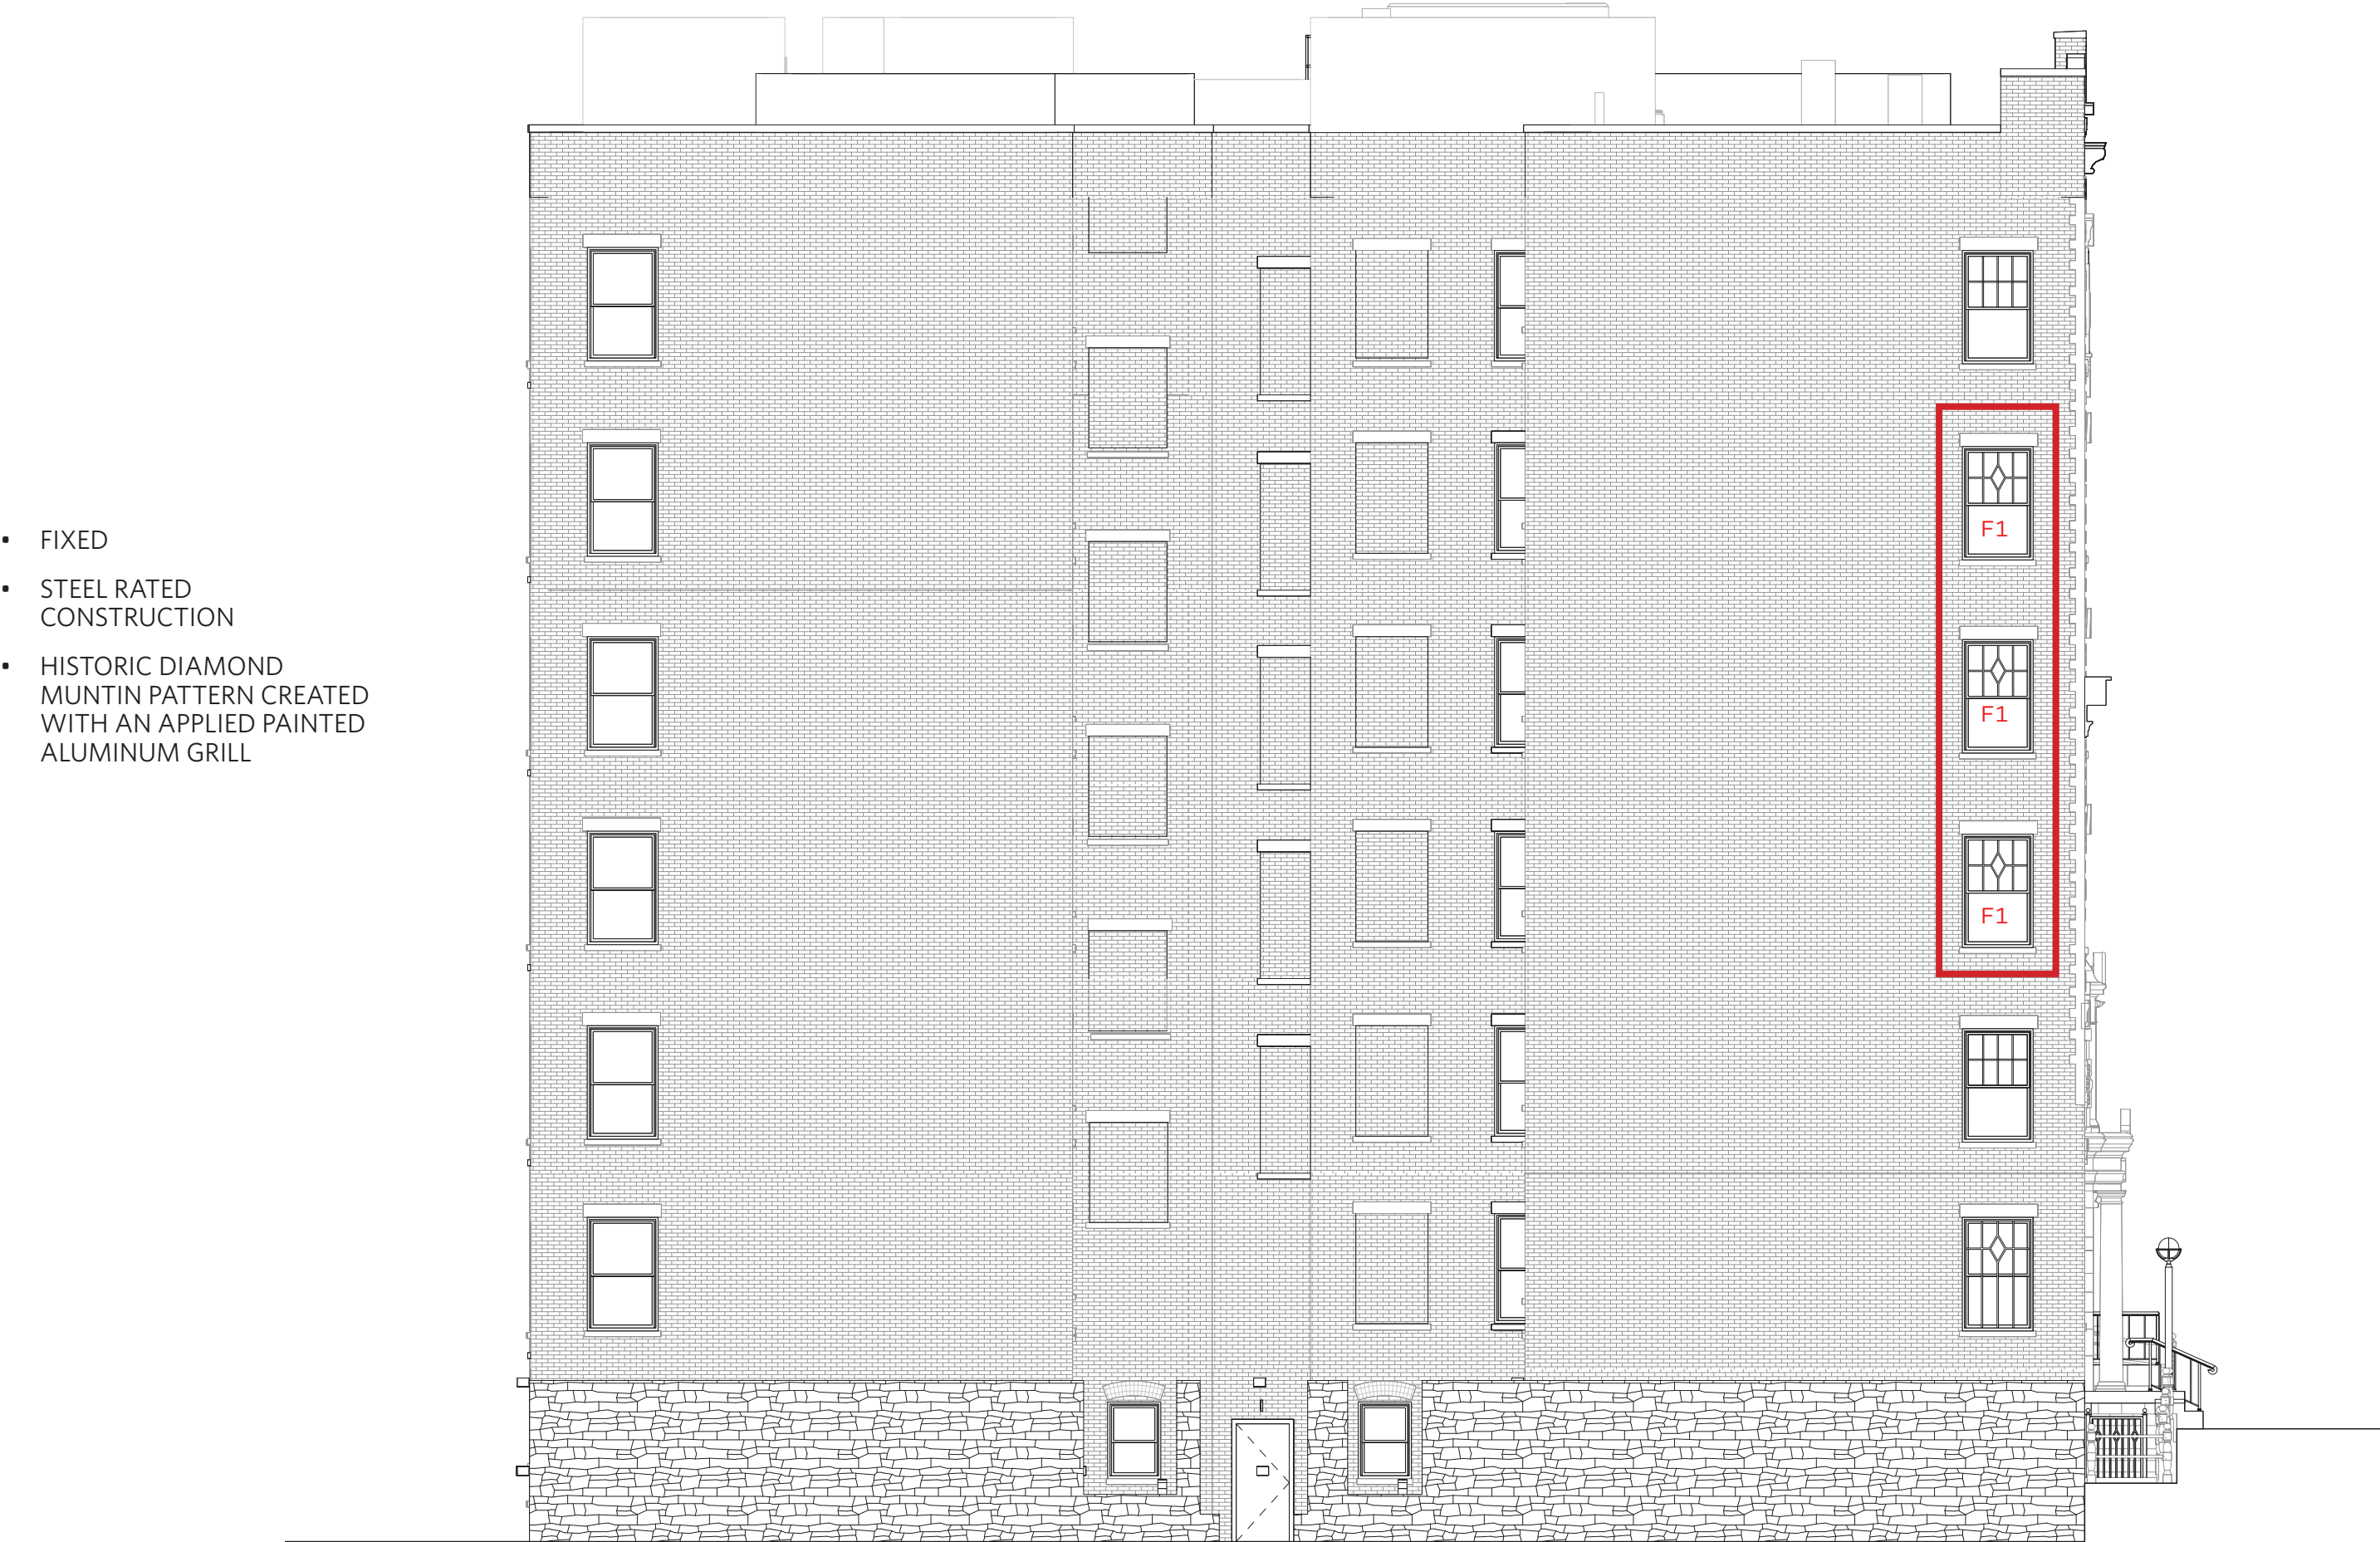
- FIXED
- STEEL RATED CONSTRUCTION
- HISTORIC DIAMOND MUNTIN PATTERN CREATED WITH AN APPLIED PAINTED ALUMINUM GRILL

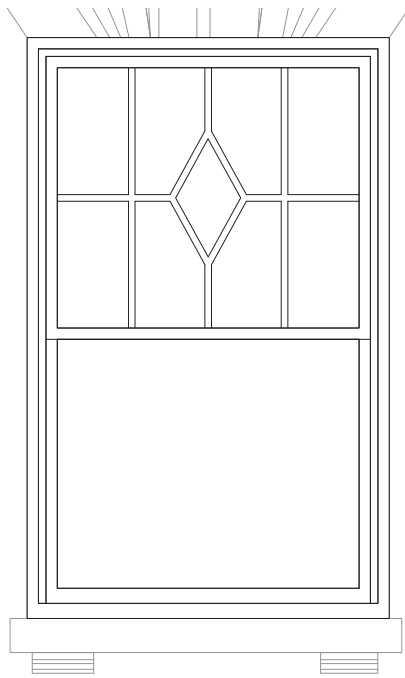
PROPOSED

SH1: Aluminum Clad Wood Single Hung Unit with Painted Aluminum Simulated Divide Lite with Spacer Bar

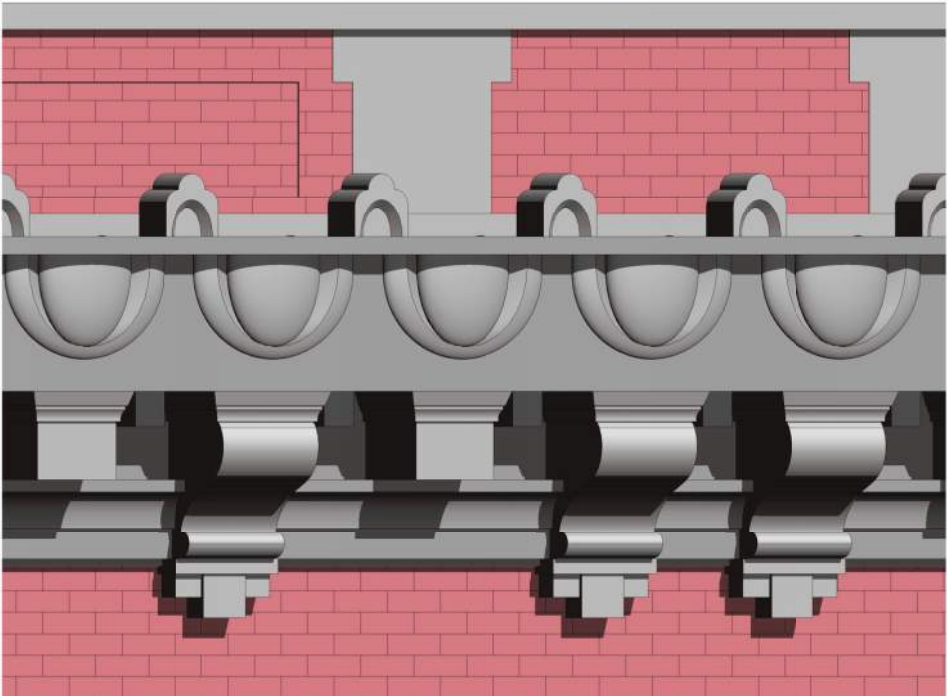
Proposed 3D View

GFRC DECORATIVE
SCROLLS
REBUILT TO MATCH
HISTORIC

GFRC RAISED
CENTRAL PARAPET
REBUILT TO MATCH
HISTORIC

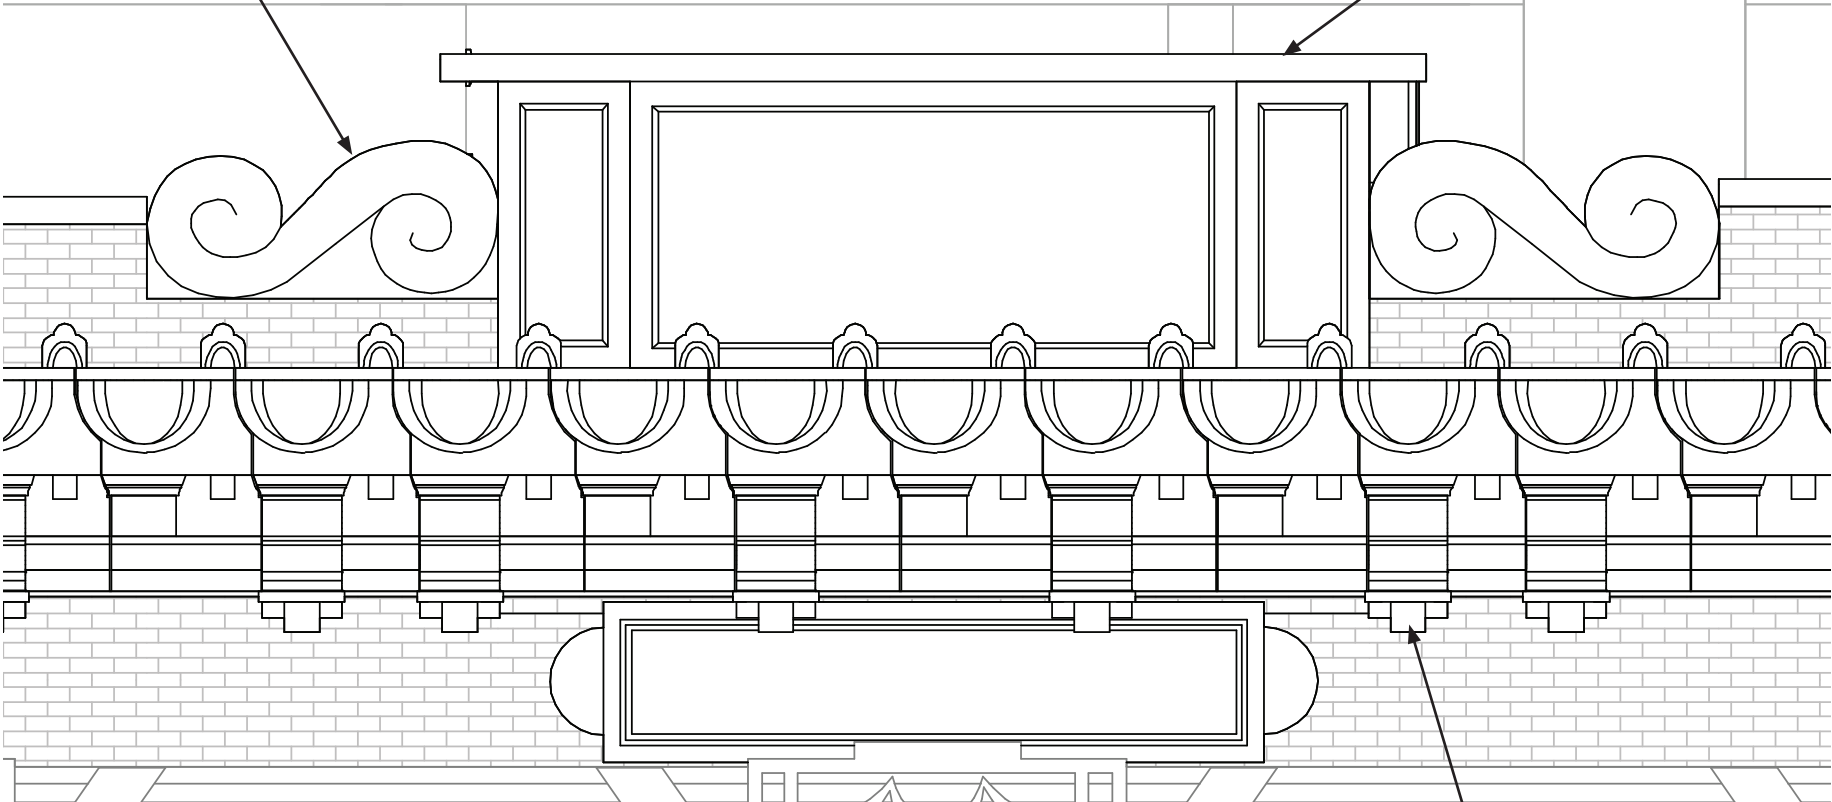
Proposed Central Parapet Elevation

GFRC PAIRED
GUTTAE TO MATCH
HISTORIC
