# 10 East 76th Street – Upper East Side Historic District Borough of Manhattan

Presentation to the Landmarks Preservation Commission

## 10 East 76th Street Upper East Side Historic District

25 July 2023

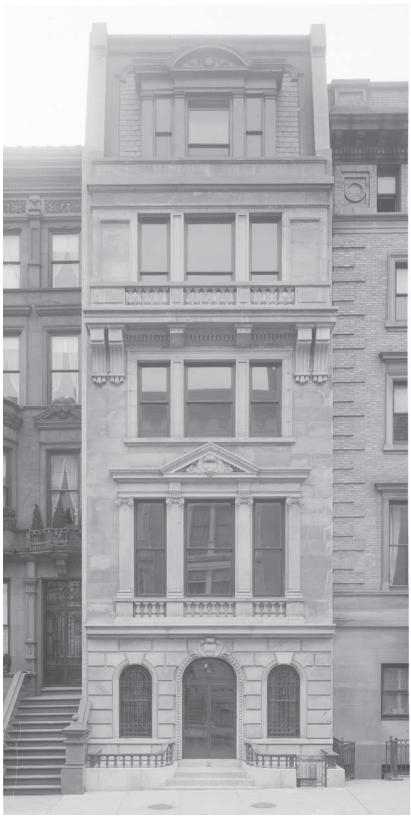
10 East 76th Street, ca. 1910 (MCNY)

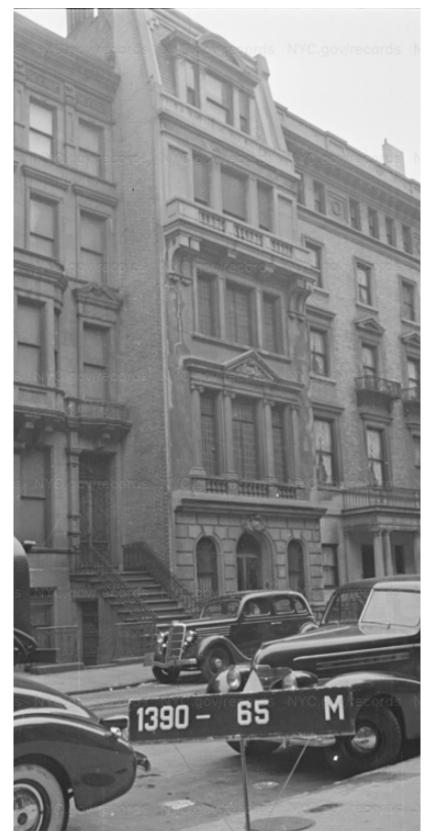
10 East 76th Street, ca. 1940 (Tax Photo, NYC Municipal Archives)

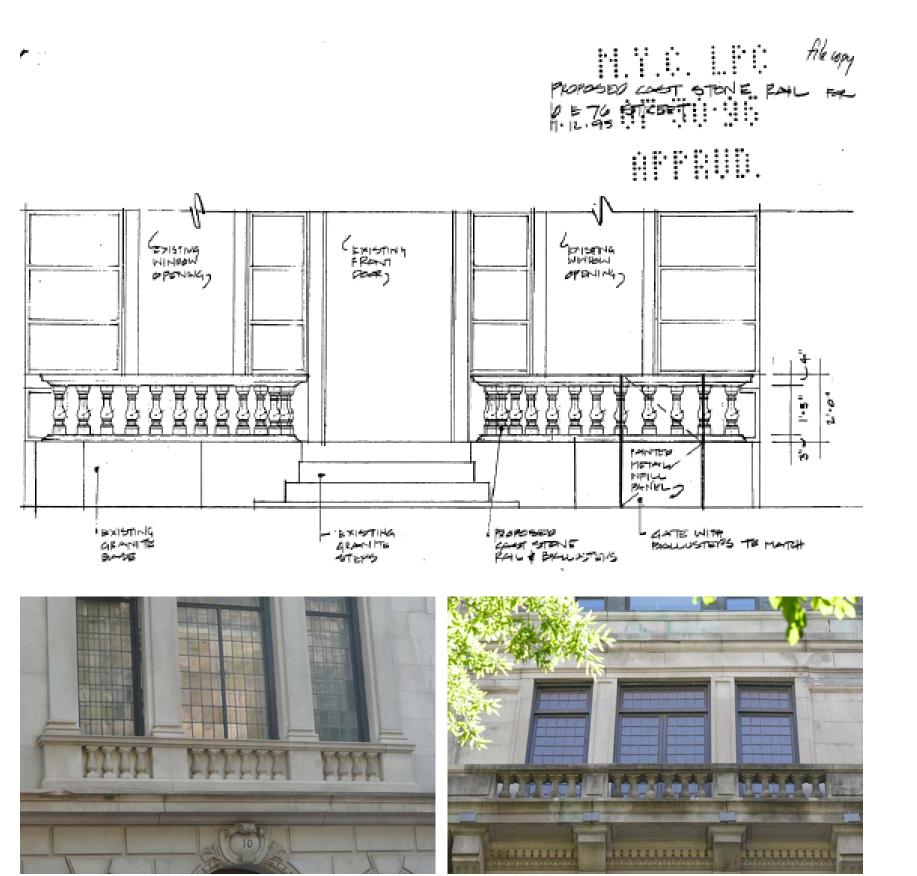
Existing stone balusters at the fourth floor.

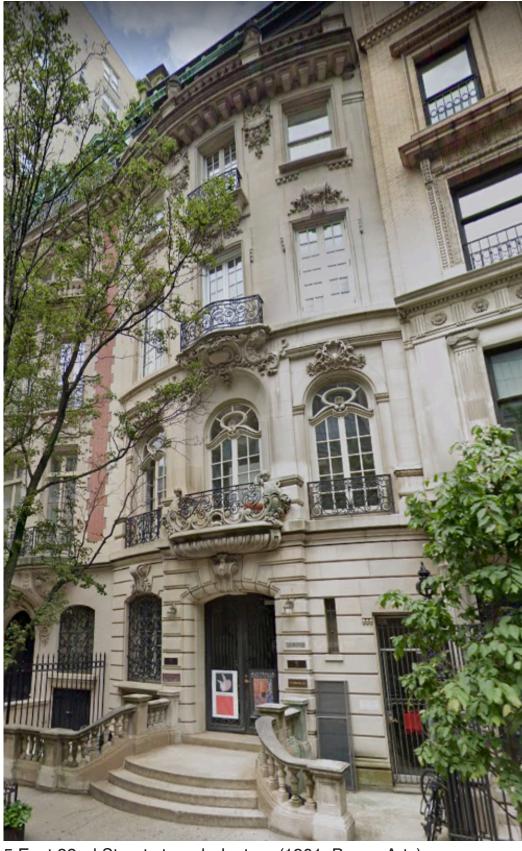
Existing stone balusters at the second floor.

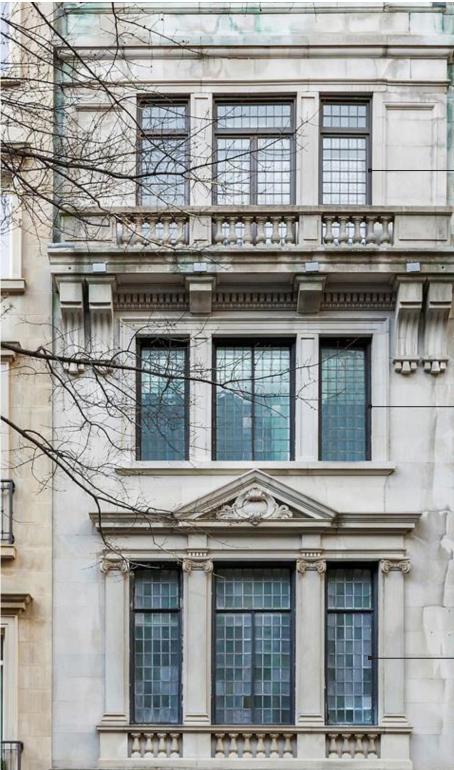
10 East 76th Street Upper East Side Historic District Original & Existing Windows

#### FOURTH FLOOR

1995 metal windows installed with simulated divided lights and spacer bars. One-over-one, double-hung windows prior to 1995.

THIRD FLOOR Steel windows installed ca. 1920-1940. Replacement glazing and caming.

SECOND FLOOR ca. 1920s steel windows and glazing with lead caning

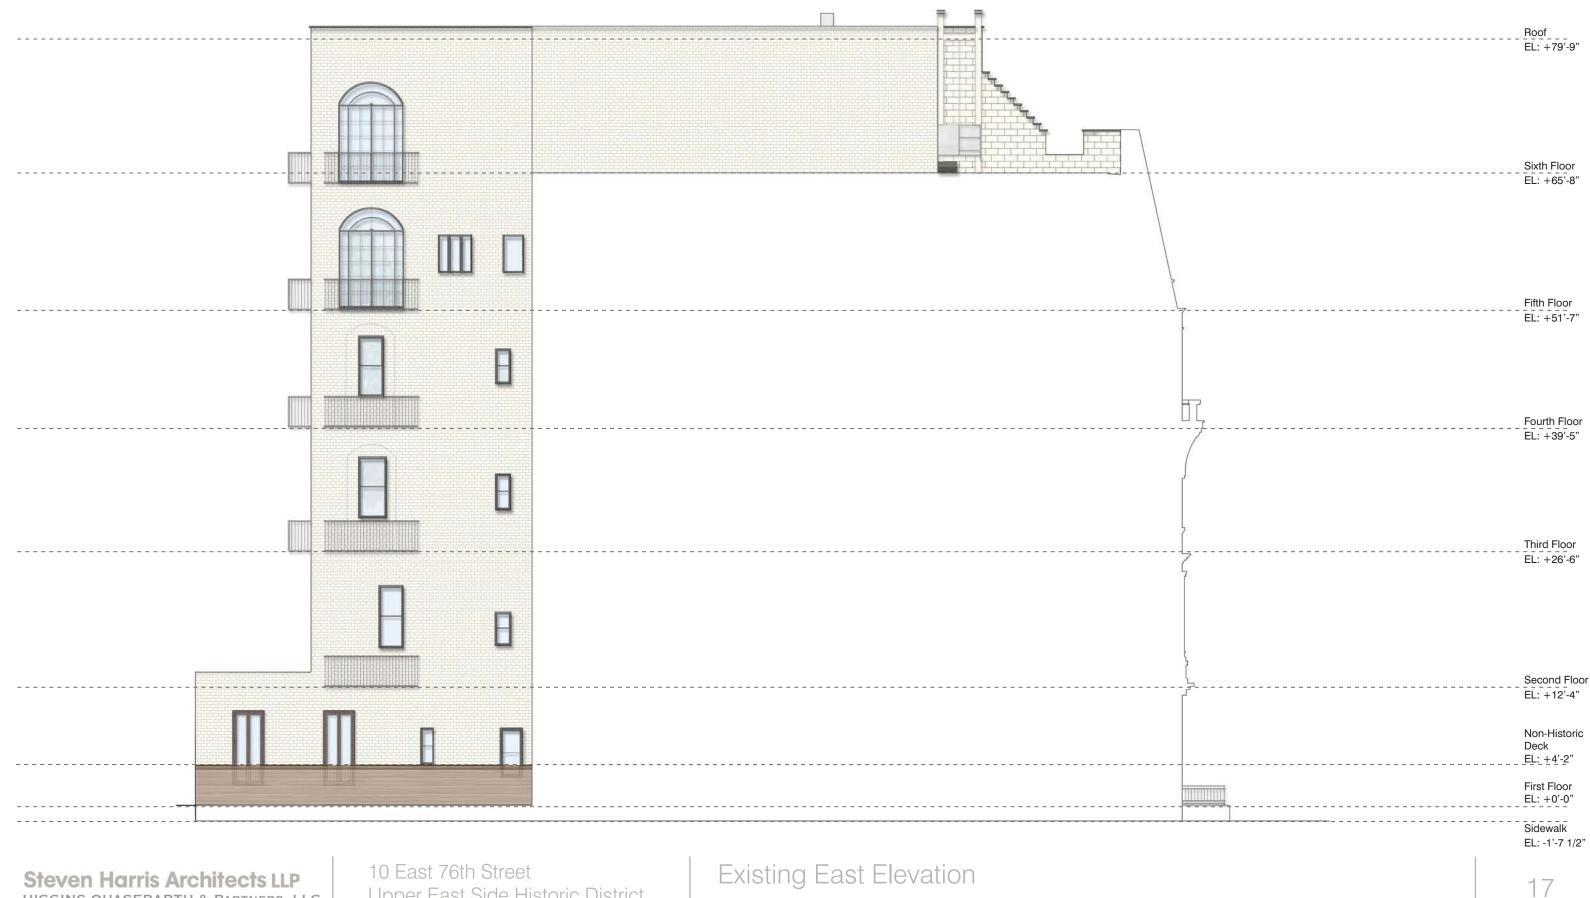
Existing East Elevation

Elevator Bulk EL: +93'-11 1 Stair Bulkhead
New Stucco Elevator					EL: +89 <sup>7</sup> -9"
New Guardrail					
New Cast Stone Lintels (Typ.)					Roof EL: +79'-9'
New Steel Clerestory Windows in New Openings (Typ.) New Cast Stone Sills (Typ.) Repaint Existing Brick Facade					
Mesh on Metal Frame					Sixth Floor EL: +65'-8
New Steel Windows in New Openings (Typ.)					Fifth Floor EL: +51 <sup>7</sup> -7"
New Cast Stone Lintels (Typ.)				2	Fourth Floc
New Cast Stone Lintels (Typ.)			2		EL: +39'-5'
New Cast Stone Lintels (Typ.)			 7 		Third Floor EL: +26'-6'
New Cast Stone Sills (Typ.)			   		Second Flo EL: +12'-4"
New Cast Stone Linters (Typ.)			8.9		First Floor EL: +0'-0"
· · · · · · · · · · · · · · · · · · ·					Sidewalk
<b>Ven Harris Architects LLP</b> 10 East 76th SINS QUASEBARTH & PARTNERS, LLCUpper East Side	treet de Historic District	Proposed East Ele	vation		EL: -1'-7 1/2 18

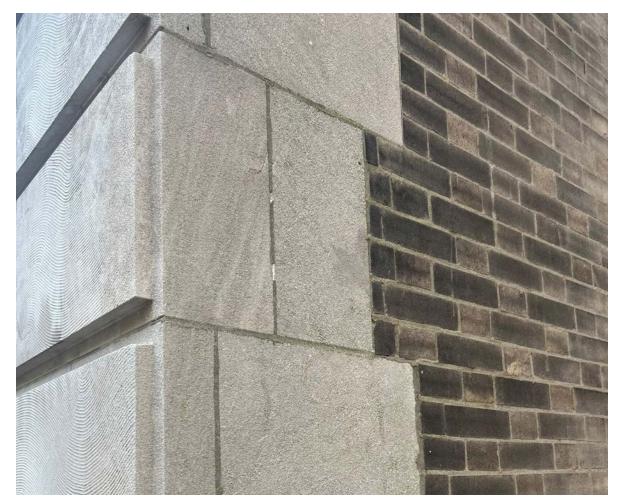
Street Facade Masonry

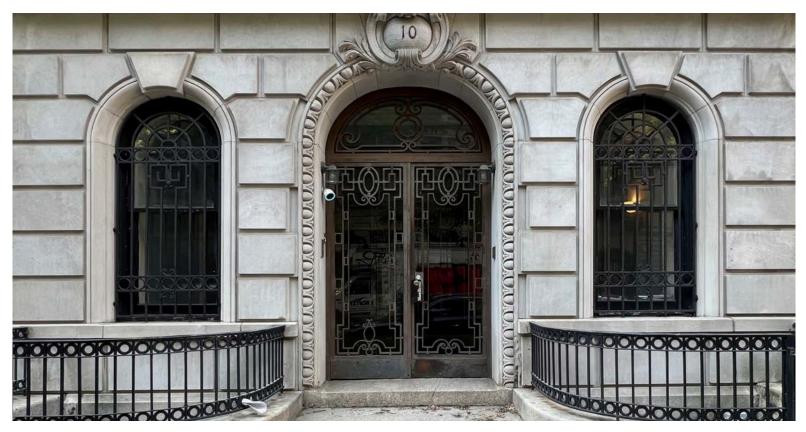
Lower Windows on Front Facade

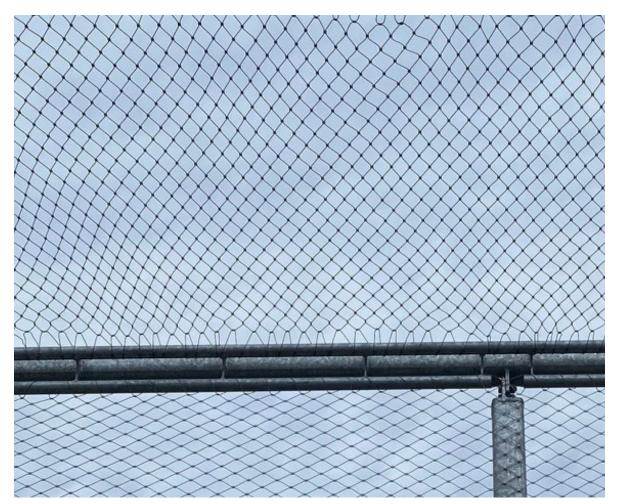
Mesh on Painted Steel Tubes

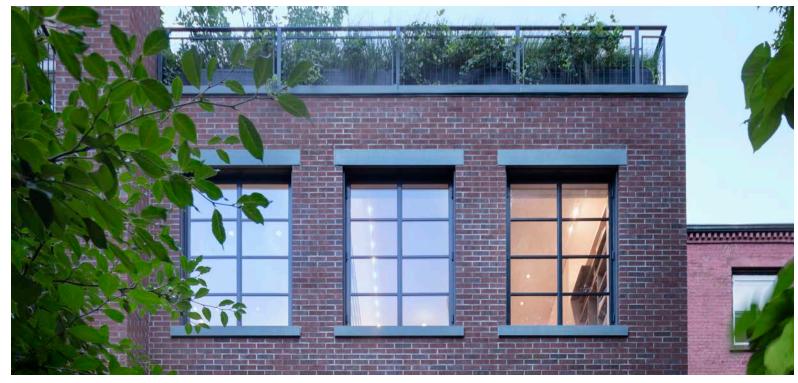
Steel Windows on Rear Facade

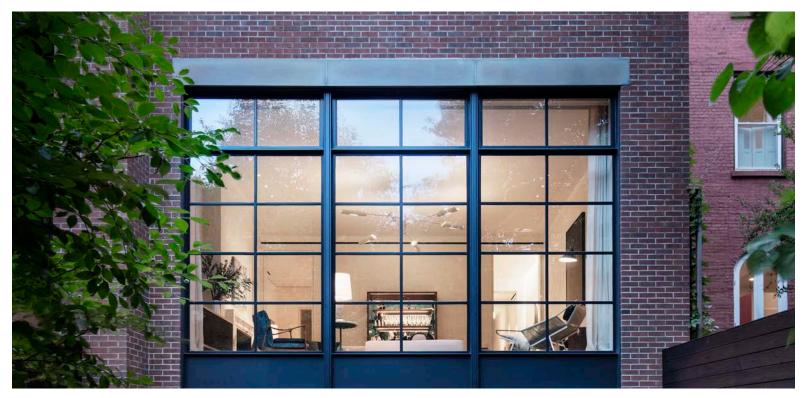
Steel Windows on Rear Penthouse

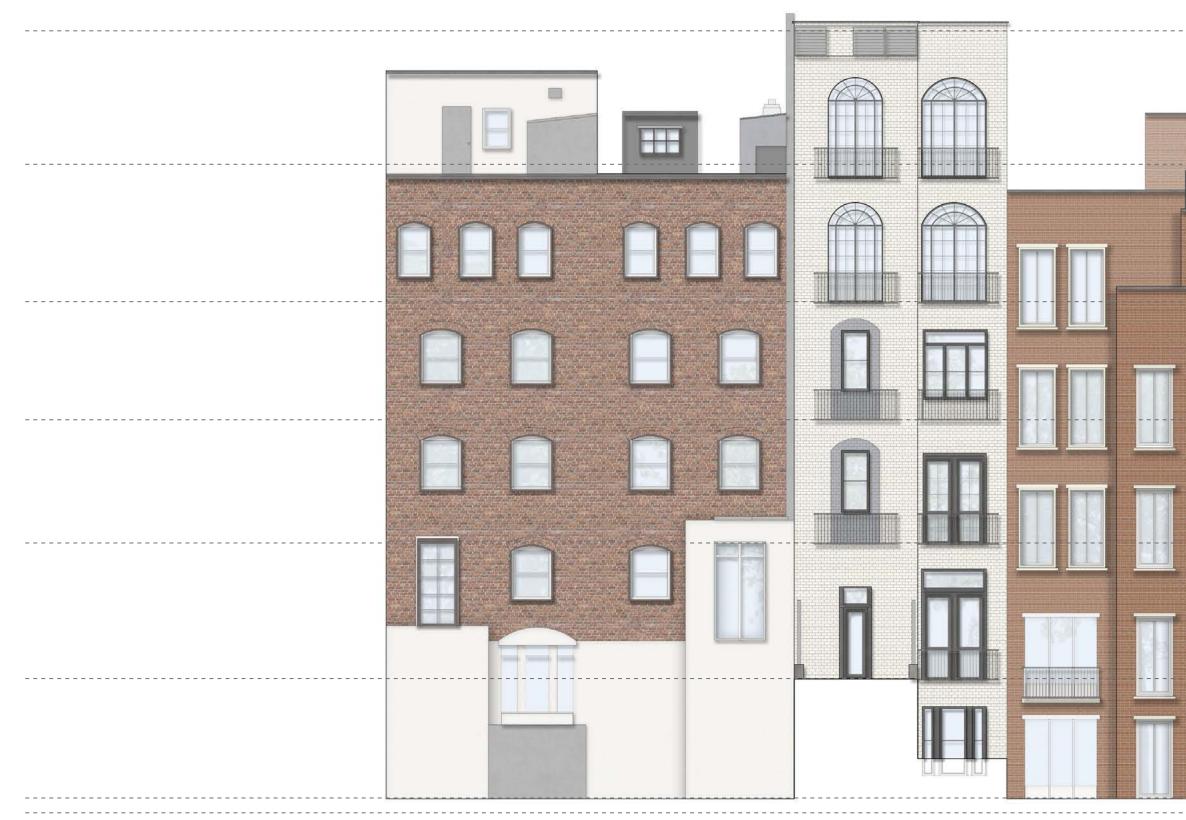
Existing Rear Elevation

_	 	 	 	 	 Roof EL: +79'-9"
	 	 	 	 	 Sixth Floor EL: +65'-8"
	 	 	 	 	 Fifth Floor EL: +51'-7"
	 	 	 	 	 Fourth Floor EL: +39'-5"
	 	 	 	 	 Third Floor EL: +26'-6"
	 	 	 	 	 Second Floor EL: +12'-4"
	 	 	 	 	 First Floor EL: +0'-0" Sidewalk EL: -1'-7 1/2"
					34

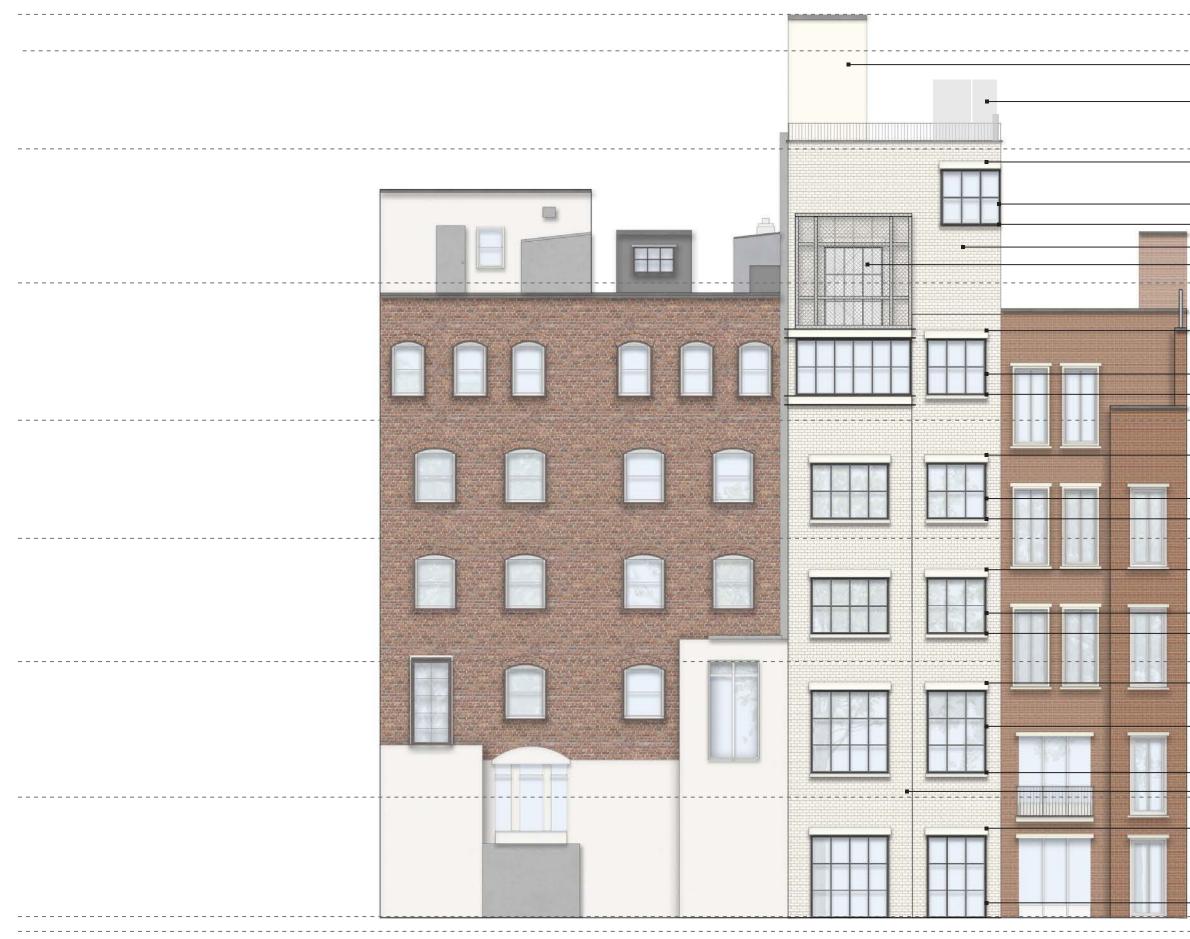
Proposed Rear Elevation

Elevator Bulkhead EL: +93'-11 1/2"
 	Stair Bulkhead EL: +89'-9"
- New Elevator & Stair Bulkhead	
- Mechanical Equipment	
 - New Cast Stone Lintels (Typ.)	Roof EL: +79'-9"
New Steel Windows - in New Openings (Typ.)

- New Cast Stone Sills (Typ.)	
<ul> <li>Repaint Existing Brick Facade</li> <li>New Steel &amp; Glass Doors</li> </ul>	
 In New Openings (Typ.)	Sixth Floor EL: +65'-8"

- New Cast Stone Lintels (Typ.)	
 New Steel Windows - in New Openings (Typ.)	
 - New Cast Stone Sills (Typ.)	
 	EL: +51'-7"
 - New Cast Stone Lintels (Typ.)	
New Steel Windows - in New Openings (Typ.)

- New Cast Stone Sills (Typ.)	Fourth Floor
 	EL: +39'-5"
- New Cast Stone Lintels (Typ.)	
 New Steel Windows - in New Openings (Typ.)	
 - New Cast Stone Sills (Typ.)	Third Floor

- New Cast Stone Lintels (Typ.)	EL: +26'-6"
- New Steel Windows in New Openings (Typ.)	
 - New Cast Stone Sills (Typ.)	
 - New Infill Masonry & Mortar to Match Existing	EL: +12'-4"

- New Cast Stone Lintels (Typ.)	
New Steel & Glass Doors	First Floor
 - in New Openings (Typ.)	EL: +0'-0"
 	Sidewalk EL: -1'-7 1/2"
	35
