Preservation Department – Item 1, LPC-21-03229

27 East 4th Street – NoHo Historic District Extension

27 EAST 4TH STREET

LANDMARKS PRESERVATION COMMISSION

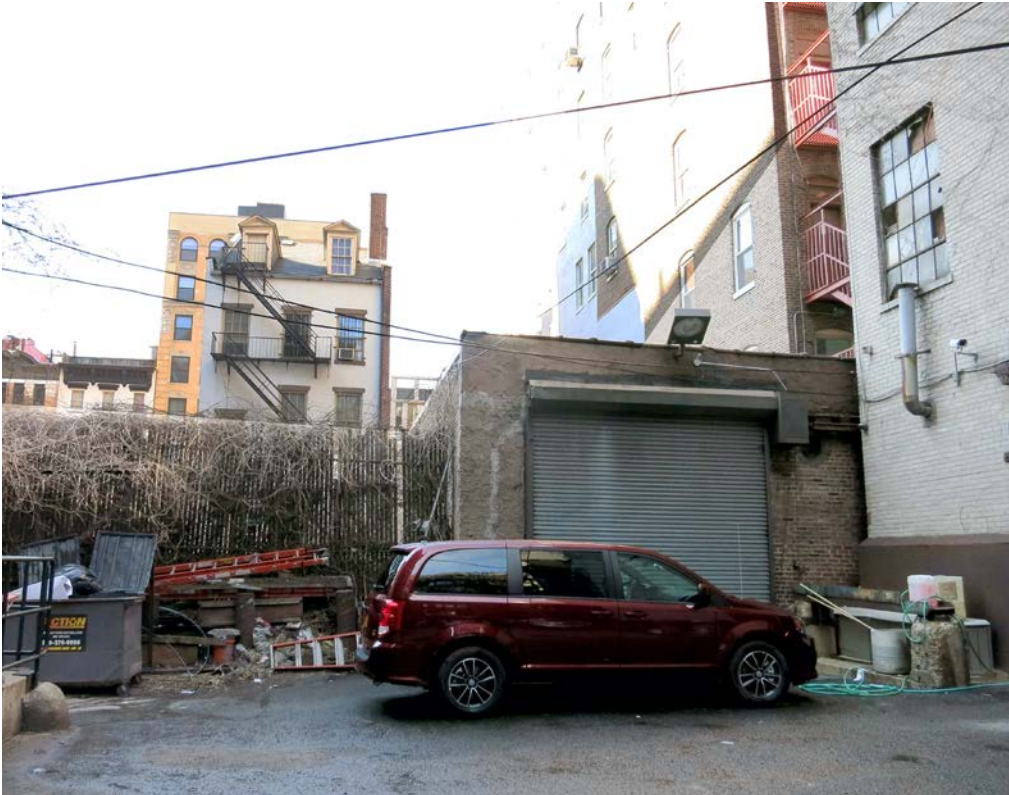
C - EXISTING CONDITIONS - STABLE COURT, FACING REAR OF LOT 72

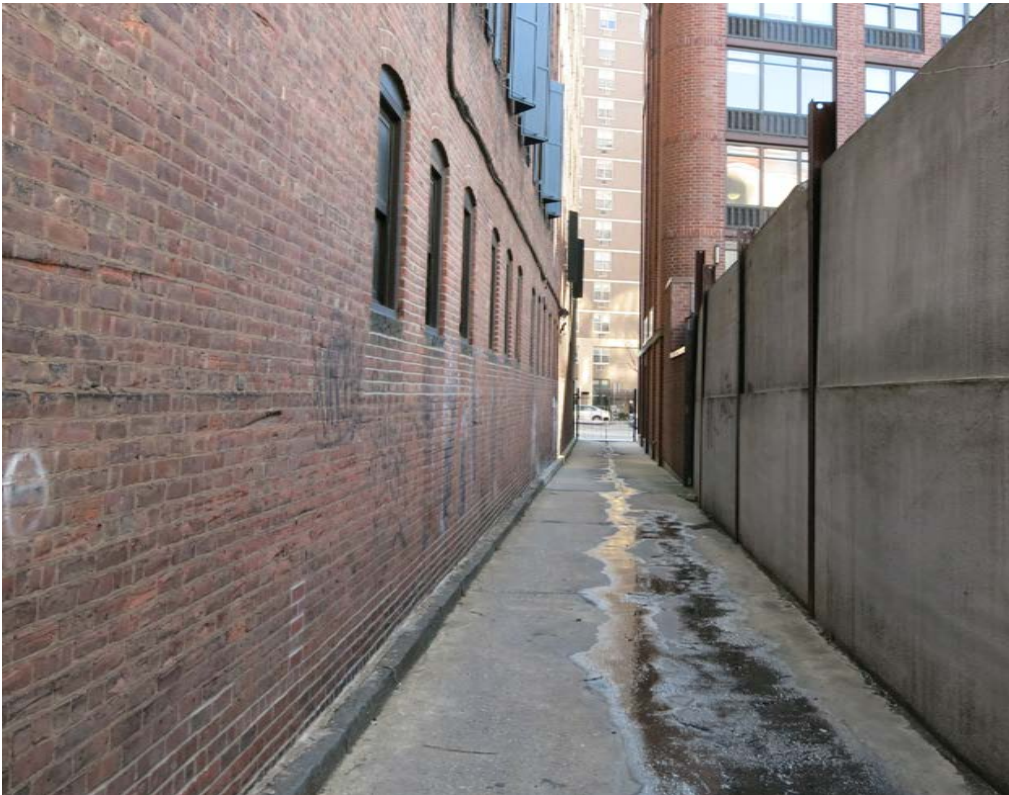
D - EXISTING CONDITIONS - STABLE COURT, ALLEY ACCESS TO BOWERY

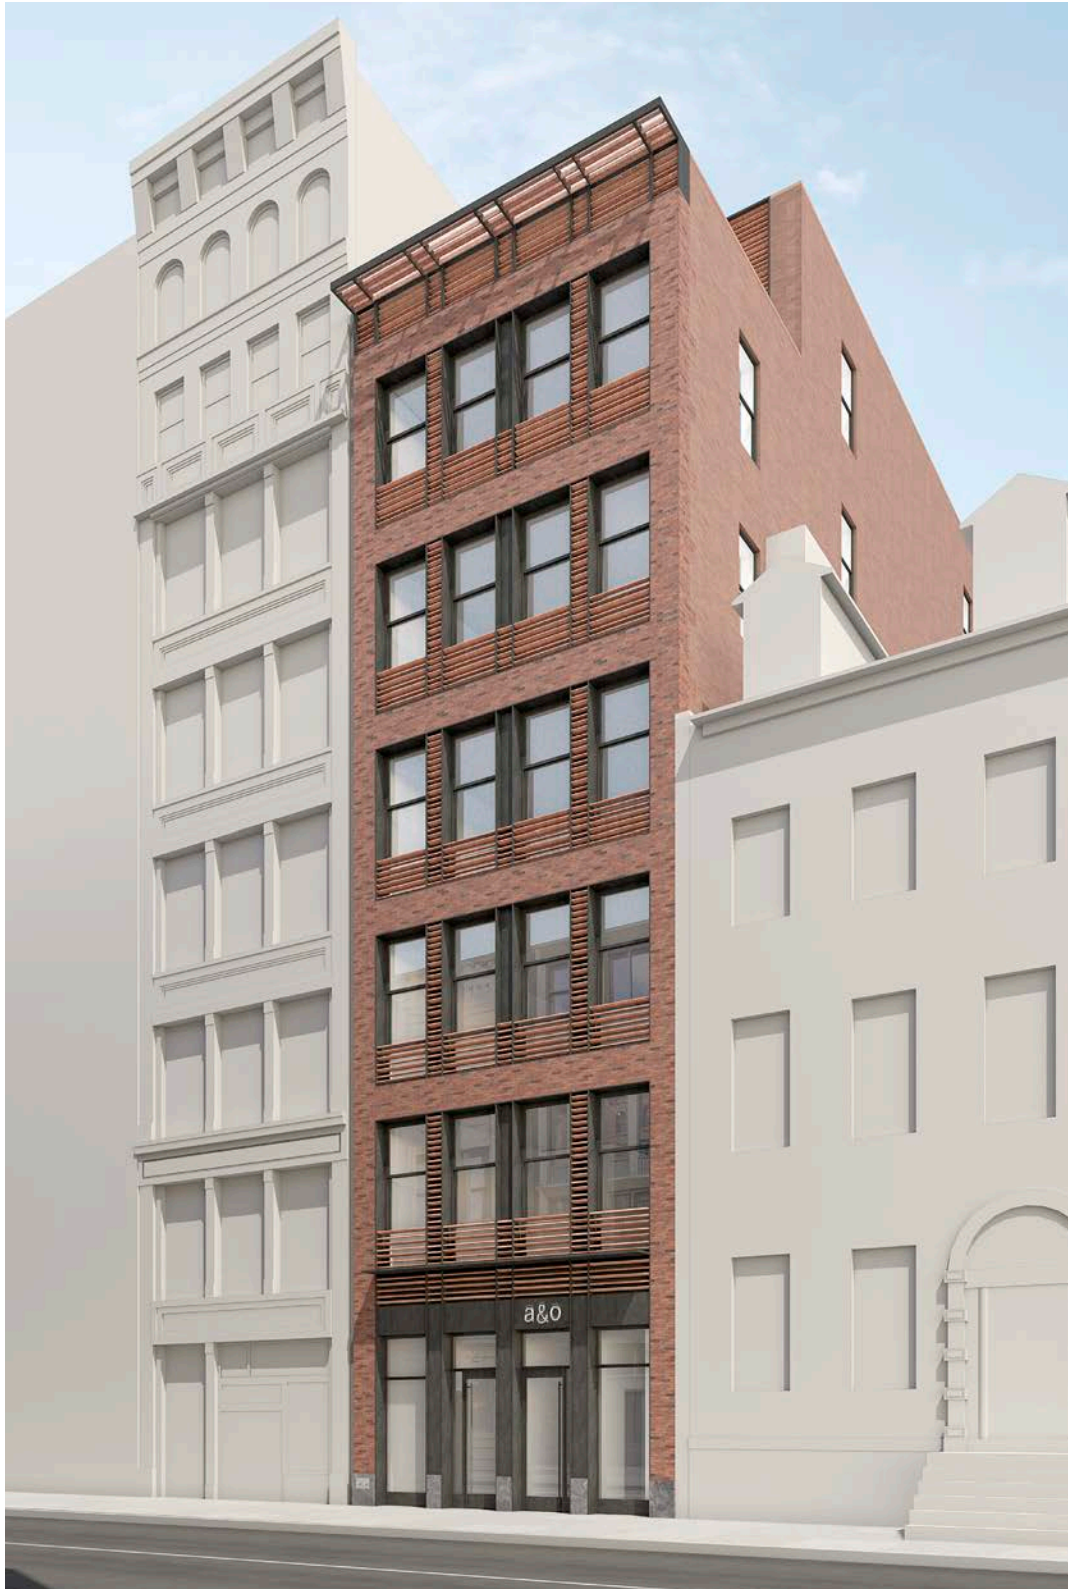
PROPOSED BUILDING

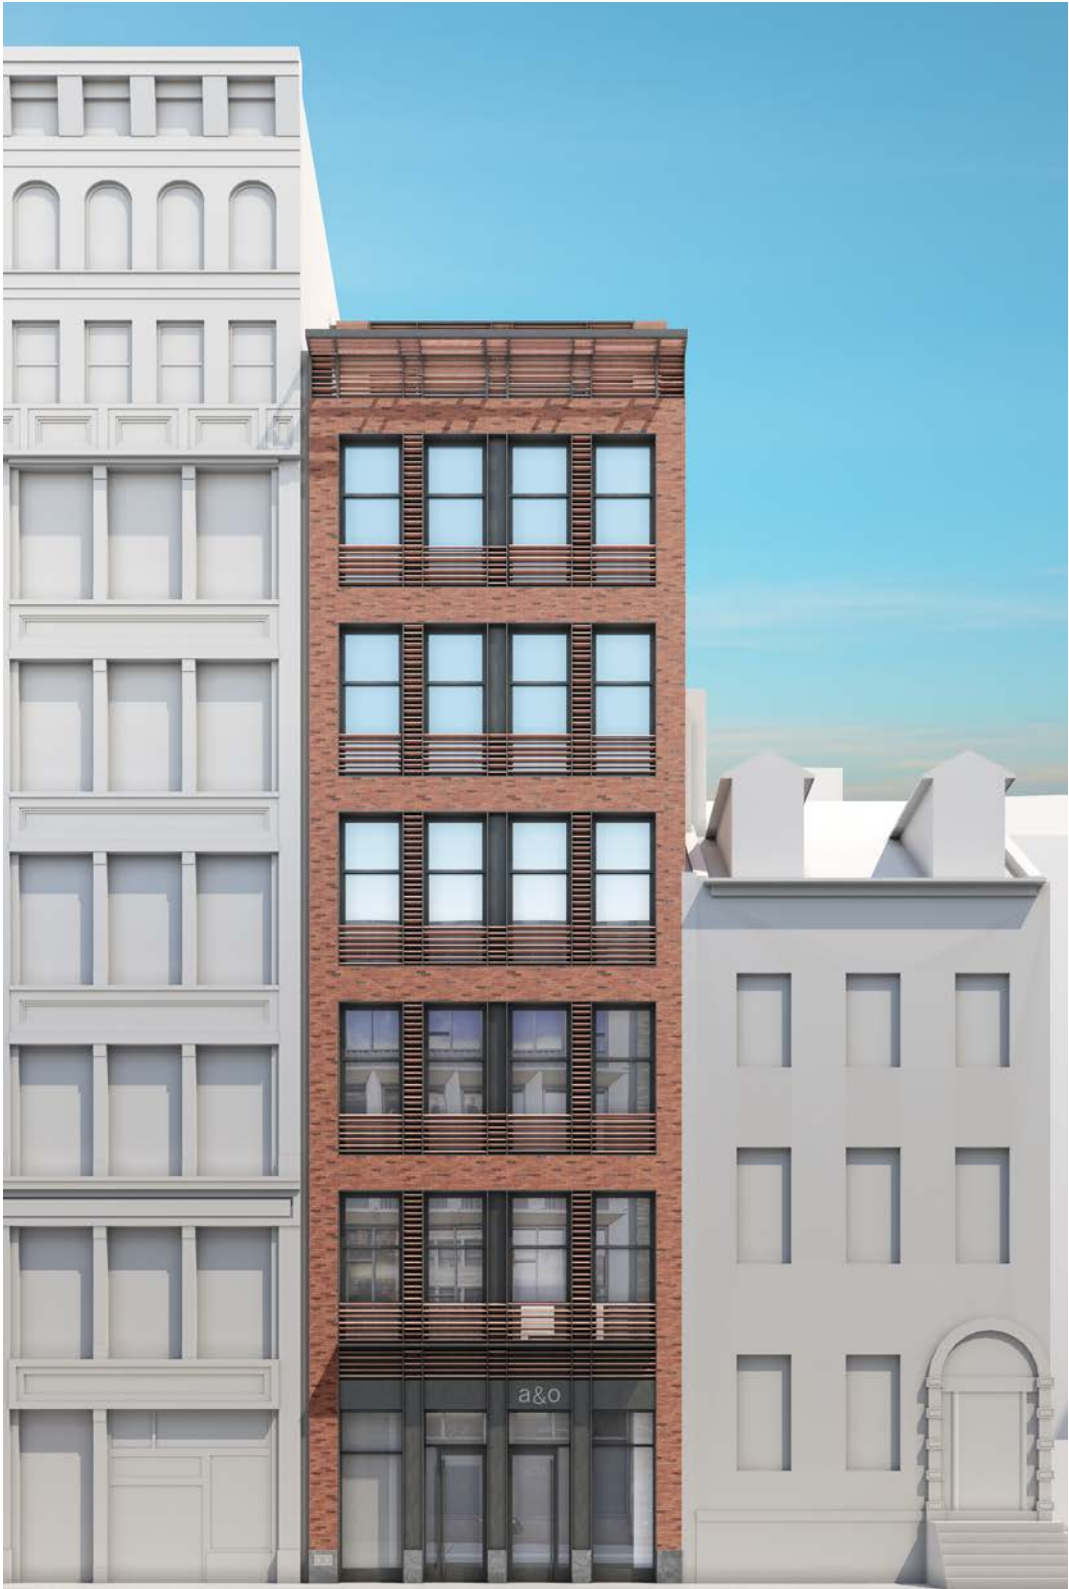
PROPOSED ELEVATION

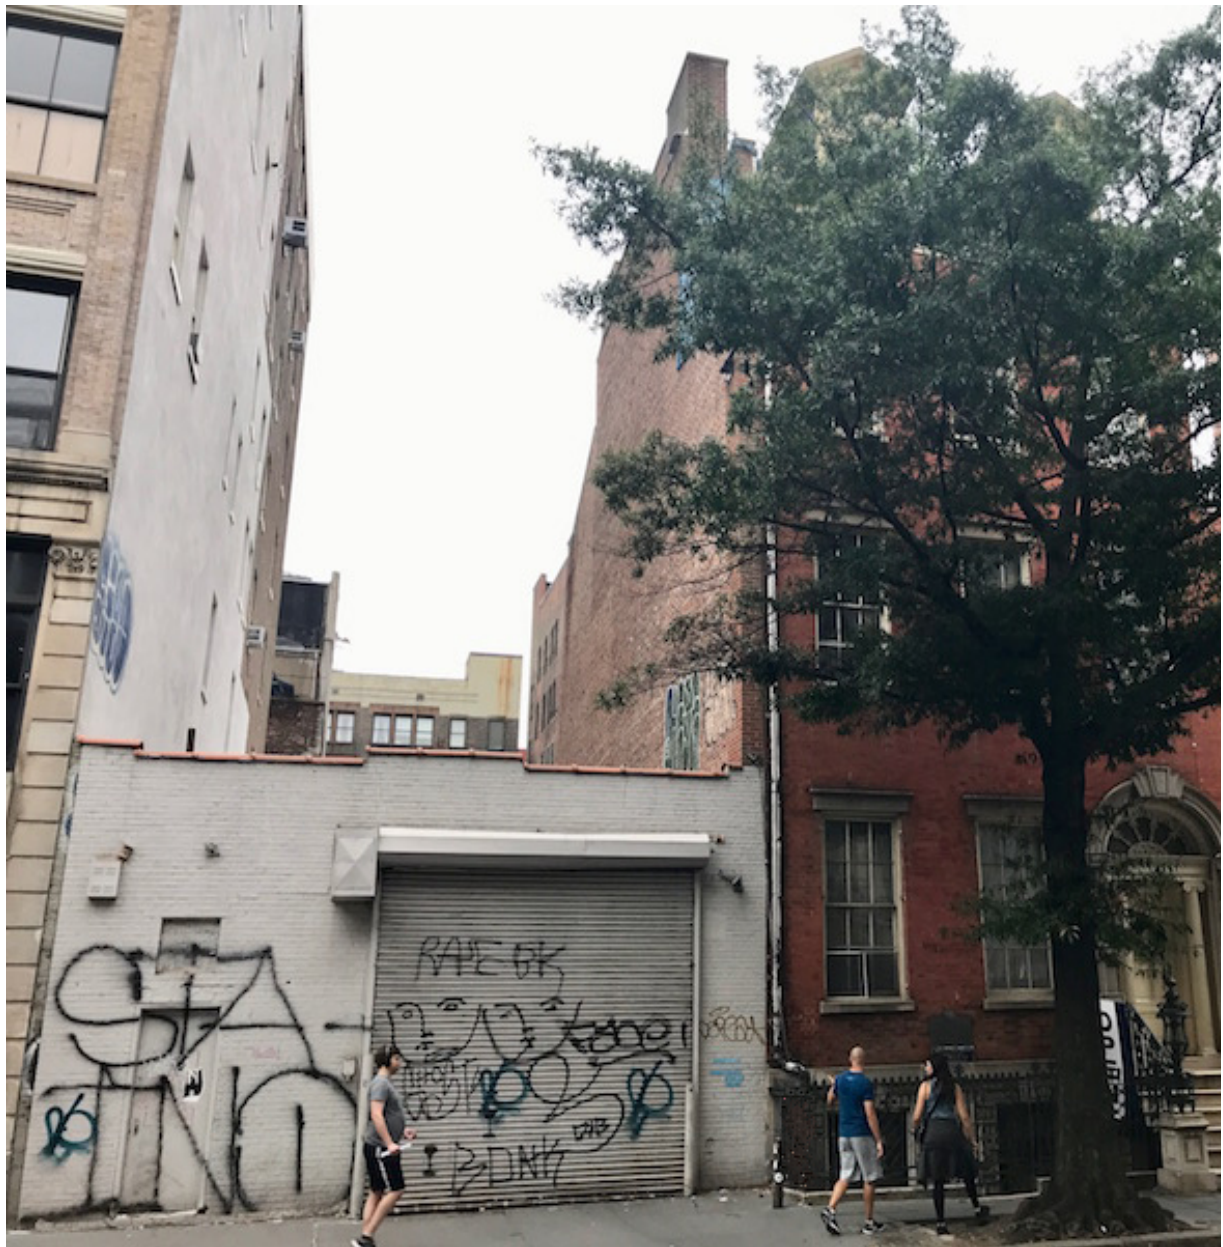
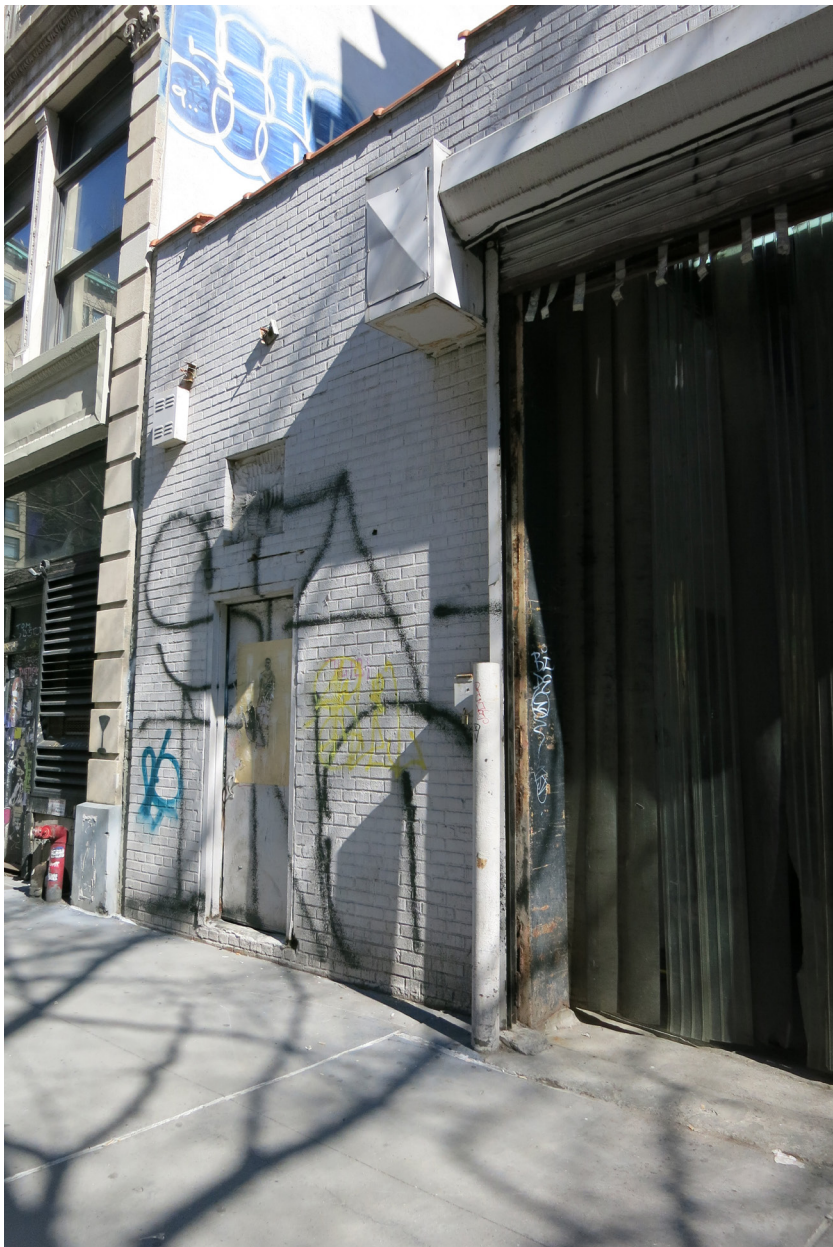
“This one-story structure designed by architect Herman Kron was built for Paramount Filling Stations, Inc. c.1945 for use as a garage and repair shop. The building, which is currently used as storage for food carts, has a simple brick façade and large vehicle entrance.”

EXISTING GARAGE AND REPAIR SHOP, CONSTRUCTED 1946

DEMOLITION OF SINGLE STORY GARAGE - **APPROVED**

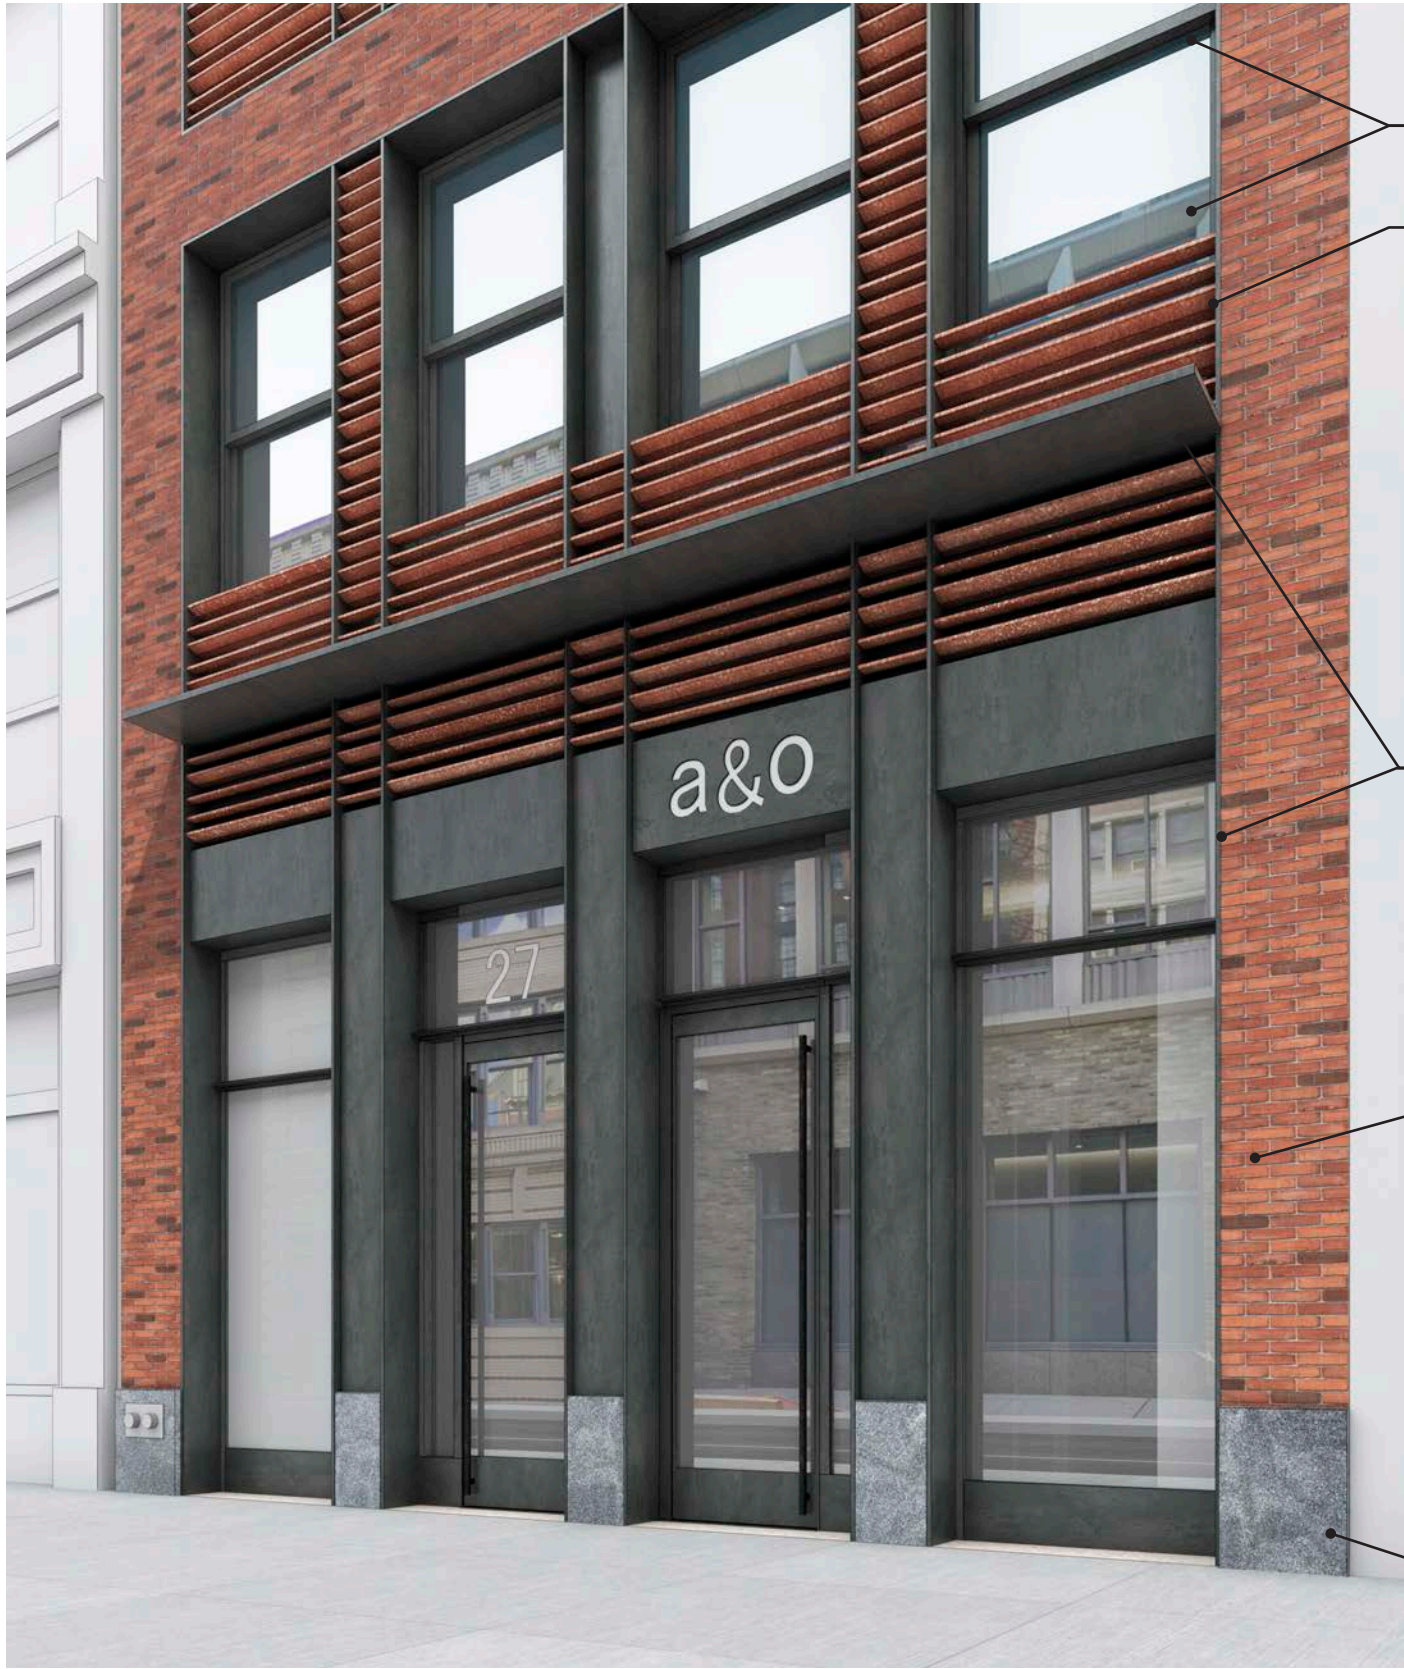
STOREFRONT AT STREET LEVEL

DOUBLE-HUNG WINDOW
OVER SINGLE (FIXED)
GLASS PANEL

TERRACOTTA FIN IN
RANDOMIZED PATTERN

BOSTON VALLEY
TERRA COTTA
IRON-SPOT

METAL FIN, SURROUND
& FRAME

15% "50-DD"
GLEN-GERY
MID-ATLANTIC PLANT
50% "53-DD" & 35% "51-DDX"

STONE SOURCE
"JET MIST" HONED

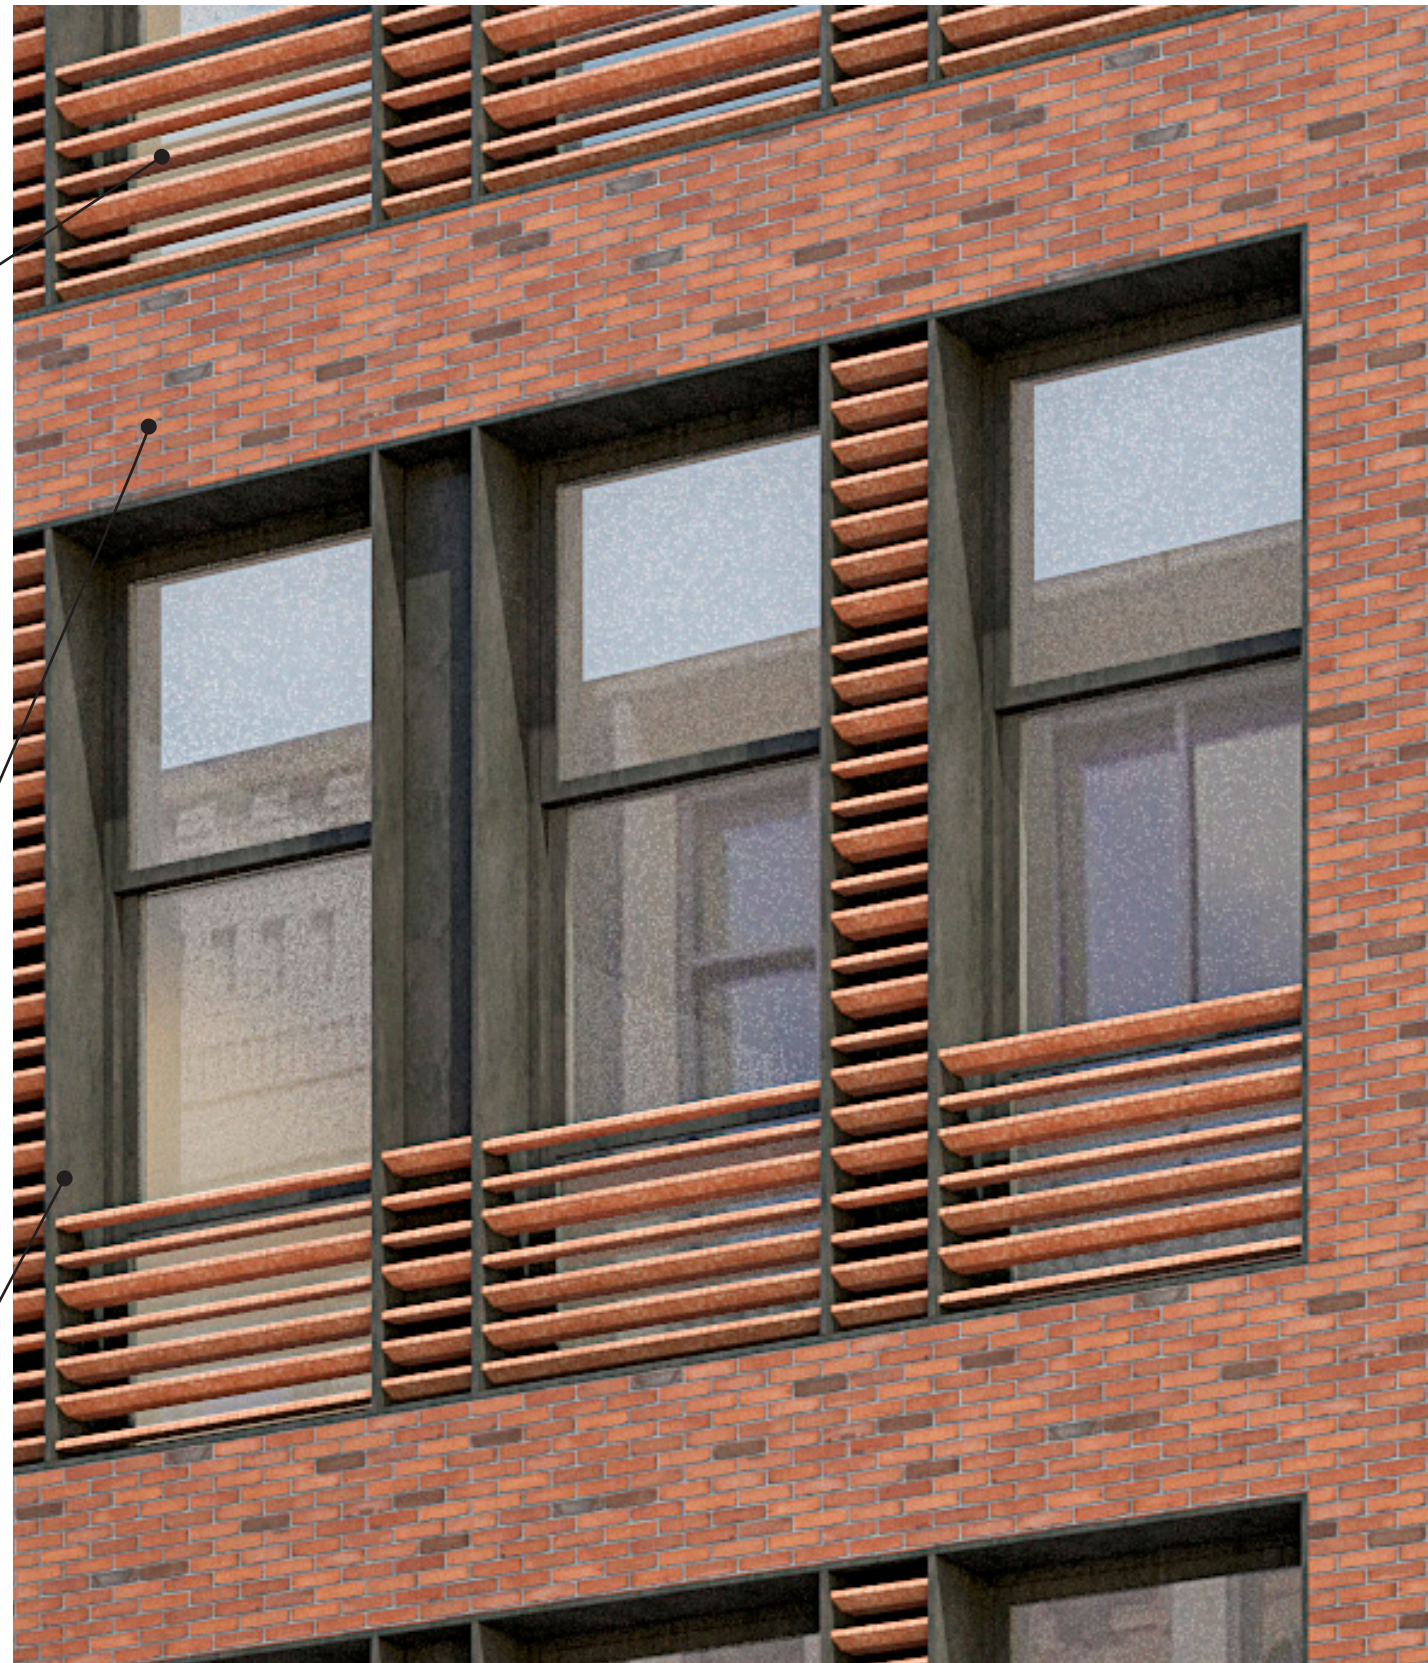
CLOSE UP OF TERRA COTTA SCREENS IN METAL FRAMES OVER CONTINUOUS WINDOWS

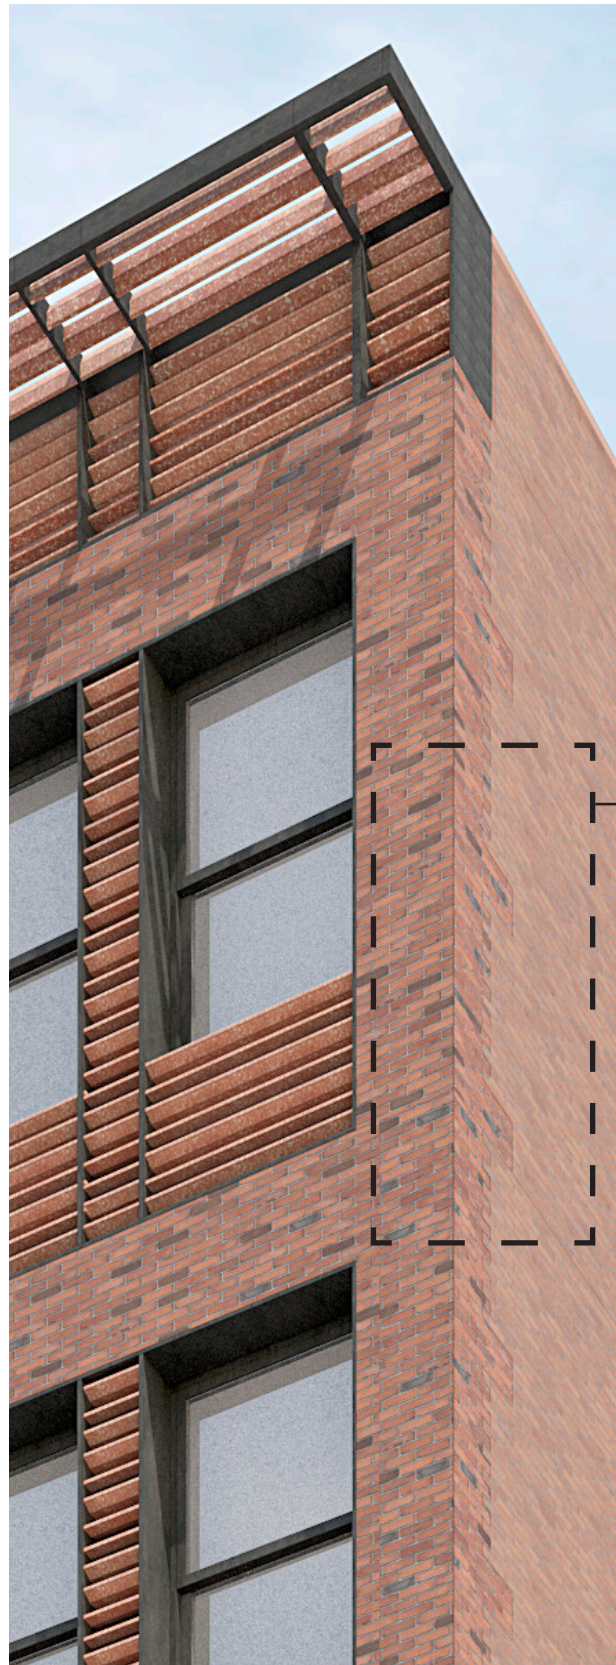
ZIPPER BRICK PATTERN WHERE
MOTTLED WEATHERED BRICK MEETS
UNIFORMLY TONED BRICK

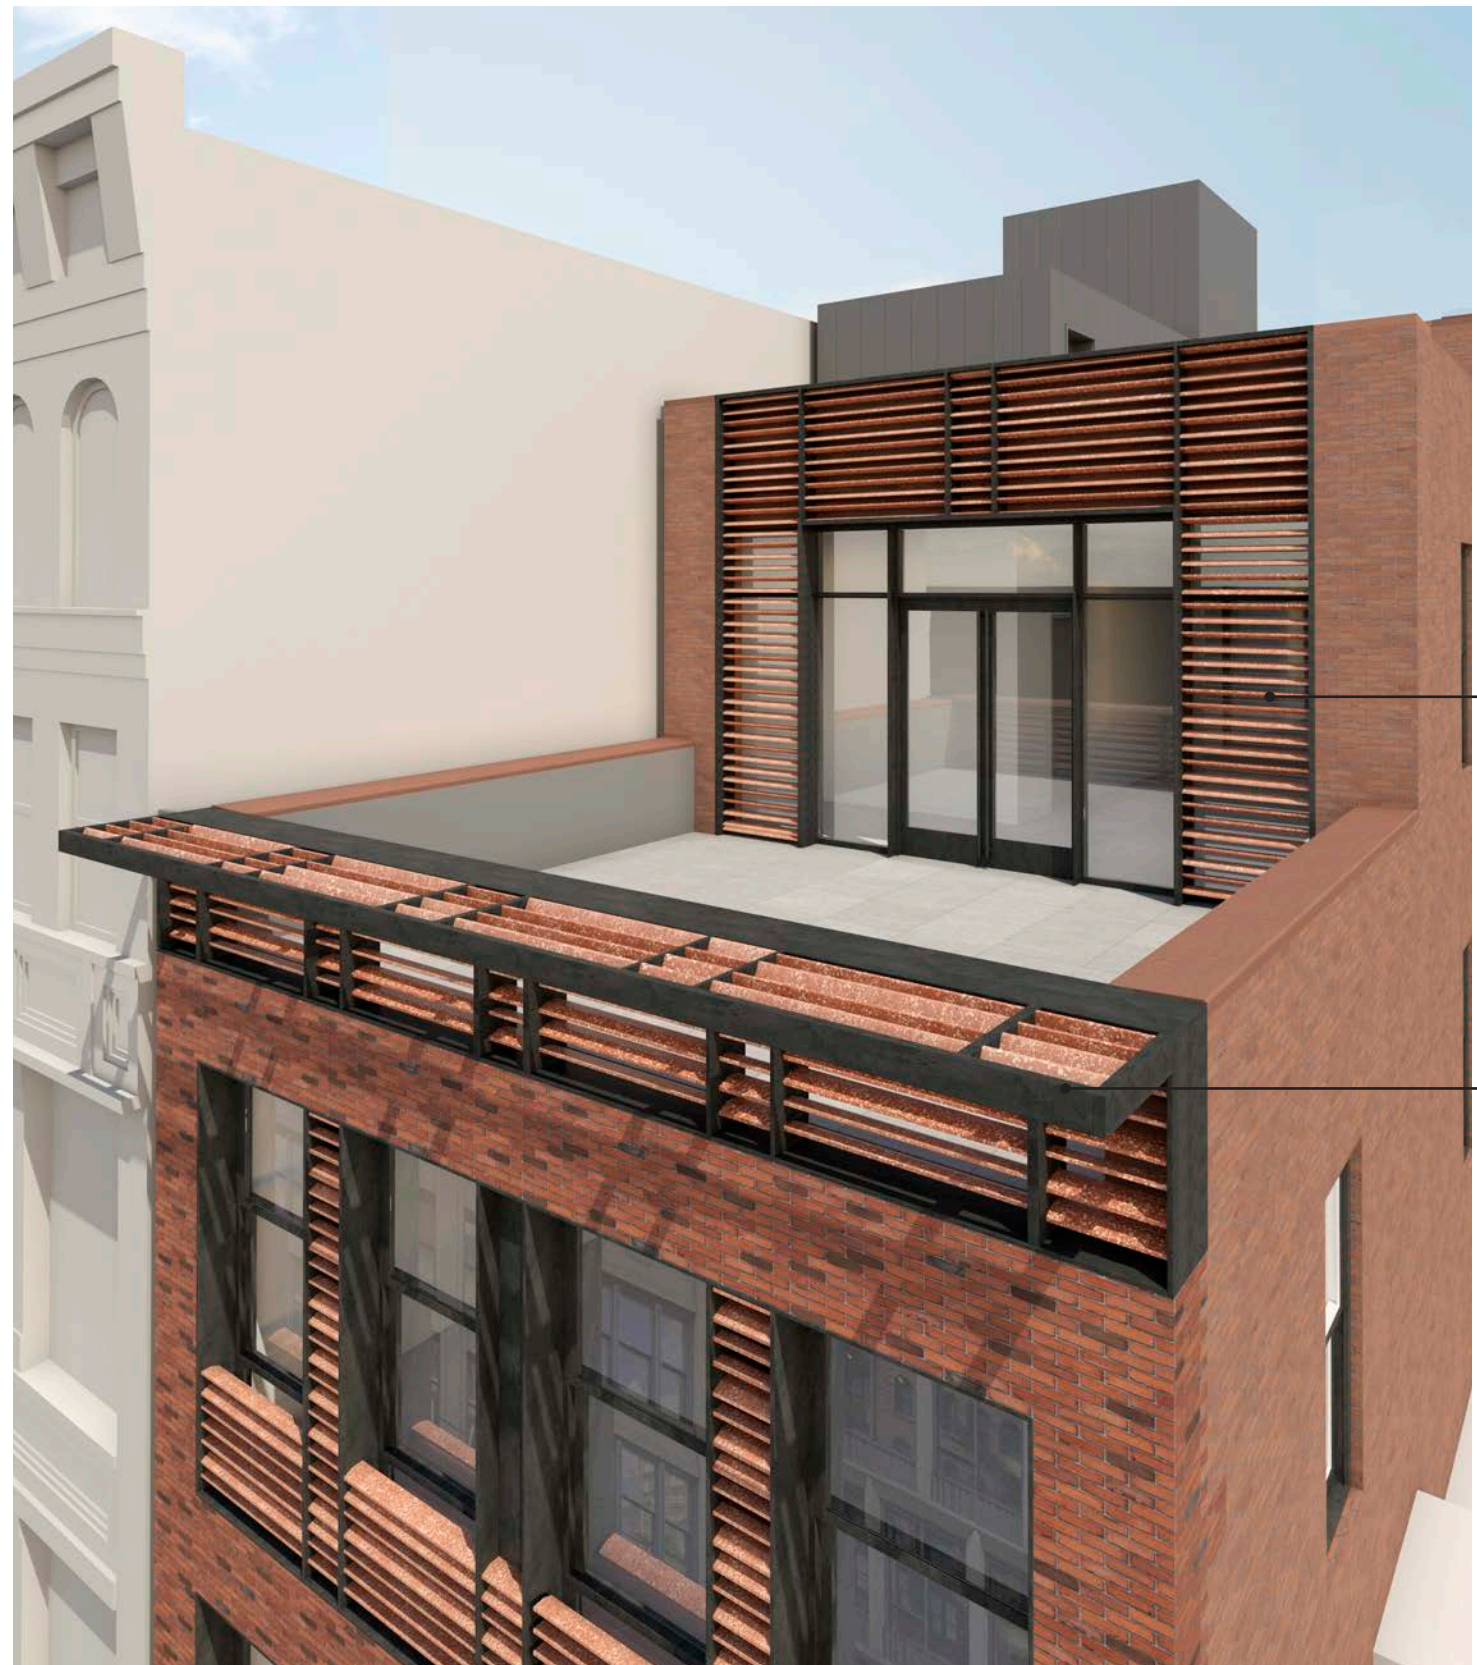
SETBACK
PENTHOUSE
FLOOR WITH
TERRA COTTA
FIN AND METAL
FACADE

CORNICE:
TERRA COTTA
SCREEN IN
METAL FRAME

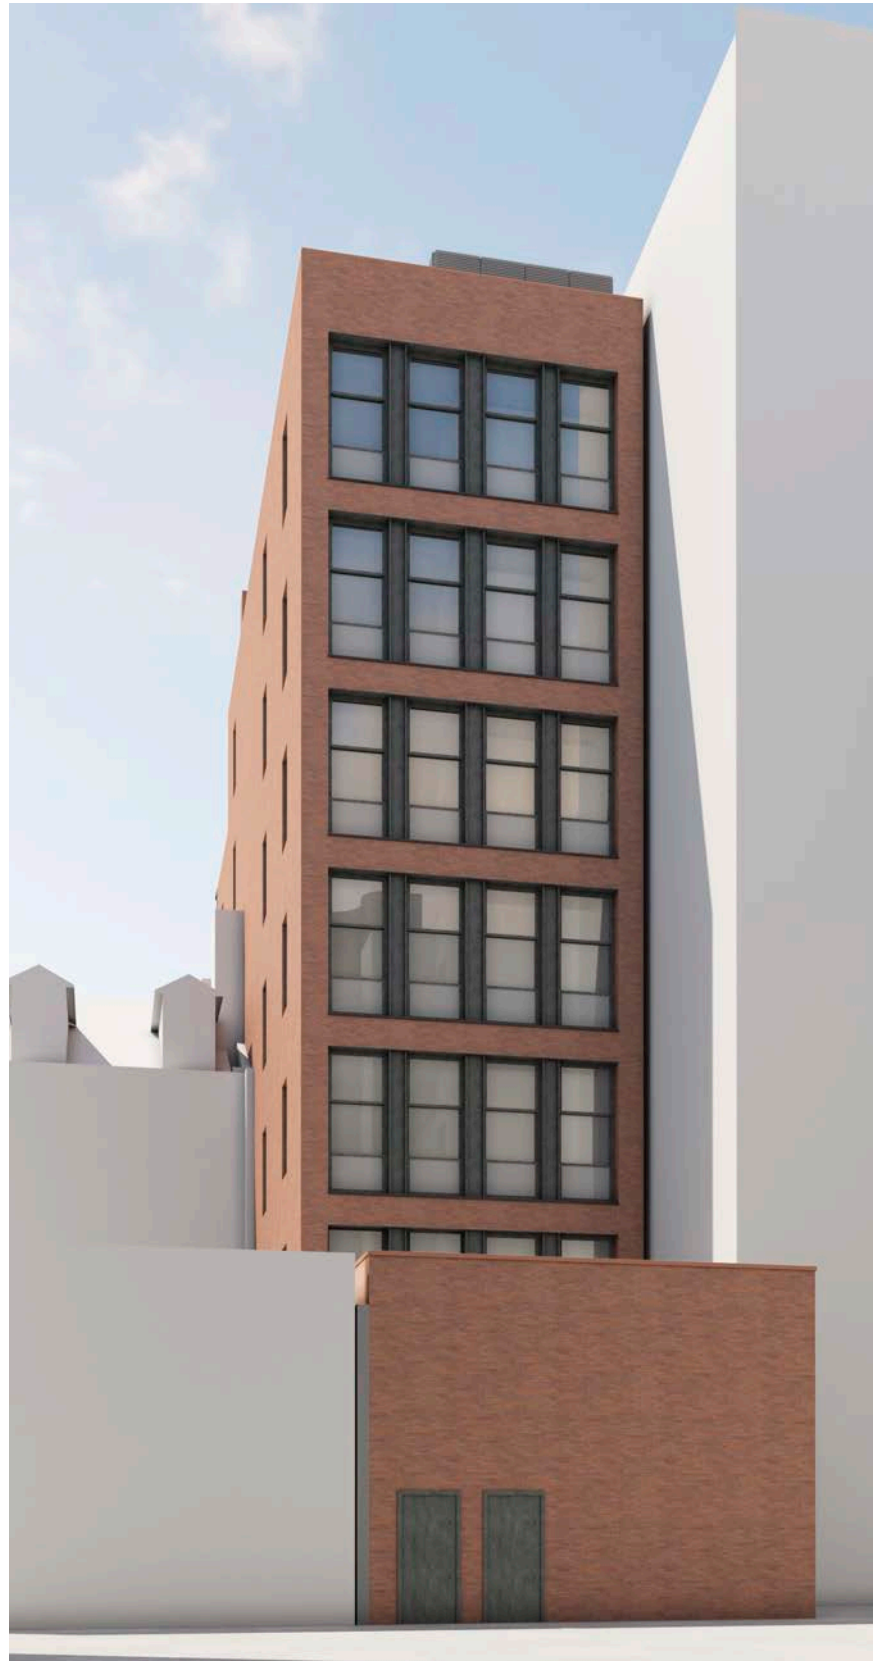
PROPOSED PERSPECTIVE OF BUILDING REAR

BULKHEAD - METAL PANEL
WITH VERTICAL REVEAL 15"
O.C. IN CHARCOAL

HORIZONTAL LOUVERED METAL
MECHANICAL SCREEN IN
CHARCOAL

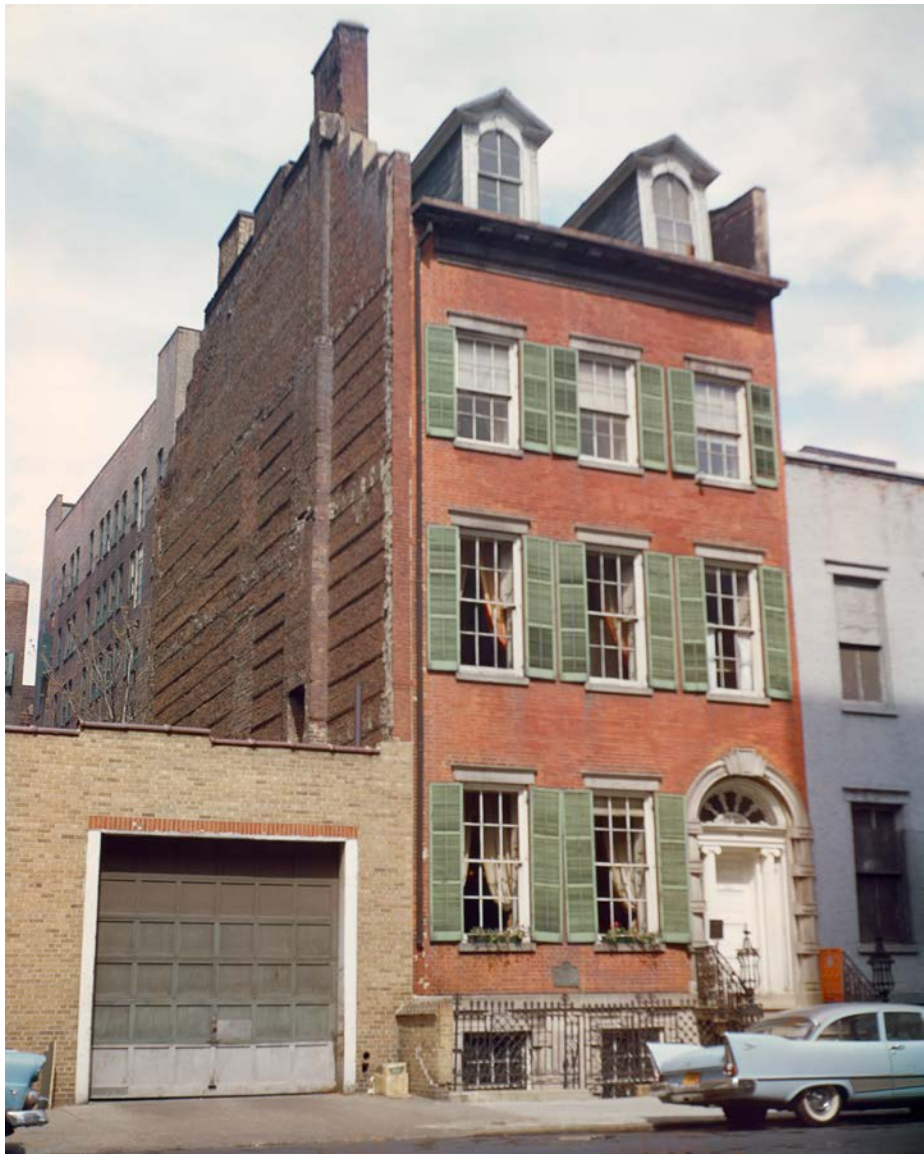
1960'S LOT LINE WALL CONDITION

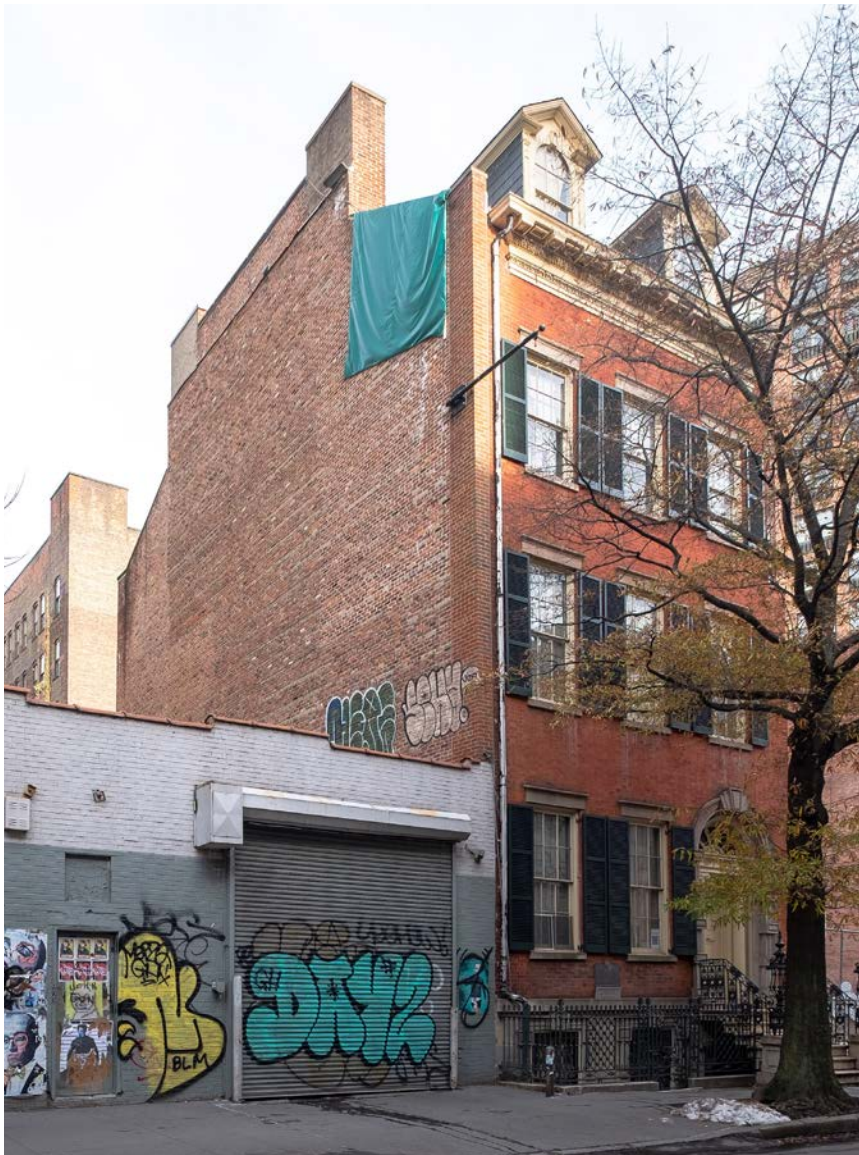
CURRENT LOT LINE WALL CONDITION

REVISED NEW NAVD 88 DATUM

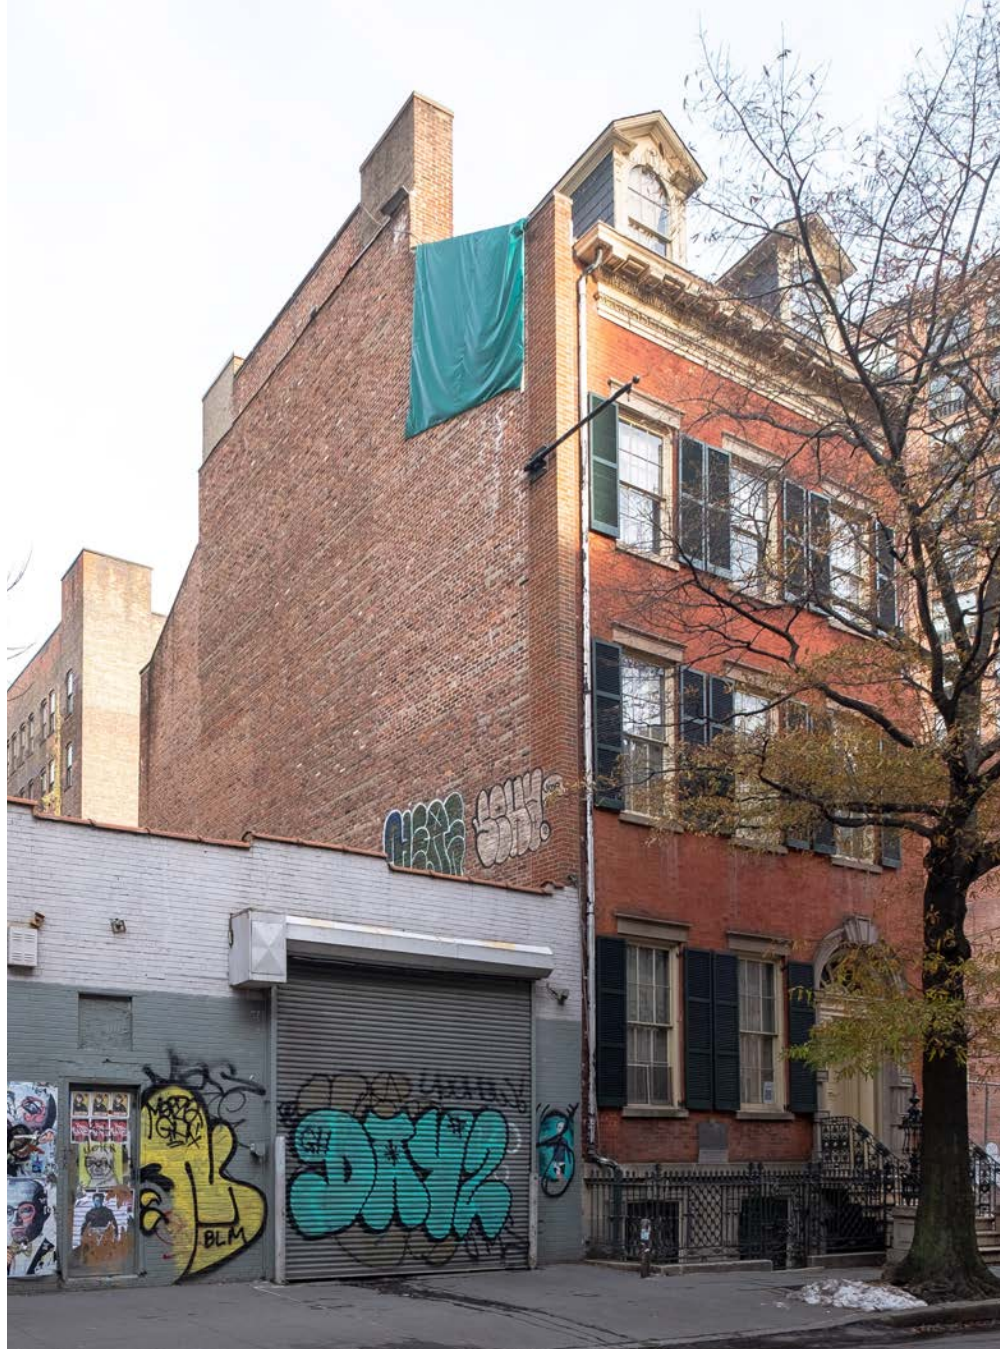
CURRENT LOT LINE WALL CONDITION

REVISED TO INCLUDE TEST PIT 1A

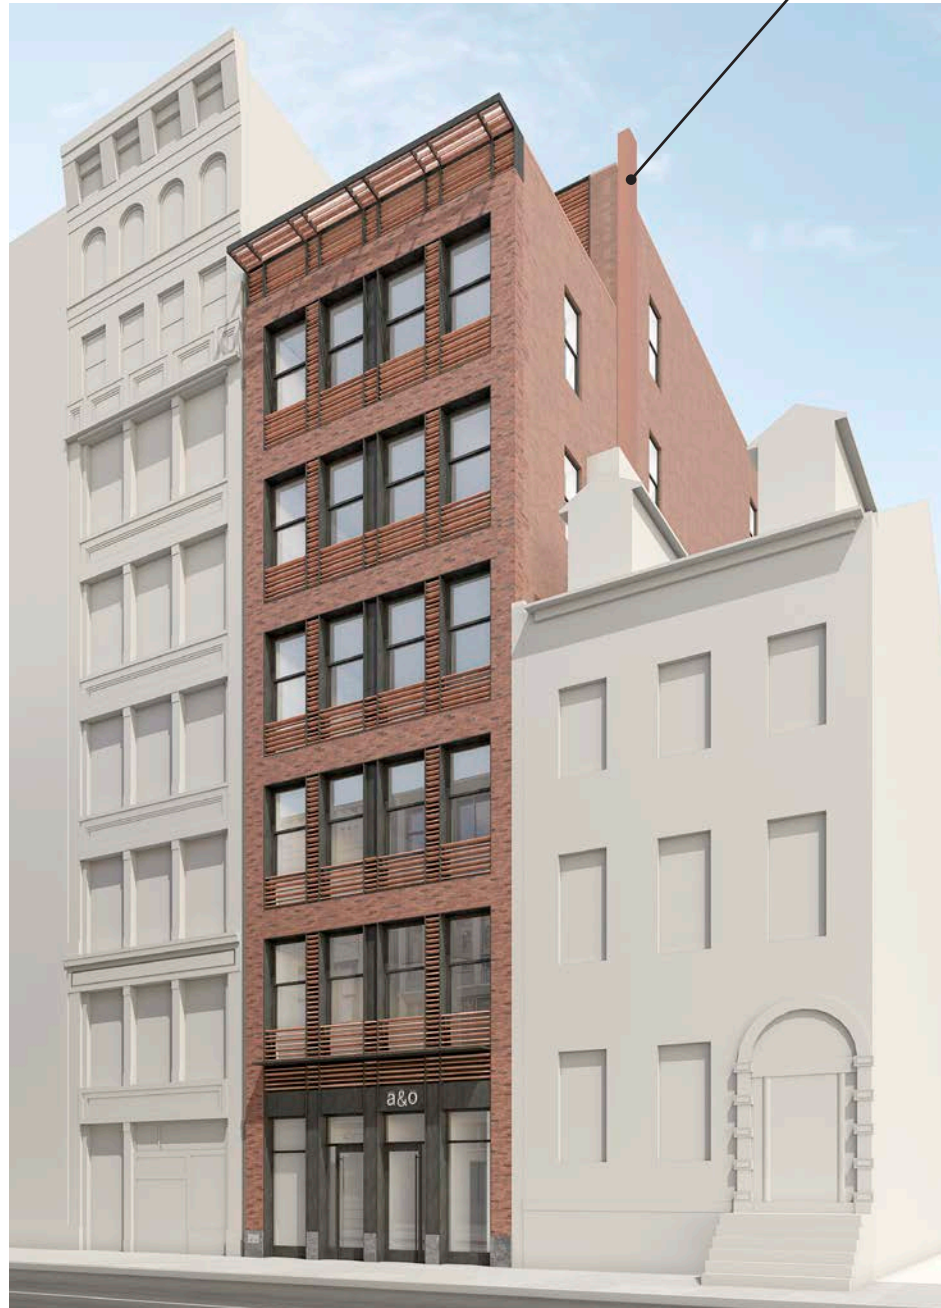
FLUE WITH RECTANGULAR METAL
CLADDING PAINTED TO MATCH BRICK

- 1) ADDITIONAL TEST PIT FOR REVIEW OF FOUNDATION AT LOT LINE WITH MERCHANT'S HOUSE MUSEUM.
 - 2) CONSIDER ADDITIONAL STRUCTURAL MEASURES TO MINIMIZE ANY POTENTIAL SETTLEMENT
 - 3) DESIGN WAS SUPPORTED WITH ONE EXCEPTION
- CONSIDER PROPOSING A DIFFERENT BRICK.
 - 4) STATUS OF EXISTING SINGLE FUNCTIONING FLUE, WITH MERCHANT'S HOUSE MUSEUM.
-
