Landmarks Preservation Commission Public Hearing

675 Hudson St / 24 9th Ave

2023.12.19

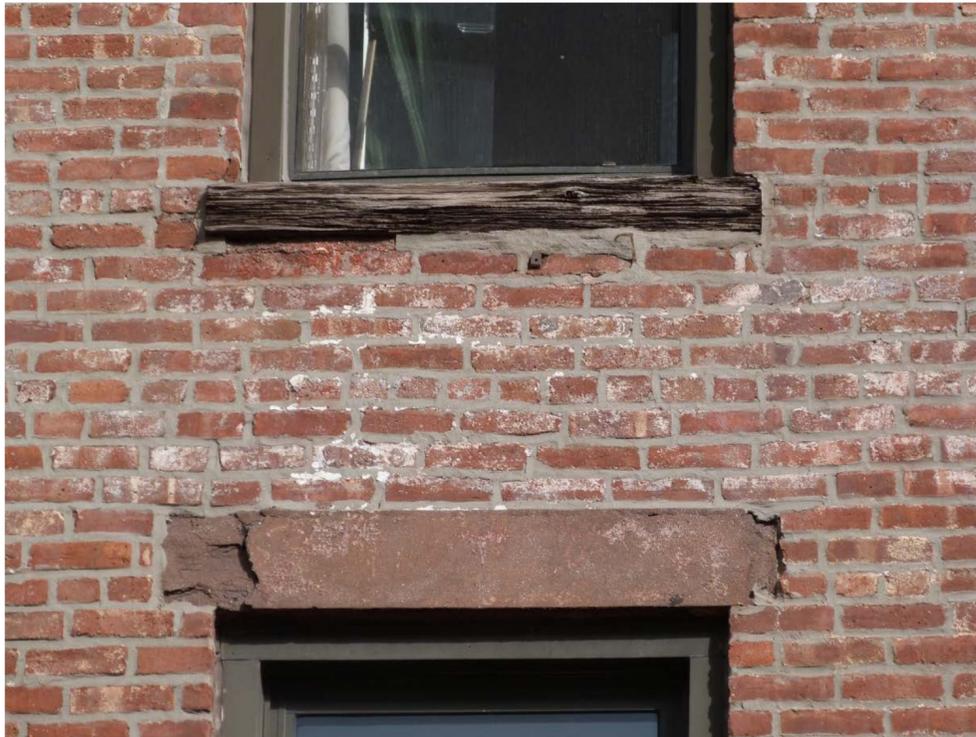
Lintel & Sill Detail

Cornice/parapet Detail

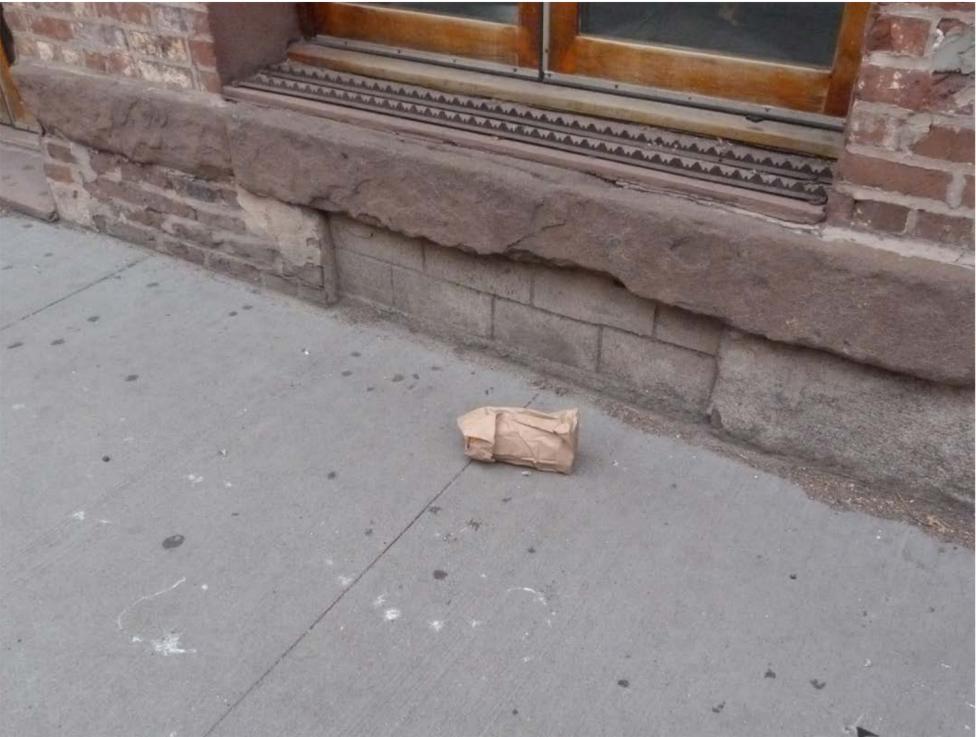
Along Hudson Street- repair work over the years

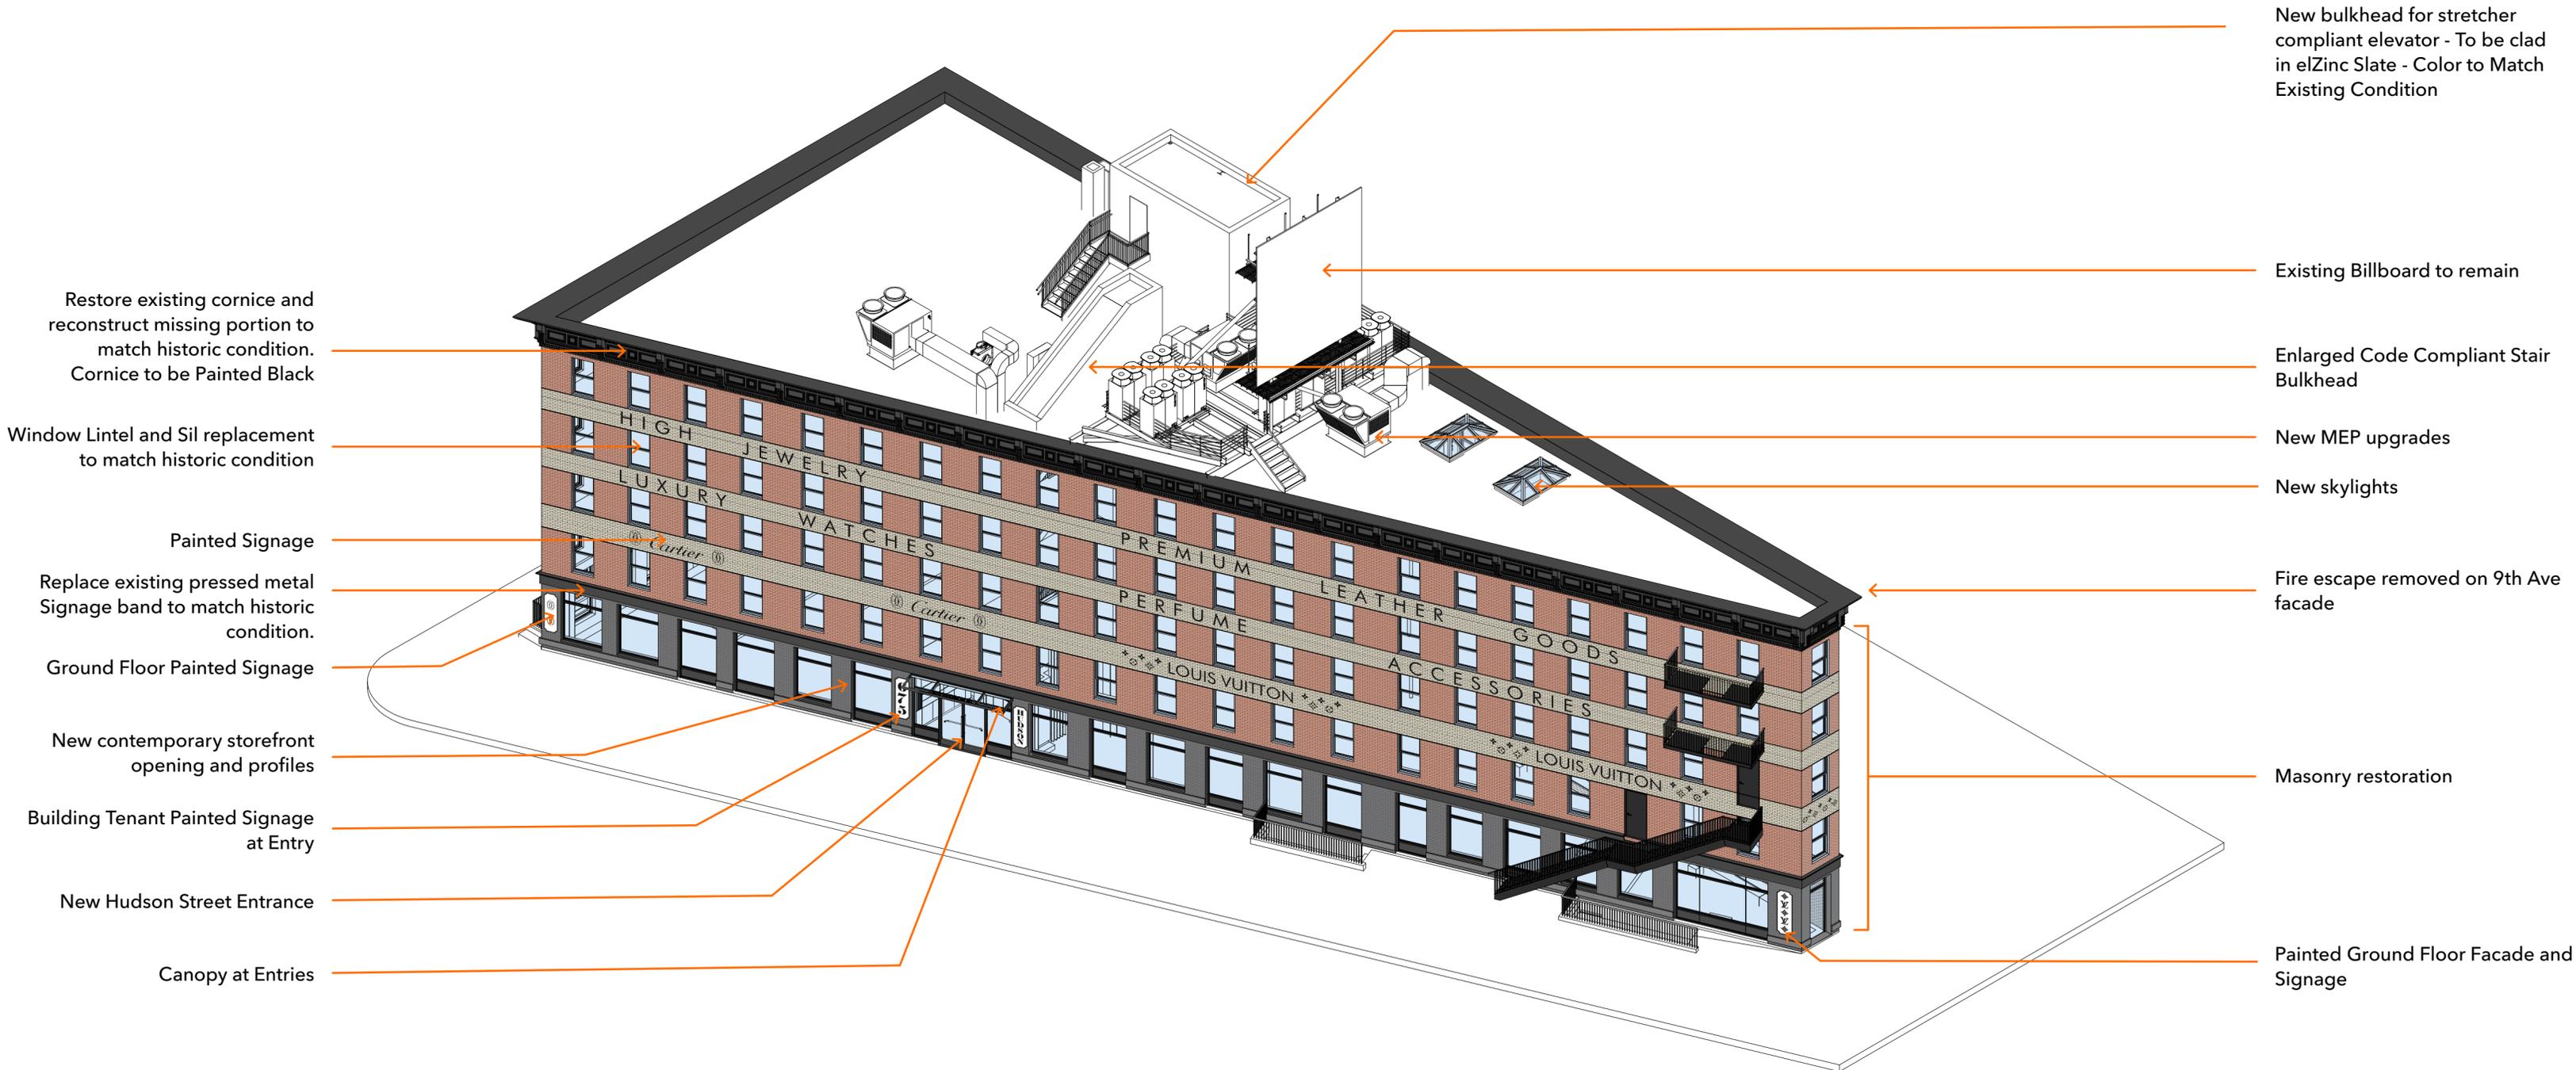
Existing vs Proposed Work - Proposed New Design

- Restore existing cornice and reconstruct missing portion to match historic condition. Cornice to be Painted Black
- Window Lintel and Sil replacement to match historic condition
- Painted Signage
- Replace existing pressed metal Signage band to match historic condition.
- Ground Floor Painted Signage
- New contemporary storefront opening and profiles
- Building Tenant Painted Signage at Entry
- New Hudson Street Entrance
- Canopy at Entries

- New bulkhead for stretcher compliant elevator - To be clad in eZinc Slate - Color to Match Existing Condition
- Existing Billboard to remain
- Enlarged Code Compliant Stair Bulkhead
- New MEP upgrades
- New skylights
- Fire escape removed on 9th Ave facade
- Masonry restoration
- Painted Ground Floor Facade and Signage

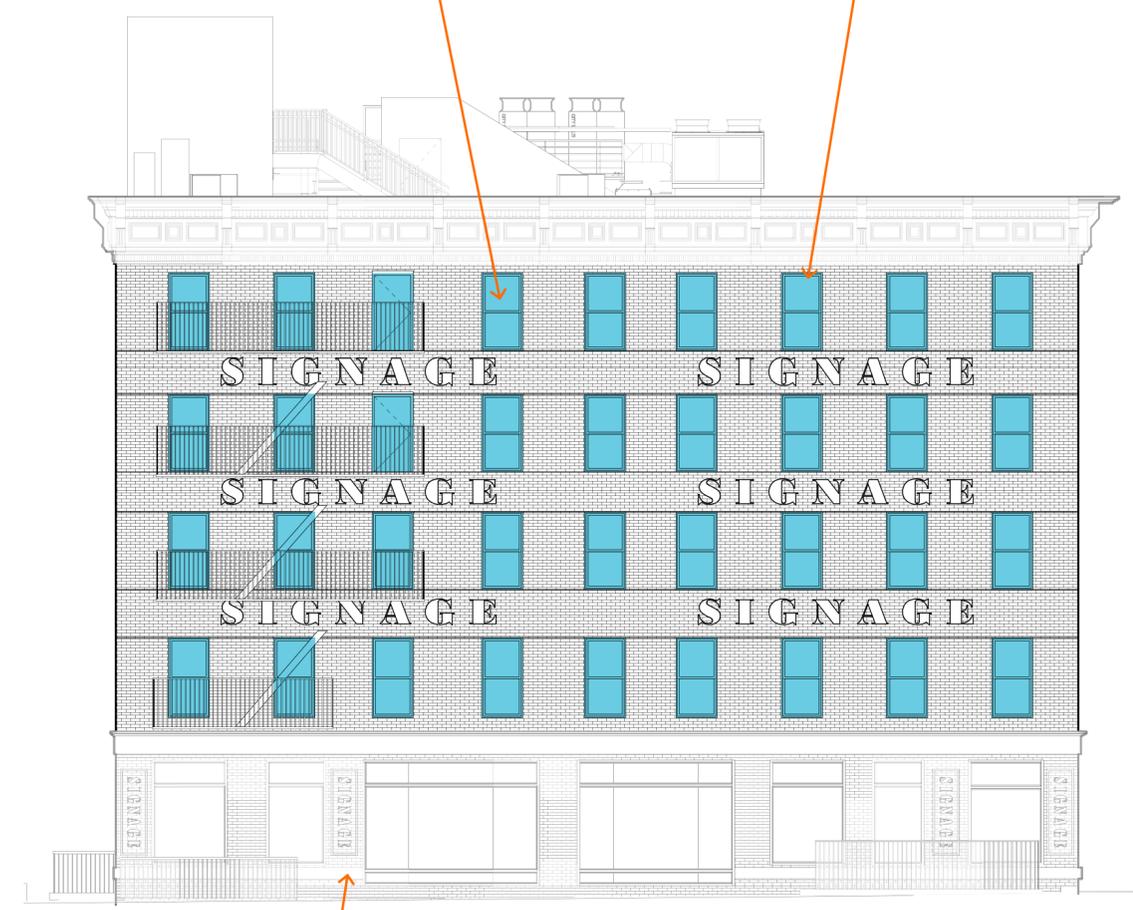
New aluminum window replacement to match historic

Lintel and Sills to be replaced. Cast Stone to match historic brownstone

Typical brick restoration as required
