Preservation Department – Item 2, LPC-24-07729

### Governors Island – Building 140 – Governors Island Historic District Borough of Manhattan

Governors Island Adaptive Reuse LPC Commission

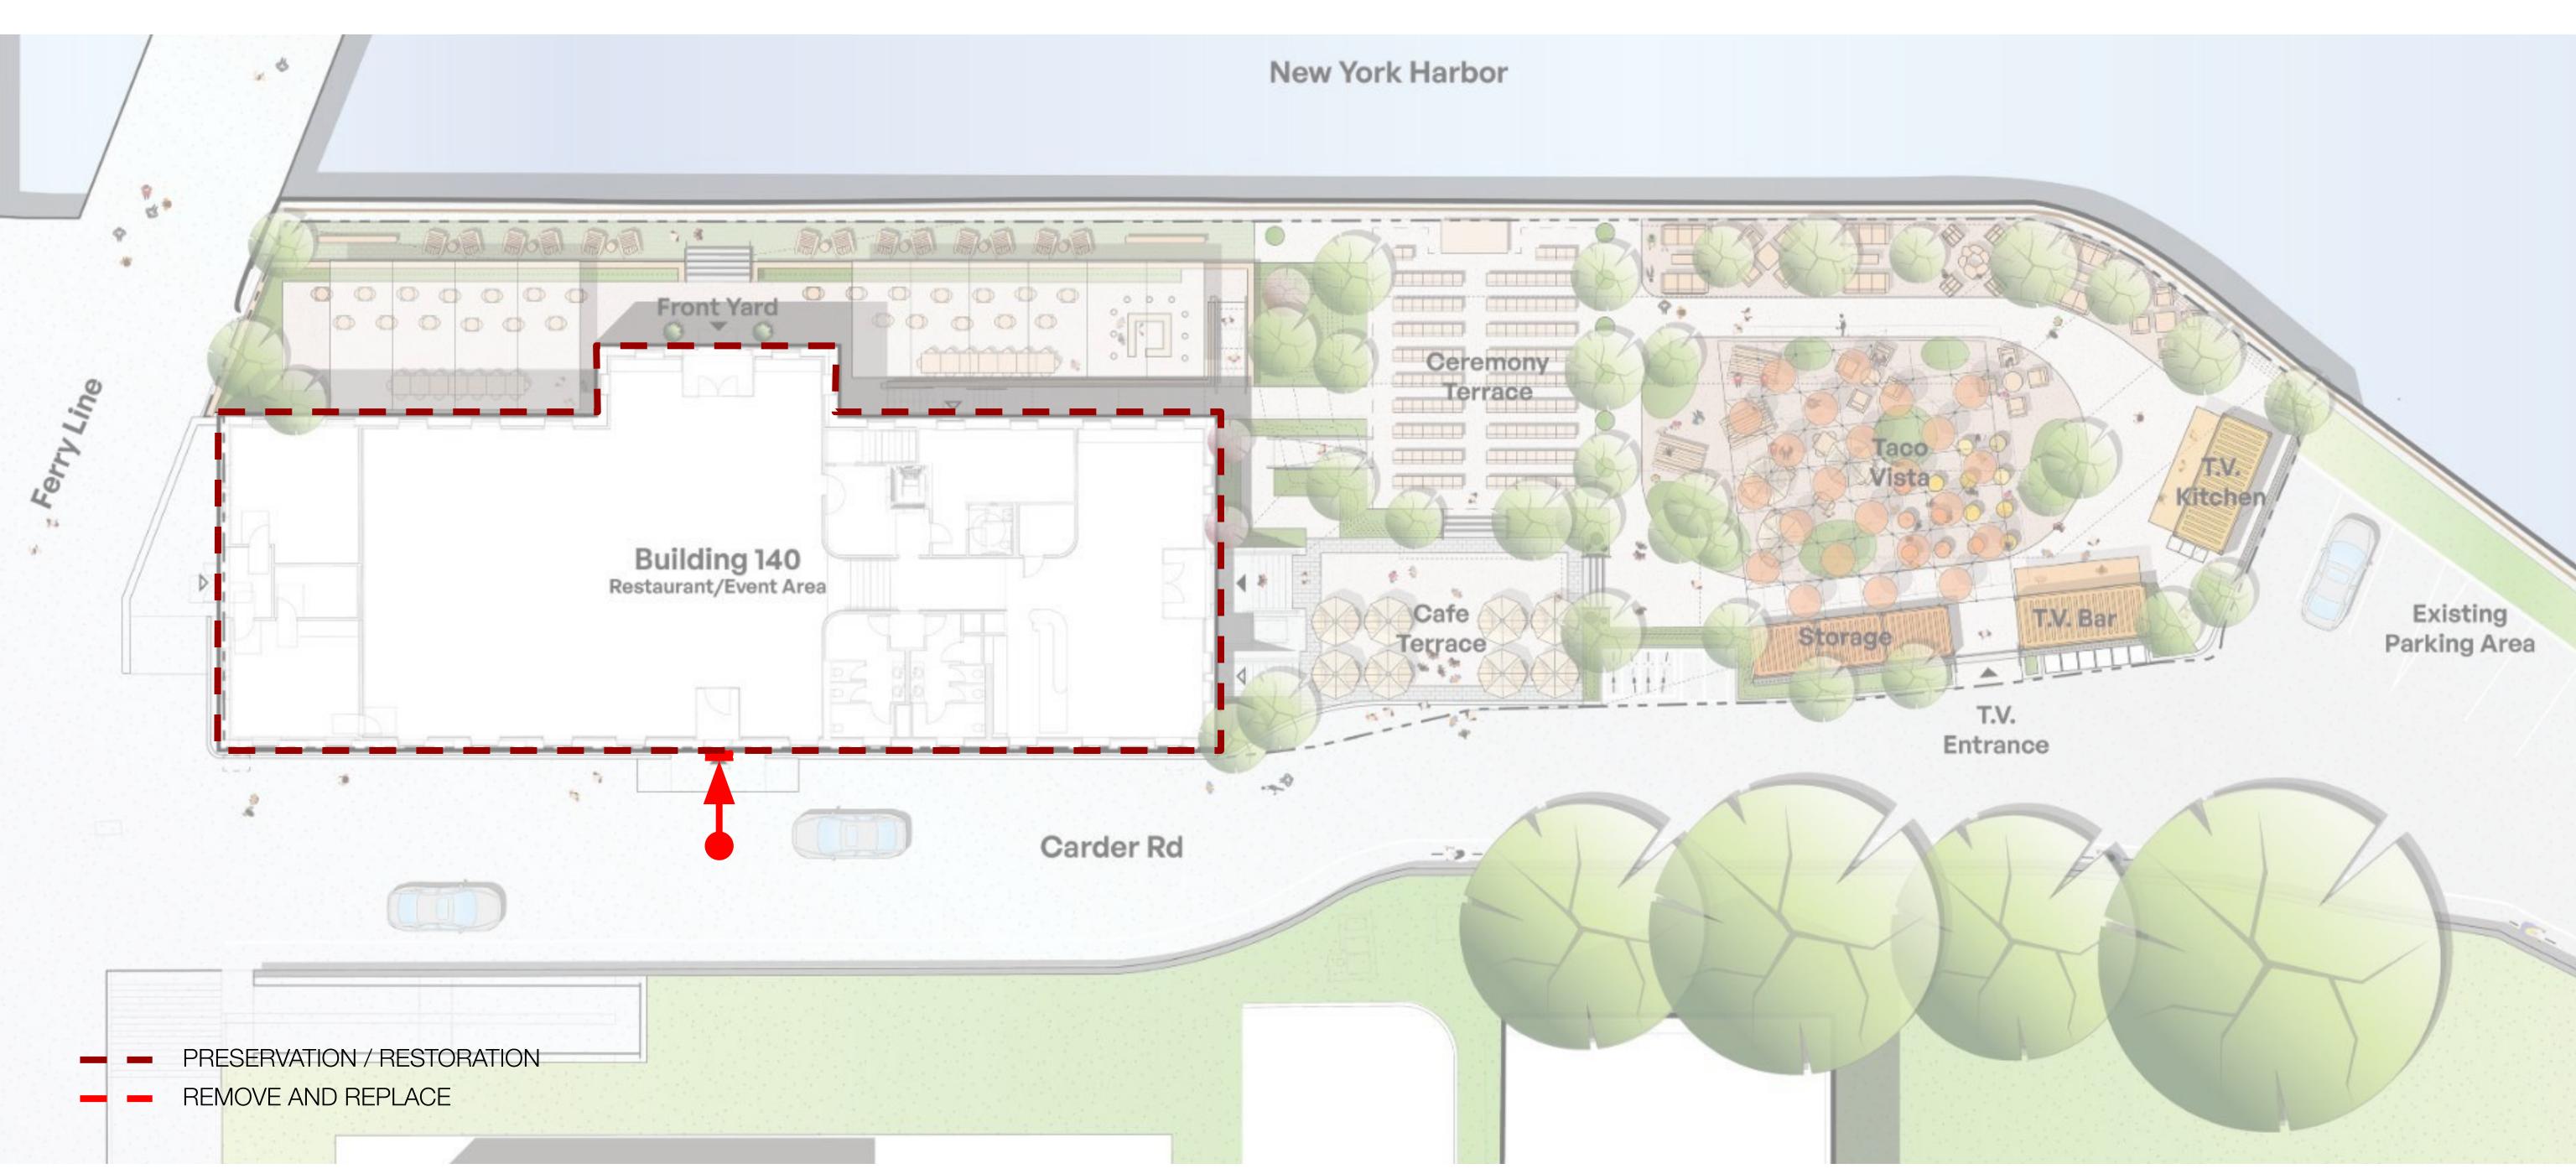
Request #3: Remove existing window and install new door at Carder Road

CUT AND REMOVE ——
EXISTING BRICK MASONRY,
BROWNSTONE BELT
COURSE AND VENT LOUVER
FOR NEW DOOR
INSTALLATION

REMOVE AND DISCARD EXISTING WINDOW,
PROVIDE SHORING FOR NEW DOOR
OPENING CONSTRUCTION; PROVIDE NEW
DOOR, FRAME, AND SURROUND.

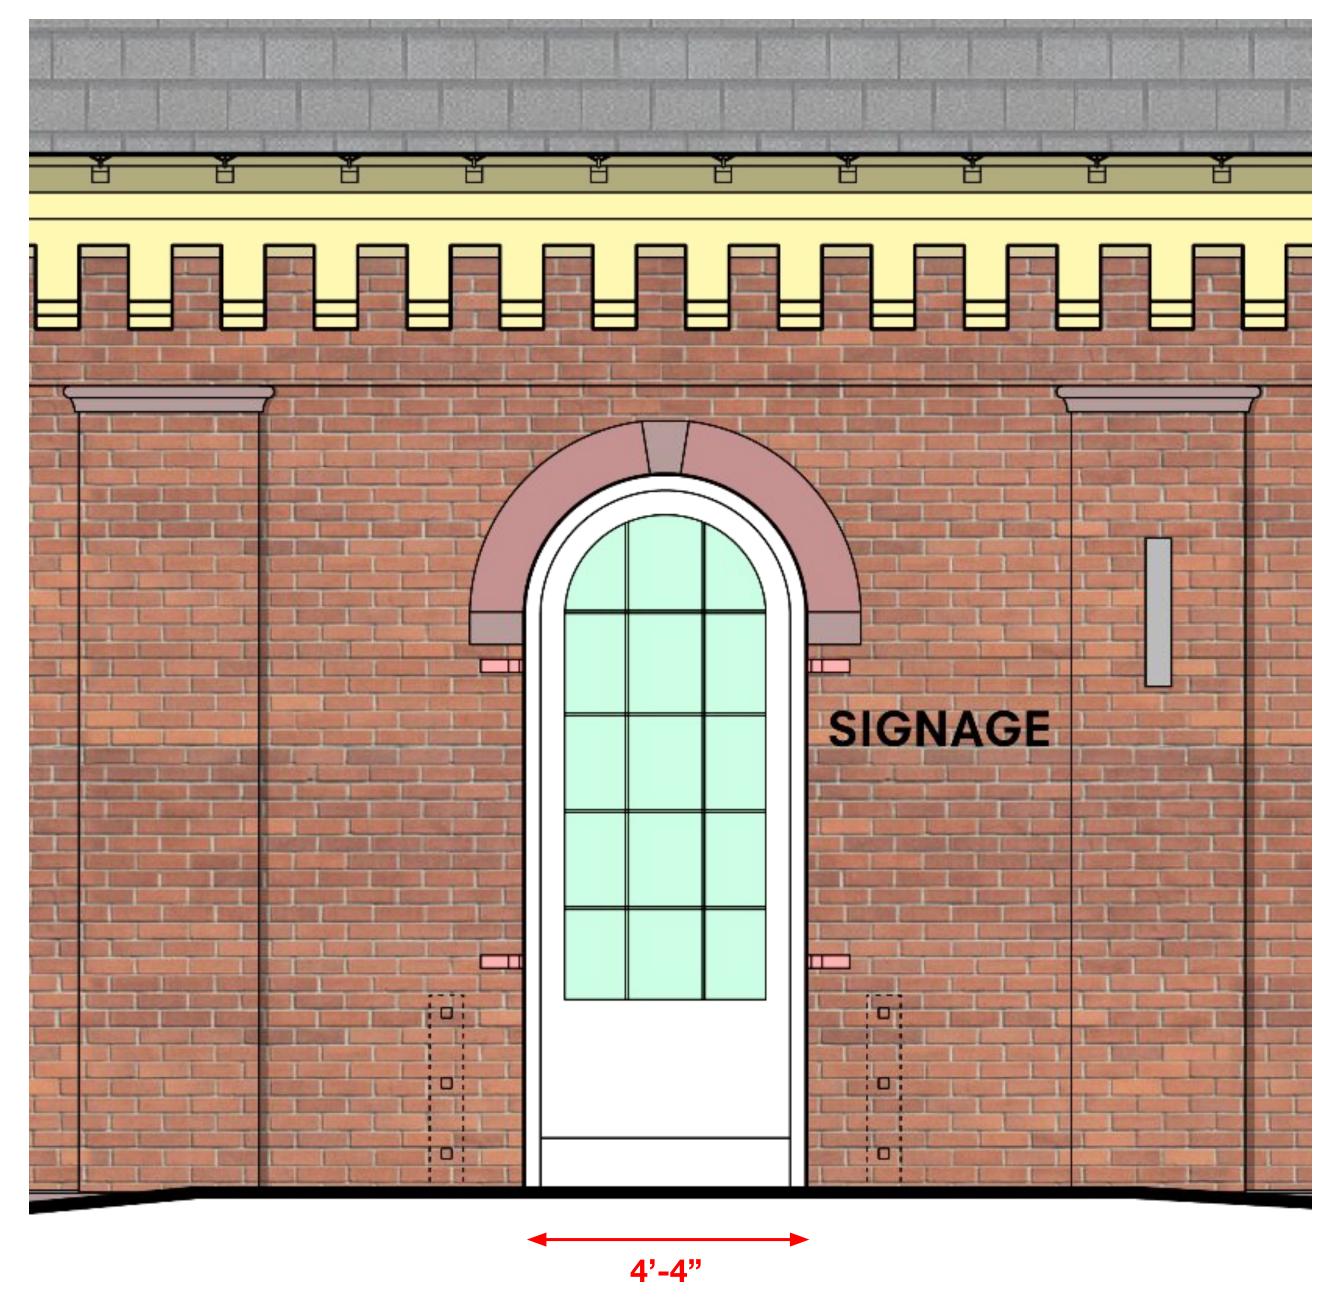
Carder Rd Entrance - Proposed Conditions

REMOVAL AND REPLACEMENT

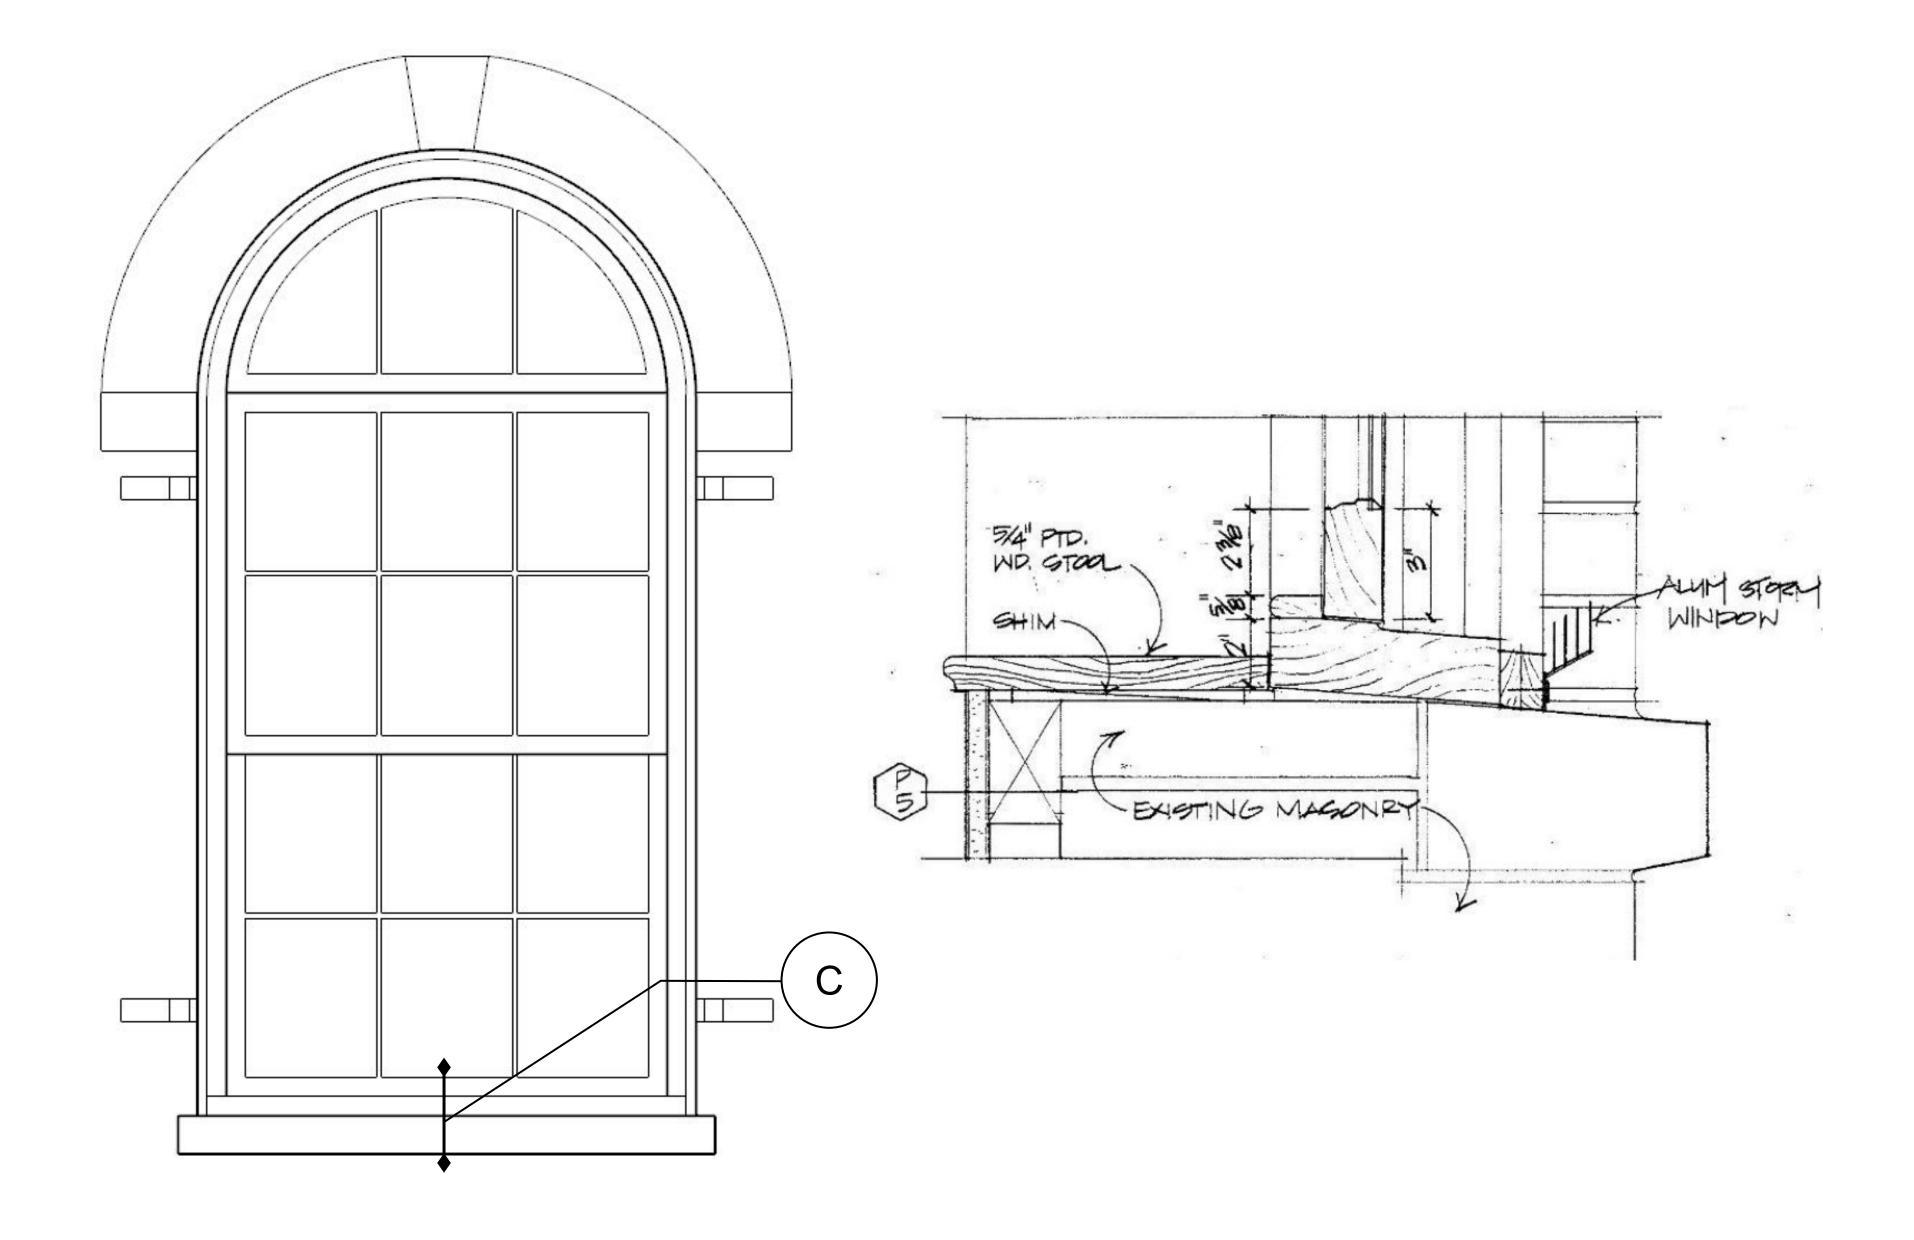
**Typical Exterior Double Hung Window Elevation**

C\_WOOD SILL DETAIL

C\_ALUM SILL DETAIL
