**381 West End Avenue – West End - Collegiate Historic District
Borough of Manhattan**

*As-Built / Proposed Revisions
of Secondary (West) Façade
Window Configuration for
381 West End Ave*

*presented to:
Landmarks Preservation Commission
June 17, 2025*

presented by: Altin Batska, XXII Eleven LLC

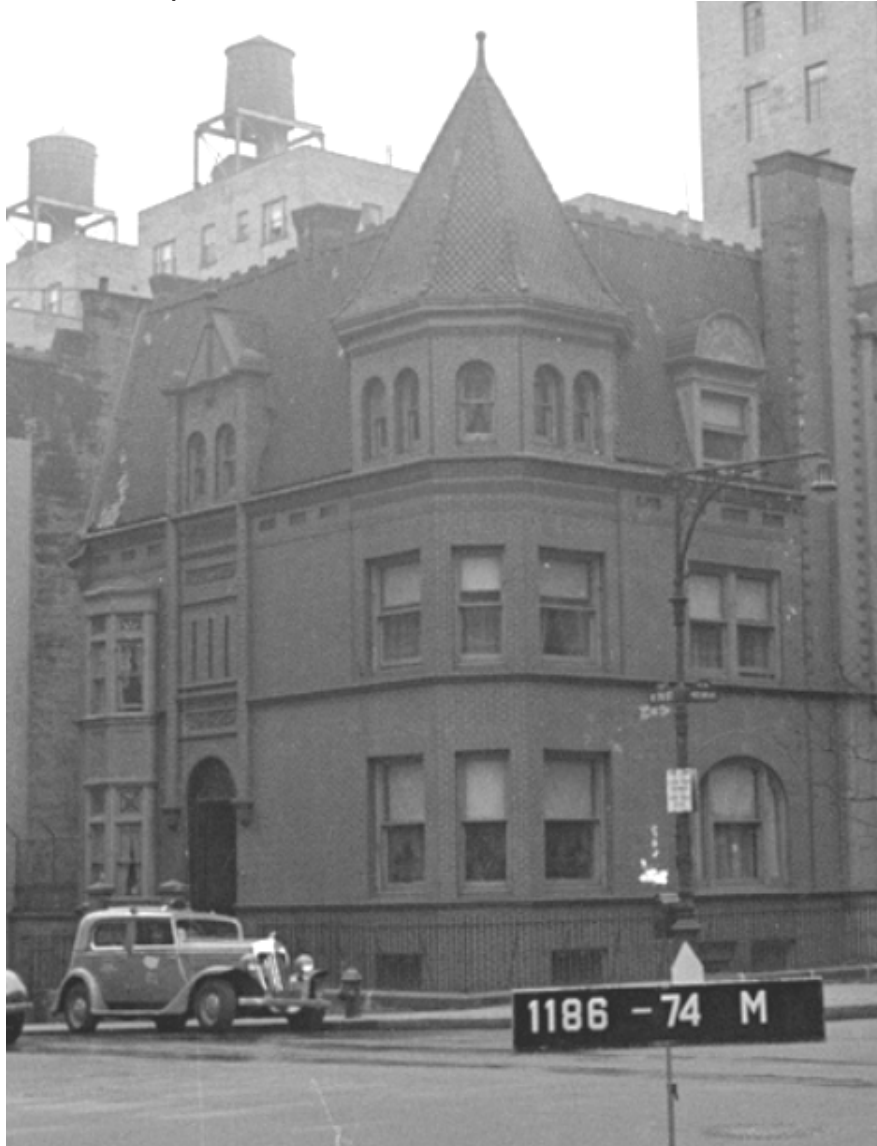
historical photo circa 1940

- 1886 Construction of Original Building
- 1940 Earliest Available Historic Photo – all original features apparently intact
- 1979 Sometime before this date the building lost many of the original architectural details
- 1984 Building Designated as Landmark as part of the West End Collegiate Historic District
- 2018 Building gut renovation and entire façade restoration project approved by LPC
- 2021 (January) Project stalled. Building unsafe. DOB mandated sidewalk bridge. Change of Ownership.
- 2021 (June) LPC Staff approves changes proposed by new ownership

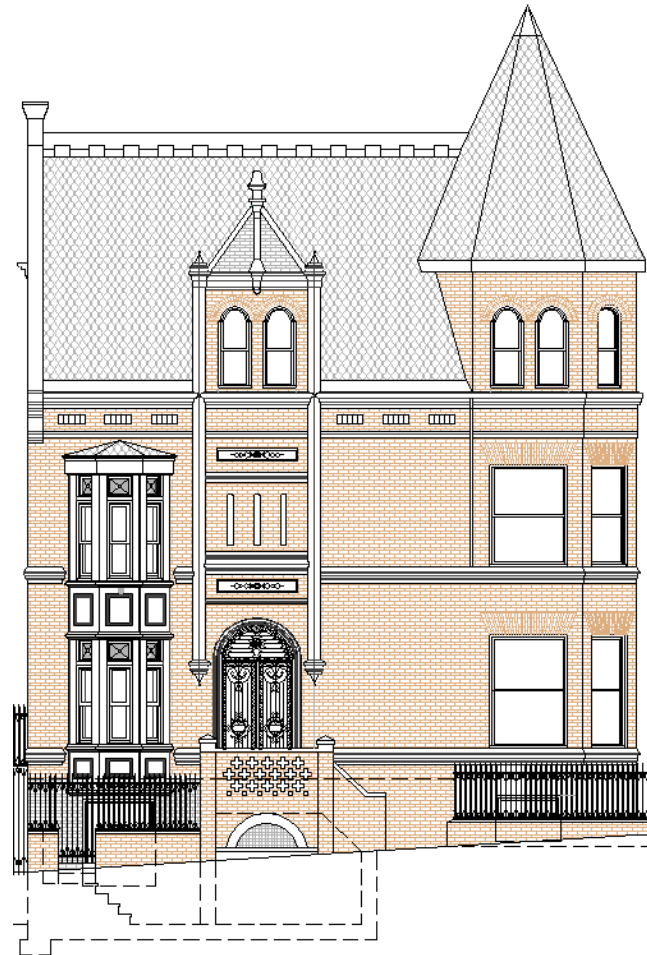
South Façade

2018 LPC Approved Scope

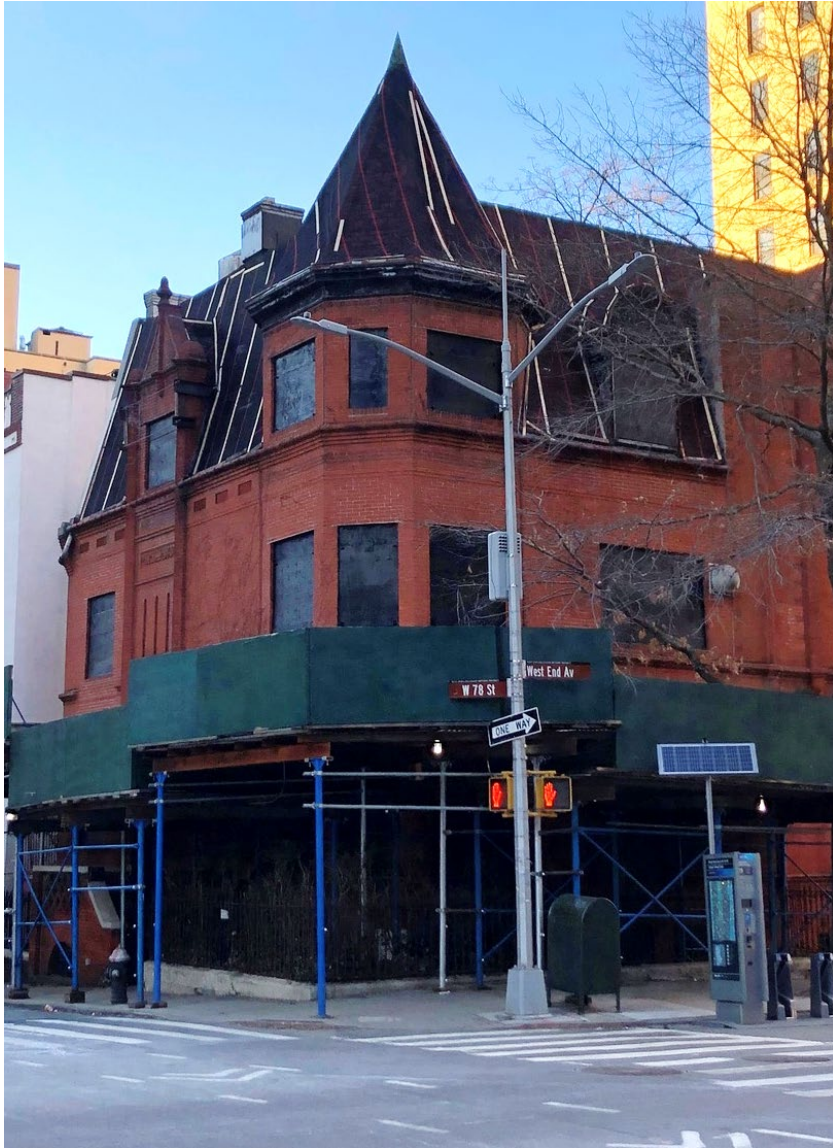
2021 photo

Project Status at change of Ownership:

- Stuck in litigation – NYC DOB withheld issue of permit for proposed improvements.
- Building declared unsafe to public by DOB.
- DOB-mandated sidewalk bridges installed

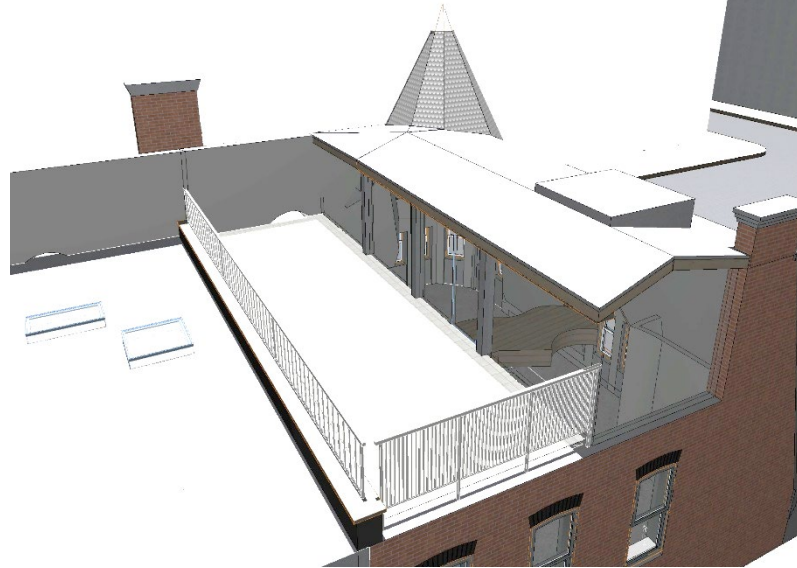
2021 – approved Rooftop Addition

- Replaced the Rooftop addition with a Bulkhead / Clerestory.
- Relocated elevator from shared north wall to the west wall, thus resolving the neighbors / CB7 main objection
- Height of Rooftop Addition was reduced from 50" to (currently) 14" above mansard elevation, essentially making the addition non-visible from public view.
- Removed excavation of cellar level from scope, thus removing a major disruption to the neighbors.
- (subsequently) Reconstructed the shared East Chimney at this owner expense, securing approval from neighbor and LPC Staff

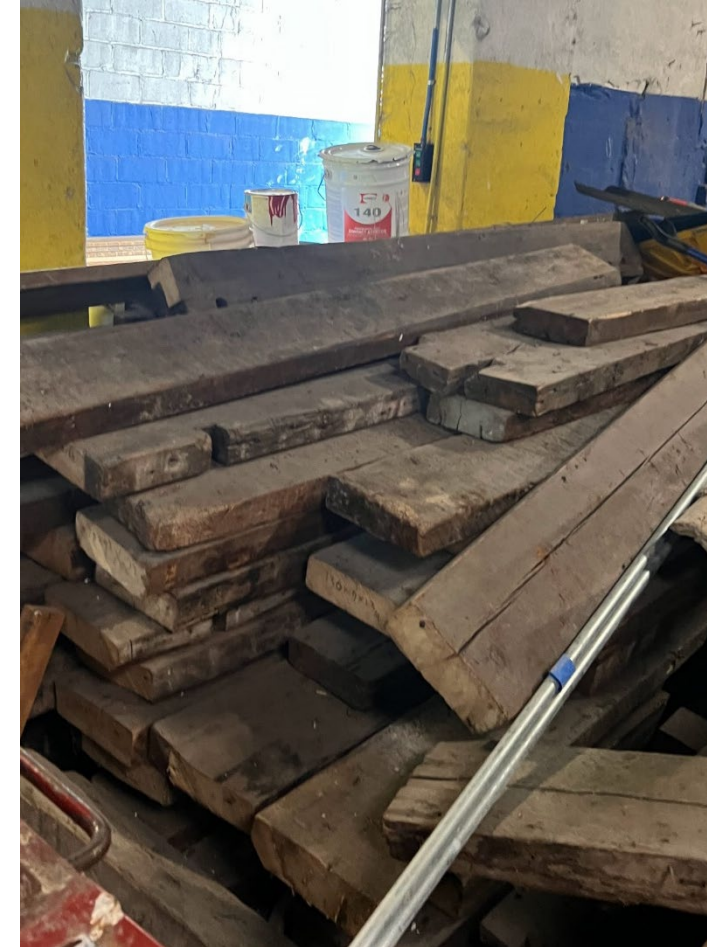
photo of original wood joists

Most existing joists were saved to be reused and repurposed for stair cladding and other millwork.

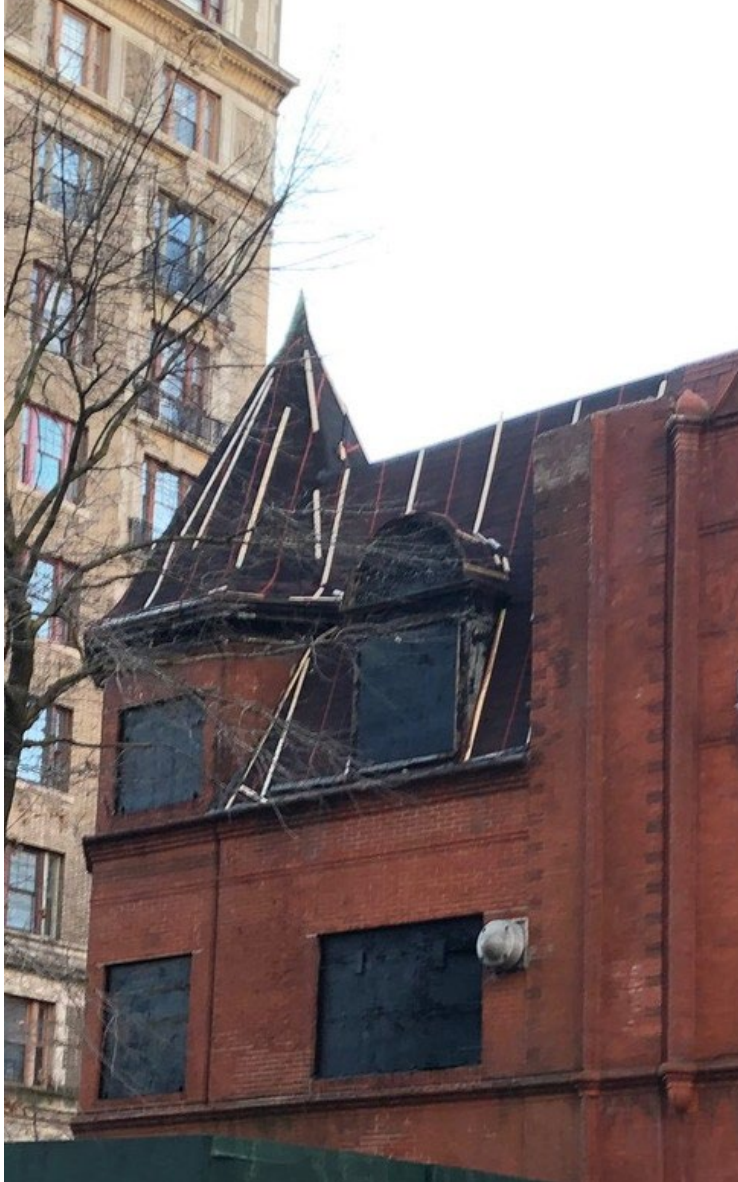
East Façade – 2021 photo

Additional Items Added during Restoration:

- Refabricated cornice details around the turret eve
- Refabricated all architectural details of the East Dormer.
- Reconstructed East Chimney

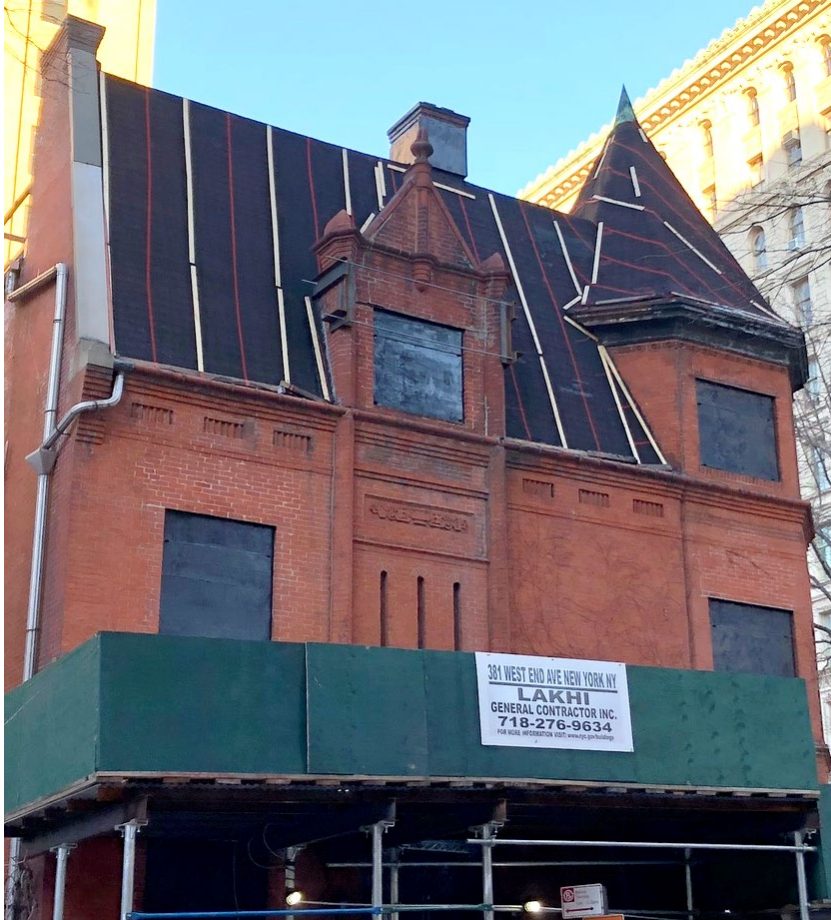
South Façade – 2021 photo

Additional Items Added during Restoration:

- Structurally reconstructed the South Dormer.
- Structurally reconstructed the West Chimney

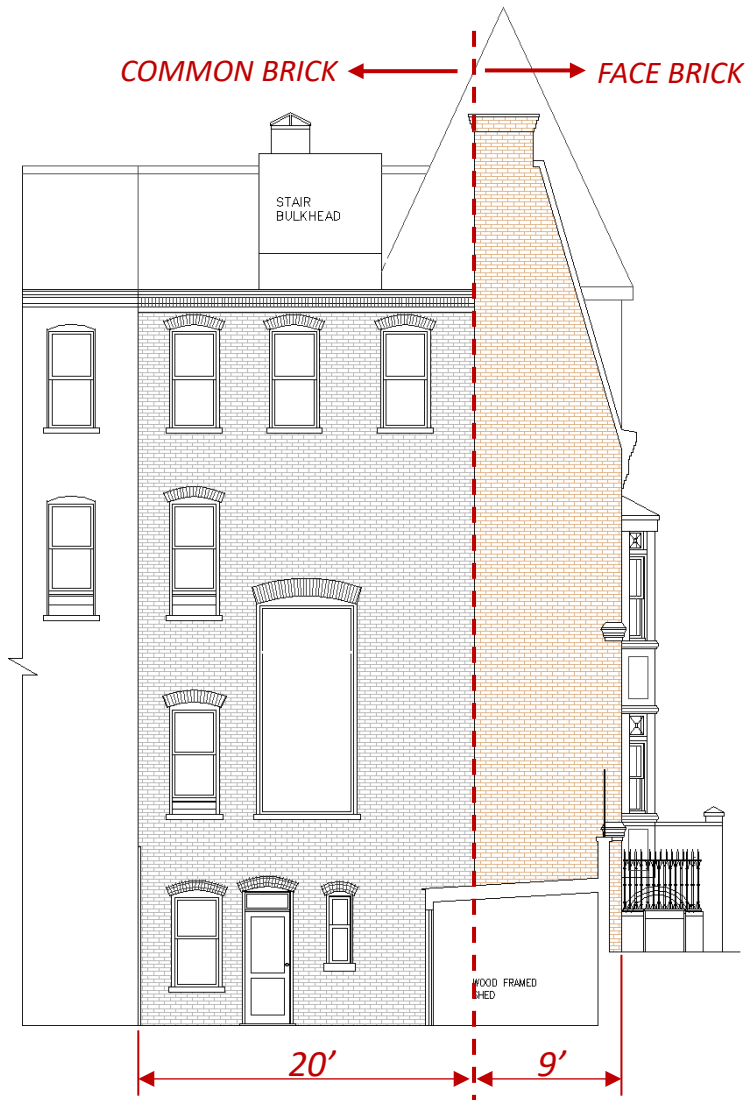
1886 Original Design

- The secondary (west) façade is *intentionally* designed in two distinct sections: Face Brick, and Common Brick.
- This deliberate differentiation clearly signals a *hierarchy of visibility* and *architectural intent*.
- Common brick section of the West Façade is *transiently visible*
- Window configuration seems a *function of interior layout*

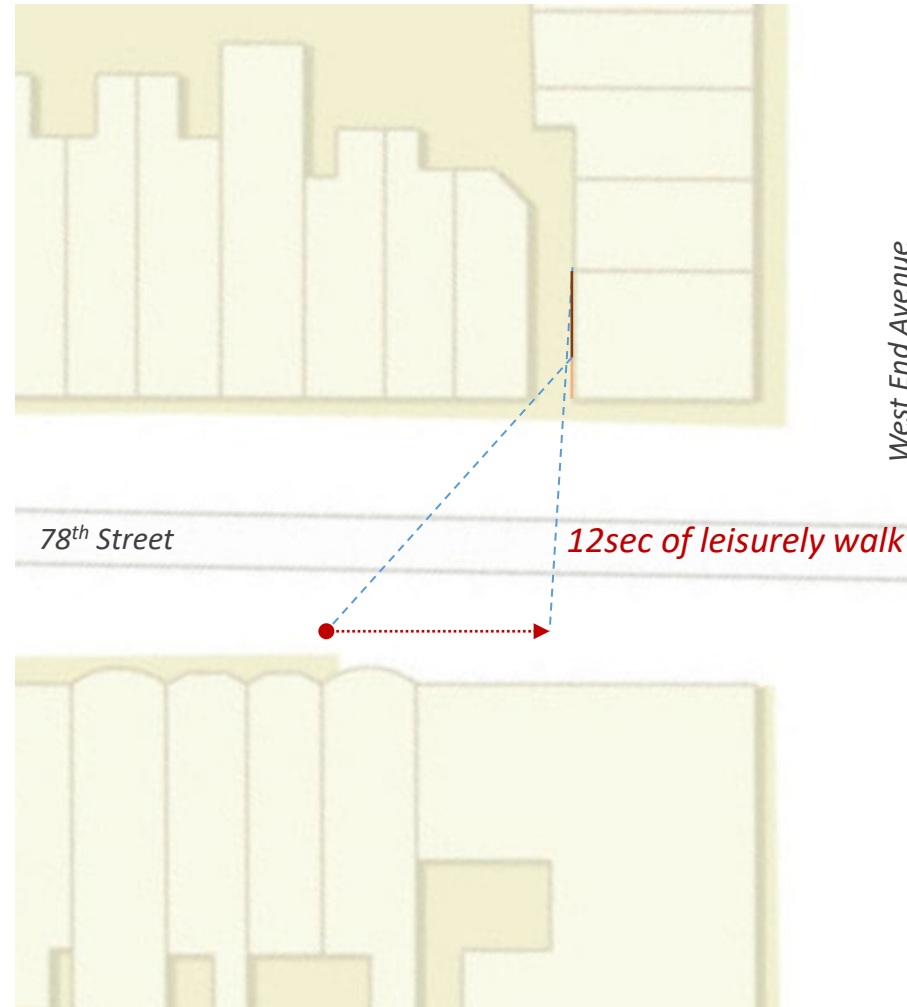
Secondary Façade Visibility from Opposing 78st Sidewalk

... a secondary façade is “minimally visible” if the façade is seen at such an angle that the configuration of the windows cannot be seen or is very difficult to discern, or *only a small portion of the façade is seen through a gap in the streetwall* and is visually disconnected from the primary façade of the building.

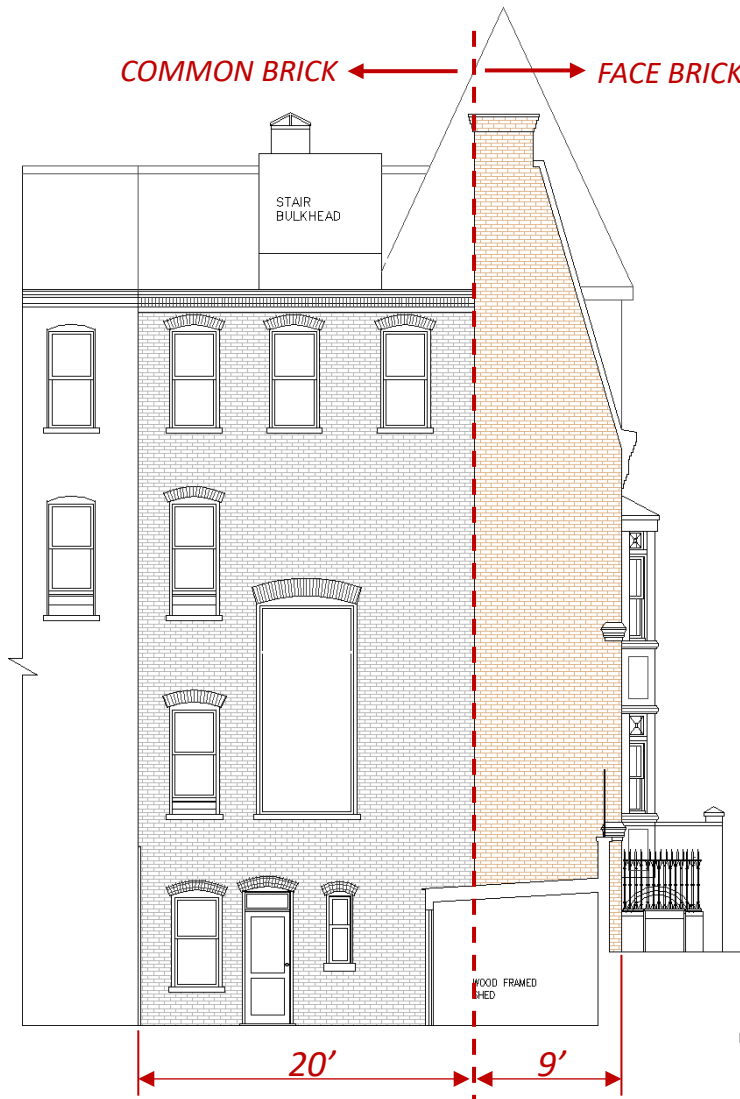
1886 Original Design

- The secondary (west) façade is *intentionally* designed in two distinct sections: Face Brick, and Common Brick.
- This deliberate differentiation clearly signals a *hierarchy of visibility* and *architectural intent*.
- Common brick section of the West Façade is *transiently visible*
- Window configuration seems a *function of interior layout*

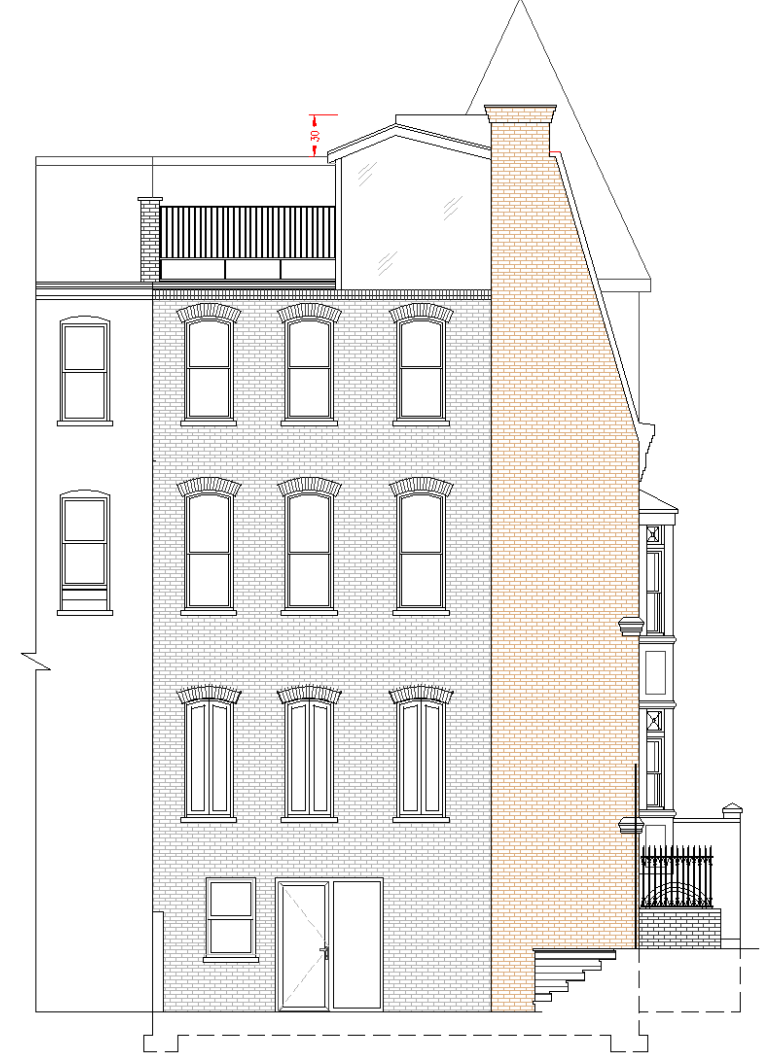
Currently Approved Elevation

380 SF Openings

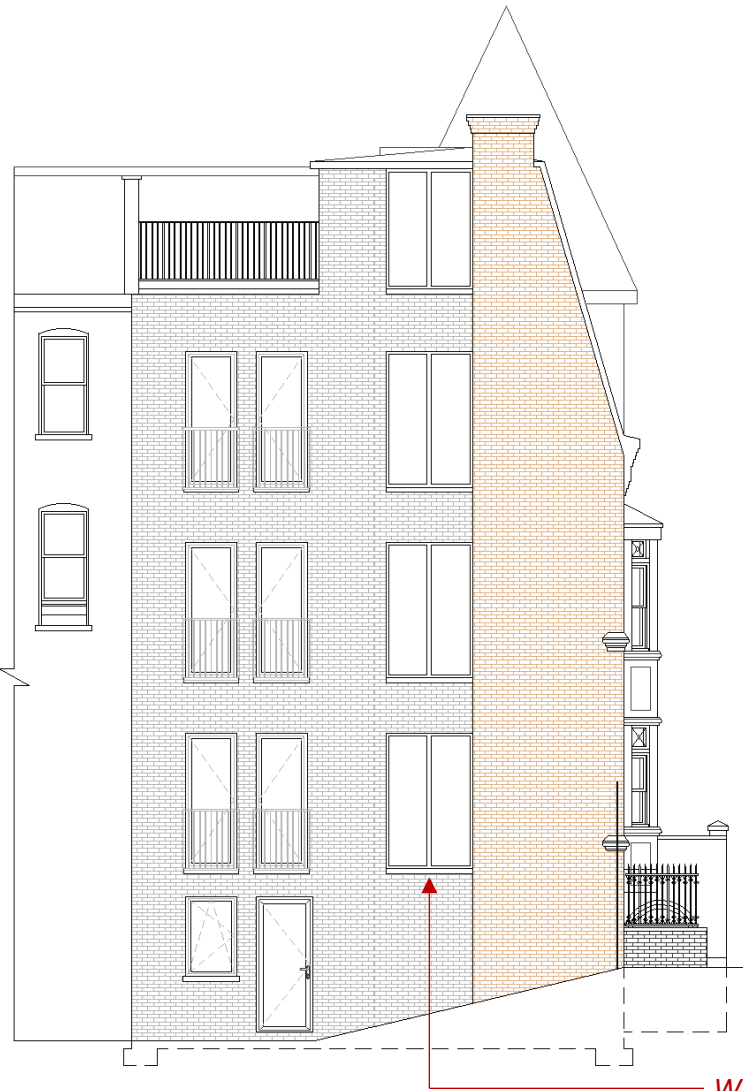
2025 – As-Built / CB7 Approved

344 SF Openings

Window column aligned with center of elevator

Relocation of Elevator triggered a new interior layout, which in turn triggered a need for a revised West Façade window configuration

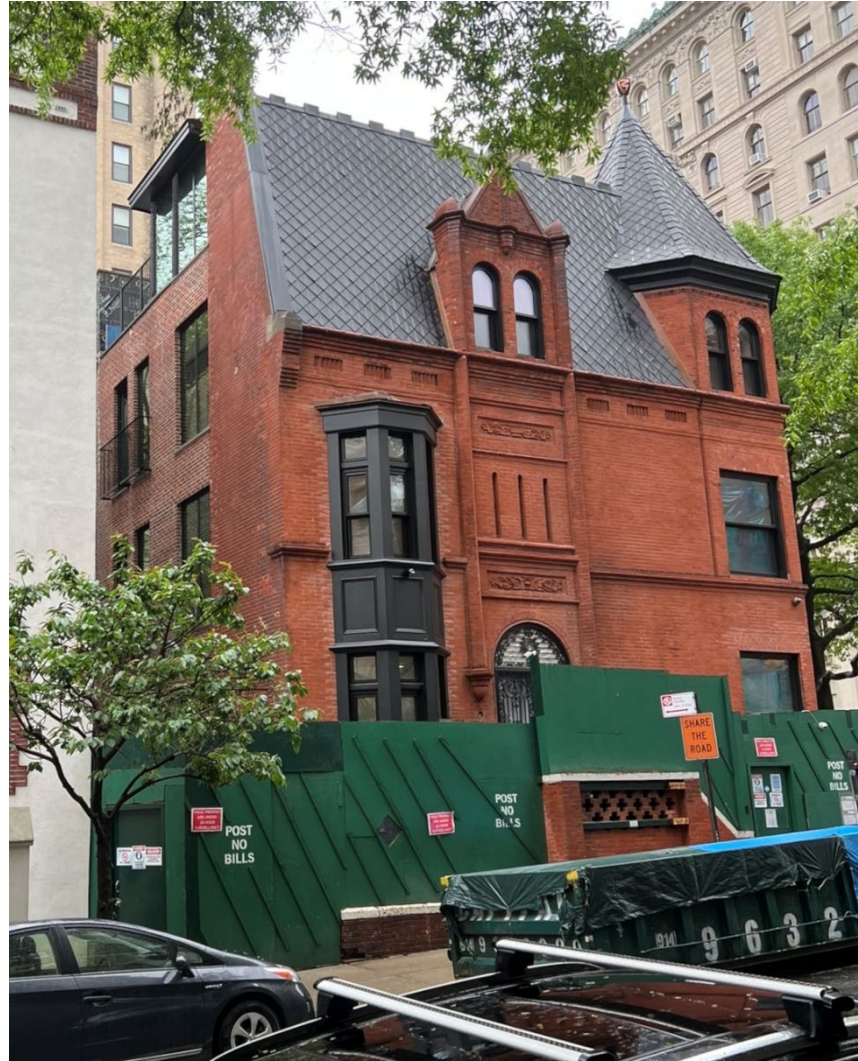
Proposed (rendering)

- *The proposed layout maintains architectural intent and hierarchy of visibility*
- *Consistent with original design the window configuration is a function of interior layout*
- *The proposed bulkhead revision maintains the original roof line and brings this layout much closer to the currently approved version.*
- *The limited and transient visibility of the common brick section of the Secondary Façade does not compete with the primary facades in texture, color or composition.*
- *Proposed change improves on as-built elevation which CB7 approved*
