10 East 82nd Street

Landmarks Presentation
July 2025

SUK | design studio
ARCHITECTURE

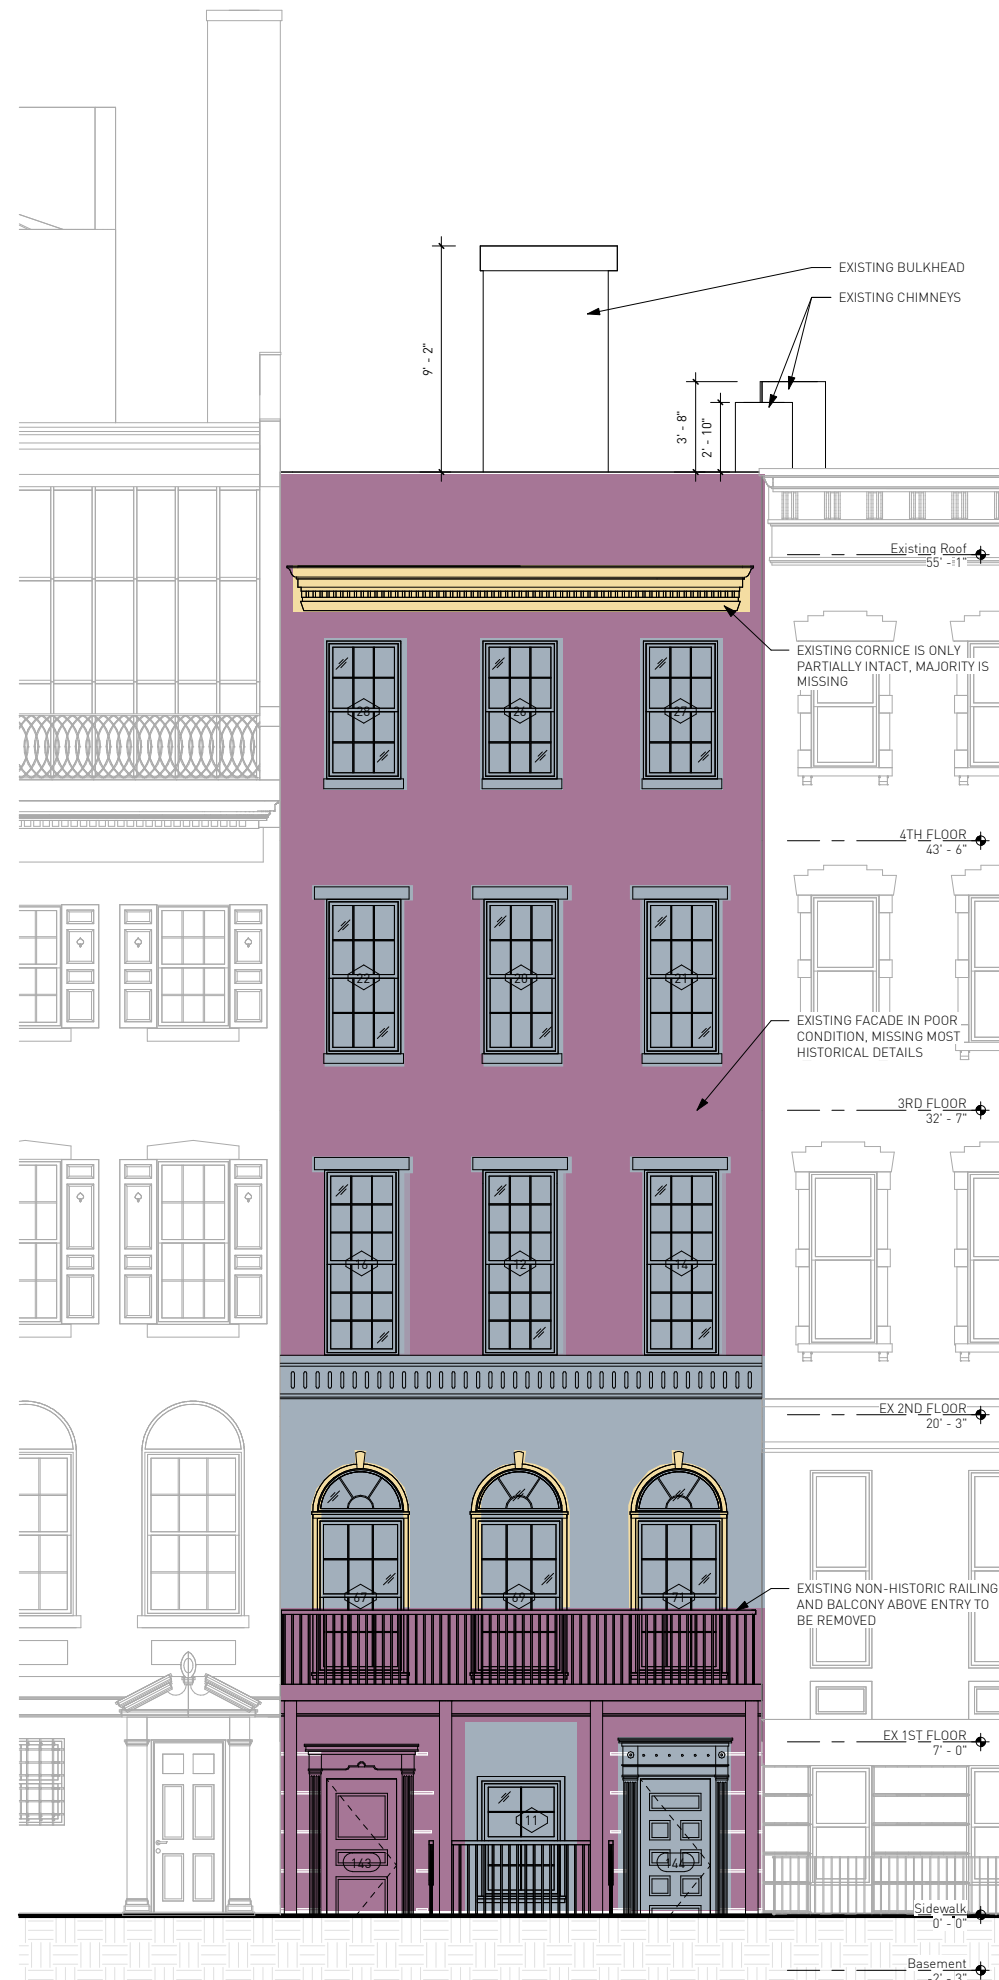
1970s designation photo

new wrought iron balcony added over front entrances

left entrance has new enframement

1940s enframement on the right entrance is altered, the top portion is removed

entire facade is painted with lintels and cornice in dark color

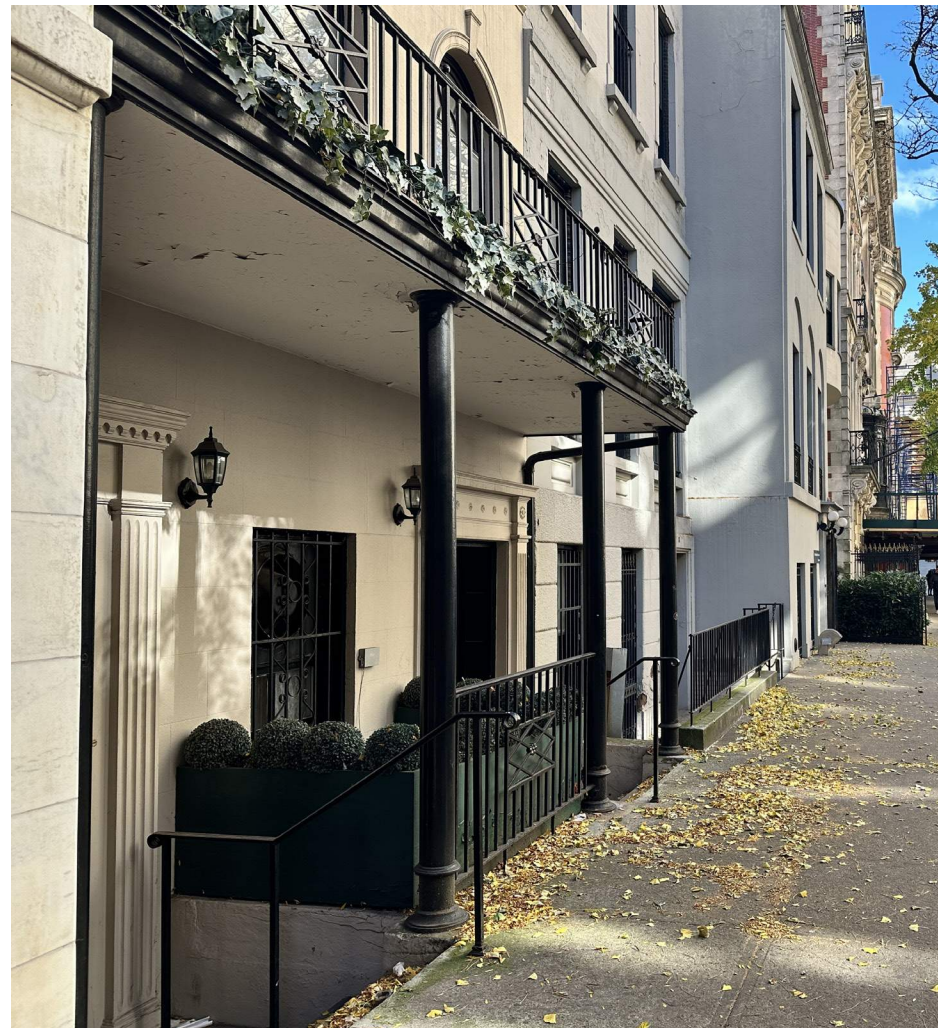
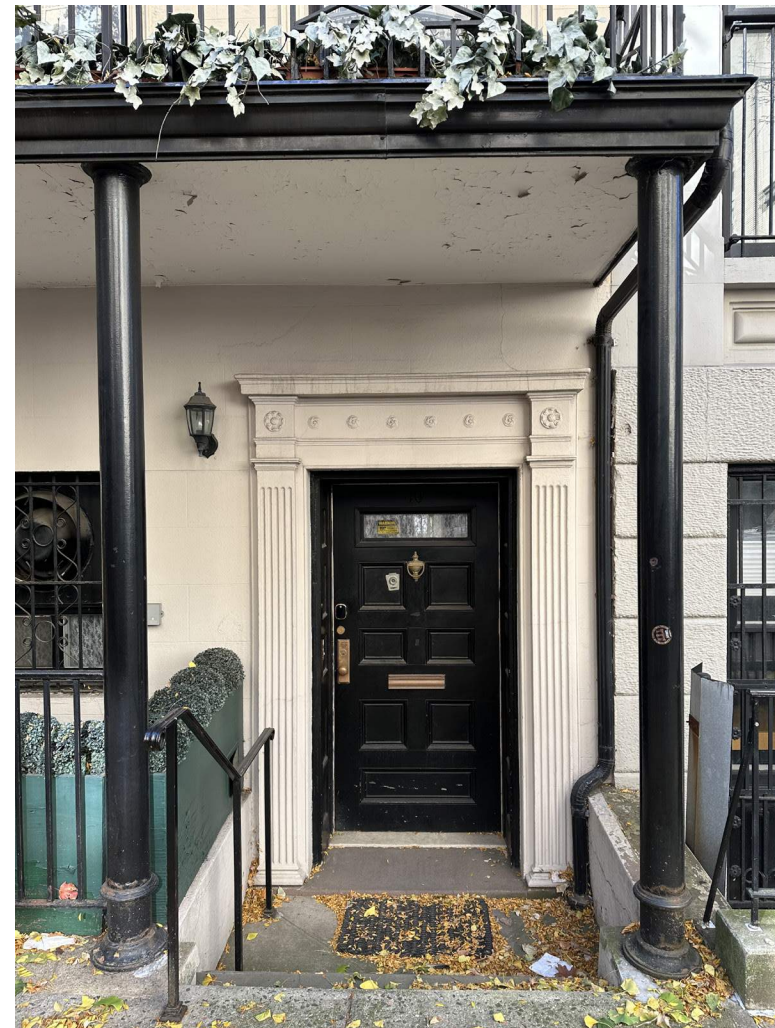
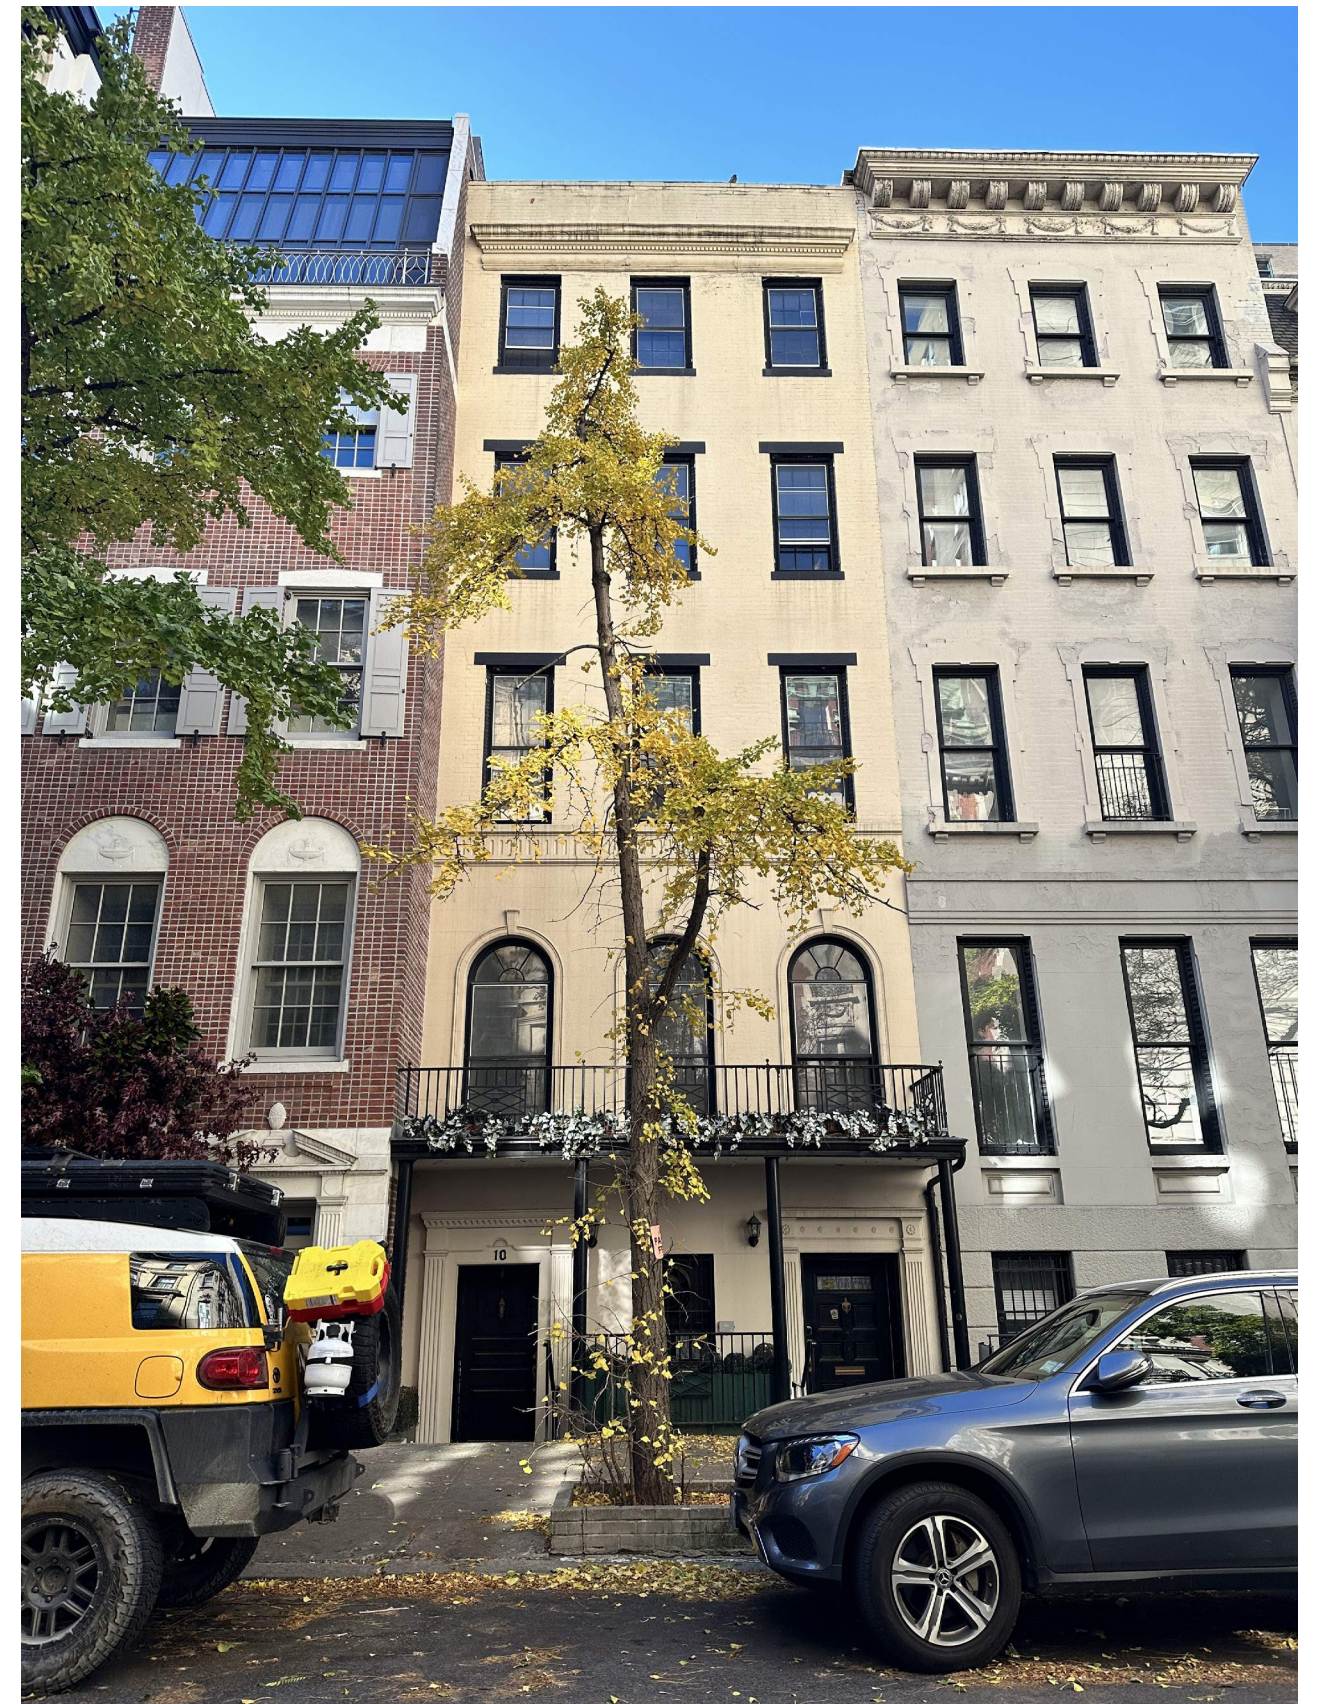
existing conditions

cornice has been repainted to match facade color

trim around parlor windows has been painted to match facade color

facade is cracking and paint is peeling off of brick

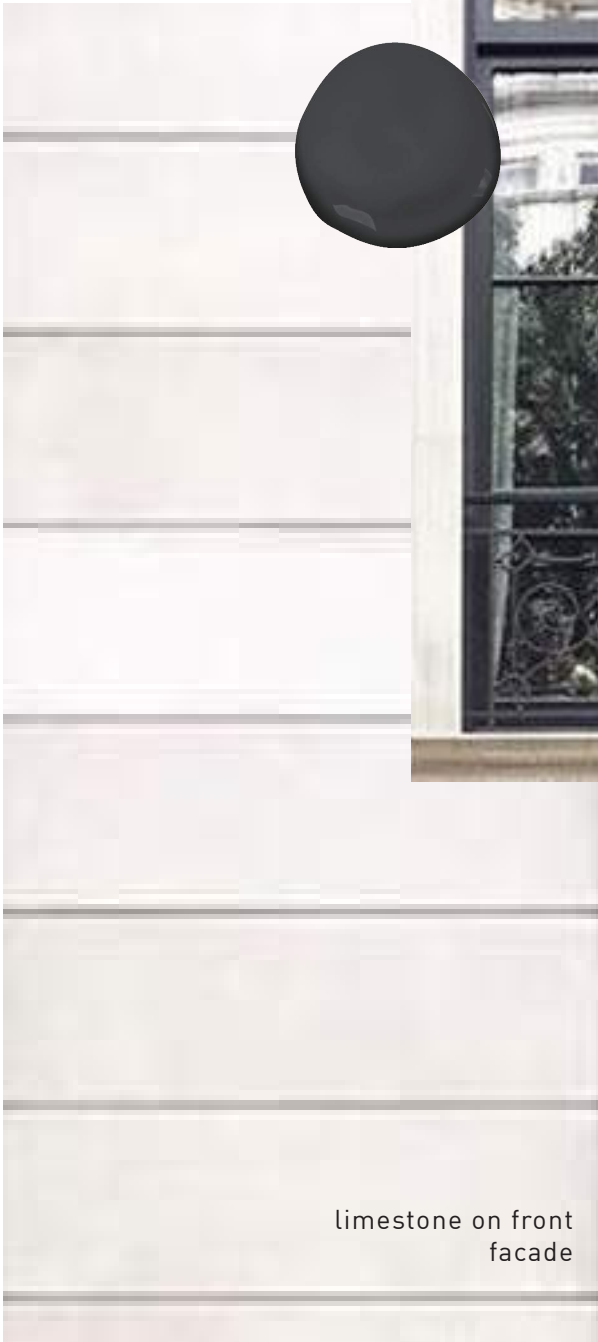
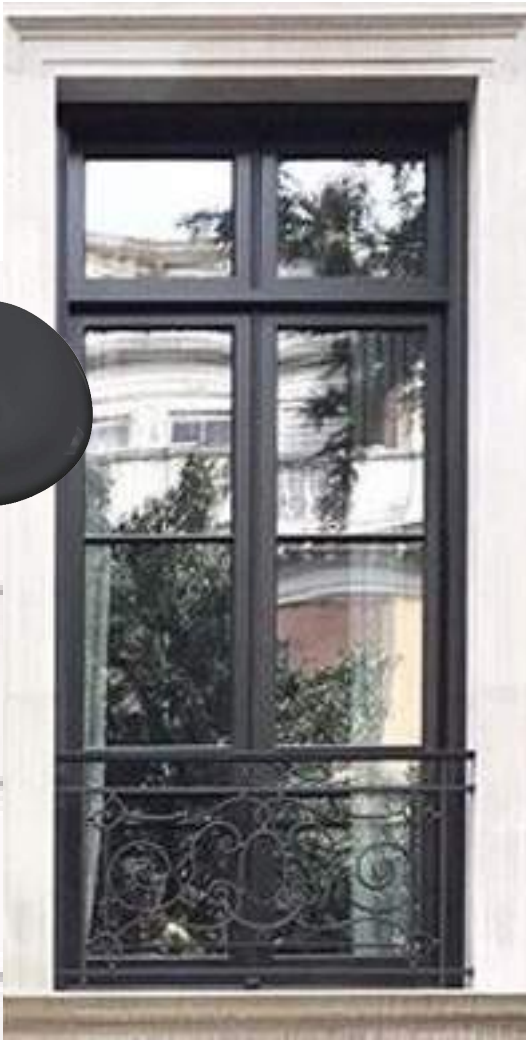
wrought iron railings at
parlour floor and areaway
(see elevations for design)
