**Preservation Department – Item 4, LPC-25-12136**

**2 Park Place – Woolworth Building – Individual and Interior  
Landmark  
Borough of Brooklyn**

# WOOLWORTH PINNACLE

LANDMARKS PRESERVATION COMMISSION PUBLIC HEARING

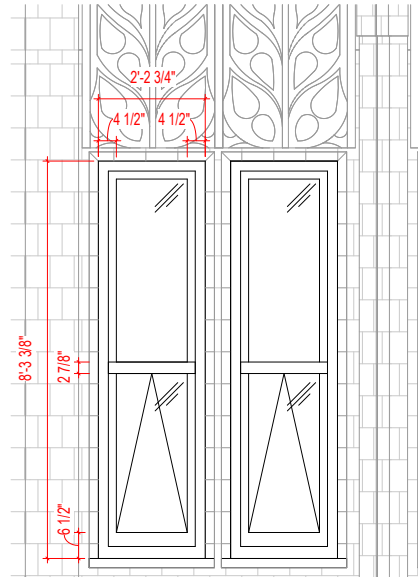
**TYPICAL EXISTING CONDITION**  
 - NO INSULATION  
 ~10.5 SF OF VISION AREA

WUFI analysis and detail thermal studies have been conducted to determine the best solution for renovating the interior side of the exterior walls.

The existing position of the windows within the plane of the terracotta and brick masonry construction. Masonry does not have a low rate of conductivity per inch, in the same way continuous insulation or an IGU would have. The current position of the window, without insulation at the interior, creates a thermal bridge around the perimeter (Figure 2). If insulation is added, there is still a thermal bridge that may result in condensation risk (Figure 3).

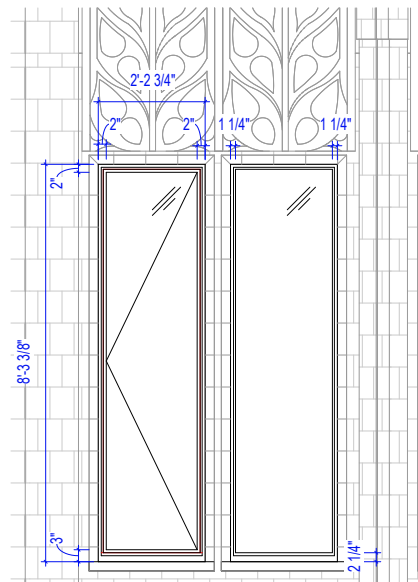
**TYPICAL PROPOSED CONDITION**  
 - 2" INSULATION  
 ~16.5 SF OF VISION AREA - FIXED WINDOW  
 ~14.9 SF OF VISION AREA - OPERABLE WINDOW

**Proposed condition mitigates moisture build-up within interior wall cavities, condensation at the perimeter edge of windows and doors, and improving the thermal performance and air barrier continuity.**

**In addition to the performance benefits, the proposed design also increases vision area by 60%**

It was determined that through a few small adjustments to the window location, it would minimize condensation risk while maintaining the historic significance of the exterior. The small moves were to shift the plane of the glass inboard < 5" inches to align with the 2" thick insulation boards and to nest the window framing ~ 1.5 inches at the jambs and head behind the masonry opening to minimize any thermal bridging through the window frames (Figure 4). The result is that condensation risk is successfully mitigated (Figure 5).

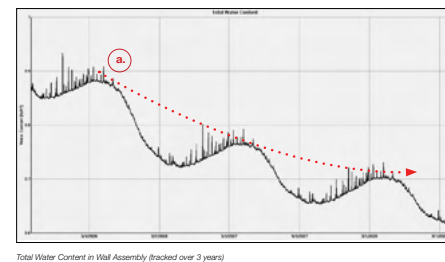
#### Thermal Analysis Studies / Opaque Wall WUFI Analysis

##### Opaque Wall 1\_Case Study #4\_Mineral Wool Insulation

a. Similar to Case Study #1 and 3, water content is observed steadily decreasing over the 3 year period, which is positive. The range of the total water content is similar to Case Study #1.

b. Relative humidity (RH) is maintained below 100%, limiting the risk of condensation within the wall cavity. Greatest risk is located near the vapor permeable air barrier layer.

c. Similar to Case Study #1, the Intello Plus variable relative humidity barrier is observed limiting vapor from entering into the wall cavity from the interior. The range of RH inside of the stud wall cavity is also lower, similar to Case Study #1.

SUMMARY: Overall, the wall assembly is successful in managing moisture content, within the assembly, as well as limiting condensation risk. Due to concerns with spray foam insulation, mineral wool insulation is also a more desirable insulation product.

Total Water Content in Wall Assembly (tracked over 3 years)

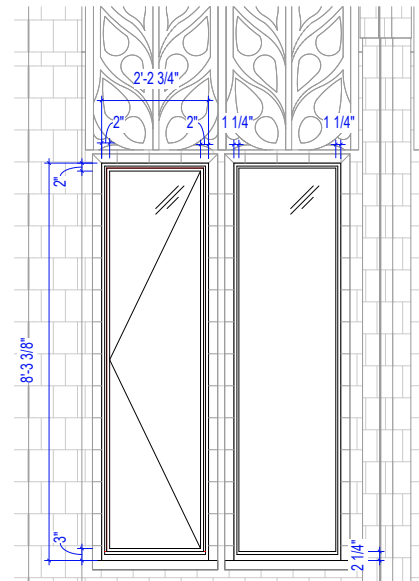
TYPICAL WINDOW  
REMOVE EXISTING DOUBLE HUNG  
WINDOWS AND REPLACE WITH  
FIXED AND OPERABLE WINDOWS TO  
INCREASE NATURAL DAYLIGHT

WINDOW FRAME SET BACK TO  
REDUCE THERMAL BRIDGING AND  
INCREASE THE UNIT'S ENERGY  
EFFICIENCY

TYPICAL PROPOSED CONDITION

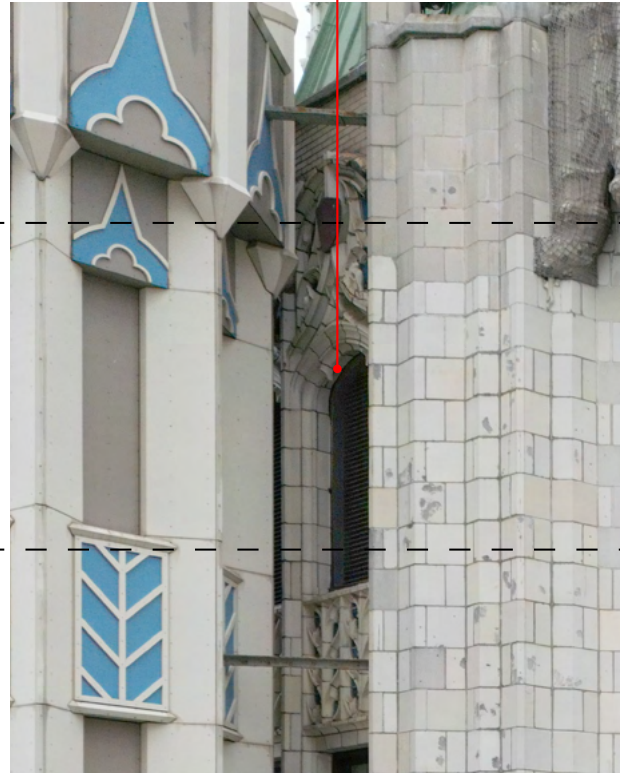
EXISTING CONDITION

NON-HISTORIC LOUVER

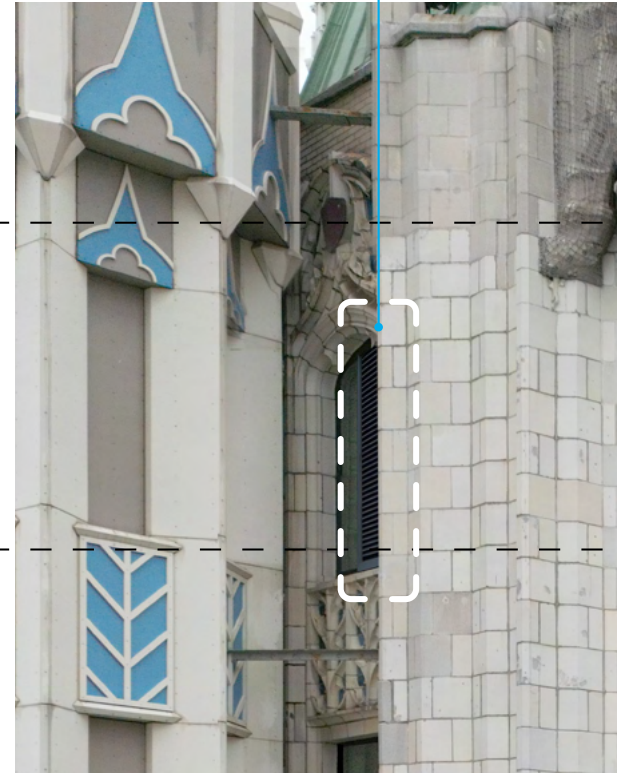
PROPOSED CONDITION

PROPOSED MECHANICAL LOUVER. PAINTED TO MATCH ADJACENT TERRA COTTA

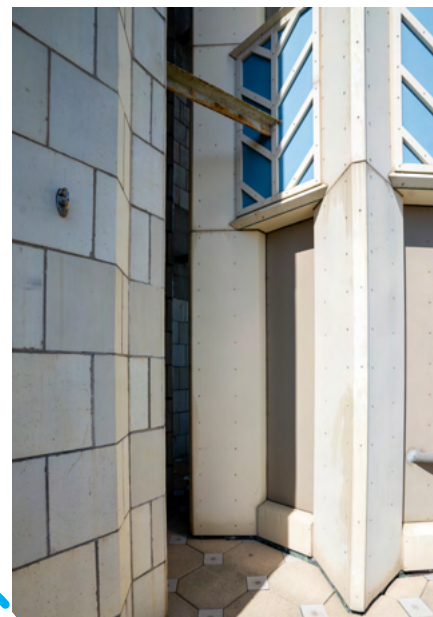
THE CURRENT GEOMETRY OF THE TOURELLES MAKES ACCESS TO THE TERRACE DIFFICULT FOR BOTH: THE UNIT AND FOR FACADE MAINTENANCE ACCESS

CURRENT CONDITION

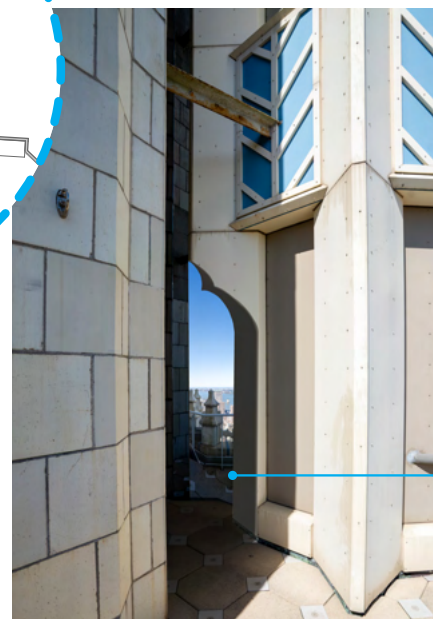
IT IS PROPOSED TO REMOVE THE NON-HISTORIC FINIS SHOWN TO CREATE WIDER ACCESS POINTS AT THE CORNERS OF THE BUILDING

PROPOSED CONDITION

IMPROVED ACCESS AT TERRACE FOR OCCUPANTS AND FACADE MAINTENANCE

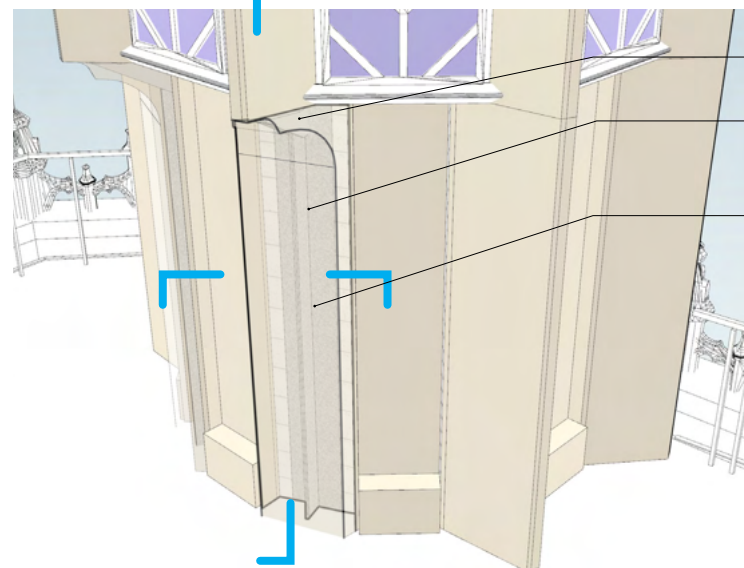
PROPOSED CONDITION

- GALVANIZED STEEL LINTEL
- ZINC RICH PRIMER AND EXTERIOR FIREPROOFING ON COLUMN
- METAL PANEL PAINTED TO MATCH ADJACENT TOURELLE

BENJAMIN MOORE:  
MANCHESTER TAN

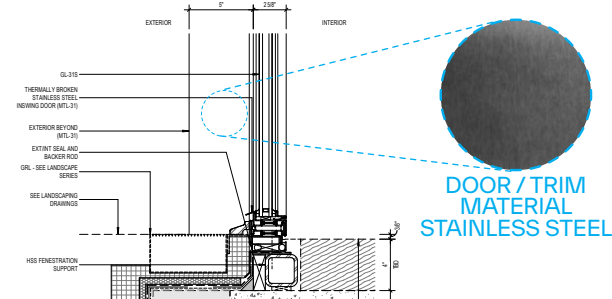
DOOR / TRIM  
MATERIAL  
STAINLESS STEEL
