Preservation Department – Item 2, LPC-25-12470

118 Rutland Road – Crown Heights North Historic District Borough of Brooklyn

This is part of an application to legalize the removal of a low ironwork railing that was installed atop the property's areaway curb

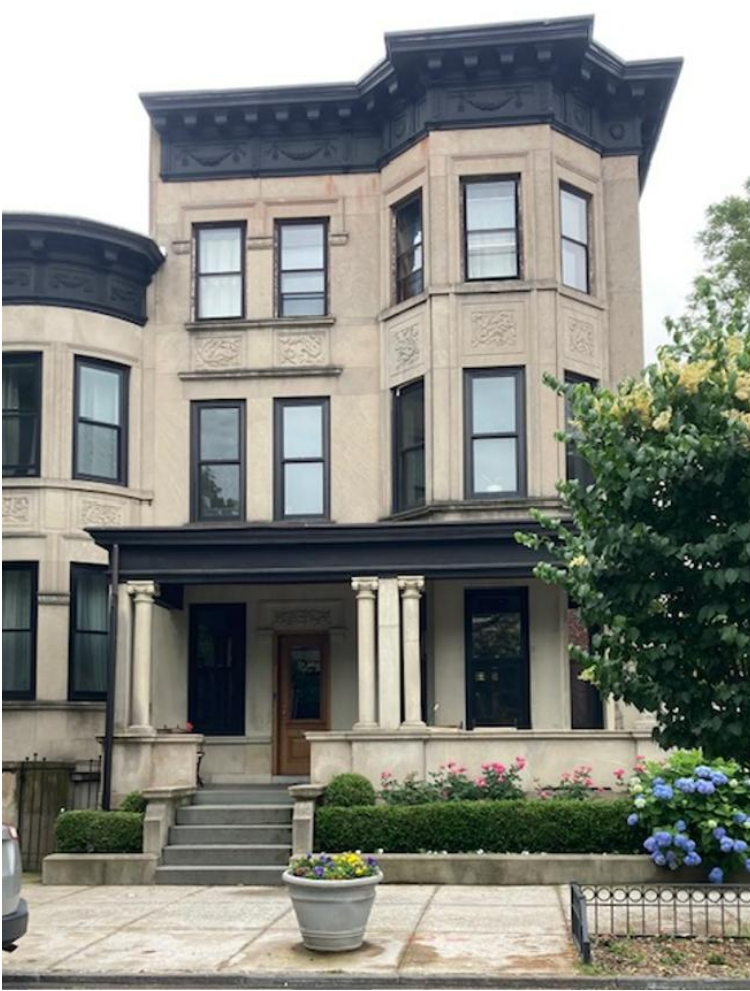
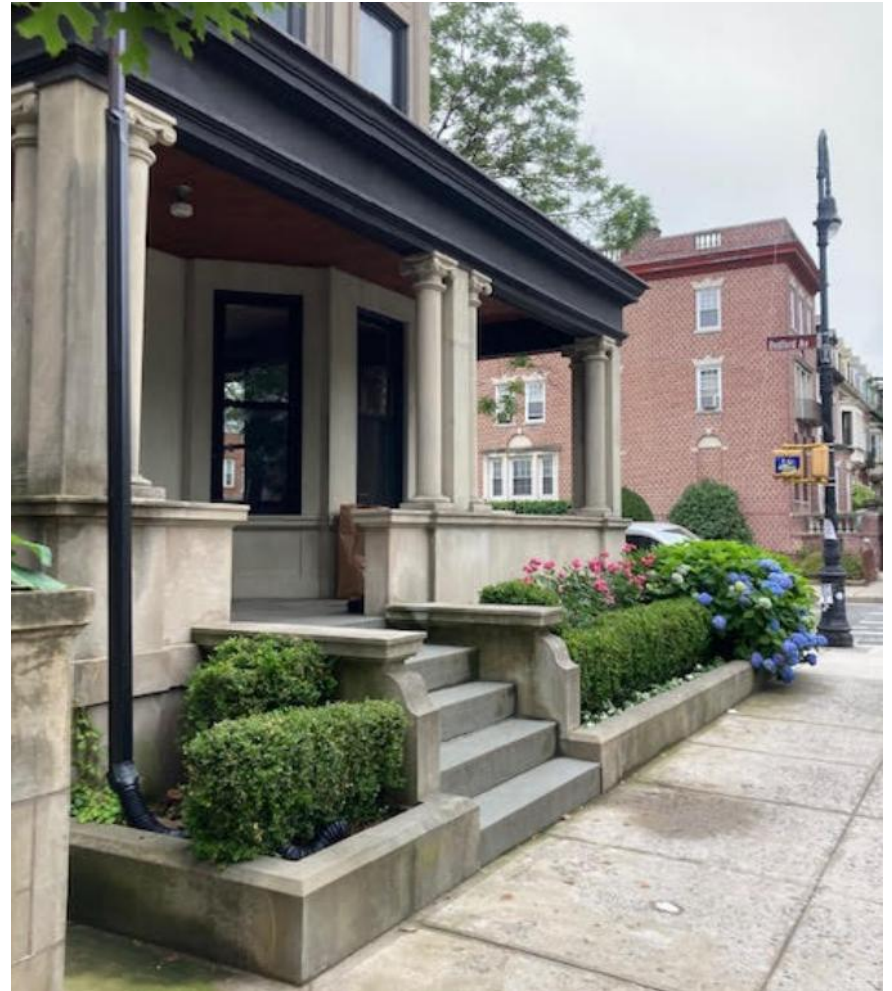
118 Rutland Road – views of repaired stair, curb, & porch

Damaged bluestone curb patched & refinished

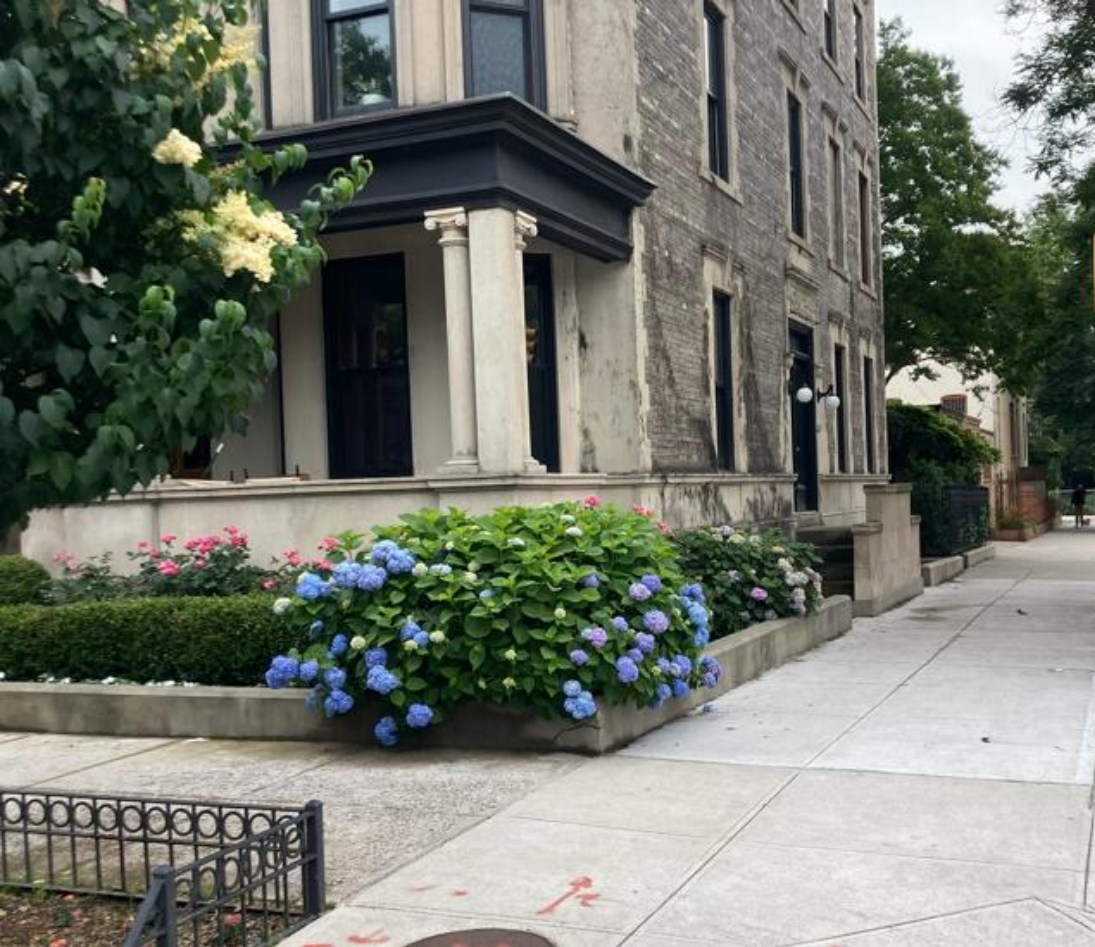
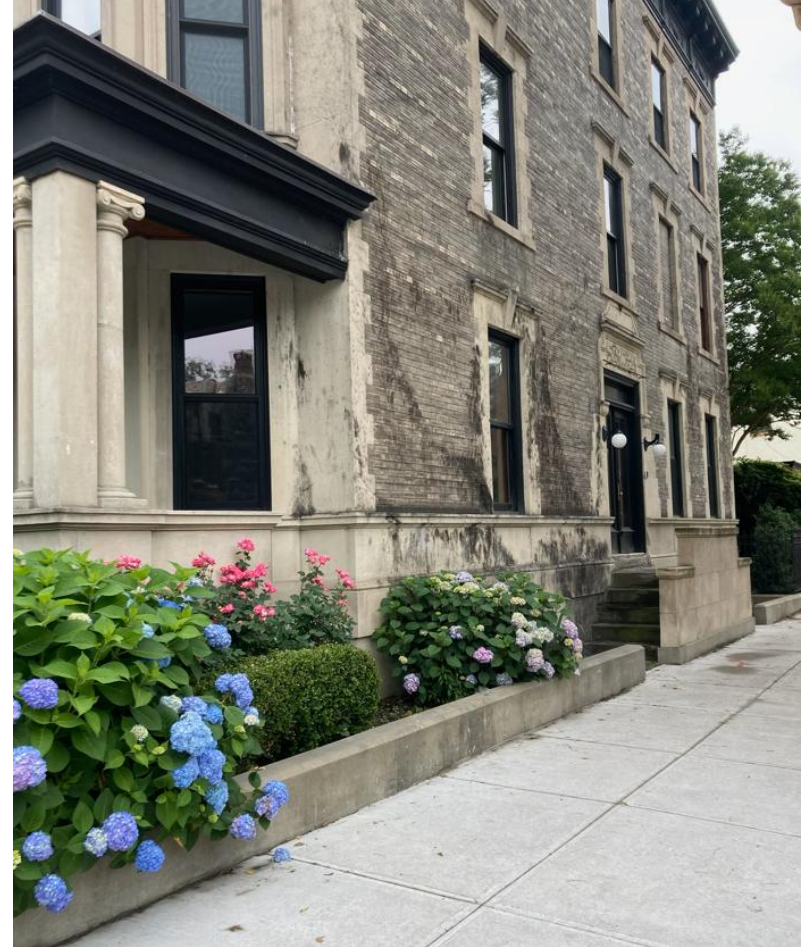
118 Rutland Road – views of repaired curb along Bedford Avenue

Damaged bluestone curb patched & refinished

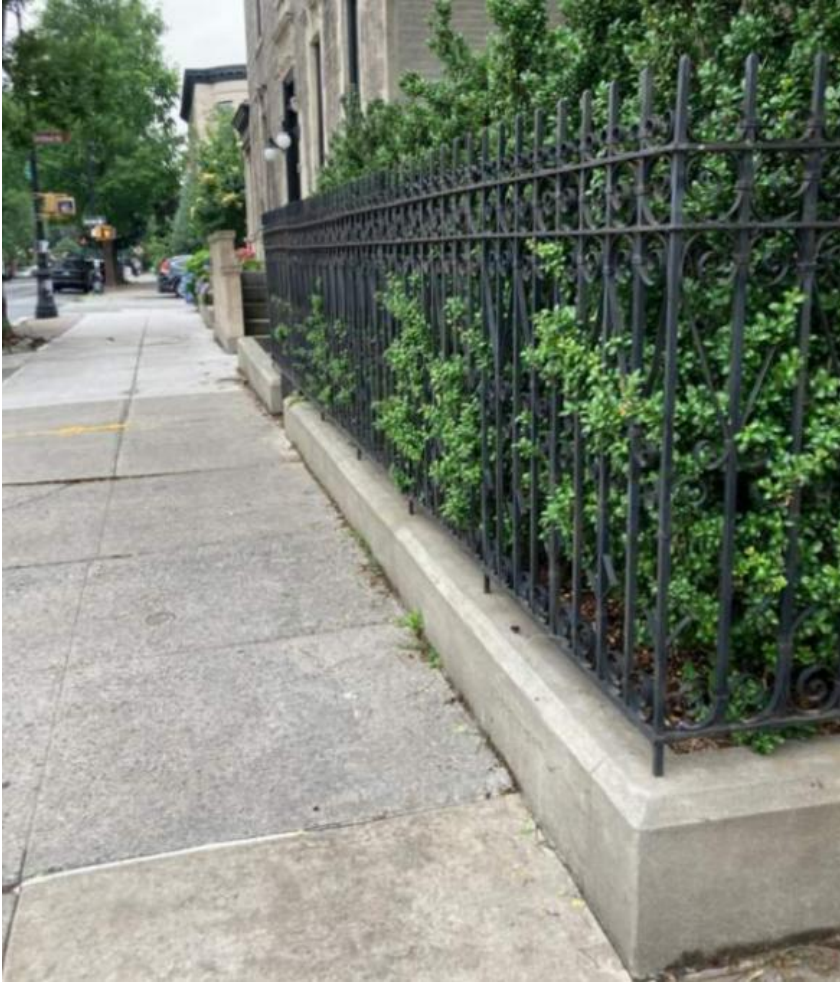
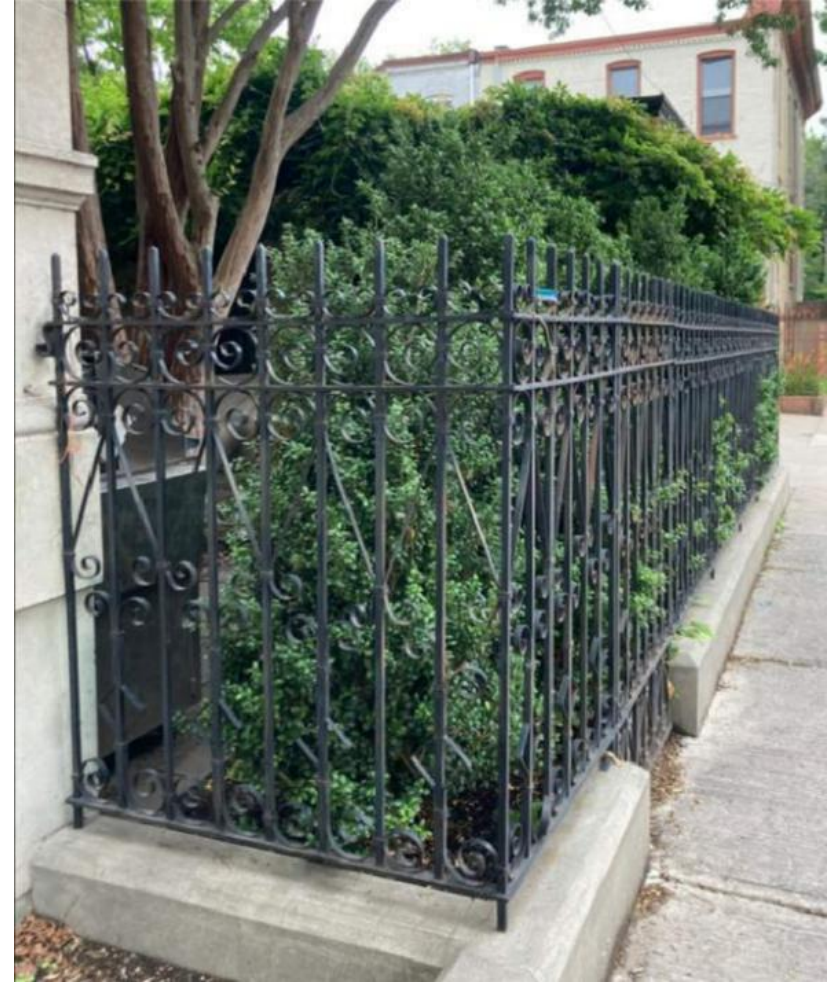
East side of Bedford Avenue – rear yard fence at 118 Rutland Road

Rear historic fence has been repaired, repainted, & preserved

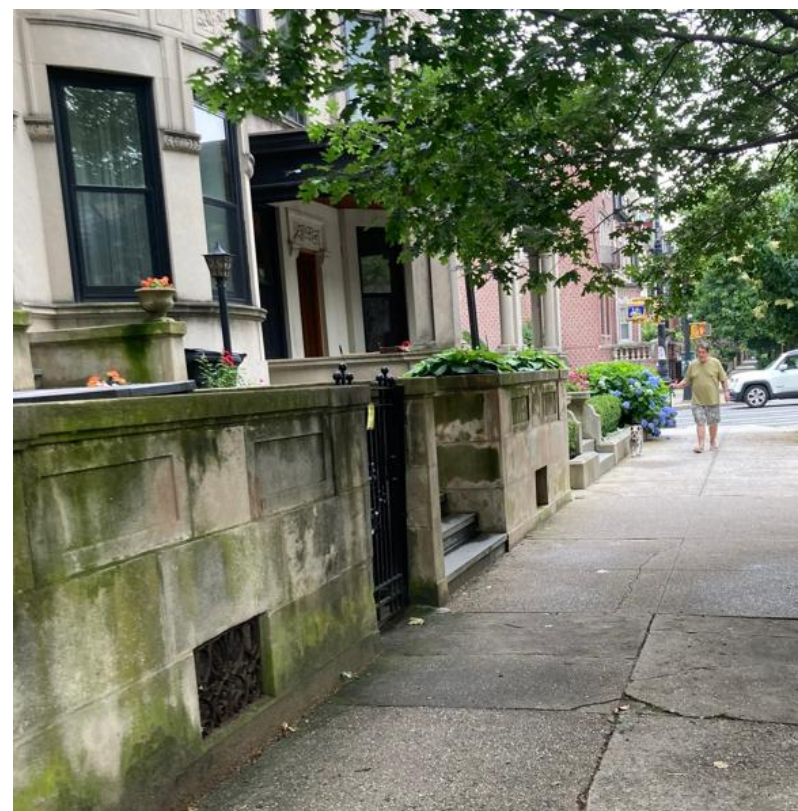
Looking toward 118 along Rutland Road

Adjacent properties in foreground by Benjamin Dreisler do not have fences
(Google street view)

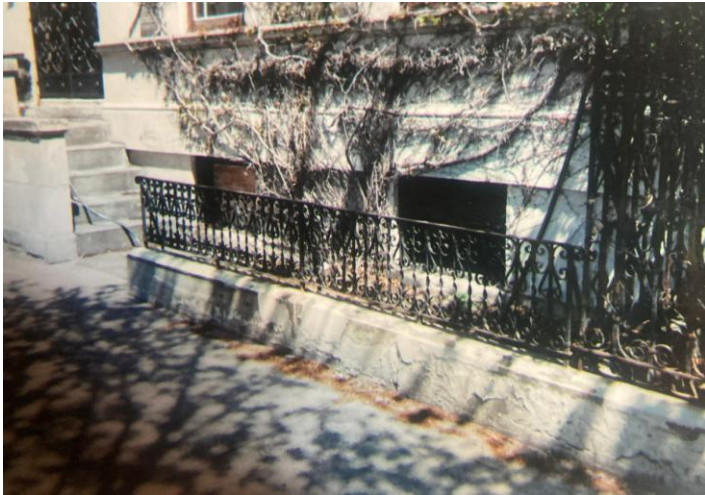
Photos of the curb and low railing prior to the accident

Looking along Bedford Avenue (before to January 23rd, 2017)

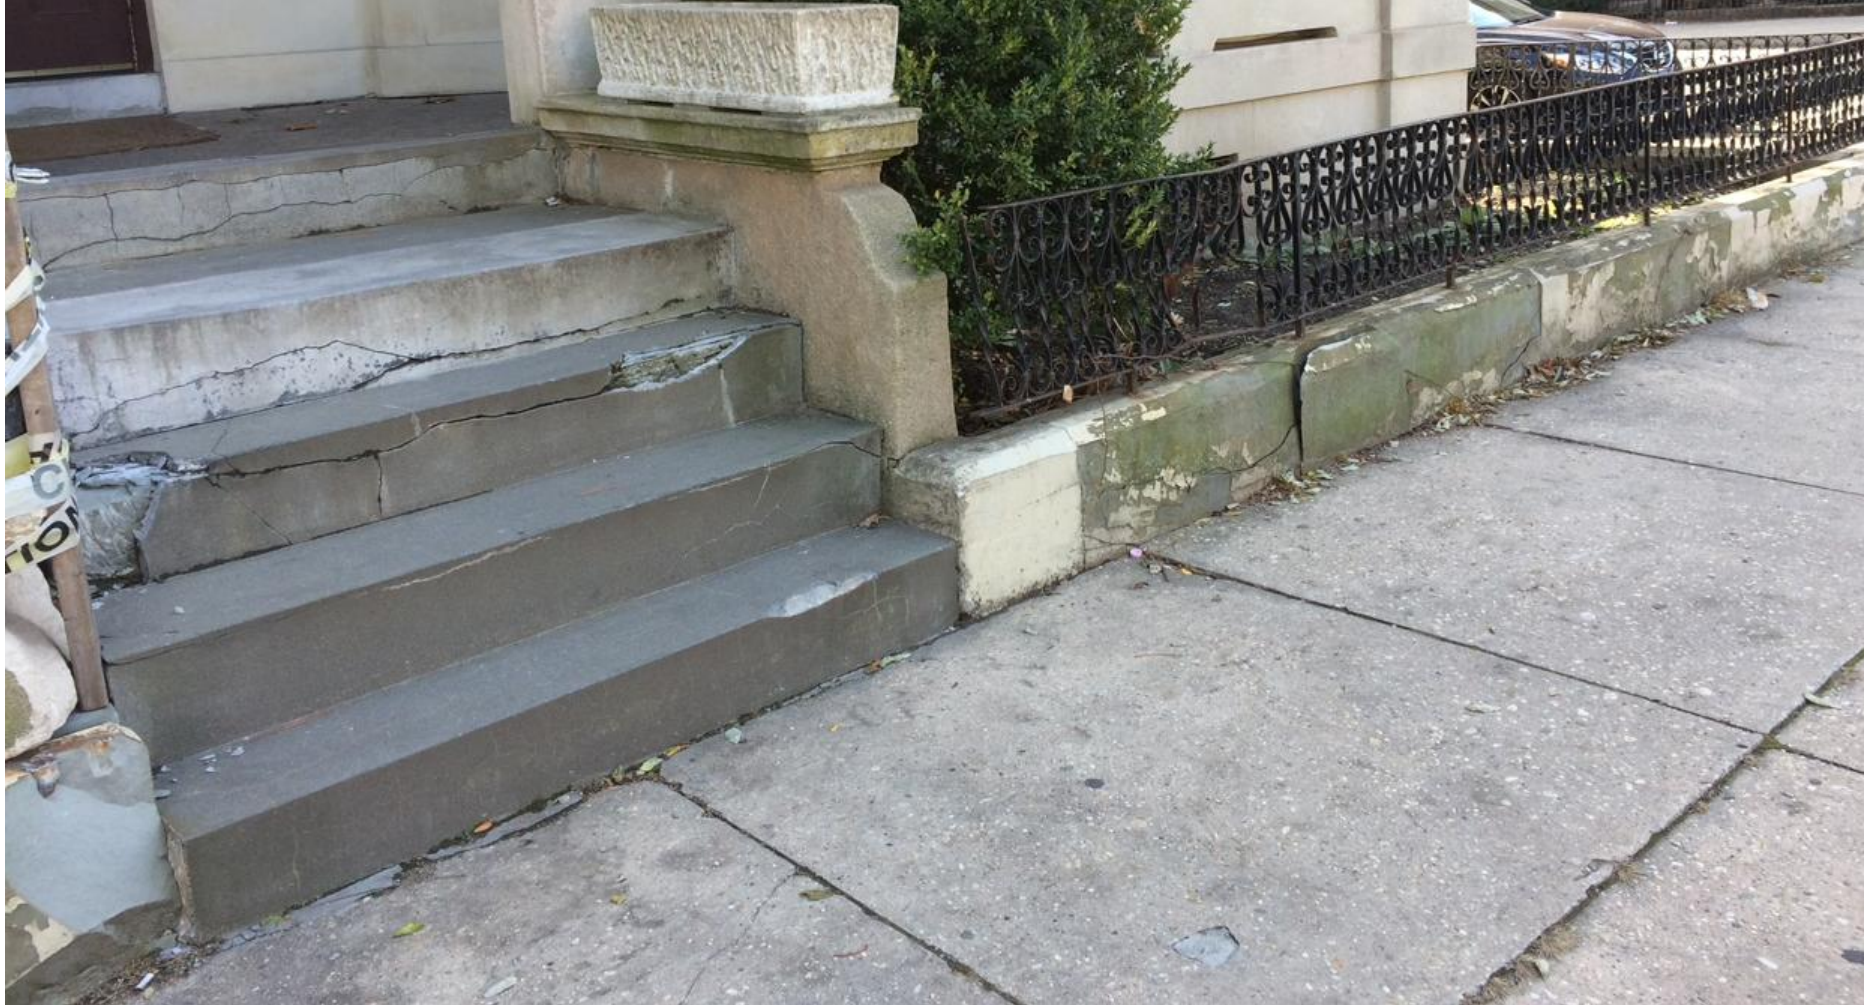
After the accident

Photo of the condition of the curb, low railing, and Rutland Road Entry Stair

The low decorative fencing was removed during the repair and restoration work undertaken after the car accident so the entire curb could be resurfaced.

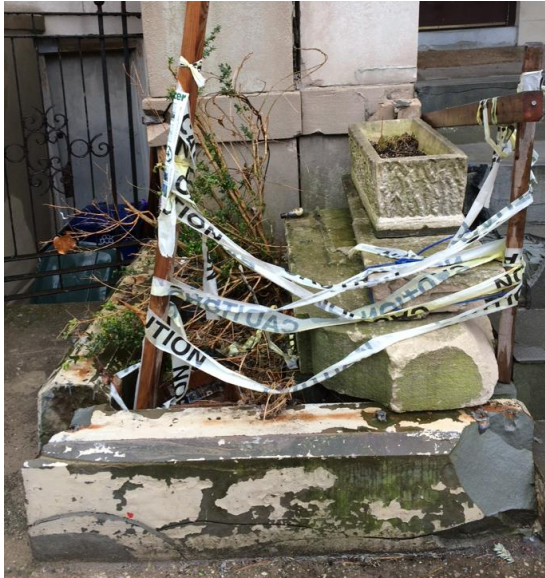
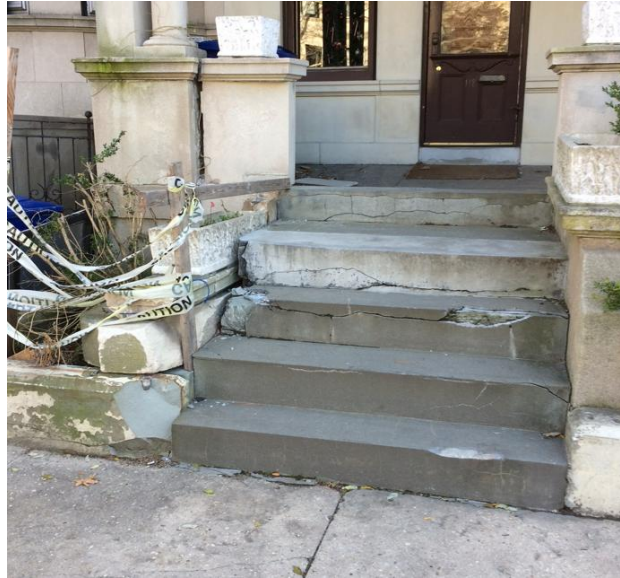
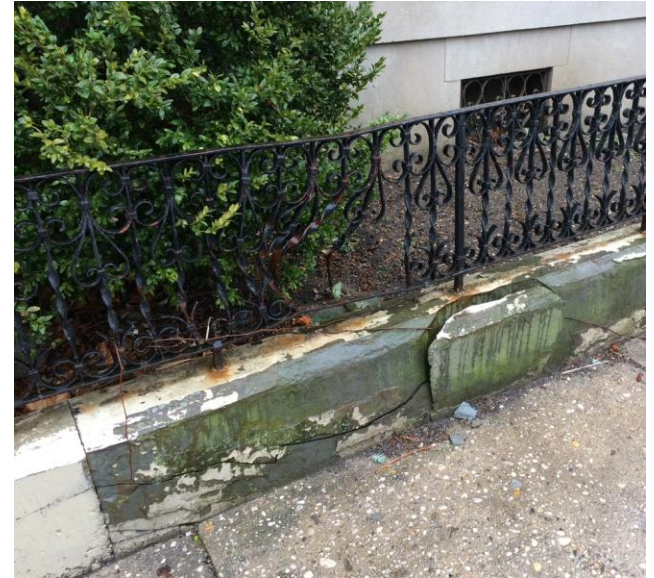
After the accident

Detail photos of the condition of the curb, low railing, and Rutland Road Entry Stair

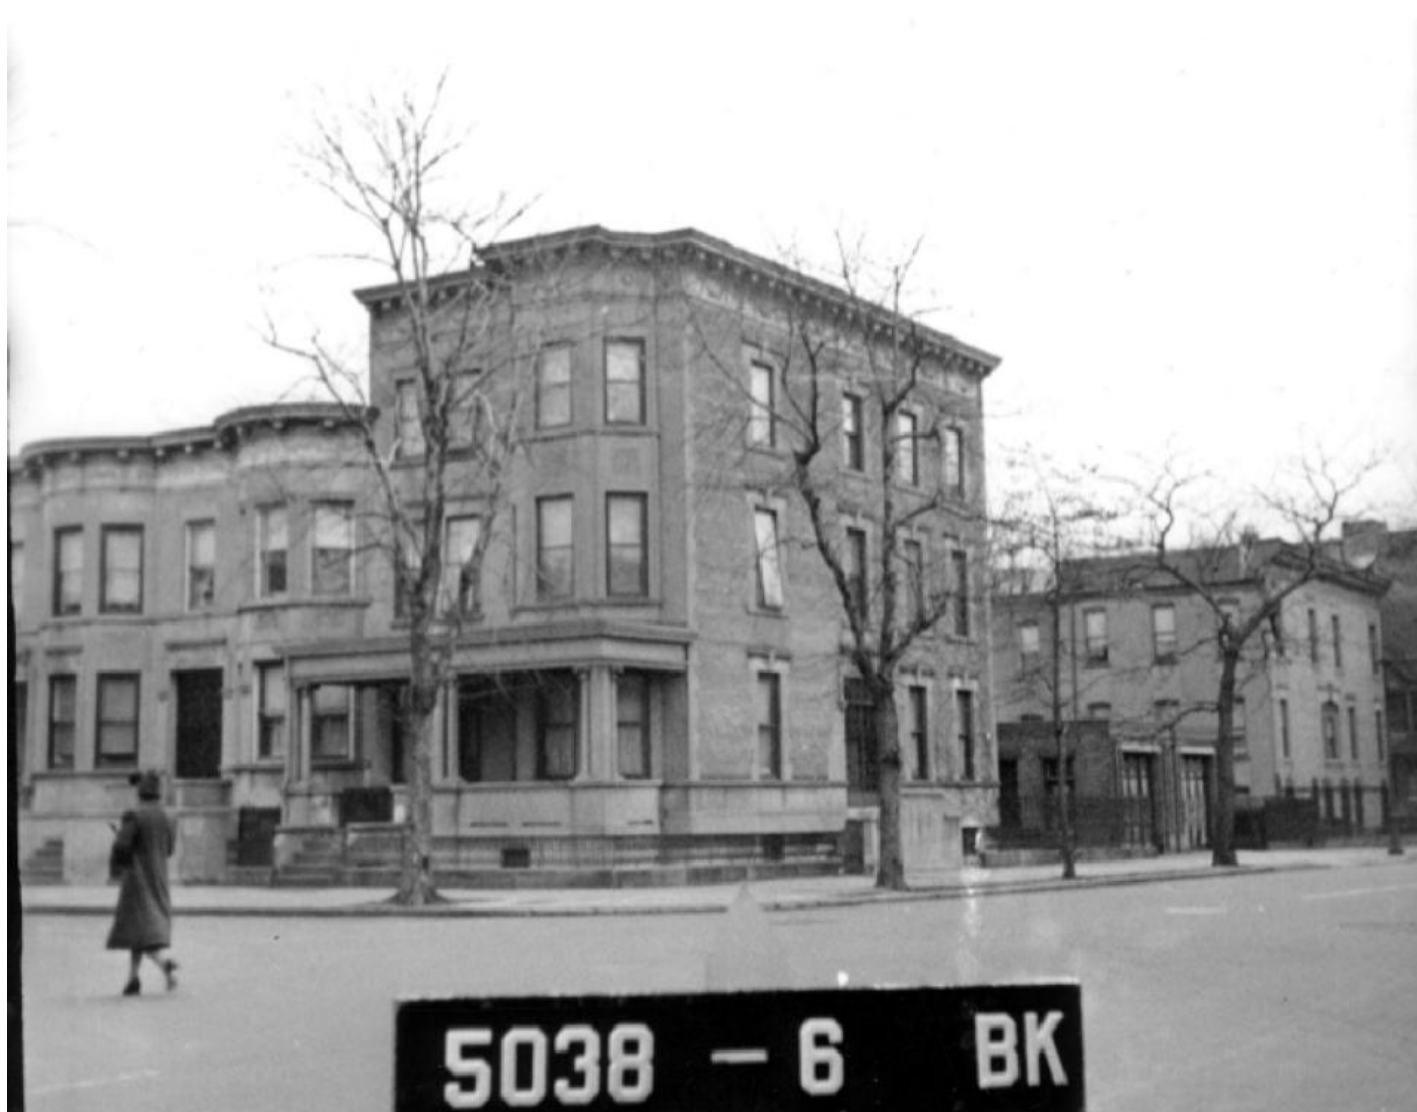
Historic Tax Photo from the 1940s

- The circa 1940 Tax Photo does illustrate the decorative rail having been installed on top of an areaway curb along Rutland Road and Bedford Avenue. So, by 1940 the railing and areaway curb had been installed.

Original construction 1911

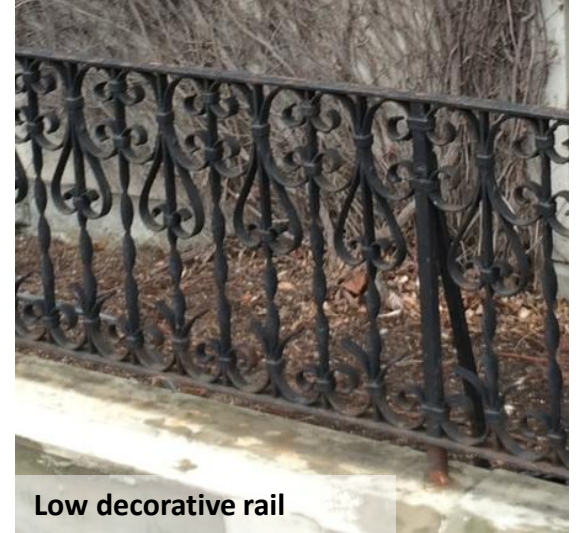
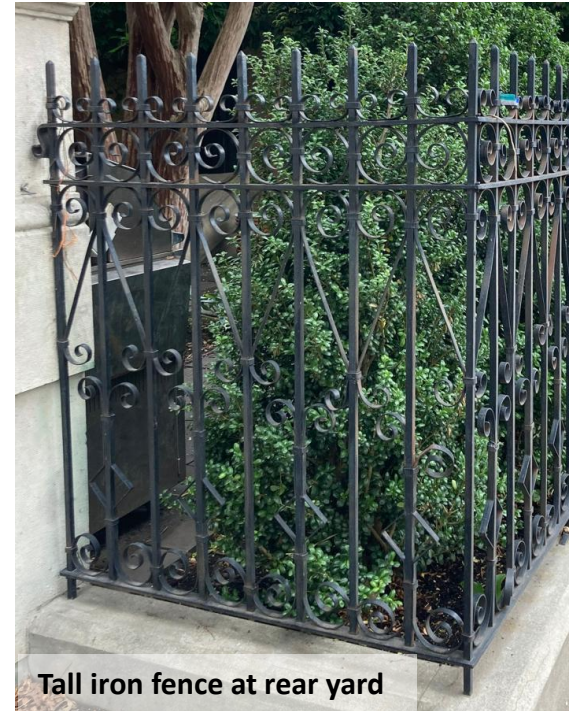
Comparison of fences

The decorative rail on the curb tall and iron fence at the rear yard and ARE NOT similar in fabrication.

- The low decorative rail that was installed atop the curb was made with thinner stock material pieces including machine twisted verticals framing the scrolling.

- The iron fence framing the rear yard is fabricated from substantial solid iron square post material with decorative scrolling that matches the party line fence separating the neighboring yard. The scrolled pieces were hand shaped and wrapped to the upright fence pieces with metal strapping. The tall fence has an asymmetry to the delicate scrollwork and looks handmade.

- The fences don't intersect with one another and were clearly fabricated and installed in different construction eras.
- The low decorative railing is not 'original' to the property but was added at some point prior to the Tax Photo being taken. None of the other buildings along Rutland Road that were constructed at the same time as 118 have this kind of fencing.

Low decorative metal rail at front vs. tall iron fence at rear yard

The original tall rear yard fencing has been preserved and restored.

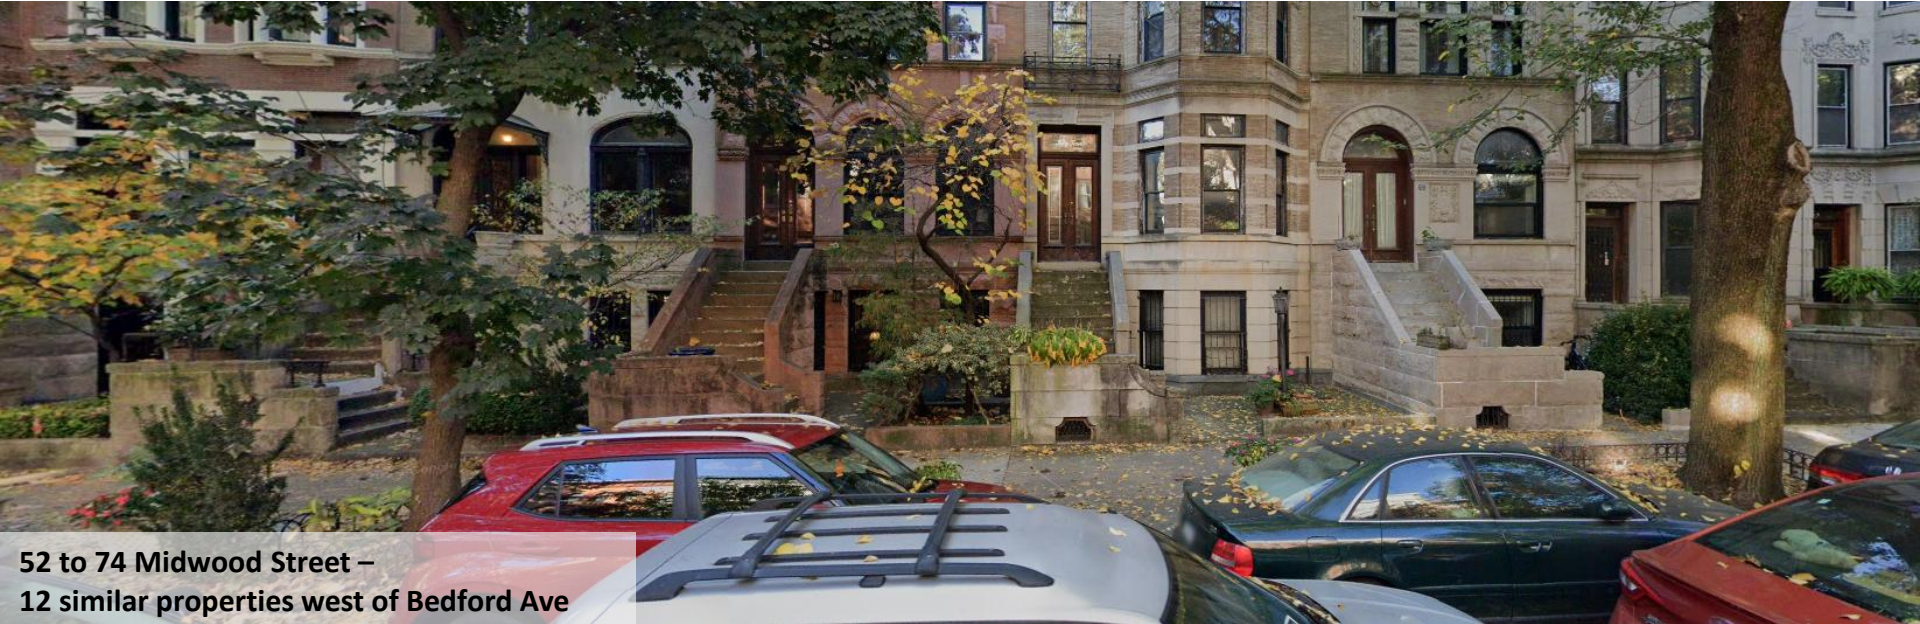
**52 to 74 Midwood Street –
12 similar properties west of Bedford Ave**

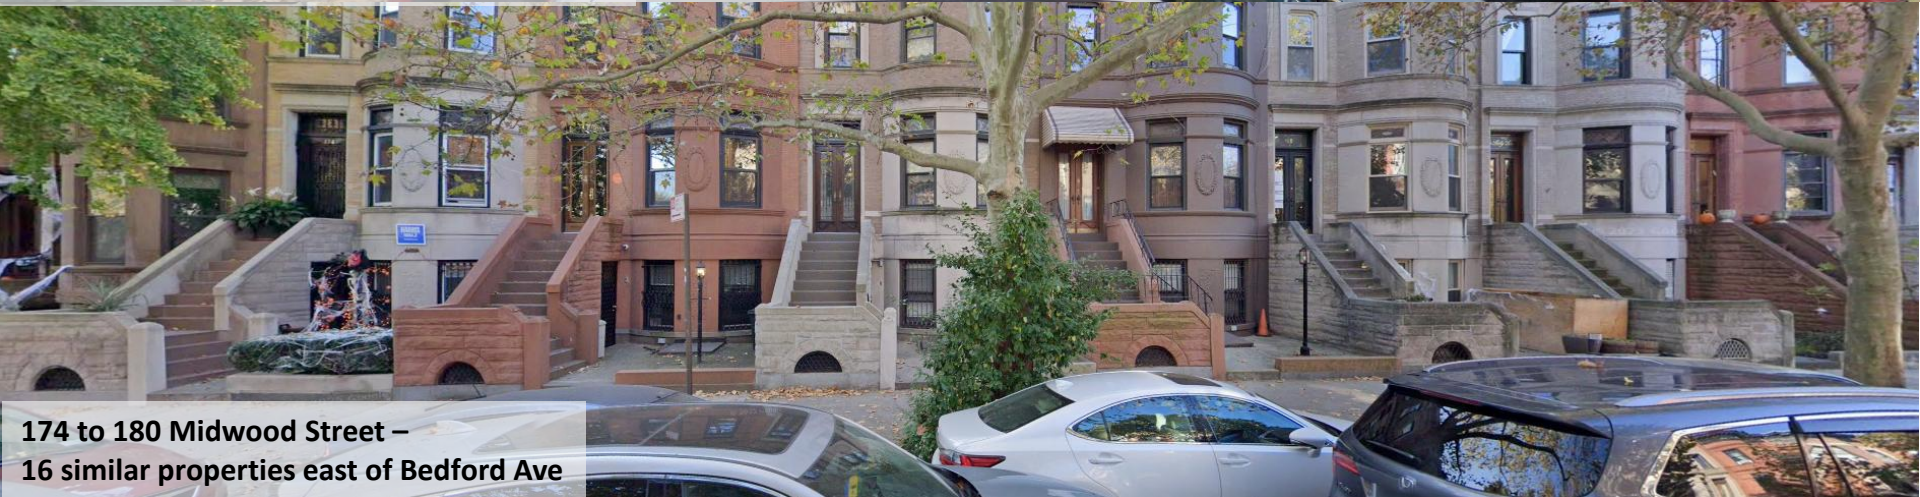
**174 to 180 Midwood Street –
16 similar properties east of Bedford Ave**

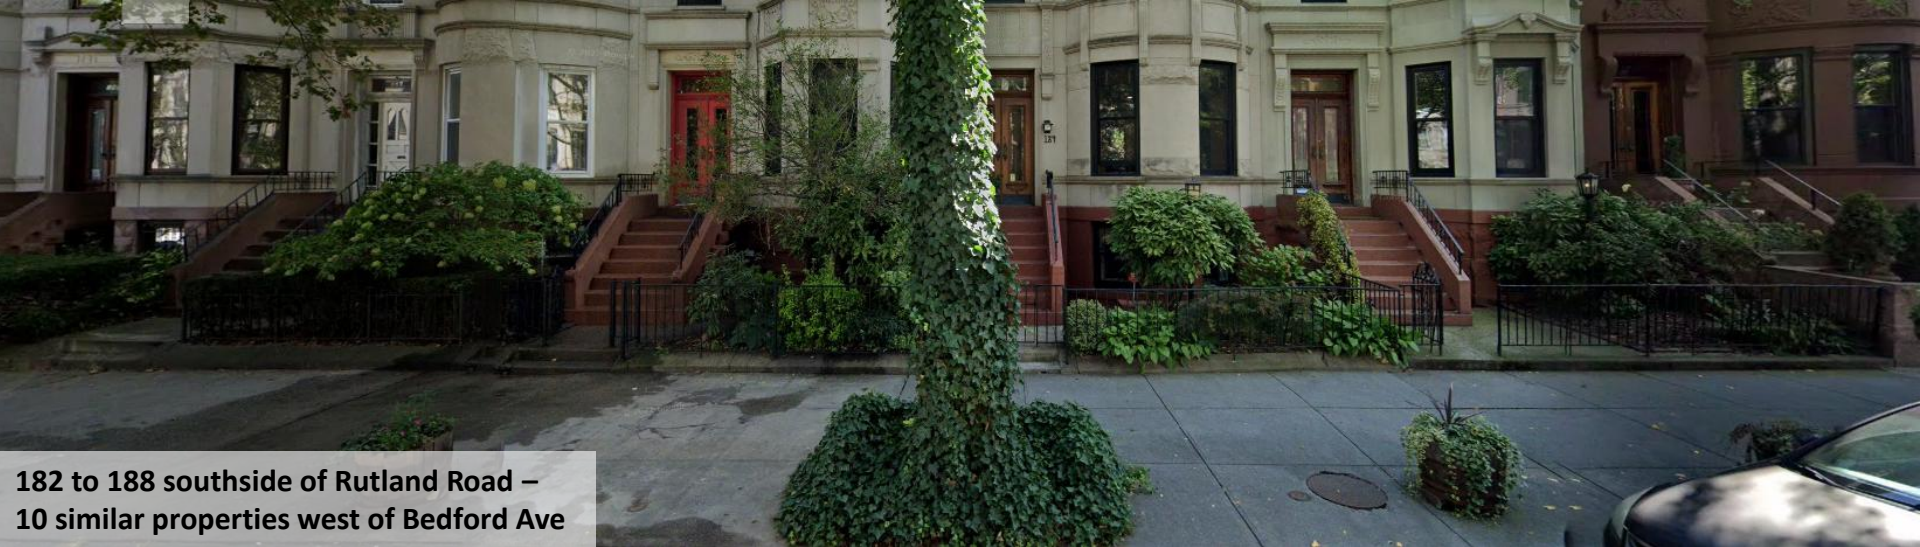
182 to 188 southside of Rutland Road –
10 similar properties west of Bedford Ave

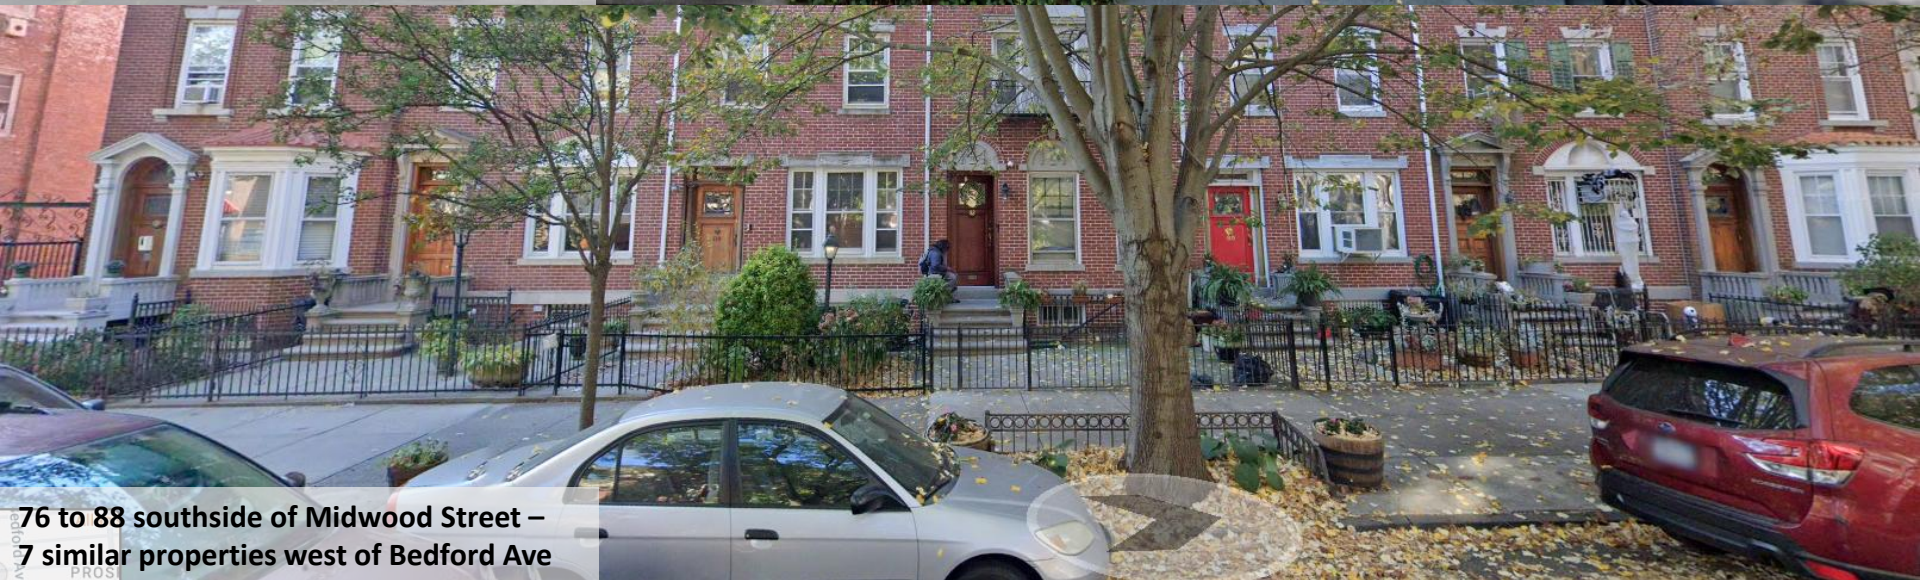
76 to 88 southside of Midwood Street –
7 similar properties west of Bedford Ave

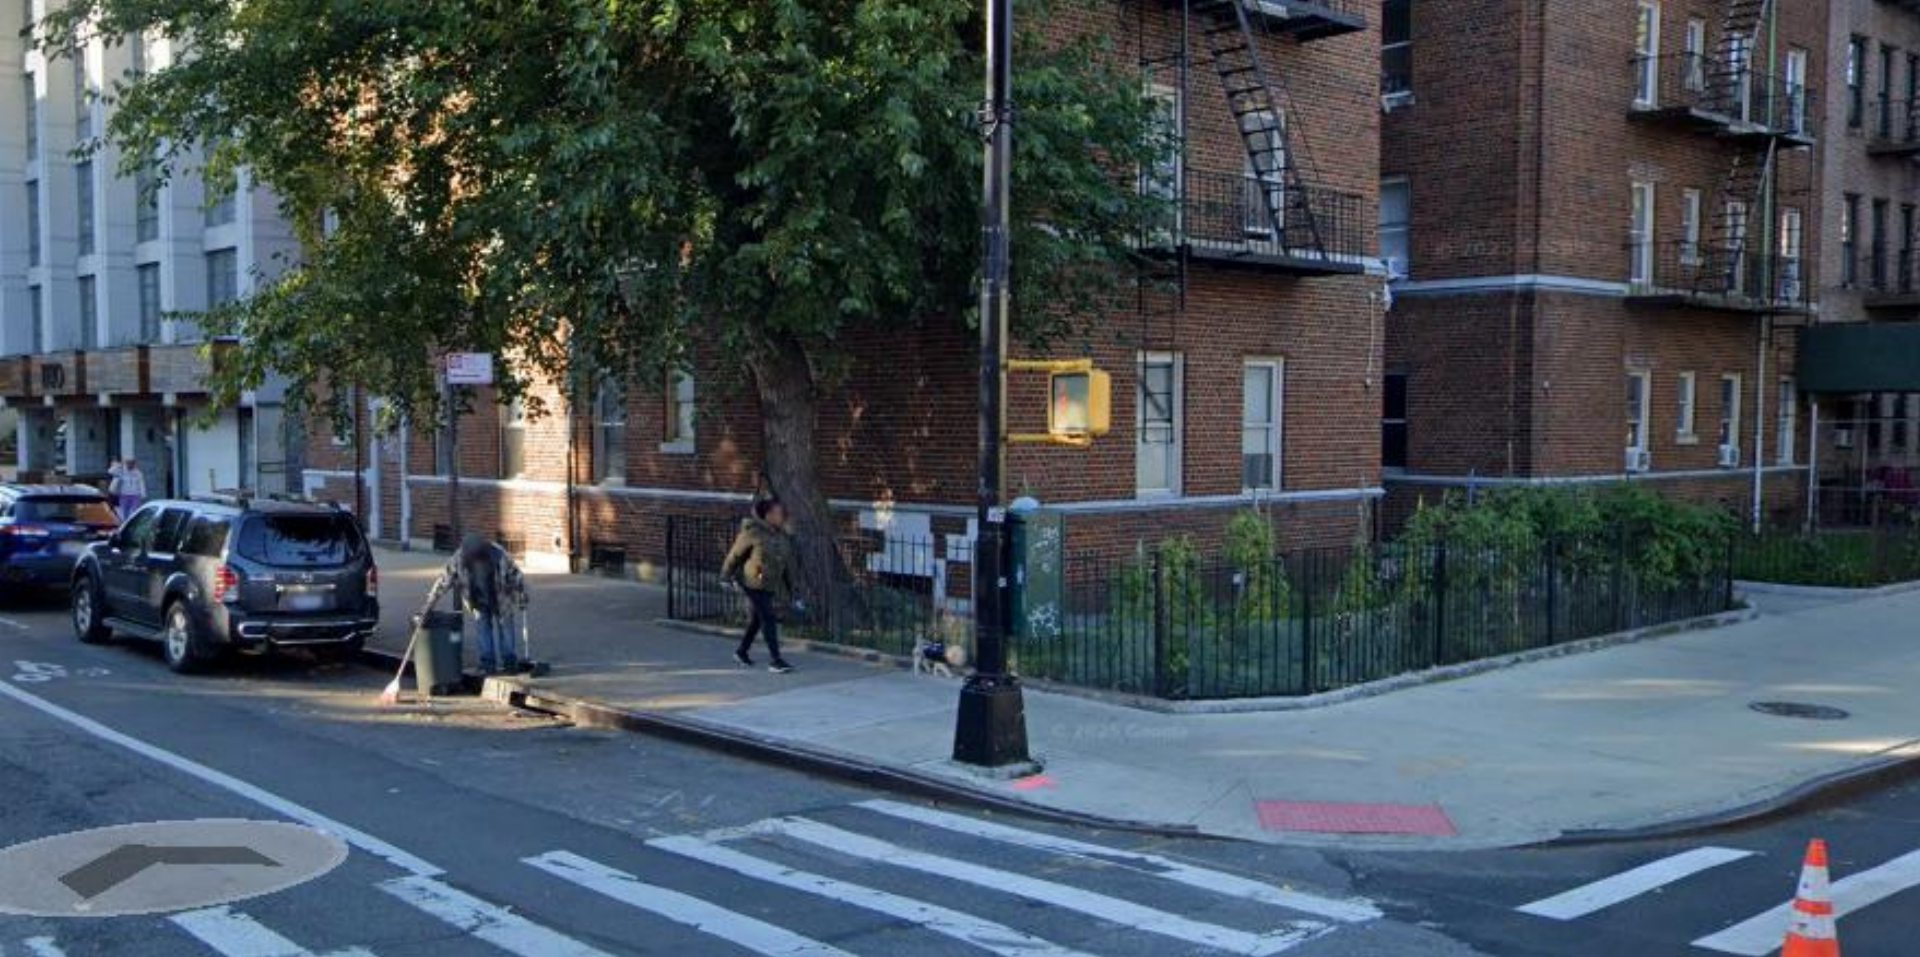
A-20

170 Fenimore Street at Bedford Avenue – SW corner

Type D – Front / side yard, fence low curb (outside Historic District)

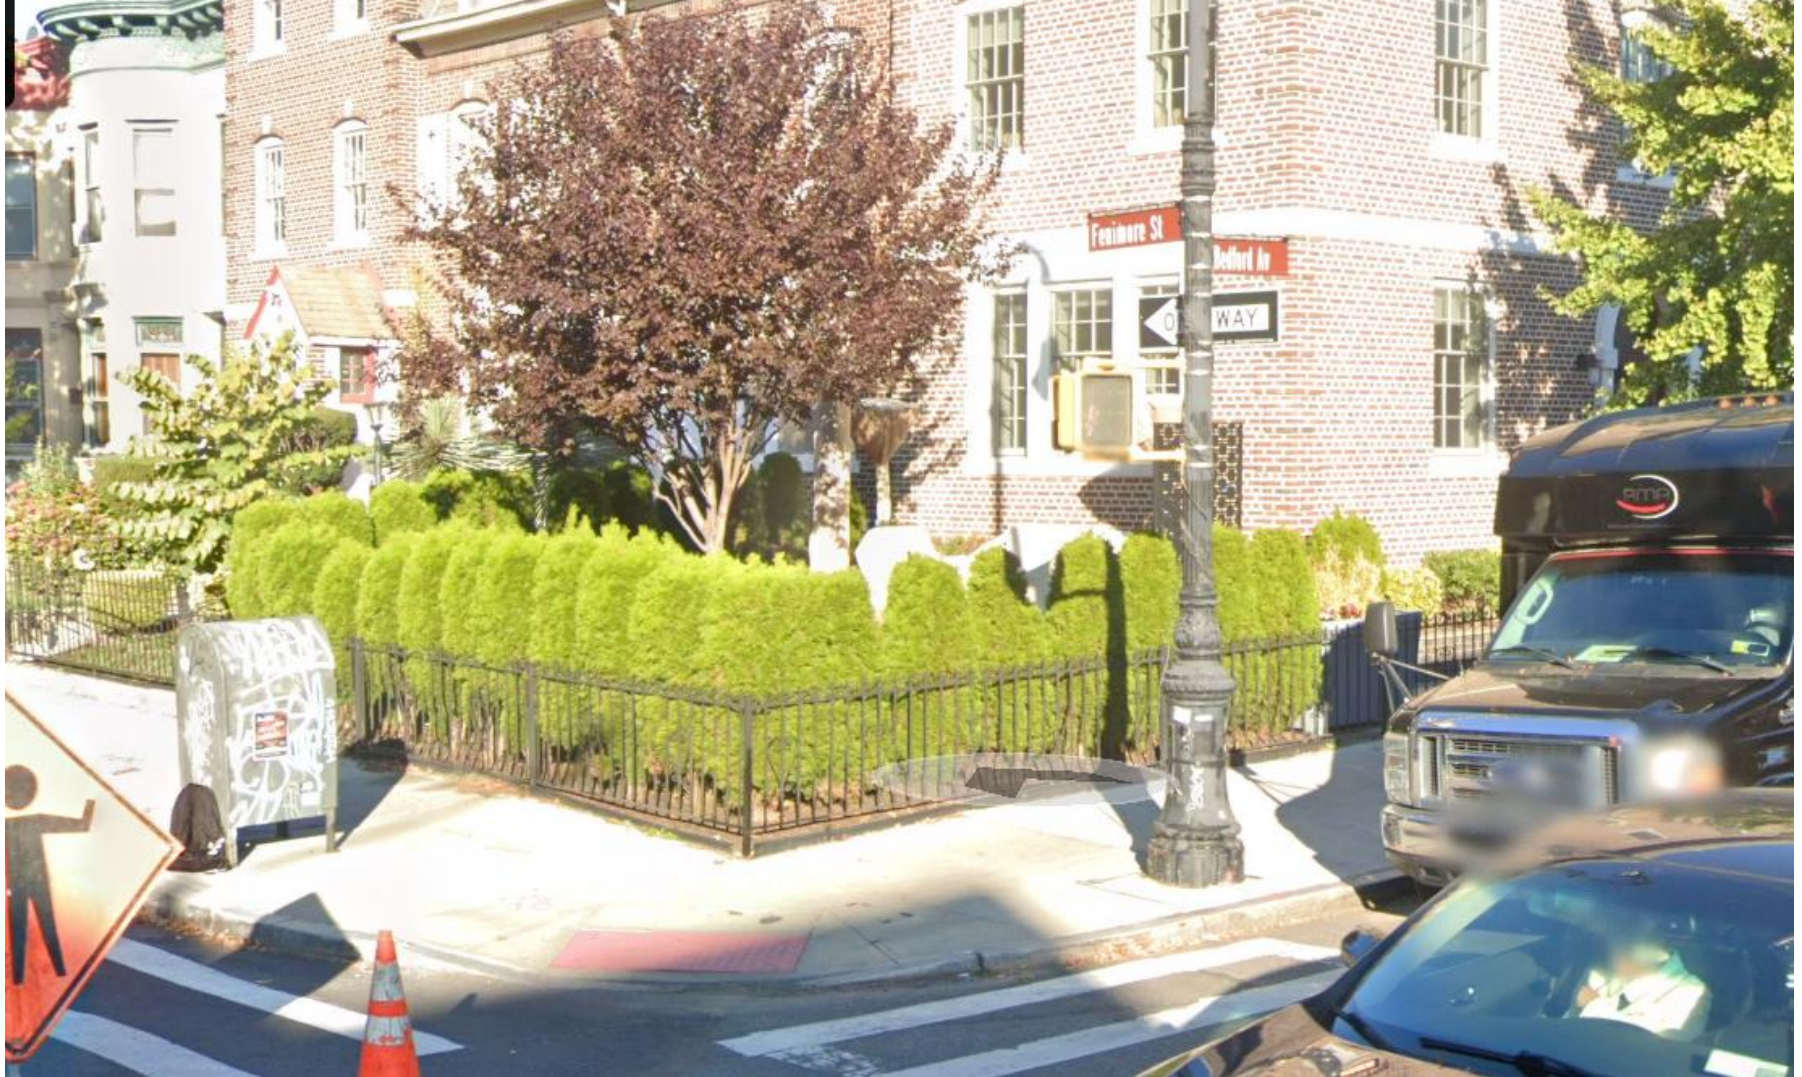
A-21

171 Fenimore Street at Bedford Avenue – NW corner

Type D – Front / side yard, fence no curb

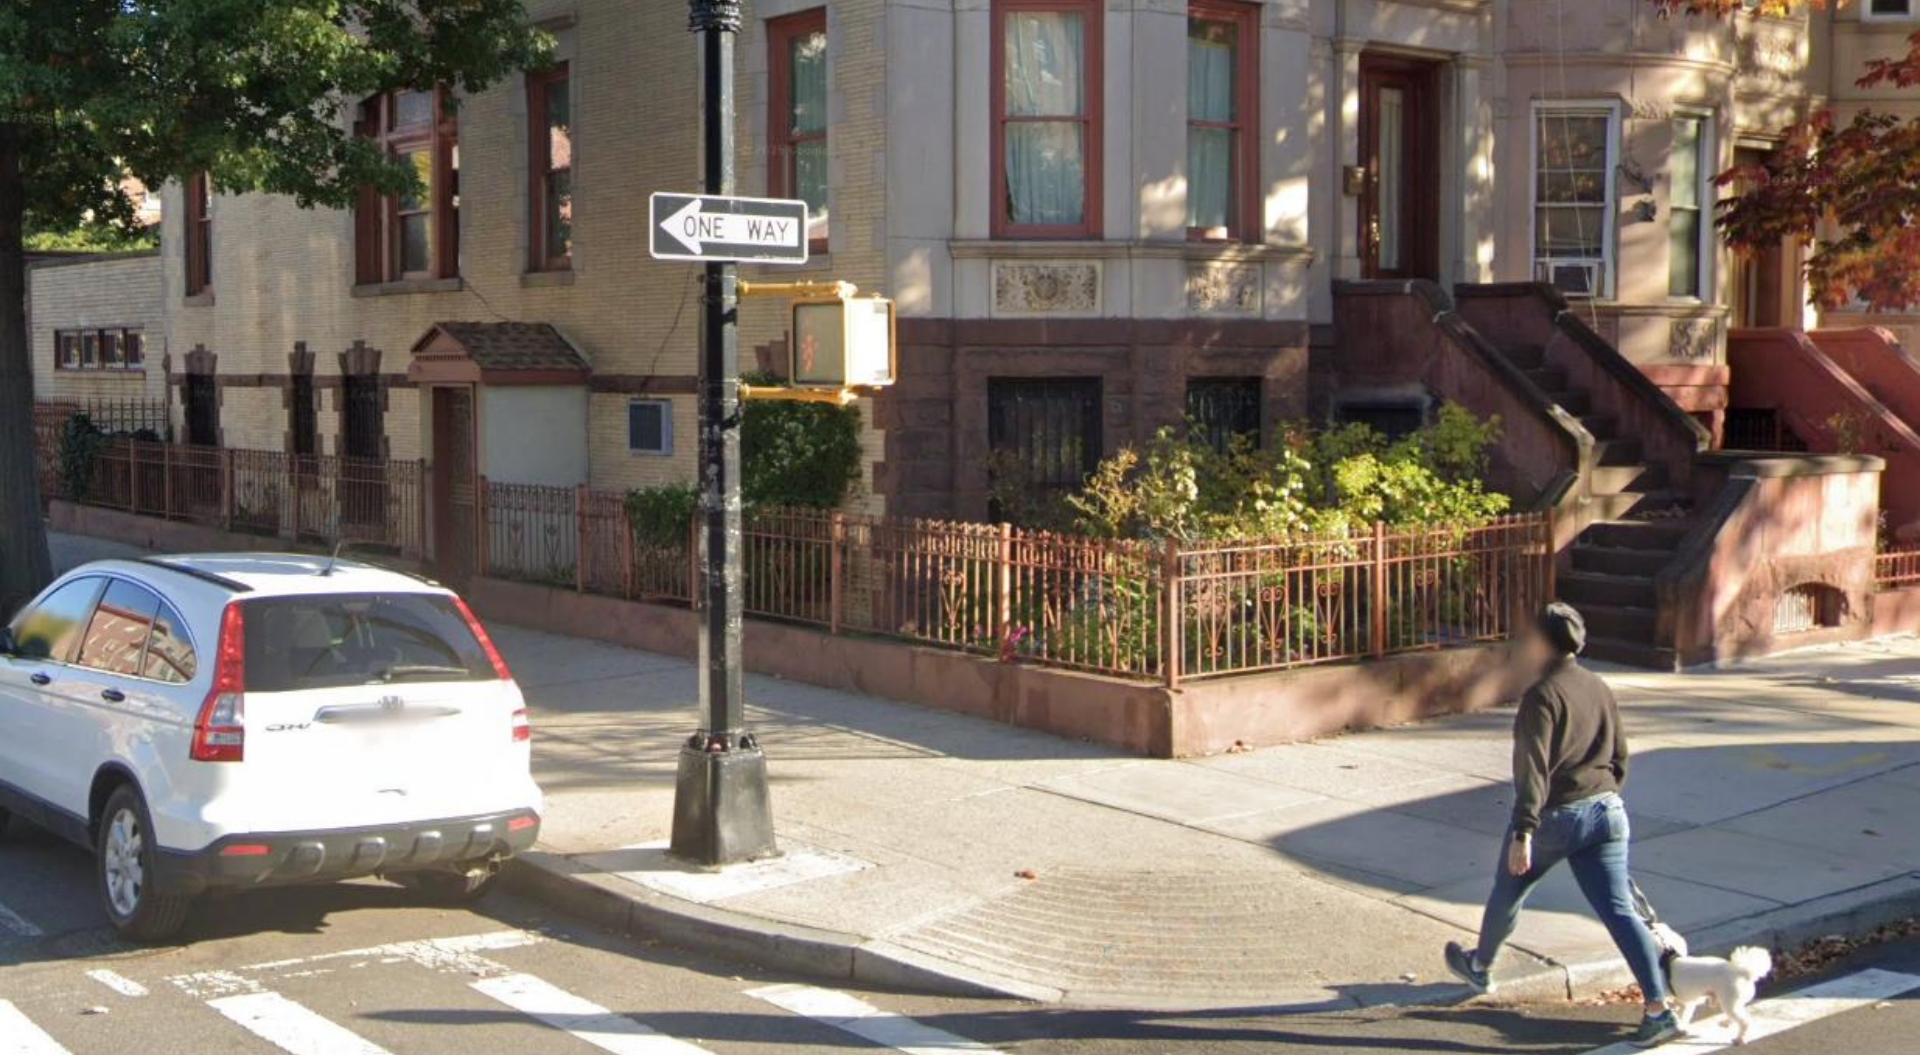
A-22

175 Fenimore Street at Bedford Avenue – NE corner

Type E – Front / side yard, fence on curb
