Preservation Department – Item 2, LPC-25-12470

118 Rutland Road – Crown Heights North Historic District Borough of Brooklyn

This is part of an application to legalize the removal of a low ironwork railing that was installed atop the property's areaway curb

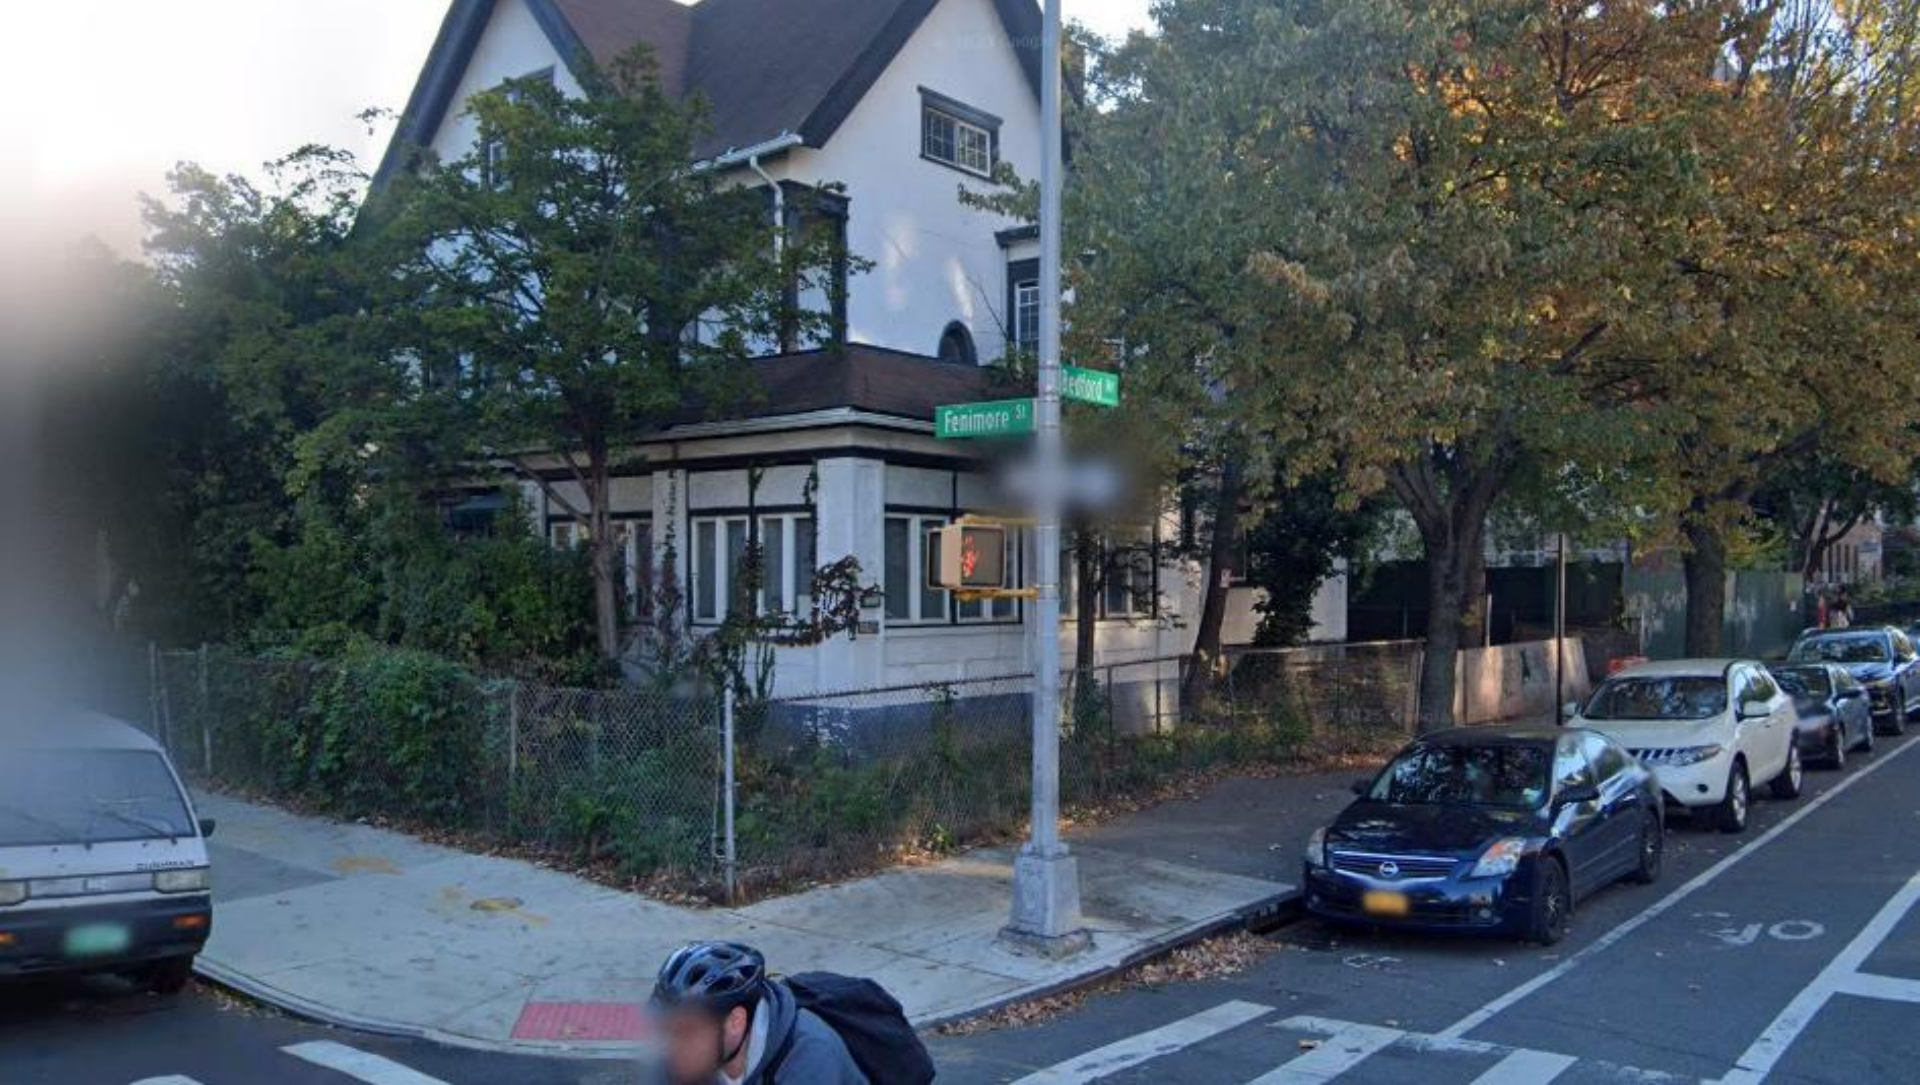
A-23

1919 Bedford Avenue at Fenimore Street – SE corner

Type D – Front / side yard, fence no curb (outside Historic District)

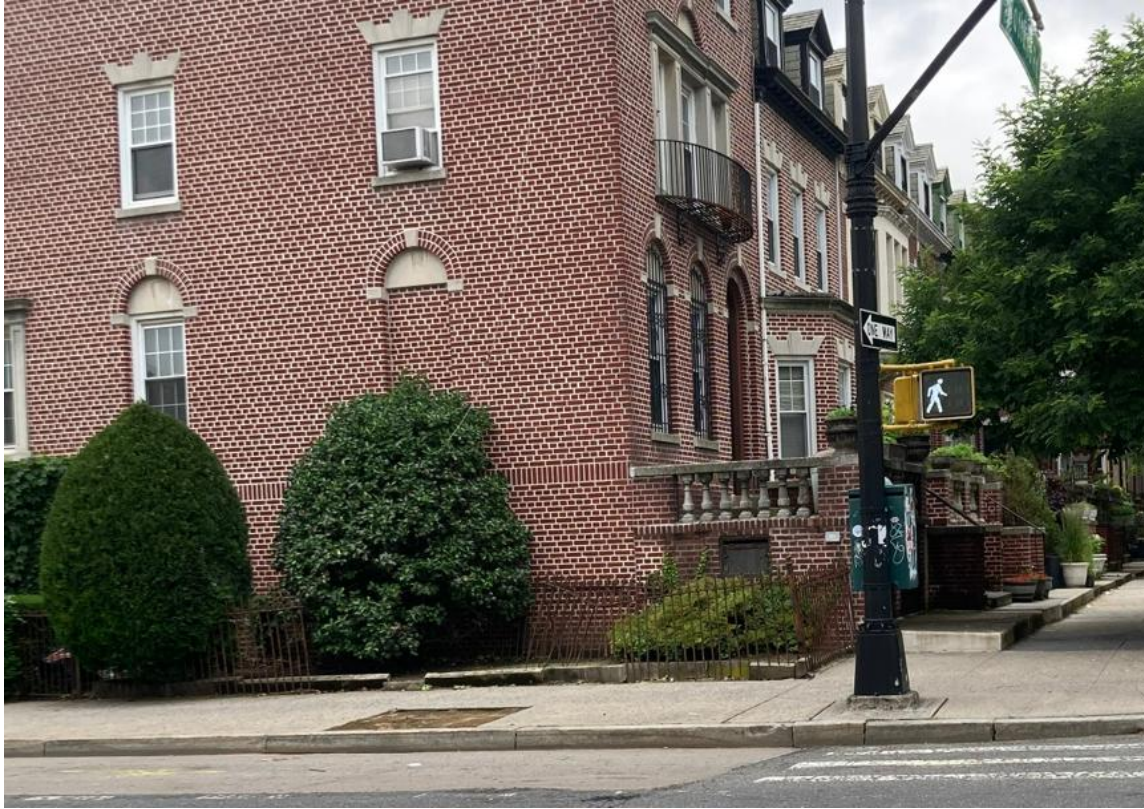
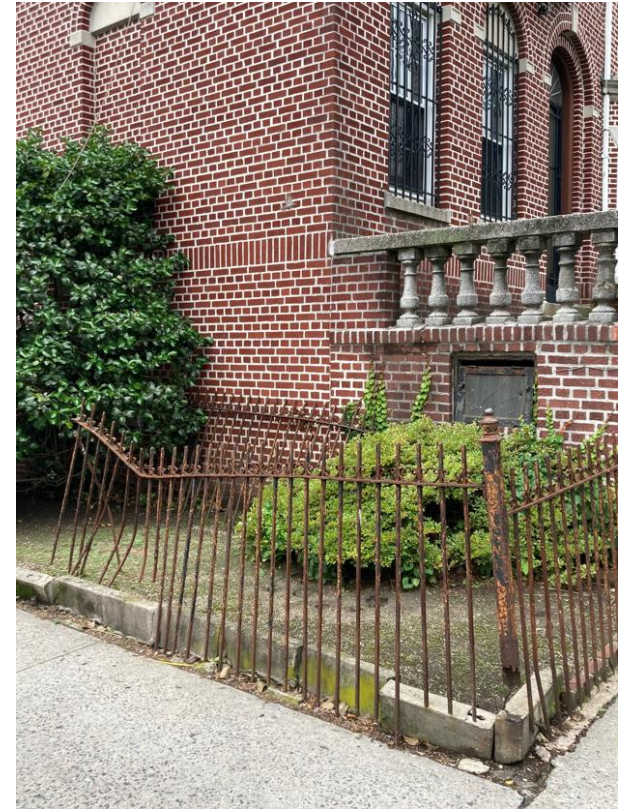
116 Rutland Road at Bedford Avenue – SW corner

Across Bedford Avenue from 118 Rutland Road: Type D – Side yard, no curb, damaged fence

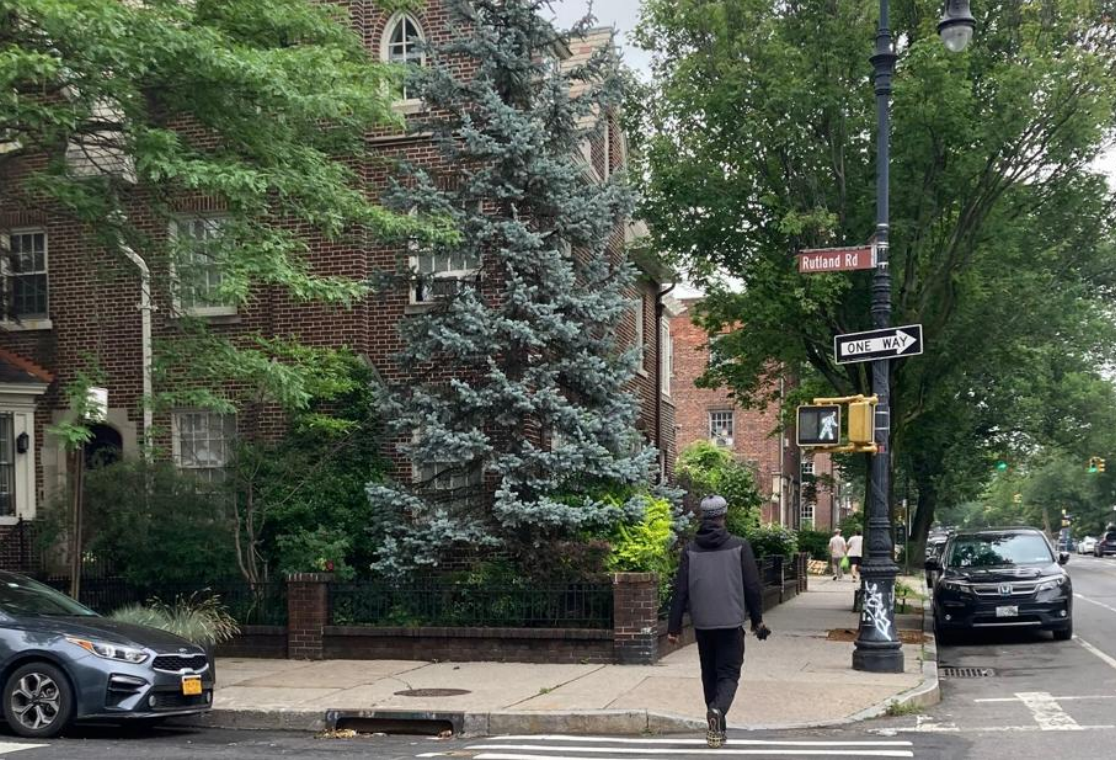
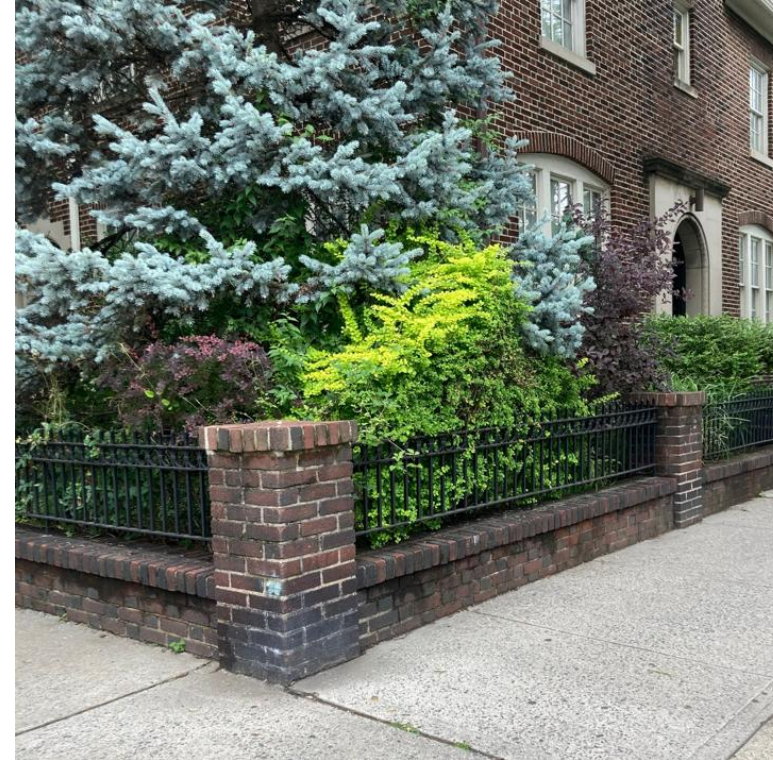
115 Rutland Road at Bedford Avenue – NW corner

Across Bedford Avenue & Rutland Road from 118 Rutland: Type E – Brick curb, and newer fence

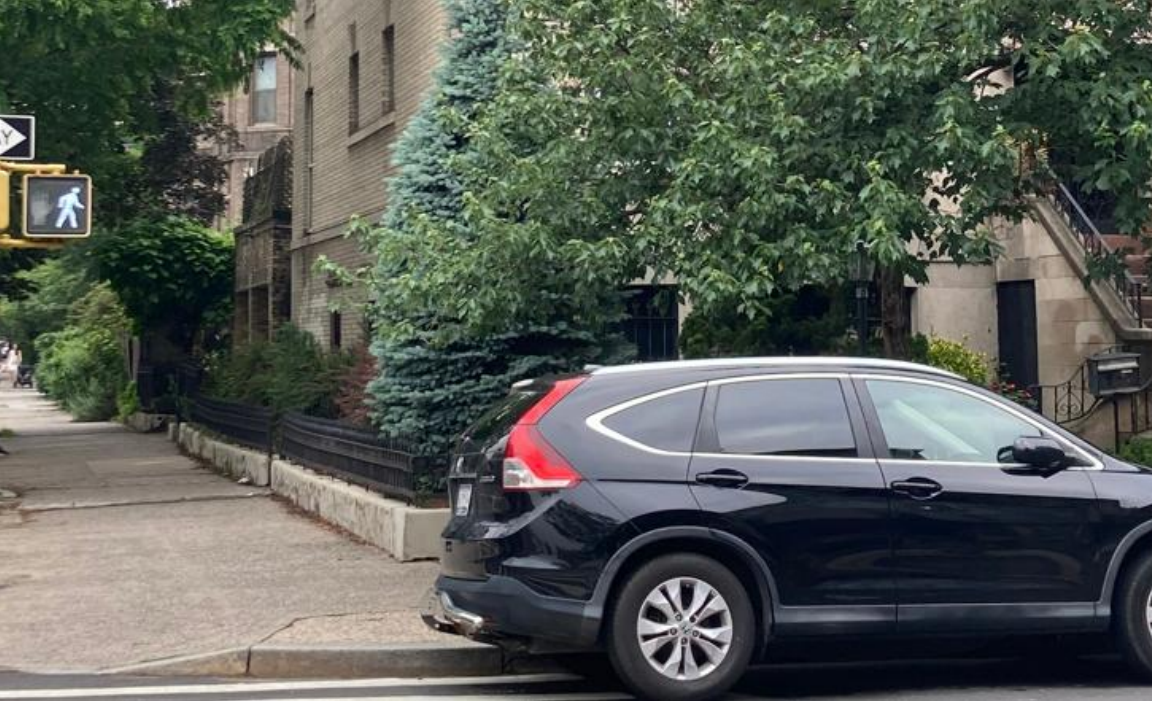
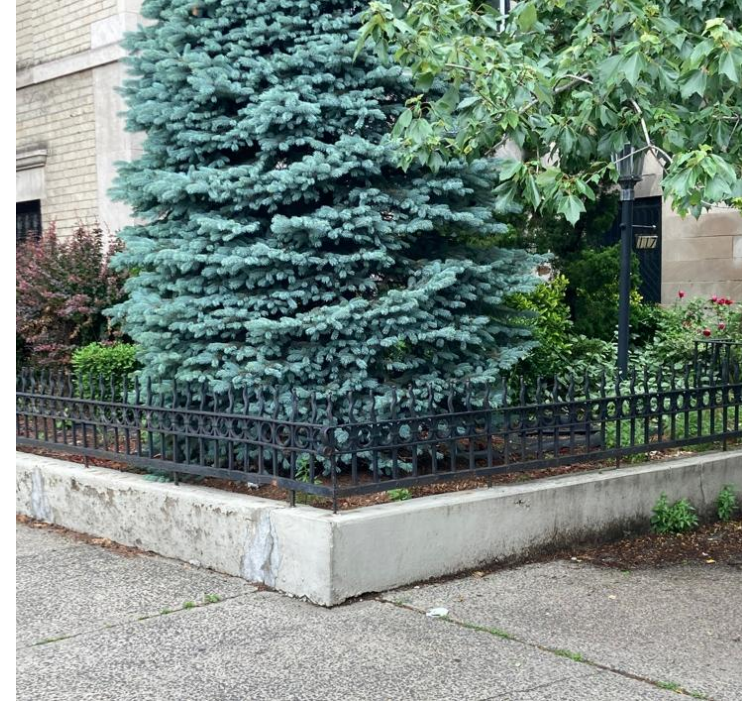
117 Rutland Road at Bedford Avenue – NE corner

Across Rutland Road from 118 Rutland Road: Type E – Painted curb, newer fence without detail

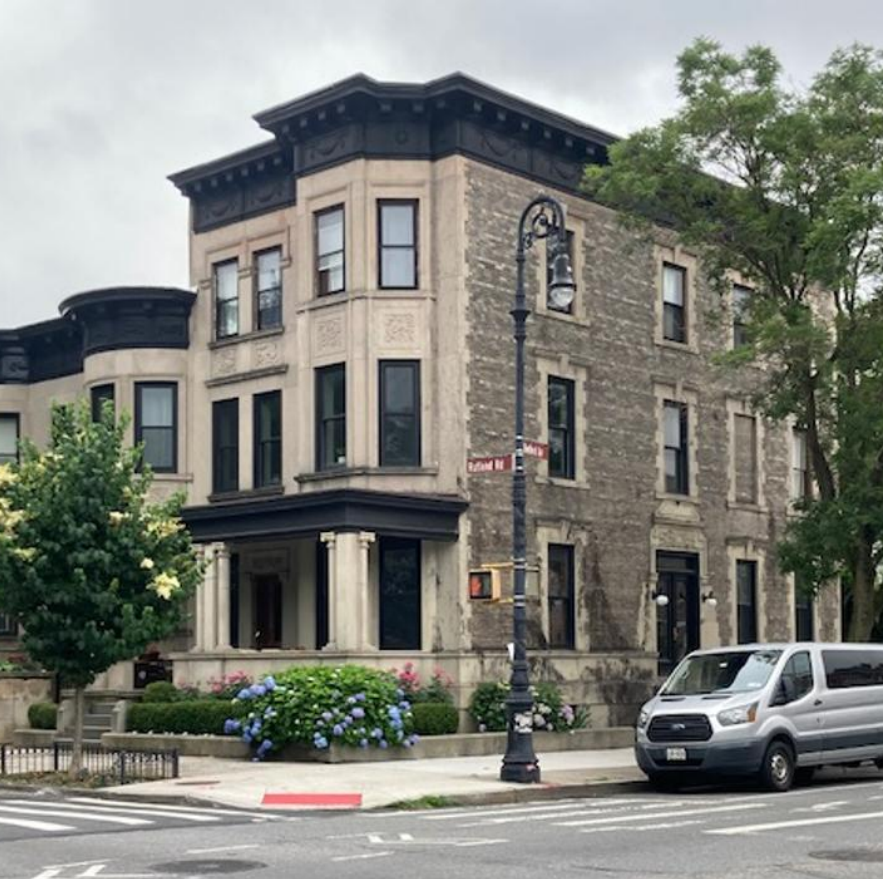
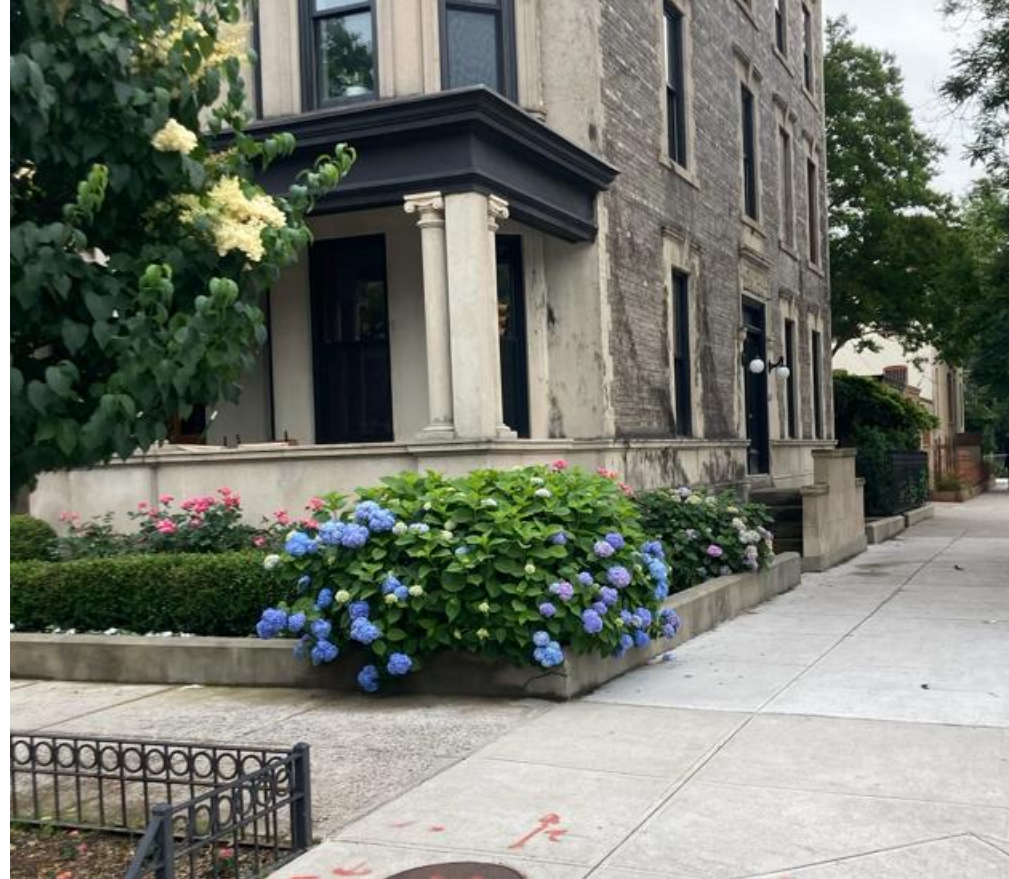
118 Rutland Road at Bedford Avenue – SE corner

Subject property: Repaired and refinished curb, stair, and wall

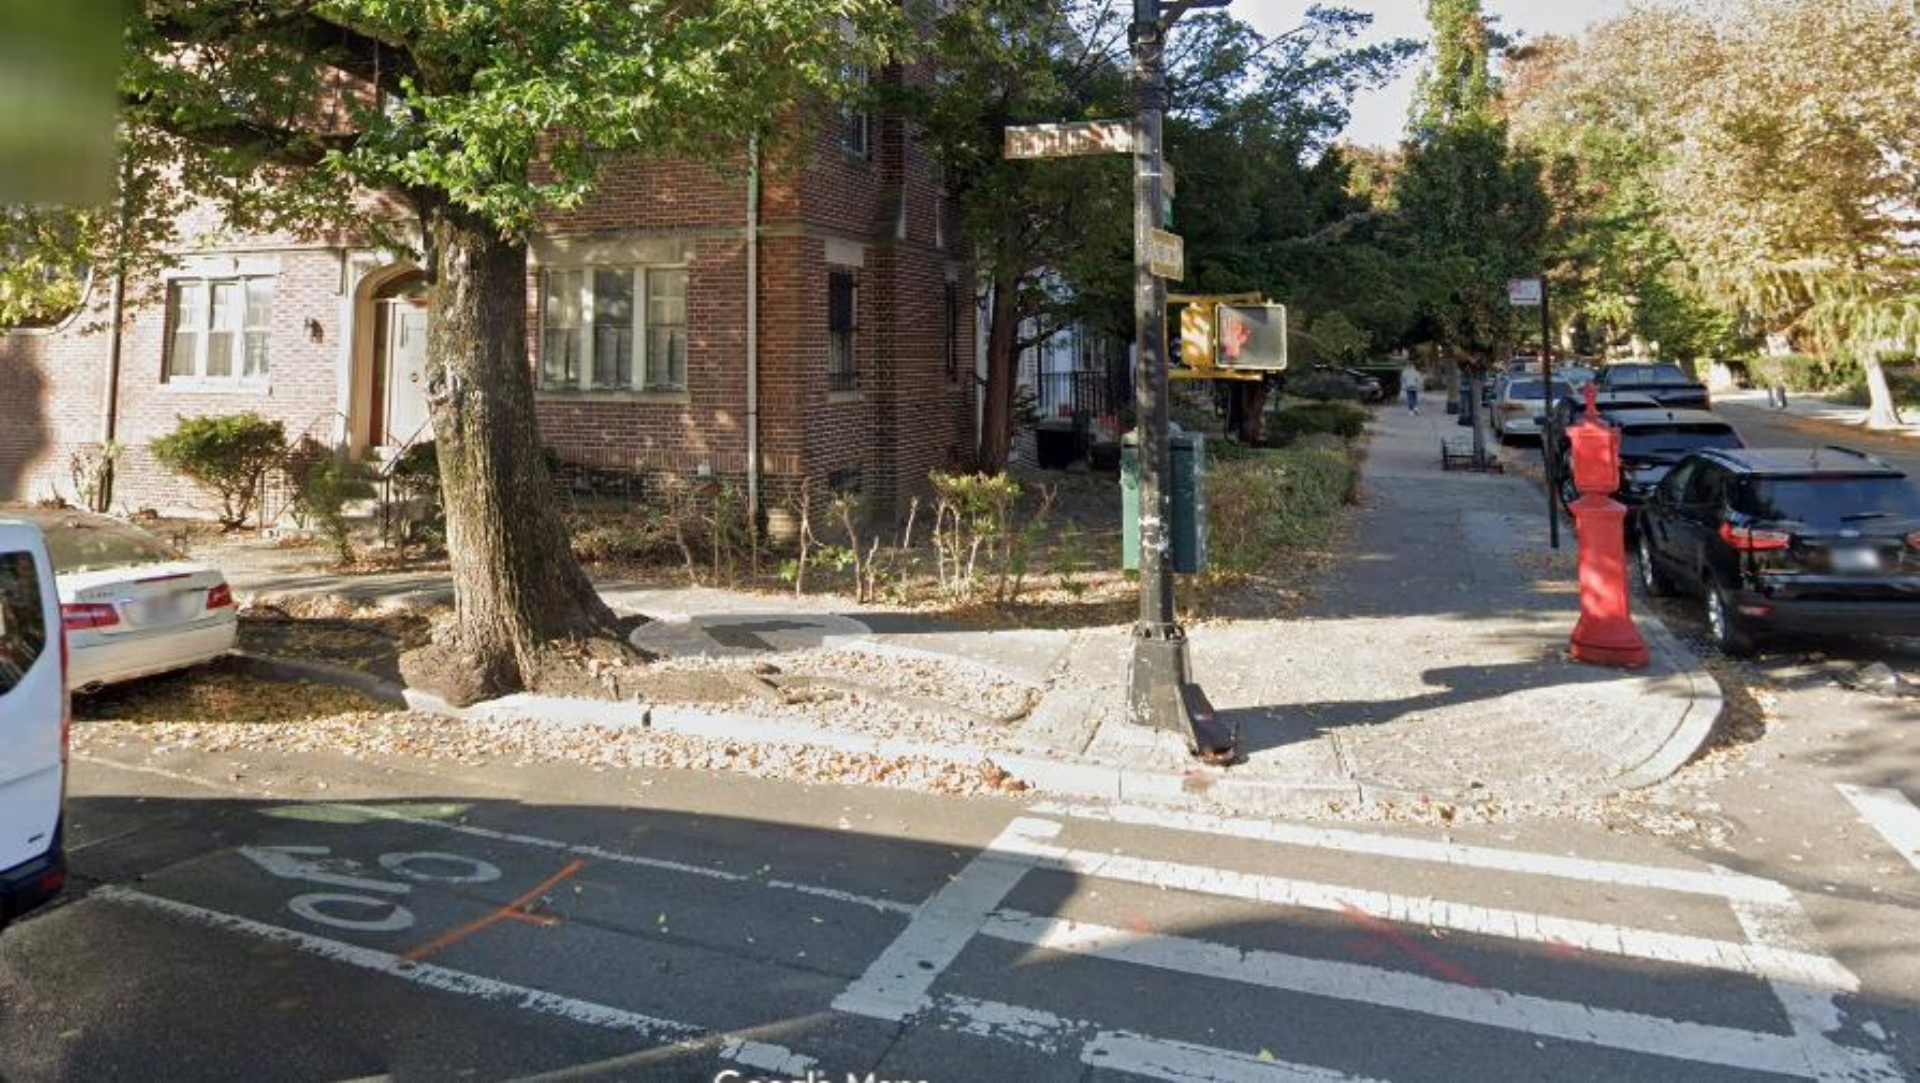
116 Midwood Street at Bedford Avenue – SW corner

One block north on Bedford Avenue: Type A – No fence and no curb

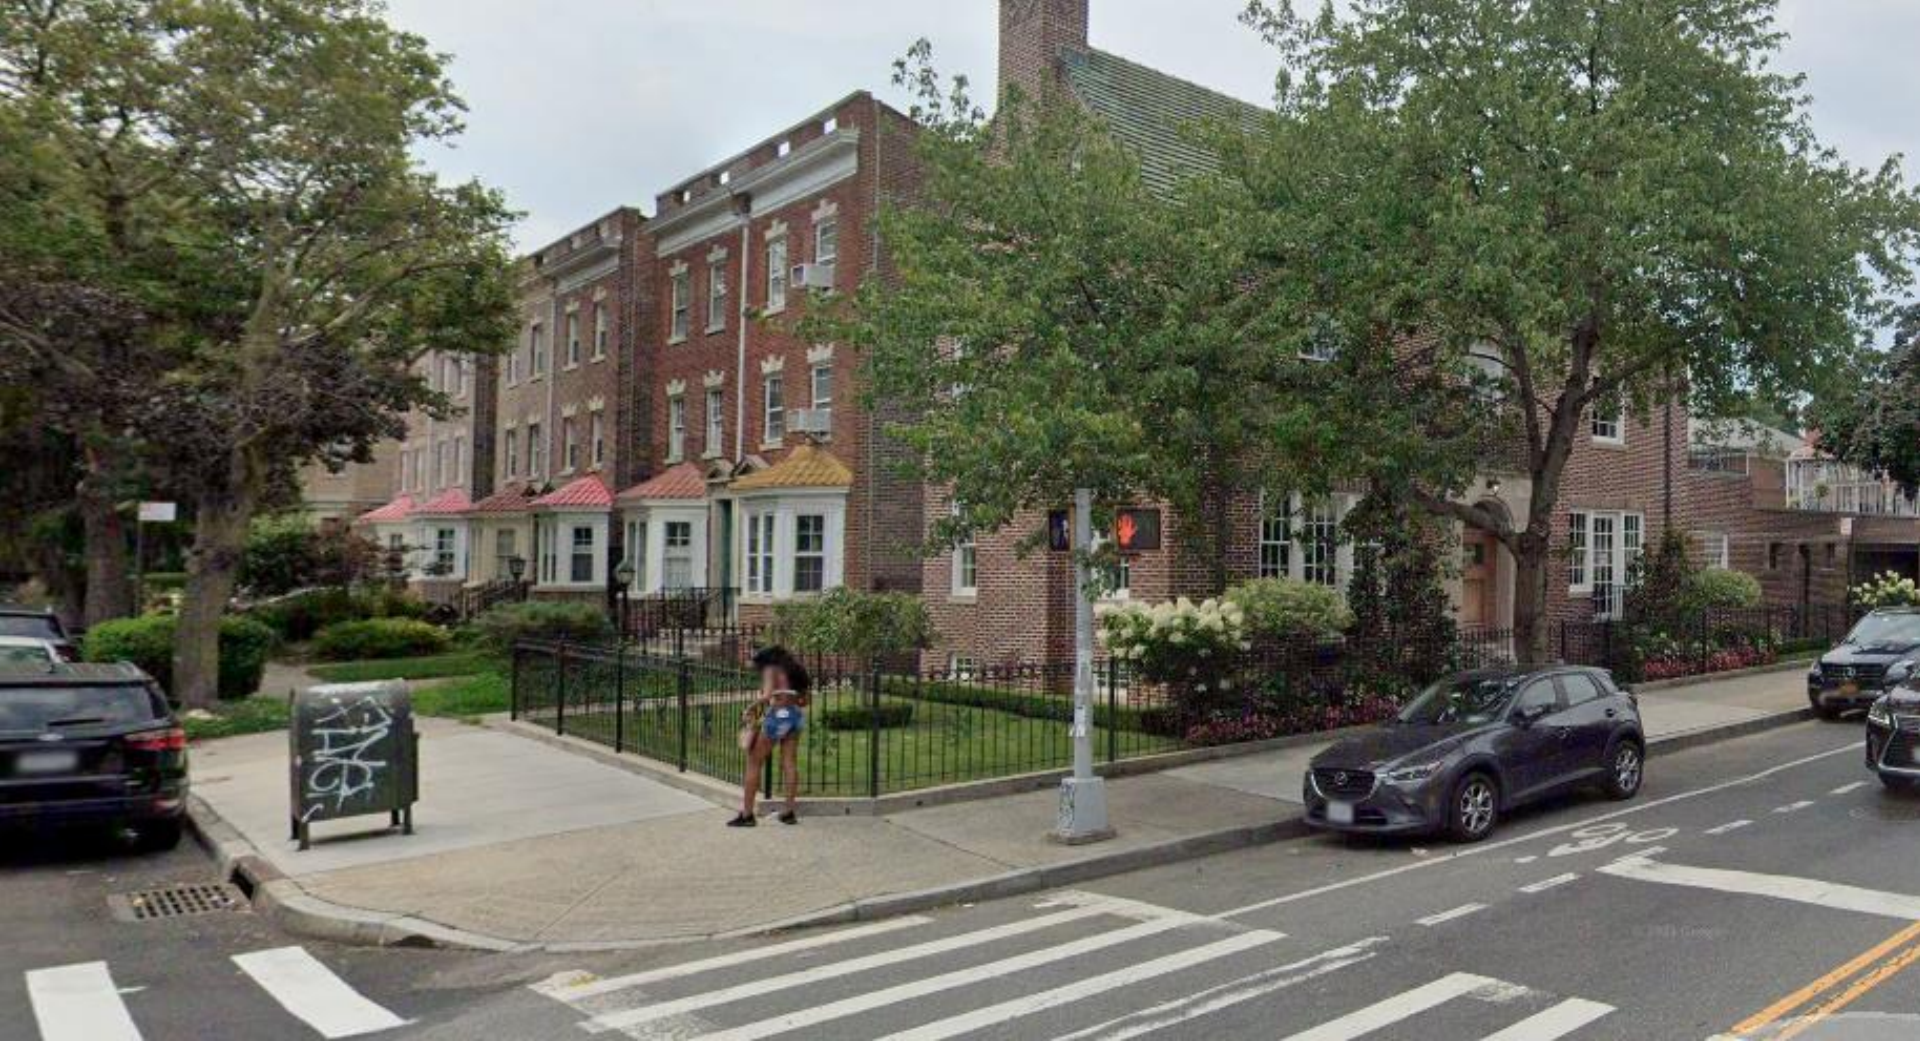
115 Midwood Street at Bedford Avenue – NE corner

One block north on Bedford Avenue: Type D – Newer high fence on low curb

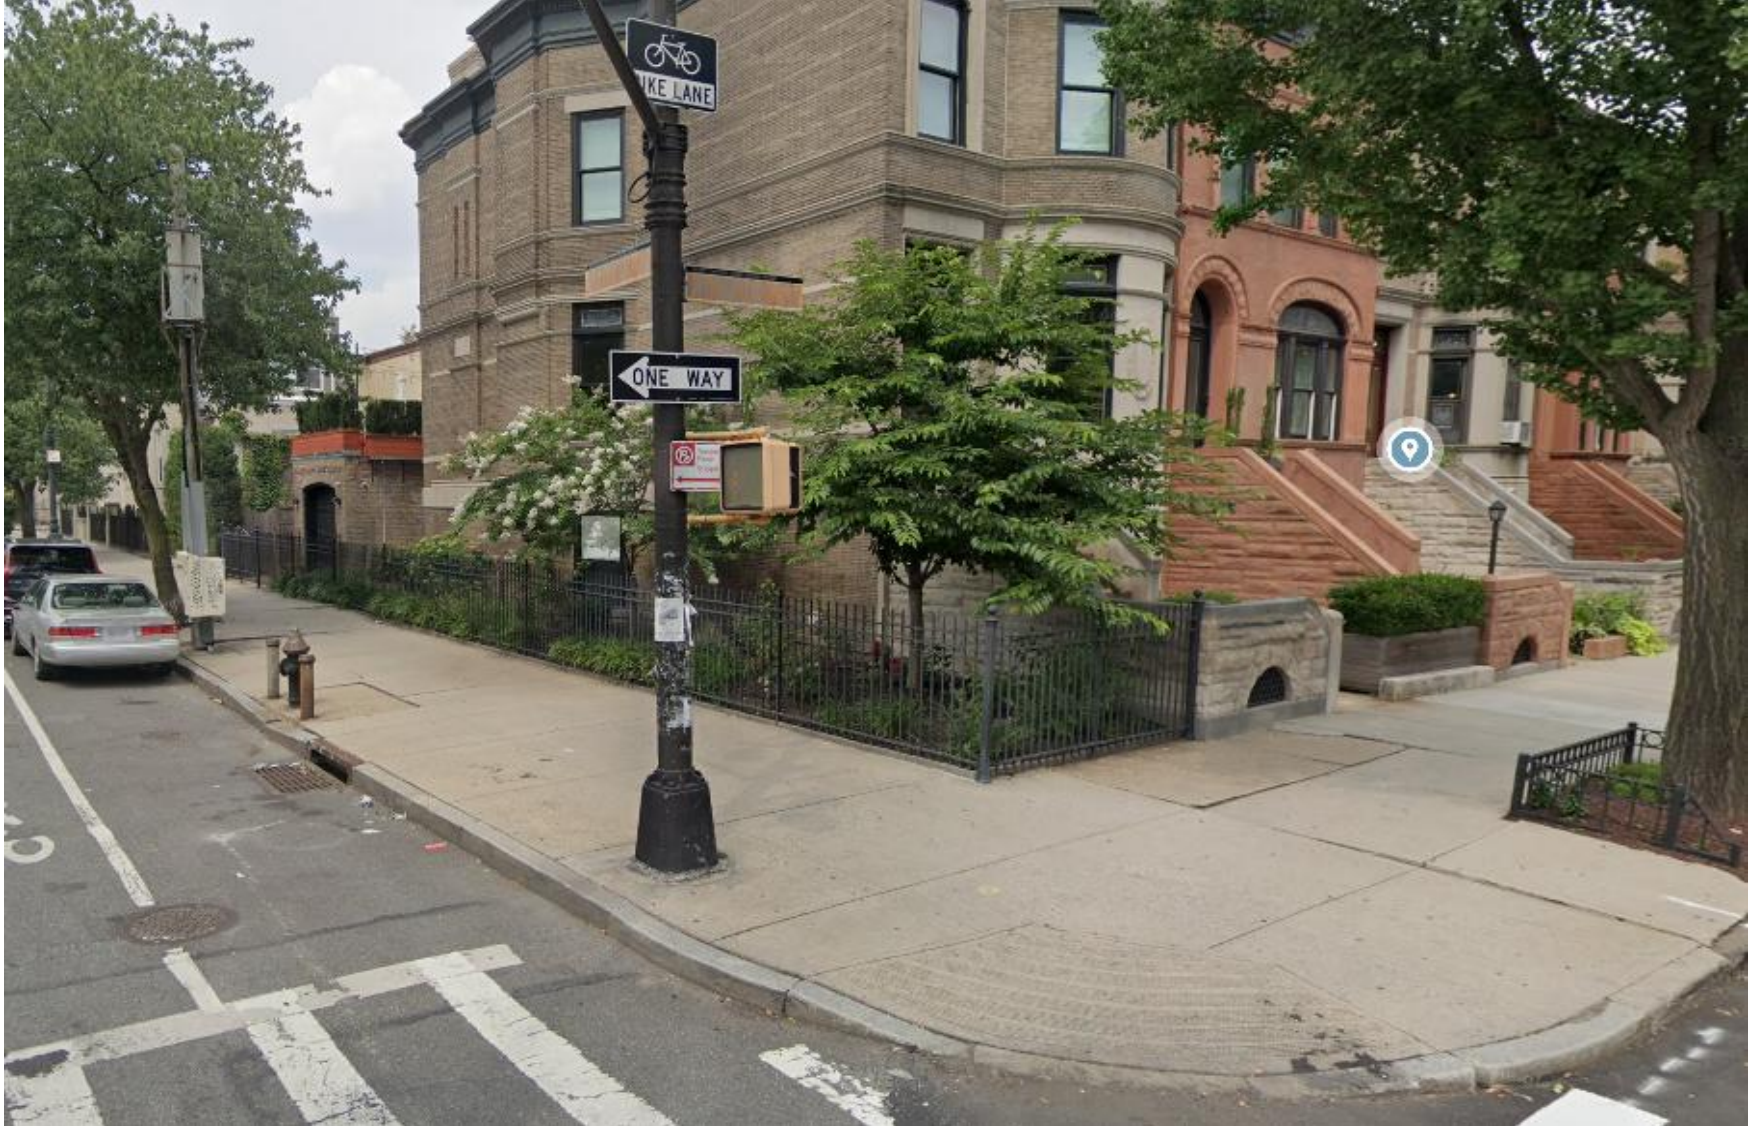
117 Midwood Street at Bedford Avenue – NE corner

One block north on Bedford Avenue: Type D – Newer high fence at side yard

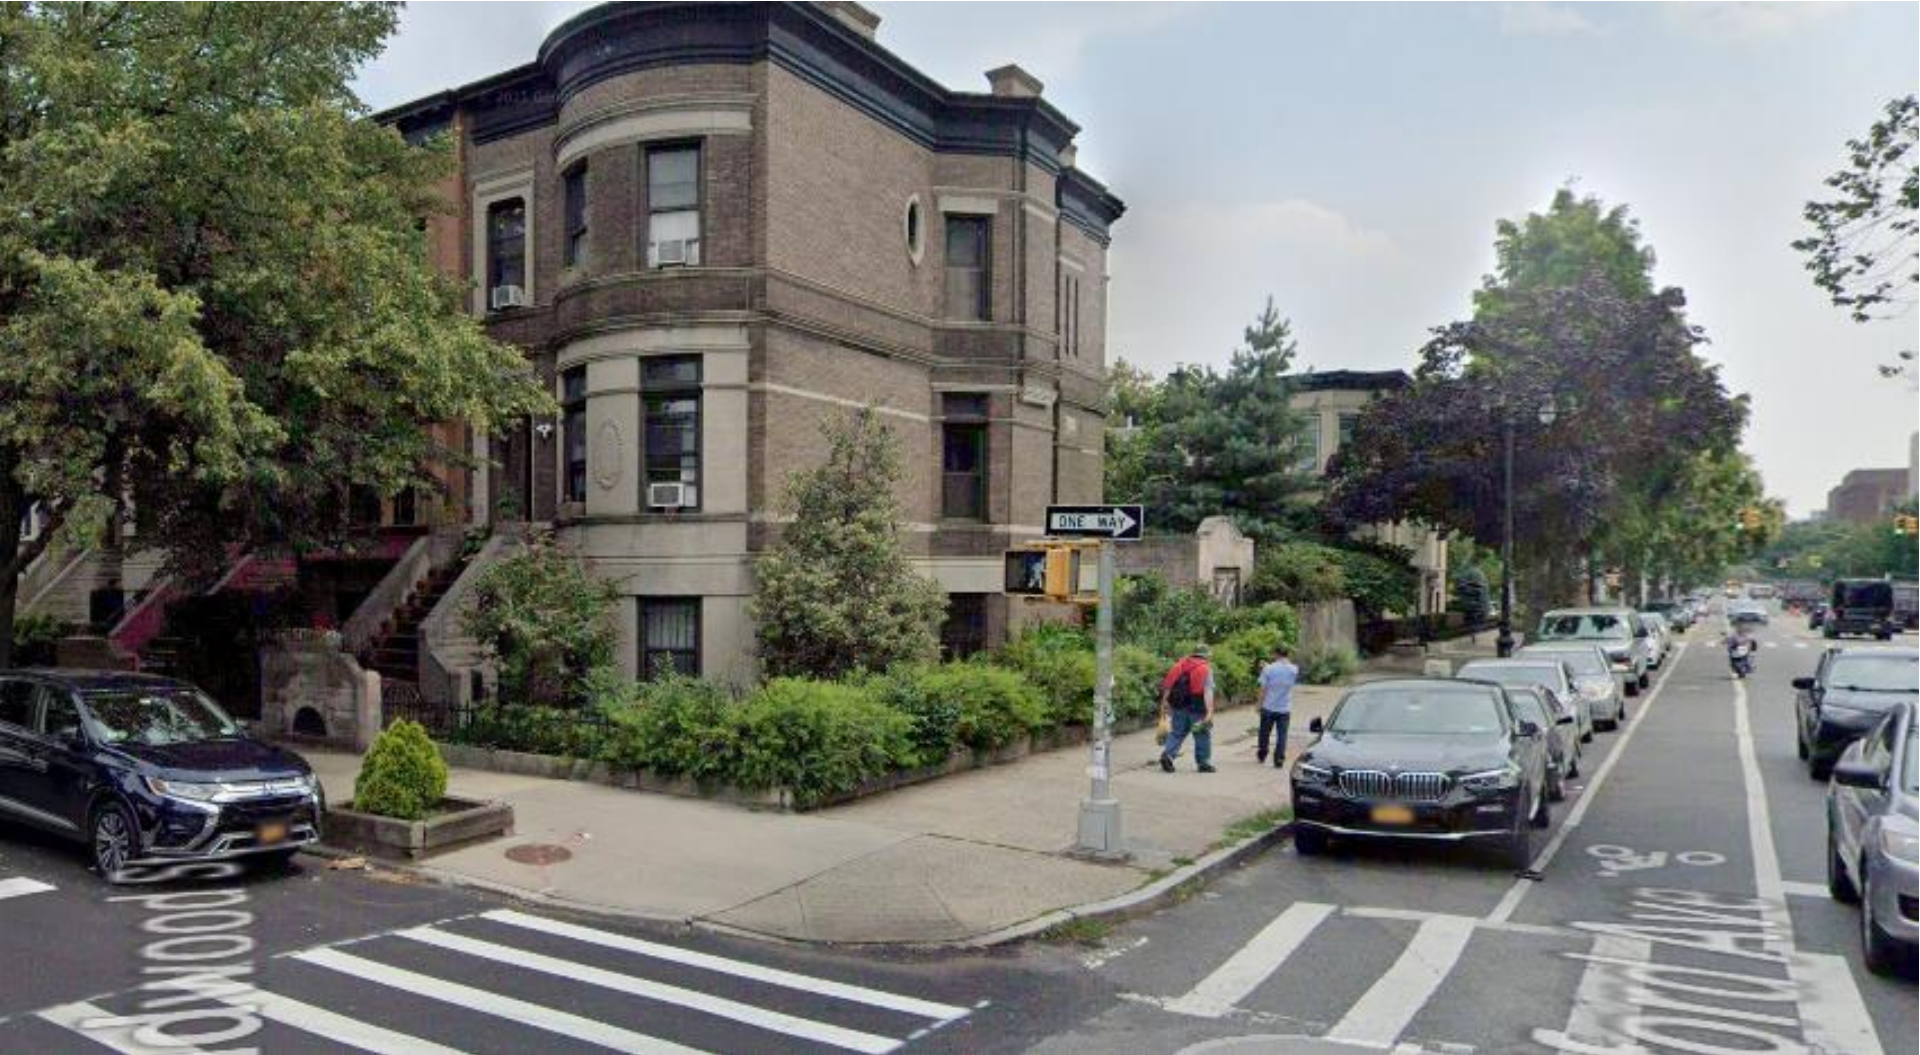
118 Midwood Street at Bedford Avenue – S corner

One block north on Bedford Avenue: Type E – Fence on curb

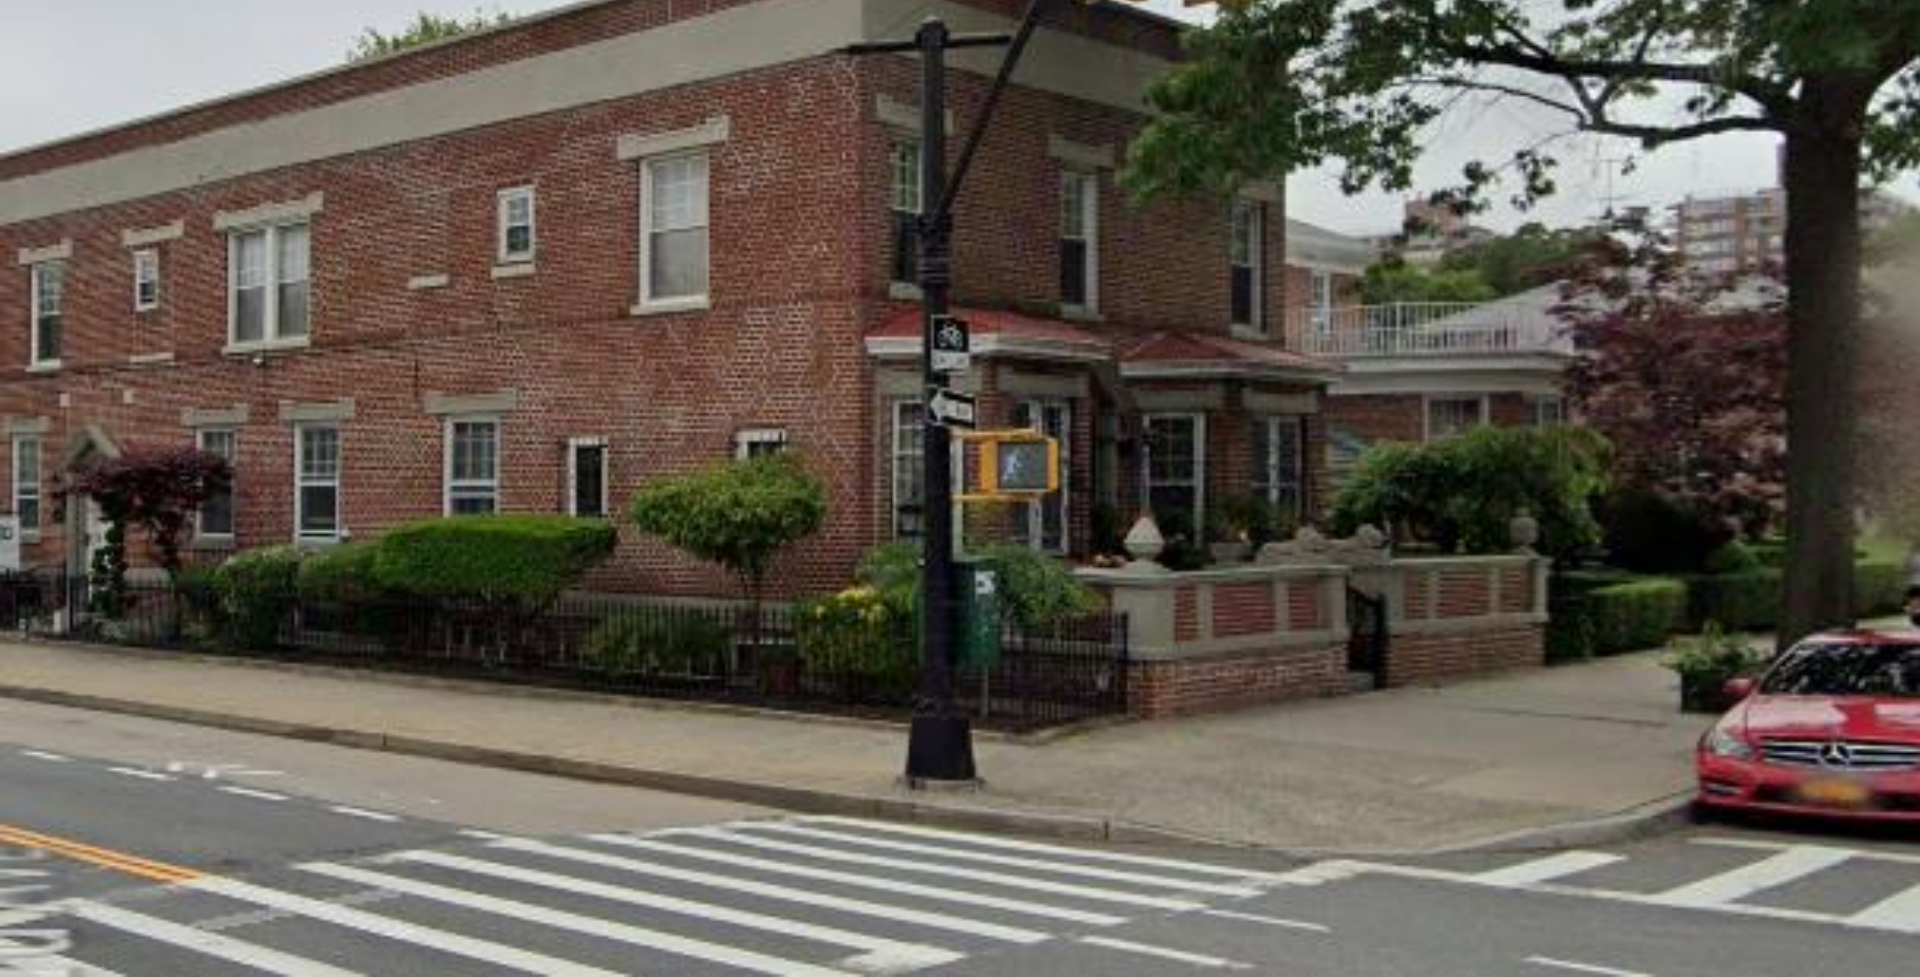
114 Maple Street at Bedford Avenue – SW corner

Two blocks north on Bedford Avenue: Type F – Mixed side yard with high fence & front with wall

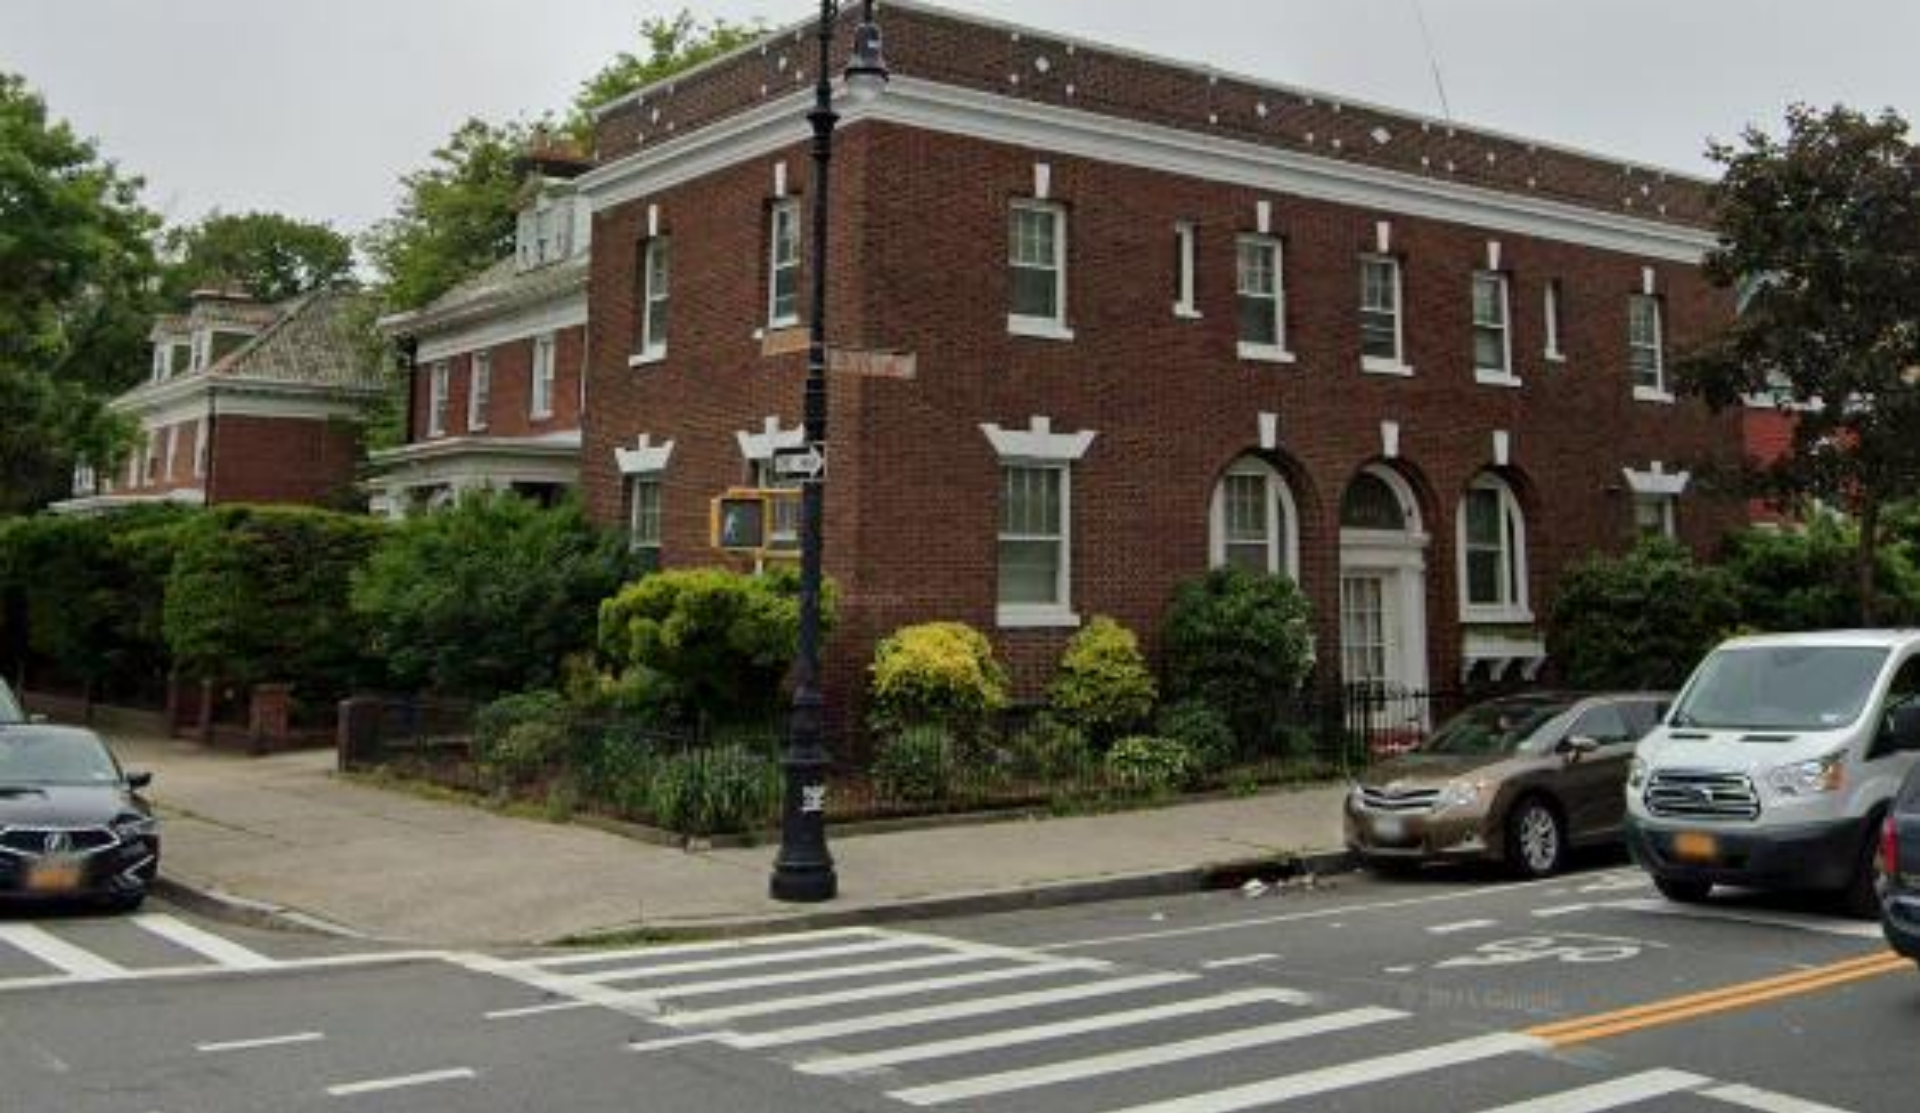
A-32

111 Maple Street at Bedford Avenue – NW corner

Two blocks north on Bedford Avenue: Type D – Front / side yard with fence on low curb

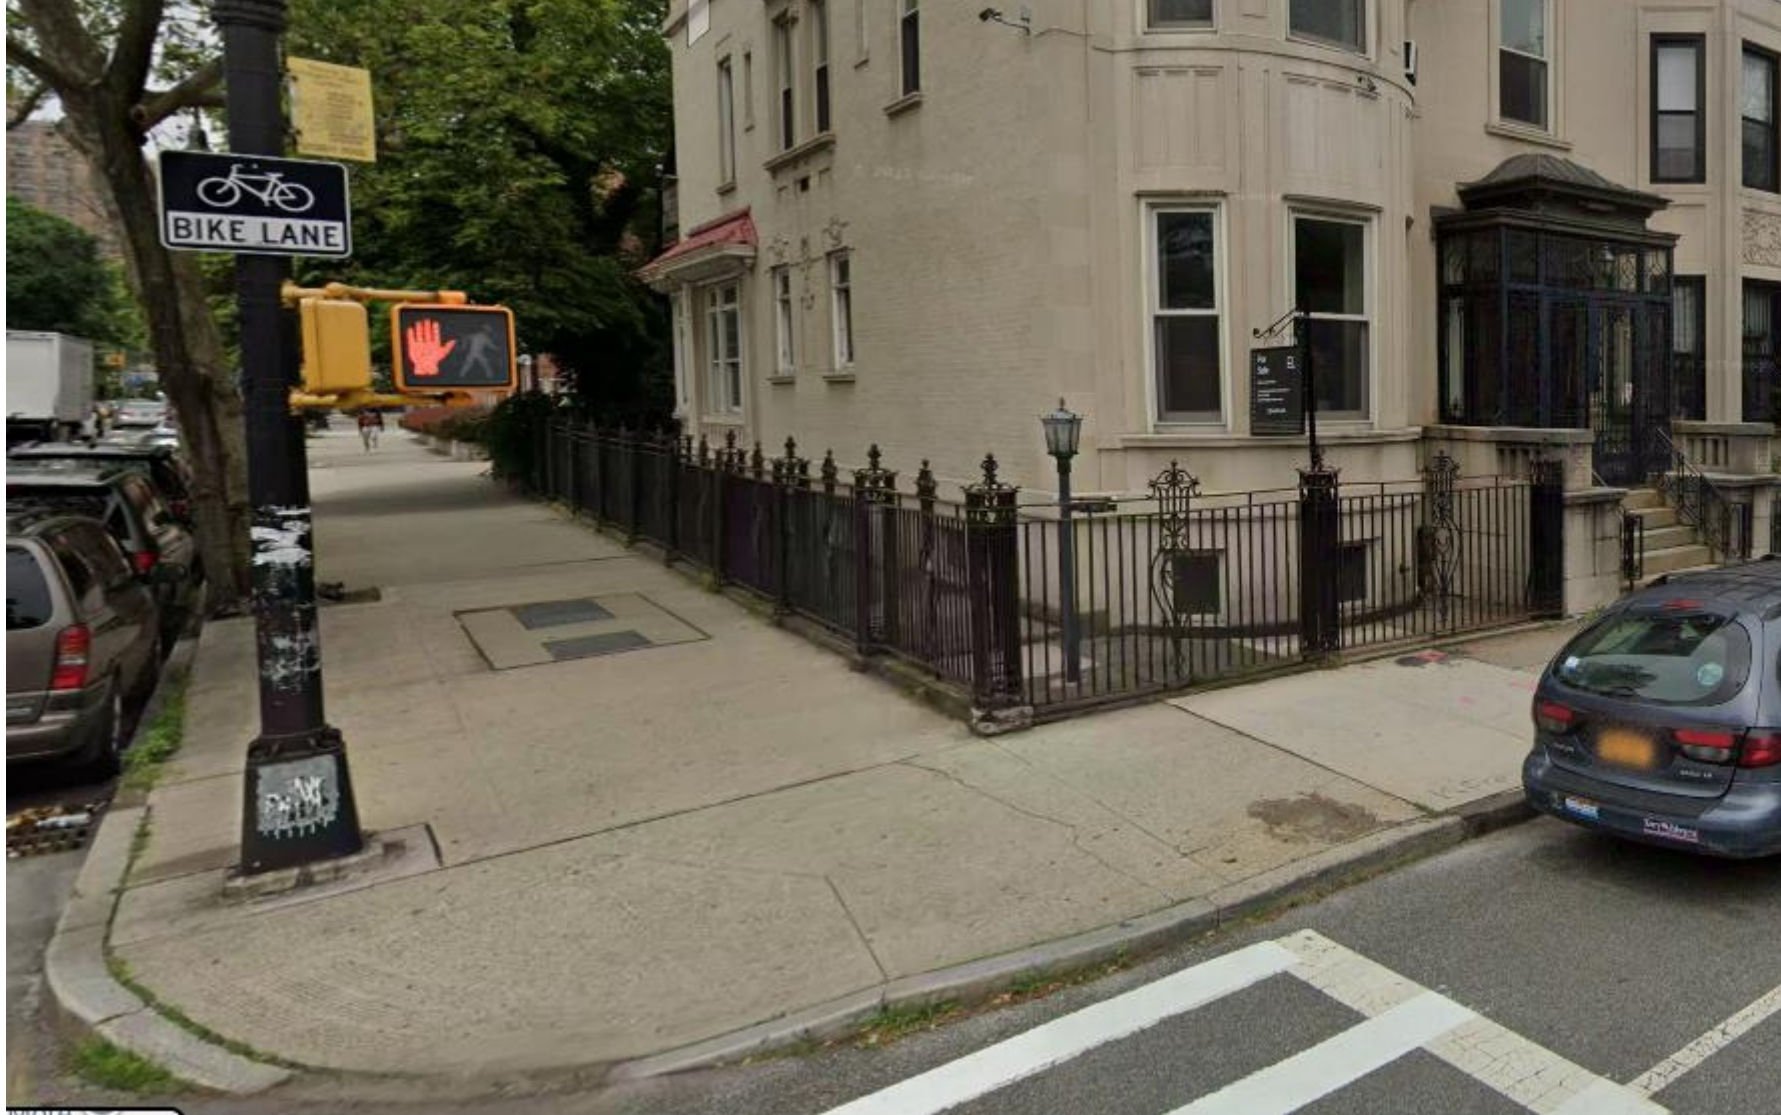
A-33

125 Maple Street at Bedford Avenue – NE corner

Two blocks north on Bedford Avenue: Type D – Ornate high fence on low curb
